**Pacific Northwest
National Laboratory**

Radiochemical Processing Laboratory High-Level Vault Characterization Report

October 2007

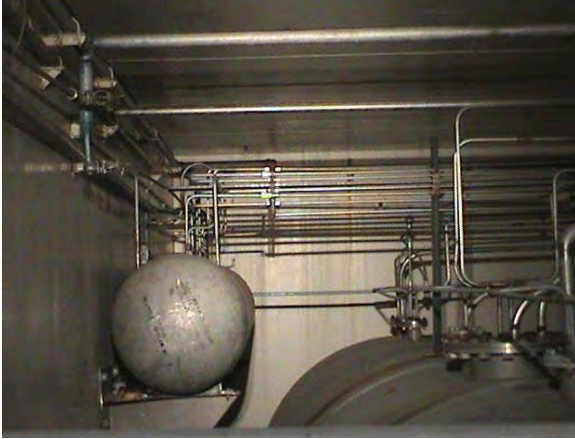
Illustration 41: A-Vault - Tank W-4

Tank WT-1 is supported on three cradles, one at the middle of the tank and one near each end. These cradles support the tank approximately 18” above the floor of the vault. Tank W4 is supported on brackets mounted to the wall well above the floor of the vault. Tank W4 is visible end-on in the overview camera view below and the top portion of tank WT-1 is visible in the lower right of the image. An ROV-eye view from floor level directly beneath this location is also shown. The tank supports are visible in the right side of the image, as is a portion of tank WT-1, and tank W-4 is visible in the upper center of the image. Views of A-Vault are shown in illustrations 41 through 46.

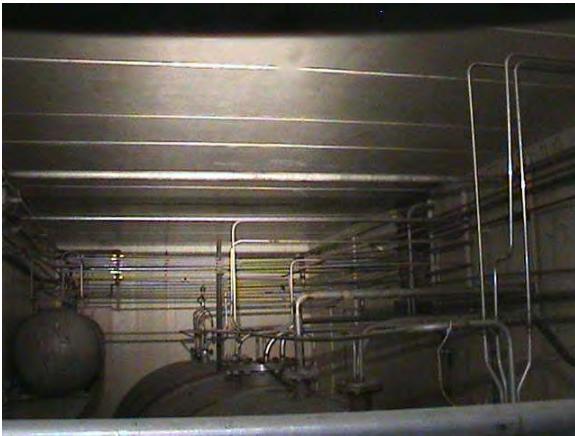
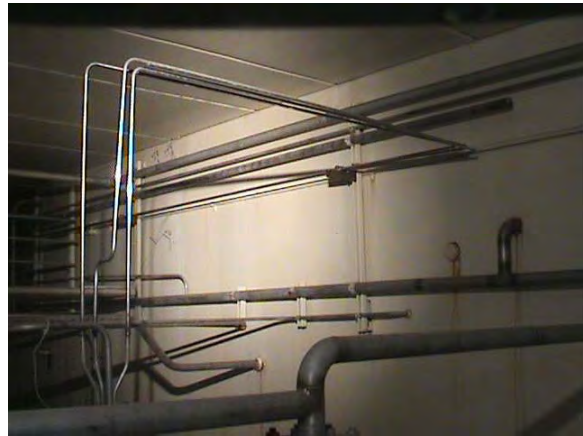
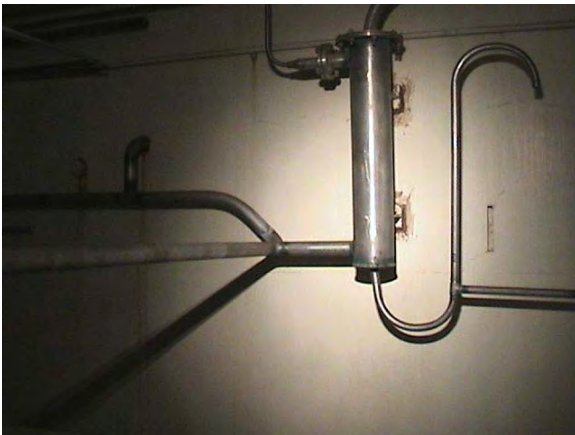
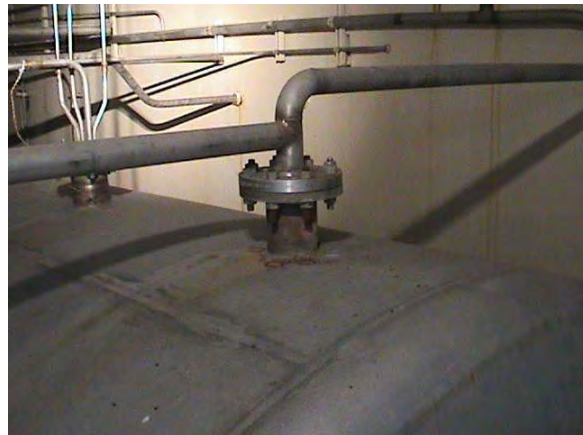
Illustration 43: A-Vault Piping

This vault is well populated with piping, some of which is visible above. Additional images of the piping above the tanks are shown below. The large size of this vault allowed the team to simplify the

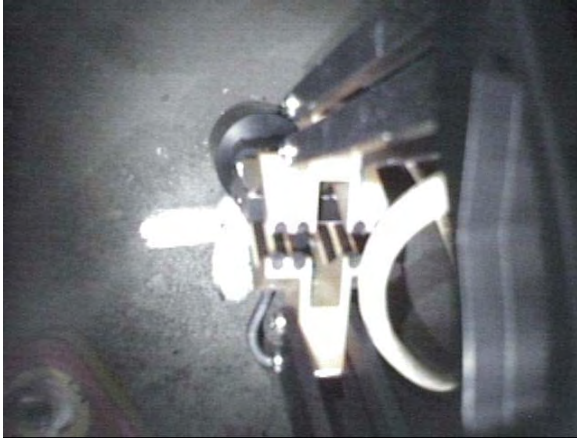
Illustration 51: A-Vault Sample 6

Sample #6 was taken at approximately 13:17 on the floor west of the large tank between the center and north supports near the trench. Dose rates of approximately 801 mR/hr were observed.

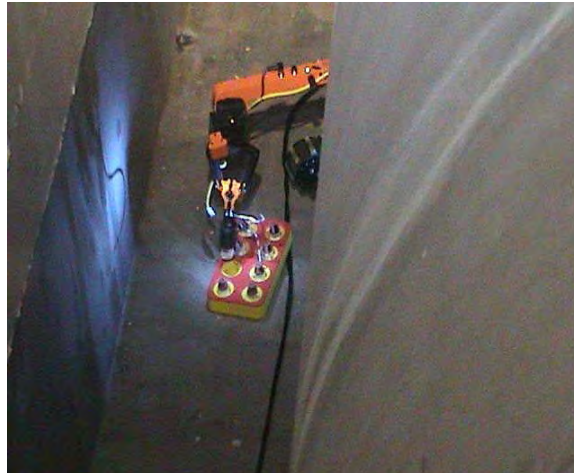
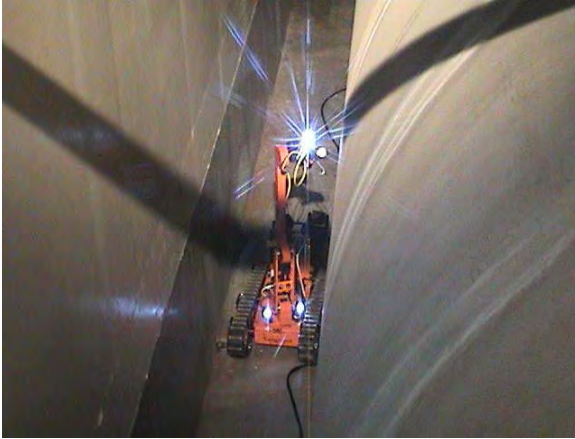
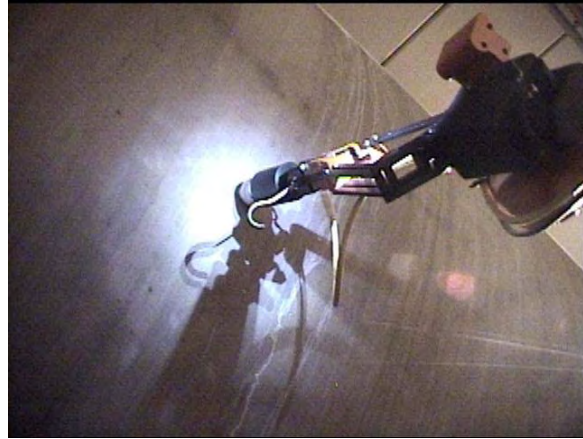
Illustration 53: Acquiring Seventh Sampler

The seventh smear sample, as shown in illustrations 53 through 55, was taken from the East side of WT-1 a short distance north of the center support with the arm extended upward as far as it would reach.

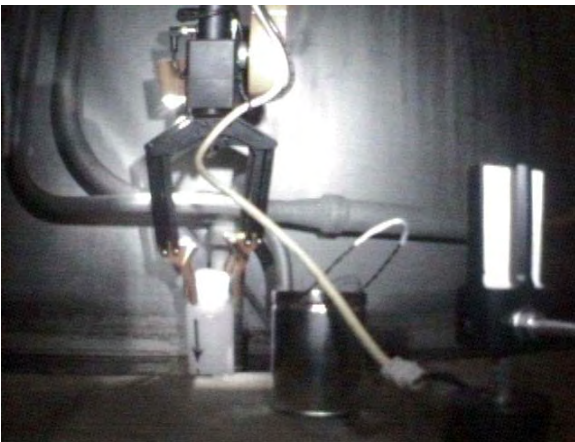
Illustration 56: A-Vault Sump Sampling

The eighth sample was taken on the North wall approximately centered in the East-to-West direction and about 12" below the liner top. Once this sample was taken, work concluded for the day. The next day (August 17th), work began with the extraction of the sample tray and insertion of a liquid sample bottle shown in illustration 56. The ROV transported the sample bottle to the sump and extracted a sample.

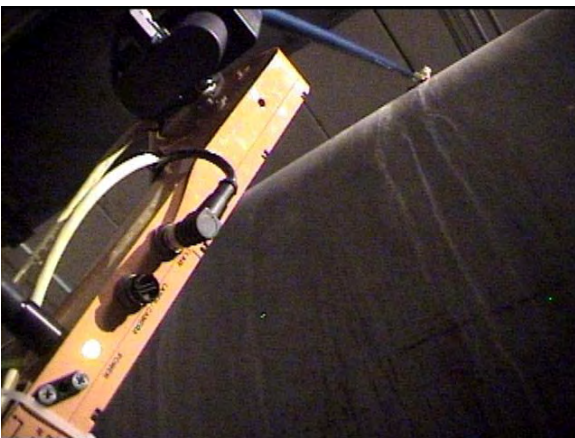
Illustration 57: Pole Tool from ROV

Little particulate was observed in this vault, so no solid debris sample was collected. There was interest, however, in tank W4, which was out of reach of the hand held pole tools. A handle designed to mate with the gripper was fabricated and attached to a section of pole. A dosimeter holder and dosimeter was attached to the other end, and the resulting tool lowered to the ROV, which grasped the handle in its gripper. The ROV carried this tool to the far end of the vault and used it to sample the W4 tank.

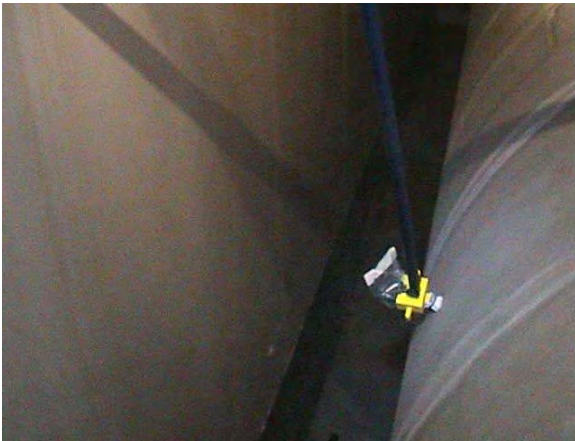
Illustration 61: Sampling on WT-1

Once vehicle sampling was completed, samples were taken using handheld pole tools, as shown in illustrations 57 through 63.

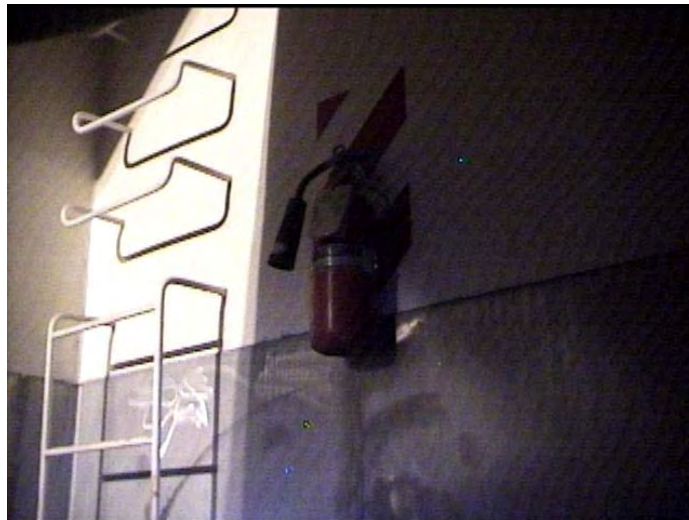
Illustration 66: Fire Extinguisher

Another item of interest in the vault is a fire extinguisher hanging on the wall just west of the caricature, illustrations 66.

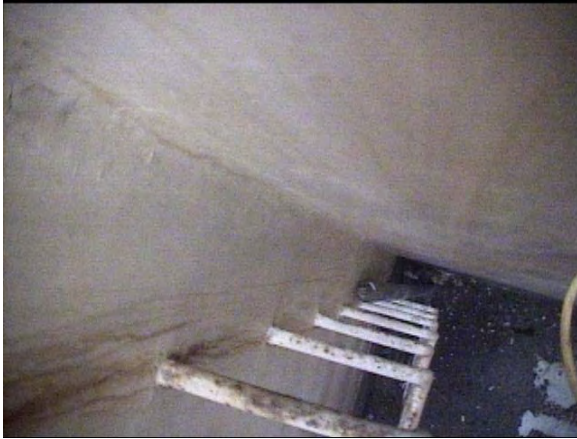
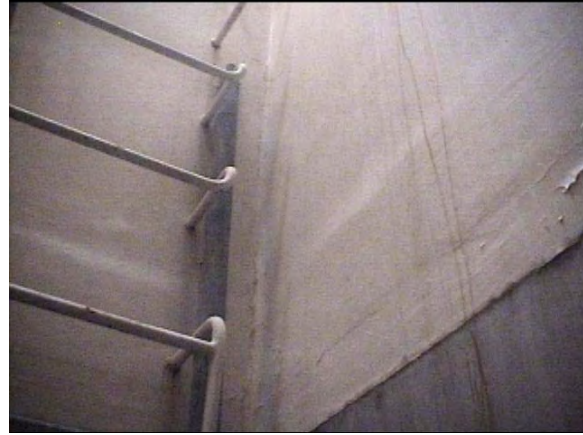
Another item remaining in the vault is a section of twist-lock scaffold tube, which can be seen in the illustrations 67 and 68.

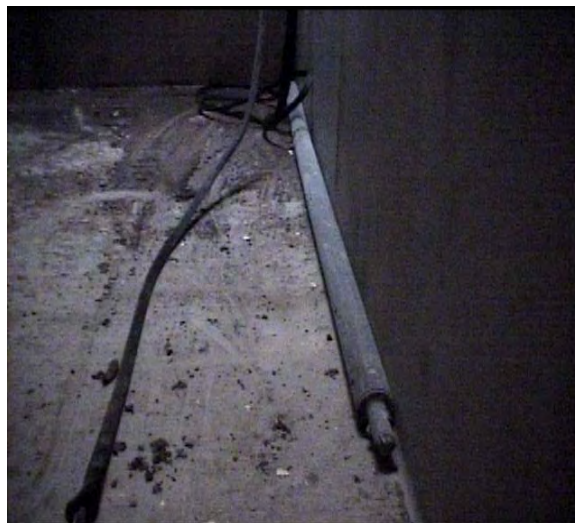
Illustration 69: Scaffold Tube on Floor

During the deployment (while preparing for tank W-4 sampling), a piece of scaffold pipe, illustration 69, was dislocated by the ROV tether strain relief when the ROV turned tightly at the base of the ladder at the North end of the vault.

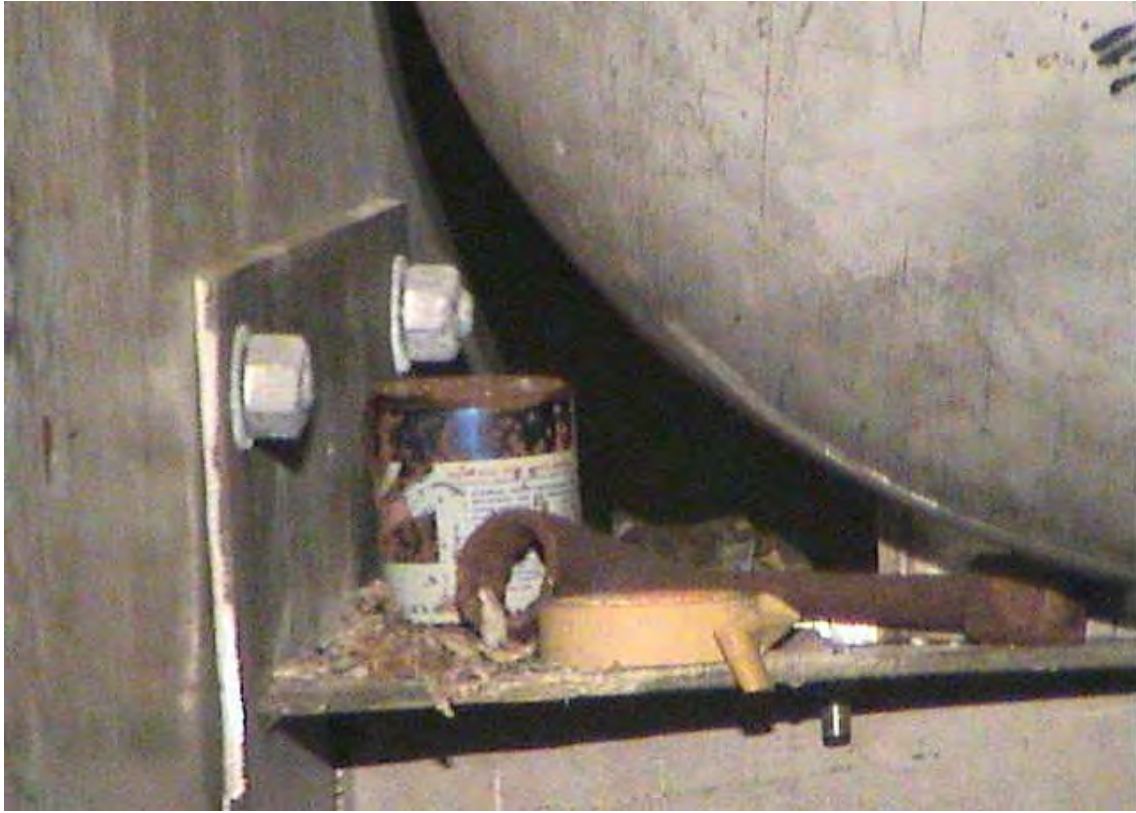
Illustration 70: Never-Seez on W4 Bracket

The final item of interest is a can of Never-Seez, a wrench and a roll of tape on the bracket supporting tank W-4. These items are shown in illustration 70.
