ORNL/TM-2007/033

**Assessment of Cavitation-Erosion Resistance of Potential
Pump Impeller Materials for Mercury Service at the
Spallation Neutron Source**

Materials Science and Technology Division

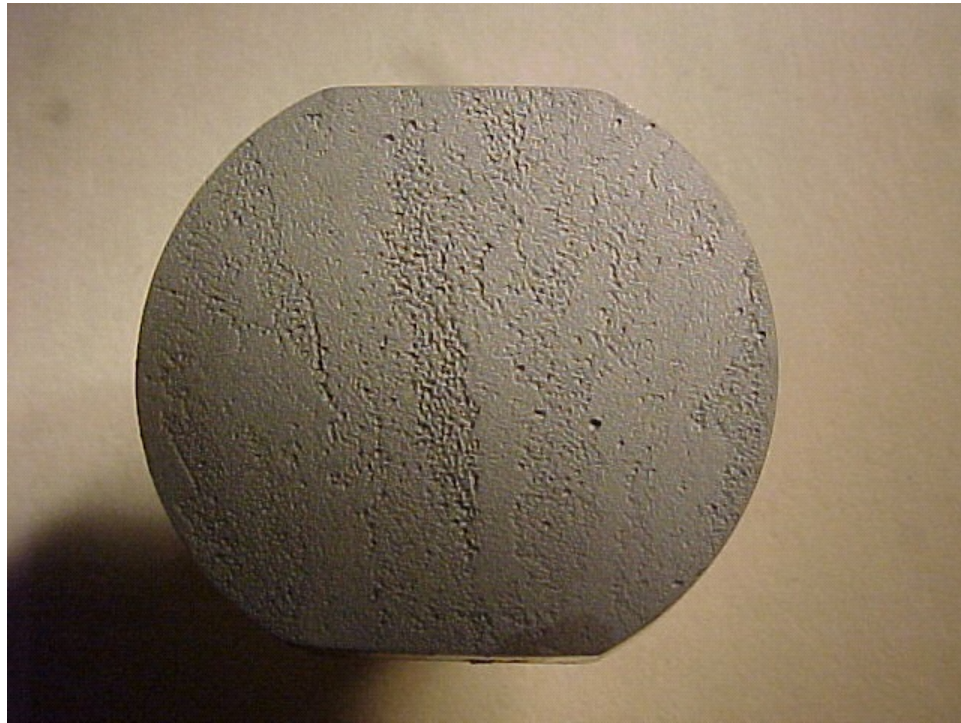
Fig. 2. Test surface of an untreated CF8M test button (actual diameter = 16 mm) following 6 h sonication (2 mm depth) in mercury. Surface relief appears related to grain orientation.

Figure 2 is a macrograph of the untreated CF8M test surface following 6 h sonication (2 mm depth) in mercury. Considerable surface relief and a few pits/craters are obvious, but note that the surface relief is not uniform across the specimen surface but rather seems to be sensitive to the particular grain orientation exposed to the test surface. Using the microscope to estimate relative surface profile indicated some areas (whole grains) revealed as little as 35-40 µm of profile following 6 h exposure, but

adjacent grains exhibited as much as 100 μm of profile and individual pits 150 μm or more deep.

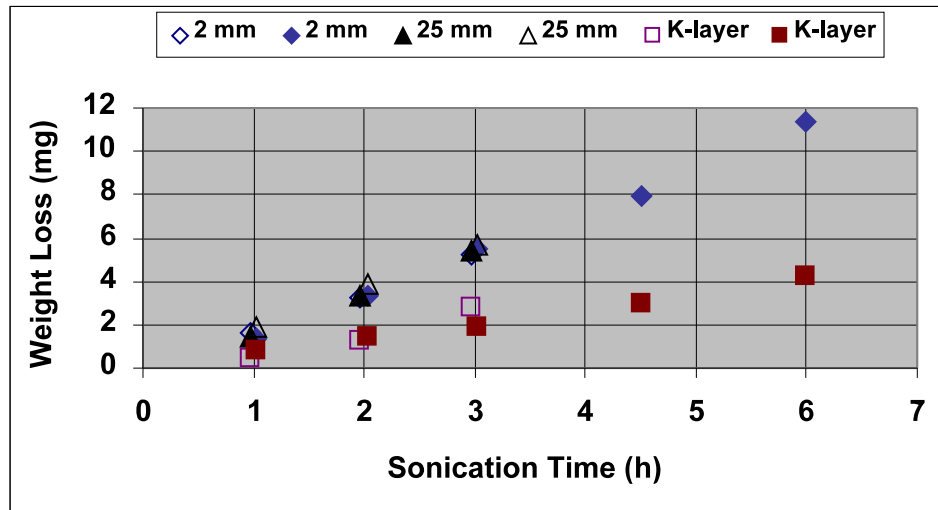
Fig. 5. Weight loss as a function of sonication time in mercury for untreated specimens (2 mm and 25 mm immersion depth) and treated specimens (2 mm immersion depth) of as-cast CD3MWCuN. "K-layer" indicates specimens treated with the Kolsterisation® process. Note that data points are sufficiently close together that several are at least partially obscured.

Figure 5 summarizes the cavitation-erosion data gathered for CD3MWCuN during this evaluation. The data reveals that the performance of the untreated specimens, whether immersed 2 mm or 25 mm in mercury, is indistinguishable (also noted in Table 2), and the slope of the weight loss curves for the untreated materials is essentially constant at about 2.0 mg/h, even to the extended exposure time of 6 h for one untreated specimen. Figure 6 shows the untreated test specimen surface following the 6 h exposure – note the relatively smooth and pit-free surface. Post-test metallography of this specimen confirmed only a very modest roughness of up to 15 μm, and that the ferrite and austenite phases were similarly eroded (that is, neither was attacked preferentially).

Following the incubation period, the slope of the weight loss curves for the treated specimens (Fig. 5) is approximately constant at 0.7 mg/h, or about a third the value of the untreated specimen. As noted previously, this value is similar to that observed for 316LN wrought material and several other successfully treated specimens.

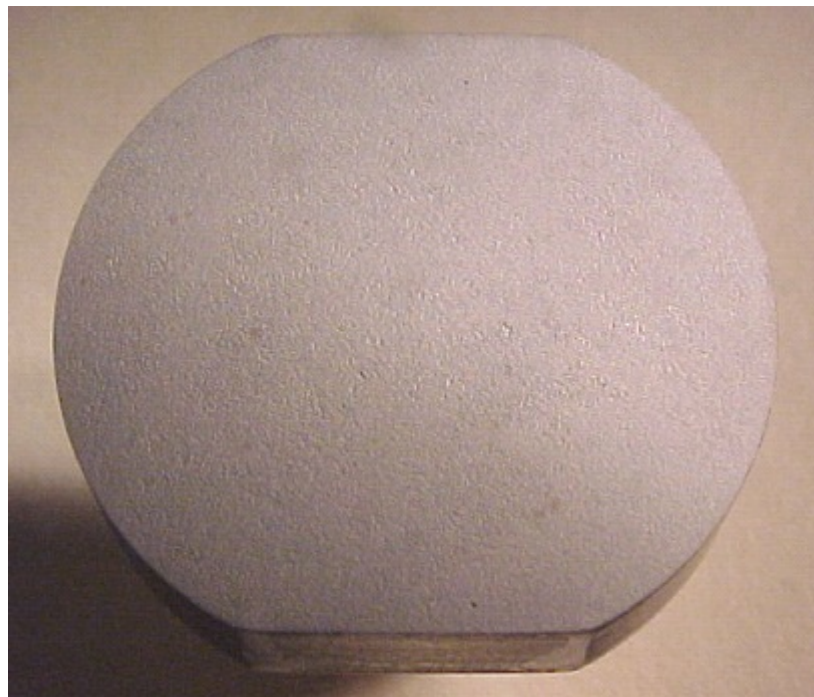
Fig. 6. As-received CD3MWCuN specimen (actual diameter = 16 mm) following sonication for 6 h (2 mm depth) in Hg. Note the relatively smooth and pit-free surface.

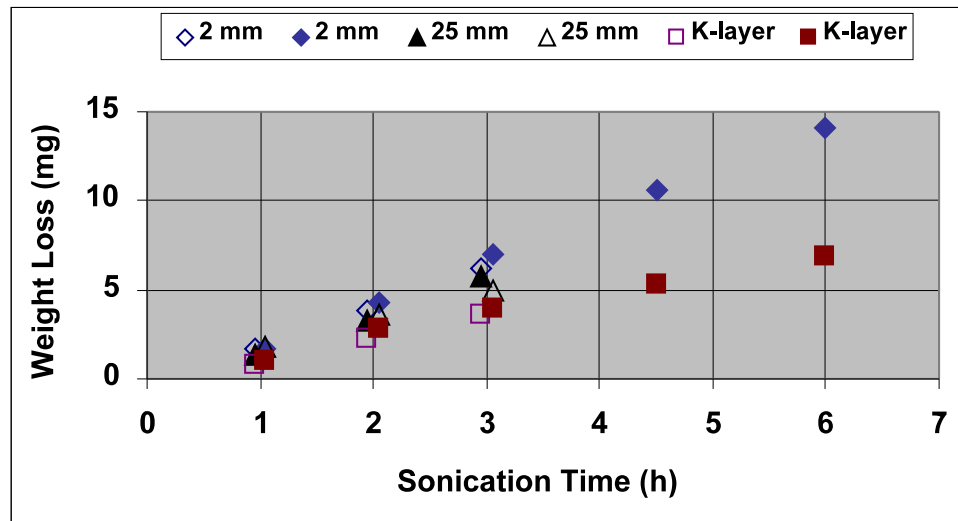
Fig. 9. Weight loss as a function of sonication time in mercury for untreated specimens (2 mm and 25 mm immersion depth) and treated specimens (2 mm immersion depth) of as-cast CA-15. “K-layer” indicates specimens treated with the Kolsterisation® process. Note that data points are sufficiently close together that several are at least partially obscured.

Figure 9 shows the weight loss data as a function of sonication time for the CA-15 specimens. Although there was more scatter in the data for CA-15 than several other materials, it is apparent that the weight loss rate was somewhat greater for the 2 mm depth test condition (~2.5 mg/h) than for the 25 mm depth test condition (~1.9 mg/h).

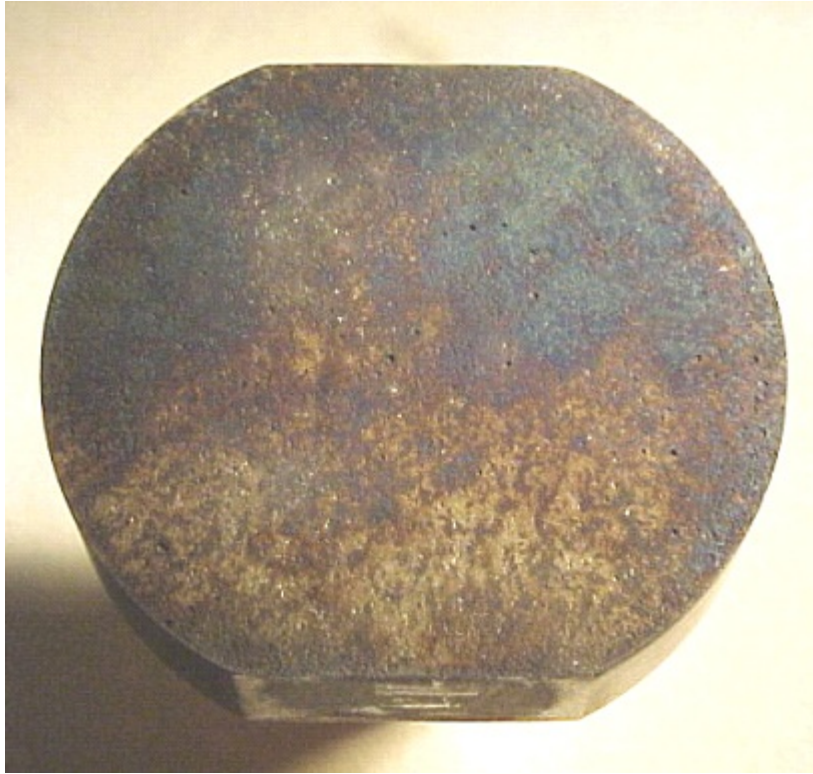
Fig. 10. As-received/untreated CA-15 specimen (actual diameter = 16 mm) following sonication for 6 h (2 mm depth) in mercury. Note significant discoloration and pits scattered across the surface.

Figure 10 is a macrograph of the CA-15 test specimen sonicated 6 h in mercury at the 2 mm immersion depth. Compared to the other “stainless” alloys in this investigation, the CA-15 specimens were significantly discolored following exposure, but the aqueous cleaning procedure contributes somewhat to this behavior. The test surface reveals a general roughening and a number of modest pits generally in the range of 75-100 μm deep.

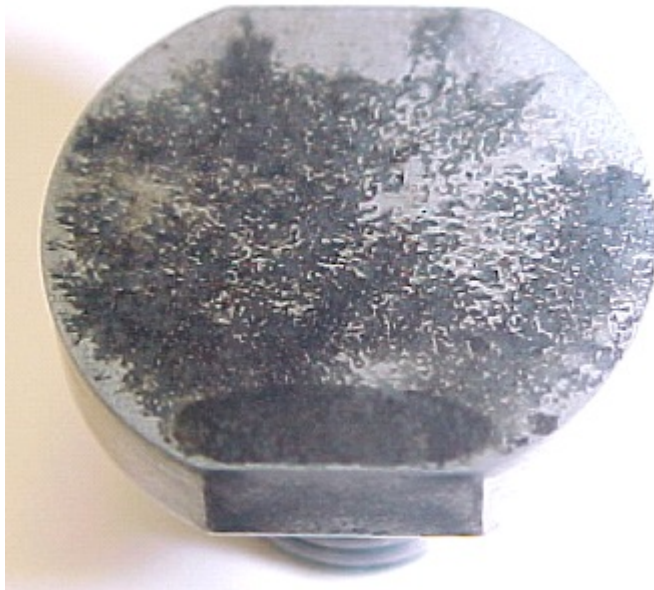
Fig. 12. Treated CA-15 specimen (actual diameter = 16 mm) following sonication for 6 h (2 mm depth) in mercury. Specimen surface reveals significant discoloration following testing.

Figure 12 shows the treated CA-15 specimen following 6 h sonication time (2 mm depth), which reveals widespread discoloration of the test surface. Although it is not particularly evident in Fig. 12, the other surfaces of the test specimen (sides, threads) were not similarly discolored. This observation suggests that material exposed and/or left behind on the test surface as a result of the cavitation-erosion process is responsible for the majority of the discoloration.

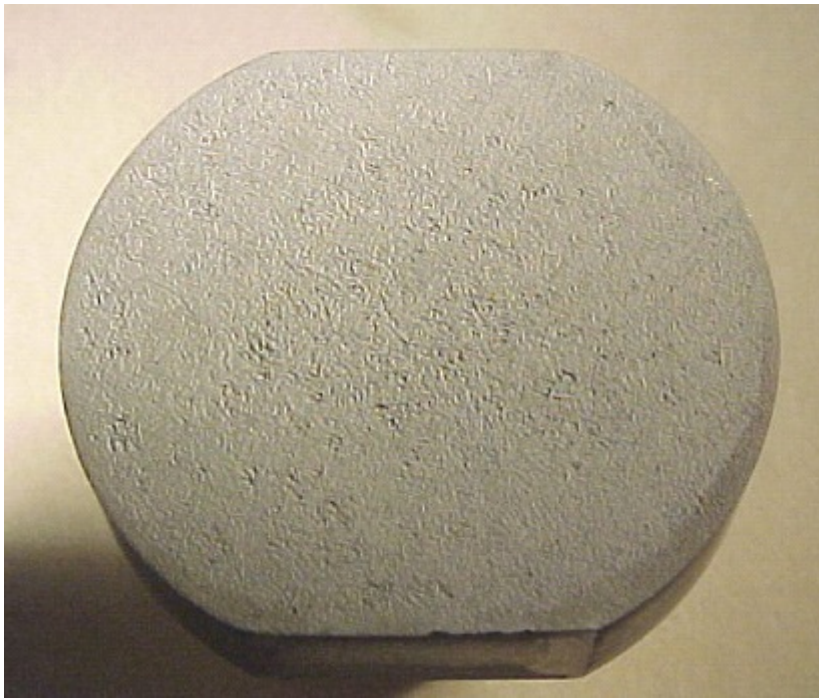
Fig. 16. As-received/untreated CD3MN specimen (actual diameter = 16 mm) following sonication for 6 h (2 mm depth) in mercury. Note the slight general roughness with no pitting.

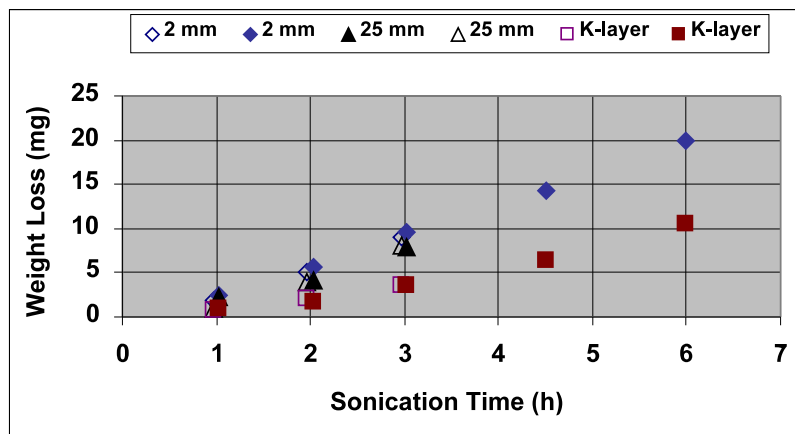
Fig. 20. Weight loss as a function of sonication time in mercury for untreated specimens (2 mm immersion depth) and treated specimens (2 mm immersion depth) of as-cast CD12MW. “K-layer” indicates specimens treated with the Kolsterisation® process. Note that data points are sufficiently close together that several are at least partially obscured.

Figure 20 summarizes the cavitation-erosion data gathered for CW12MW in this investigation. The slope of the weight loss curve for the untreated specimens tested at the 2 mm immersion (3.5 mg/h) is about 13% higher than the average slope for the untreated specimens tested at the 25 mm depth condition (3.1 mg/h), which is consistent with the difference indicated between these test conditions calculated using total weight loss and profile development in Table 2.

The cavitation-erosion results for the treated specimen were somewhat mixed. Clearly (Fig. 20 and Table 2), the Kolsterising® treatment reduced weight loss and profile development compared to the untreated condition. However, rather than a constant slope over the short test duration, the average weight loss rate increased from

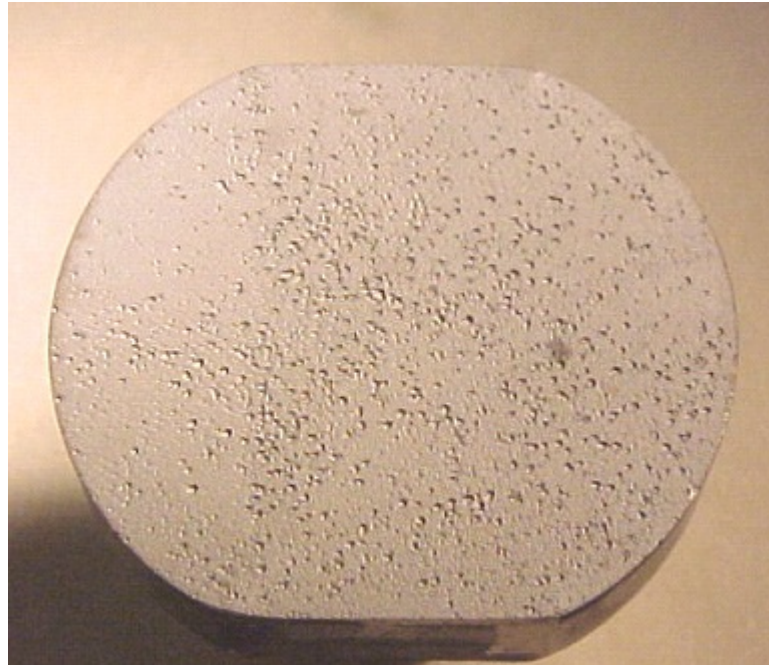
Fig. 21. As-received/untreated CW12MW specimen (actual diameter = 16 mm) following sonication for 6 h (2 mm depth) in mercury. Surface reveals non-uniform pitting damage.

Figure 21 shows the surface of the untreated specimen following sonication for 6 h (2 mm depth). It reveals a non-uniform surface, with some areas relatively smooth (little profile development) and others yielding the development of pits/craters. The nominal profile development in areas without an obvious crater was determined with the microscope to be about 30 μm for this specimen, with many pits/craters in the range of 75 to 110 μm deep.

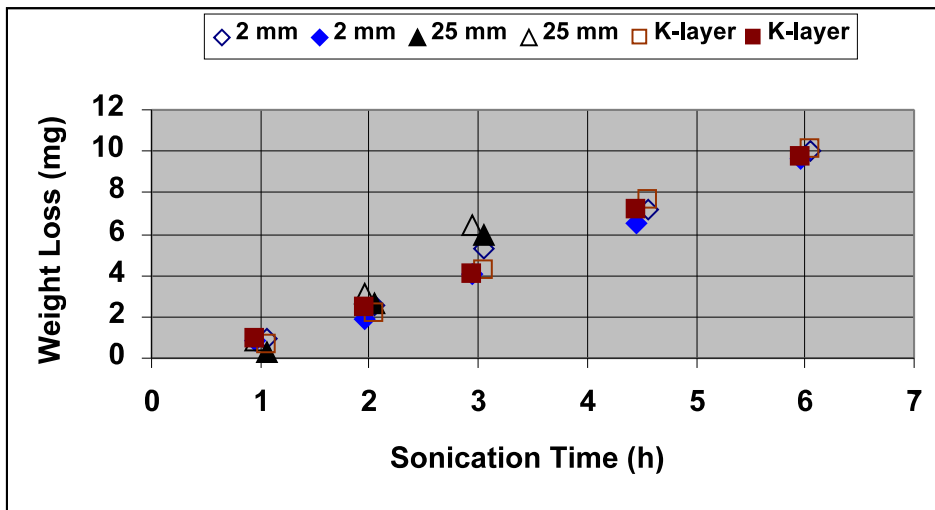
Fig. 24. Weight loss as a function of sonication time in mercury for untreated specimens (2 mm and 25 mm immersion depth) and treated specimens (2 mm immersion depth) of as-cast and hardened HC-600. “K-layer” indicates specimens treated with the Kolsterisation® process. Note that data points are sufficiently close together that several are at least partially obscured.

Figure 24 summarizes the cavitation-erosion data gathered for specimens of HC-600. Among the untreated specimens, the 25 mm depth condition was actually slightly more aggressive than the 2 mm exposure (unique behavior among the alloys showing good cavitation-erosion resistance). The graph also shows that the performance of the treated and untreated specimens is largely indistinguishable.

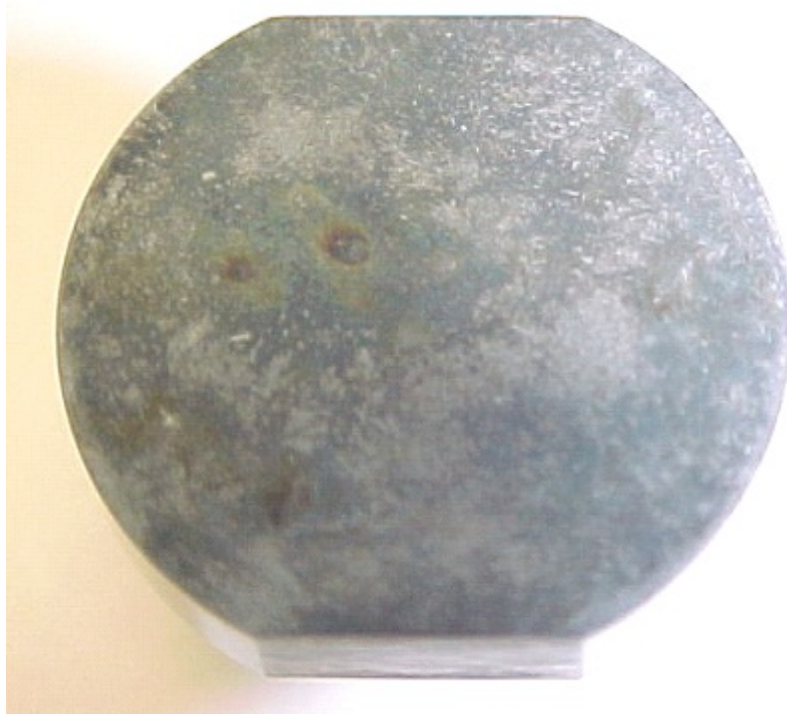
Fig. 25. As-received/untreated HC-600 specimen (actual diameter = 16 mm) following sonication for 6 h (2 mm depth) in mercury. The test surface shows a general surface roughness of $\sim 15 \mu\text{m}$ as well as slight discoloration.

Figure 25 shows the test surface of an untreated HC-600 specimen sonicated in mercury for 6 h (at the 2 mm depth). Slight discoloration of the test surface among the sonicated specimens was common, and a general surface roughness/profile of about 15 μm was observed following 6 h sonication. In addition, the surface exhibited scattered pitting of the type shown in cross section in Fig. 26. It is possible that many of these pits initiate when interdendritic carbides intersecting the surface are dislodged. Martensite is the matrix phase depicted in Fig. 26 for HC-600.

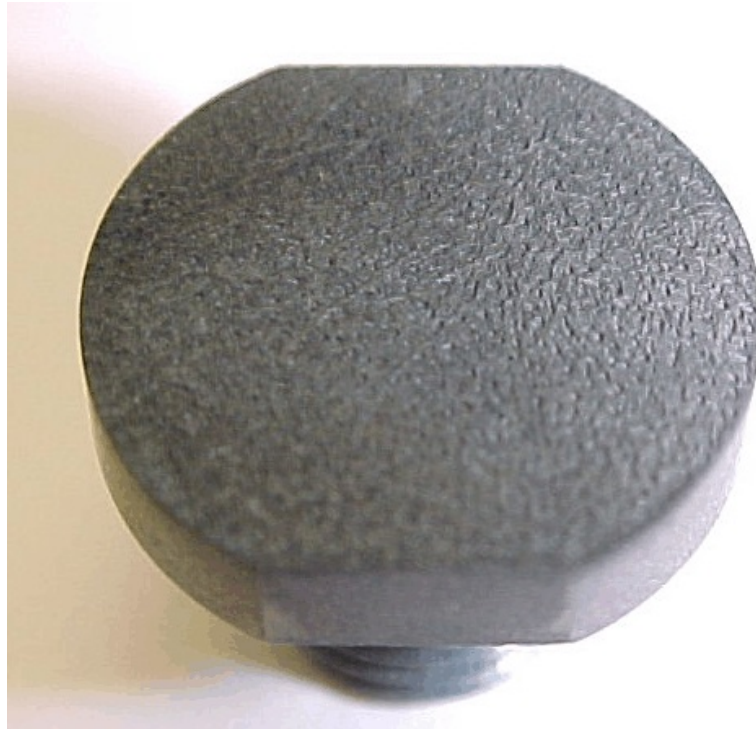
Fig. 27. As-received/untreated Class 30 gray cast iron specimen (actual diameter = 16 mm) following sonication for 3 h (2 mm depth) in mercury. Compared to other similar photos in this report, this one is at more of an angle to reveal the overlapping craters in the profile.
