**OAK RIDGE
NATIONAL LABORATORY**

ORNL/TM-2007/063

Assessment of End-of-Life Behavior of the Surface Modification to Improve Cavitation-Erosion Resistance in the Mercury Target at the Spallation Neutron Source

S. J. PAWEL

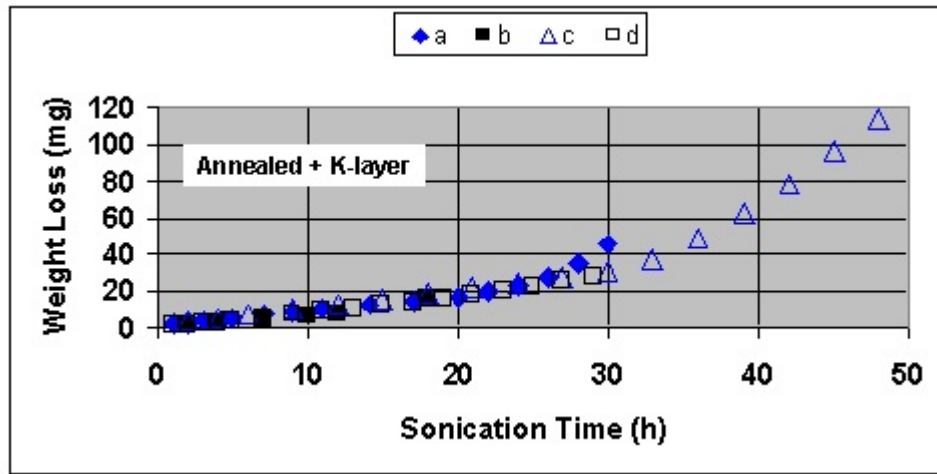
Fig. 1. Weight loss as a function of sonication time in Hg at 25-27°C for annealed 316LN specimens that received the Kolsterising® surface treatment. Specimens “a” and “b” exhibited an initial K-layer about 33 μm thick, while specimens “c” and “d” had an initial K-layer thickness of about 40 μm . Note that there is sufficiently little scatter in the data that many of the data points are individually indistinguishable.

Figure 1 shows the weight loss data as a function of total sonication time in mercury for the annealed specimens receiving the Kolsterisation® treatment. There are a total of four specimens represented in this graph. Among these, specimens “a” and “b” had an initial case depth (also termed K-layer in this report) of 32-33 μm , while specimens “c” and “d” exhibited an initial K-layer thickness of 40 μm .

Figure 1 suggests that the Kolsterisation® process results in a relatively consistent surface condition in that there is remarkably similar weight loss and resistance to pitting among a group of specimens treated in three different processes over a span of almost two years. The steady-state weight loss rate observed for each specimen – independent of initial K-layer thickness within the limited range examined – was essentially constant at 0.7-0.8 mg/h over a sonication period of up to 25 h or more. The weight loss rate observed previously for identical annealed specimens without the Kolsterisation® treatment was also constant over extended periods but in the range of 12-13 mg/h.^{2,3} In

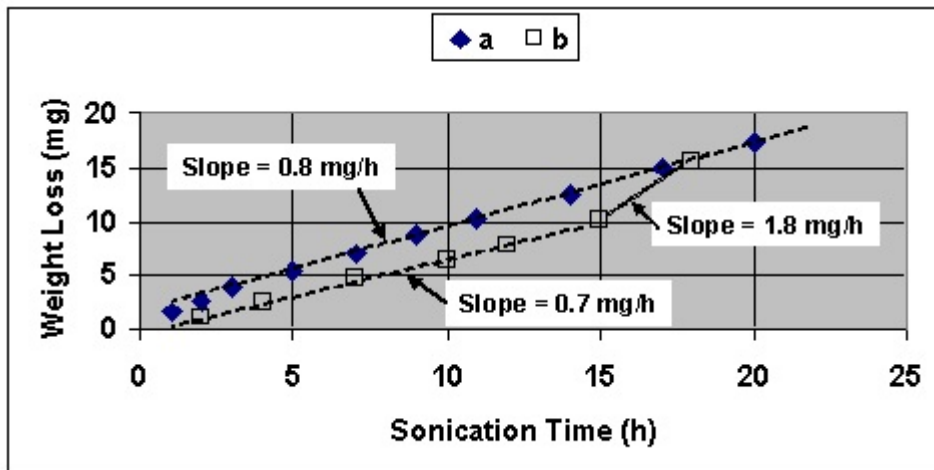
Fig. 2. Weight loss as a function of time for two of the annealed 316LN specimens. Note the change in slope in the data for specimen “b” between 15 and 18 h sonication time.

Figure 2 is a segment of the data in Fig. 1 that has been re-scaled for clarity. It shows the weight loss data as a function of sonication time for the first two K-layer specimens with an annealed substrate (“a” and “b”) evaluated in this investigation. Aside from a slightly accelerated weight loss very early in the exposure for specimens “a,” the weight loss as a function of time for these two specimens was nearly identical over a period of about 15 h. Following 15 h sonication, both specimens exhibited a nominal surface profile on the order of 5 μm and only very limited/isolated pitting – perhaps 8-12 roughly hemispherical pits in the range of 50-100 μm deep. In addition, immediately following sonication, the specimen test surfaces shed essentially all mercury within seconds of removal from the mercury bath, indicating very limited wetting had developed.

However, a change in the slope of the weight loss curve between 15 and 18 h exposure for annealed specimen “b” signaled the potential onset of a change in the protective quality of the Kolsterised® layer. As a result, specimen “b” was sacrificed for metallography after 18 h of sonication; Fig. 3 shows a representative cross-section of the specimen following light etching to reveal the structure. The band of material across the top of the specimen that appears relatively featureless is the Kolsterised® layer – in this view, the layer has a relatively uniform thickness of about 20 µm. Heavier etching would reveal that the Kolsterised® layer actually has a structure continuous with the substrate features, but one aspect of Kolsterising® is that it tends to impart slightly increased corrosion resistance to many environments, and that feature was utilized here to highlight the thickness of the remaining layer with very light etching. The specimen surface, as represented by the view in Fig. 3, reveals a maximum surface profile of less than 10 µm between the high and low spots and an average roughness of less than 5 µm.

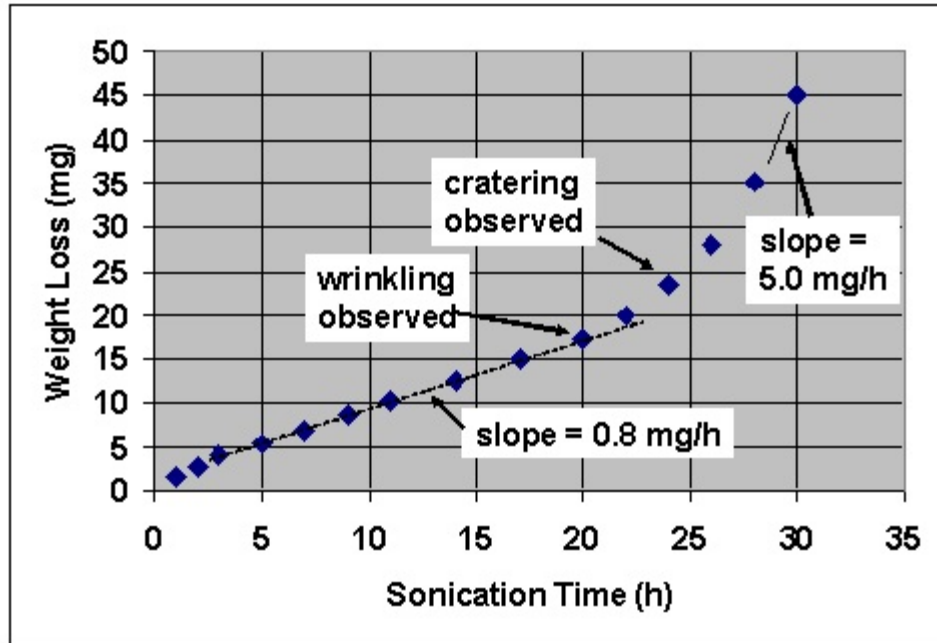
Fig. 4. Weight loss as a function of sonication time in mercury at 25-27°C for specimen “a” (annealed 316LN with a Kolsterised® surface).

olsterised® specimen “a” was extended until a much more significant/persistent change in slope was observed at 30 h total exposure. Figure 4 incorporates the extended exposure time data for specimen “a” as a stand-alone curve.

Corresponding surface profile data for the weight loss curve in Fig. 4 revealed that the test surface roughness remained at about 3 µm or less until about 9 h exposure, and the surface roughness had increased to only about 5 µm following 14 h exposure. Following 20 h of exposure for specimen “a,” the average surface profile was measured with the optical microscope to be 19 µm. Figure 5 shows the test surface of annealed-plus-Kolsterised® specimen “a” following 20 h exposure – it includes about 10 pits large enough to easily detect at this modest magnification and some “wrinkling” of the surface – a general loss of smoothness that seems to be a precursor to the initiation of higher weight loss rates. This “wrinkling” of the specimen surface is simply the macroscopic manifestation of the increase in surface roughness/profile of the specimen – in effect, the onset of failure in the K-layer – and as a generality among these test specimens, it becomes detectable at low magnification (e.g., 10x) at 10-12 µm roughness. Among the

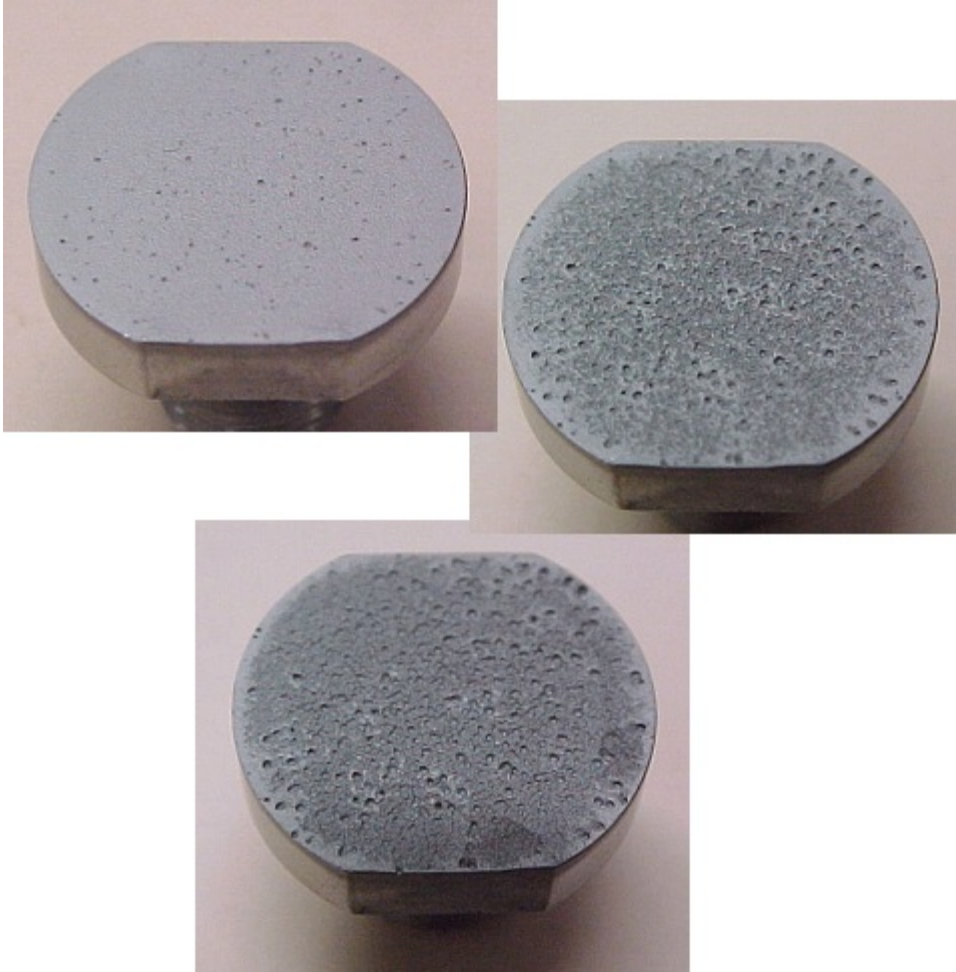
Fig. 15. Annealed-plus-Kolsterised® specimen “c” following 24-, 36-, and 42-h of sonication in mercury, respectively, clockwise from top left. Actual test surface diameter is 16 mm.

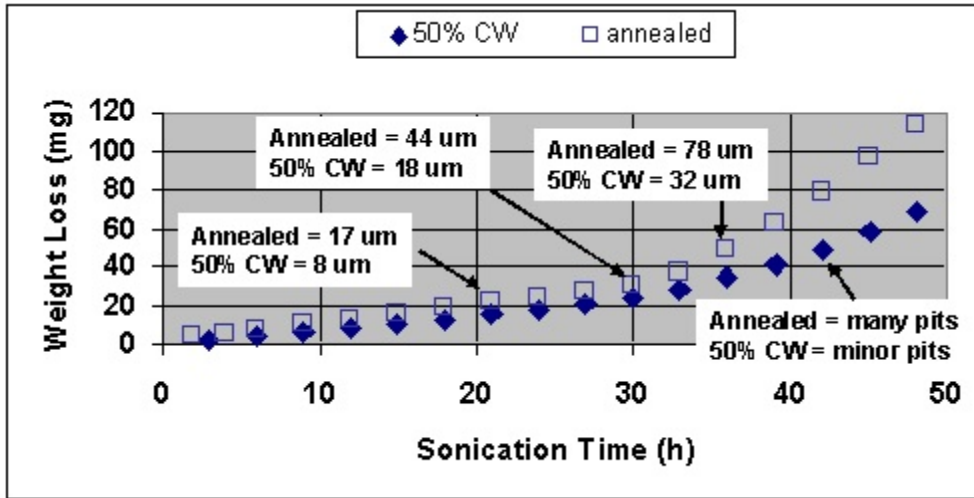
Fig. 21. Weight loss as a function of sonication time for annealed/Kolsterised® specimen “c” and cold-worked/Kolsterised® specimen “c.” Average surface profile is given for each specimen at equivalent exposure durations denoted by the arrows.

Figure 21 shows a comparison of the weight loss results for the two specimens with the longest exposure times in this evaluation; that is, annealed substrate specimen “c” with an initial K-layer thickness 40 µm, and cold-worked substrate specimen “c” with an initial K-layer thickness of 35 µm. Graphed in this fashion, it is easy to see that the

steady-state weight loss rate for each specimen type is essentially identical. Although limited in number, remaining K-layer thickness measurements as a function of sonication time collected via metallography confirm this trend. The similarity in the steady-state weight loss and K-layer thinning rates for the two different substrates suggests general erosion is primarily controlled by the properties of the K-layer itself as opposed to the properties of the substrate. However, note that as the K-layer is degraded by thinning and cavitation damage begins to accumulate in both the remaining K-layer (thinned to less than 15-20 μm) and the adjacent substrate, the average mass loss rate and the average surface profile both become much greater much faster for the K-layer on the annealed substrate.

In addition to data on the average surface roughness as a function of sonication time included in Fig. 21, the depth of a few individual pits on the surface of each specimen was also tracked as a function of sonication time. For both the annealed/treated specimens as well as the cold-worked/treated specimens, pit depth increased slowly – only about 2 $\mu\text{m}/\text{h}$ or less – until the pit depth reached approximately 30-35 μm . Beyond this depth, the K-layer was either breached or sufficiently thinned that its protective ability was compromised and the pit growth rate accelerated. On the annealed substrate specimens, pits were found to increase in depth at an average rate in the range of approximately 5-9 $\mu\text{m}/\text{h}$ following breach of the K-layer, while the rate for specimens with a cold-worked substrate was only 3-6 $\mu\text{m}/\text{h}$. In each case, these rates are roughly consistent with the rate of change in average roughness of the bulk surface following the departure from steady-state change associated with a protective K-layer. For both substrates, however, pit depth did not necessarily increase uniformly with time. Rather, there was significant variability and even occasional exposure periods during which the pit depth did not measurably increase followed by a period in which the pit depth increased significantly more than the average rate. This behavior may have occurred across the entire surface, but individual pits in specific locations on the specimen surface lend themselves to trending this pattern, while more generalized areas on the specimen surface do not. In any case, these data suggest that the cavitation-erosion process on the test surface of vibratory horn specimens is somewhat random in that damage is not necessarily focused at existing flaws/pits – otherwise, the pits would grow deeper at a rate much faster than the change in the average profile of the surface. That there are periods during which existing pits do not change depth appreciably is curious but nevertheless a reproducible observation in the vibratory horn testing.
