# Critical Causes of Degradation in Integrated Laboratory Scale Cells During High-Temperature Electrolysis

May 2009

**Idaho National Laboratory  
Idaho Falls, Idaho 83415**

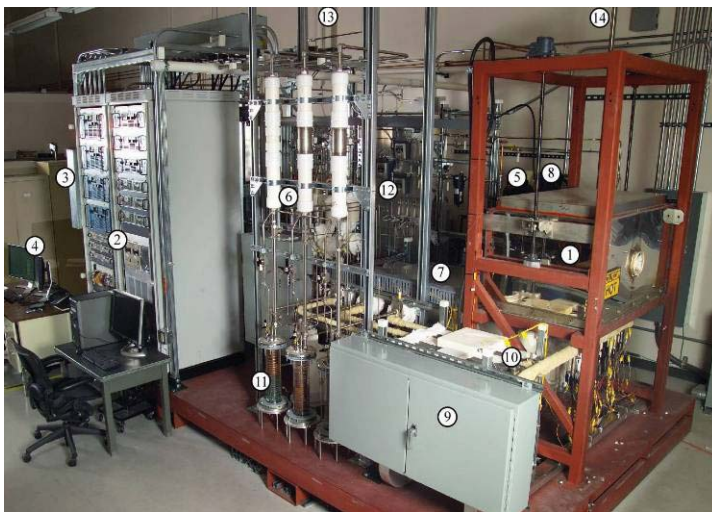
Integrated Laboratory Scale 720 cells, 3 modules, 46,080 cm<sup>2</sup>, (2008)

Figure 3 shows the progression of the HTE experiments performed at INL during the last five years, from a 2.5 cm<sup>2</sup> button cell to the ILS, which had an active area of 46,080 cm<sup>2</sup> when all three modules were installed during 2008. This series of experiments represents a growth in active area (and in the hydrogen production rate) by a factor of 15,000. The ILS design includes three four-stack modules with 60 electrolysis cells in each stack for a total of 12 stacks and 720 cells in a single hot zone. This configuration utilizes the solid oxide cells similar to those used in the small stacks previously tested at INL. In the ILS, the inlet steam-hydrogen flow was preheated to 830°C (electrolyzer operating temperature) prior to entering the hot zone using superheaters and recuperators. The electrolysis module is configured so that the steam/hydrogen gas mixture enters through the bottom of the steam inlet manifold and exits through the bottom of the outlet manifold in the module's center. Airflow enters through the bottom of the air inlet manifold, flows through the stack perpendicular to the steam-hydrogen gas mixture, and exits at the front of the stacks directly into the hot zone. Furthermore, each electrolysis module has its own independent instrumentation system, which allowed for independent testing of each of the three HTE ILS modules under different operating conditions (gas mixture, current density, etc.). To measure fuel cell performance, the area-specific resistance (ASR) value was closely monitored. Fuel cell testing showed that the resistance of the cell gradually increased over time, reducing the hydrogen production rate. This degradation was evidenced by increased calculated ASR values. As the solid oxide cell technology improves, the cell's lifetime and degradation should also improve, resulting in efficiently producing large quantities of hydrogen over long periods ( $\geq 50,000$  hrs) of time.

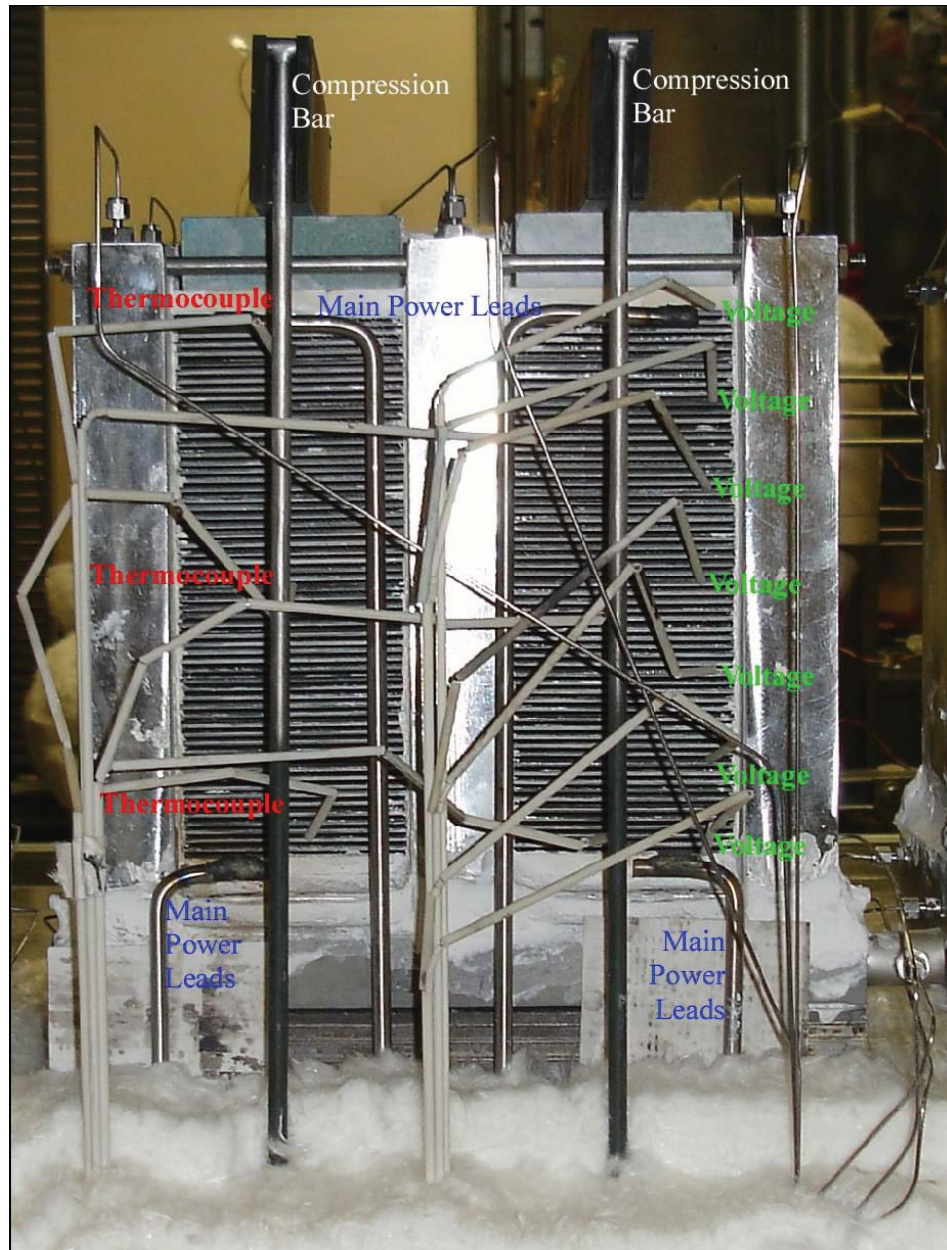
Figure 4. Photograph of installed module and lead placement.

The ILS test was a 720-cell, three-module test comprised of 12 stacks of 60 cells each. The stacks were arranged on three internally manifolded base plates that sat upon the heat exchangers. Each base plate contained a module, which was comprised of two pairs of stacks. Paired stacks had individual steam inlet manifolds and shared a common hydrogen outlet manifold. Each stack pair sat on the base plate across from another stack pair, with the stacks and manifolds forming an air plenum between the pairs that was completed by metal sheet closure. The inlet and outlet ports were at the bottom of the hydrogen/steam manifolds, which slid over tube nipples extending up from the base plate. The seal at this connection was largely a slip fit between the tube and the manifold's port with a small amount of zirconia paste between the outside mating surfaces. Stacks were held down on the base plate with an applied axial load using crossbars; each crossbar loaded one stack of each opposing pair as shown in Figure 4.

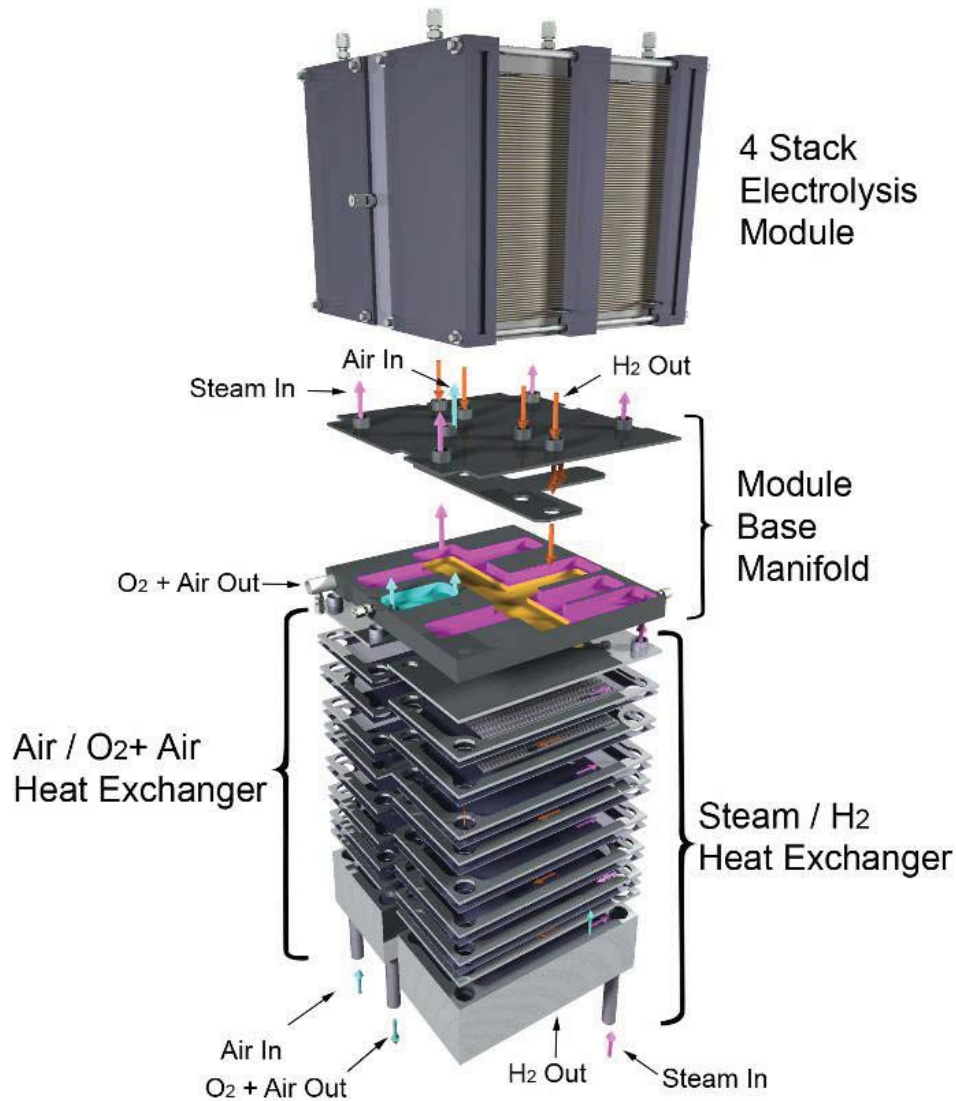
Figure 5. Exploded view of heat exchanger, base manifold unit, and four-stack electrolysis unit.

Figure 5 shows an exploded view of one of the ILS module assemblies including the recuperative heat exchanger, base manifold unit, and four-stack electrolysis unit. For each four-stack electrolysis module, there were two heat exchangers and one base manifold unit. Nine flow tubes entered or exited each base manifold at its top, and only four flow tubes entered or exited at the bottom of the unit and at the bottom of the heat exchangers, thereby reducing the number of tube penetrations passing through the hot zone base plate from nine to just four. This feature also reduced the thermal load on the hot zone base plate. An internally manifolded plate-fin design concept was selected for this heat recuperator application. This design provides excellent configuration flexibility in terms of selecting the number of flow elements per pass and the total number of passes in order to satisfy the heat transfer and pressure drop requirements. Theoretical counterflow heat exchanger performance can be approached with this design. This design can also accommodate multiple fluids in a single unit. More details of the design of the recuperative heat exchangers are provided by Housley et al. (2008).

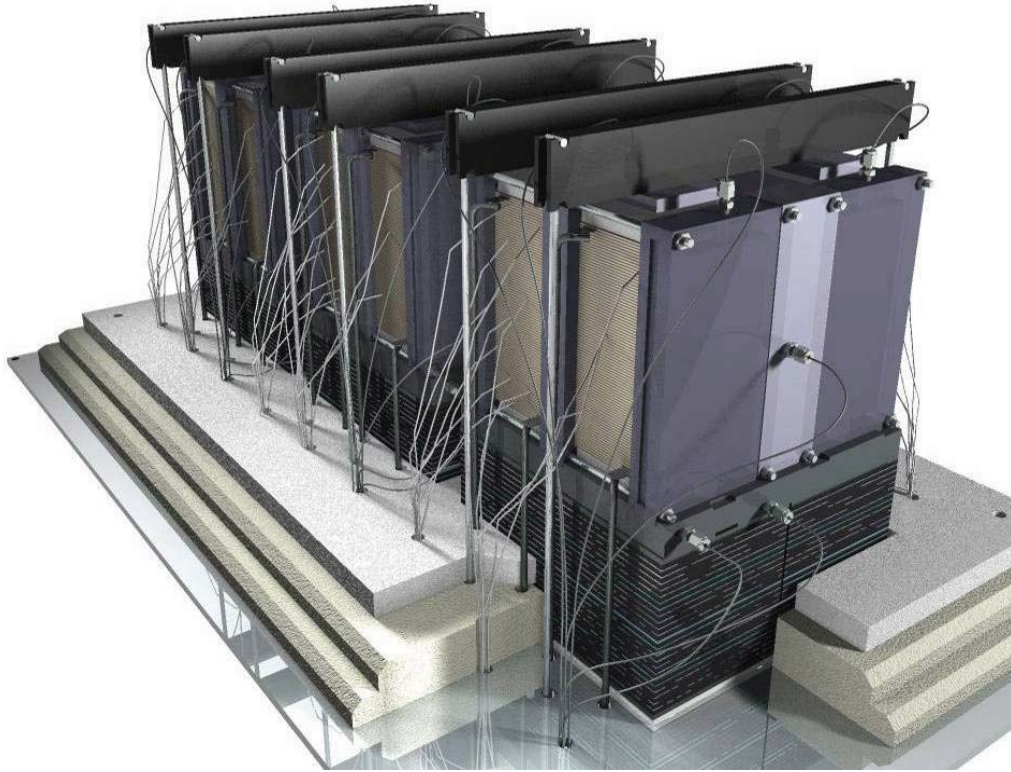
Figure 6. Installation of electrolysis modules, base manifolds and paired heat exchangers.

Figure 6 shows three ILS electrolysis modules with their base manifolds and heat exchangers beneath. This illustration also shows the instrumentation wires for intermediate voltage and temperature readings. Each module is instrumented with twelve 1/16" sheathed thermocouples for monitoring gas temperatures in the electrolysis module manifolds and in the base manifold. These thermocouples are attached to the manifolds using compression fittings. There are also 12 miniature 0.020"-diameter inconel-sheathed type-K thermocouples per module that are used for monitoring internal stack temperatures. Access to the internal region of the stacks is provided via the air outlet face. The internal thermocouples are inserted into the small exit air-flow channels. Similarly, seven intermediate voltage tap wires per module are inserted into the air-flow channels of the four stacks. Two compression bars are shown across the top of each module in Figure 6. These bars are used to maintain compression on all of the stacks during operation in order to minimize electrical contact resistance between the cells, flow channels, and interconnects. The bars are held in compression via spring-loaded tie-downs located outside of the hot zone under the base plate.

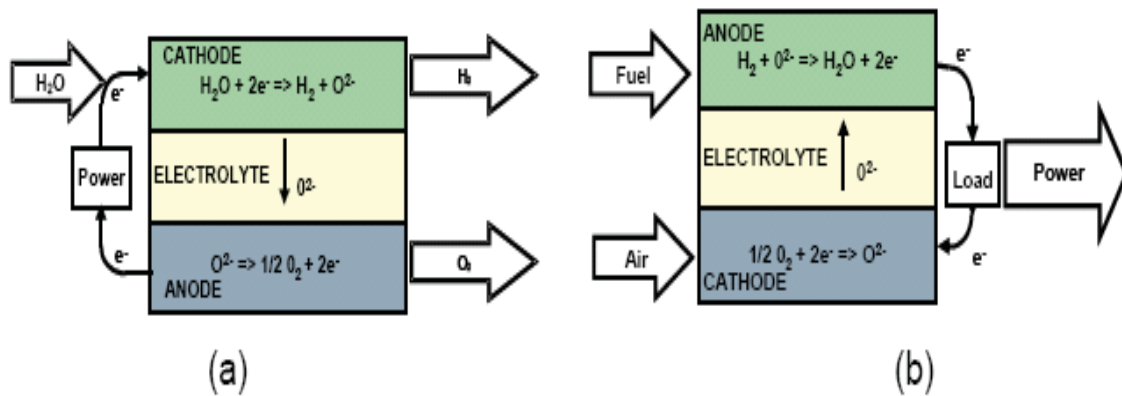
Figure 7. (a) SOEC; (b) solid oxide fuel cell (SOFC) operating in reverse compared to an SOEC (Guan et al. 2006).

A solid oxide cell is a key component of the electrolysis system. It consists of three main components: an electrolyte and two electrodes (Figures 7 and 8). The electrolyte is a ceramic membrane that can conduct ions and is sandwiched between two porous electrodes that can conduct electrons: the steam/hydrogen electrode (or anode in fuel cell mode) and the air/oxygen electrode (or cathode in the fuel cell mode). In the fuel cell mode, oxygen molecules dissociate at the oxygen electrode and combine with electrons coming from an external electric power source to form oxygen ions. The oxygen ions conduct through the electrolyte and migrate towards the hydrogen electrode. The fuel (hydrogen or natural gas) is fed to the anode and reacts with the oxygen ions to form water and  $\text{CO}_2$ . If the fuel cell is operated in the electrolysis mode, the names and functions of the electrodes get reversed, as shown in Figure 7a.

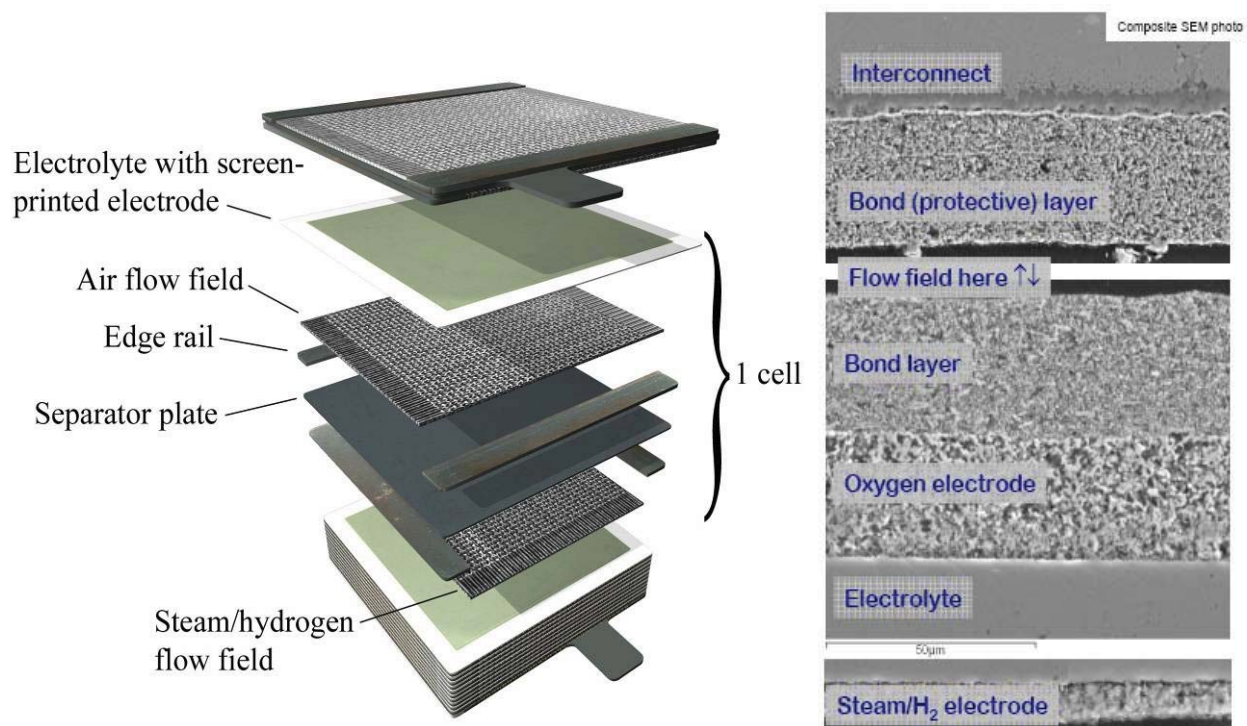
Figure 8. Ceramtec solid oxide cell/stack construction; (scanning electron microscopy figure on the right is taken from Carter et al. 2008).

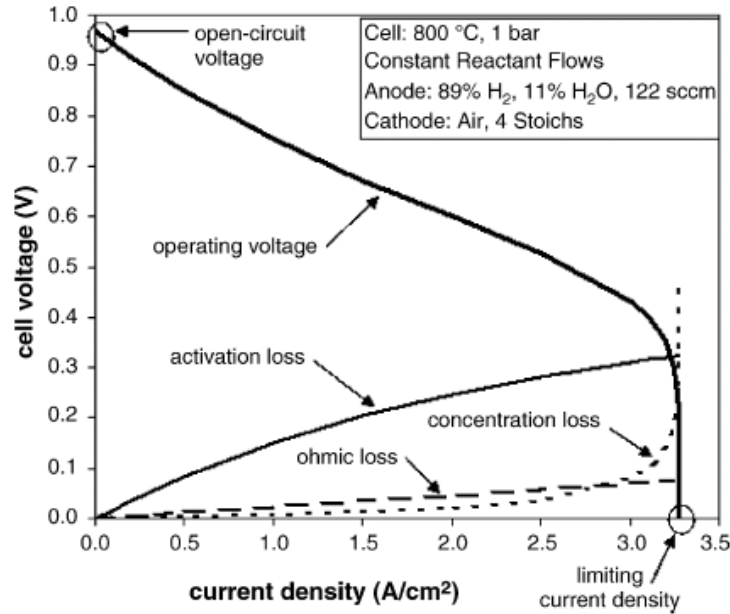
Figure 9. SOFC voltage-current characteristics for a single cell operating at 800°C (Windisch et al. 2002).

Figure 9, developed by Windisch et al. (2002), shows the relative magnitude of various polarization losses in a SOFC. It shows that activation losses are the dominant mode of three types of polarization losses. It also shows the upper limit of current density for the fuel cell to operate.

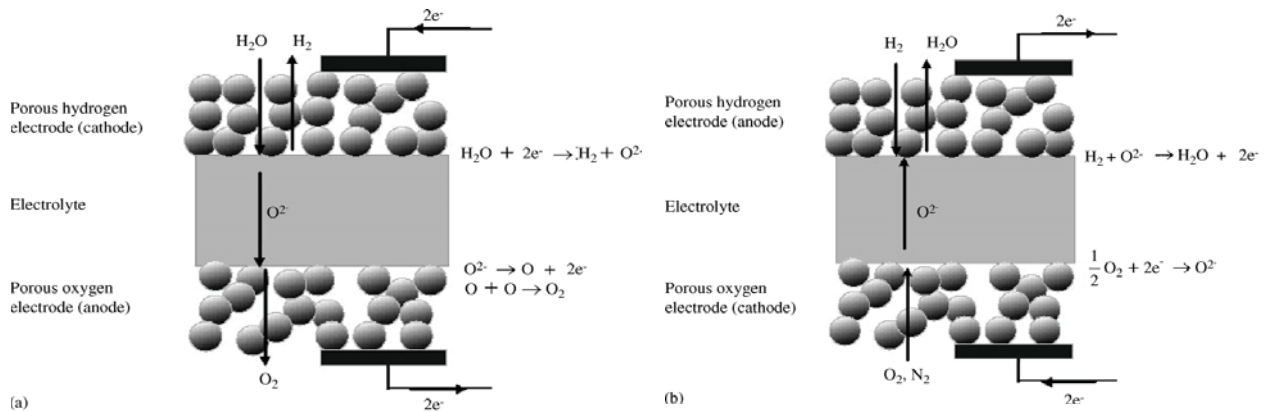
Figure 10. Operating mechanisms of solid oxide cells: (a) a SOEC in electrolysis mode, and (b) a SOFC in fuel cell mode (Ni et al. 2006).

Ni et al. (2006) have developed models for concentration overpotential in SOECs and SOFCs, as shown in Figures 10(a) and 10(b), respectively. The cathode (hydrogen electrode) in the electrolysis mode is termed “anode” in the fuel cell mode. Similarly, the anode (oxygen electrode) in the electrolysis mode is termed “cathode” in the fuel cell mode.

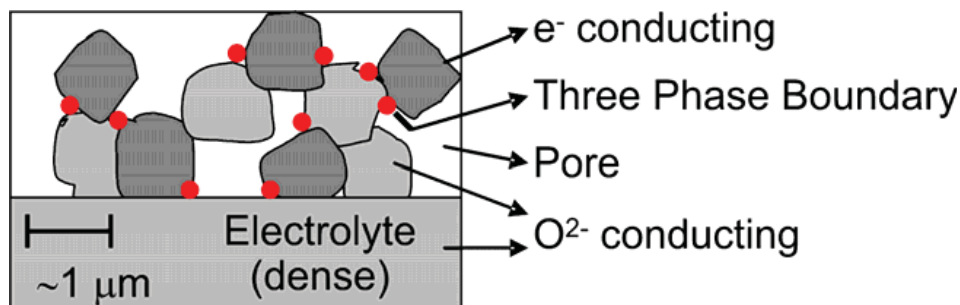
Figure 11. TPBs in a solid oxide cell, shown as red dots, where reactions take place (Hauch 2007a).

One important term used for describing reactions at both electrodes is the so-called triple-phase boundary (TPB). The TPB describes a site in the electrode where the electrochemical reaction takes place, shown as red dots in Figure 11 (Hauch 2007a). At the steam/H<sub>2</sub> electrode, this site is where all three phases (Ni, YSZ, and gas) are in contact with each other. Since the supply of oxygen ions at YSZ, supply of gas in the pores, and means of transporting the electrons away from Ni are simultaneously required, the electrochemical reactions are facilitated at the TPB. Therefore, in order to optimize the electrode performance, it is important to maximize the electrochemical activity at the TPBs. For a reaction to take place at the TPB, the gas stream must flow through the pores, Ni must be connected to the interconnect plate, and the YSZ must be connected to the electrolyte either directly or via YSZ in the electrode. Changes in the electrode-electrolyte interfaces and grain boundaries are highly influential in the degradation of the cell. These interfaces not only provide the TPB, but are also active for mass transfer, diffusion, and segregation of species involved in the fuel cell reactions during operation. Microstructural changes in the interfacial regions, such as impurity segregation, will also affect the cell's performance.

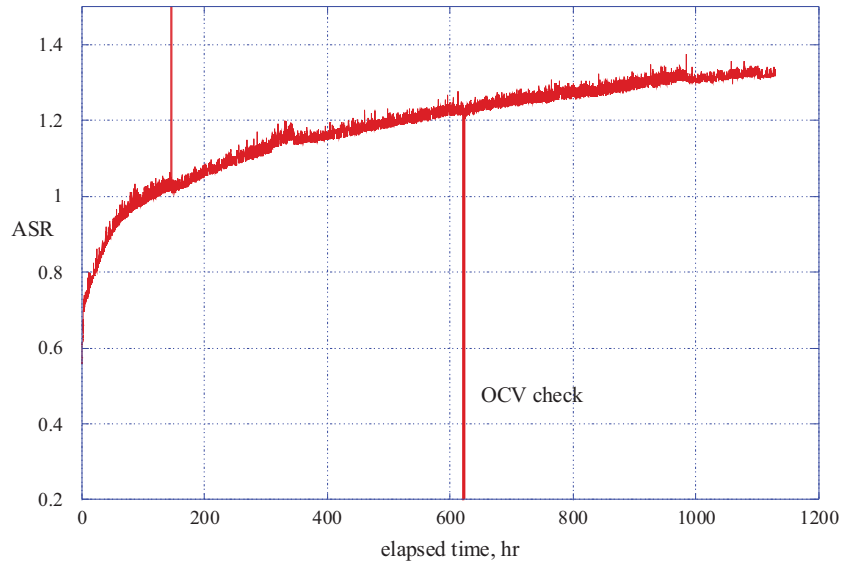
Figure 12. Area-specific resistance of a button cell as a function of time for the 1,100-hour test.

resistance, flow channels, or interconnects, because these components are not present. The results of a long-term, button-cell test are presented in Figure 12. This figure shows the ASR of a button cell plotted as a function of time over the duration of an 1,100-hour test. The ASR increases quite rapidly at the start of the test from an initial value of  $\sim 0.6 \text{ ohm cm}^2$  to a value of  $0.9 \text{ ohm cm}^2$  over about 40 hours. Between 100 and 1,100 hours, the ASR increases from  $0.98 \text{ ohm cm}^2$  to  $1.33 \text{ ohm cm}^2$ . If the initial 100 hours is considered to be a cell conditioning period, the degradation rate over the following 1,000 hours is about 35%. This is obviously an unacceptable rate of degradation. As a comparison, the Phase-III DOE Solid State Energy Conversion Alliance (SECA) target degradation rate is  $0.1\%/1,000 \text{ hours}$ . Several companies are currently coming very close to meeting that target in the SOFC mode of operation.

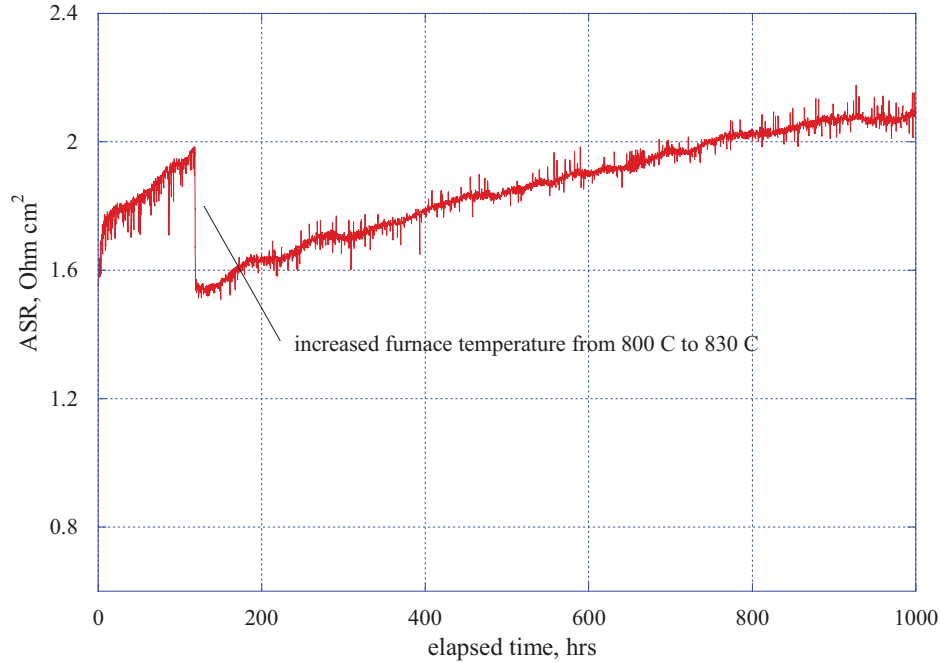
Figure 13. Area-specific resistance of a 25-cell stack as a function of time for a 1,000-hour test.

Performance degradation results with a 25-cell Ceramtec SOEC stack tested for 1,000 hours at INL were presented by O'Brien et al. (2007) and are shown in Figures 13 and 14. Figure 13 plots the stack ASR as a function of time for the 1,000 hours. The furnace temperature was increased from  $800$  to  $830^\circ\text{C}$  over an elapsed time of 118 hours, resulting in a sudden drop in ASR. The increase in ASR with time represents degradation in stack performance. The degradation rate decreases with time and is relatively low for the last 200 hours of the test. However, from the 118-hour mark to the end of the test, the ASR increased more than 40% over approximately 900 hours. Reduction of this performance degradation is an objective of ongoing research. Figure 14 shows the corresponding generation of hydrogen.

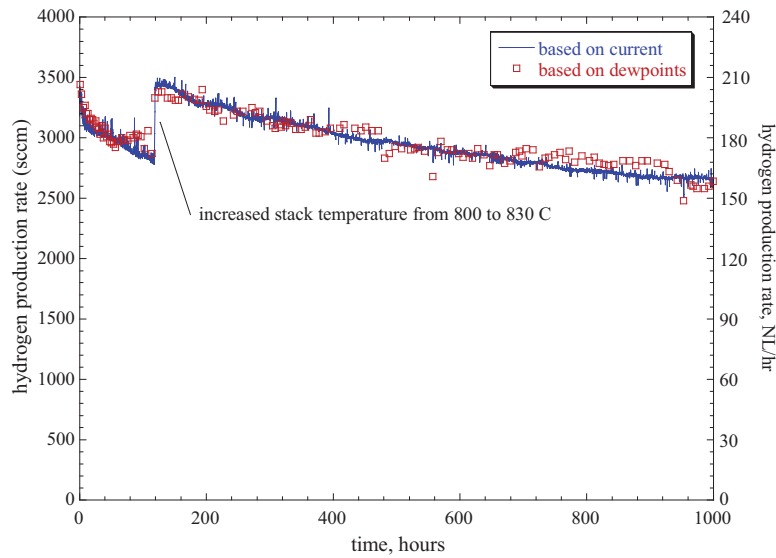
Figure 14. Hydrogen production rates during 1,000-hour long-term test.

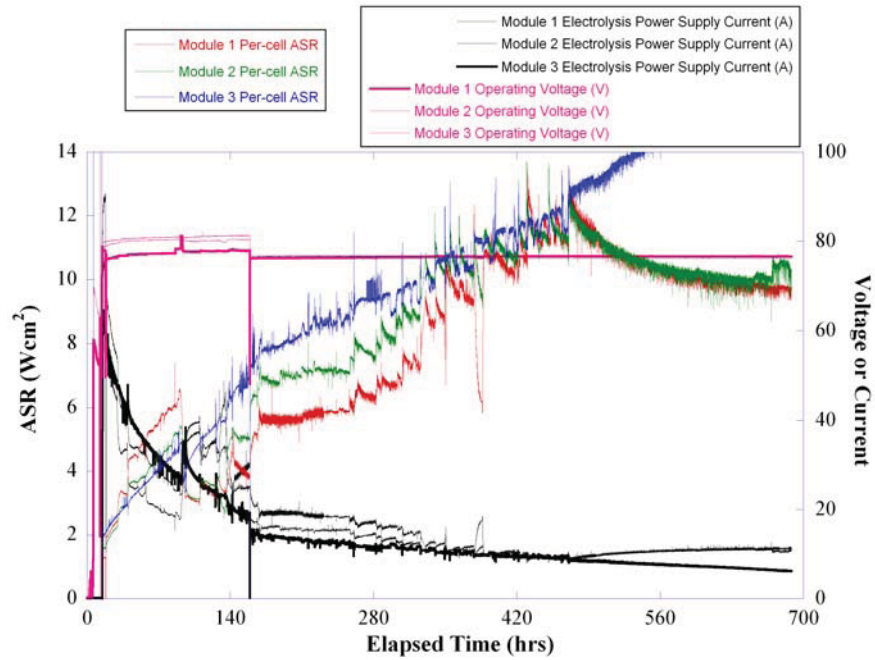
Figure 15. Time history of ILS module ASR values, voltages, and current over 700 hours of operation.

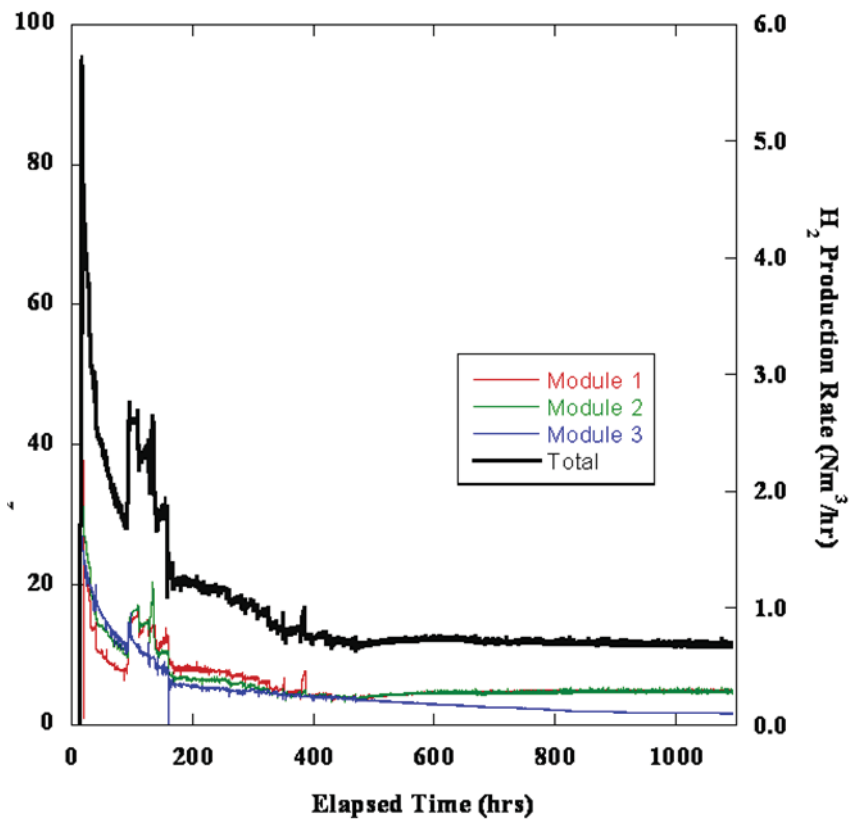
Figure 16. Time history of hydrogen production rate in the ILS.

Hydrogen production rate for the test duration is displayed in Figure 16. Peak H<sub>2</sub> production rate of 5.7 Nm<sup>3</sup>/hr and peak electrolysis power input of 18 kW were achieved after ~17 hours elapsed test time (Figure 18). Module ASRs ranged from 1.25 Ωcm<sup>2</sup> to just over 2 Ωcm<sup>2</sup>. Total H<sub>2</sub> production rate decreased from 5.7 Nm<sup>3</sup>/hr to a steady state value of 0.7 Nm<sup>3</sup>/hr. The decrease was primarily due to cell degradation. Adjustments in electrolyzer power supply voltage had to be made as well to maintain internal stack temperatures within an acceptable range (Figure 19). Most of the test was conducted at a constant electrolyzer power supply voltage of 76 V.

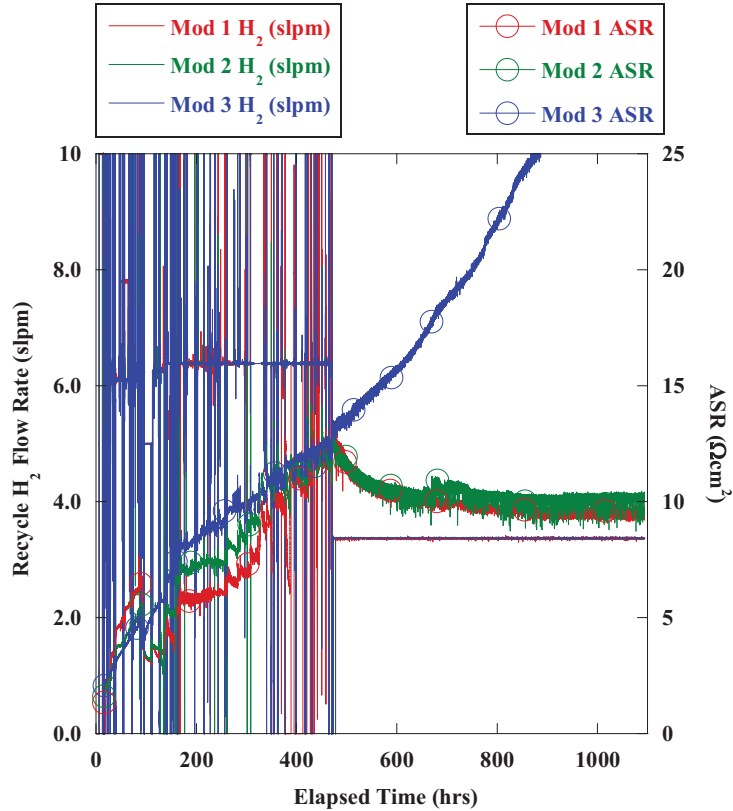
Unfortunately, the condensate problem may have caused accelerated degradation of the ILS modules. Again referring to Figure 17, the module ASR values rise sharply with time up to 480 hours. Beyond 480 hours, the ASR values for modules 1 and 2 actually decrease and ultimately level out while the ASR for module 3 continues to increase. Condensate interfering with the H<sub>2</sub> recycle mass flow controllers caused interruptions in H<sub>2</sub> flow. These interruptions could have caused electrode oxidation to occur in the modules. Once H<sub>2</sub> flow resumed, reduction would occur on the electrode surfaces. This cycling of oxidation and reduction may have contributed to the high rate of performance degradation observed. The reason for the continued performance degradation of Module 3 after the condensation problem was solved, while Modules 1 and 2 improved, is not understood.

Figure 17. Full history of module ASRs and H<sub>2</sub> recycle flow rates.

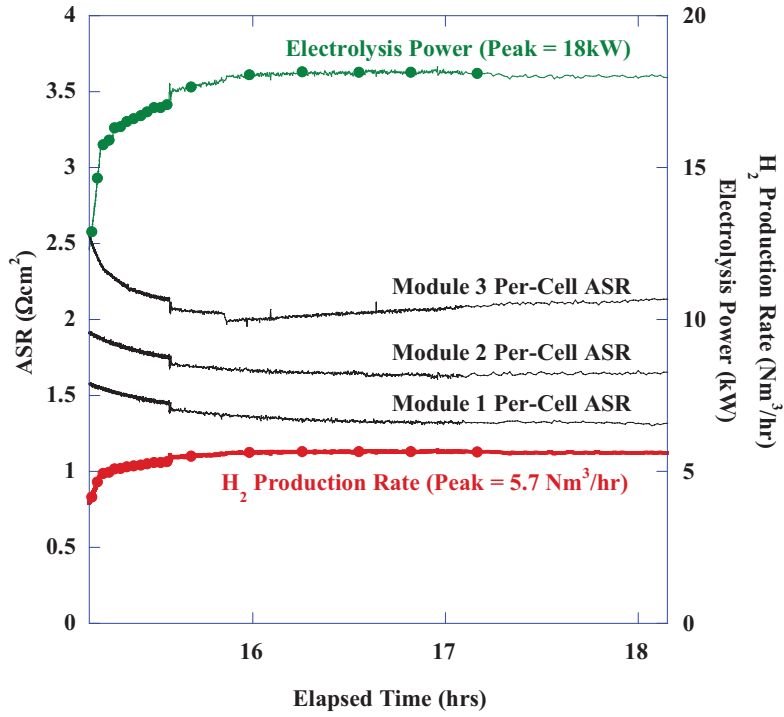
Figure 18. Peak electrolysis power, H<sub>2</sub> production rate, and ASRs.

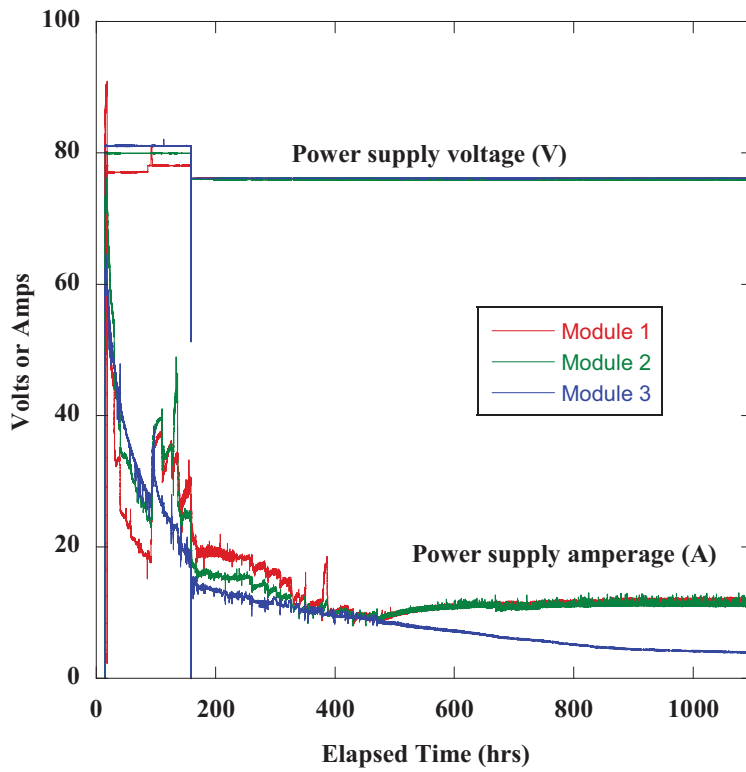
Figure 19. Time history of electrolyzer power supply amperage and voltage.

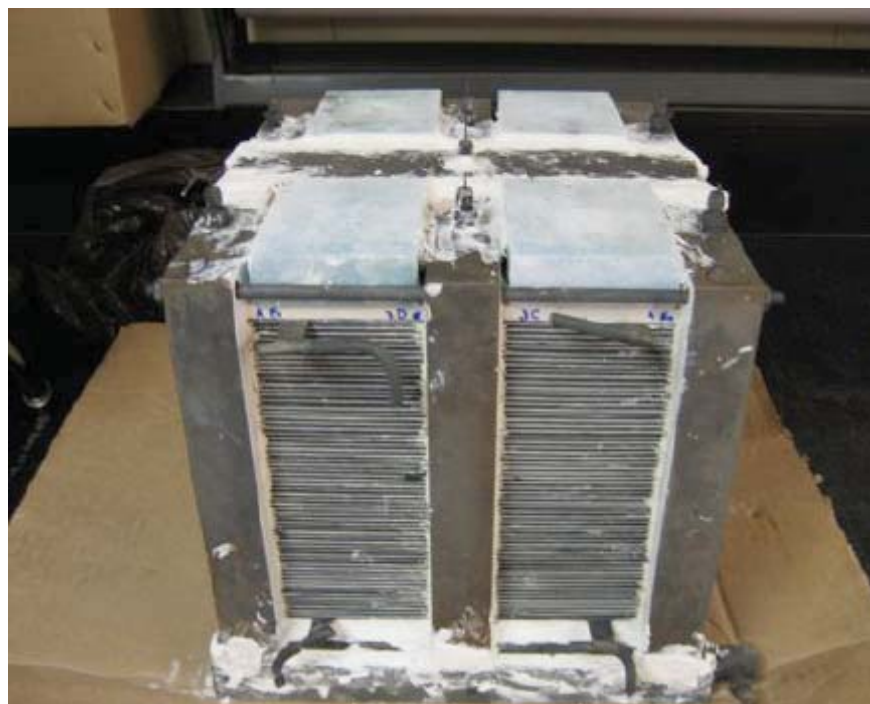
Module 3 was delivered to Ceramatec with the base plate attached (Figure 20). The stainless steel bolts that held the hydrogen manifolds on were cut or broken off and the air manifold cover removed. The electrical tie bars were cut and each pair of stacks was removed from the base plate. Then the tie bars were cut from the interconnect tabs using an abrasive cutoff wheel on an angle grinder.

Figure 20. ILS Module 3 on base plate.

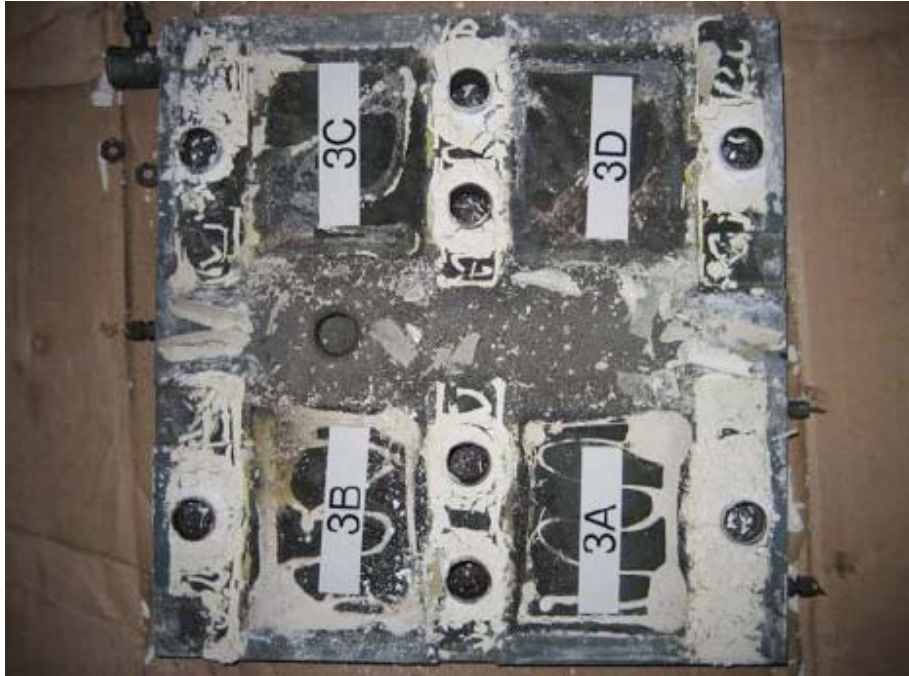
The base plate condition was good, with no evidence of gas leaking from the ports or seals although the seal paste was heavily cracked (Figure 21). The overall appearance of the exterior faces of the stacks was also good. There was very little evidence of hydrogen burning due to cracked cells or leaking manifold seals. No areas of runaway scale growth on the edge rails could be observed from the exposed air exhaust side.

Figure 21. Module 3 base plate after stacks were removed.

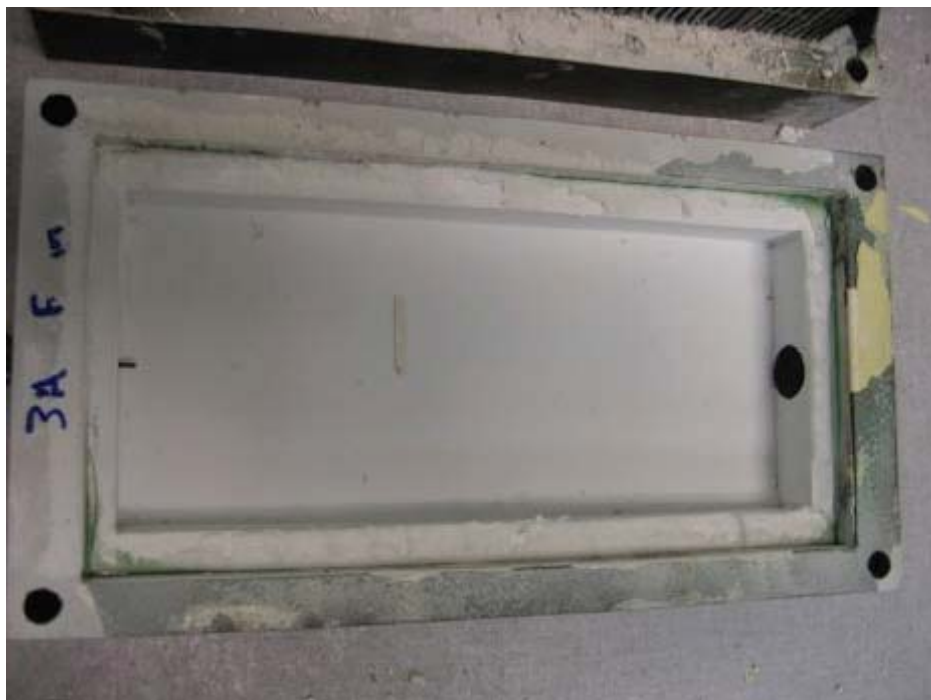
After the stacks were clamped to compress them enough to be removed from the manifolds, the manifolds were removed by lightly tapping on the corners with a hammer. The stacks were then righted and the clamps removed. The hydrogen manifolds showed small signs of gas mixing by the presence of greenish stains at various locations (Figure 22). The manifold plasma spray insulation layer had spalled off in some non-critical areas.

Figure 22. Hydrogen manifold showing green deposit due to gas mixing.

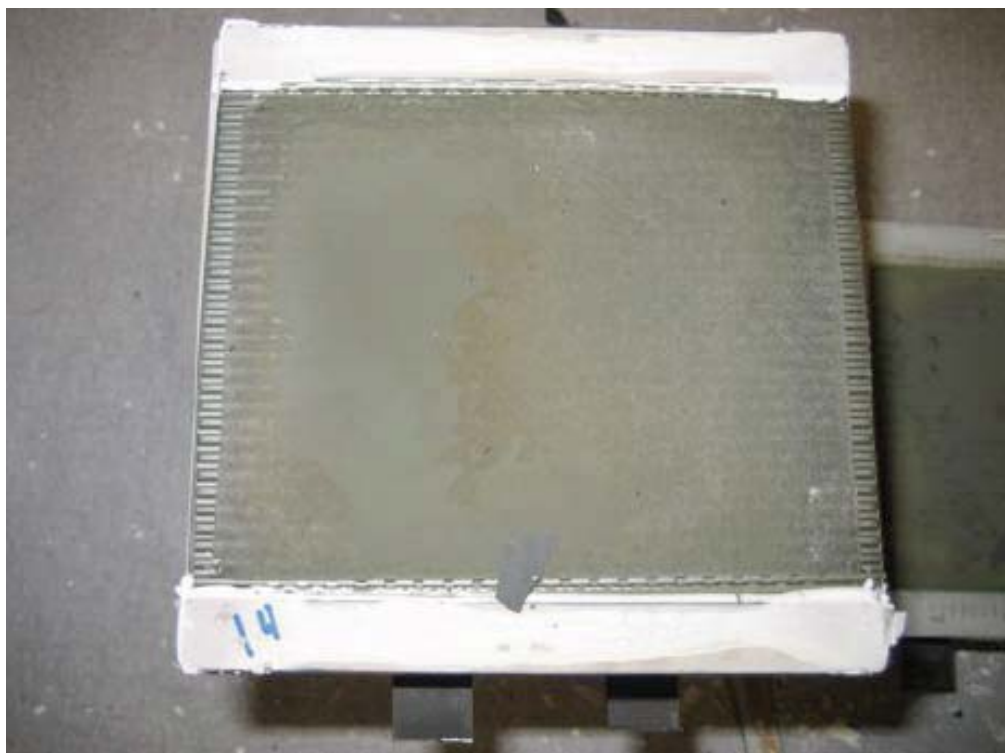
Overall impression of the cells is that all the hydrogen side electrodes were partially to mostly oxidized. It is likely that this is from the lack of hydrogen on cool down after the test operation was concluded. The electrode was well attached and grayish in appearance but nonconductive. The Ni bond layer was green, indicating some oxidation. This layer had low resistance (around  $3\ \Omega$ ) where it pulled away from the electrode, but the flow channel side of the layer was nonconductive. The nickel felt was dark grayish black and could have been conductive around 6 ohms or nonconductive, depending on how deeply the probe contacted. The hydrogen side flow channels were a dark metallic color and had high resistances on the order of  $50\ M\Omega$ . The Ni bond layer on the separator plate under the flow channel had low resistance at about  $15\ \Omega$ . The cells were difficult to separate from the hydrogen side flow channels and a few cells cracked during separation. There was a little evidence of gas mixing on the hydrogen side, and most cells had a darker green electrode region that extended into the first hydrogen channel on each side from the small amount of air leaking through the edge seal. Figures 23 and 24 show representative samples of hydrogen side components.

Figure 23. Hydrogen side interconnect, flow channel, and felt.

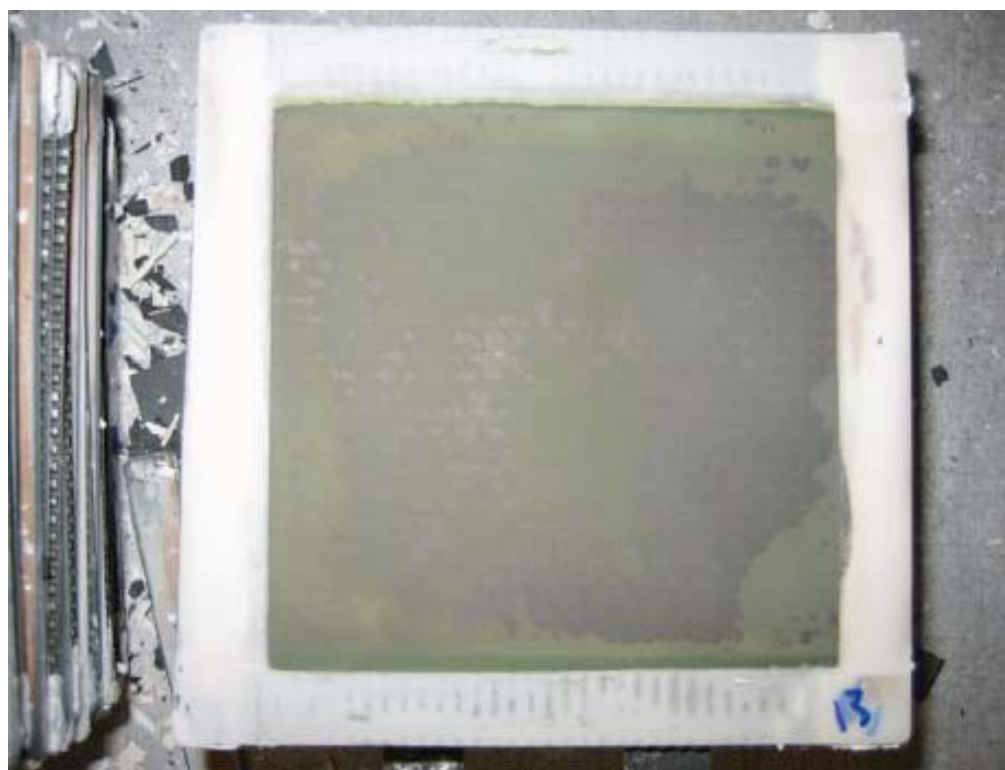
Figure 24. Cell hydrogen electrode after separation from interconnect.

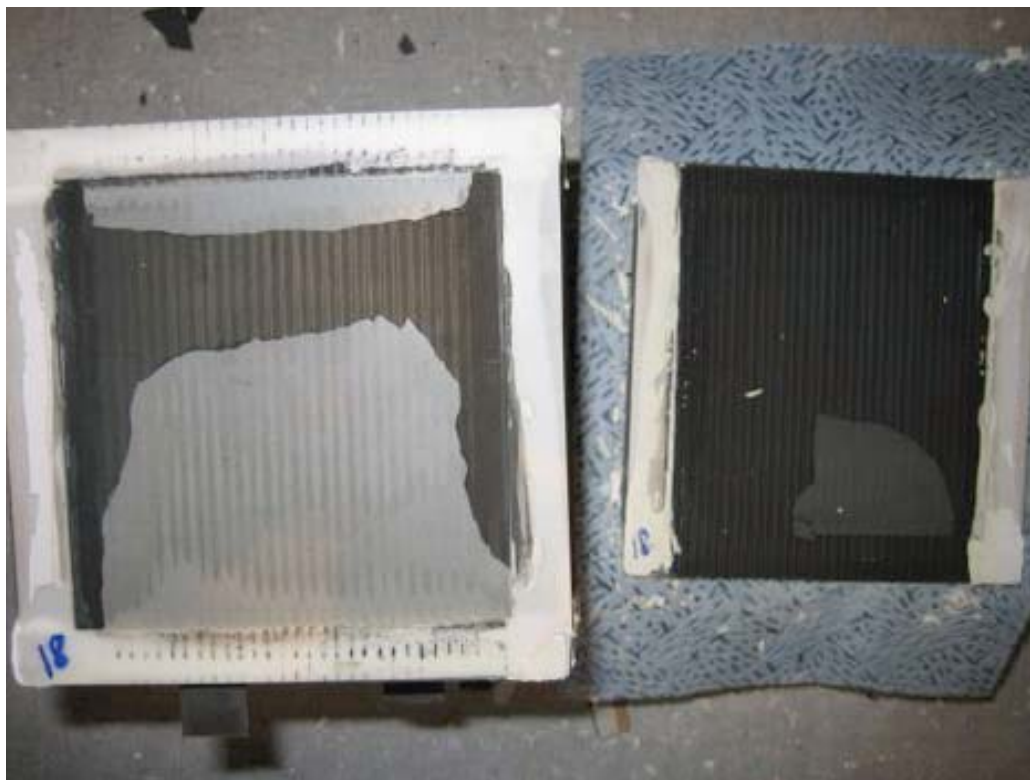
The air/oxygen electrodes of most cells have 50% or greater of the electrode area showing delaminating from the electrolyte. There were at least three cells with 100% delamination of oxygen electrode. The oxygen electrode was delaminated in large sections of roughly 2 cm × 2 cm that curled away from the electrolyte. Along the edges of the cell positioned inside the hydrogen inlet and exhaust manifolds, the electrode was still mostly attached, but darker in color. This may be an indication of a slight hydrogen leak through the edge seals. This leak rate was relatively low, since the electrode material was still intact and not crumbling off or greenish, as has been seen in stacks where hydrogen leakage was sufficient to partially reduce the perovskite. The exposed electrolyte underneath the delaminated electrode showed a dark stain at the locations that corresponded to the flow channel ribs. Figures 25 and 26 show typical air side cell and interconnect parts.

Figure 25. Cell and interconnect surfaces from the oxygen electrode side of Cell 18.

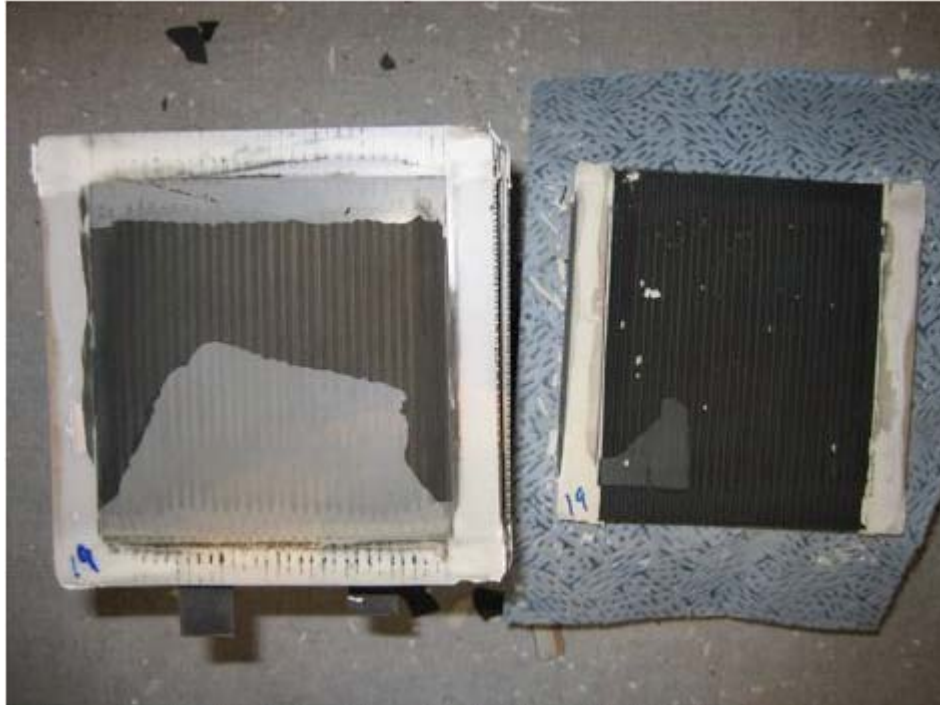
Figure 26. Cell and interconnect surfaces from the oxygen electrode side of Cell 19.

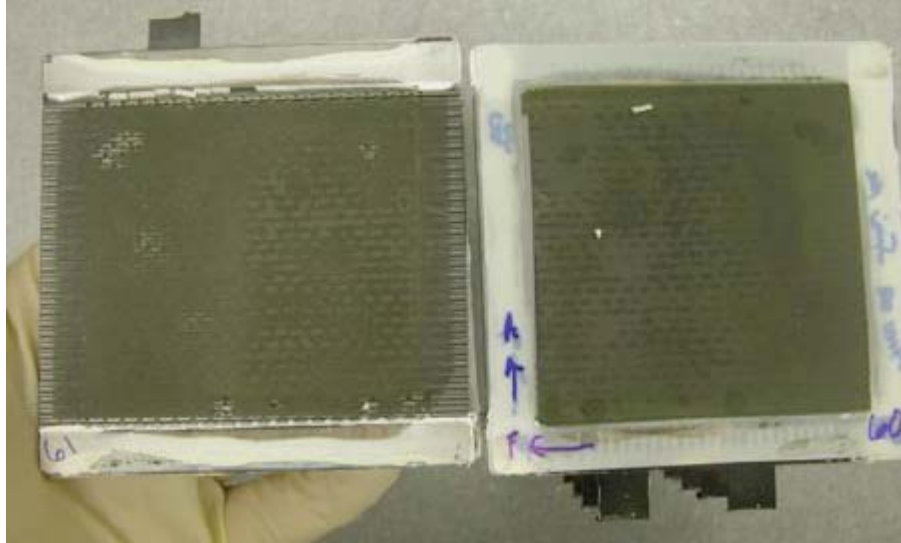
The hydrogen side appearance and resistance values of cells and interconnects from Stack 3B were almost identical to those of 3A, but it was slightly harder to separate the cells from the interconnects (Figure 27).

Figure 27. Hydrogen side cell and icon from Stack 3B.

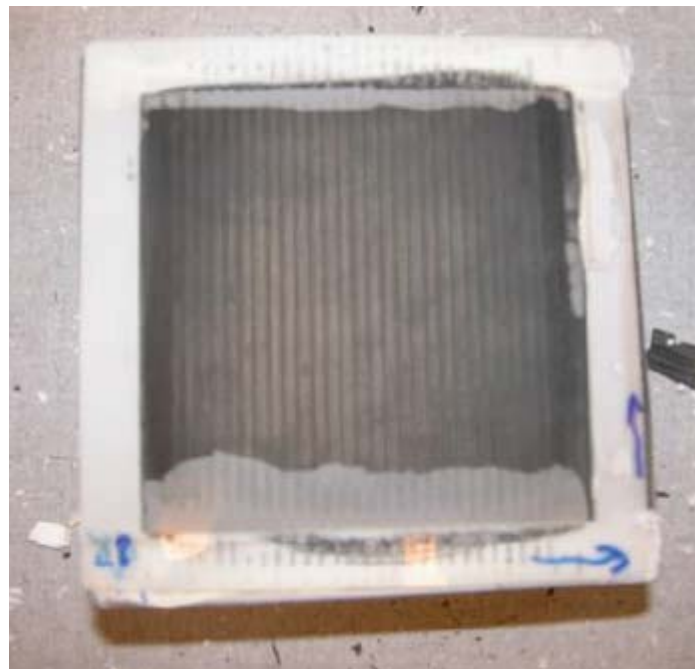
The oxygen electrode side of cells from this stack looked better than those from 3A, since the electrode was delaminated less, with most of the cells only having electrode delamination along the oxygen inlet and exhaust edges to a distance of only 0.5 cm to 2 cm (less than 25%). There were just a few cells that had over 50% delamination, with the exception of the cell in contact with the air single flow (bottom cell), which was 100% delaminated (Figure 28). The resistance measurements on the electrode and interconnect materials were in the same range as for Stack 3A.

Figure 28. Air electrode of a typical cell from Stack 3B showing less electrode delamination than seen in Stack 3A.

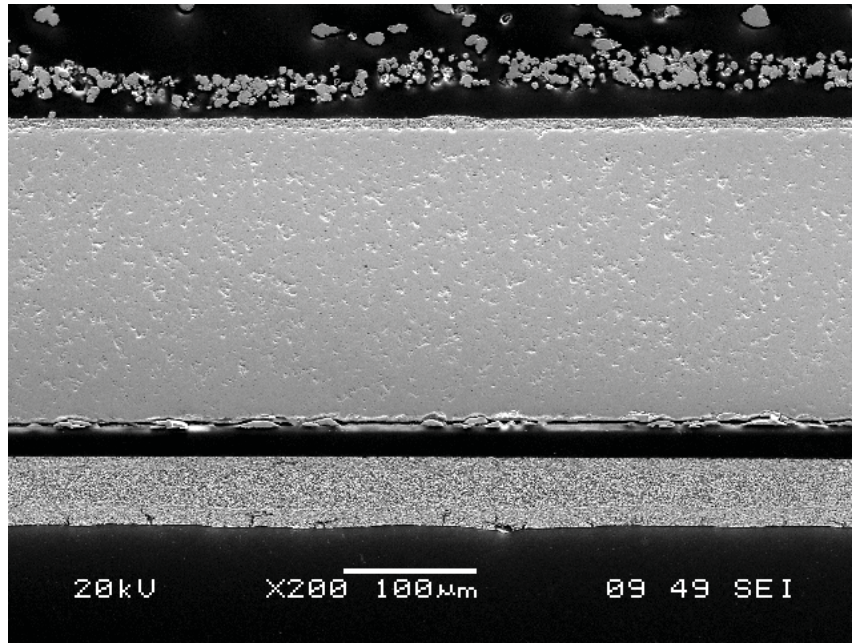
The hydrogen electrode appeared to be in good condition and no abnormal chemistry changes were noted (Figure 29). This is consistent with the findings reported by Argonne National Laboratory (Carter 2008). A cross section of the cell is shown in the image below. The hydrogen electrode is on top and the oxygen electrode is on the bottom. The hydrogen electrode bond layer appears to have pulled away in separating the stack from the interconnect; however, indications are that this was attached in operation. The oxygen evolution electrode does show delamination in operation and an apparent foreign layer deposited at the electrolyte interface.

Figure 29. Hydrogen electrode in normal condition.

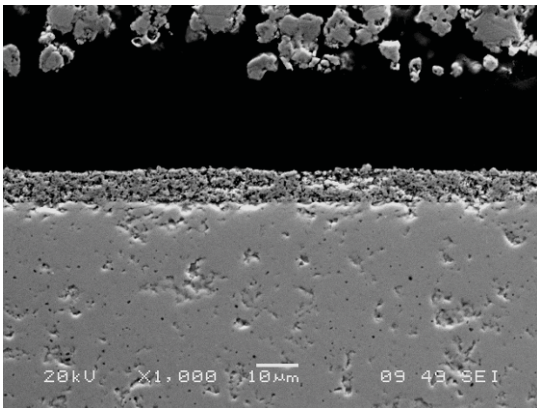
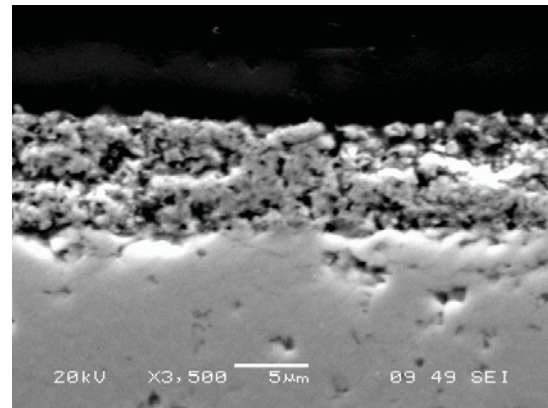
Current distribution layer (bond layer) got separated in disassembly (Figure 30).

Figure 30. Separated bond layer on the hydrogen electrode side.
