# Critical Causes of Degradation in Integrated Laboratory Scale Cells During High-Temperature Electrolysis

May 2009

**Idaho National Laboratory  
Idaho Falls, Idaho 83415**

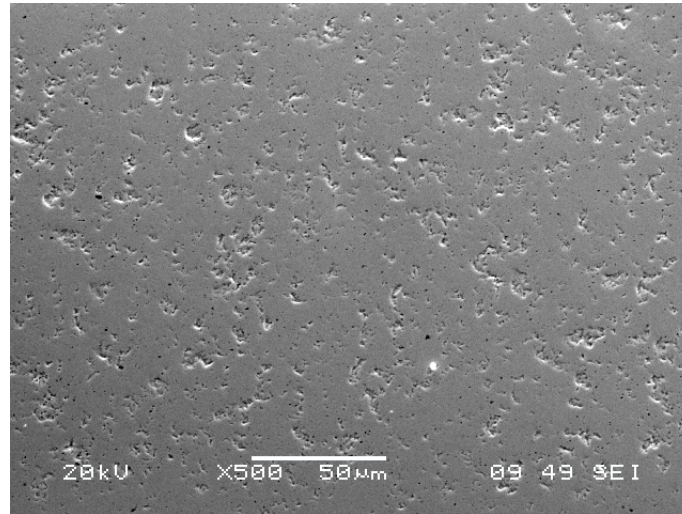
The 6Sc zirconia electrolyte material shows good density and no indication of excessive grain growth or microcracking (Figure 31).

Figure 31. Electrolyte in normal condition.

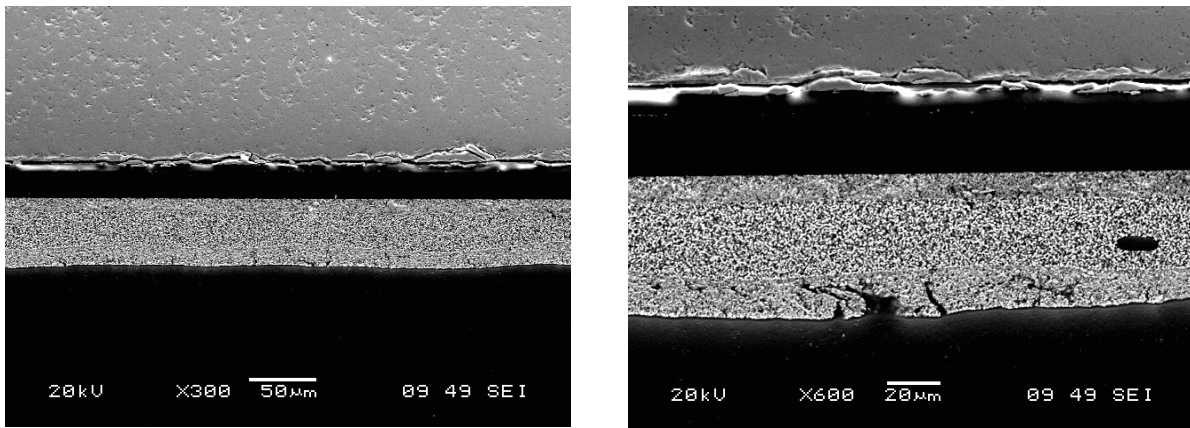
The oxygen electrode and current distribution layer (bond layer) remain attached to each other but the oxygen electrode has delaminated from the electrolyte as shown in Figure 32. Visually, it appears that there is a foreign layer deposited at the interface; however, energy dispersive X-ray spectroscopy (EDS or EDX) of the delamination region of the electrolyte shows only electrolyte materials (Figure 33).

Figure 32. Separation at the oxygen electrode-zirconia electrolyte interface.

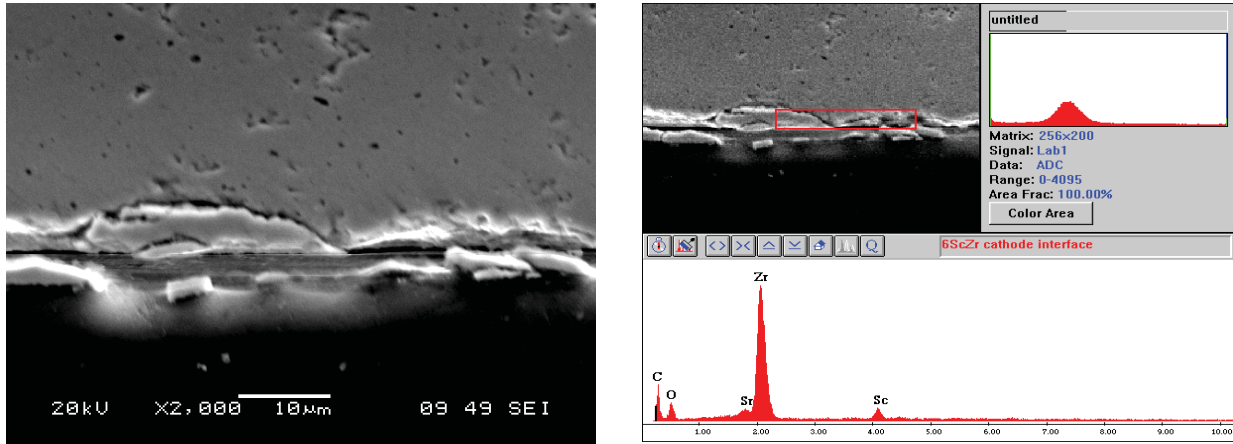
Figure 33. EDS picture (on the right) showing only zirconia electrolyte material at the interface.

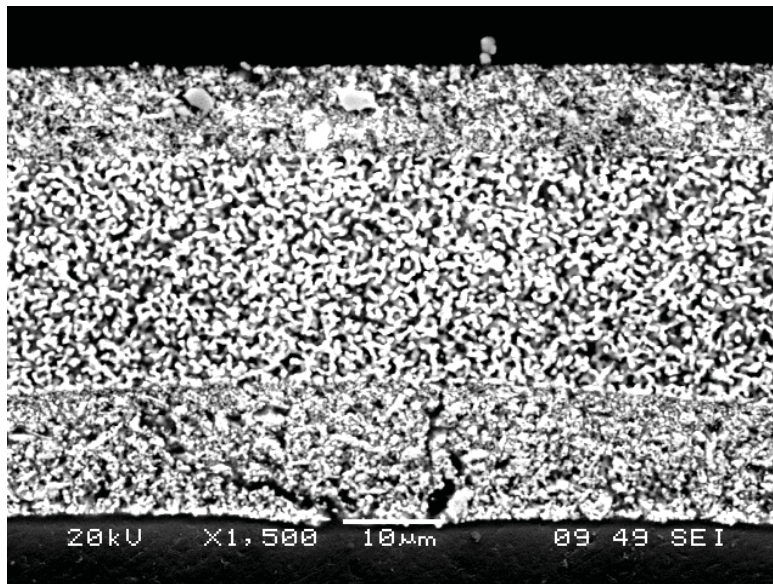
This view of the delaminated electrode and bond layer (Figure 39) shows the top layer (electrolyte interface) consisting of the manganite-zirconia composite, a center layer of manganite and an outer layer (interconnect interface) of lanthanum cobaltite. These layers are well attached to each other but have separated from the electrolyte.

Figure 34. Separation of oxygen electrode from the electrolyte.

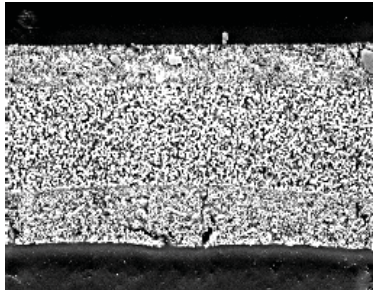
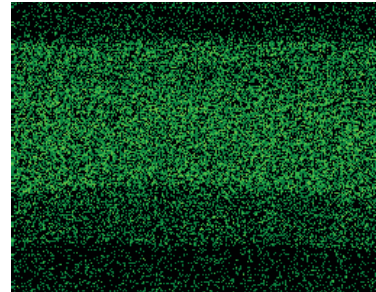
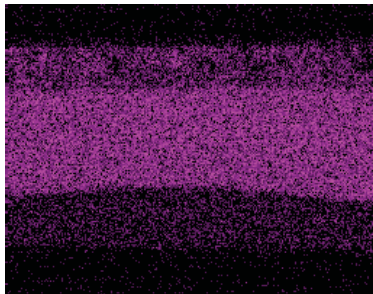
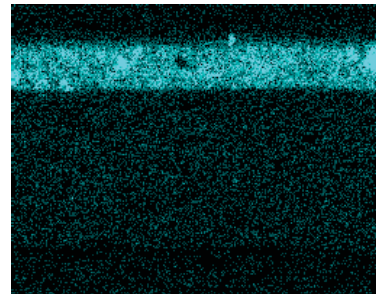
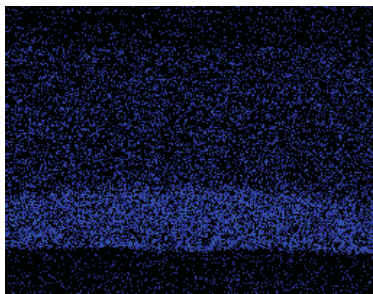
The element distribution maps (Figure 35) show the Zr in the composite layer and some migration of Sr, Mn, and Co between layers.

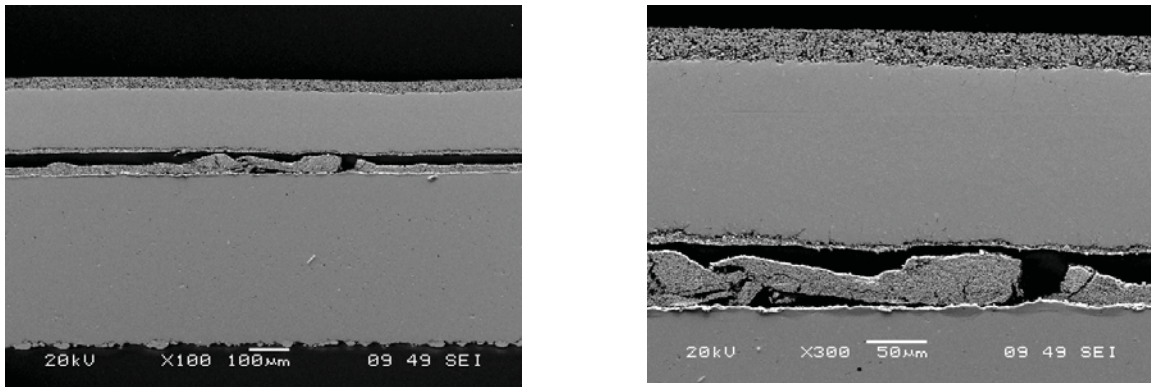
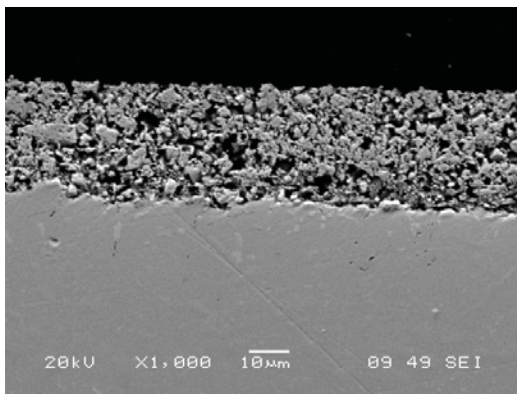
The oxygen electrode side flow channel and oxygen electrode separator plate are shown in Figure 36.

Oxygen electrode flow channel and oxygen electrode bond layer interface.

Figure 36. Oxygen electrode side flow channel (flow field) (upper) and oxygen electrode side flow channel-bond layer interface (lower).

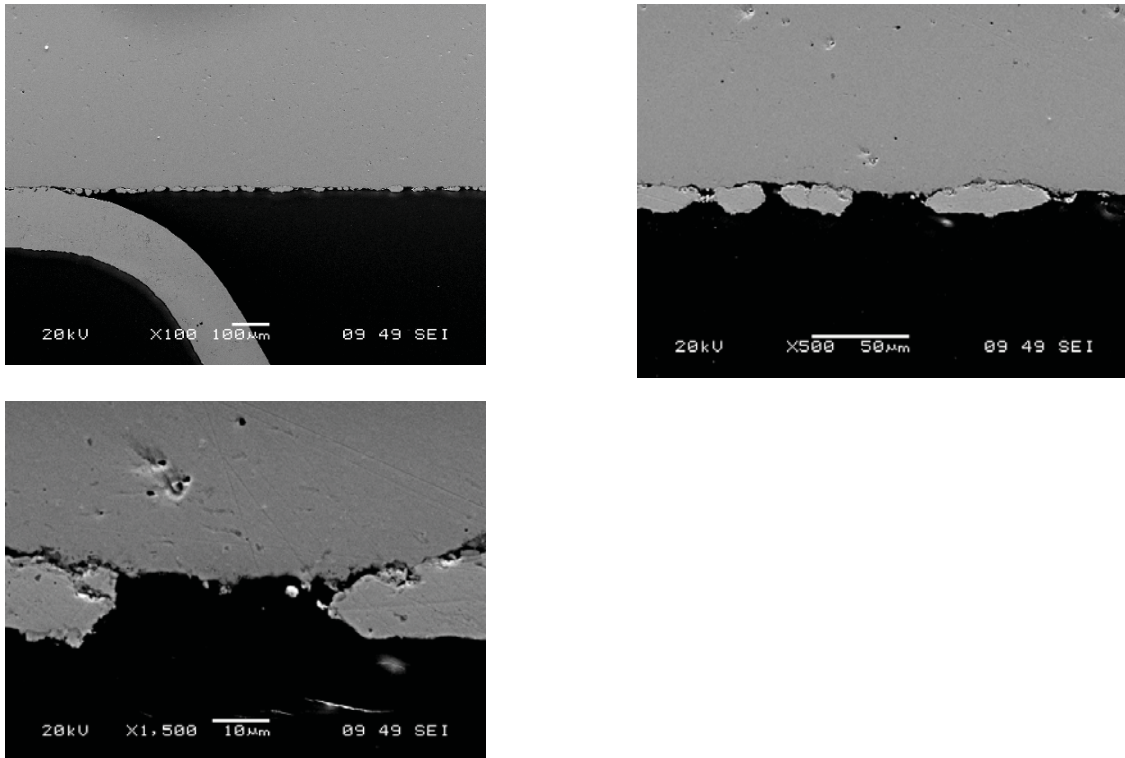
Hydrogen electrode side of separator plate is shown in Figure 37.

Figure 37. Separator plate- hydrogen electrode bond layer interface and hydrogen electrode bond layer.

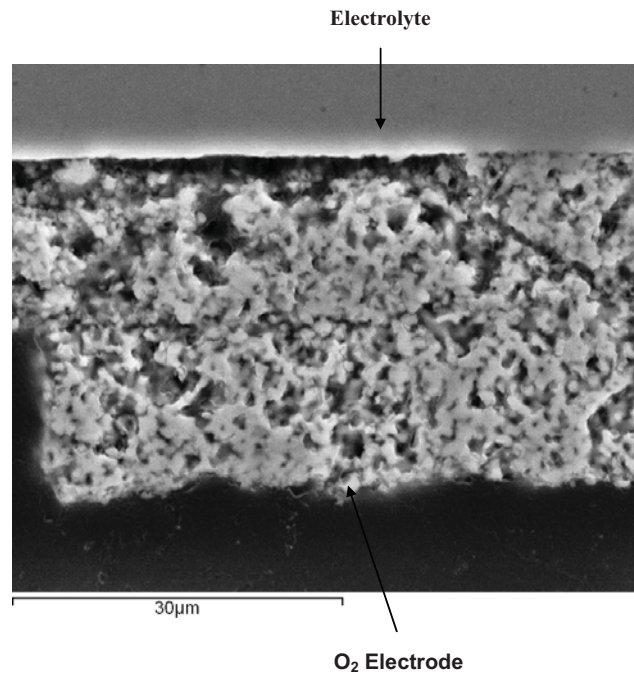
Some Ceramatec cells were examined by Argonne National Laboratory (ANL) and Mawdsley et al. (2007) presented results of a 1,000-hour test at  $\sim 830^{\circ}\text{C}$  (O'Brien et al. 2007). The cells were examined using four-point resistivity measurements, X-ray fluorescence, and Raman spectroscopy. The surface characteristics of cells and bipolar plates were examined for potential causes of long-term degradation. The X-ray fluorescence measurements revealed that during the test, Mn and Co from the oxygen electrode and bond layer showed no macroscale interdiffusion. On the other hand, Cr had diffused from the ferritic stainless steel bipolar plate toward the electrode-electrolyte interface preferentially through the active electrode area. Raman spectroscopy identified a monoclinic phase in the exposed regions of the zirconia plate near the edge of the plates, which gives evidence of the instability of the zirconia cubic phase. Also, Cr-doped  $\text{Al}_2\text{O}_3$  was identified in areas near the seal. SEM images showed delamination and cracking on the edges of the electrodes, where most of the cell degradation occurred. For example, the image in Figure 39 shows that the  $\text{O}_2$  electrode had begun to delaminate from the electrolyte near the edge where the four-point measurements had shown a large increase in resistivity. Cracks can also be seen within the  $\text{O}_2$  electrode, which would increase resistivity. Towards the center of the cell (right), adherence to the electrolyte improves and the cracks begin to disappear. If this delamination continues, it would be a source of cell degradation.

Figure 39. SEM view of the electrolyte and  $\text{O}_2$ -electrode (Mawdsley et al. 2007).

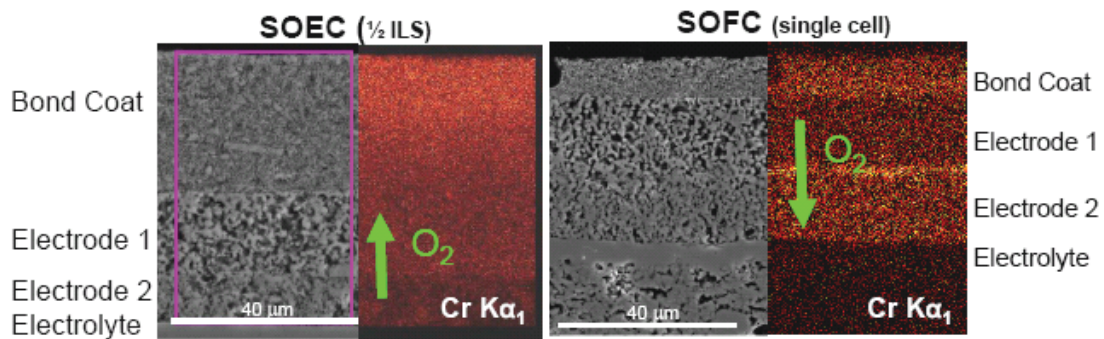
Figure 40. Chromium deposition in SOEC and SOFC (Carter et al. 2008).

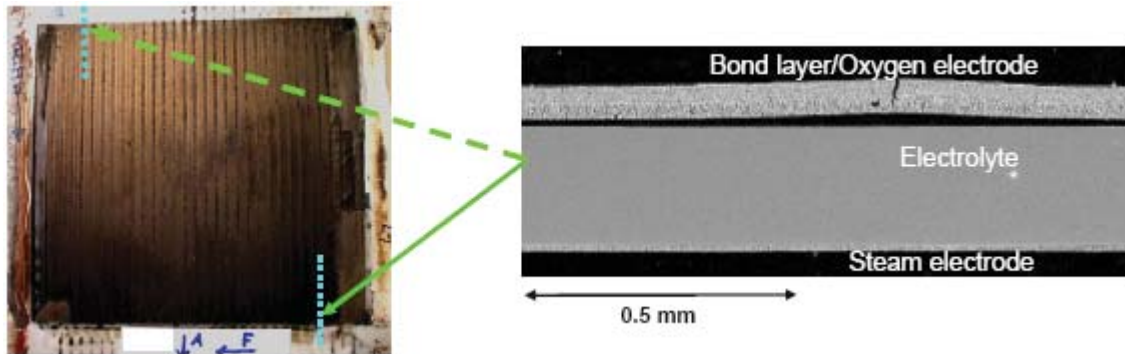
Figure 41. Electrode delamination after 1500 hrs of operation (Carter et al. 2008).

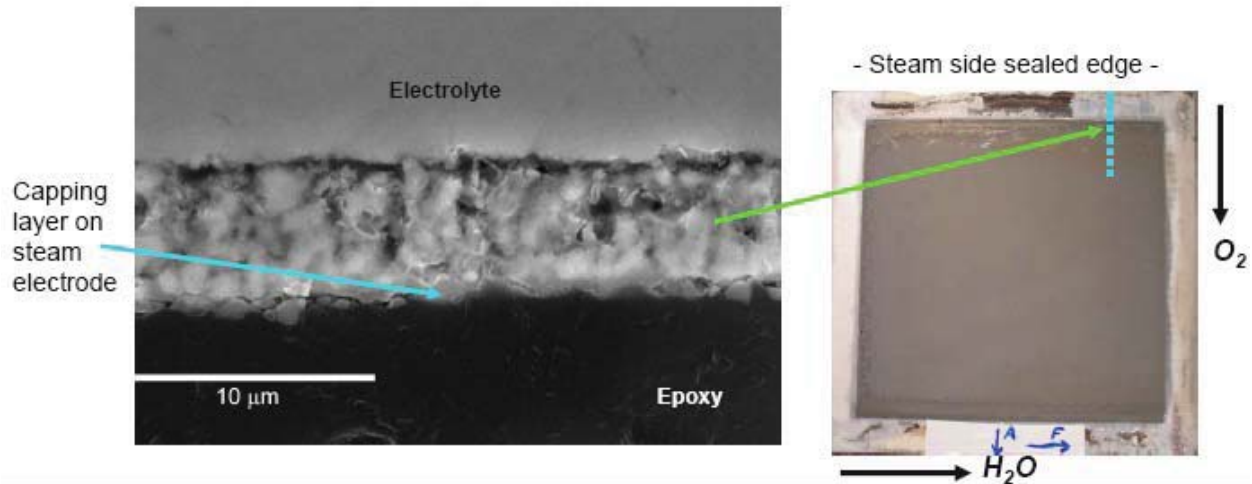
Steam at the steam/H<sub>2</sub>-electrode inlet can also carry Si from the seal and deposit it on the H<sub>2</sub>-electrode as shown in Figure 42 (Carter et al. 2008). SiO<sub>x</sub> can also come from interconnects, but the bond layer on the H<sub>2</sub>-electrode does not show the same kind of degradation/delamination as is seen on O<sub>2</sub>-electrode in Figure 41. Evidence of Mn, Si, and Ti deposition on the interconnect surface and interconnect-passivation layer interface was also found.

Figure 42. Si capping layer on H<sub>2</sub>-electrode (Carter et al. 2008).

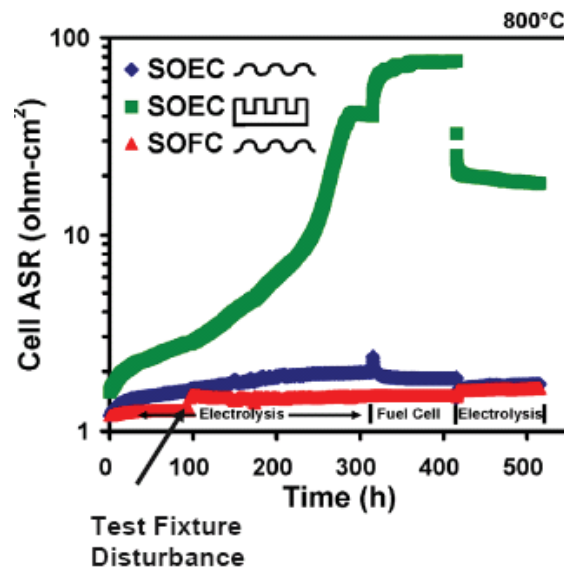
Figure 43. Some reversal of SOEC degradation (Carter et al., 2008).

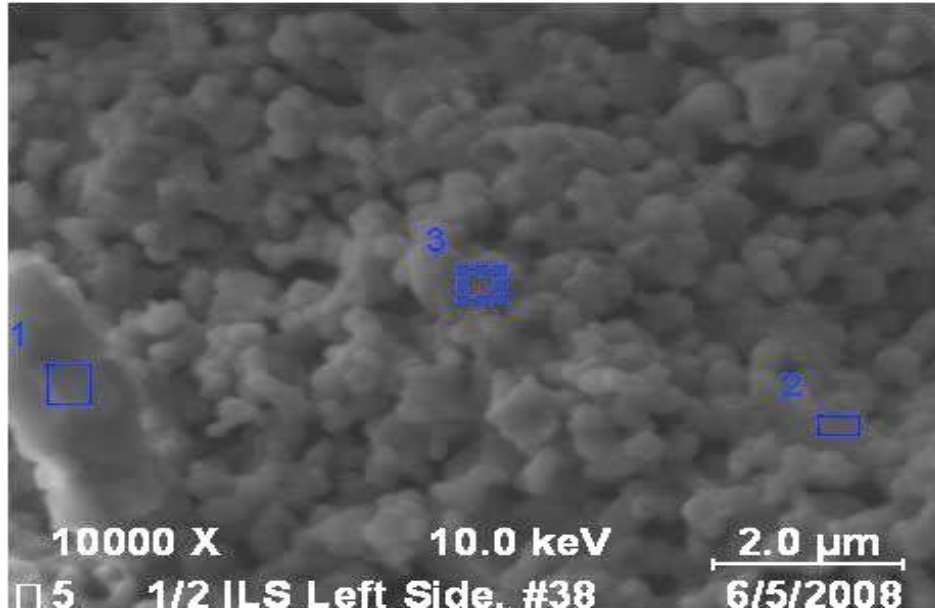
Element	O	Cr	La	Co	Cr/(La+Co+Cr)
Area 1	0.70	0.08	0.08	0.13	0.27
Area 2	0.57	0.01	0.38	0.04	0.02
Area 3	0.61	0.02	0.29	0.07	0.05

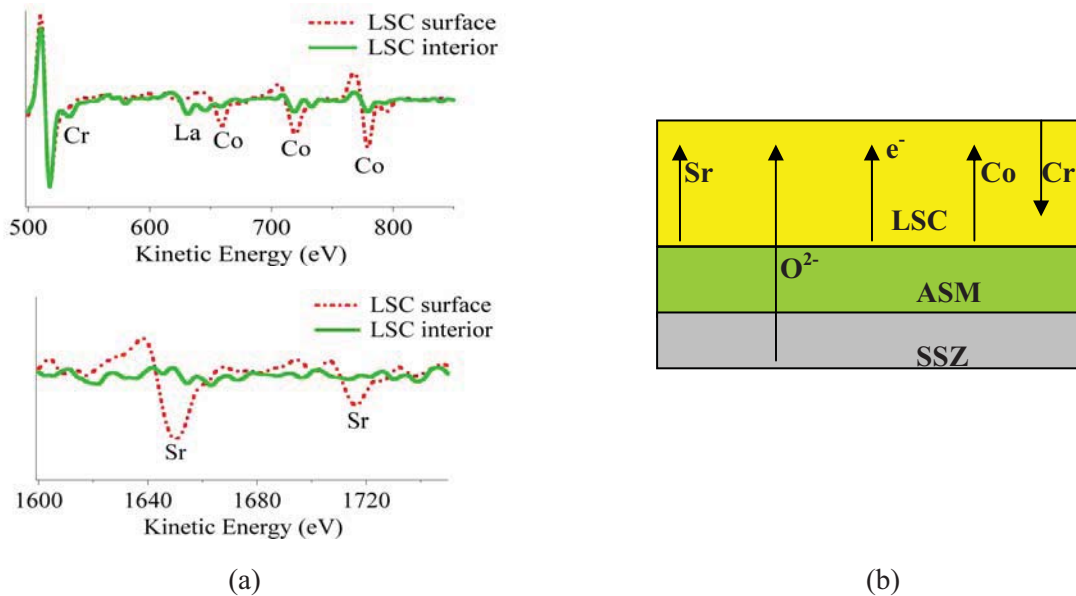
Figure 45. (a) AES spectrum comparing the Co-rich crystallites and the Sr-rich layer at the top of the LSC to the Co and Sr spectra from the LSC cross section. (b) Schematic for the transport of cations and charge carriers across the SOEC.

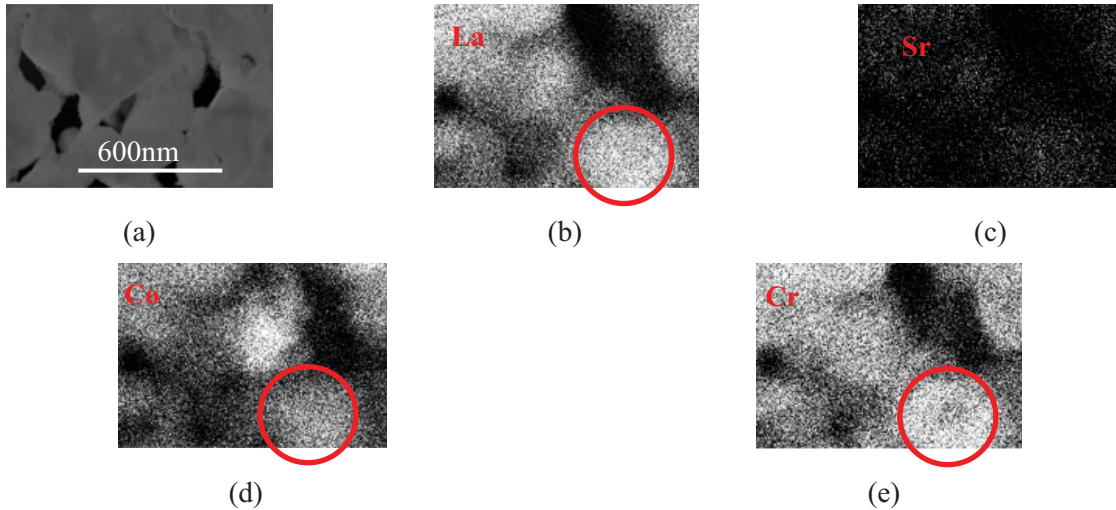
Figure 46. (a) A dark field TEM image in LSC ( $1.3 \mu\text{m} \times 0.9 \mu\text{m}$ ), with the elemental maps for (b) La, (c) Sr, (d) Co and (e) Cr.

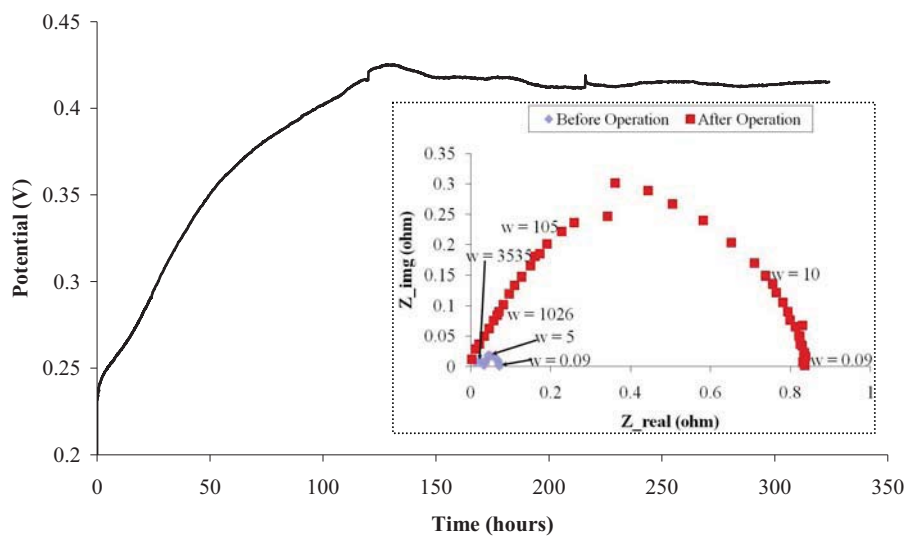
Figure 47. Performance for the reference half cell at  $0.4\text{A/cm}^2$  in air at  $820^\circ\text{C}$  degraded significantly during the first 125 hrs, and the anode + LSC resistance increased (inset).
