Investigation into Interface Lifting Within FSW Lap Welds

Trends in Welding Research, 8th International Conference

June 2008

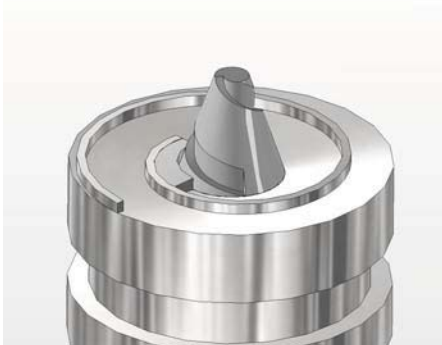
Figure 2: All tools were based on this scrolled pin and shoulder design. The tool with no scrolls was flat on the shoulder and the pin was smooth. The shoulder of the scrolled pin tool was also flat. The unscrolled pins were the dimensions of the pin above prior to cutting the scroll into it.

Four different tool designs, all made of T15 tool steel, were used in the conduct of our experiments and they differed in pin and shoulder configuration. The first tool was plain, i.e., it had no scrolls cut into it. The second tool was constructed with a scrolled shoulder and a plain pin, while the third tool was made with a plain shoulder and a scrolled pin. The fourth tool had a scroll on both the shoulder and the pin, see Figure 2.
