# Chief Joseph Kokanee Enhancement Project

## Strobe Light Deterrent Efficacy Test and Fish Behavior Determination at Grand Coulee Dam Third Powerplant Forebay

Annual Report 2005 - 2006

DOE/BP-00000652-33

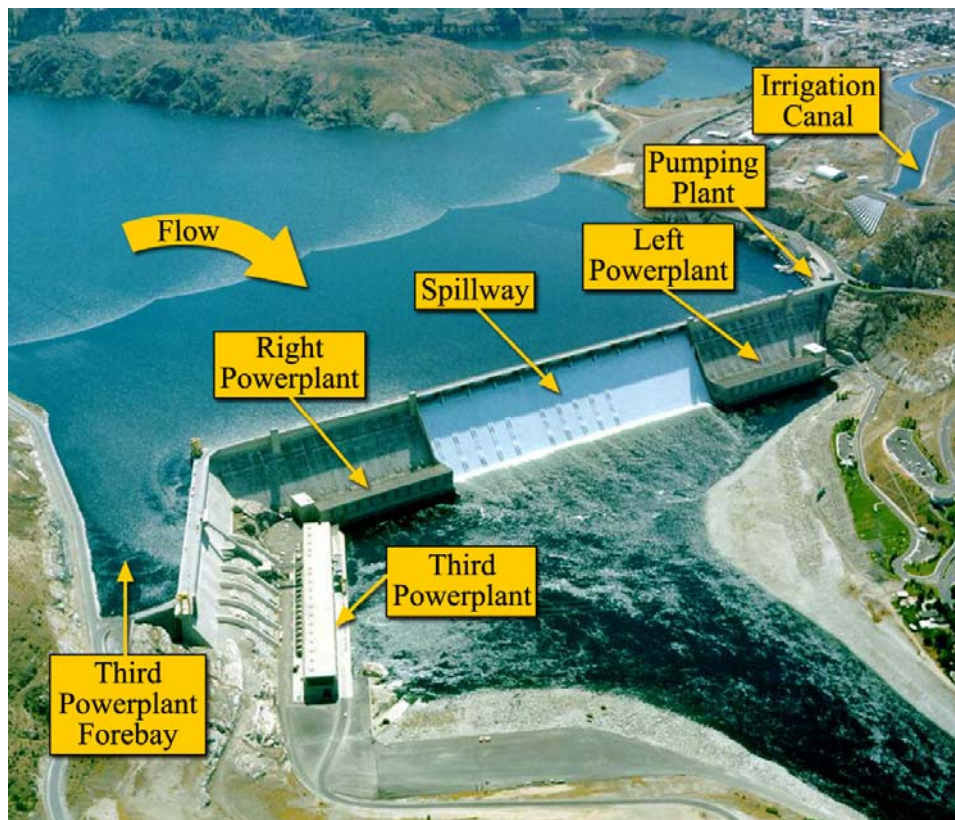
**Figure 2.2.** Location of Powerplants and Third Powerplant Forebay at Grand Coulee Dam

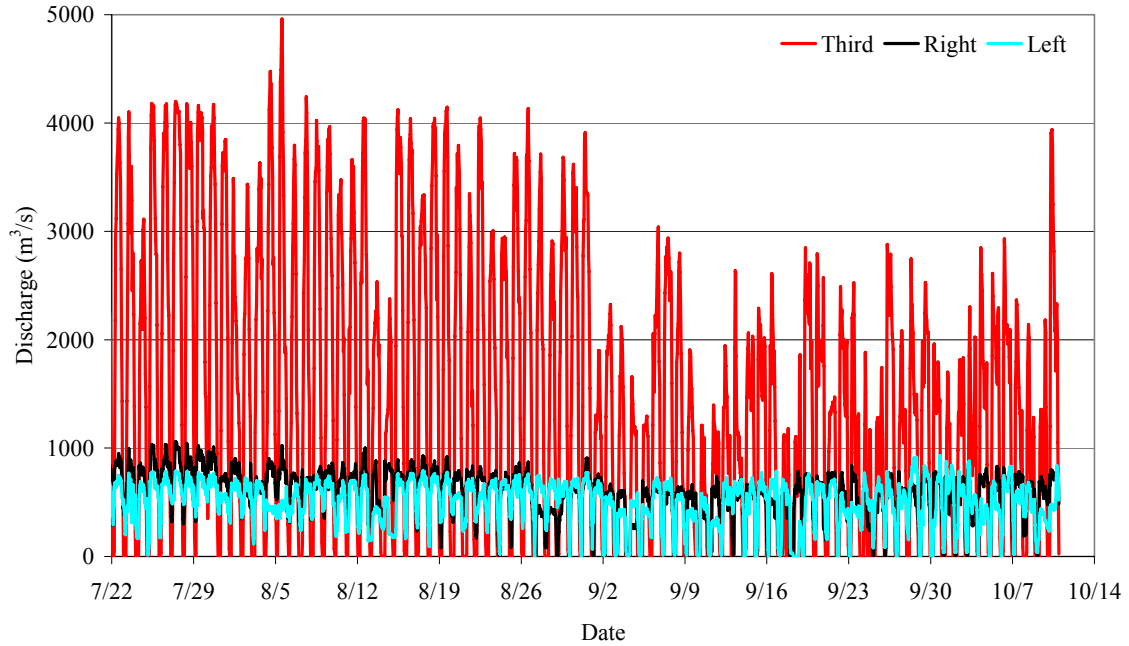
**Figure 2.3.** Discharge at Grand Coulee Dam from the Left, Right, and Third Powerplant During the 2005 Study Period

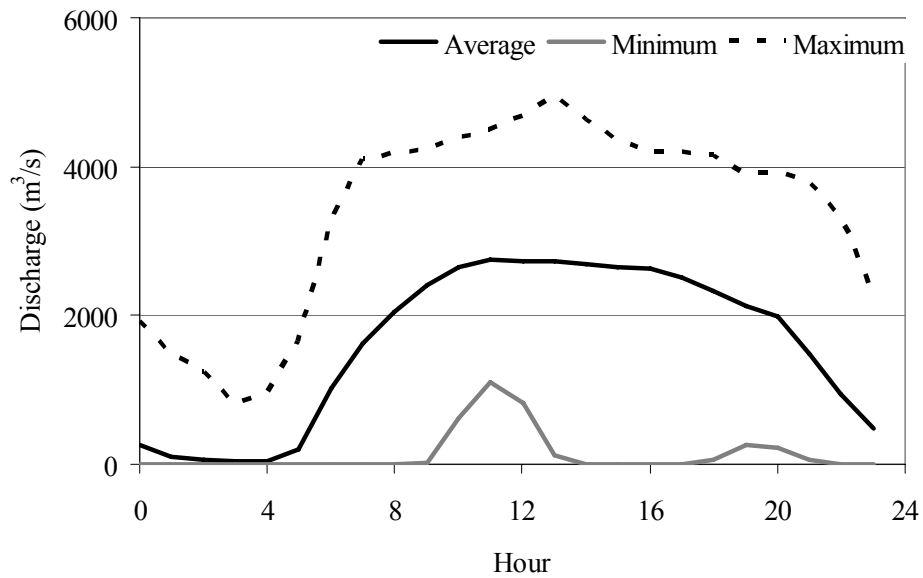
**Figure 2.4.** Average, Minimum, and Maximum Hourly Discharge at the Third Powerplant at Grand Coulee Dam Between July and October 2005. Zero hour is midnight.

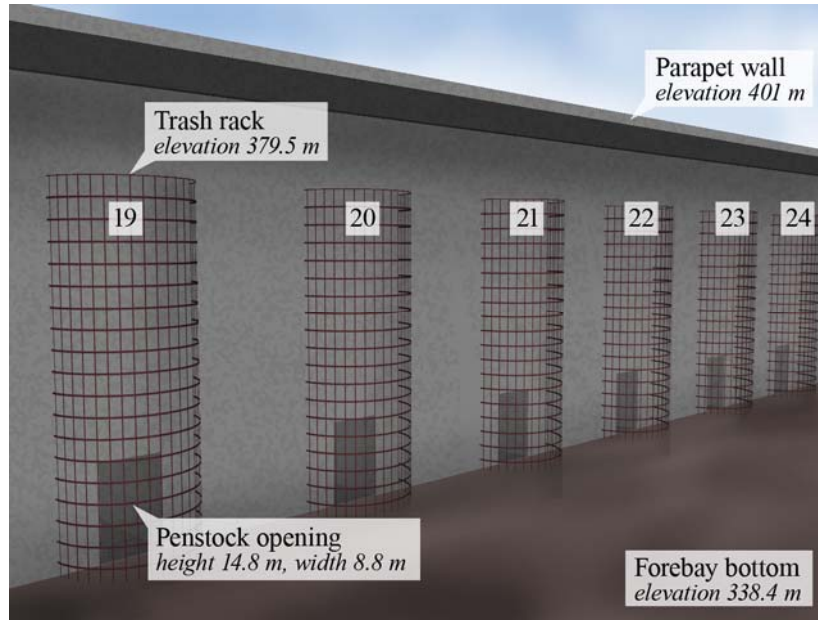
**Figure 2.5.** Turbine Unit Locations in Third Powerplant, Grand Coulee Dam

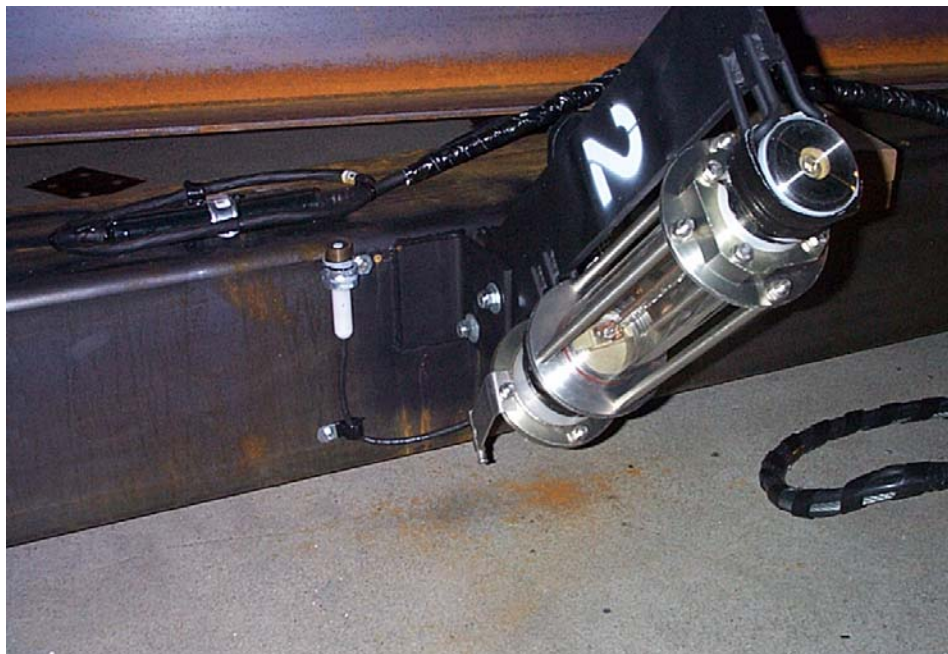
**Figure 3.1.** Aquatic Guidance Lighting Strobe Light Attached to Steel Beam for Deployment at Grand Coulee Dam in 2005

Four FH-920-1 Aquatic Guidance Lighting™ strobe lights (manufactured by Flash Technology, Franklin, Tennessee) were used in the study (Figure 3.1). These lights are omni directional with a beam spread of 360 degrees in the horizontal direction and 100 degrees in the vertical direction. The strobe lights produced approximately 20,000 lumen-s/flash with the flash rate set at 360 flashes per minute. Each strobe light was controlled by a control box linked via RS485 communication to a control panel. The control panel was operated manually using a circuit breaker switch.

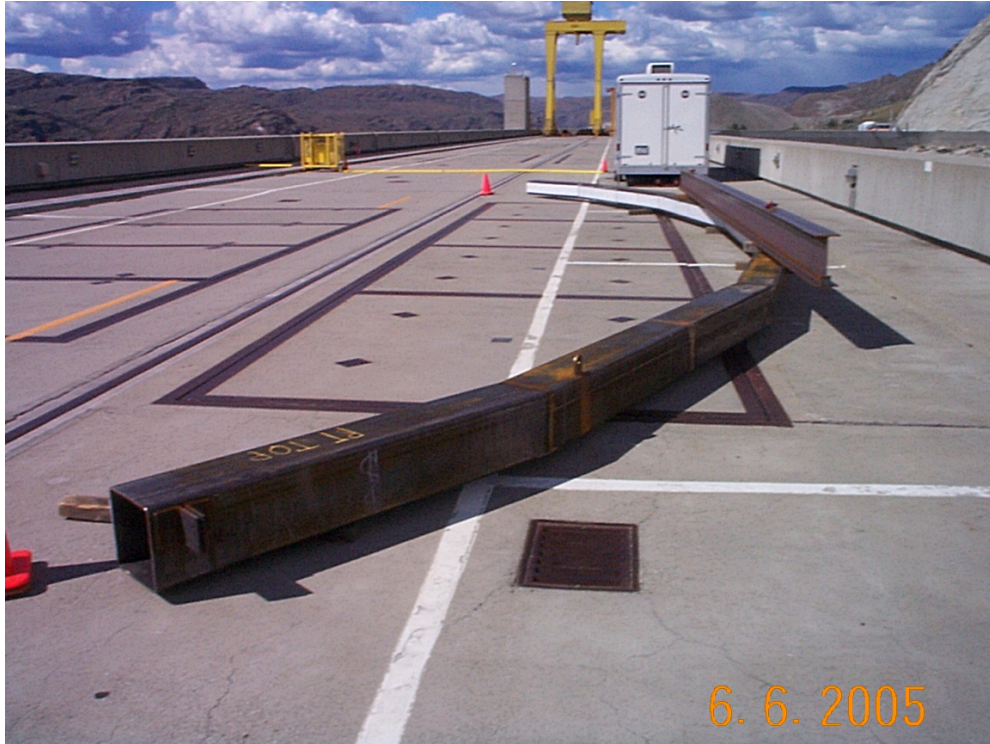
**Figure 3.2.** Strobe Light Assembly Bar (pictured prior to attaching strobe lights) with 11.3-m Lifting I-Beam on Top

The four strobe lights were attached to bracket bars measuring 10.2 cm × 68.6 cm × 1.3 cm. These bracket bars were attached to a 0.95-cm × 30.5-cm × 20.9-m strobe light assembly bar, which was designed to follow the contour of the trash rack in front of the penstock opening (Figure 3.2). The strobe lights were spaced approximately 6.2 m apart along the bar and adjusted to a 45-degree downward tilt angle. The light bar was positioned directly in front of the trash rack opposite the top of the penstock opening of turbine unit 21 (Figure 3.3). The placement of the bar and the tilt of the strobe lights provided maximum illumination above the penstock opening behind the trash rack and in front of the trash rack opposite the penstock opening.

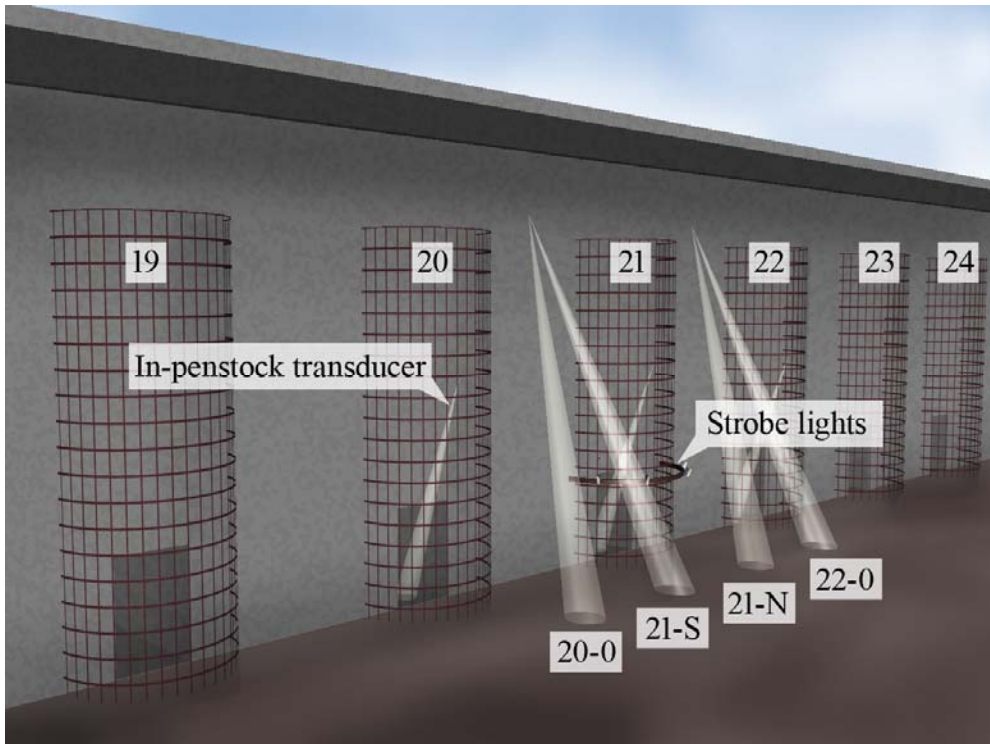
**Figure 3.3.** Transducer and Strobe Light Placements with Respect to Third Powerplant Turbine Units

Splitbeam transducers were attached to the trash racks of Units 20, 21, and 22 (Figure 3.3). The trash-rack-mounted transducers were lowered into position from the deck of the dam using attached underwater video cameras to locate openings in the trash rack, and a boat tethered to the face of the dam to assist in positioning the mount. The transducers were placed 12.2 to 15.2 m above the penstock openings and oriented to look inside the opening, with depth depending on ability to pass the mounts through the trash racks at a specific location. Some areas of the trash racks were so badly corroded or bent that it was difficult to insert the transducers into openings in the trash rack using the underwater video. To accommodate placement of these transducers, each was attached to a mount assembly hanger containing a motorized actuator (Figure 3.4). The motorized actuator made it possible to retract the transducer during insertion through the trash rack while the frame of the hanger protected the transducer during deployment. Once the transducer was in place, the actuator rotated it into position so that the top and bottom of the penstock opening were acoustically visible (Figure 3.5). The remaining four transducers were mounted in pairs between Units 20 and 21 and between Units 21 and 22 (Figures 3.3 and 3.6). The transducer pairs were attached to the wall of the dam at the bottom of a 7.3-m pole. One transducer in each pair was aimed at the area in front of the lights on Unit 21, while the other was aimed in front of the adjacent turbine unit (either Unit 20 or 22).

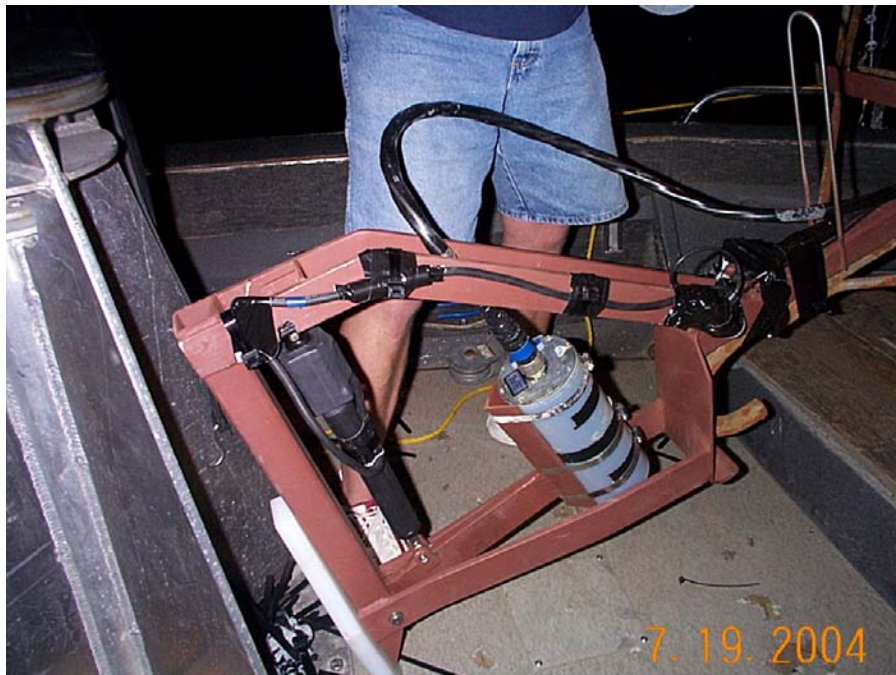
**Figure 3.4.** Splitbeam Transducer and Motorized Actuator on Trash-Rack Mount

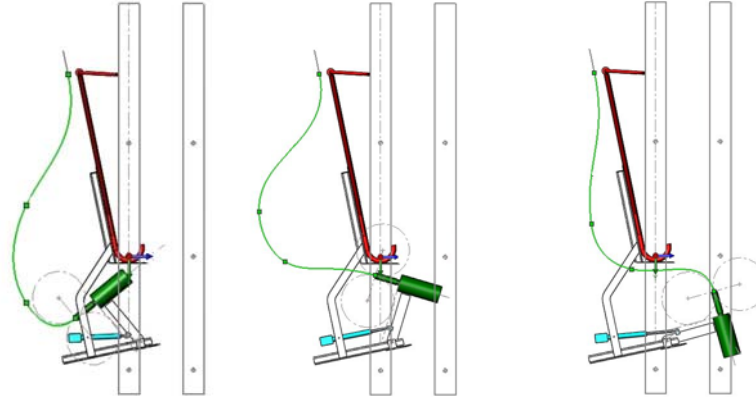
**Figure 3.5.** Trash-Rack-Mounted Splitbeam Transducer (left to right: fully retracted; partially retracted; fully deployed). Splitbeam transducer is pictured in green; motorized actuator is in blue.

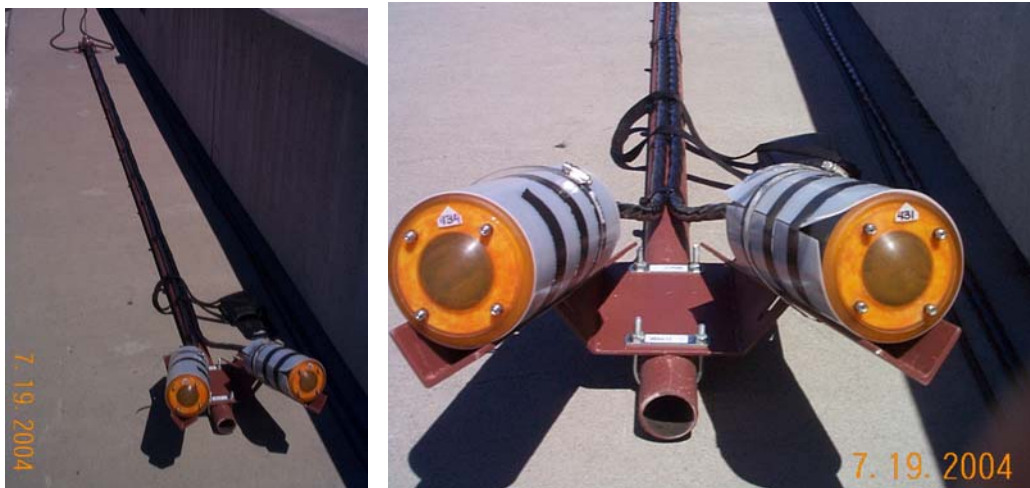
**Figure 3.6.** Wall-Mounted Splitbeam Transducers (pictured with acoustic lenses that were later removed; see discussion in Appendix B)

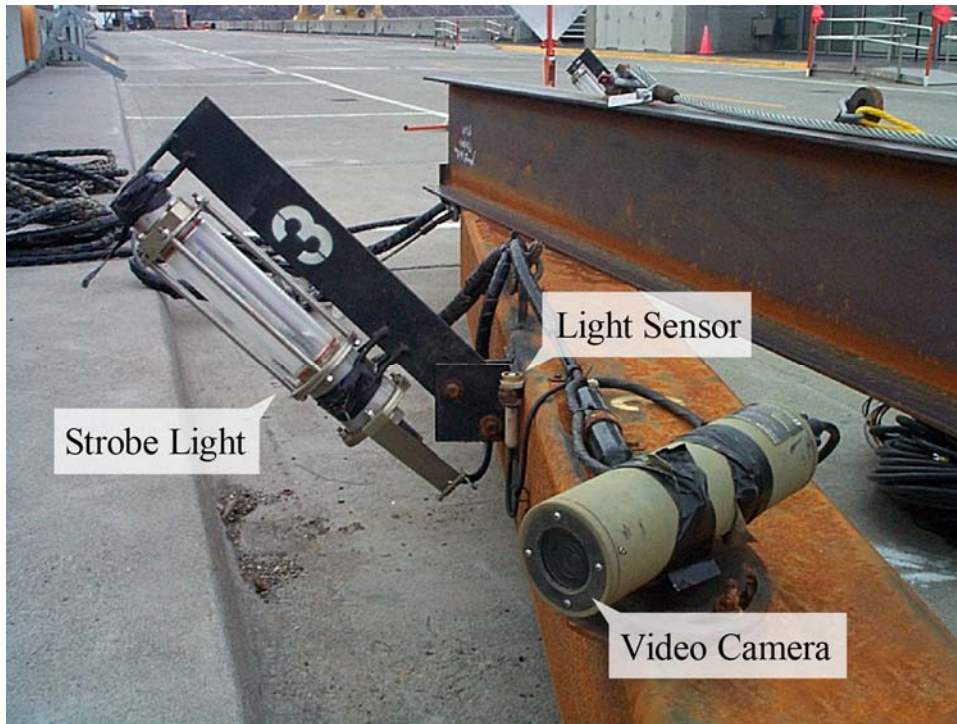
**Figure 3.7.** Strobe Light 3, Light Sensor, and One of Two Video Cameras (shown post-deployment)

Two video cameras (JAI CV-M10 SX Progressive Scan with Tamron 23FM08-L 8-mm locking lenses) were mounted on top of the strobe light bar in underwater housings (Figure 3.7). The cameras were positioned to capture images directly in front of the center of the trash rack between the center two strobe lights. The cameras were designed to record in sync with the strobe lights. However, because of problems with this feature, the cameras operated only from September 7, 2005, until September 24, 2005. In addition, video was recorded only when the strobe lights were on; data were stored on VHS videotape.

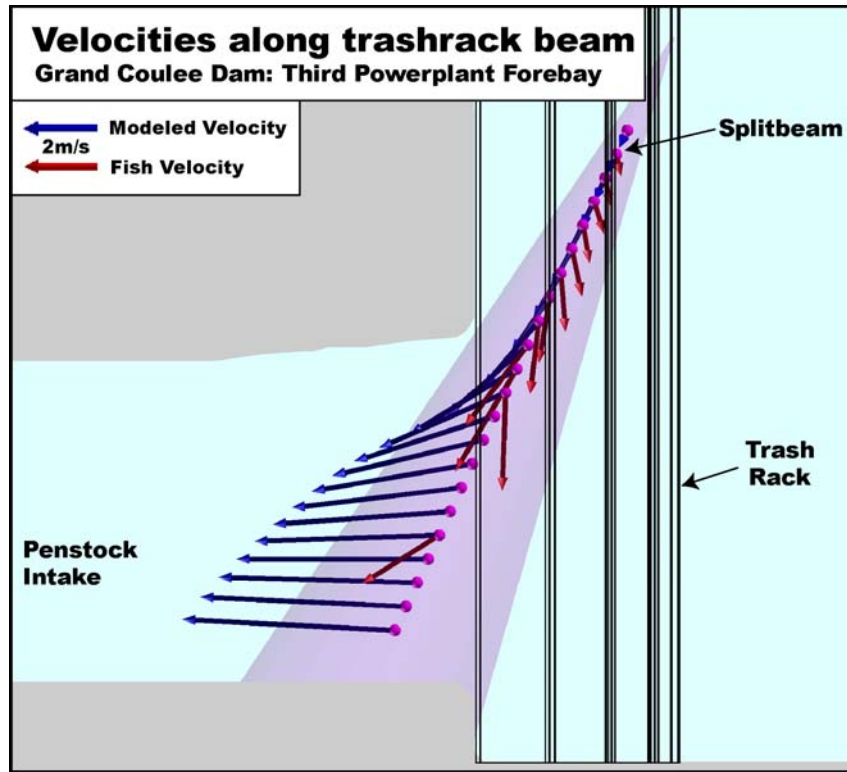
**Figure 4.1.** Average Direction of Travel and Velocity for Fish Detected Inside the Trash Racks at Turbine Units 20, 21, and 22. Water velocities shown are simulated for August 20, 2005, conditions at Unit 21 for comparison.

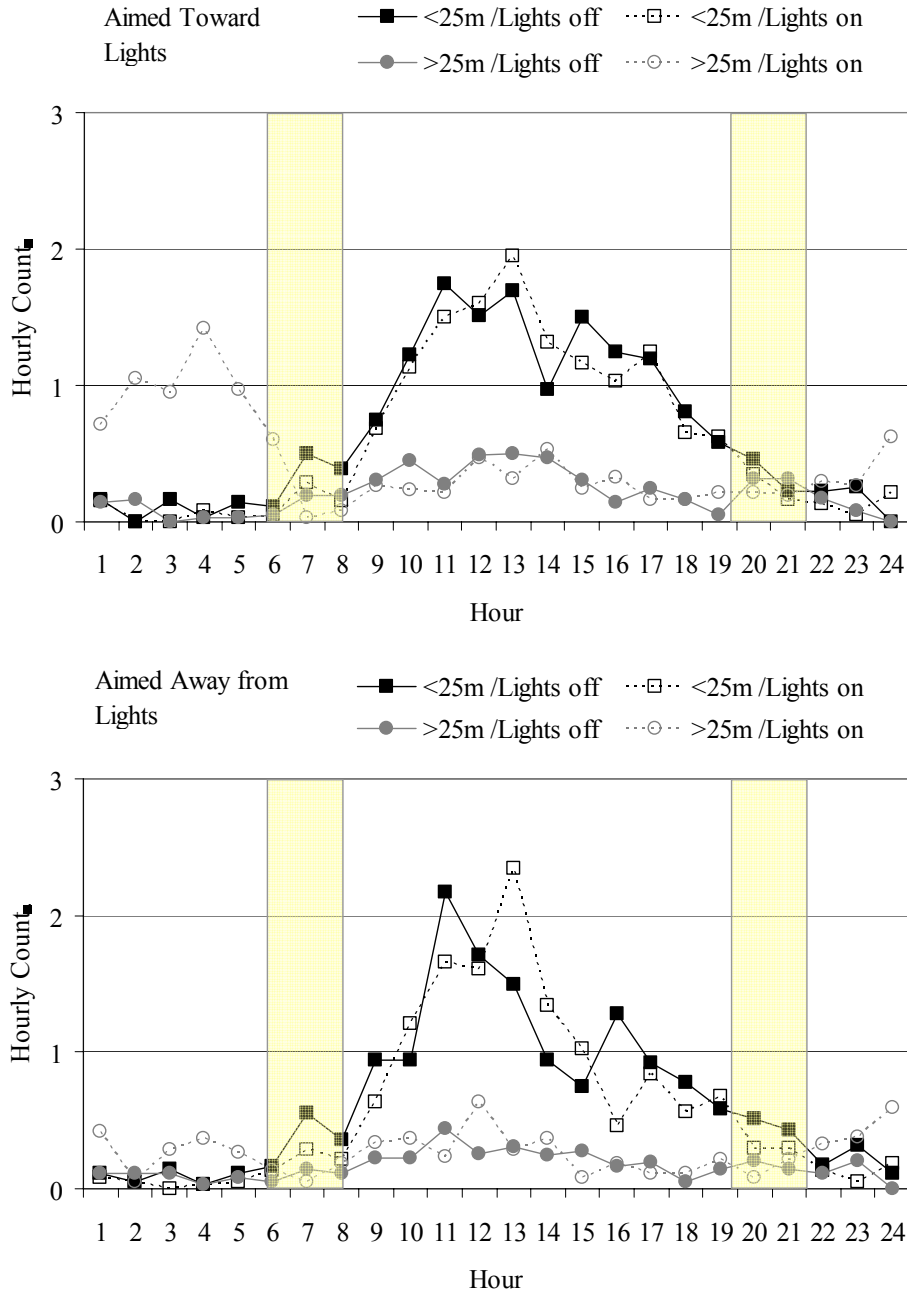
**Figure 4.2.** Average Hourly Counts of Fish Detected by Splitbeam Transducers Aimed Toward (21-N and 21-S) and Away (20-O and 22-O) from the Strobe Lights When the Lights Were Off and On. The water column was divided into two depth ranges: <25 m and >25 m from the splitbeam transducers. Shaded areas are sunrise and sunset periods. Hours are military time.

Approximately 72 hours of video recordings were made when the strobe lights were on. Six fish were close enough to the camera to be identified (see Figure 4.8 for two examples), and these appeared to be either walleye or salmonids. Other fish species noted in the forebay were bass, seen by observers standing on the deck of the dam and in boats adjacent to the face of the dam during the daytime. These fish appeared to be at the same depth as the transducers (i.e.,  $<25$  m) and coincided with times when large numbers of targets were detected by the transducers in the upper part of the water column during the daylight hours (Figure 4.2).

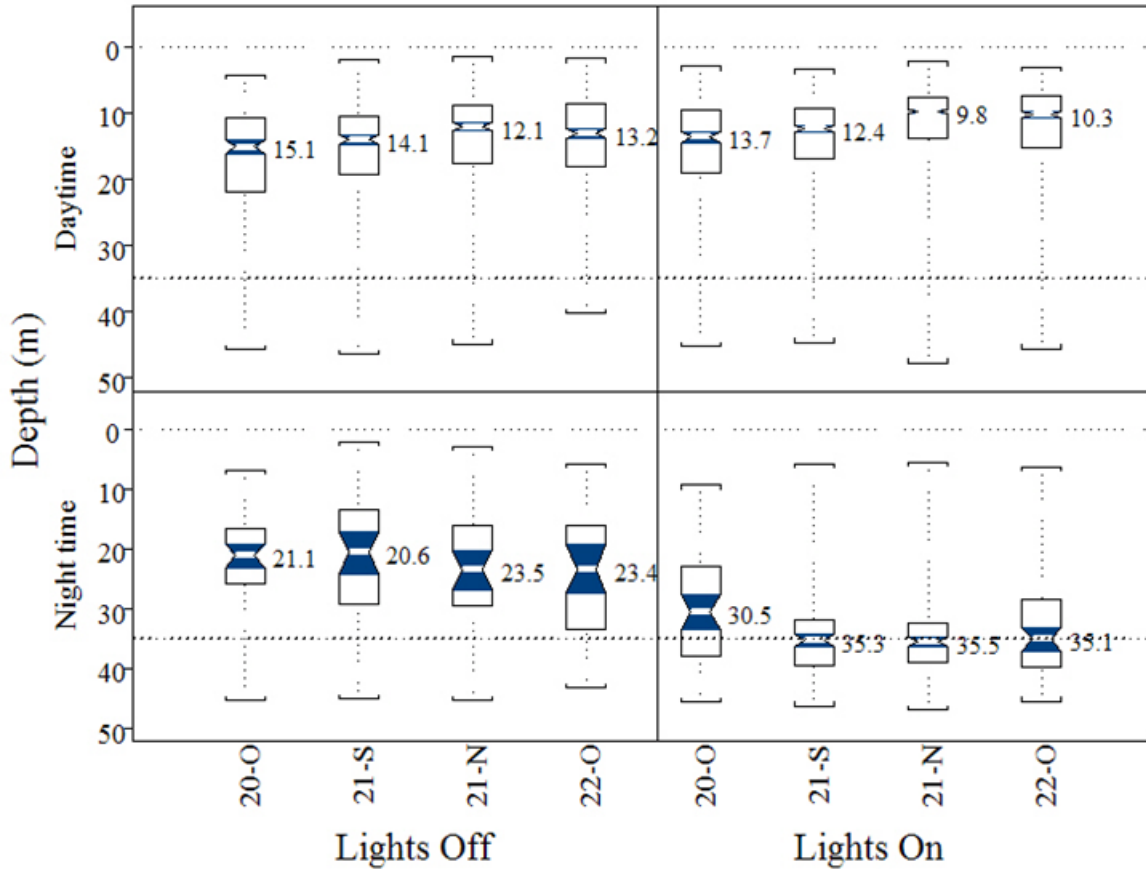
**Figure 4.3.** Depth Distribution for Fish Targets Detected Outside the Trash Racks During Daylight and Nighttime Hours When the Strobe Lights Were Off and On. Splitbeam transducers 20-O and 22-O were aimed in front of turbine units 20 and 22, respectively; 21-N and 21-S were aimed in front of turbine unit 21, one from the north and one from the south. The grey dashed line indicates the approximate depth of the strobe lights relative to the splitbeam transducers. The boxes represent the middle 50% of the data (25th to 75th percentile); the notch represents the median. Lines bracketing the boxes are the widths of the 1st to the 99th percentile.

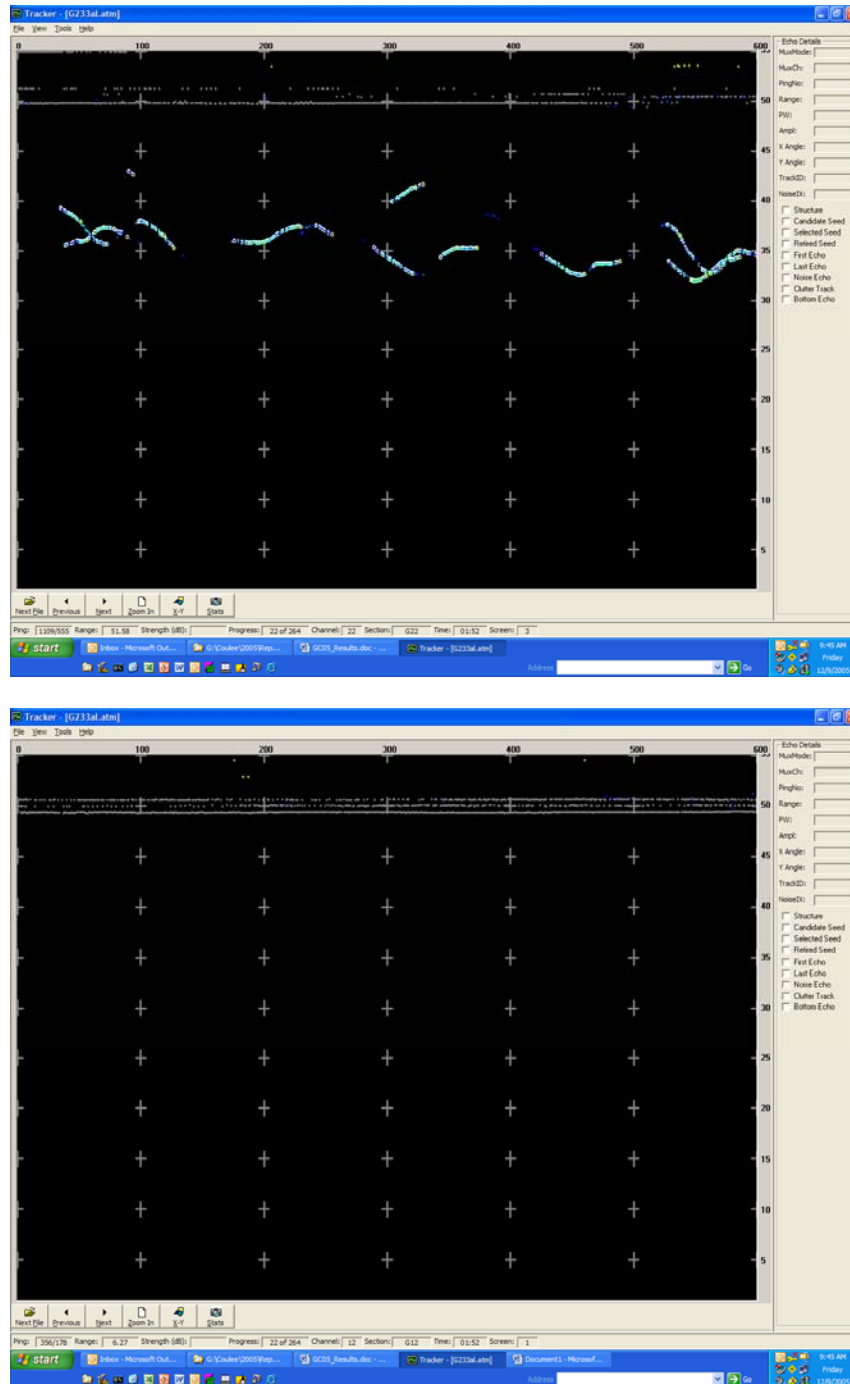
**Figure 4.4.** Screen Shot of Raw Data Collected by Multiplexed Splitbeam Transducers Aimed Outside the Trash Racks. Top shows data collected by transducer 21-N aimed toward the strobe lights on Unit 21. Bottom shows data collected by transducer 22-O aimed in front of the trash rack at Unit 22. Data were collected on August 21, 2005, at 1:52 a.m. when the lights were on. The x-axis is time (0 to 600 s); the y-axis is distance from the transducer (0 to 55 m; axis reversed). The targets on the top half of the figure are at approximately 35 m.

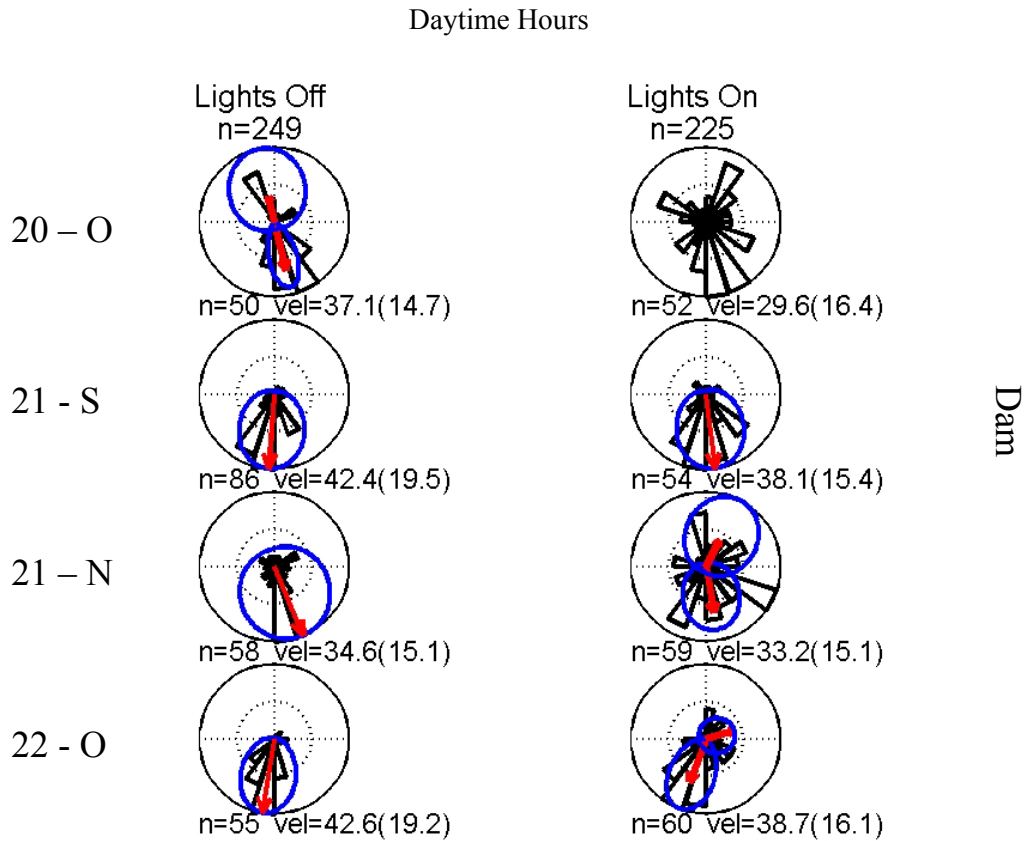
**Figure 4.5.** Horizontal Component of Swimming Direction for Fish Detected Between 25 and 50 m from the Splitbeam Transducers (strobe lights at 35 m) During Daylight Hours When the Strobe Lights Were Off and On. Arrows are the mean vectors for the distribution; blue ovals are the probability densities for the fitted Von Mises distribution (1 oval – unimodal; 2 ovals – bimodal; none – uniform). Sample size (n), mean swimming speed (vel, cm/s), and standard deviation are given for each distribution.

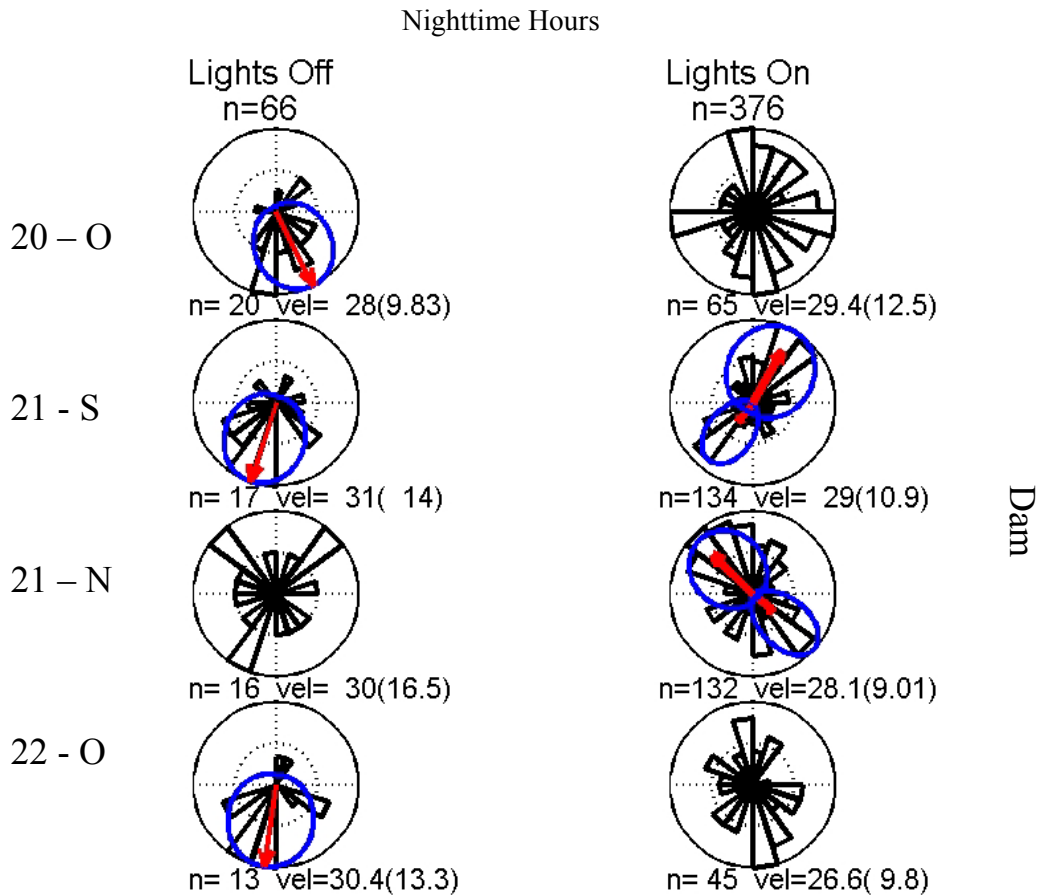
**Figure 4.6.** Horizontal Component of Swimming Direction for Fish Detected Between 25 and 50 m from the Splitbeam Transducers (strobe lights at 35 m) During Nighttime Hours When the Strobe Lights Were Off and On. Arrows are the mean vectors for the distribution; blue ovals are the probability densities for the fitted Von Mises distribution (1 oval – unimodal; 2 ovals – bimodal; none – uniform). Sample size (n), mean swimming speed (vel, cm/s), and standard deviation are given for each distribution.

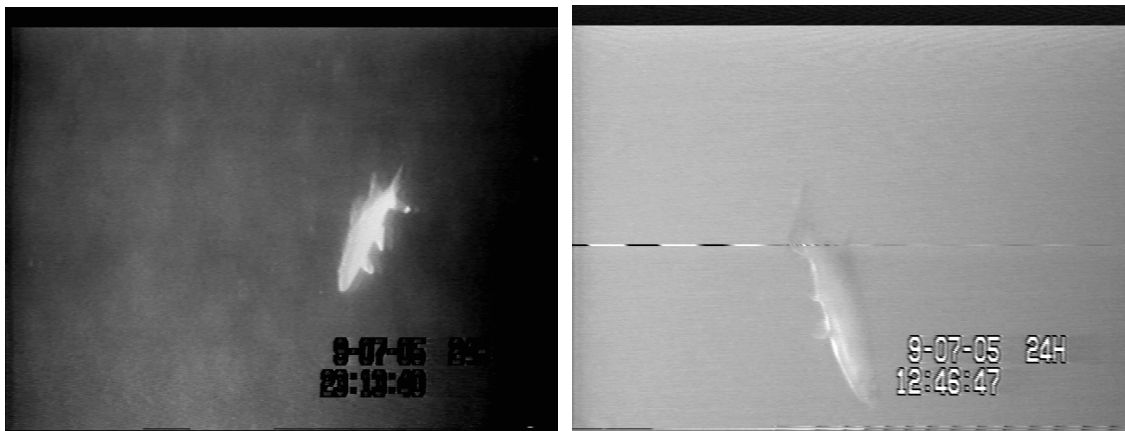
**Figure 4.8.** Fish Images Captured by Video Cameras Positioned near the Strobe Lights in Front of the Trash Rack on Turbine Unit 21. Image to the left appears to be a walleye (note white tip on tail and double dorsal fins), while the one on the right is a salmonid.

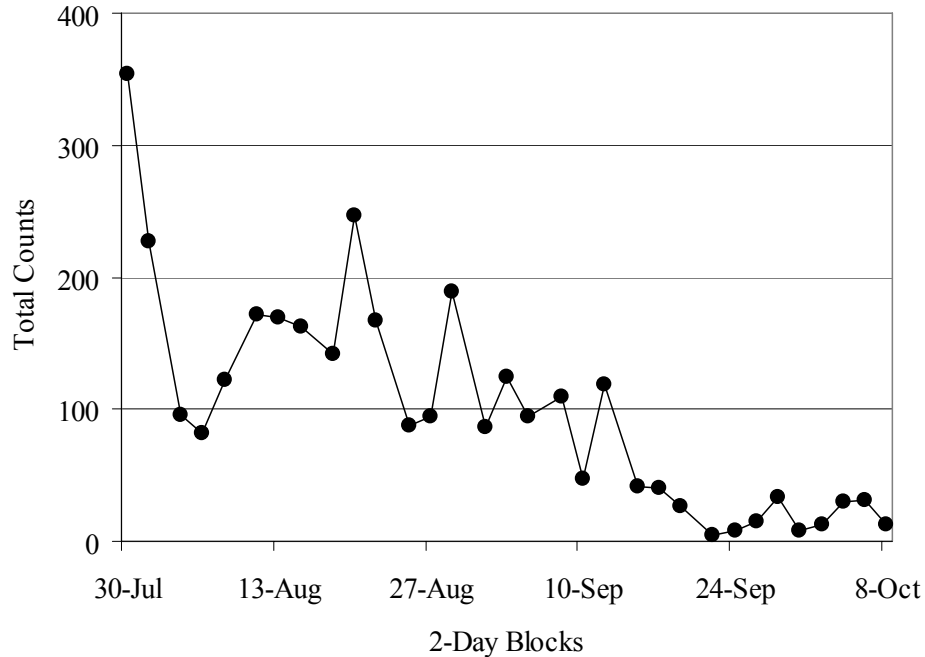
**Figure 5.1.** Total Number of Fish Detected Within a Two-Day Block Between July 30, 2005, and October 8, 2005, in Front of the Trash Racks at Turbine Units 20, 21, and 22 at Grand Coulee Dam

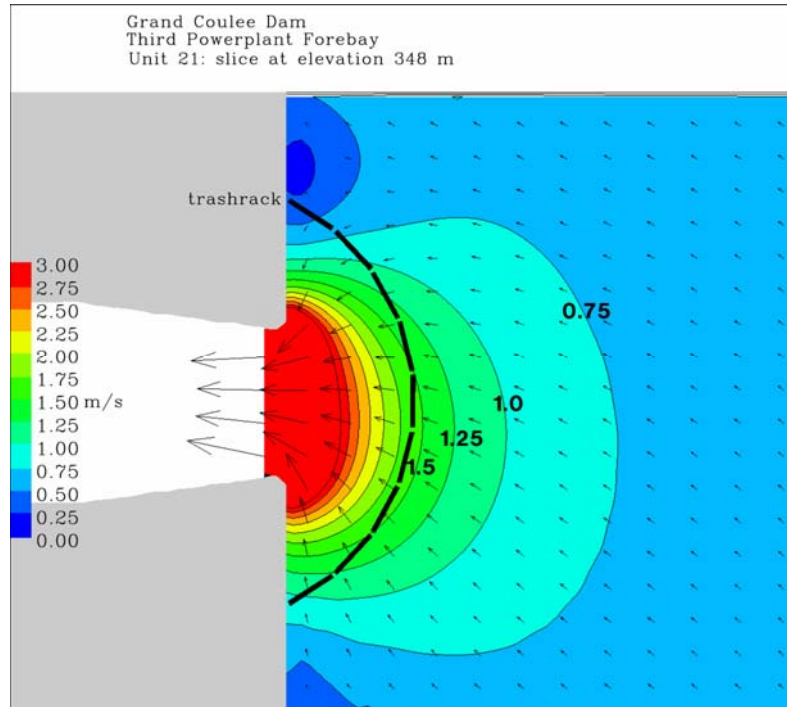
**Figure 5.3.** Water Velocities at Center of Turbine Unit 21 Penstock Opening Modeled Using a Computational Fluid Dynamics Model

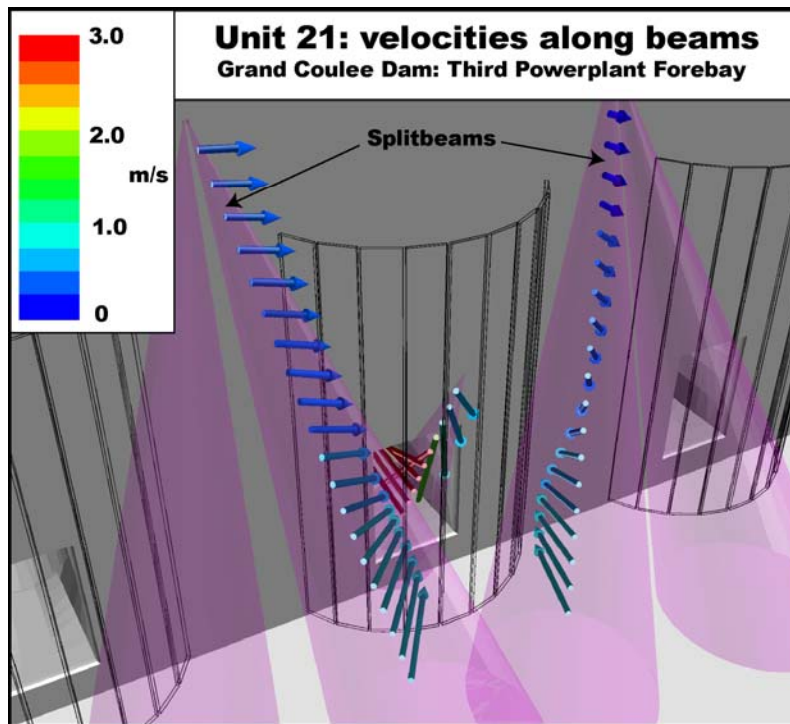
**Figure 5.4.** Simulated Water Velocities Within Areas Ensonified by Splitbeam Transducers Positioned in Front of and Behind the Trash Rack at Turbine Unit 21. Flows simulated for conditions on August 20, 2005.

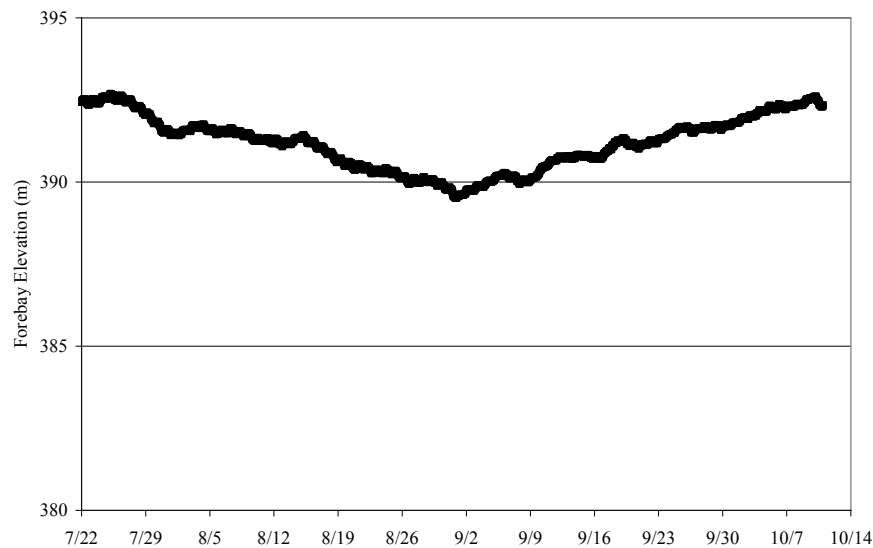
**Figure A.1.** Forebay Elevation in Front of the Left Powerplant During the 2005 Field Season

Forebay elevation data in front of the left powerplant were obtained from the U.S. Department of the Interior Bureau of Reclamation. Over the 2005 field season, the water level in the forebay changed approximately 3 m, starting at 392 m in mid July, declining to 389 m in early September, and then rising back to 392 m by the end of the study in mid October (Figure A.1).

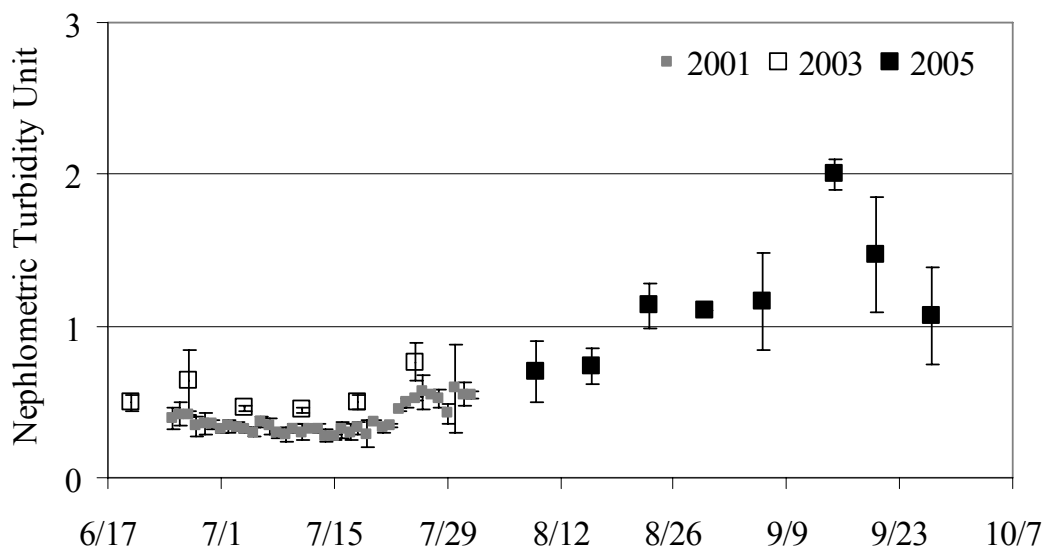
**Figure A.2.** Surface Turbidity Levels at Grand Coulee Dam for Three Study Years (June 30 through August 1, 2001; June 20 through July 25, 2003; August 6 through September 27, 2005)

Surface turbidity measurements ranged from 0.7 nephelometric turbidity unit (NTU) in early August to 2.0 NTU by mid-September. Values then declined through the end of the month. These values are higher than those measured in 2001 and 2003 at the entrance to the forebay (Figure A.2). The difference could be related to where the measurement were taken—center of the forebay in previous study years—compared to next to the dam in 2005. Another factor may be the time of year; no measurements were made in September in 2001 and 2003. Turbidity values in early August 2005 were similar to those measured in late July in 2001 and 2003. An increase in turbidity in late summer may be related to changes in reservoir levels and/or increased phyto- and zooplankton production, which generally peaks in August within the reservoir (Lee et al. 2003). No adverse physiological effects have been noted in salmonids at turbidity levels less than 10 NTU (Bash et al. 2001). However, turbidity as low as 3 NTU was found to affect the response of lake trout to prey under low light levels (Vogel and Beauchamp 1999). In addition, increased turbidity would affect the visible range of the strobe lights.

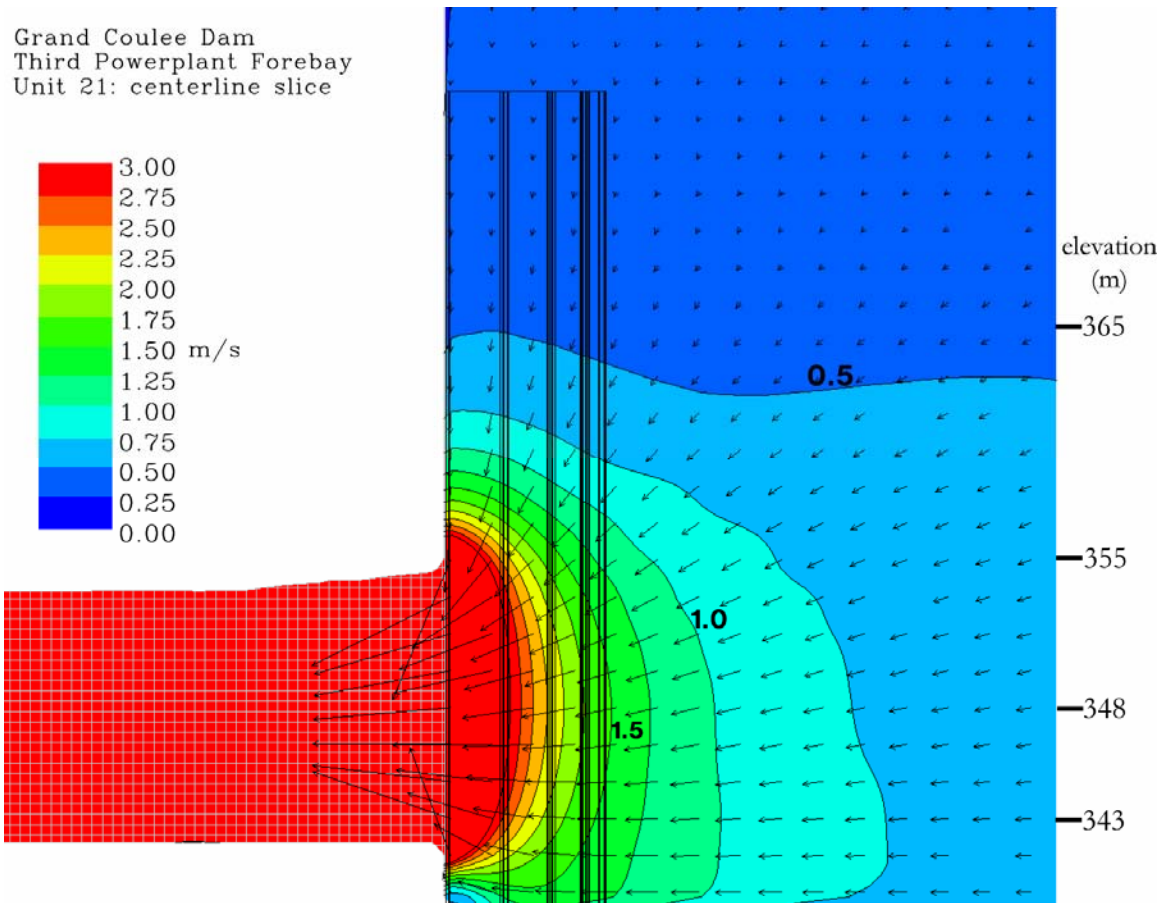
**Figure C.1.** CFD Model Results for August 20, 2005, between 1300 and 1700 Hours at Turbine Unit 21, Third Powerplant, Grand Coulee Dam. Black vertical bars are the trash rack.

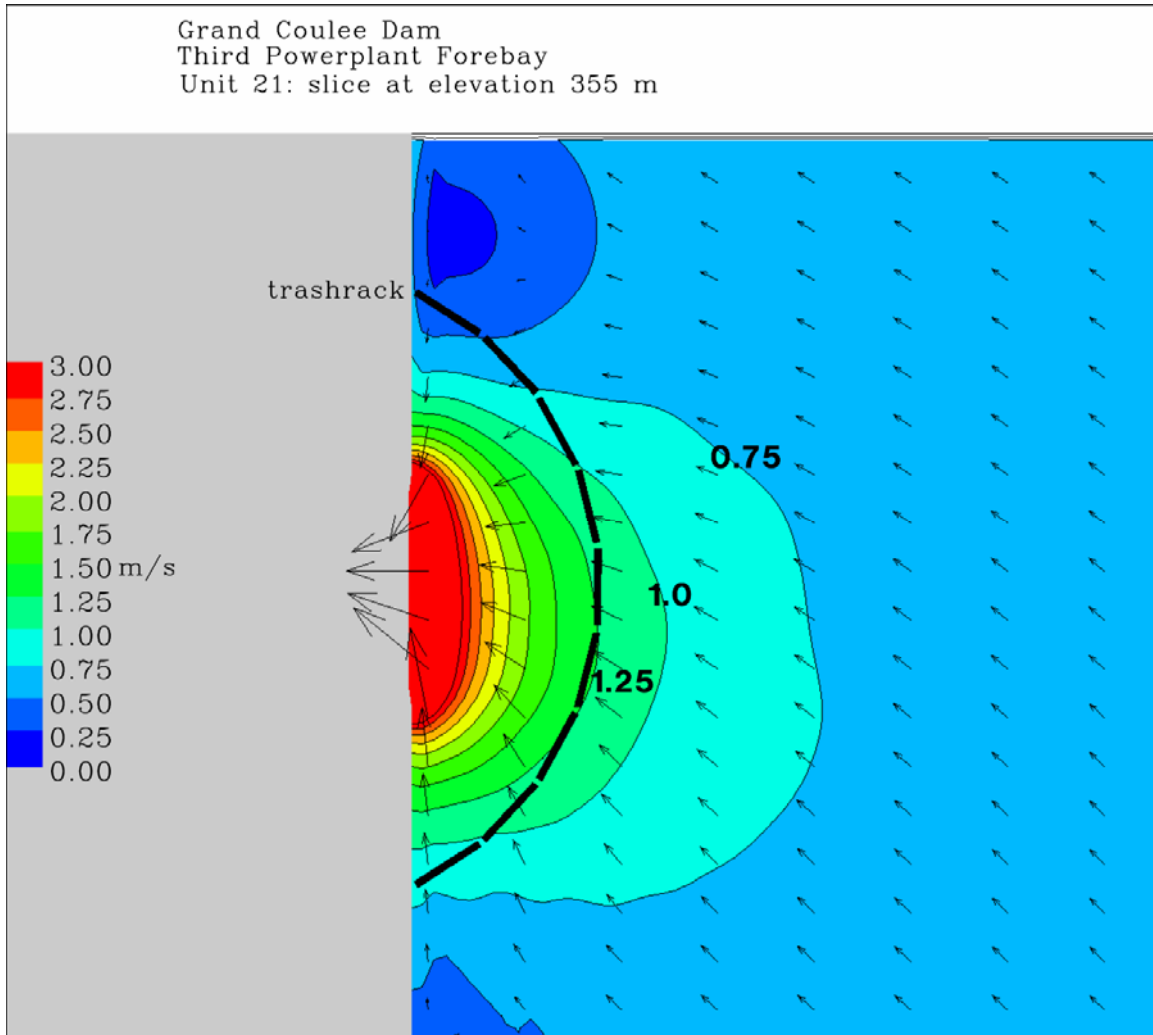
**Figure C.3.** Top View of Turbine Unit 21, Third Powerplant, Grand Coulee Dam, at Elevation 355 m (top of penstock opening) Showing Modeled Water Velocities for August 20, 2005

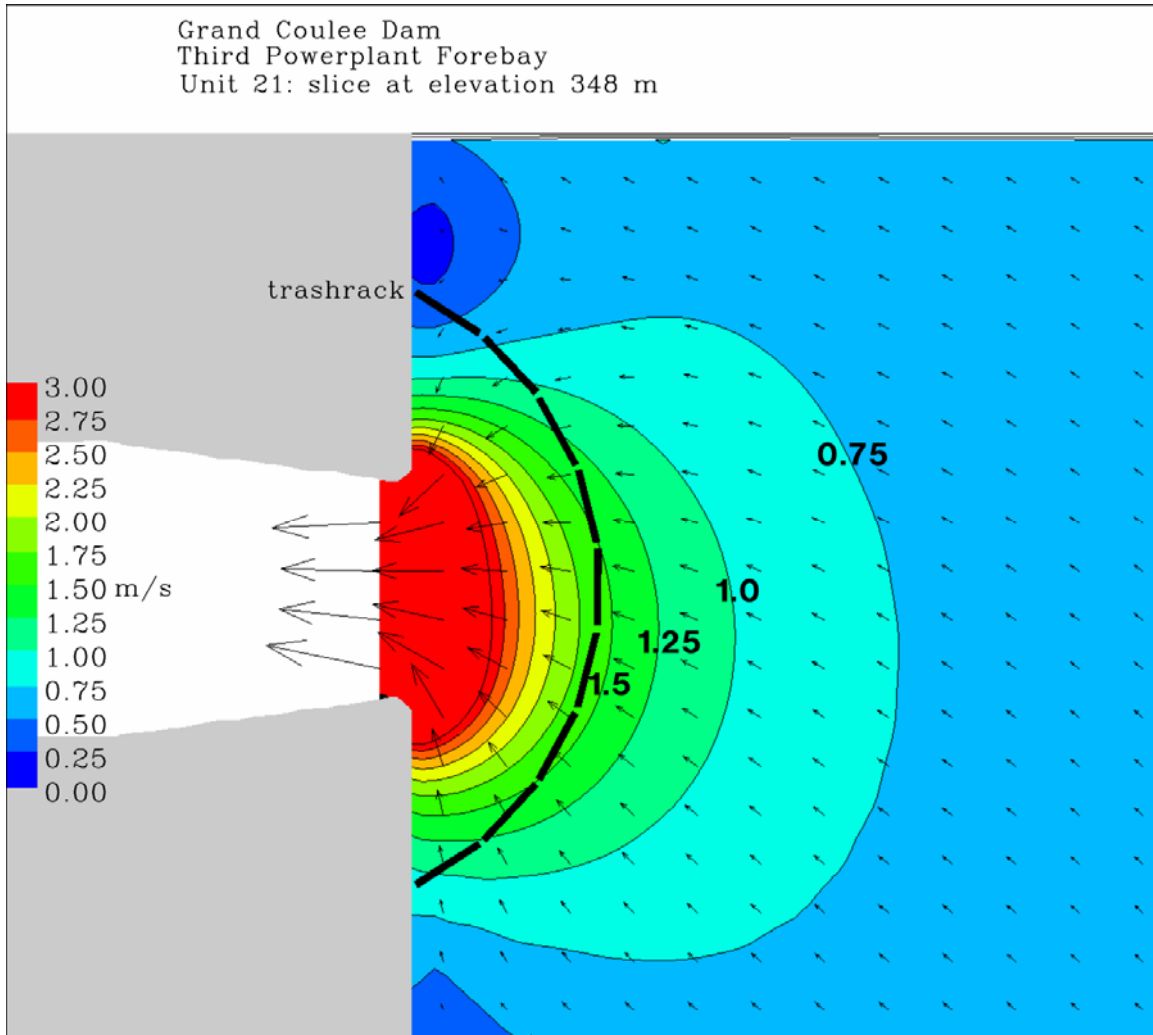
**Figure C.4.** Top View of Turbine Unit 21, Third Powerplant, Grand Coulee Dam, at Elevation 348 m (center of penstock opening) Showing Modeled Water Velocities for August 20, 2005
