# Chief Joseph Kokanee Enhancement Project

## Strobe Light Deterrent Efficacy Test and Fish Behavior Determination at Grand Coulee Dam Third Powerplant Forebay

Annual Report 2005 - 2006

DOE/BP-00000652-33

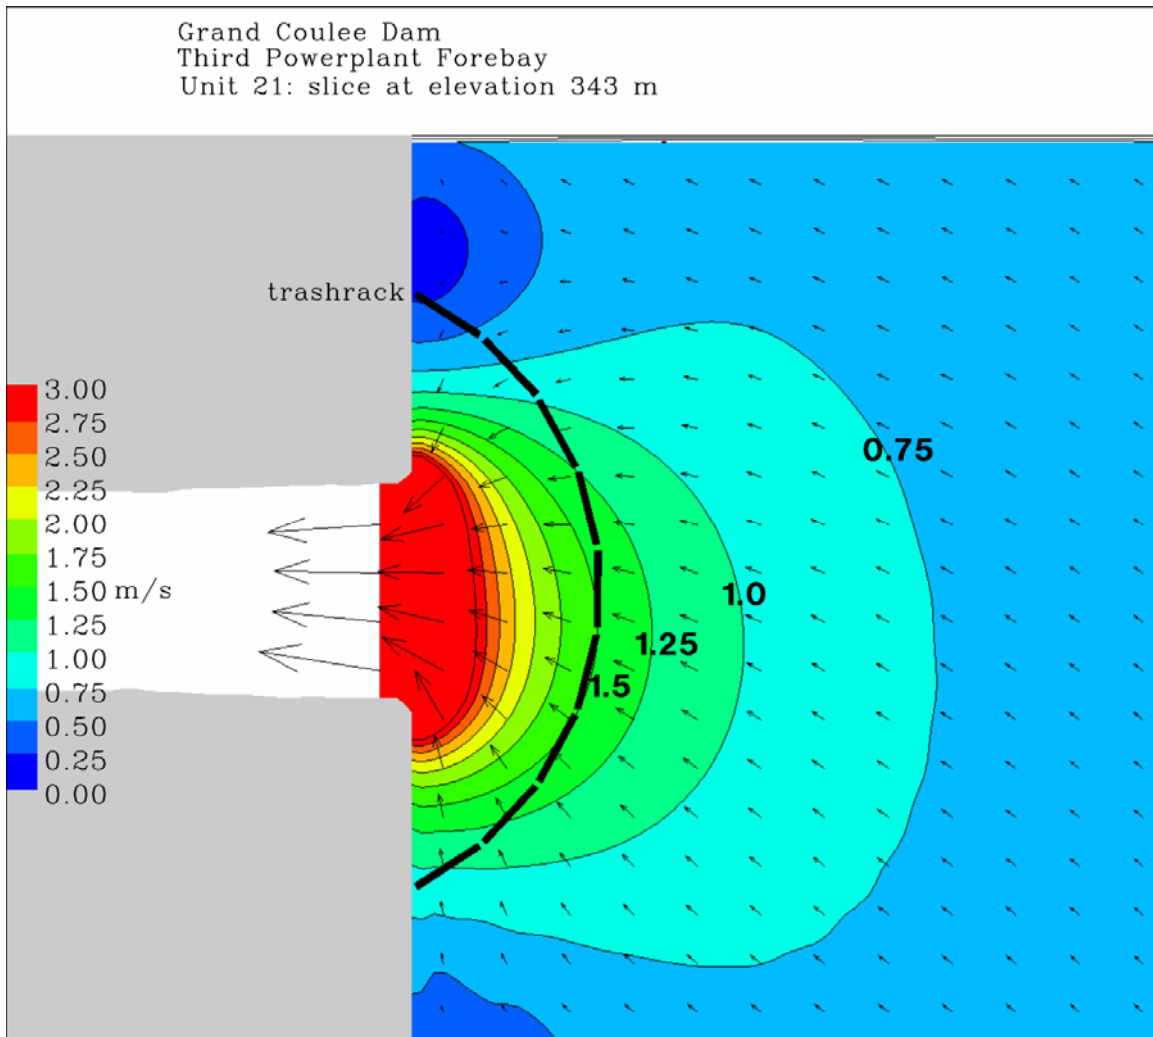
**Figure C.5.** Top View of Turbine Unit 21, Third Powerplant, Grand Coulee Dam, at Elevation 343 m (bottom of penstock opening) Showing Modeled Water Velocities for August 20, 2005

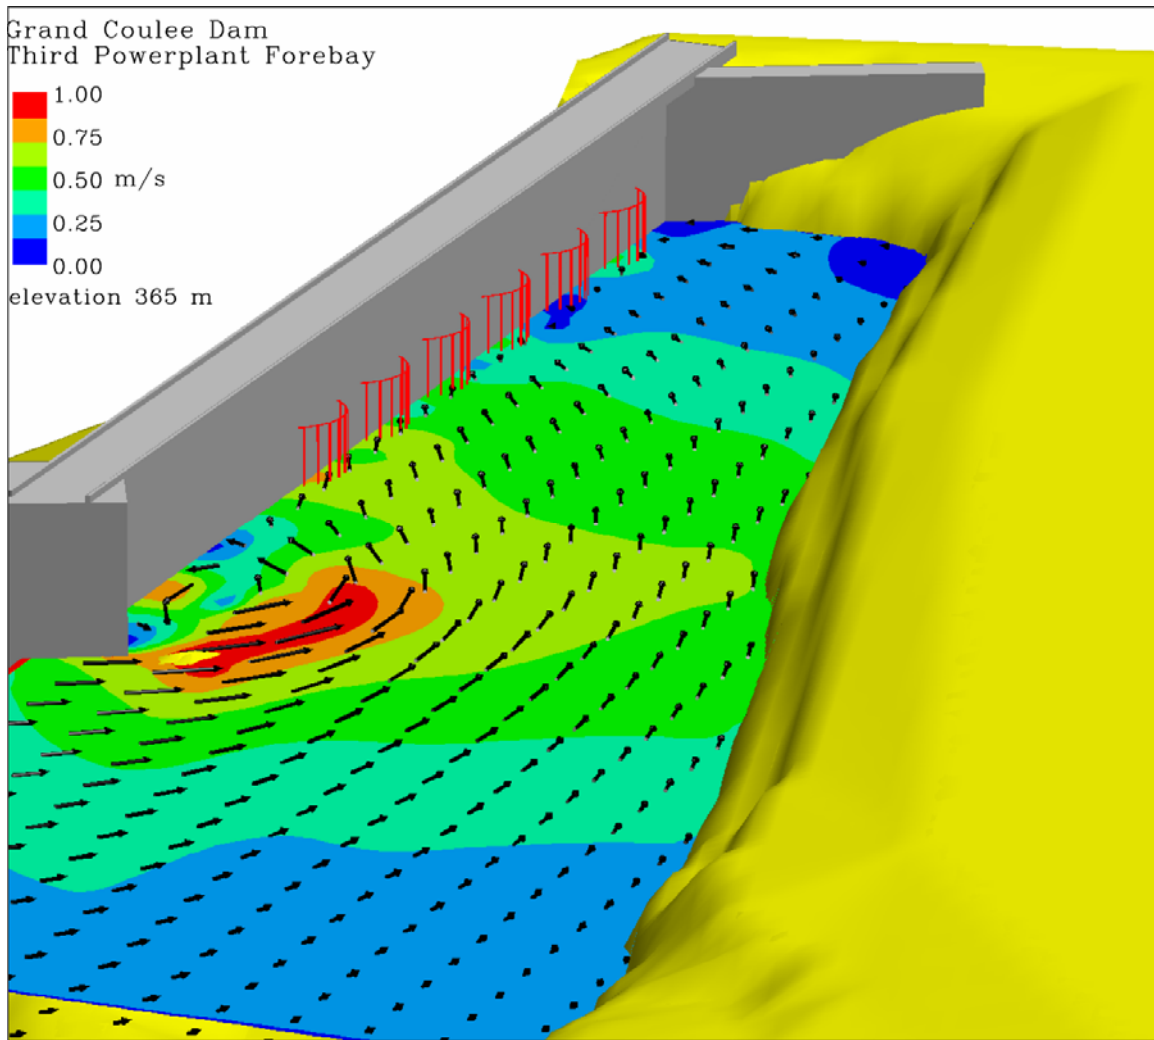
**Figure C.6.** Water Velocities Modeled for the Third Powerplant Forebay, Grand Coulee Dam, at Elevation 365 m (elevation of splitbeam transducers aimed in front of the trash racks) for August 20, 2005

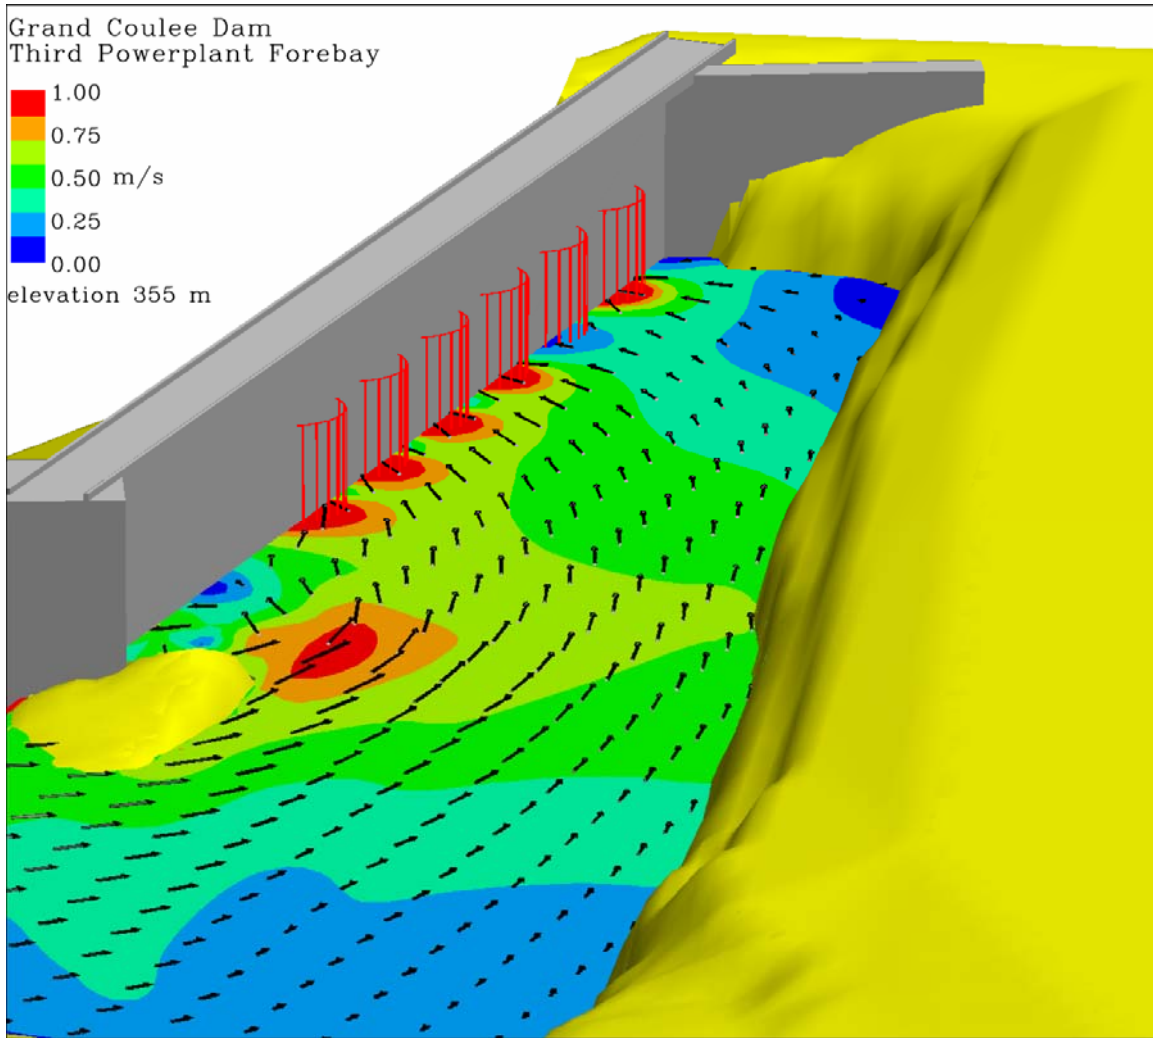
**Figure C.7.** Water Velocities Modeled for the Third Powerplant Forebay, Grand Coulee Dam, at Elevation 355 m (top of the penstock opening) for August 20, 2005

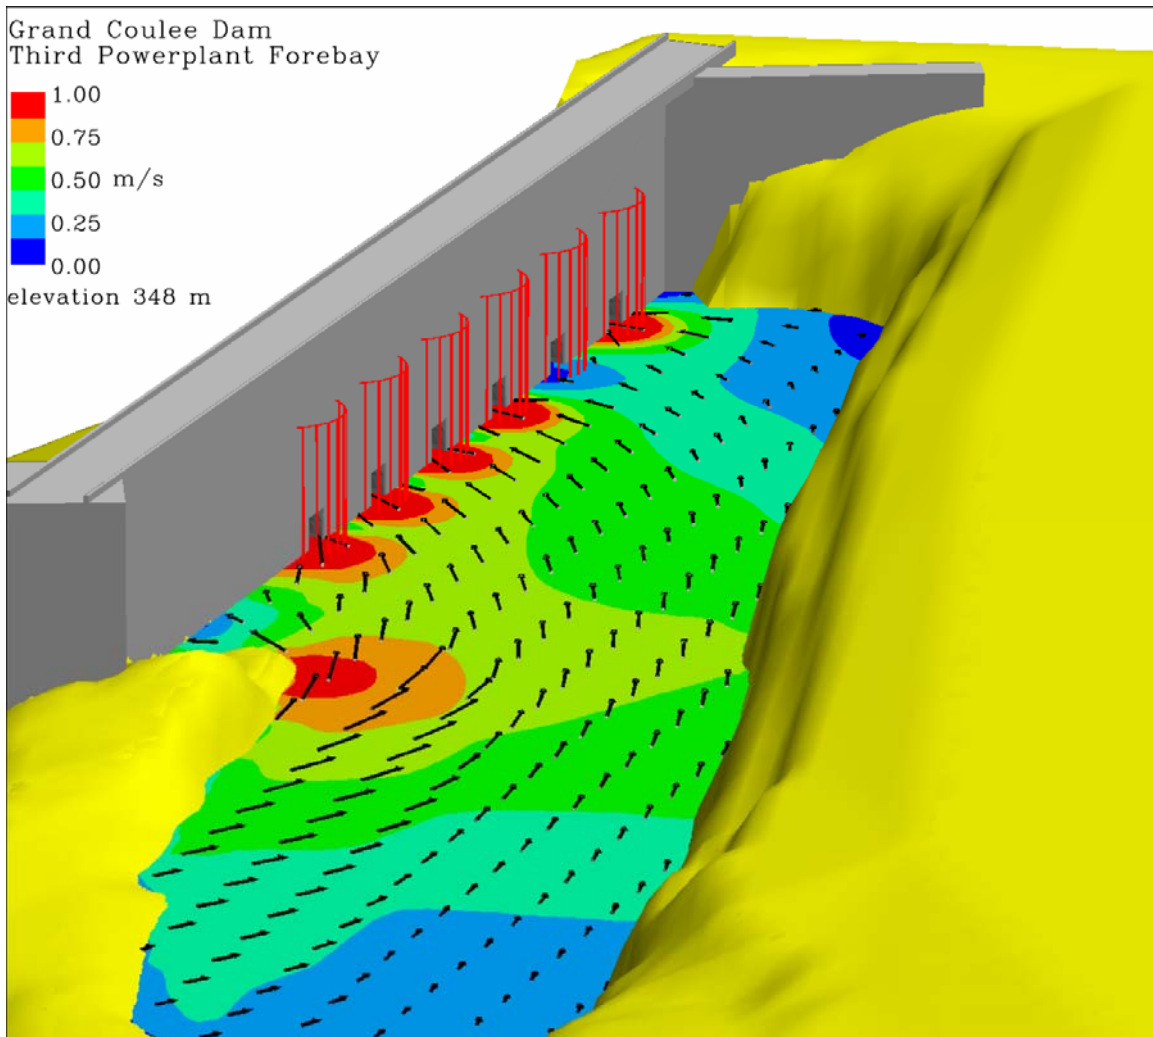
**Figure C.8.** Water Velocities Modeled for the Third Powerplant Forebay, Grand Coulee Dam, at Elevation 348 m (middle of the penstock opening) for August 20, 2005
