Big Canyon Creek Ecological Restoration Strategy

October 2007

Lynn Rasmussen, Project Manager
Nez Perce Soil and Water Conservation District
and
Shannon Richardson, Fisheries Biologist
Nez Perce Tribe – Department of Fisheries Resource Management – Watershed
Division

Funded by the Bonneville Power Administration

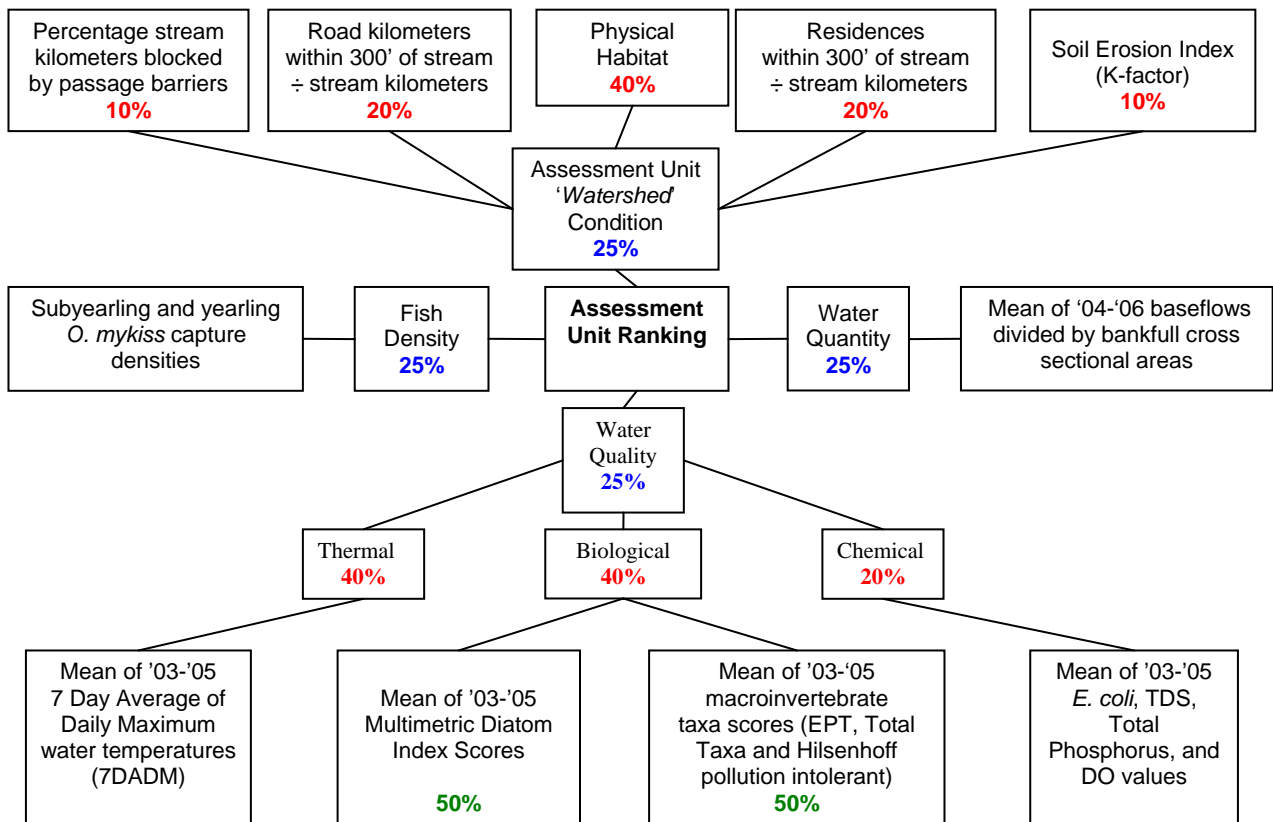
Each component in the Prioritization Framework was weighted equally (25% of overall score), although Fish Density was internally ranked inversely to the other components. This provides a mechanism to place emphasis on protecting areas where fish are present, regardless of the condition of the habitat. Thus, an assessment unit with high fish but relatively low habitat quality would receive a higher priority ranking than an area containing relatively high quality habitat but devoid of fish.

Figure 9. Assessment Unit Ranking Flow Chart

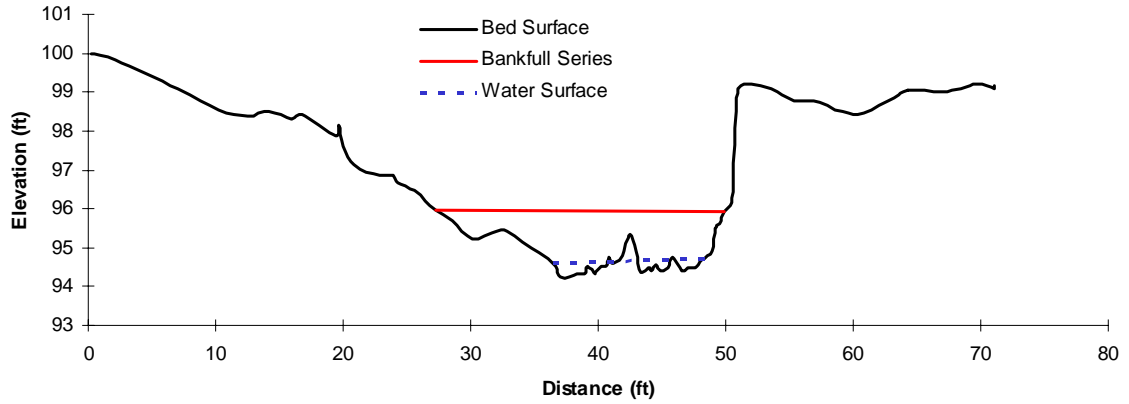
The three year base-flow mean for each site was divided by the derived bankfull cross-section² to establish monitoring site base-flow to high-flow ratios. Water Quantity rankings of 1-5 were assigned to each assessment unit on the basis of these ratio values. Assessment Units with low ratios, reflecting low base-flow relative to high spring flow events, received high scores (Figure 10) while AUs demonstrating less variability between high and low flow levels received low scores (Figure 11). A score of 1 indicates optimal water quantity relative within all 5 AUs and a score of 5 indicates relatively impaired water quantity conditions. This ranking paradigm reflects an intent to prioritize restoration within those areas with diminished levels of summer flow relative to total flow available.

Figure 10. Low baseflow to bankfull ratio resulting in poor ranking.

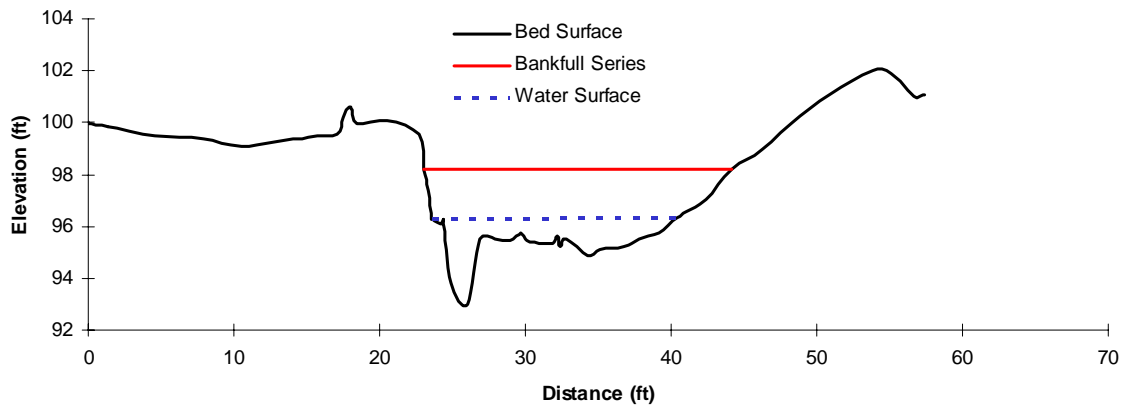
Figure 11. Higher baseflow to bankfull ratio resulting in better ranking.

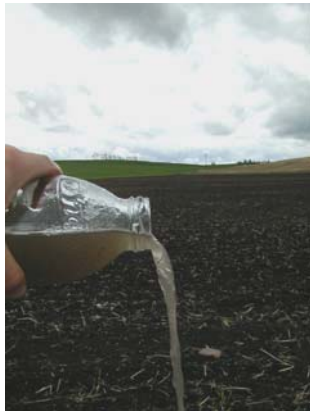
Figure 20. Current Condition.

Figure 20 shows the current condition of the majority of cropland acres within the watershed and Figure 21 shows the desired condition. Note the land cover changes which have resulted in reduced erosion. The images used for both figures were taken from practices installed within the watershed. The field runoff was collected on the same day on adjacent fields. The cropland management practices are highly successful in reducing upland erosion. Additional benefits for hydrologic alteration are also obtained. These benefits are discussed in Group G.

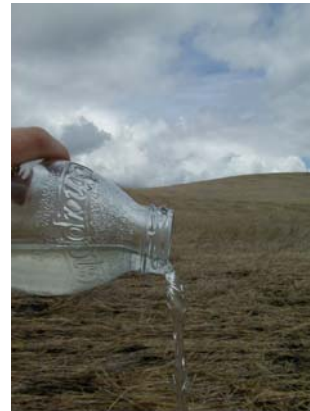
Figure 21. Optimal Condition.

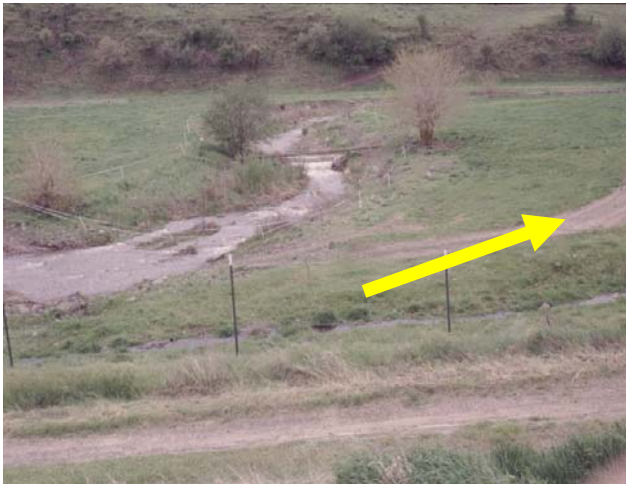
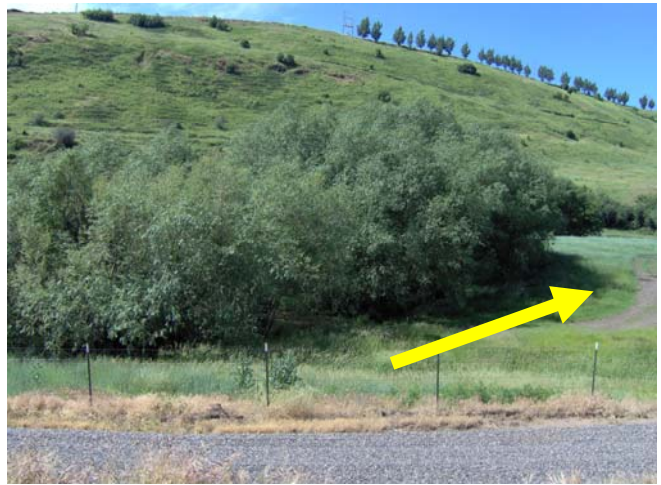
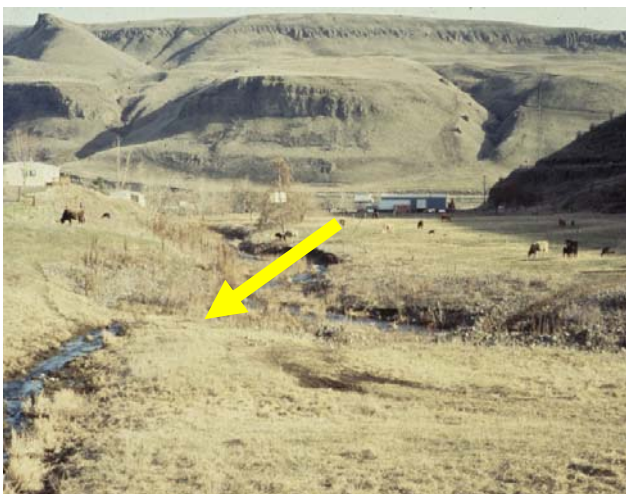
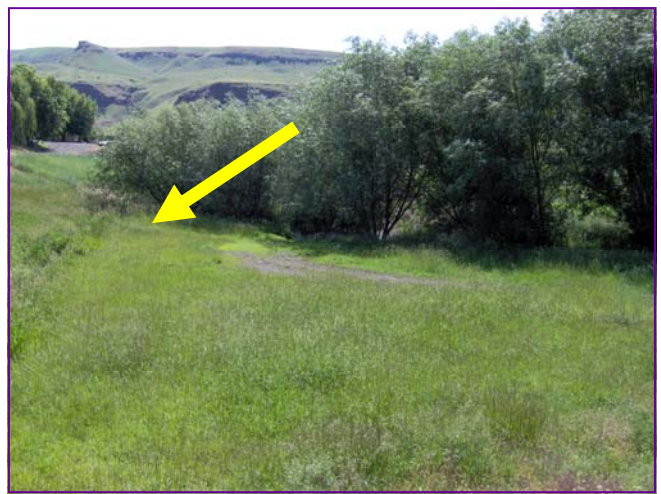
BEFORE TREATMENT - 1992

AFTER TREATMENT - 2006

Figure 23. Before and after treatment at the Hatwai Creek Restoration site.
