Crucial Factors for the Recovery and Conservation
Of
An Archaeological Ship

A Thesis

Presented To the Faculty of the Department of Maritime Studies
East Carolina University

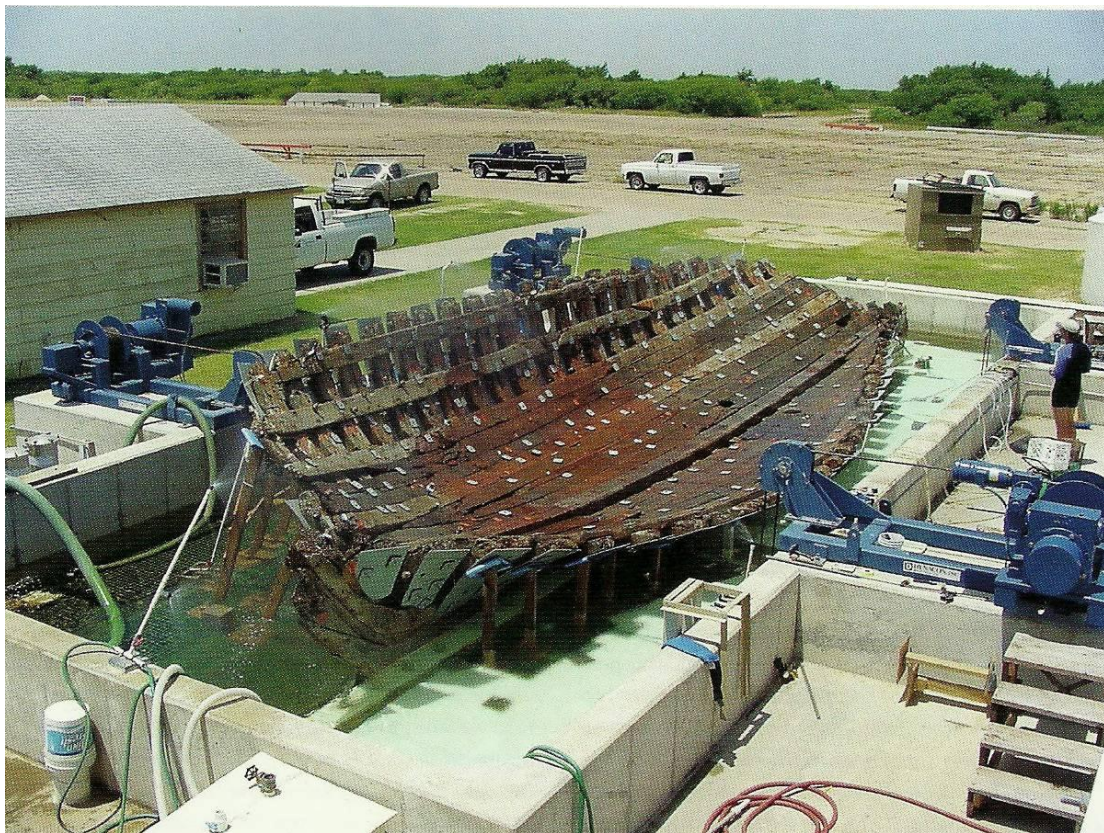
Figure 1: *La Belle* in concrete vat built for conservation (Bruseth and Turner 2005:66)

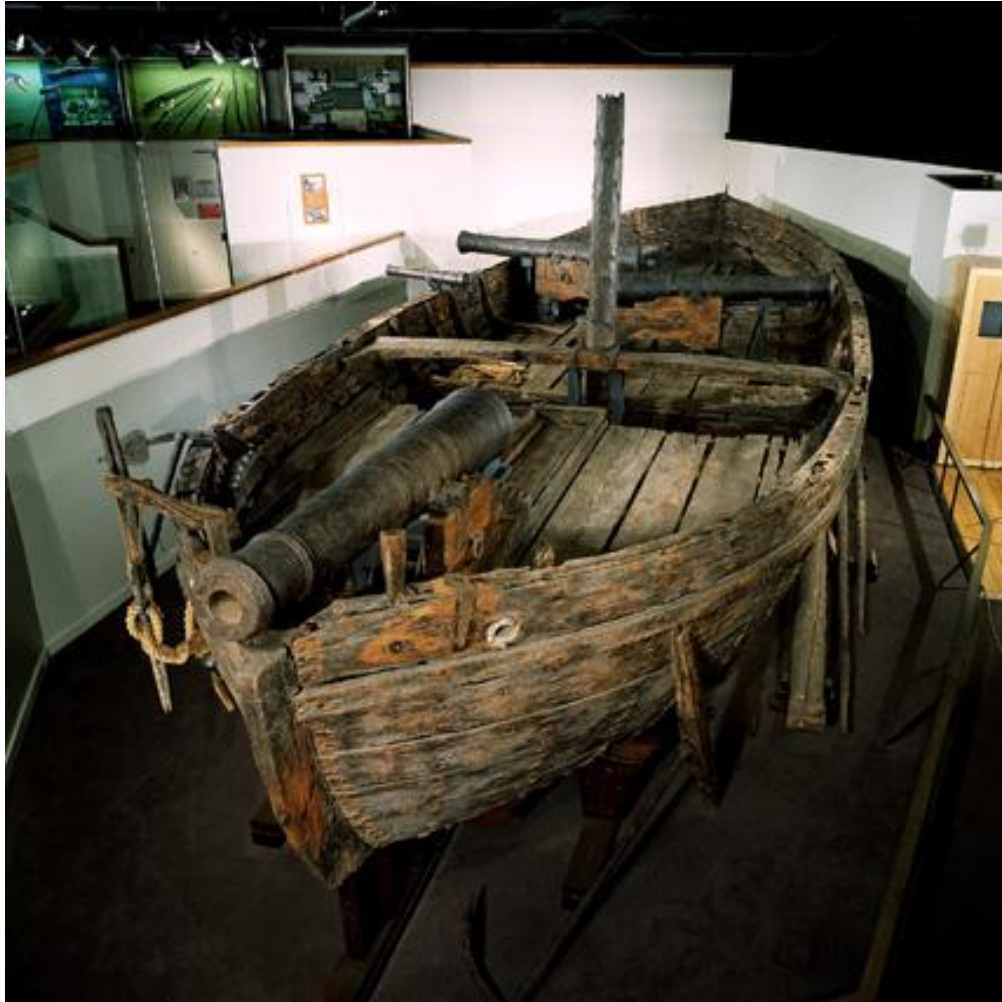
Figure 2: Gondola *Philadelphia* on display (Smithsonian Institution 2011)

In 1935, Colonel Lorenzo F. Hagglund found the ship three hundred yards south of Valcour Island. *Philadelphia* was recovered August 9, 1935 and placed on a barge as a floating exhibit that toured the Hudson River and Lake Champlain for several years. In 1961, it was acquired by the Smithsonian Institution, where it became a central exhibit in the National Museum of American History (Bratten 2002:64, 74, 85, 90-91).

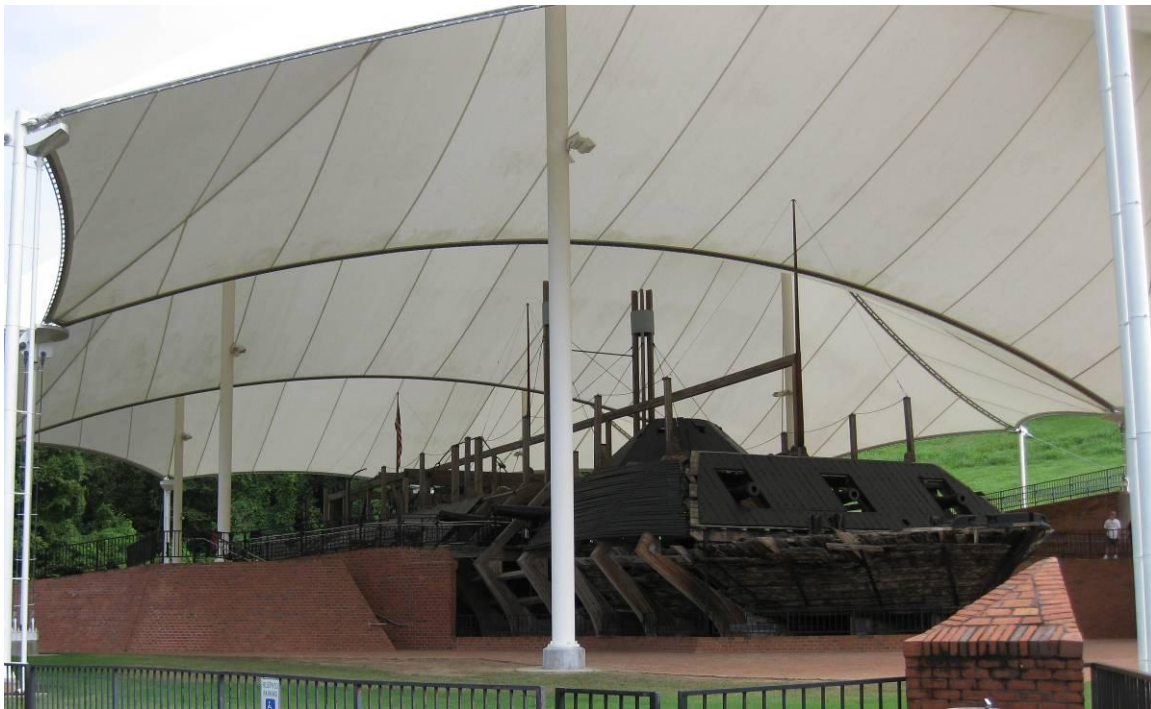
Figure 3: U.S.S. *Cairo* under canopy (photo taken by Melissa Ashmore)

Construction of U.S.S. *Cairo* (pictured in figure 3), along with seven other City Class ironclads, began in September 1861. Often called Pook's Turtles after their designer, naval constructor Samuel M. Pook, these ships were steam powered, had a shallow draft, and an iron casemate. *Cairo* was commissioned on January 25, 1862 and was 175 feet long by 51 feet in beam (Hon and Taras 1988:2; Quarstein 2006:62, 79, 93).

In January 1966, it was determined that reconstruction of the *Cairo* on a permanent barge would cost \$1.5 million, which had yet to be acquired (Bearss 1980:172). After many objections to placing the ship on a barge were lodged, the plan was changed. The ship would become part of a permanent exhibit at Vicksburg National Military Park (Bearss 1980:174). The ship stayed at Ingalls Shipyard during the exhibit's planning and construction while funding was being located. In autumn 1976, the shipyard gave notice that, because of space restrictions, they could no longer house *Cairo*. The ship had to be prepared and transported on short notice. It reached Vicksburg, Mississippi, on June 19, 1977. In a bout of fortuitous timing, the concrete cradle that would support the ship had been completed. Once the ship was placed in the cradle, formal conservation began some twelve years after it was raised (Bearss 1980:182-186). The site currently includes a wooden support structure and a large canopy over the ship which protects it from some of the elements (Joyner 2006:12).

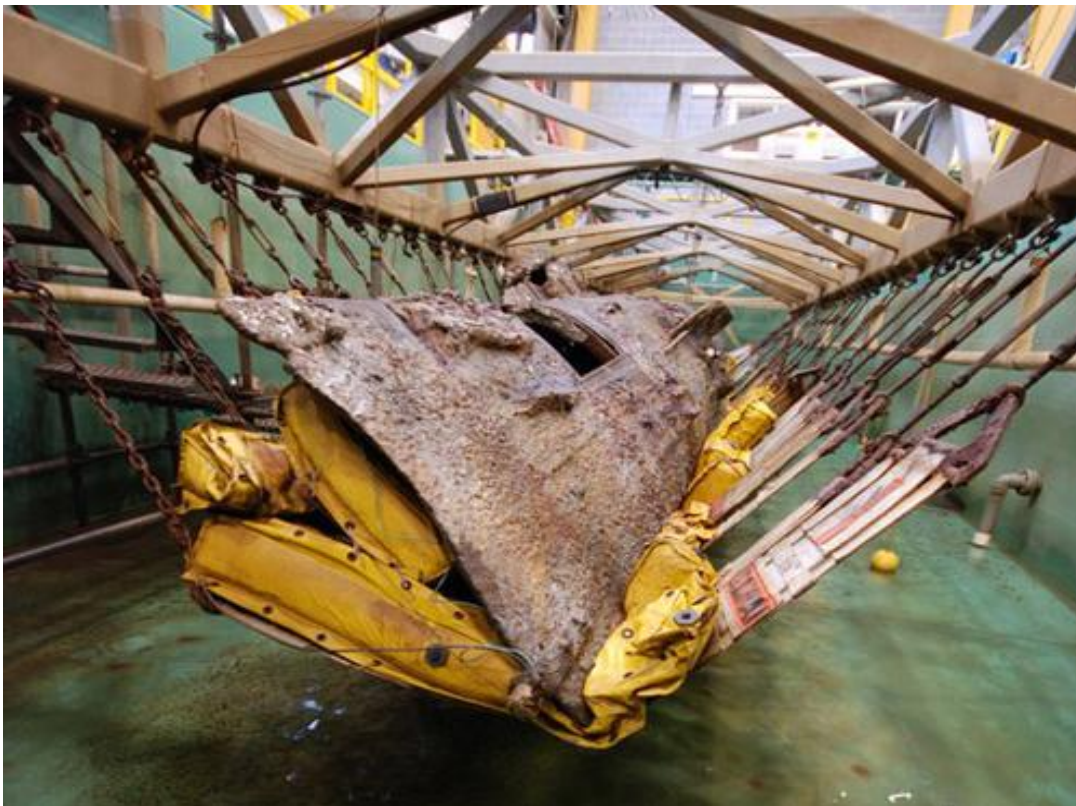
Figure 4: *H.L. Hunley* in water tank (Friends of the Hunley 2010)

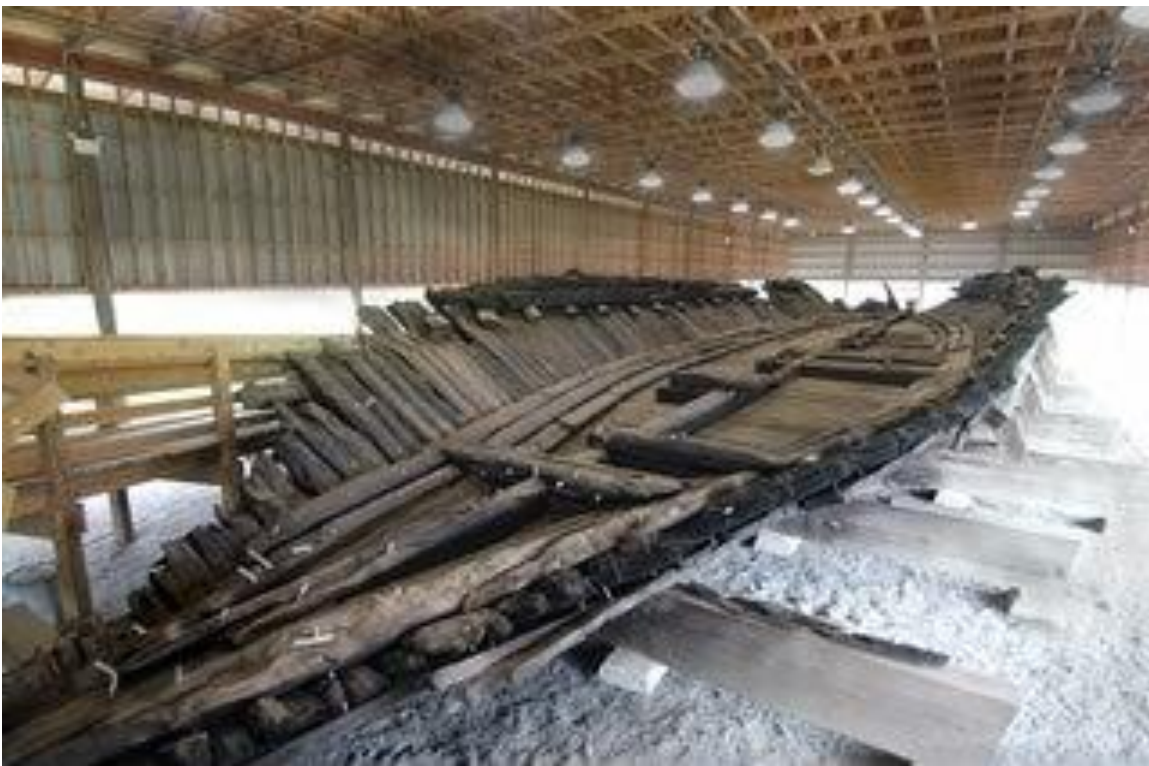
Figure 5: C.S.S. *Neuse* under shelter (photograph courtesy of Don Pierce)

The contract for C.S.S. *Neuse* (pictured in figure 5) was signed on October 17, 1862 and construction began shortly after in White Hall, North Carolina (Bright et al. 1981:6). Built for river travel, it was flat bottomed with an iron casemate (Bright et al. 1981:7). It was approximately 150 feet long with an extreme beam of 36 feet (Campbell 2009:63). Construction moved slowly, due to delays in receiving construction materials (Still 1966:4). This was set back

There were plans to move the ship to an environmentally controlled area, but flood damage from Hurricane Fran in 1996, made moving the ship farther from the river more vital. Its location in the park was shifted to accommodate the decision. In 1999, Hurricane Floyd caused massive flooding and once again damaged the ship and visitors' center, which housed the artifacts (North Carolina Historic Sites 2011). A climate controlled facility for the ship and the artifacts is planned to occupy two lots in downtown Kinston (Guy Smith 2010, elec. comm.).

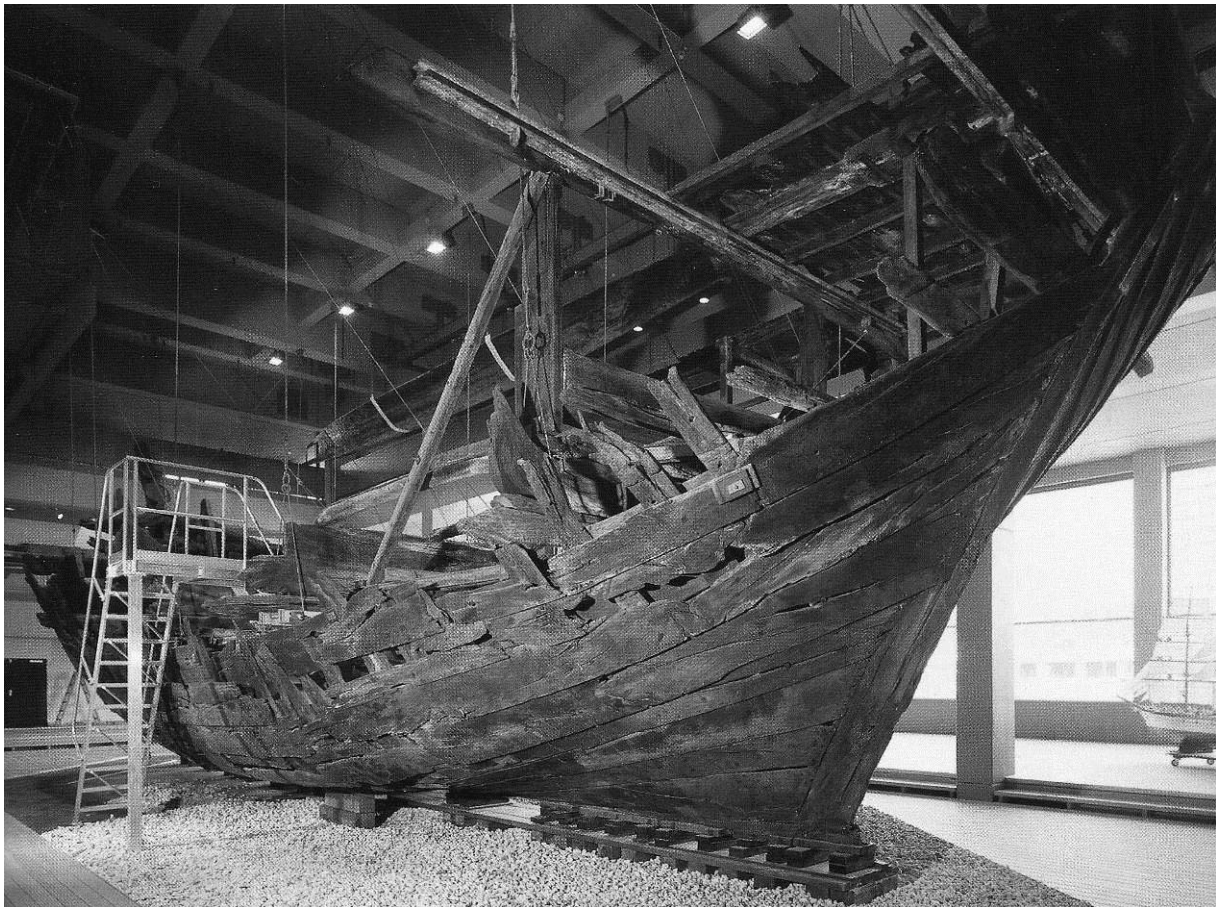
Figure 12: Bremen Cog on display (Hoffmann 2003a:16)

The Bremen cog (pictured in figure 12) was found in an old bed of the Weser River during 1962, (Crumlin-Pedersen 2000:231-232). The seventy-six foot cog had not been completed before it was deposited. Because the mast had not been set in place, there was no ballast, no decking, and no tar was evident on the planking, it was assumed that the ship was lost in a flood during construction (Fliendner 1985:10; Fliendner 2003:51; Hoffmann 2003a:17). According to dendrochronology, the vessel was constructed circa 1380 AD (Fliendner 2003:50).

The cog is a ship type from the Middle Ages. Cogs were typically used for transporting trade goods and had a single mast, a deep hull, and a pronounced rise at the bow and stern. The Bremen vessel has all of these features (McGrail 2001:233; Sauer 2003:30-31. The ship was made of oak planks held together with iron nails, which had corroded away before the ship was found (Hoffmann 2003a:14; Sauer 2003:18).

The ship was removed in pieces in 1962 using both helmet divers and a diving bell. The pieces were stored in water tanks until the Bremerhaven Museum was completed in 1975 (Fliendner 1985:8; Pohl-Weber 1985:16-17; Hoffmann 2003b: 81; Lahn 2003: 66). The museum was designed to allow the public to observe the reassembly and conservation (Hoheisel 2003:73).

After several experiments, it was determined that a two-step process of polyethylene glycol (PEG) impregnation would be most effective. It was feared that rigidity of the timbers, a result of conservation might, make it much more difficult to reassemble. To eliminate this problem, the ship was reassembled before conservation, and suspended in the exhibit gallery (Hoffmann 2001:129; Hoffman 2003b:81, 85; Lahn 2003:69). After reassembly, a steel tank was built around the ship and the first of two PEG baths began. The ship sat in the first PEG bath

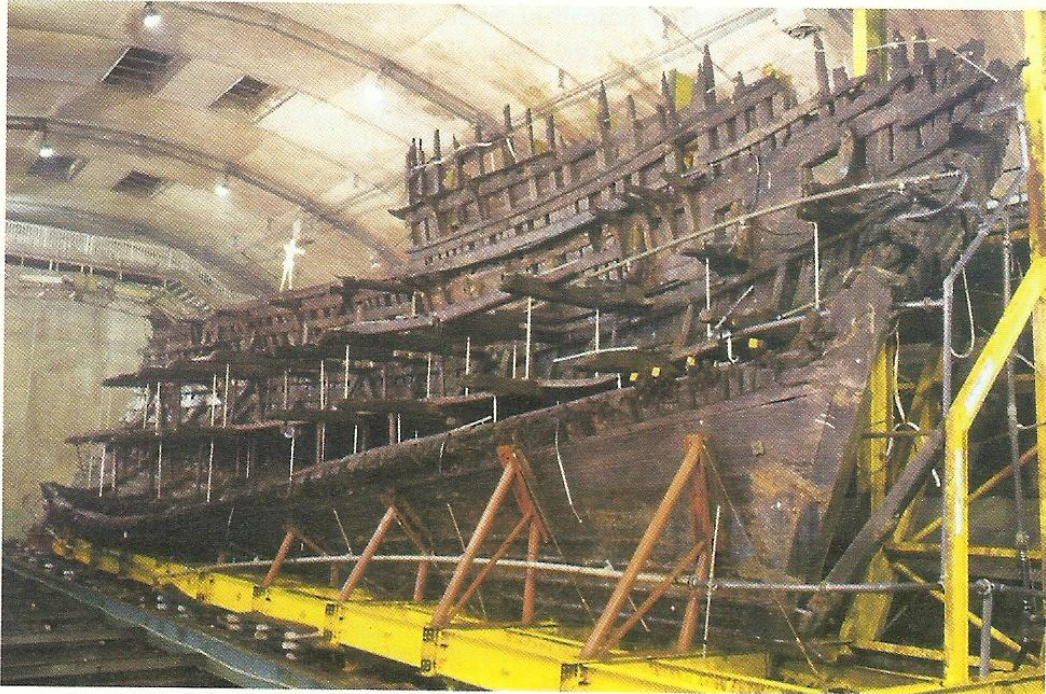
Figure 13: *Mary Rose* during conservation (Jones 2003:plate 6)

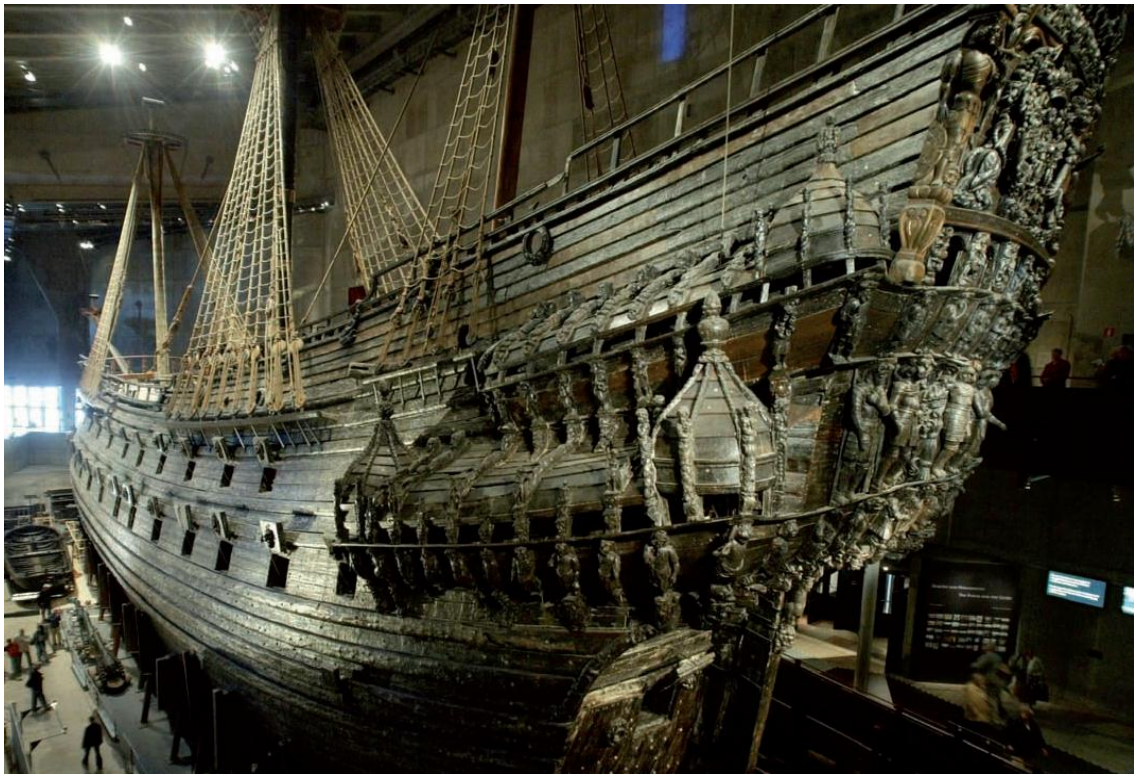
Figure 14: *Vasa* on display (Jeffries 2009:54)

The ship's conservation began in 1962, with hand sprayed treatments of a PEG and boric acid solution, with a biocide. For nearly two years, six days a week, the ship was sprayed. In 1964, the ship was placed on a permanent cradle. In the same year, the ship was transferred to the National Maritime Museum in Stockholm. In March 1965, an automated spray system was installed. From 1965 to 1972, the ship was sprayed up to thirty-two times in any twenty-four hour period. After 1972, the number of spraying episodes was incrementally lowered, while the PEG concentration was increased until spraying was stopped in 1979. Once spraying ceased, a surface treatment of PEG spraying and heating was done by hand. After the treatment was completed, the *Vasa's* surface was cleaned and the ship allowed to dry. *Vasa* was moved to its permanent site when the new museum was ready in 1988 (Cederlund 2006a:447, 449, 452; Håfors 2010:34-37, 58-66, 78-80).

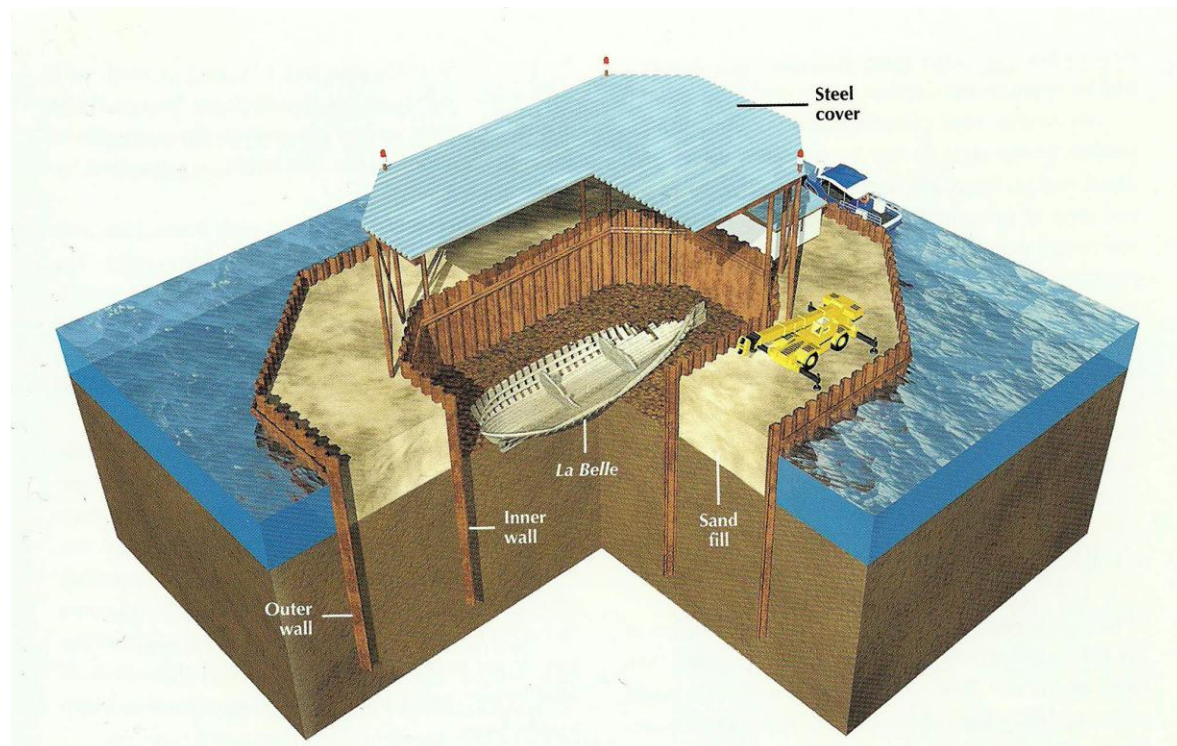
Figure 15: Cut away drawing of *La Belle* cofferdam (Bruseth and Turner 2005:53)

The inner space was 82x53 feet and had a steel cover for shelter. (see figure 15)

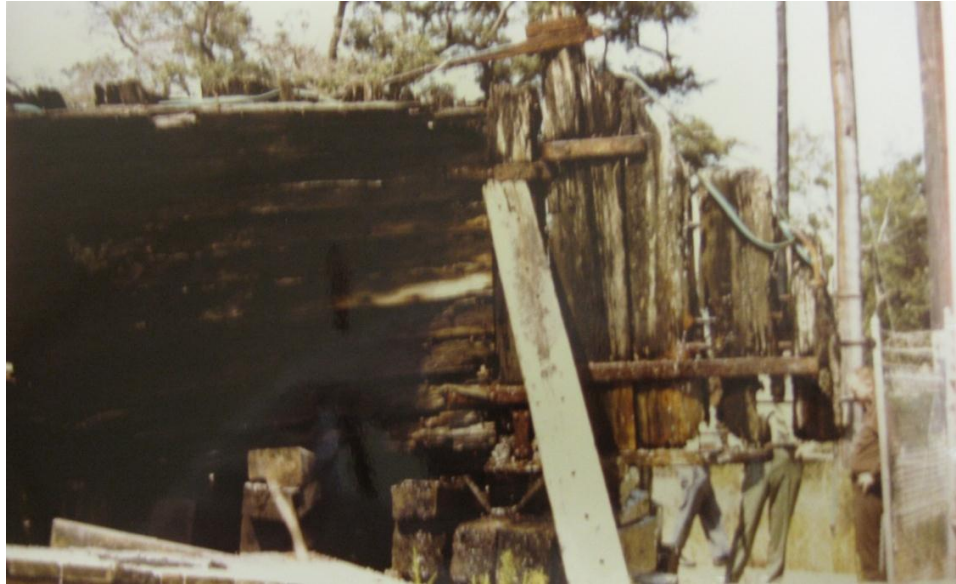
Figure 16: U.S.S. *Cairo* at Ingalls, port side rudder (photo courtesy of National Park Service, Vicksburg, Mississippi)

After recovery, deterioration of U.S.S. *Cairo* was more severe than it could have been. While there was some effort to keep the ship wet while at Ingalls Shipyard, wetting occurred infrequently. The cycle of wetting and drying actually did more damage to the ship than if it had been left to dry, because the stress of drying was repeated, which further damaged the wood (Kaye et al. 2000: 234; Joyner 2006:12). The extent of damage sustained during storage of the ship was partially responsible for the U.S.S. *Cairo* generally being considered by the professional community to be an example of what not to do (Delgado 1997:82). An example of the damage caused by the wetting and drying cycle can be seen in figures 16 and 17 below. The

first photograph was taken shortly after *Cairo* arrived at Ingalls Shipyard. The second was taken in October 2009 at Vicksburg Military Park. The missing wood from the rudder and stern of the ship was too degraded to integrate into the reconstruction.

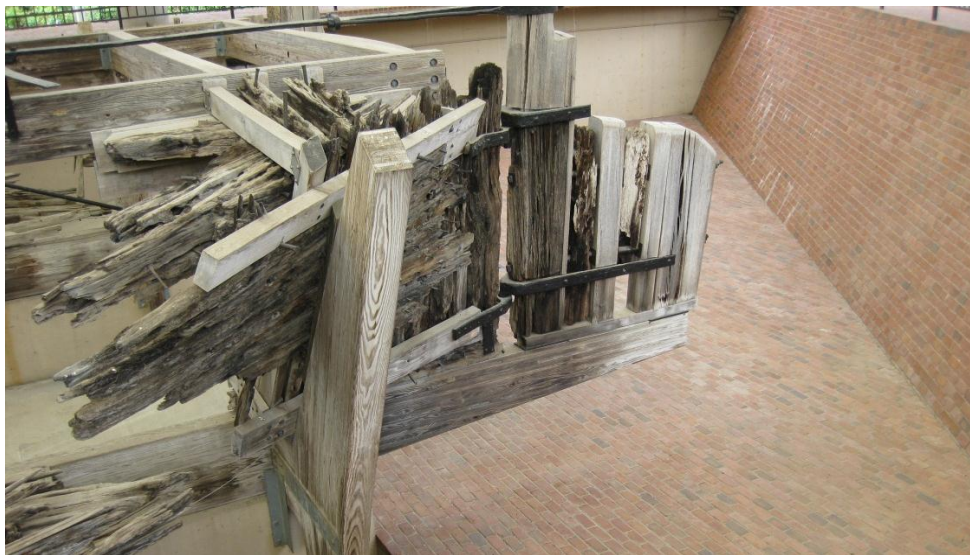
Figure 17: U.S.S. *Cairo* at Vicksburg, port side rudder (photo taken by Melissa Ashmore)³

³ Repair work can be seen in the Vicksburg photograph. Missing wood in the rudder was replaced for aesthetic purposes.
