# **ONLINE CONDITION MONITORING OF RAILWAY WHEELSETS**

A thesis submitted to  
The University of Birmingham  
For the degree of  
**DOCTOR OF PHILISOPHY**

School of Electronic, Electrical and Systems Engineering  
College of Engineering and Physical Sciences  
University of Birmingham  
May 2016

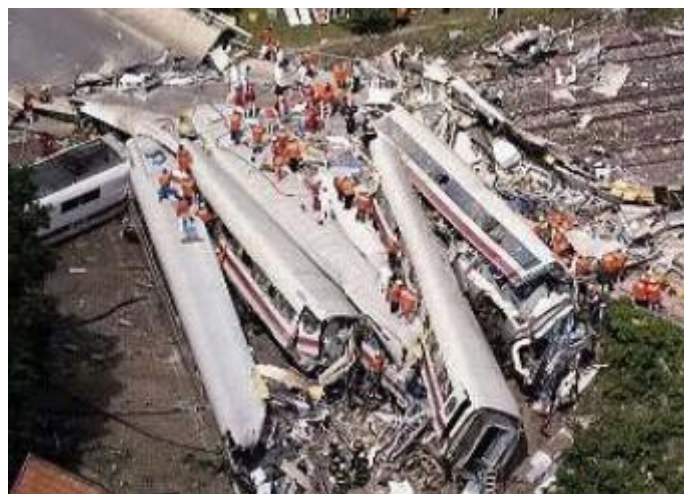
Figure 1-1: Remains of the high-speed train involved in the Eschede accident (Germany) in 1998 [2].

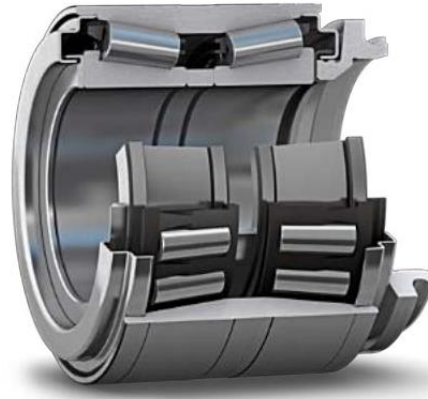
- **Tapered roller bearings:** This bearing type is designed to sustain high radial and thrust load levels. As a result of their load adaptability, they are found in car hubs due to the levels of both radial and thrust loads that car wheels are expected to sustain. Tapered roller bearings are the most common bearings employed in railway rolling stock. This is also the type of bearing considered within this project. The schematic in Figure 2-6 shows the key aspects of tapered roller bearing.

Figure 2-6 : SKF tapered roller bearing designed for railway wheelsets [20].

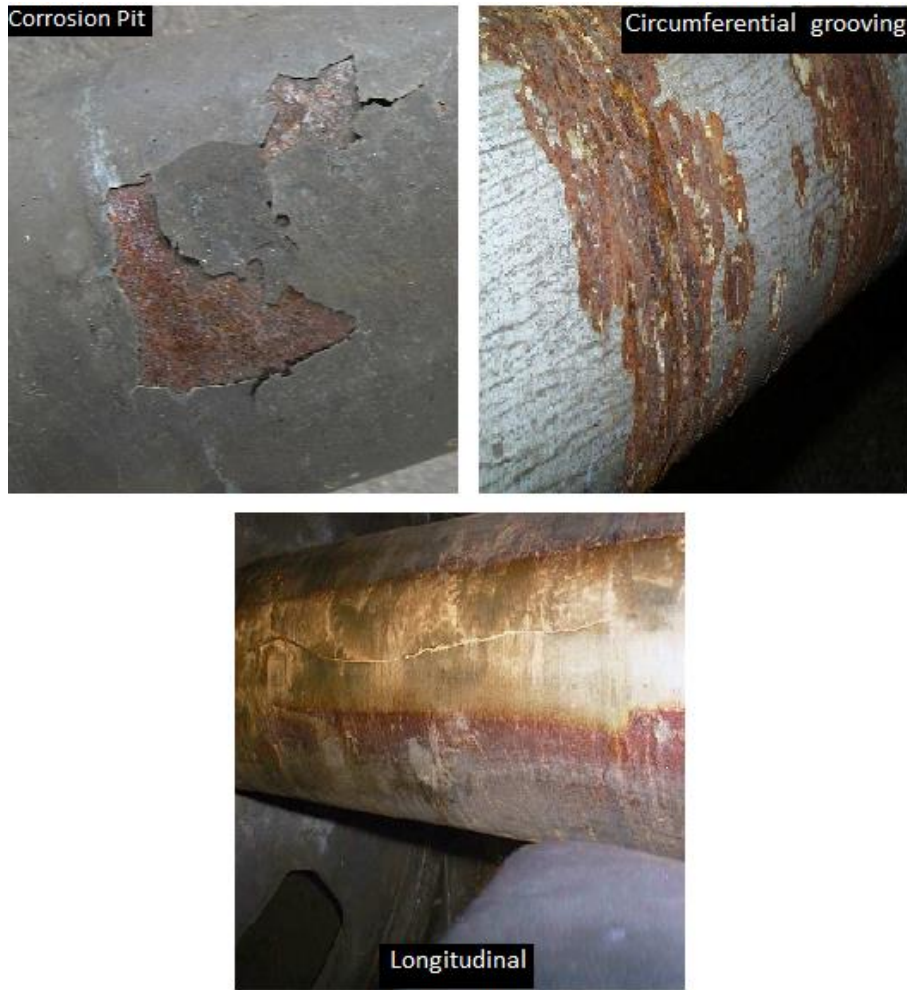
Figure 2-9: Axle defects [8].

Longitudinal and transverse cracks can initiate due to fatigue load during service time. Fatigue cracks will take far less time to propagate to critical severity than it took for initiation. Figure 2-9 shows some typical examples of axle defects.

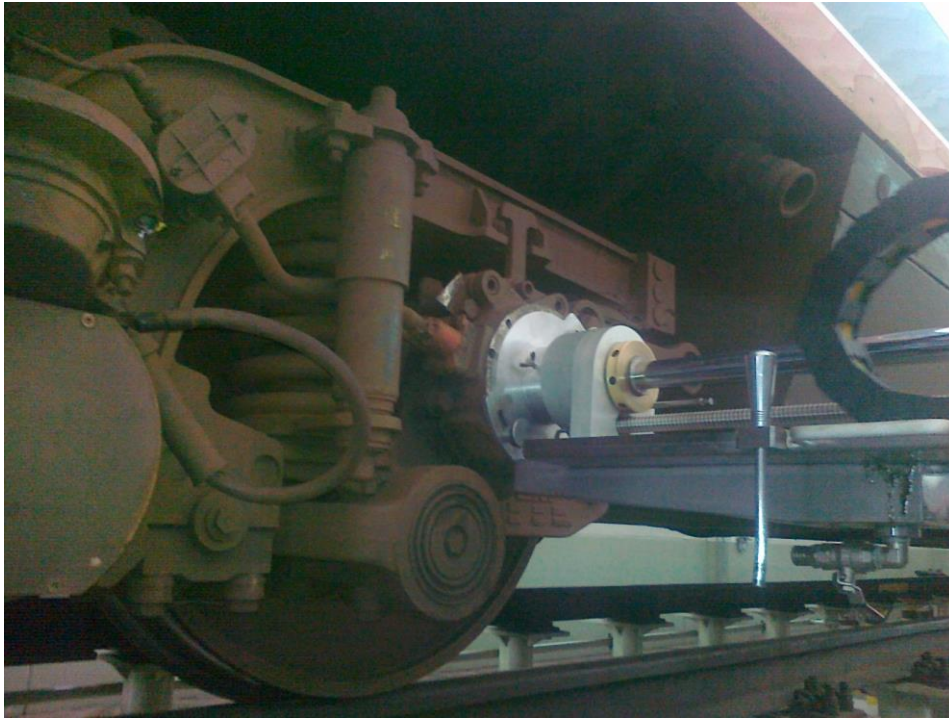
Figure 2-11: Ultrasonic inspection of a rolling stock hollow axle.

Figure 2-11 shows the ultrasonic inspection of a rolling stock hollow axle using transducers emitting ultrasonic waves.

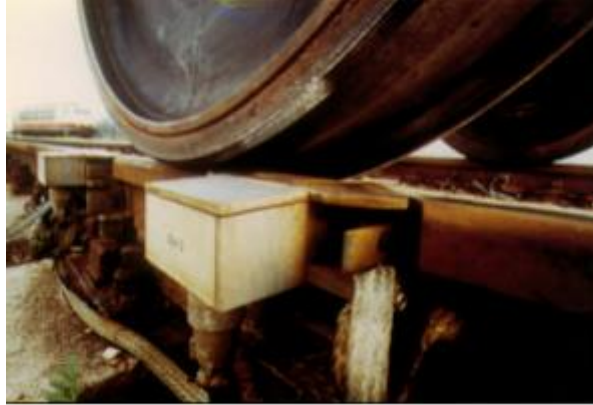
The electromagnetic acoustic transducer (EMAT) is an ultrasonic transducer for non-contact sound generation based on magnetostriction and Lorenz force interactions within the inspected material. Although, there is no need for application of couplant when EMATs are employed, the signal amplitude is much lower in comparison with that of a piezoelectric transducer and as a result signal to noise ratio is poor. EMAT is only preferred if inspection needs to be carried out at speed without any contact with the test piece. It can also be used at very hot environmental conditions or when couplants cannot be used due to the possibility of a chemical reaction occurring. EMATs can be used for in-service inspection of the rolling surface of the wheels in high-speed trains. The photograph in figure 13 shows an EMAT-

based system installed on-track for the online inspection of the rolling surface of wheels for the presence of RCF. The illustrated system has been reported to be capable of detecting critical defects when the train passes over the ultrasonic transducer [1].

Figure 2-14: EMAT-based system installed on-track for the online inspection of the rolling surface of the wheels [1].

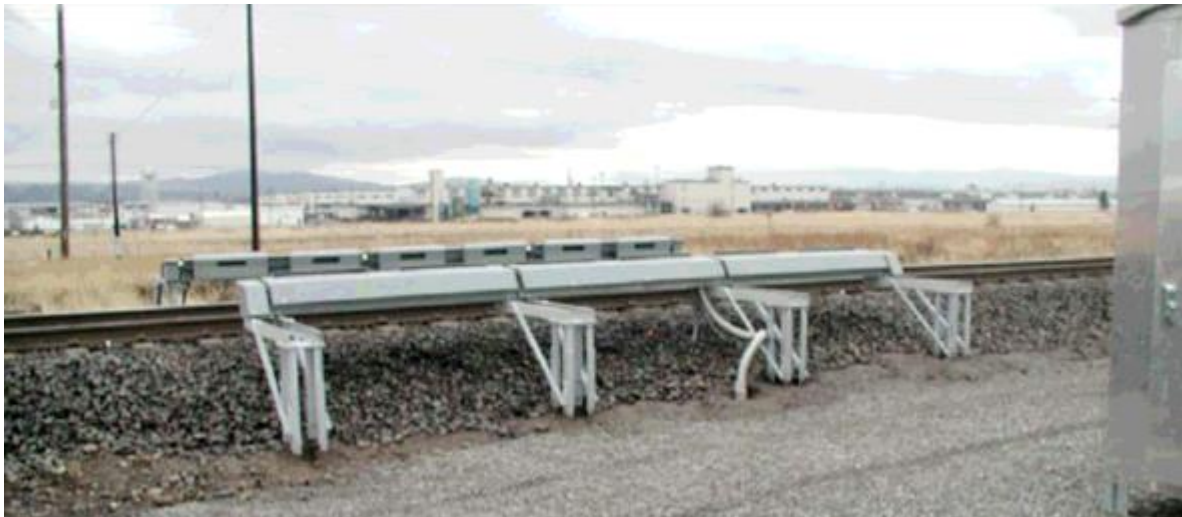
Figure 3-3 : The trackside acoustic detector system [48].

Detection System (TADS). Such systems should be more effective than HABDs since they are supposed to be able to detect developing bearing faults at an earlier stage. Moreover, they are able to trend individual wheelsets over time every time they pass from the instrumented site. Unfortunately, there is no sufficient evidence available in the literature proving the operational capability of these systems. The author of the present study has been unable to find any signals acquired from TAADs that indicate reliably the presence of an axle bearing fault. Figure 3-3 shows an example of a TAAD.

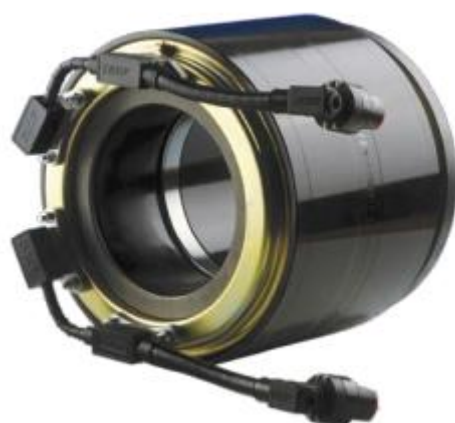
SKF is one of the leading axle bearing manufacturers. SKF has recently developed an integrated onboard condition monitoring system for monitoring railway axle bearings in real-time. Apart from using the standard temperature sensor, the SKF Axletronic system combines vertical and/or lateral acceleration measurements. In its original concept, this system also incorporated an AE sensor but the most recent design has focused on the use of a temperature sensor and accelerometer only probably to simplify data acquisition requirements and reduce overall cost. The SKF Axletronic can be installed in axlebox bearing units or axlebox front covers and can provide continuous feedback about the bearing condition [49]. Figure 3-4 shows SKF Axletronic sensor systems installed onto the bearing seal as an integral part of the bearing unit.

Figure 3-4 SKF Axletronic [49].

Unfortunately due to the cost of the SKF Axletronic system, its use is probably only cost-effective and justifiable primarily for high-speed trains. Nonetheless, other passenger trains could also be instrumented with this system. However, in the case of freight rolling stock due to the rolling stock nature as well as the small margin of profit freight leasing companies and freight rolling stock operators have, the cost of this system is currently prohibitive.

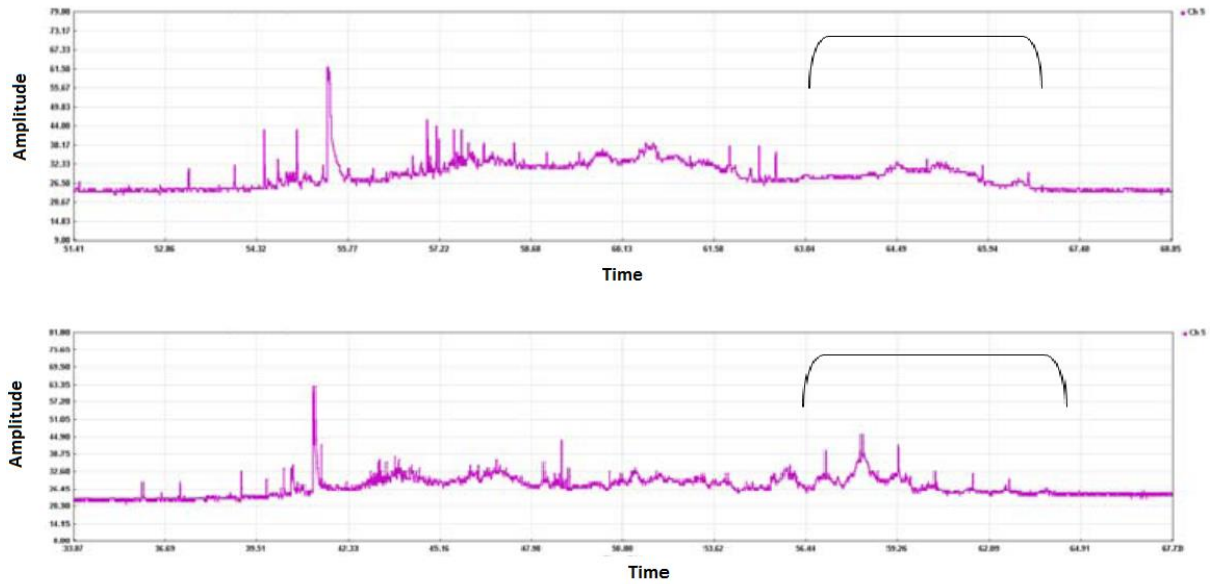
Figure 4-4: Reference train movement (top) 2.5cm flat defect surface (bottom) Extra peaks are visible in the defective wheel [98].

Also AE amplitude versus time plots were reported from a healthy wheel as reference a wheel with a 2.5cm flat present on the tread (shown in Figure 4-4). The additional peaks in the AE signal from the deteriorated wheel supposedly indicate the presence of wheel flat.

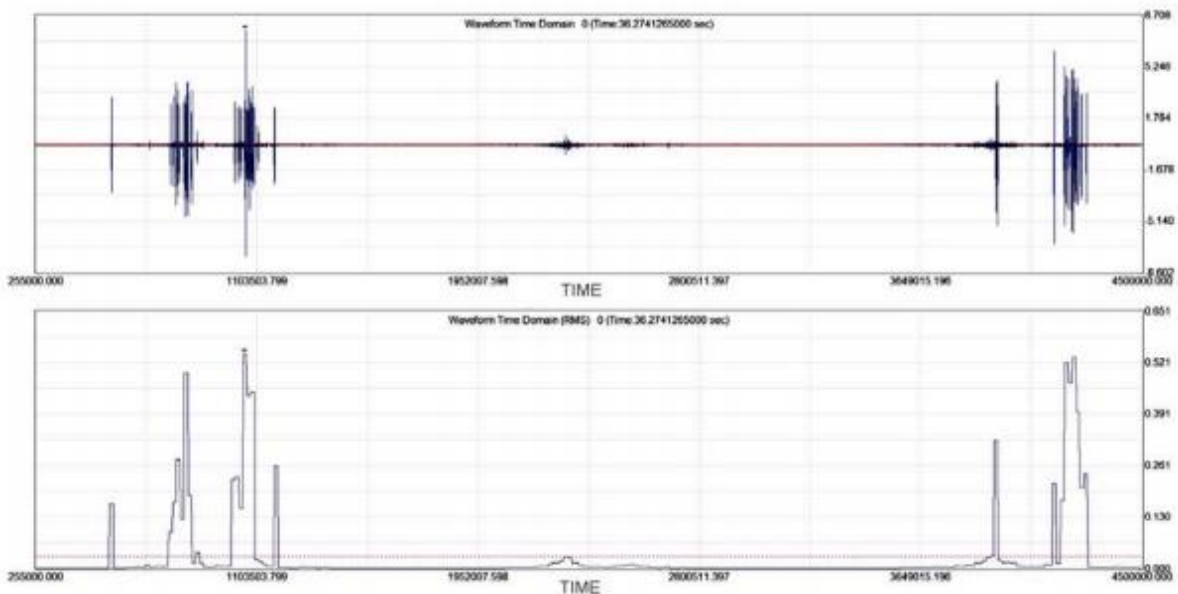
Figure 4-10: Raw AE waveform (top) and moving RMS graphs (bottom) acquired by a PAC R50 sensor during passes of a railcar with a wheel flat defect [115].

The moving RMS is a process of calculating RMS values in the signal divided into windows of a specified size such as the length of one wheel revolution. The plot shown in Figure 4-11 is an example of measured moving RMS of a passing railcar with a wheel flat defect. Analysis of the raw dataset using moving RMS allows the calculation of the main peaks of interest in the acquired signal.

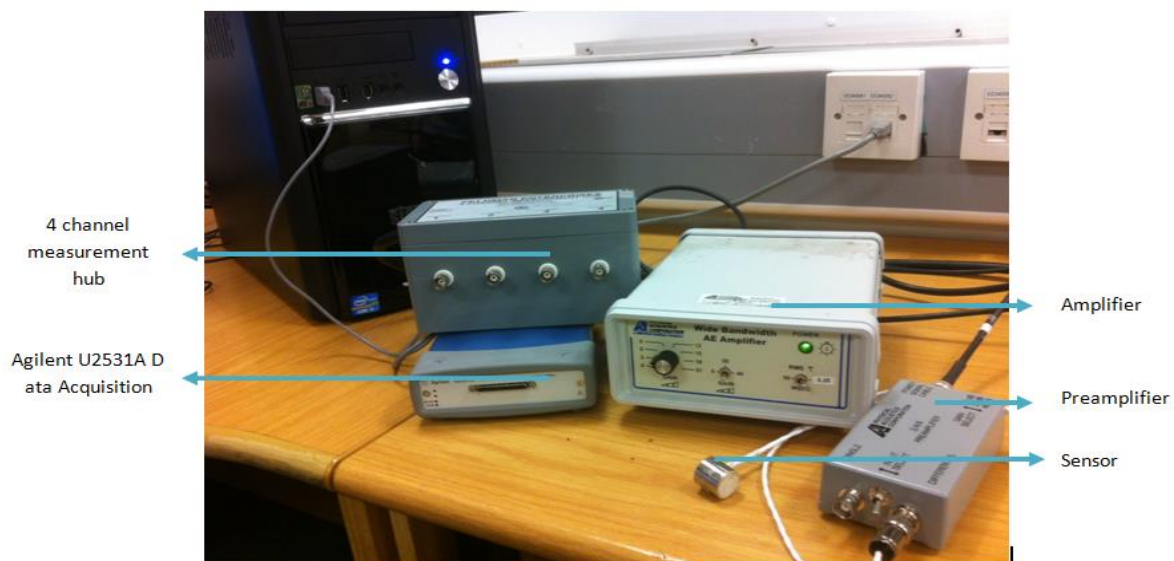
Figure 5-1 shows the equipment used for AE measurements during the experimental work carried out as part of this study. The customised system consists of the following components: a) AE resonant and wideband sensors procured from Physical Acoustics Corporation (Ltd) (PAC UK – now MISTRAS), b) Agilent U2531A data acquisition board and decoupling box, c) standard desktop computer with customised data logging and signal processing AE system software written in MATLAB by the author, d) pre-amplifier procured from PAC UK, e) AE Amplifier also procured from PAC UK, and f) BNC cables.

Figure 5-1: Instruments used in experimental work

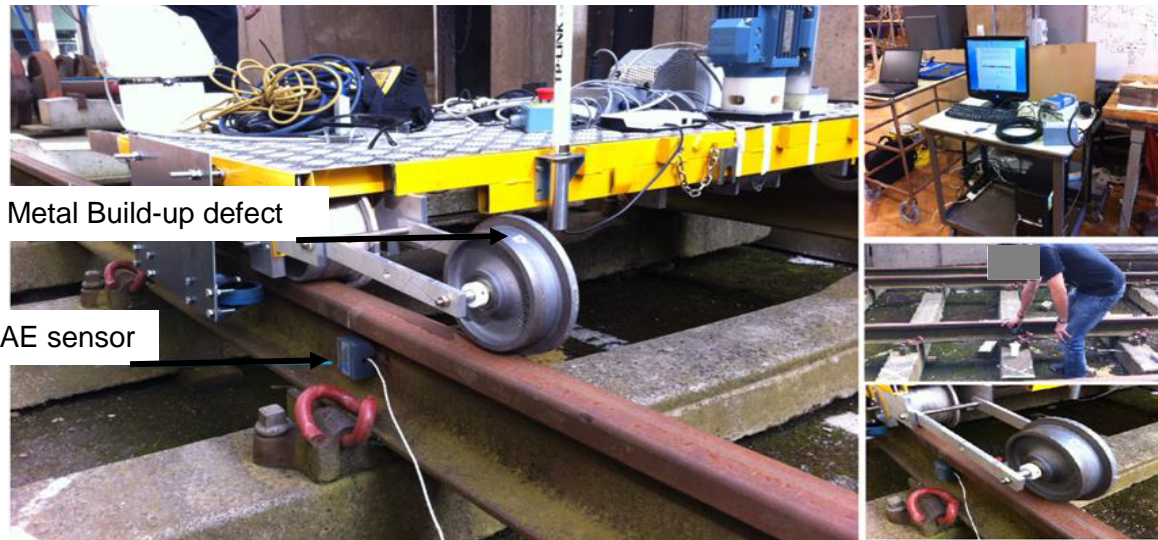
Additional experimental work was carried out using a motorised test trolley with the help of Dr Hamed Rowshandel. These tests were designed in a way that simulated as close as possible the actual operational conditions under a laboratory environment. Figure 5-21 shows the motorised trolley on which the test wheel was mounted together with the rest of

the experimental setup. The motorised trolley was moved along a 7m-long test track and during testing the speed was set to be constant at approximately 2.5 m/s using a motor controller.

Figure 5-21: Experimental work with motorised trolley.

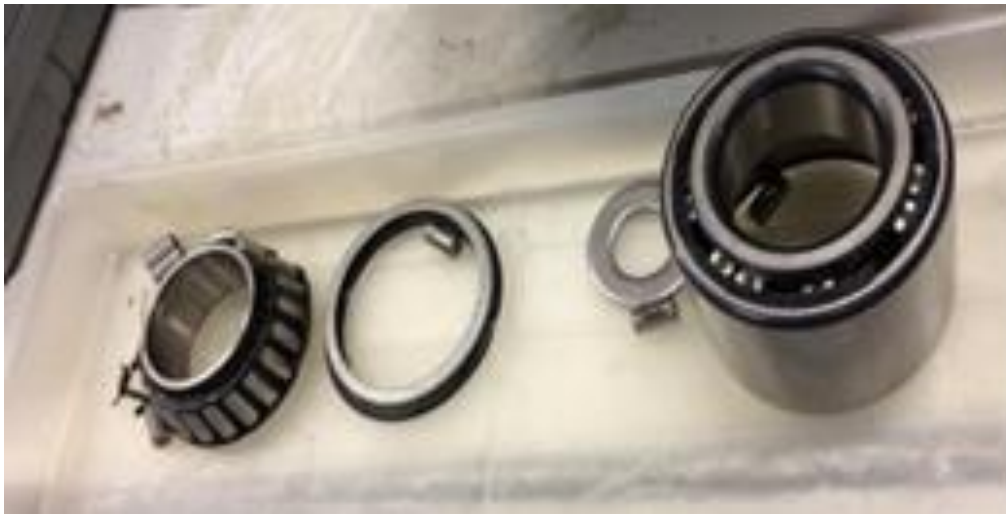
Figure 5-26: Example of a rig double-row tapered roller bearing.

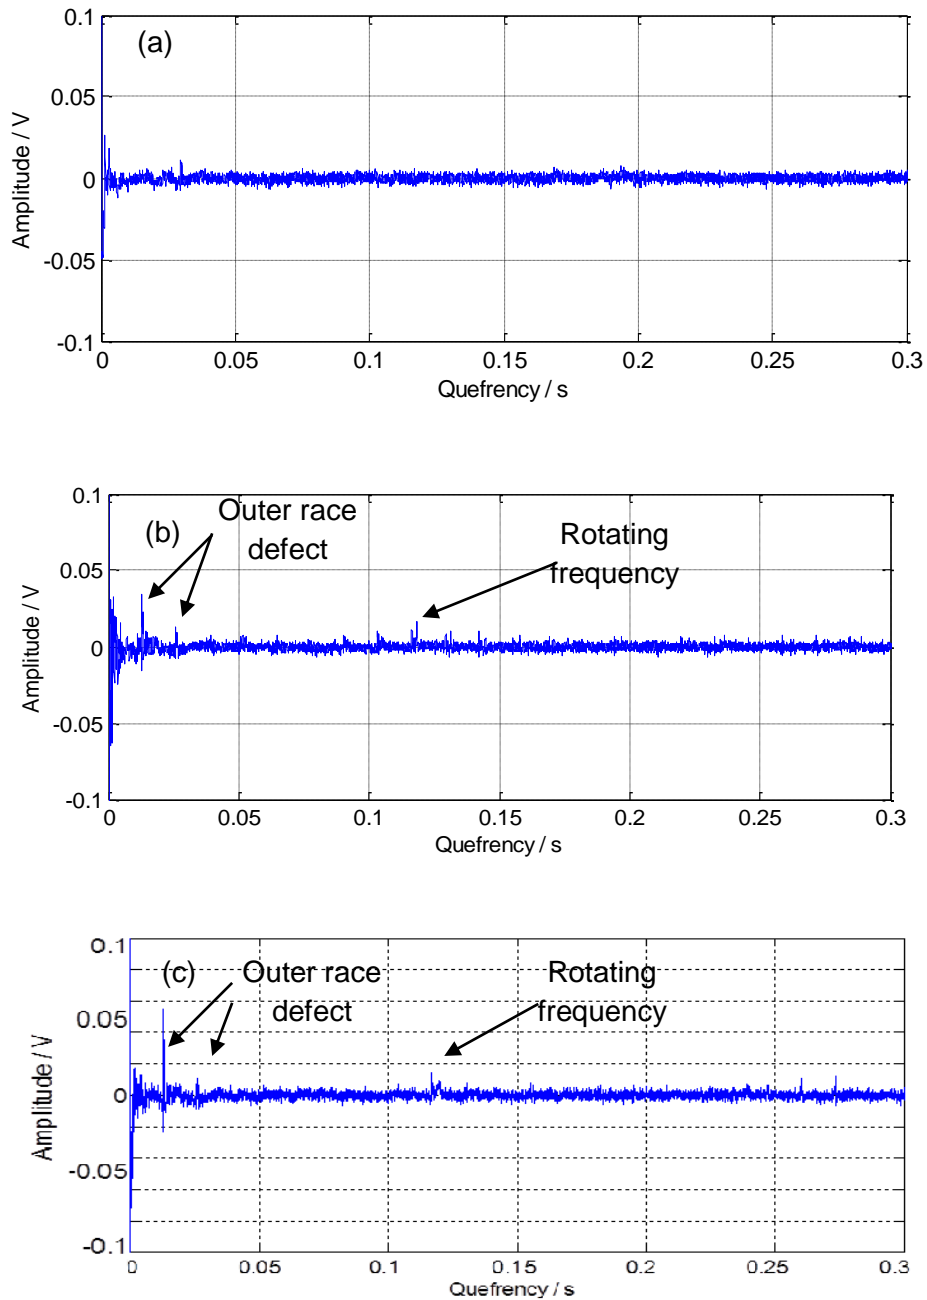
Figure 5-42: Cepstral analysis of the laboratory bearing rig vibration test at a rotating speed of 500 RPM – a) Healthy, b) F1 defect and c) F5 defect.

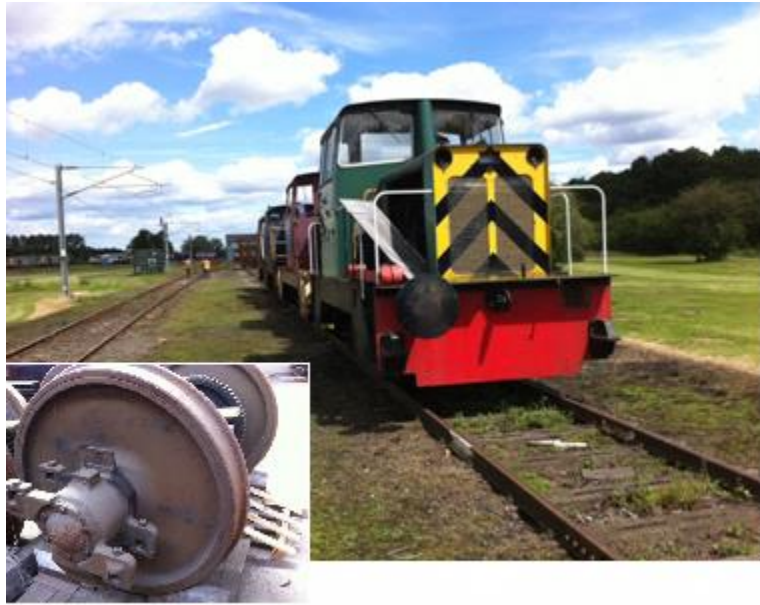
Experiments were carried out in Long Marston test track involving both onboard and wayside measurements. Figure 6-1 shows the Long Marston test track section where tests were carried out. A number of artificially induced faults were considered including wheel flats, lubricant contamination, race and roller defects. The defects on the roller and race were three different sizes (2,4 and 8 mm). Tests were carried out at a speed of 30 MPH (48 km/h) in the direction forward (engine in front) and 20 MPH (32 km/h) in the direction backwards (engine in the back). The freight cars used in the experiments were pulled over a straight section of jointed (continuously welded after re-railing of the test section was completed) track a few hundred metres long. The sampling rate for AE signals was set at 500 kS/s and vibration at 25 kS/s. The duration of the acquisition was 10 s for the onboard tests and 12-24 s for the wayside tests depending on the number of freight wagons used during testing. Between one and four wagons were used during the various set of trials. Ultrasonic coupling of the AE sensor was achieved using vaseline. The Wilcoxon accelerometers employed have a built-in magnet to keep them in place. The AE sensors were held in place using magnetic hold-downs. The axle bearing of the test freight wagons were manufactured by Timken (Timken bearing model 99591-99100). Appendix B shows the characteristic frequencies of the train bearing provided by the manufacturer. Figure 6-2 shows the artificially induced 4 mm roller bearing defect.

Figure 6-1: The Long Marston test track section where the majority of tests were carried out prior to re-railing.

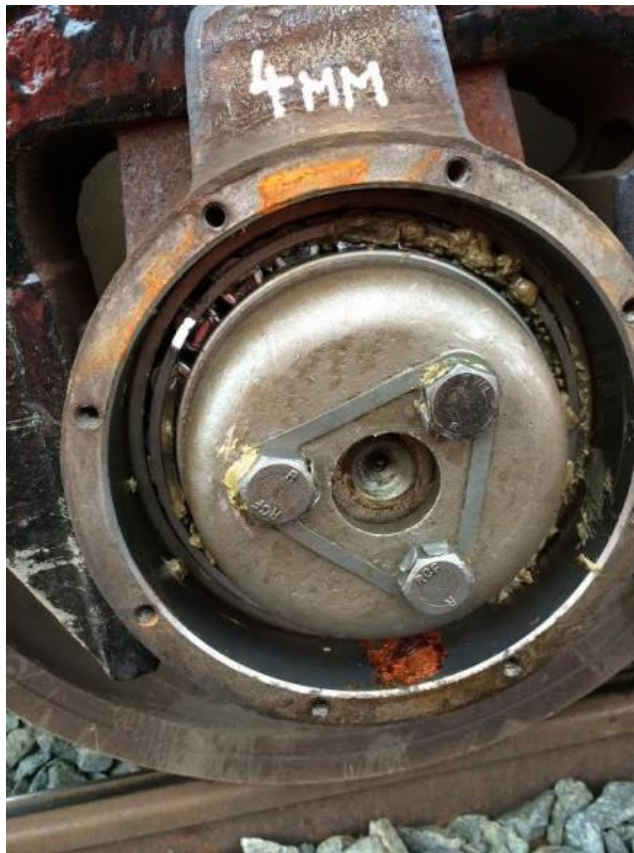
Figure 6-2: Example of a defective bearing with 4mm roller defect

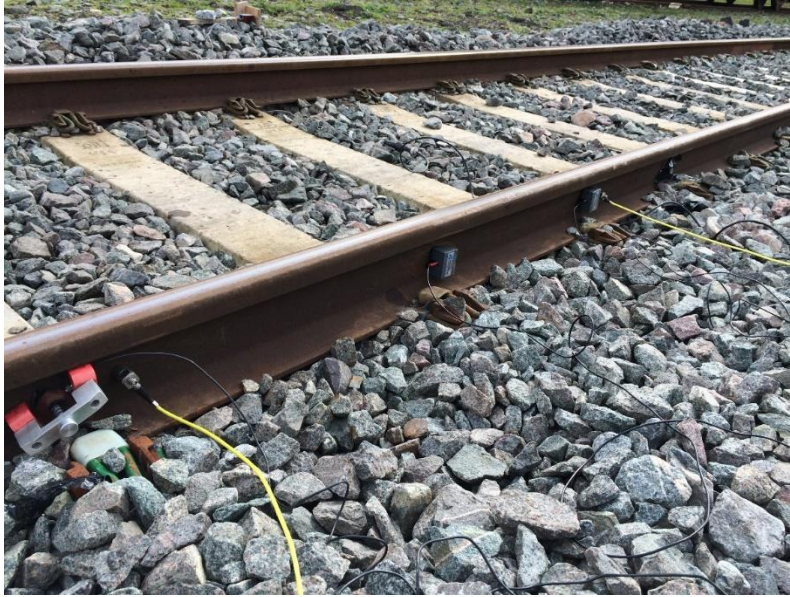
Figure 6-10: Installation of accelerometers and AE sensors on the track

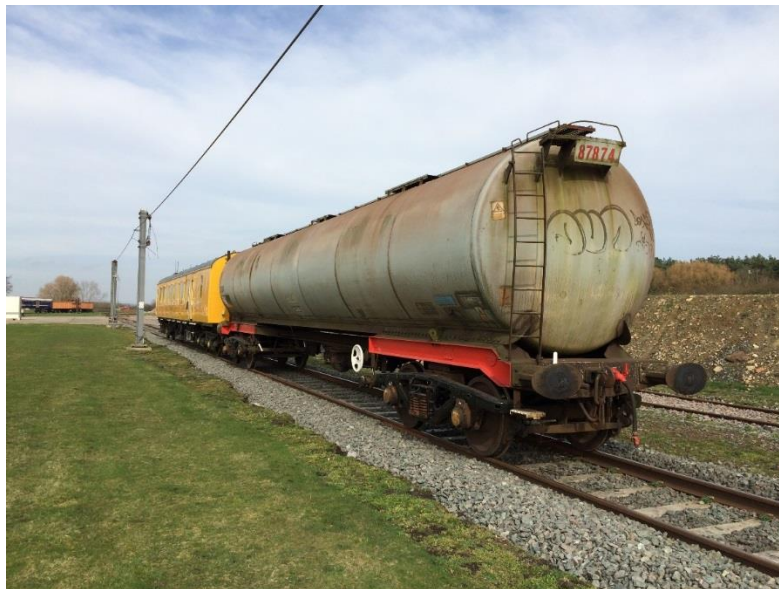
The schematic in Figure 6-10 shows the sensor installation during wayside tests carried out in Long Marston. Figure 6-11 shows the tank freight wagon containing three bearings with faulty rollers pulled by the engine.

Figure 6-11: Test car in Long Marston test field. The yellow locomotive in front pulls or pushes the test wagon depending on the direction of movement.

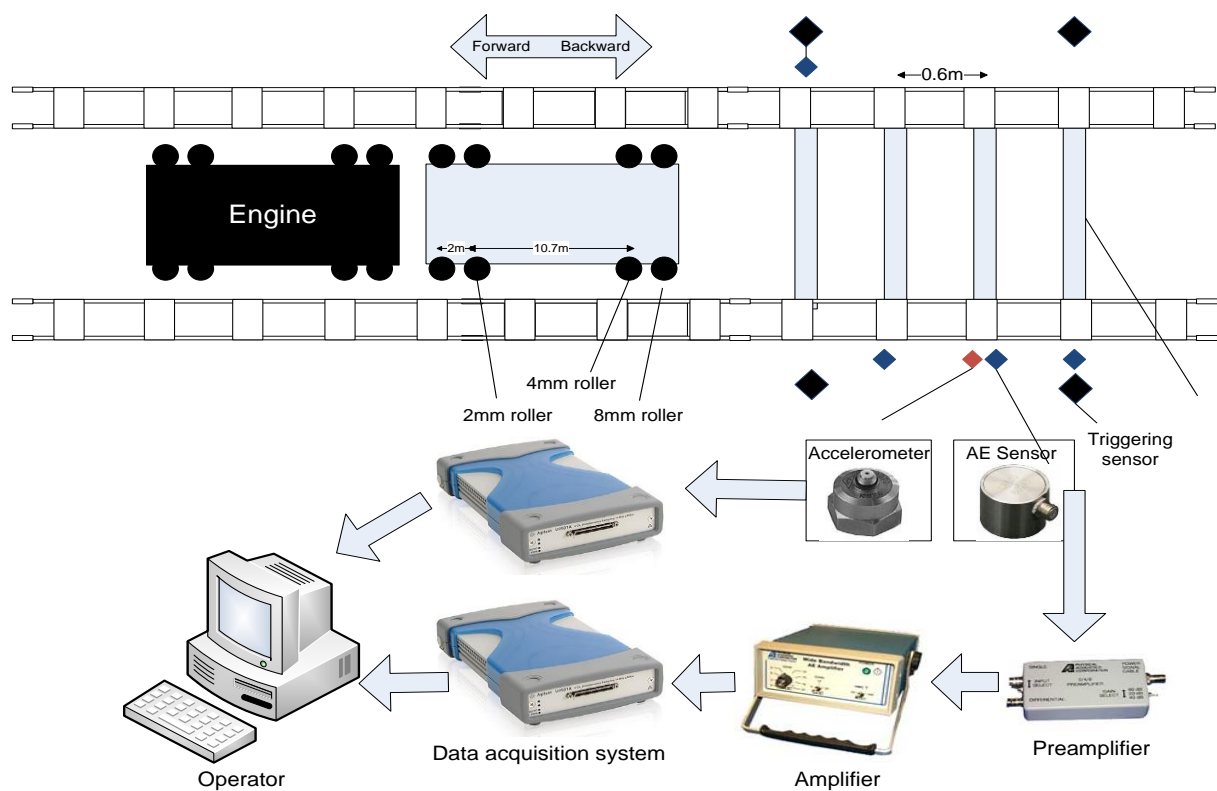
Figure 6-13: Schematic of wayside installation.

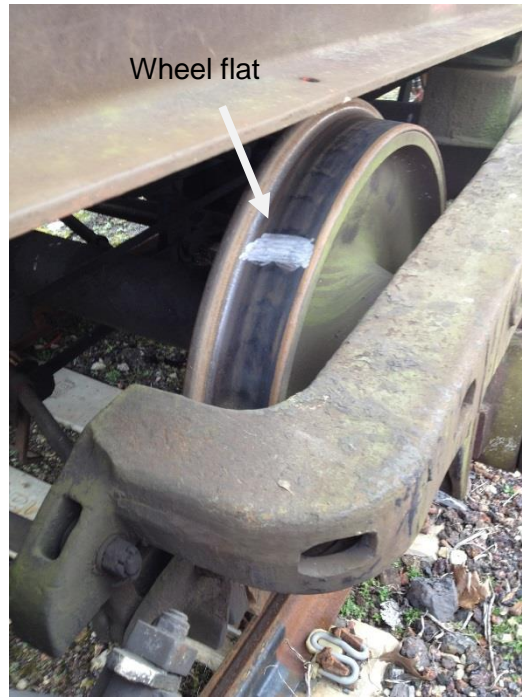
Experiments on the defective wheel, with a flat being present, were also carried out in the field. These series of experiments included the train with an engine in front along with 2 wagons. In the first wagon the first and fourth wheels, had bearing defects (lubricant contamination) and the third wheel had a 5 cm flat induced with a power tool as shown in Figure 7-3. The schematic in Figure 7-4 shows the overall experimental setup.

Figure 7-3: Artificially induced wheel flat in the field experiments.
