River Road New Castle Marsh Restoration Recommendations

Rockingham County Conservation District

**Rockingham County Conservation District
River Road Marsh and Stuart Farm Restoration Projects
Final Project Report – June 2010**

**River Road, New Castle
Marsh Restoration Recommendations
June 1, 2010**

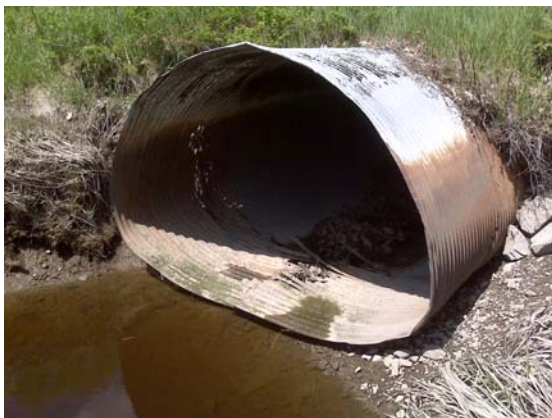
Upstream inlet

The project scope involved completing engineered plans and federal and state permits necessary to allow the replacement of a failing culvert located at the Stuart Farm in Stratham, NH. The purpose of this project was to obtain the plans and permits so that the landowners can move forward quickly with the construction component. The salt marsh directly affected by this culvert is approximately 12 acres in size, and connects to the Squamscott River. The property is owned by one landowner. The existing oval bituminous coated corrugated pipe (approximately 7 feet tall, 12 feet wide, and 60 feet long) was installed in 1993 (with assistance from NOAA & USF&W S funds) to replace a tide gate that was limiting salt water flow. With the new culvert installed, the increased influence of salt water restored approximately 12 acres of salt marsh. Salt water corrosion greatly shortened the expected life of the corrugated culvert, which has nearly completely rusted out through the bottom. Several extreme flood events in 2009 and 2010 severely deformed the culvert and caused it to be a tidal constriction. Due to the failing culvert, the road at this site has been overtopped by floodwaters repeatedly and is a source of fine sedimentation into the adjacent marsh.

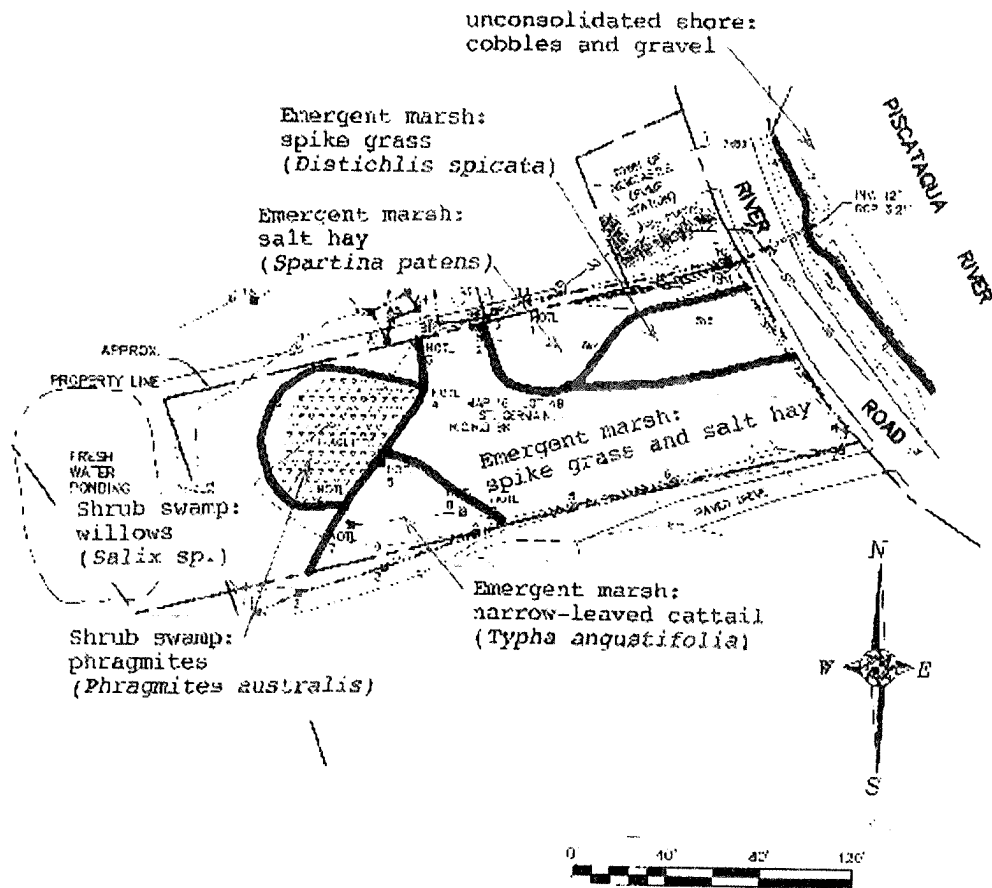
Figure 1 Generalized Vegetative Cover Type Map

Generalized Vegetative Cover Type Map
 River Road Wetland, New Castle NH

Figure 1 shows the project area and general vegetative cover in the area. It is likely that *Phragmites* will continue to expand into the marsh if no alternative is chosen. It is also likely that mosquito breeding areas will continue to flourish, and will need constant mosquito treatments.

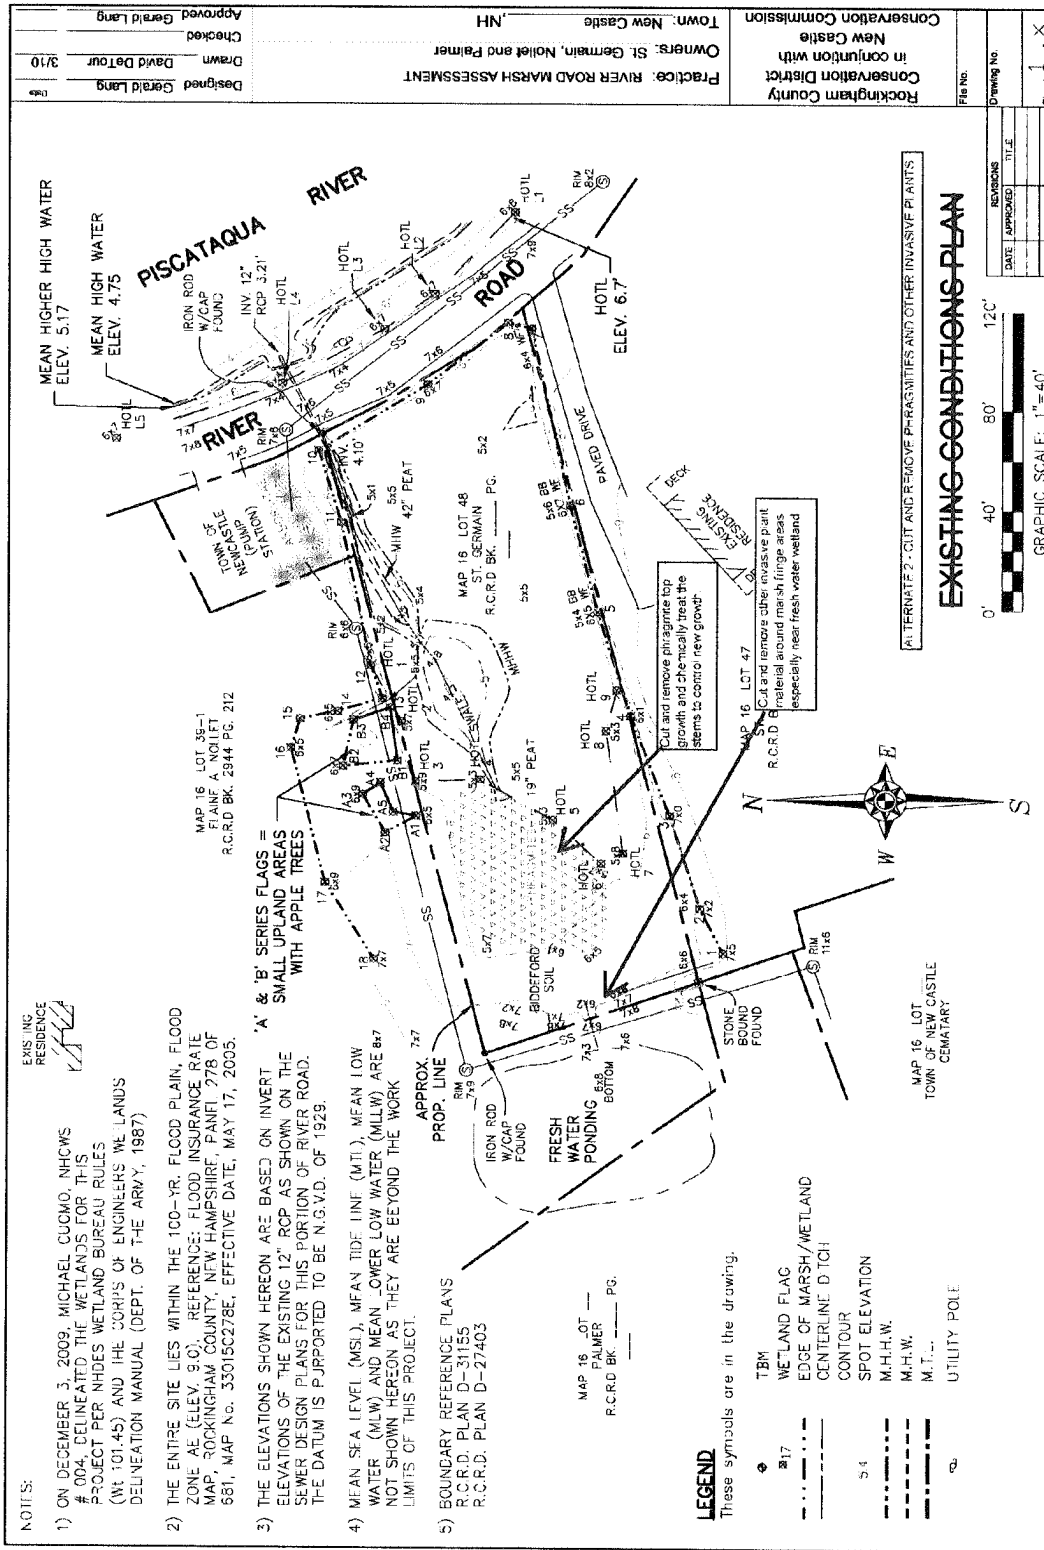
Figure 2 Alternate 2 – Cut and Remove *Phragmites* and Other Invasive Plants

Initiate restoration with invasive species control around pump station and fringes of marsh that include *Phragmites*, multiflora rose, honeysuckle, etc. Figure 2 shows the general location of invasive plants needing treatment. The estimated area for the *Phragmites* treatment is 3,025 square feet. The square footage of the other invasive plants is approximately 2000 +/- square feet. With landowner approval, the proposed treatment includes cutting within the wetland, and cutting followed by herbicide treatment in uplands. If herbicide application is used it will require a special permit.

The estimated area for the *Phragmites* treatment is 3,025 square feet as shown on Figure 2 and 3. During stream restoration activities the excavation will include removal of an average of approximately one foot of sediment within and adjacent to the *Phragmites* stand. The excavation would be graded so as to discourage ponding. This task would be completed at the same time as the stream restoration and included as a component of the NHDES Dredge & Fill permit for the stream restoration.

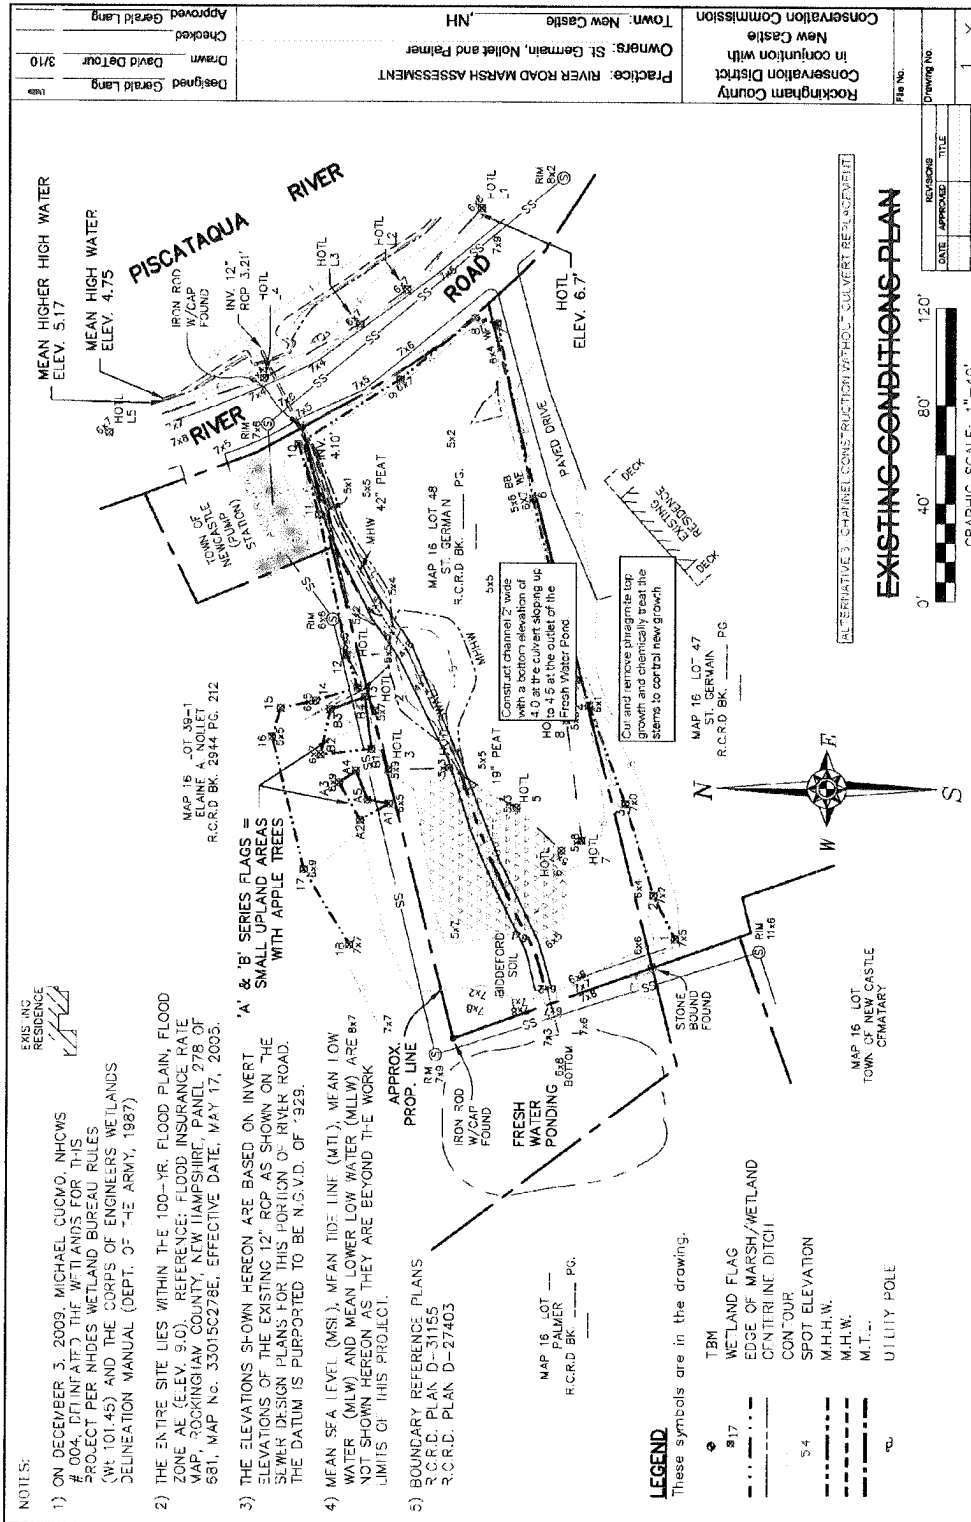
Figure 3 Alternate 3 – Channel Construction without Culvert Replacement

Figure 3 shows proposed location of the channel/swale with a width of 2 feet and depth ranging from 1.0 to 1.5 feet. Although depicted as straight in Figure 3, the restore stream would include meanders as shown on the Existing Conditions Plan Mark-Up in the appendix. Excavated material to be removed and transported to an offsite location for composting or disposal. Soil observations were performed with hand tools along the berm for the purpose of determining a minimum depth that could be excavated at the existing stream channel without damaging the underlying sewer line. This observation could only be achieved to a depth of one foot (elev. 5.8+/-) due to the extremely stony backfill that was utilized for the sewer. Based upon this information, it appears possible to extend the restored stream into the freshwater ponded area. This restored stream would continue through the existing patch of *Phragmites* to the swale, and to the culvert under River Road shown on Figure 3 and the Existing Conditions Plan Mark-Up.

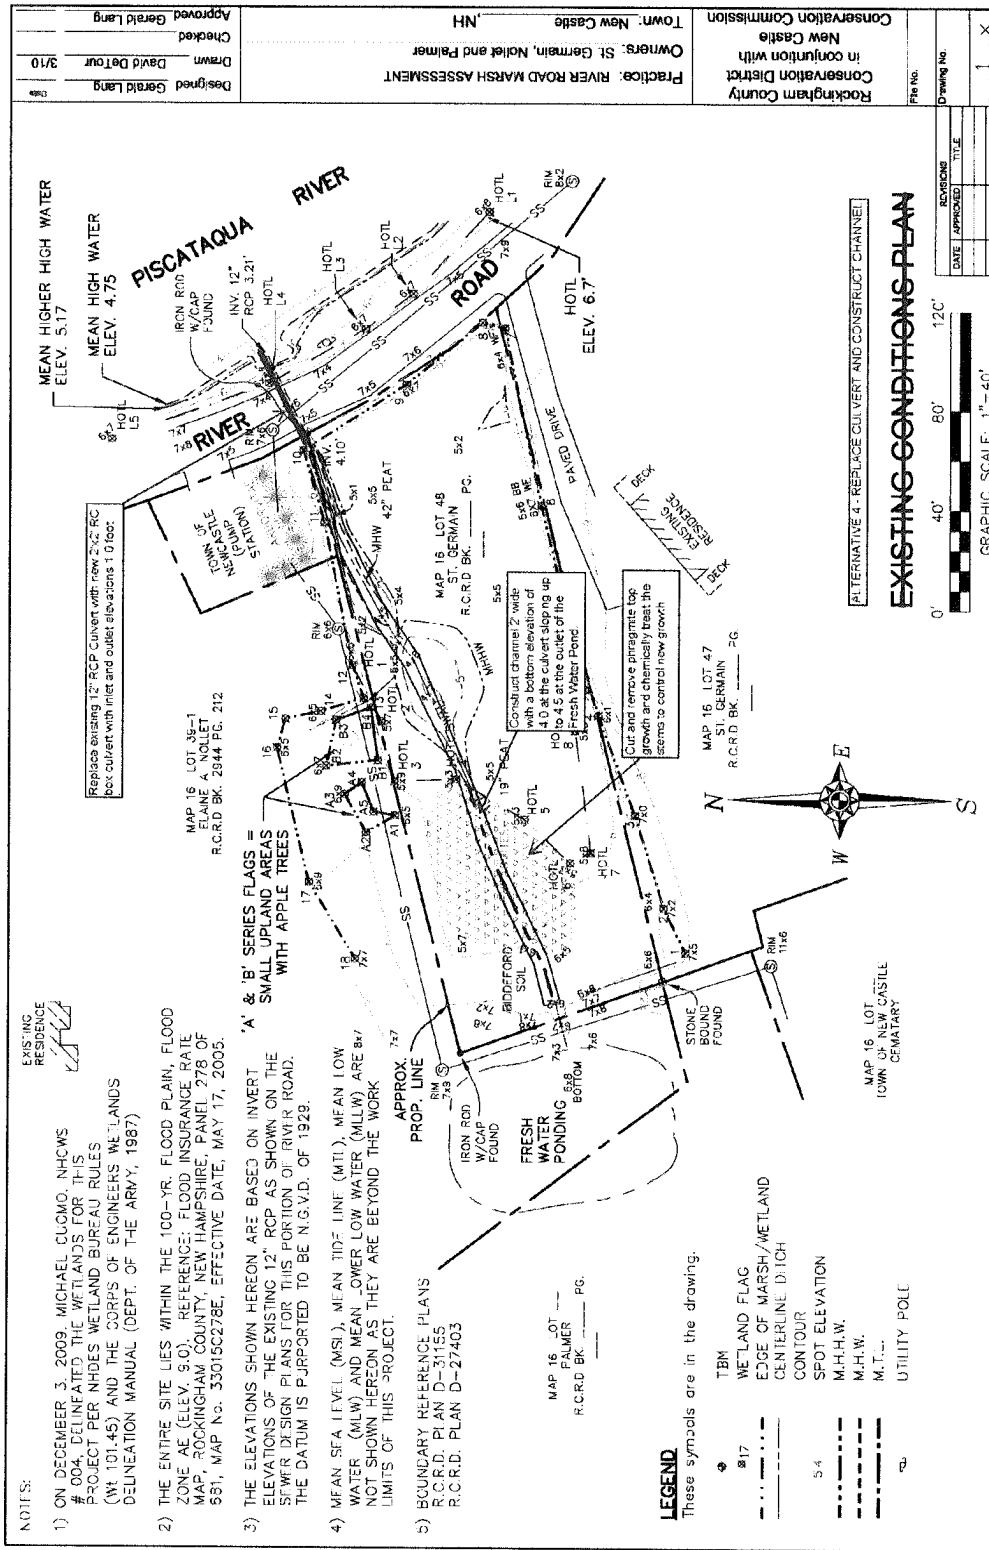
Figure 4 Alternate 4 – Replace Culvert and Construct Channel

Figure 4 shows the proposed location of the restored stream and culvert replacement location. The stream restoration is the same as noted in Figure 3 and the Existing Conditions Plan Mark-Up. The culvert replacement plan is to excavate the old 12 inch diameter RCP culvert and replace with a 24 inch diameter HDPE culvert embedded 1.0 foot lower than current culvert but refilled with sediment to match the existing channel elevation. This new culvert will allow salt water inflow to occur over a longer time period and allow a greater volume of salt water to enter the marsh area and help control invasive plant growth by increasing the salinity of the marsh. The larger culvert will also improve the discharge capacity for severe stormwater runoff events.

The main advantage of the 24 inch diameter HDPE culvert shown on Figure 4 is that the water would get into the marsh slightly faster (than the existing 12 inch diameter culvert) but it would also drain off the water quicker. This would get stormwater off of the marsh faster, even during high tides to eliminate possible road overtopping. It would also have less inundation of the neighbor's property around the apple trees. The 24 inch culvert would also be less likely to get plugged up with debris, and require less maintenance. It is highly unlikely to get a NH DES Wetlands Bureau permit to install a trash rack on the ocean side of the culvert.

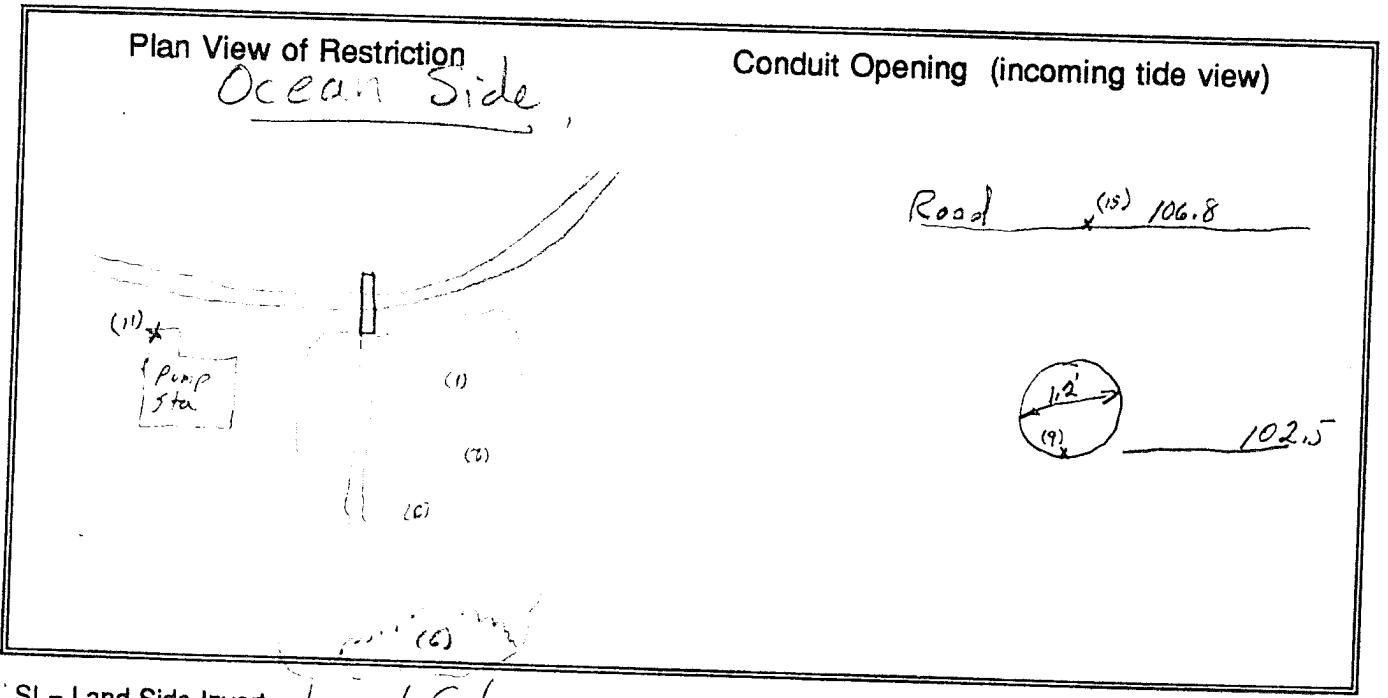
SKETCH

LSI = Land Side Invert
 OSI = Ocean Side Invert
 LSME = Land Side Marsh Elevation
 OSME = Ocean Side Marsh Elevation

LSWS = Land Side Water Surface (+/- 25' from conduit end)
 OSWS = Ocean Side Water Surface (+/- 25' from conduit end)
 PHRAG = Elevation of Phragmites
 TRM = Temporary Reference Mark
