**Restoring Salt Marsh and Functions to Newly Acquired
Shoreline in North Mill Pond, Portsmouth**

**Final Project Report
December 2011**

David Burdick
Jackson Estuarine Laboratory
85 Adams Point Road, Durham NH 03824
(603) 862-5129; dburdick@cisunix.unh.edu

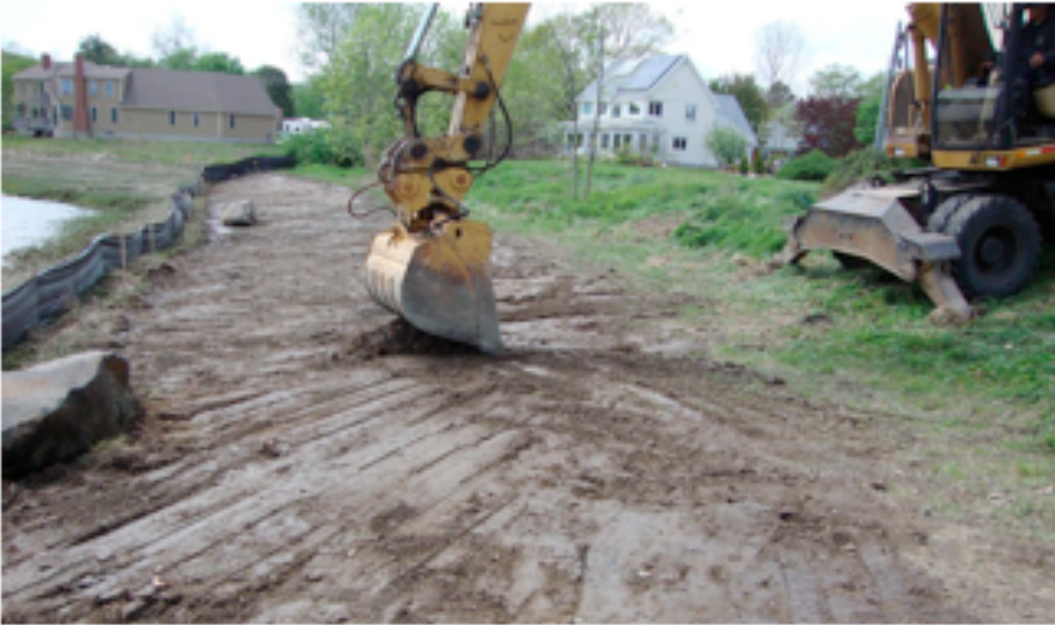
Figure 2. Re-grading the shoreline. Note that two large rocks were replaced at the site.

Year One Restoration: On May 3, 2010 the City DPW removed the berm, re-graded the shoreline (Figure 2), and disposed of debris at the stump dump off Route 33. The removal was supervised by knowledgeable and experienced DPW staff, including Dave Allen. Some plants were removed from the debris and propagated at Jackson Estuarine Laboratory. Following fill removal, the entire

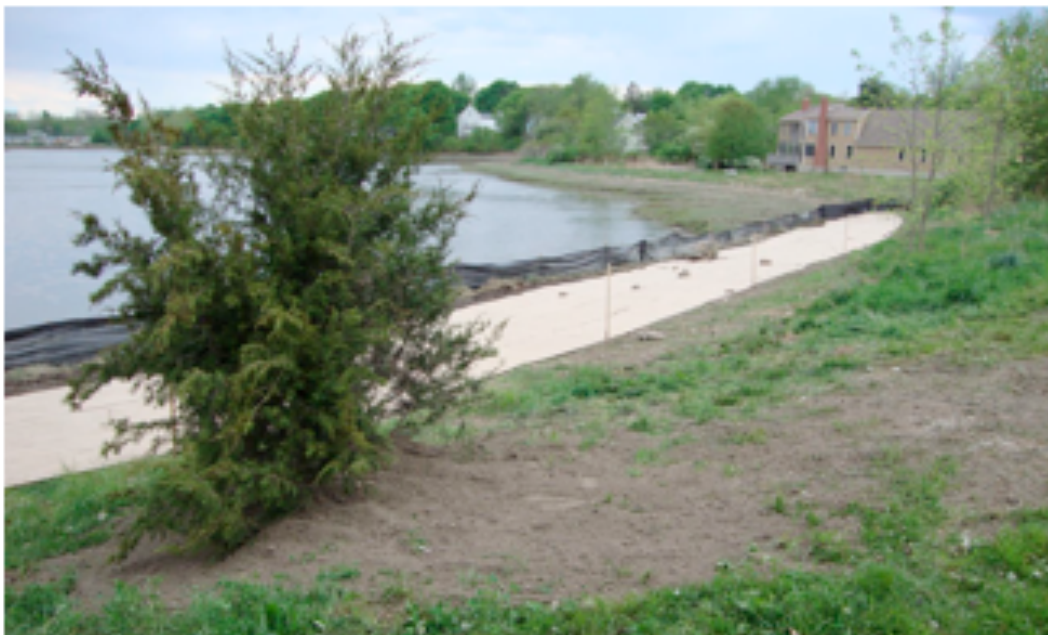
Figure 3. Burlap covering exposed soils in work area; red cedar replanted on upland. Picture taken on May 5th, 2010.

work area was covered with burlap staked to the exposed soils on May 4 (Figure 3). Natural wrack deposits were collected and bound by jute fabric and twine into rolls (4 to 6 inches in diameter, 4 feet long) and staked to the lower edge of the disturbed area to further reduce sediment movement into the pond. The berm removal area was approximately 15 by 160 feet (2,400 ft² or 223m²).

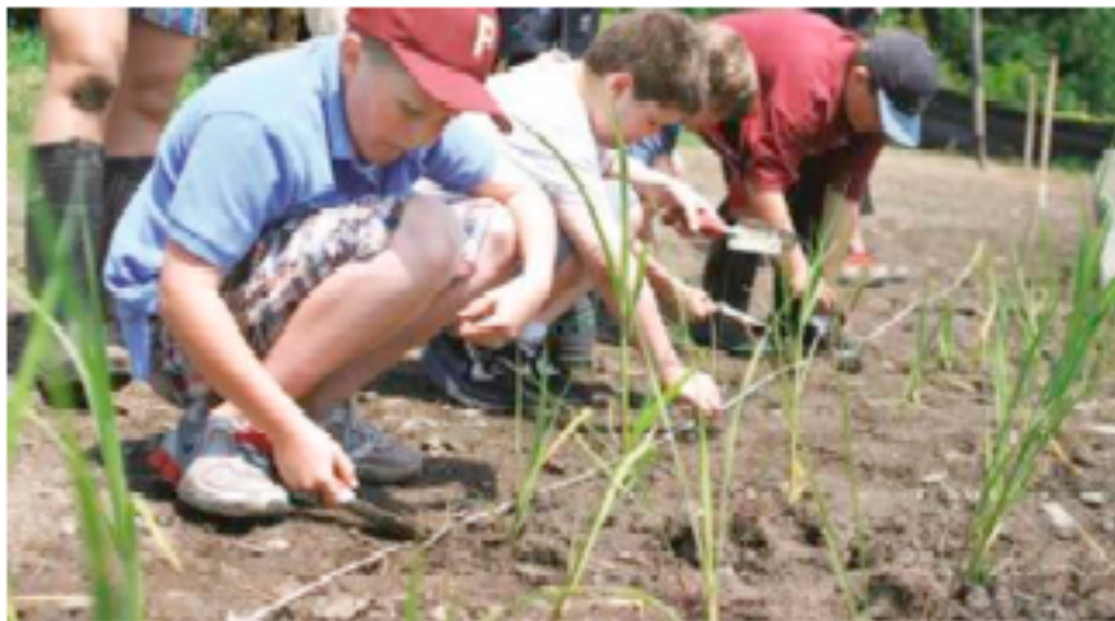
Figure 4. New Franklin School students planting the new marsh, June 2, 2010. Photo Credit: Stephanie Parshall, Portsmouth Herald.

In June of 2010 the fifth graders of NFS and community volunteers installed the plants at appropriate elevations. Soils disturbed by the berm removal were planted on two-foot centers with Smooth cordgrass (530 plants) at elevations appropriate for the low marsh and 450 plugs of high marsh plants in the upper intertidal zone (Figure 4). In addition, students planted coastal grass seed at the highest elevations rarely flooded by tides. On June 5th, community volunteers of ANMP planted marsh grasses as well as the coastal seed mix and completed the planting and site work (Figure 5). The marsh site and shrubs were watered with fresh water on this date and two more times in summer using Ms. Heather Parker's water.

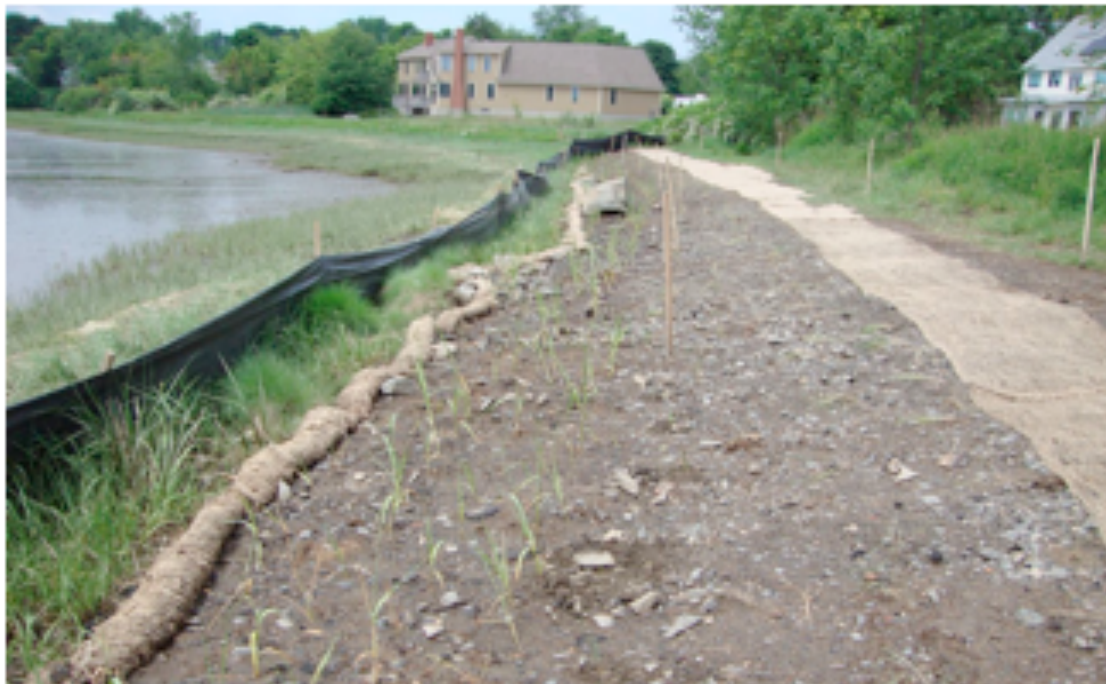
Figure 5. Planting and site work complete, June 5th, 2010.

A coastal seed mix was scattered at upper elevations and covered with Jute (Figure 5), but the area may receive too much salt water flooding for these upper edge marsh plants to survive. A white layer of salt was observed on the soils of the upper areas covered with jute. Some seedlings were noted at the northern extreme of the site, but most new shoots at upper elevations were expanding from grasses along the upper edge of the work area (that is, not from the seeds).

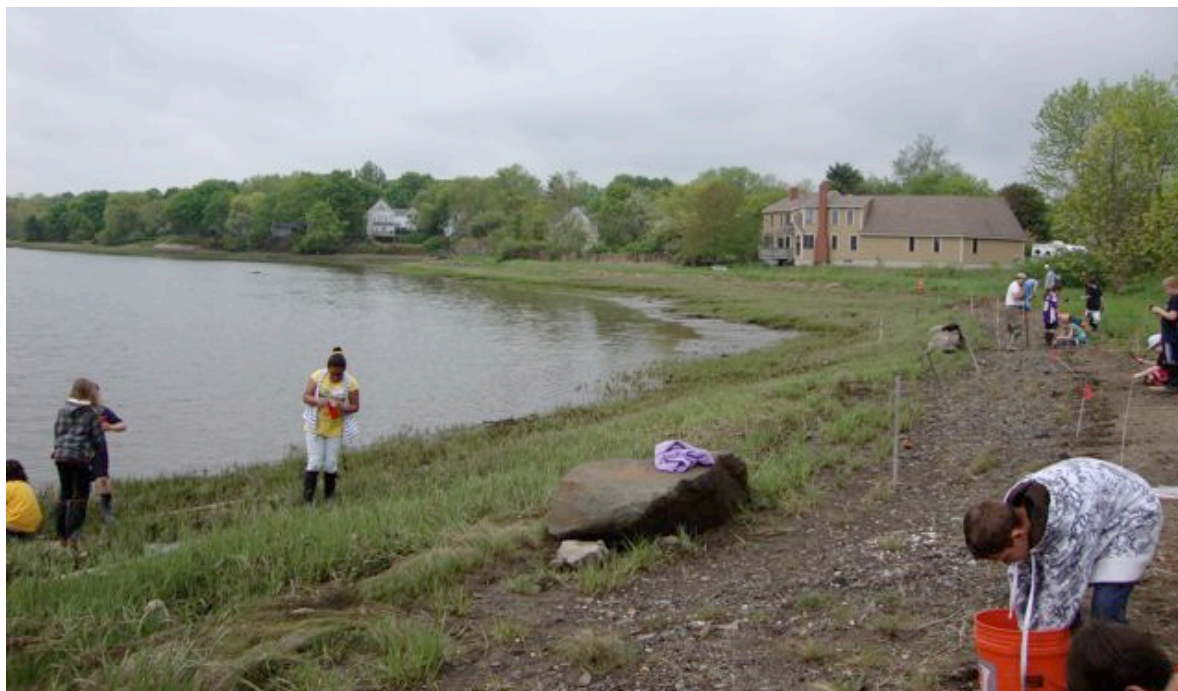
Figure 6. Fifth grade students from New Franklin School adding high marsh plants to upper marsh (right) and ribbed mussels previously existing to low marsh (left) in May 2011.

While some students were planting grasses, others were learning about and installing ribbed mussels (Figure 6). These long-lived shellfish are oriented in the mud so their byssal threads can attach to the base of a smooth cordgrass culm. Over 800 ribbed mussels were planted in the previously existing low marsh seaward of the restoration area.

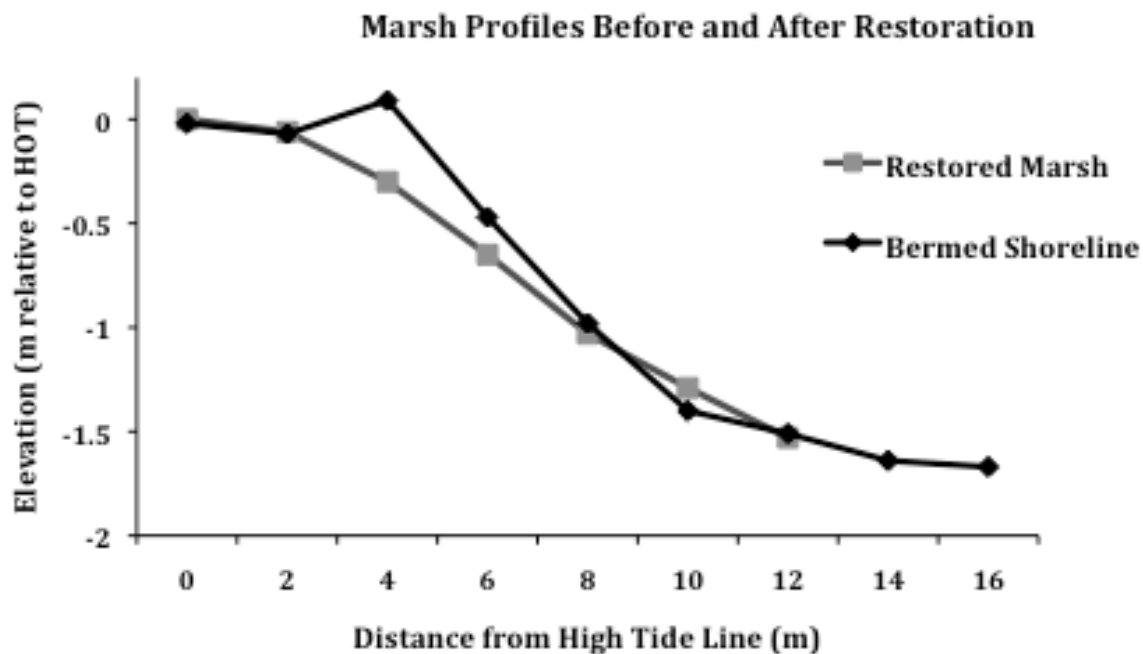
Figure 7. Shore normal profiles measured with a lazar level from the highest observable tide to the edge of the low marsh in 2009 (Bermed Shoreline) and in 2010 (Restored Shoreline).

Monitoring: Monitoring was performed to document development of the planted vegetation and natural processes on the site. Following removal of the berm, students created a profile of the re-graded site on May 7, 2010. The new shoreline profile is shown in Figure 7 with a similar profile made in 2009 prior to restoration. Both show elevations relative to the highest observable tide (HOT), as estimated in the field. Berm excavation and re-grading occurred between 2 and 8 meters on the chart. The new profile should allow unhindered tidal flooding of the site and support of native marsh vegetation.

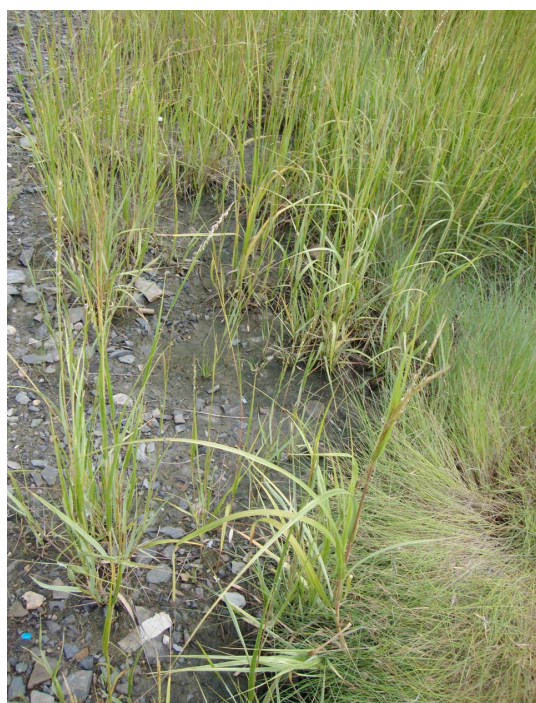
Figure 8. Low marsh with Smooth cordgrass and Salt hay. Note the multiple new shoots of cordgrass between planting units.

Overall, the high survival of plants in Year One carried over to Year Two, but could not be quantitatively assessed because underground rhizomes produced new shoots indistinguishable from planting units (Figures 8 and 9). Figure 10 shows the planted low marsh on the left. In most areas it is indistinguishable from existing marsh, forming a continuous band along the pond shoreline. Note the position of the boulder with respect to the Smooth cordgrass over time by comparing Figure 10 with Figures 2 and 6).

Algae in the low marsh were primarily Marsh felt (*Vaucheria* spp.), which can be seen as a dark green film on the soil surface among the cordgrass in Figure 8. *Vaucheria* increased to 3% cover in the high light of the exposed soil during the first growing season, but then fell by the second year as the cordgrass canopy closed. By the end of Year Two, canopy heights increased to 93 cm, shoots produced seed heads, and many plots appeared similar to existing marsh (Figure 10).

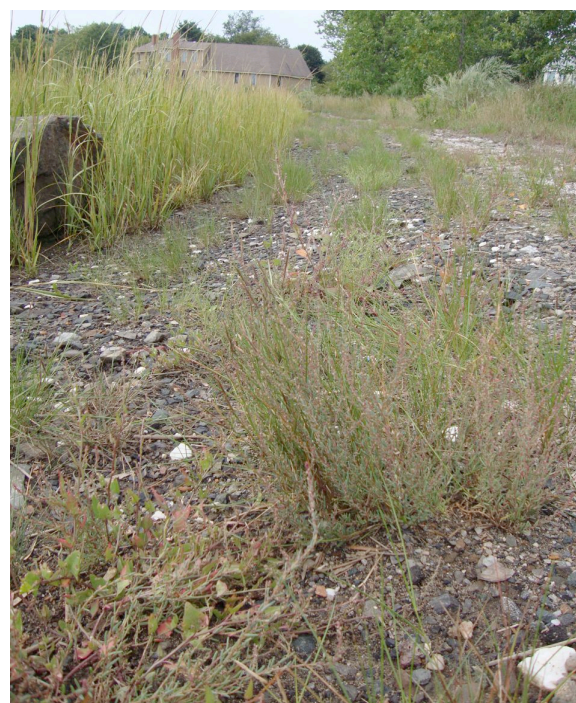
Figure 9. High marsh with Marsh orach, Sea blite (*Sueada linearis*) and Salt hay in the foreground. Note the coarse surface sediments.

Tufts of grasses and forbs in the high marsh are also shown to be expanding (Figures 9 and 10). The upper marsh shows clearly in Figure 10, as indicated by the lighter surface of the degrading burlap cover installed in 2010. It had been planted with plugs in 2011 (Figure 6) and these plugs are growing and expanding.

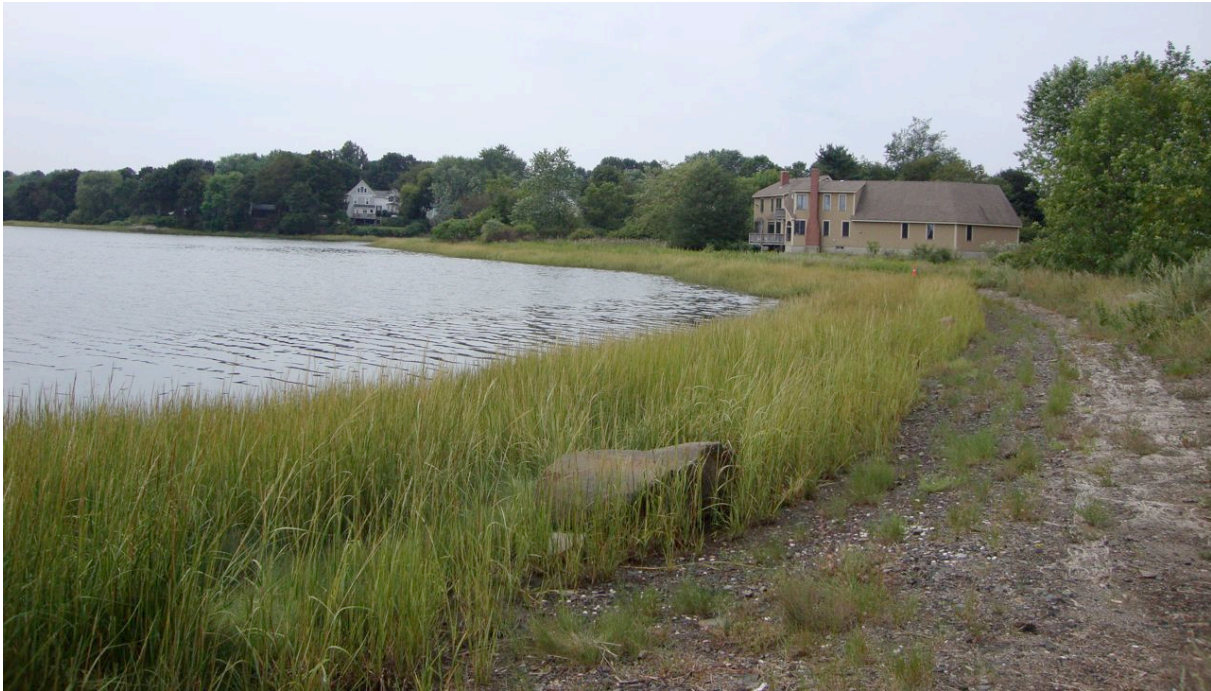
Figure 10. Mill Pond Way restoration site after two growing seasons (September 2011). Low marsh cordgrass has expanded to surround boulder (see Figure 2). High marsh plants are established and expanding, but spread rates are slow in the stressful high marsh zone. The burlap from June 2010 can be seen in the upper marsh zone at right as a lighter band; it continues to decompose under the new high marsh plants that were added in 2011.

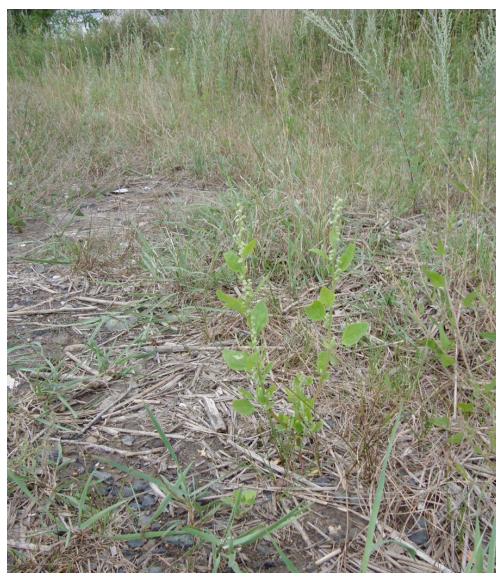
Figure 11. Marsh Elder in upper marsh.

Failure of the coastal seed mix to sprout and grow led to planting a variety of species along the upper marsh zone in May 2011 (Figures 11 and 12). This zone is typically inhabited by a mixture of high marsh grasses and forbs as well as a few species typically found only here (e.g., Marsh elder, Rough cordgrass) or even higher in elevation (e.g., Stiff-leaf quackgrass). Cover of planted and existing vegetation in the upper marsh zone reached 23% in fall 2011 (Table 2).

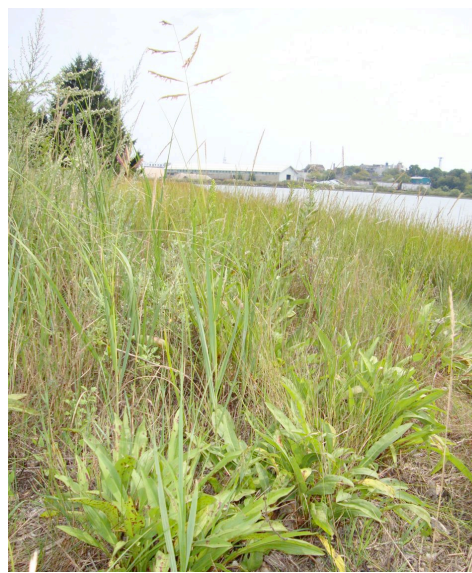
Figure 12. Seaside goldenrod and Rough cordgrass (in flower) in the upper marsh.
