Evaluating the Stormwater Treatment Performance of AbTech Industries Smart Sponge[®] Plus in Seabrook, New Hampshire

Scott Nolan and Stephen Jones

Jackson Estuarine Laboratory
University of New Hampshire
Durham, NH 03824

August, 2004

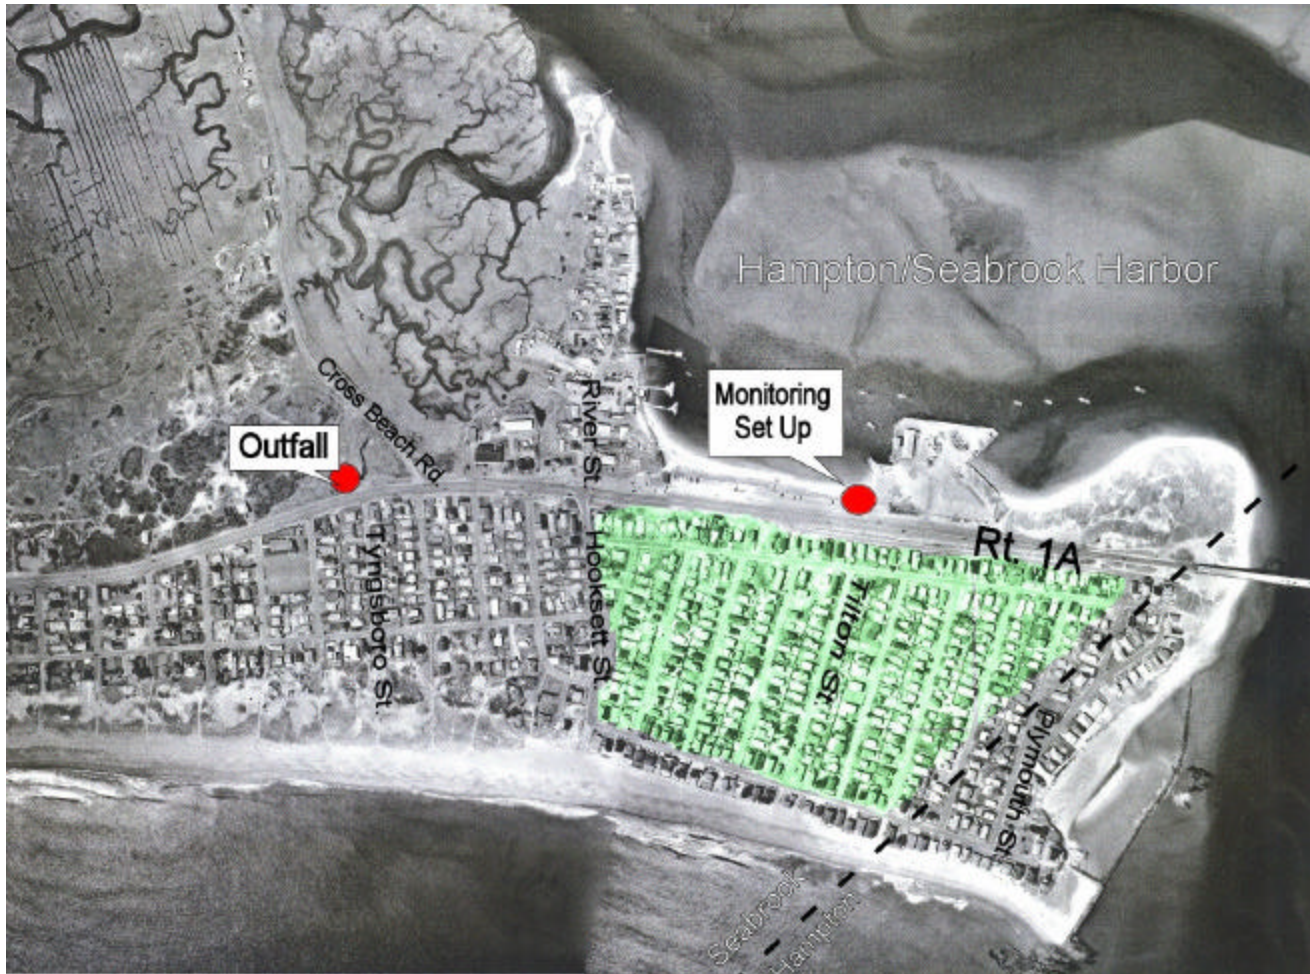
Figure 2 Aerial photo of storm drainage catchment for test site (green). (Sources: Photo-Foote, 2003; Graphics -C. Edwards [DES])

The test site is located in the Town of Seabrook in southeast New Hampshire. The AbTech Smart Sponge® Plus was installed west of Rt. 1A just south of the bridge that stretches across the mouth of Hampton/Seabrook Harbor. This storm drainage system is of concern because of the high bacterial loading it discharges to the harbor during storms

(Jones, 2003). The watershed area for the storm drainage system is approximately 60 acres with at least 65% impervious cover. Its land use is mainly high density residential with commercial establishments along Route 1A. The watershed area can be divided into three individual catchments. The catchment for this study is a series of pipes and catch basins on residential streets east of Route 1A and north of Hooksett Street up to and including Plymouth Street that collect stormwater via leaching basins and perforated and solid pipes to a pump station located on Route 1A across from Tilton Street (Figure 2). Stormwater is then pumped via a 16-inch force main to a drain manhole at the intersection of River Street and Route 1A. The second catchment area collects runoff from River Street, which then pumps via an 8-inch force main into a drain manhole at the intersection of River Street and Route 1A. Stormwater deposited into this shared manhole flows via gravity through a 24-inch pipe to the outfall. A third catchment area associated with this system consists of Route 1A from River Street to the outfall.

The outfall consists of a headwall structure with two drains and is located across from Tyngsboro Street on the western side of Route 1A. Both drains are fitted with tide flex valves to prevent salt water from entering the drainage network. The northern drain is connected to the subject watershed area, and the southern drain is connected to the residential streets east of Route 1A and south of Hooksett Street to Dracut Street. After exiting the outfall, the runoff is retained within a plunge pool, from which it slowly drains via culverts on Cross Beach Road through the salt marsh to the tidal creek to the harbor (Foote, 2003). Refer to Foote (2003) for a watershed analysis conducted by Millennium Engineering, Inc.

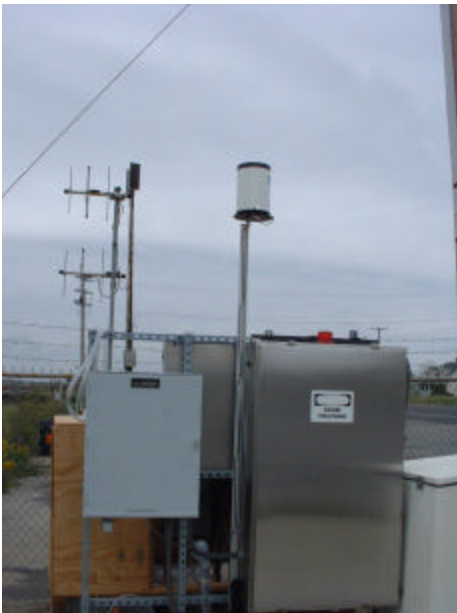
Figure 4 Monitoring site with view of rain gauge.

An ISCO Model 674 rain gauge was secured to a pole six feet above ground level in an open area away from trees and structures impacting rainfall measurements (Figure 4). The rain gauge was connected to and powered by the flow meter. The rain gauge transmitted a signal via the cable for each tip of the collector which represented 0.01 inches of rain. Prior to any samples being collected, the rain gauge and flow meter were monitored during three storms forecasted for at least 0.2 inches of rain. The rain gauge was calibrated using standard calibration techniques described in the operation manuals. Rainfall was measured for each storm event and data were recorded by the data logger.

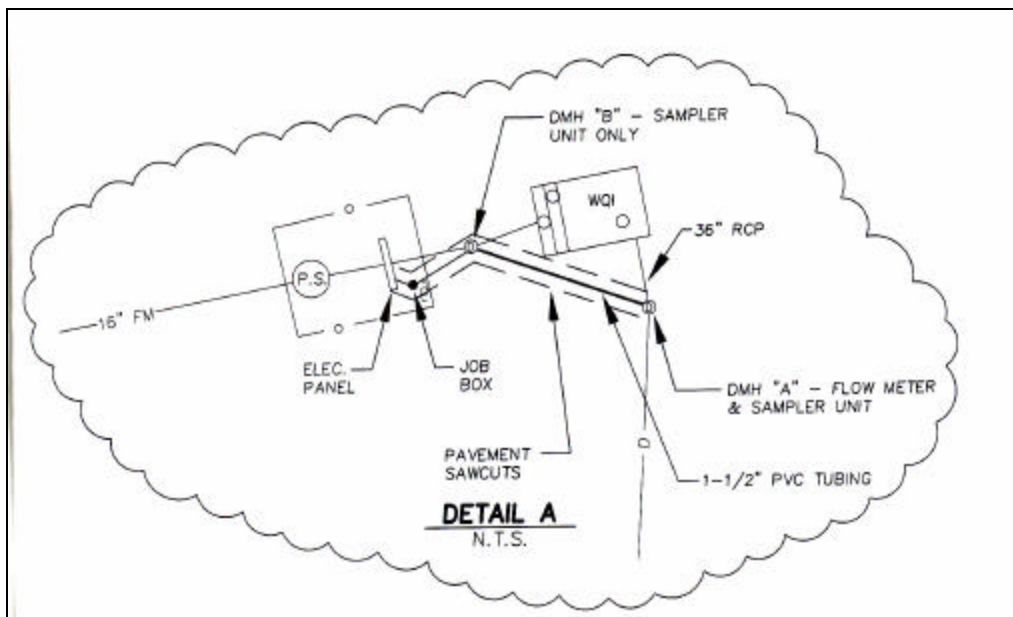
Note: DMH "A" is the location of influent sampling collection and DMH "B" is the location of effluent sampling.

Figure 5 Schematic showing locations of influent and effluent sampling points. (Source: Millennium Engineering, Inc. in Foote, 2003)

Samples were collected using ISCO Model 6712 refrigerated samplers with 24 discrete bottles at two locations within the stormwater discharge system. One sampler collected samples from a pre-treatment location just upstream of the Smart Sponge[®] Plus treatment material. The other sampler collected samples downstream of the Smart Sponge[®] Plus. See Figure 5 for a schematic showing the sampling locations.

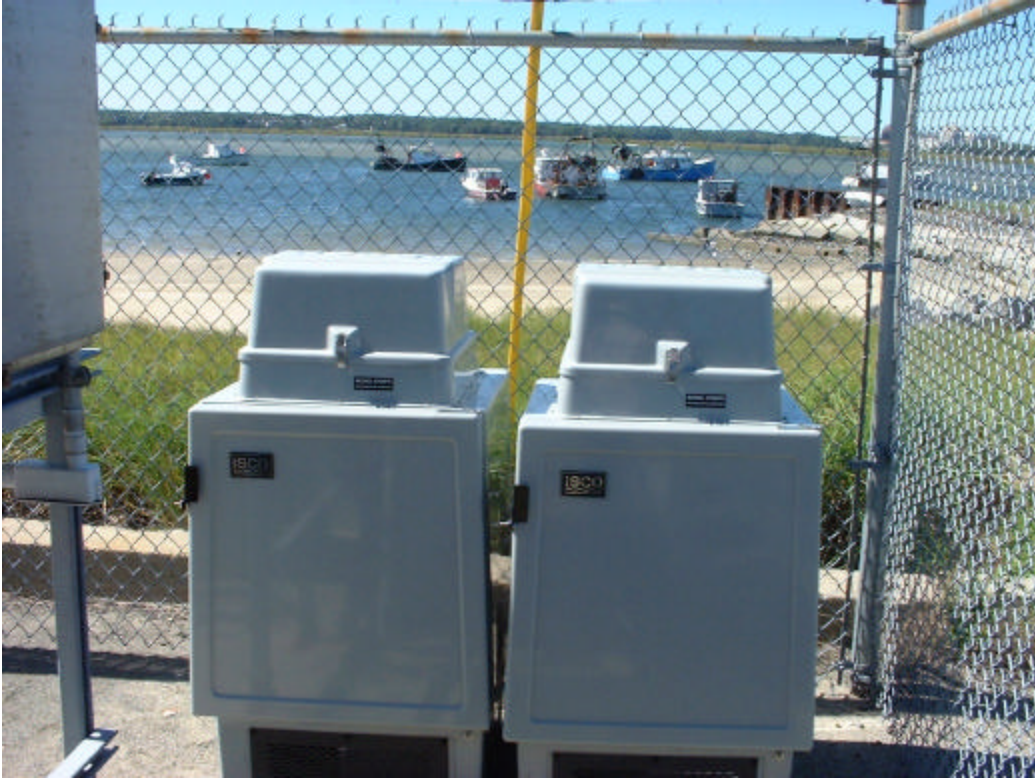
Figure 6 Autosamplers in enclosure at monitoring site.

Each autosampler (Figure 6) held up to 24 bottles in the chamber. A minimum of 8 (5 influent or effluent, 2 field duplicates and 1 field blank), 1000-mL sample bottles were placed in each autosampler chamber prior to each rain event (Table 2).
