# R/V Falkor Multibeam Echosounder System Review

UNH-CCOM/JHC Technical Report 13-001

April 2, 2013

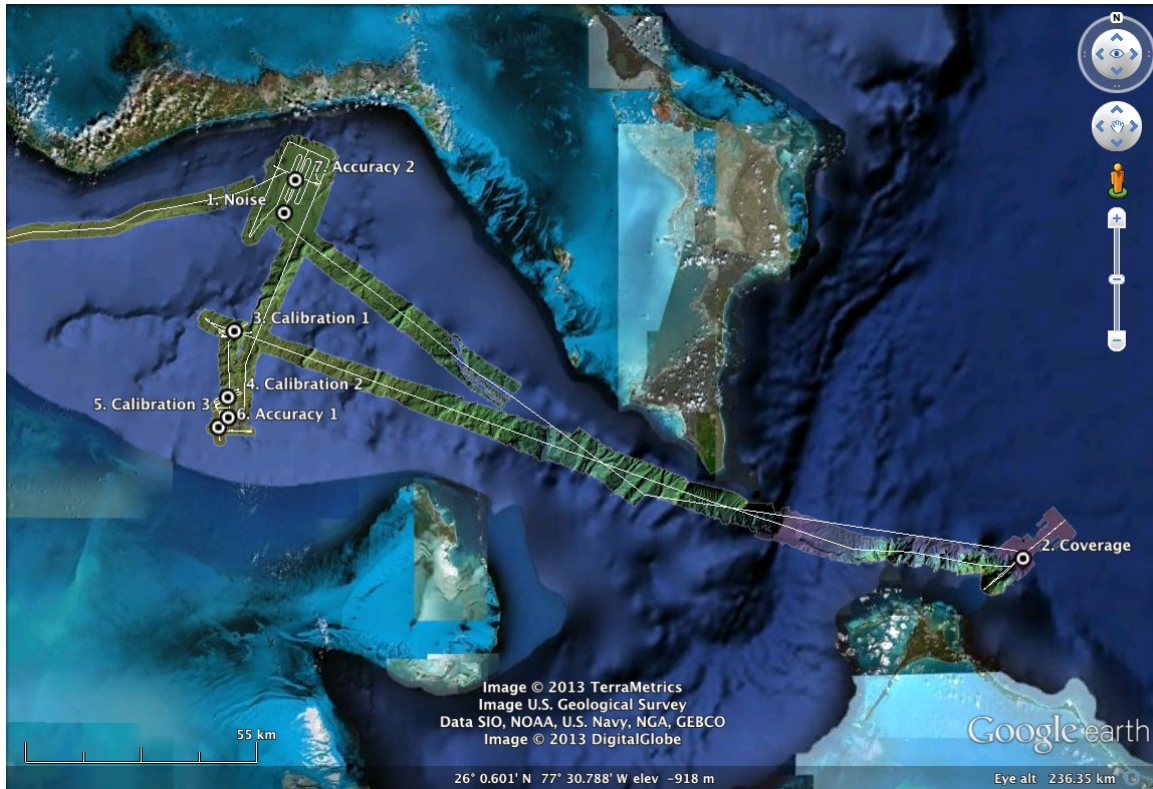
Figure 1. Overview of cruise track with EM302 bathymetry collected during the trials.

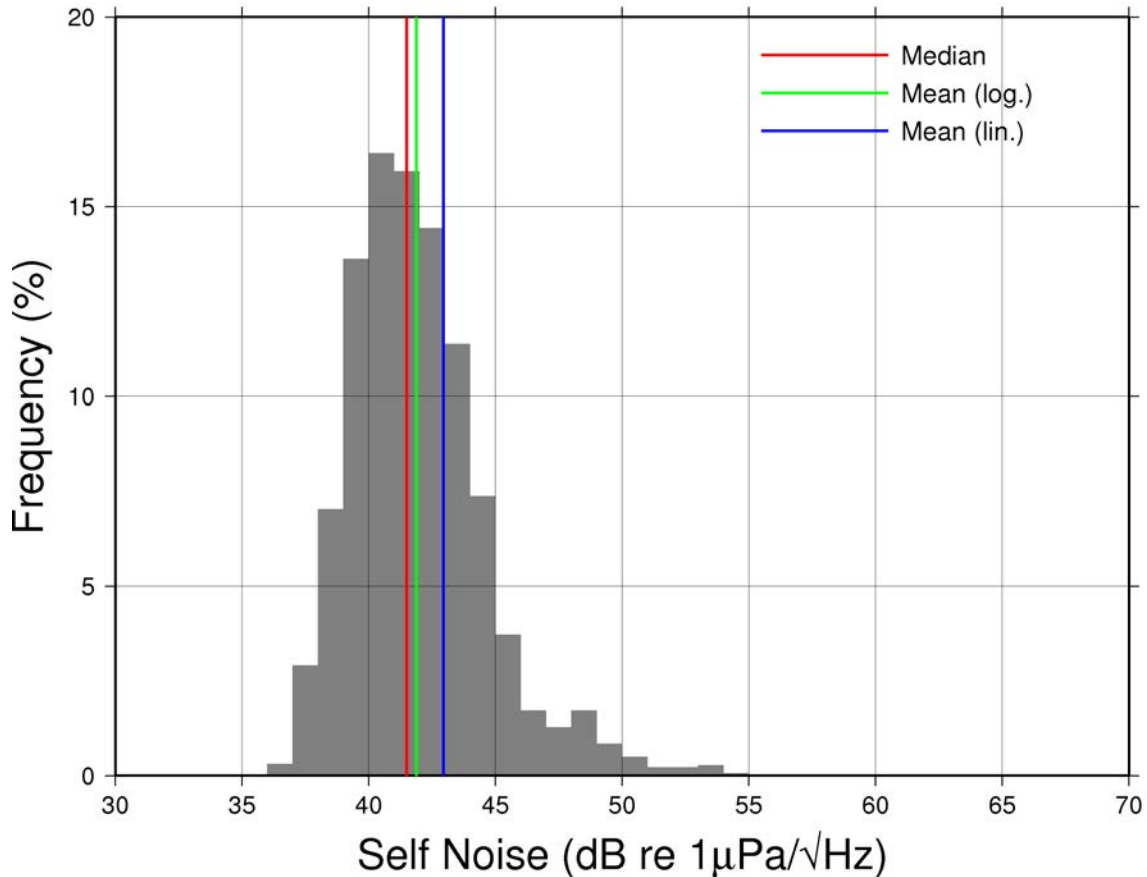
The distribution of the data points in Fig. 6 is shown in Fig. 7 along with the median, geometric mean and linear mean. The geometric mean is the mean of the dB values in their natural logarithmic units, i.e. an arithmetic mean of the dB values. The linear mean is the mean of the noise levels in linear intensity units and then expressed in dB. Refer to Appendices A and B for equivalent plots for both sensors at all speeds investigated in this work.

Figure 7. Distribution of noise level measurements for EM302 at 12 knots.

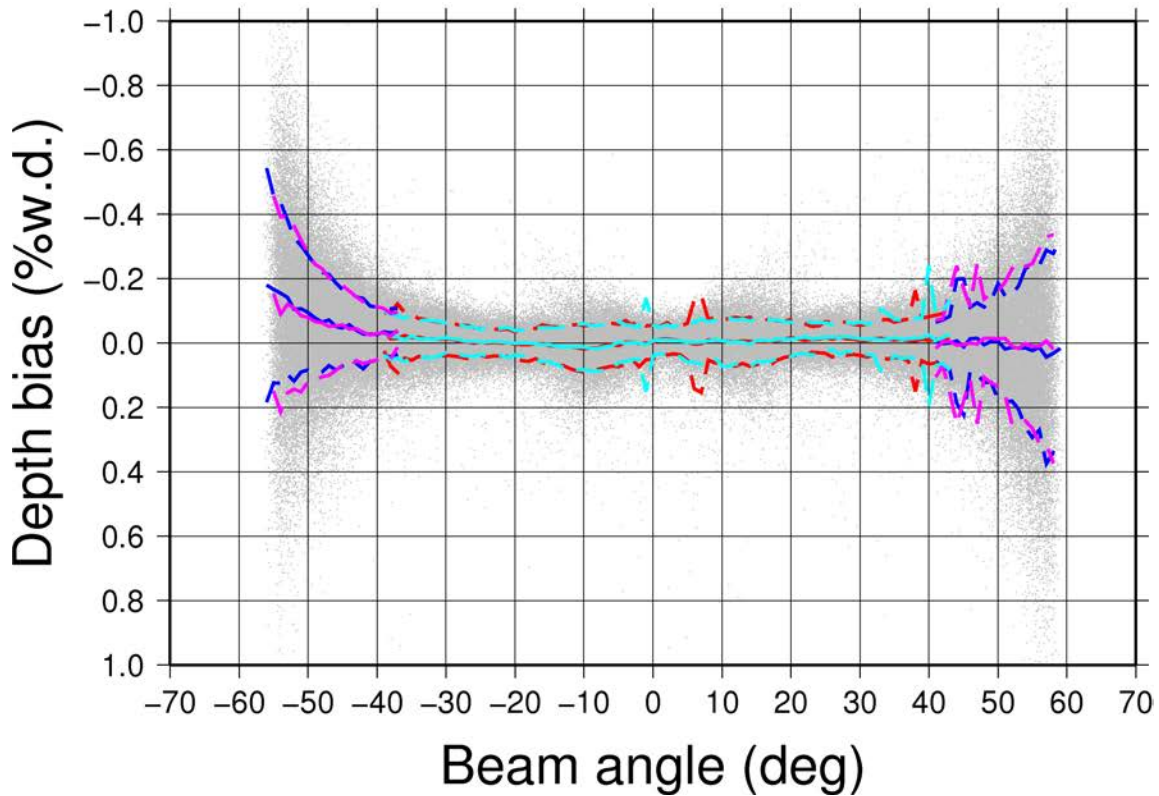
Example results are shown for EM710 Medium mode (dual swath) in Fig. 14 with a scatter plot of the depth differences between a cross line and a reference surface as a function of beam angle. The mean depth bias is computed in 1° angular bins across the swath and is shown as the solid lines, these being color coded by sector and by swath number in the dual swath geometry (blue-red is swath #1 of 2, magenta-cyan is swath #2 of 2). The dashed lines, using the same color-coding, indicate the standard deviation in each 1° angular bin; these are also plotted as a function of beam angle in Fig. 15. Similar plots are presented in Appendix C and D for the various sounder modes investigated during the accuracy tests.

Referring to the accuracy plots in Appendices C and D, both systems show beam depth biases less than 0.05% w.d. across the majority of their achievable swaths with small residual refraction-like artifacts in the outer portions of the swath. The shallow site crossline statistics highlight a slight directional dependence to the mean bias with a slight refraction artifact being observed in the outermost sector corresponding to the side of the vessel facing to the west (Fig. 14). The crosslines were acquired in the north-south direction at a speed of 5-6 kts and crabbing of  $\sim 15^\circ$  was observed in both directions due to an easterly setting current. Yaw stabilization was configured to stabilize based on mean relative heading (instead of the survey line heading), thus aggressive yaw stabilization cannot be blamed since the mean heading remained more or less constant throughout the line regardless of the crabbing. The same effect is observed in both the EM710 and EM302 though it appears more pronounced in the EM302 due to its ability to sound over its full swath in those water depths (the EM710 was signal-to-noise limited in its outer sector in the water depths chosen for the shallow reference area). Given the directional dependence and consistency of the artifact with the direction of the current, this effect is likely environmental.

Figure 14. Accuracy analysis results, EM710 MEDIUM mode (dual swath). Note the slight upward curling artifact in the outer port side sector.
