# Archaeological Testing Associated with the Stabilization of Room 4 at Mission San Juan Capistrano, San Antonio, Bexar County, Texas

©2006  
Archaeological Report, No. 368  
Center for Archaeological Research  
The University of Texas at San Antonio

Texas Antiquities Permit No. 4126

In May 2006, The Center for Archaeological Research excavated one test unit at the exterior north wall of Room 4, west of the chimney at Mission San Juan Capistrano. The excavation occurred to assess the condition of the foundation and the dimensions of a more recent concrete footing before restoration of the collapsed north wall. The excavation found disturbed deposits throughout the test unit, but was able to locate and record the architectural features for Ford, Powell, and Carson, Architects and Planners, Inc., the project sponsors. A composite map of all excavations conducted at the mission since 1931 is included with descriptions of the agency, dimensions and location of all excavations as reported to aid future cultural resource management of Mission San Juan Capistrano.

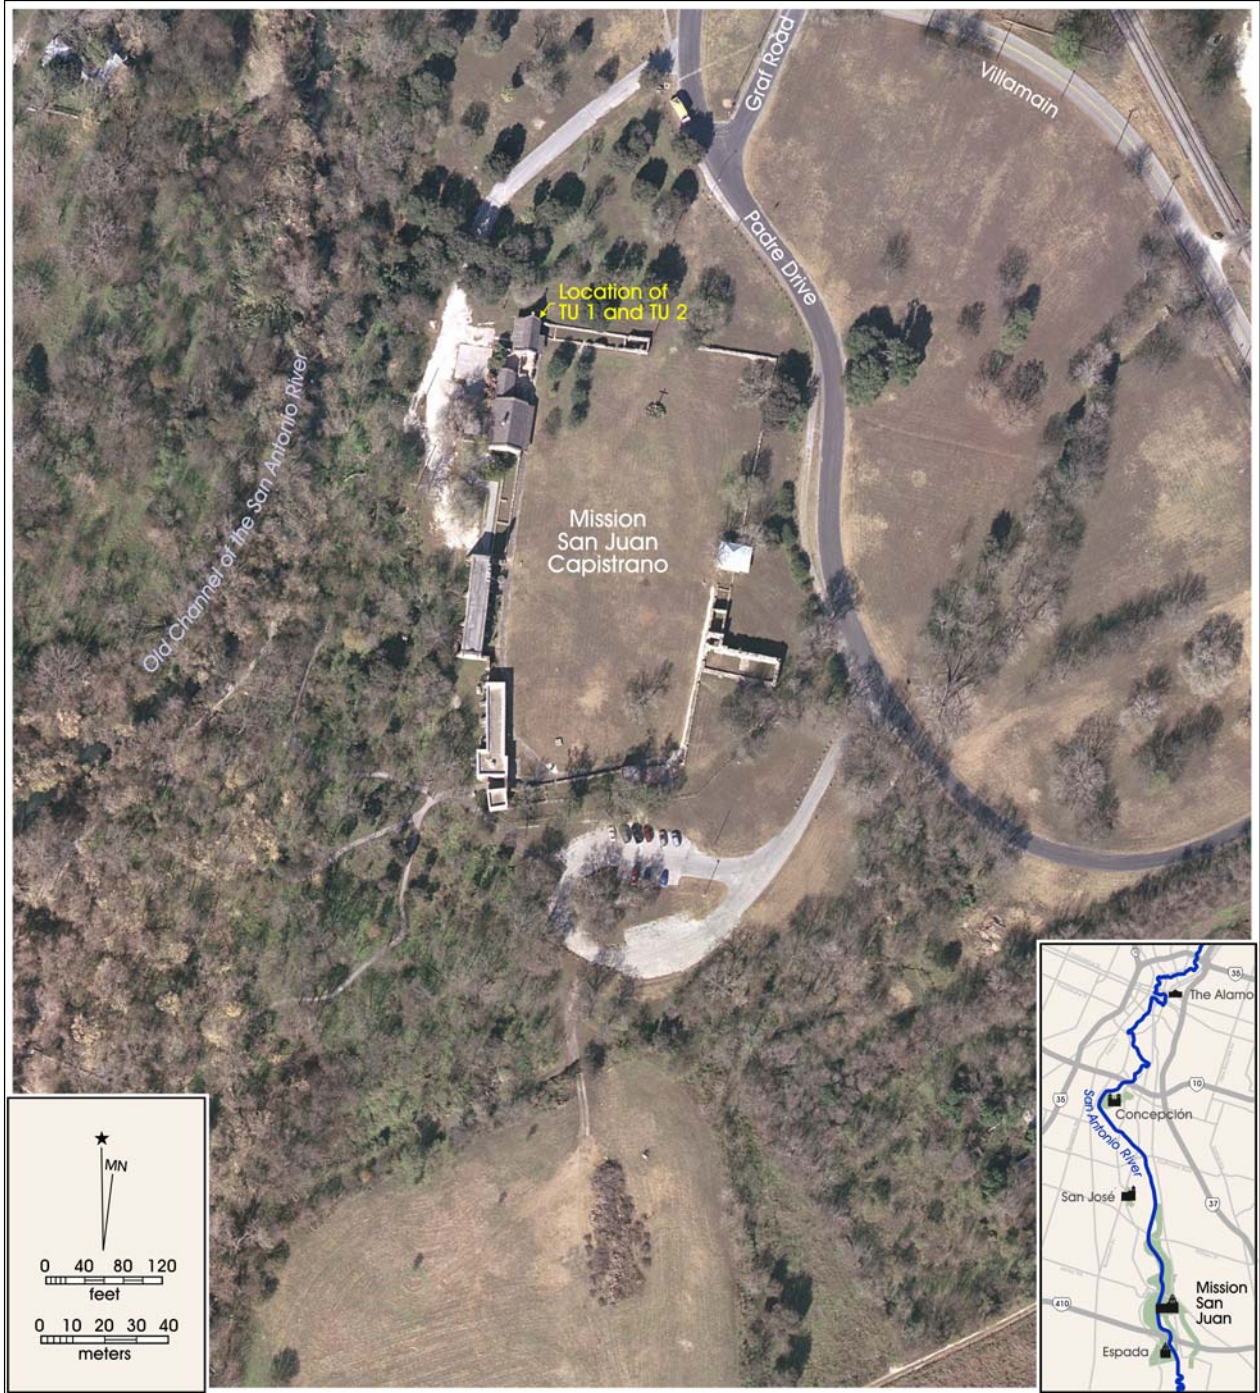
Figure 1. The location of Test Units 1 and 2 within Mission San Juan Capistrano.

In May 2006, the Center for Archaeological Research (CAR) of The University of Texas at San Antonio (UTSA) conducted testing at one location along the north wall outside Room 4 at the northwest corner of the Mission San Juan Capistrano compound (41BX5) (Figure 1). This wall recently collapsed, so the architectural firm Ford, Powell, and Carson, Inc. contracted archeological services to expose the structure's foundation for examination of its integrity before restoring and reinforcing the wall (Figure 2). This report describes the results of those excavations and provides a lengthy summary of previous excavations and a composite map showing the location of all the reported excavations since the 1960s (Figures 3 and 4). We also report on the results of attribute analysis of the Goliad ware ceramics recovered from the test unit.

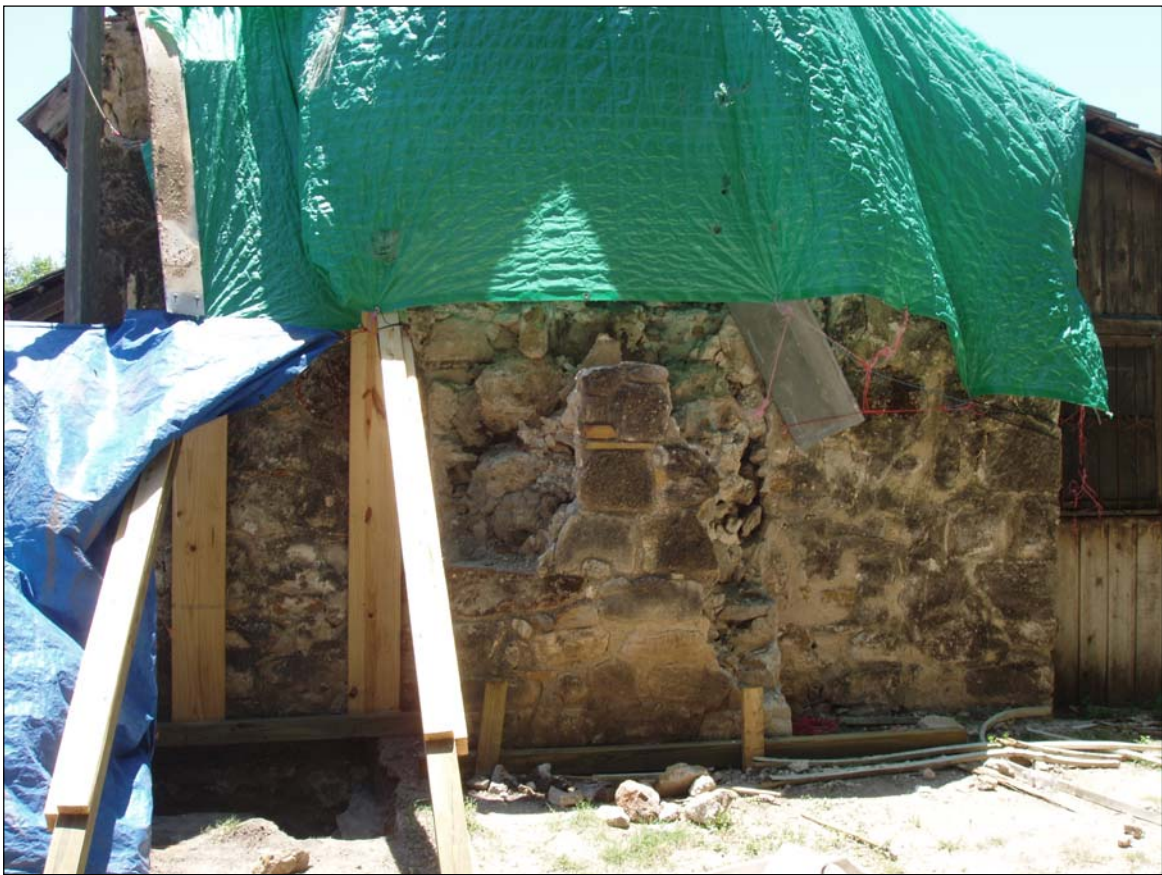
Figure 2. *The collapsed chimney and north wall of Room 4.*

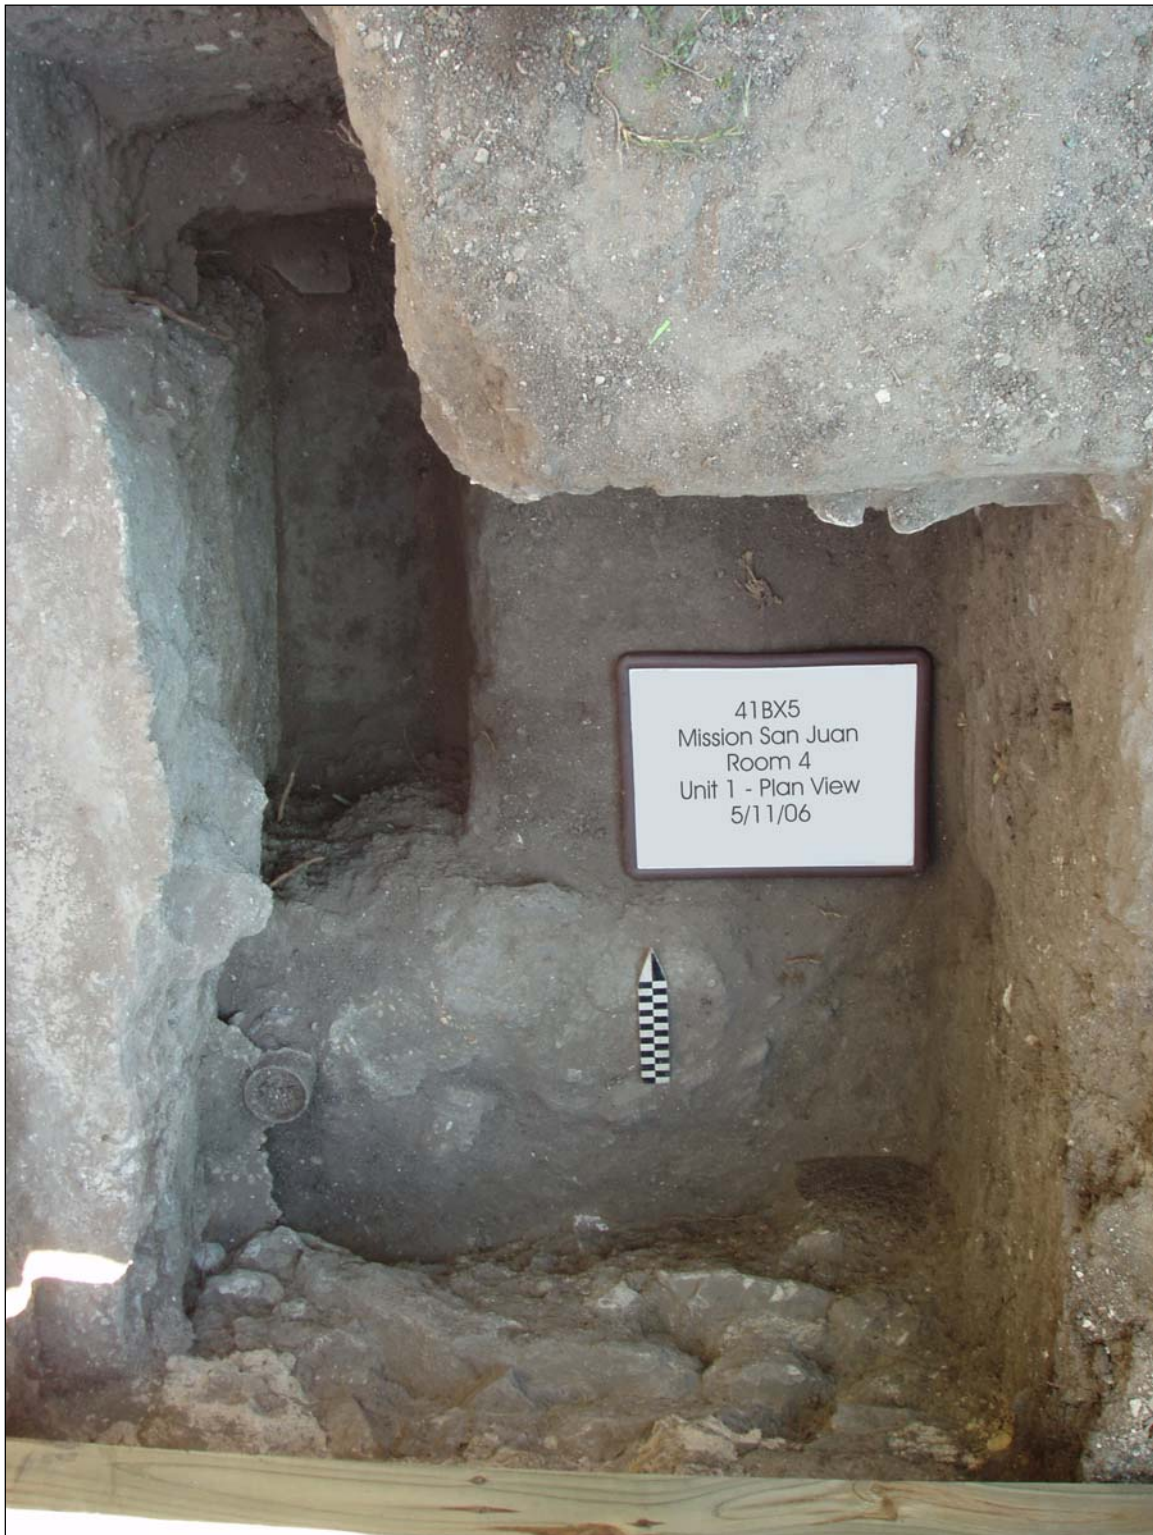
Figure 9. Photograph of final excavation of Test Unit 1.

CAR exposed the chimney footing and part of the exterior north wall of Room 4 in Test Unit 1, a 1-x-1-m (3.28-x-3.28-ft) test unit, 30 cm (11.81 in) east of the chimney (Figure 8). The unit datum was placed north of the unit. All elevations were taken from the ground surface at this point. Ground surface rises toward the building so elevations below surface were approximately 5 cm deeper near the north wall. Most of the 1-x-1-m unit was excavated to 70 cmbd (2.3 ft). In order to find the bottom of the concrete footing supporting the chimney, the northwest corner (40-x-60 cm; 1.31-x-1.97 in) was excavated deeper to 100 cmbs (3.28 ft). We also expanded 40 cm of the northwest corner 40 cm to the north in Test Unit 2 to locate the corner of the concrete footing. The units exposed 117 cm (3.84 ft) of the chimney footing (north to south) and 100 cm (3.28 ft) (east to west) of the north wall foundation (Figure 9).

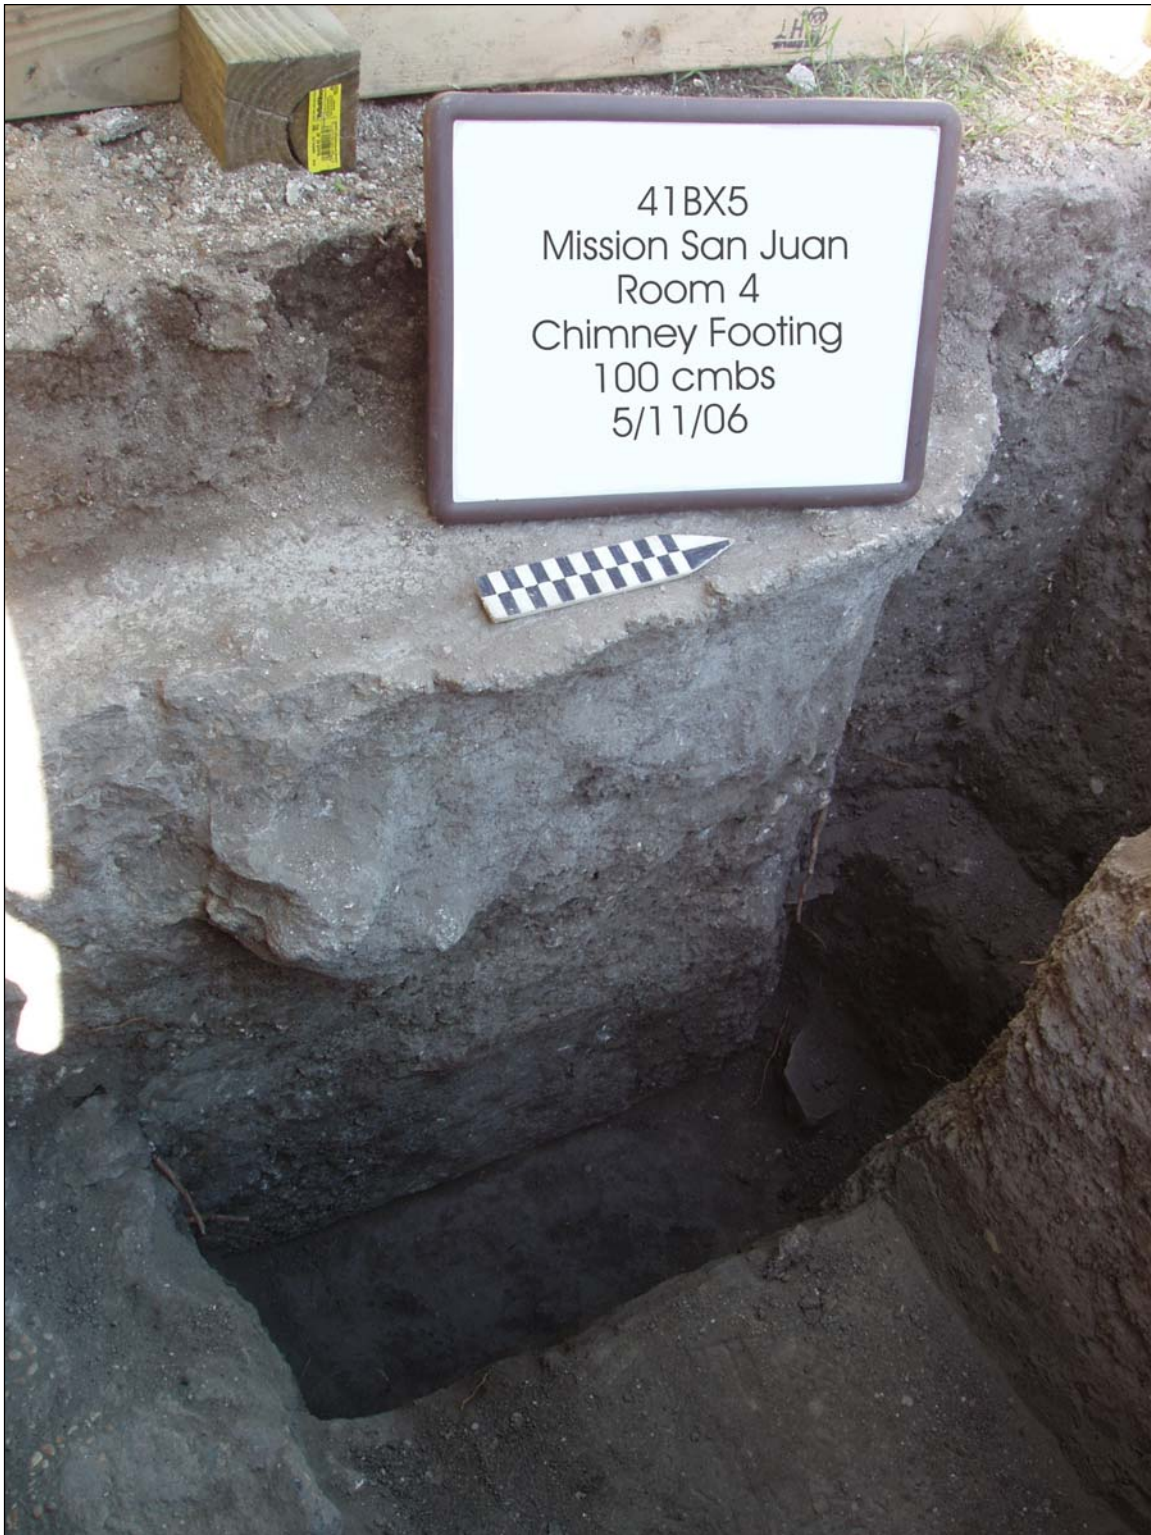
Ford, Powell, and Carson, Inc. was interested in determining the parameters of the foundation and the chimney footing of Room 4. The excavation revealed the surface of the chimney footing at 12 cmbs (4.72 in) and the edge 45 cm east of the chimney. The base of the chimney footing is at 100 cmbs. The height of the footing (top to bottom) is 88 cm (34.5 in) (Figure 10). At 48 cm (1.57 in), we uncovered a pylon set in concrete supporting the chimney footing. The center of this pylon is approximately 20 cm north of the foundation and 5 cm from the edge of the footing (Figures 8 and 9). At 69 cmbs, excavations uncovered overflow concrete across the northern portion of the unit from the pylon installation (Figure 8). Excavations revealed the base of the foundation at 60 cmbs (Figure 11). Mortar and rock crumbled from the foundation despite careful excavation. There is no recent footing supporting the foundation (Figure 12).

Figure 10. *Photograph of the chimney footing exposed in Test Unit 1.*

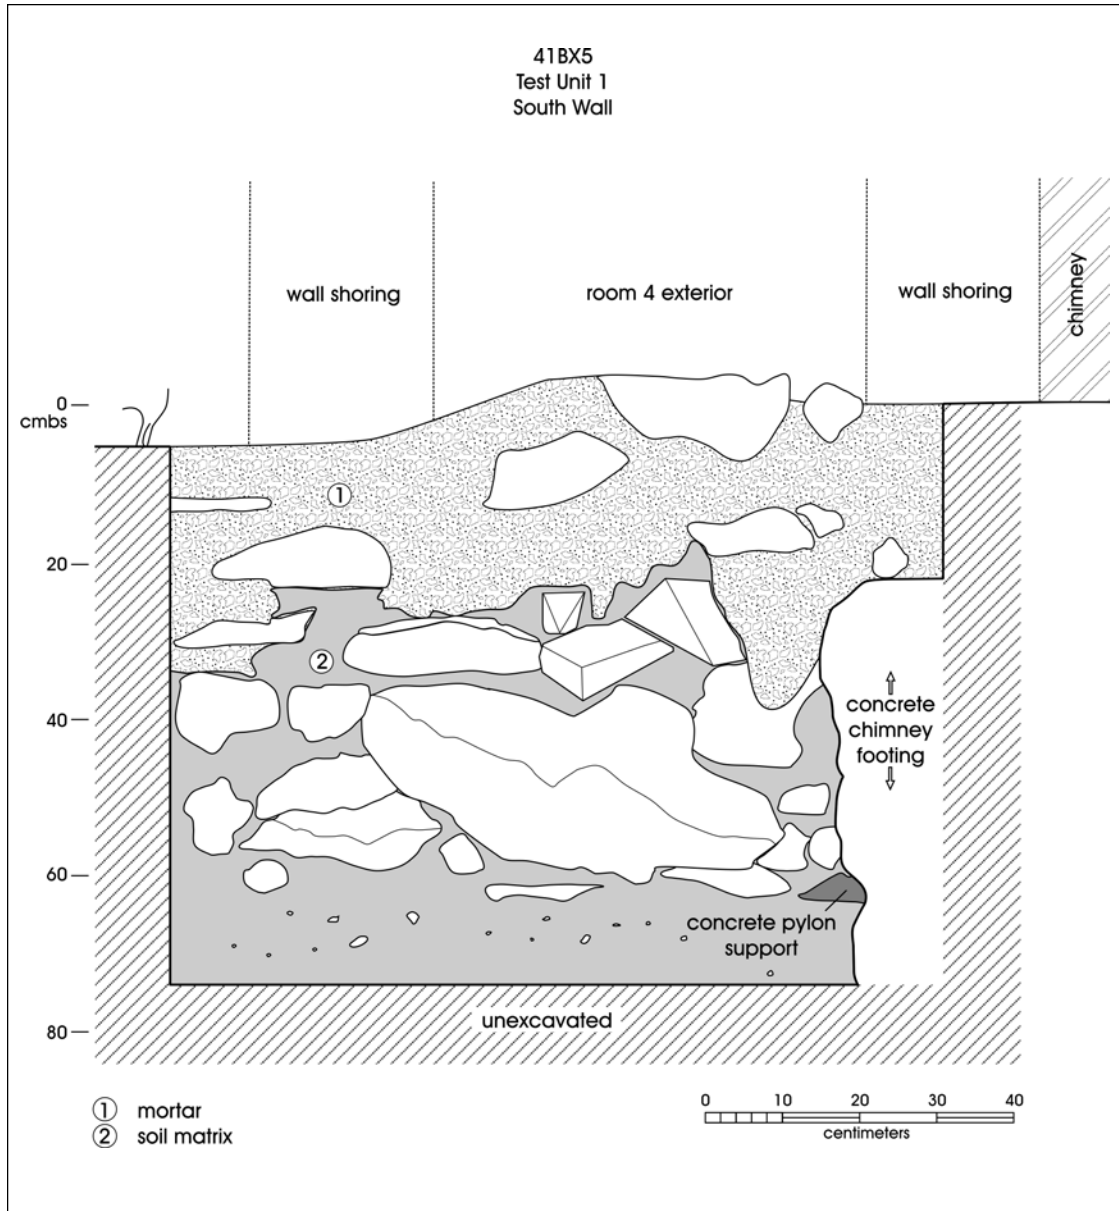
Figure 11. Profile drawing of the foundation.

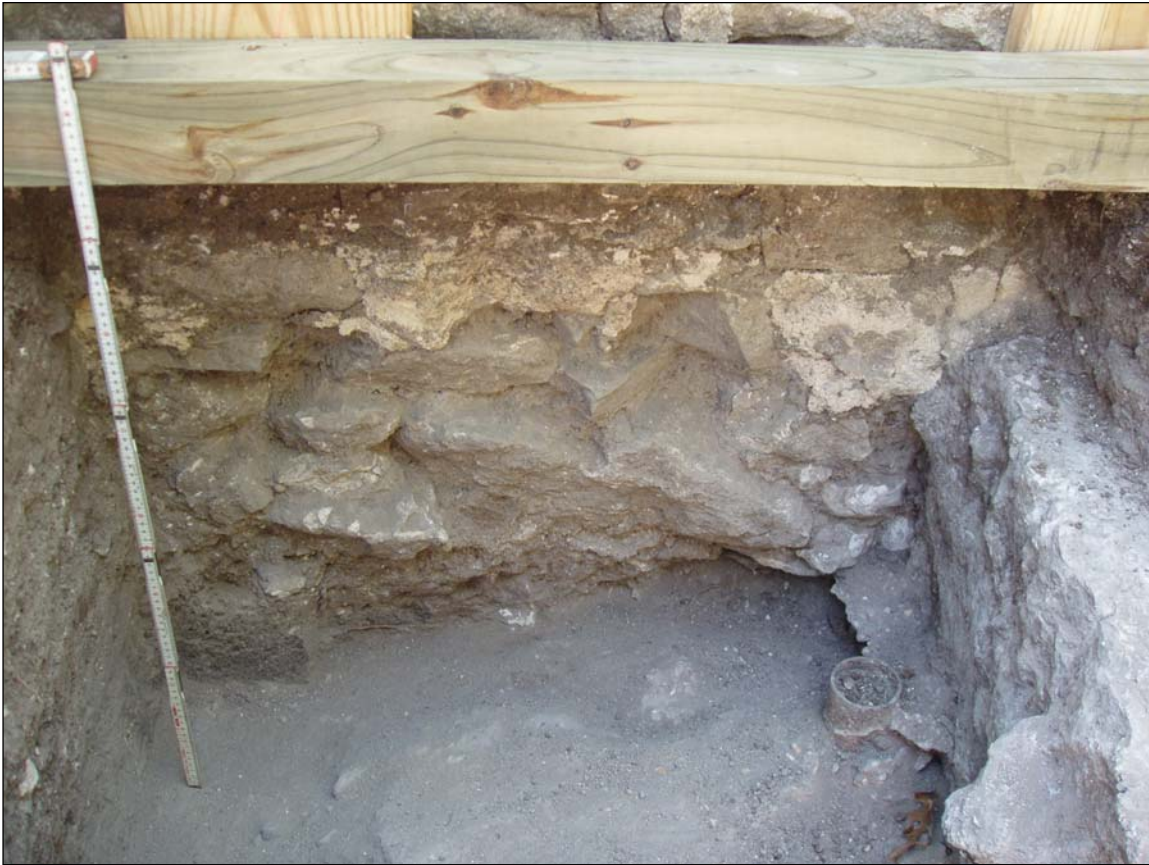
Figure 12. *Photograph of the foundation.*

Artifacts recovered from the testing included numerous ceramics from the eighteenth and nineteenth centuries, fragmented animal bone, building materials, and a few glasswares. All these artifacts were discovered in the upper 70 cm of the test unit. None is believed to contribute to new knowledge of the mission; therefore, the Center for Archaeological Research recommends that the restoration of Room 4 proceed.
