ARCHAEOLOGICAL INVESTIGATIONS AT FORT MARTIN SCOTT (41 GL 52) IN GILLESPIE COUNTY, TEXAS

Center for Archaeological Research
The University of Texas at San Antonio
Archaeological Survey Report, No. 169

During May 24-30, 1986, archaeological investigations at Fort Martin Scott (41 GL 52) were conducted by the Center for Archaeological Research at The University of Texas at San Antonio. The fort was established by the U.S. Army in 1848. It was the fifth United States fort in Texas. Only one of the fort's original buildings now exists. The foundations for an additional eight structures were identified and documented by this project. The property on which this old fort is located is owned by the City of Fredericksburg. The Fredericksburg Heritage Federation plans to develop the area as a day-use facility which includes archaeological and historical interpretations of the fort during its tenure (1848-1853) as a military outpost on the western frontier.

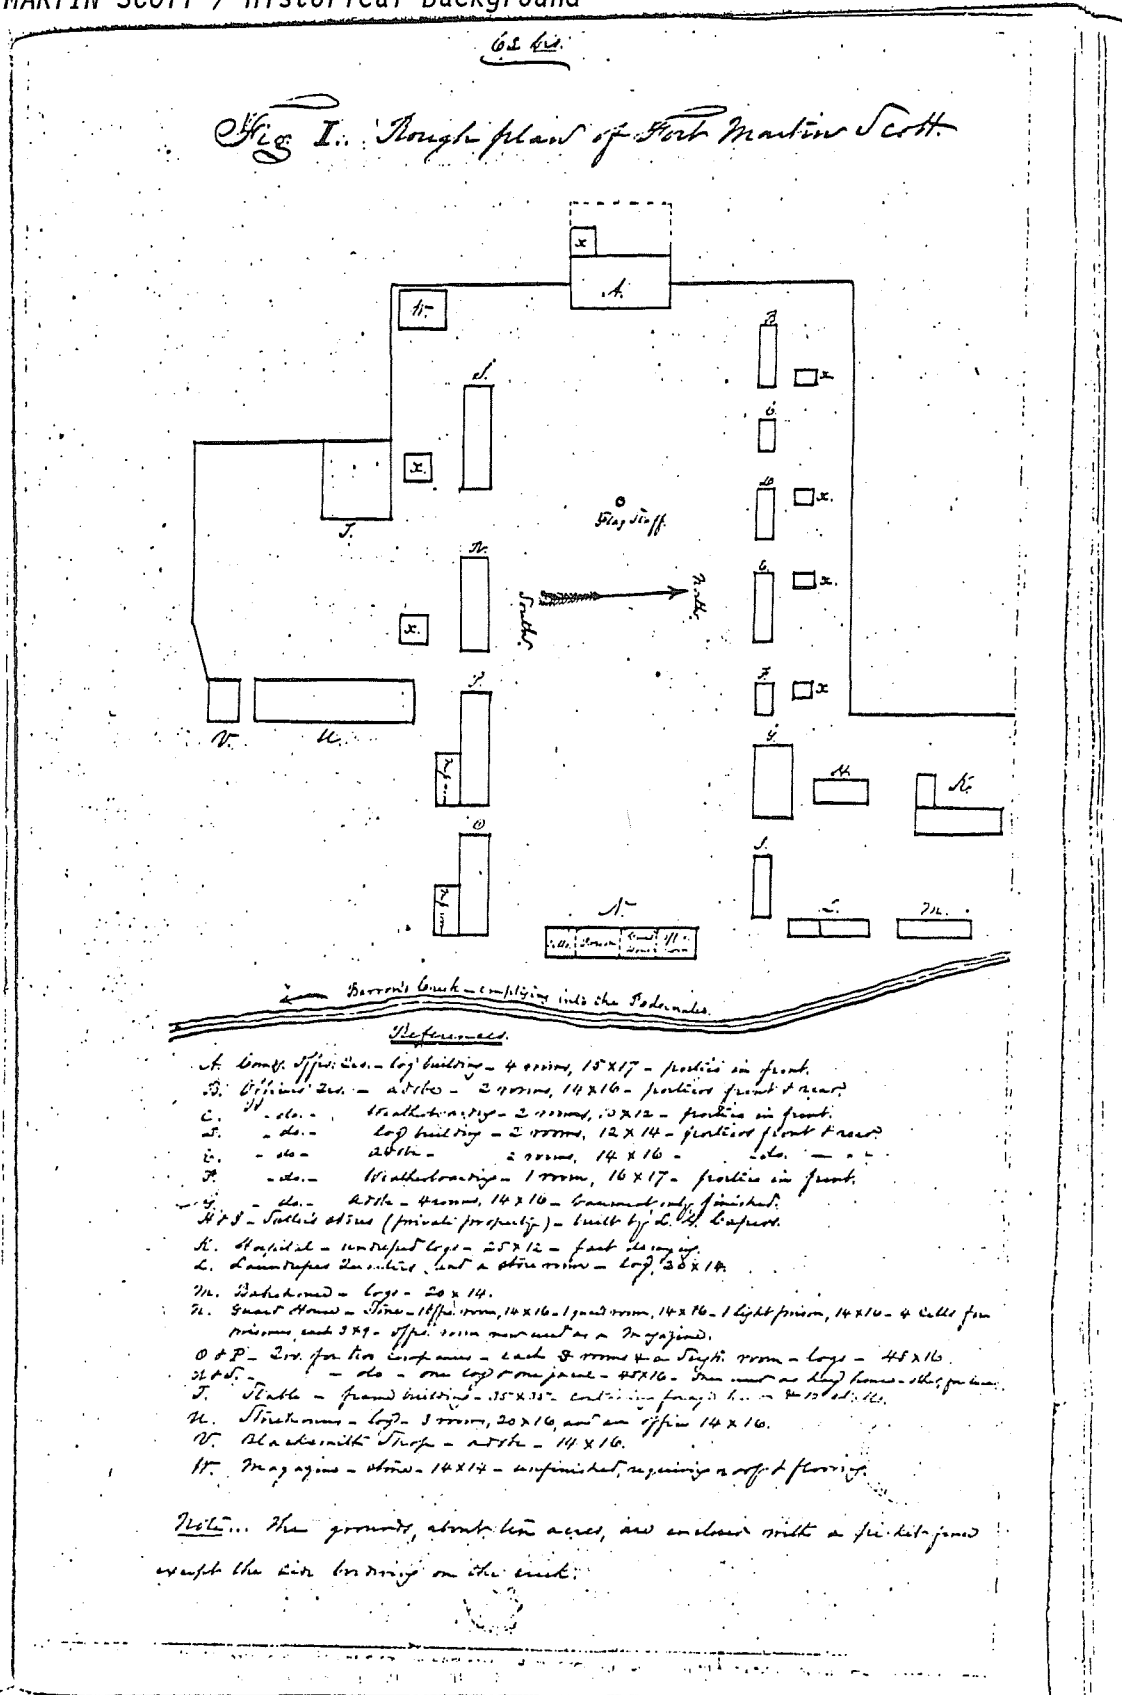
Figure 2. Photostatic Copy of the 1853 Inspection Sketch Map of Fort Martin Scott. Taken from Freeman (1853).

In 1853, the northern chain of military posts and forts was visited by U.S. Army inspectors (see Crimmins 1947a, 1947b, 1948, 1949). During August 13-15, 1853, the facilities and troops at Fort Martin Scott were inspected by W. G. Freeman (Crimmins 1949). The inspection report (see Appendix IV) documented the number and types of structures at the fort and discussed the provisions and conditions of the quartermasters, subsistence, and medical departments. Of considerable importance, attached to the 1853 inspector's report was a "Rough Plan of Fort Martin Scott" (Wagner and Klein, Inc. 1983:15) that also contained brief descriptions and measurements of structures depicted in the sketch map (see Fig. 2). The complete text of the report is presented in Appendix IV.

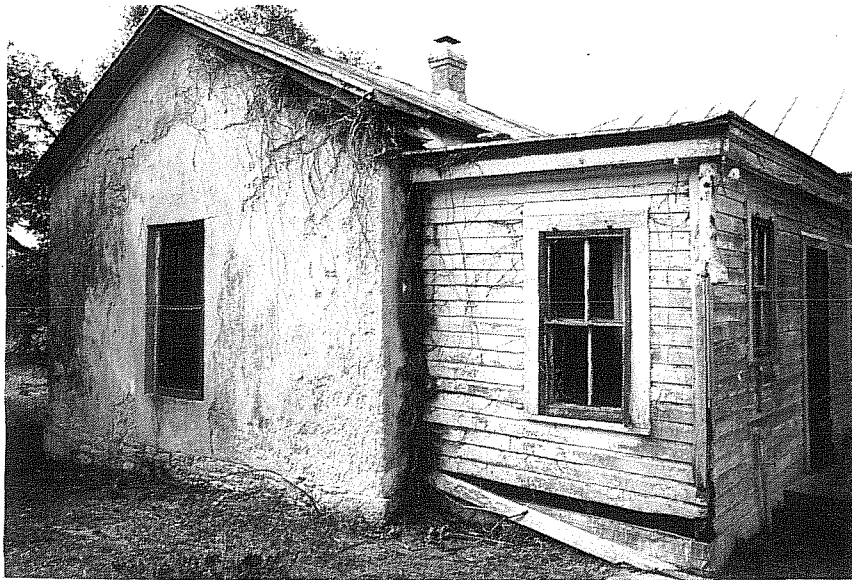
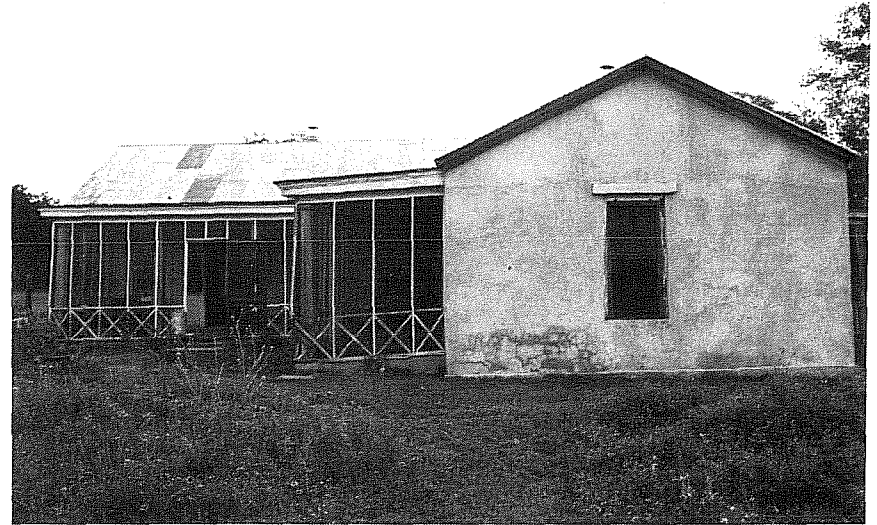
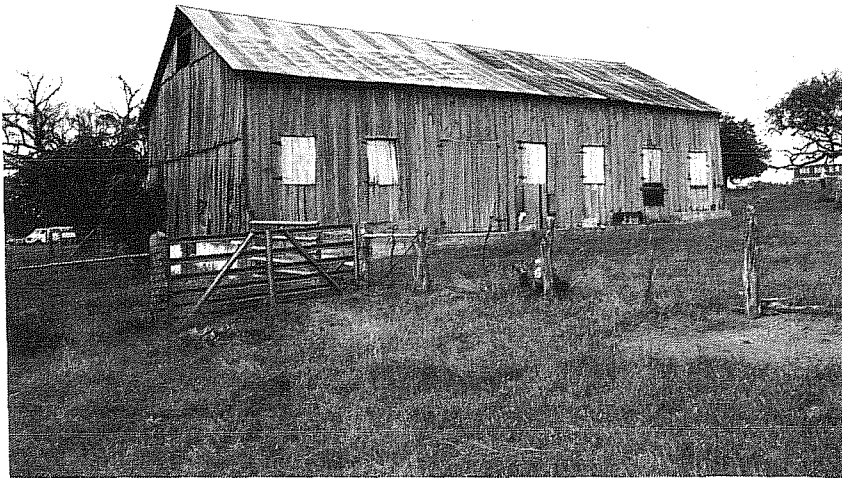
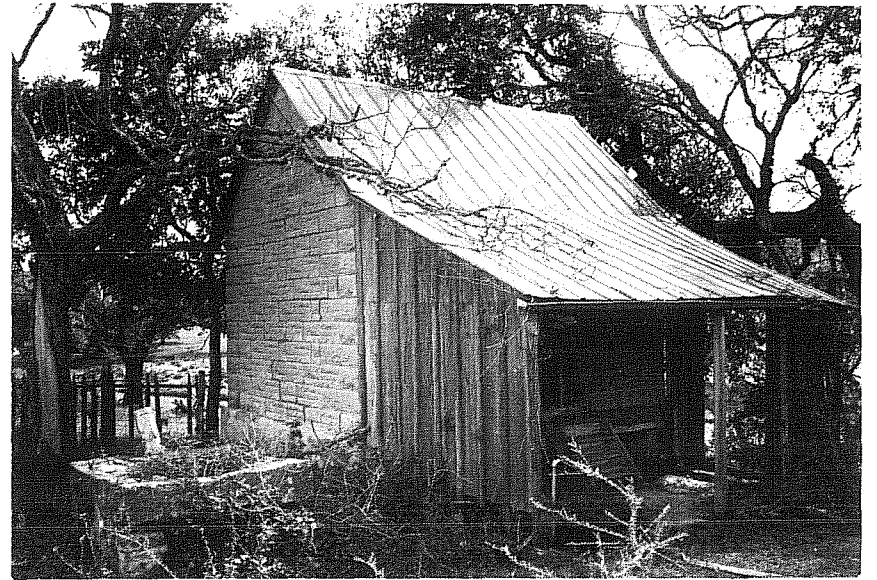
Figure 3. Existing Structures at Fort Martin Scott. a, Braeutigam Homestead, north view; b, south view; c, barn; d, outbuilding.

The Braeutigam family occupied the former site of Fort Martin Scott for 90 years. The old guardhouse (Fig. 3,a,b; Fig. 4,Structure N) served this family as their homestead beginning in 1870, and was continuously occupied until ca. 1955. This property was sold to the City of Fredericksburg in 1959. Changes in the original configuration of this structure are reported by Sauer (n.d.) to have been made by John W. Braeutigam (1829-1884), by Henry W. Braeutigam (1874-1946), and by Raymond Braeutigam (1913-).

The barn which now stands in this area (Fig. 3,c) was constructed by a Braeutigam family member sometime after 1884. The Braeutigam family history (Sauer n.d.) states that this barn was constructed with the weather boarding from the former dance hall and saloon ("Braeutigam's Garten") that was torn down following John Braeutigam's murder in 1884.

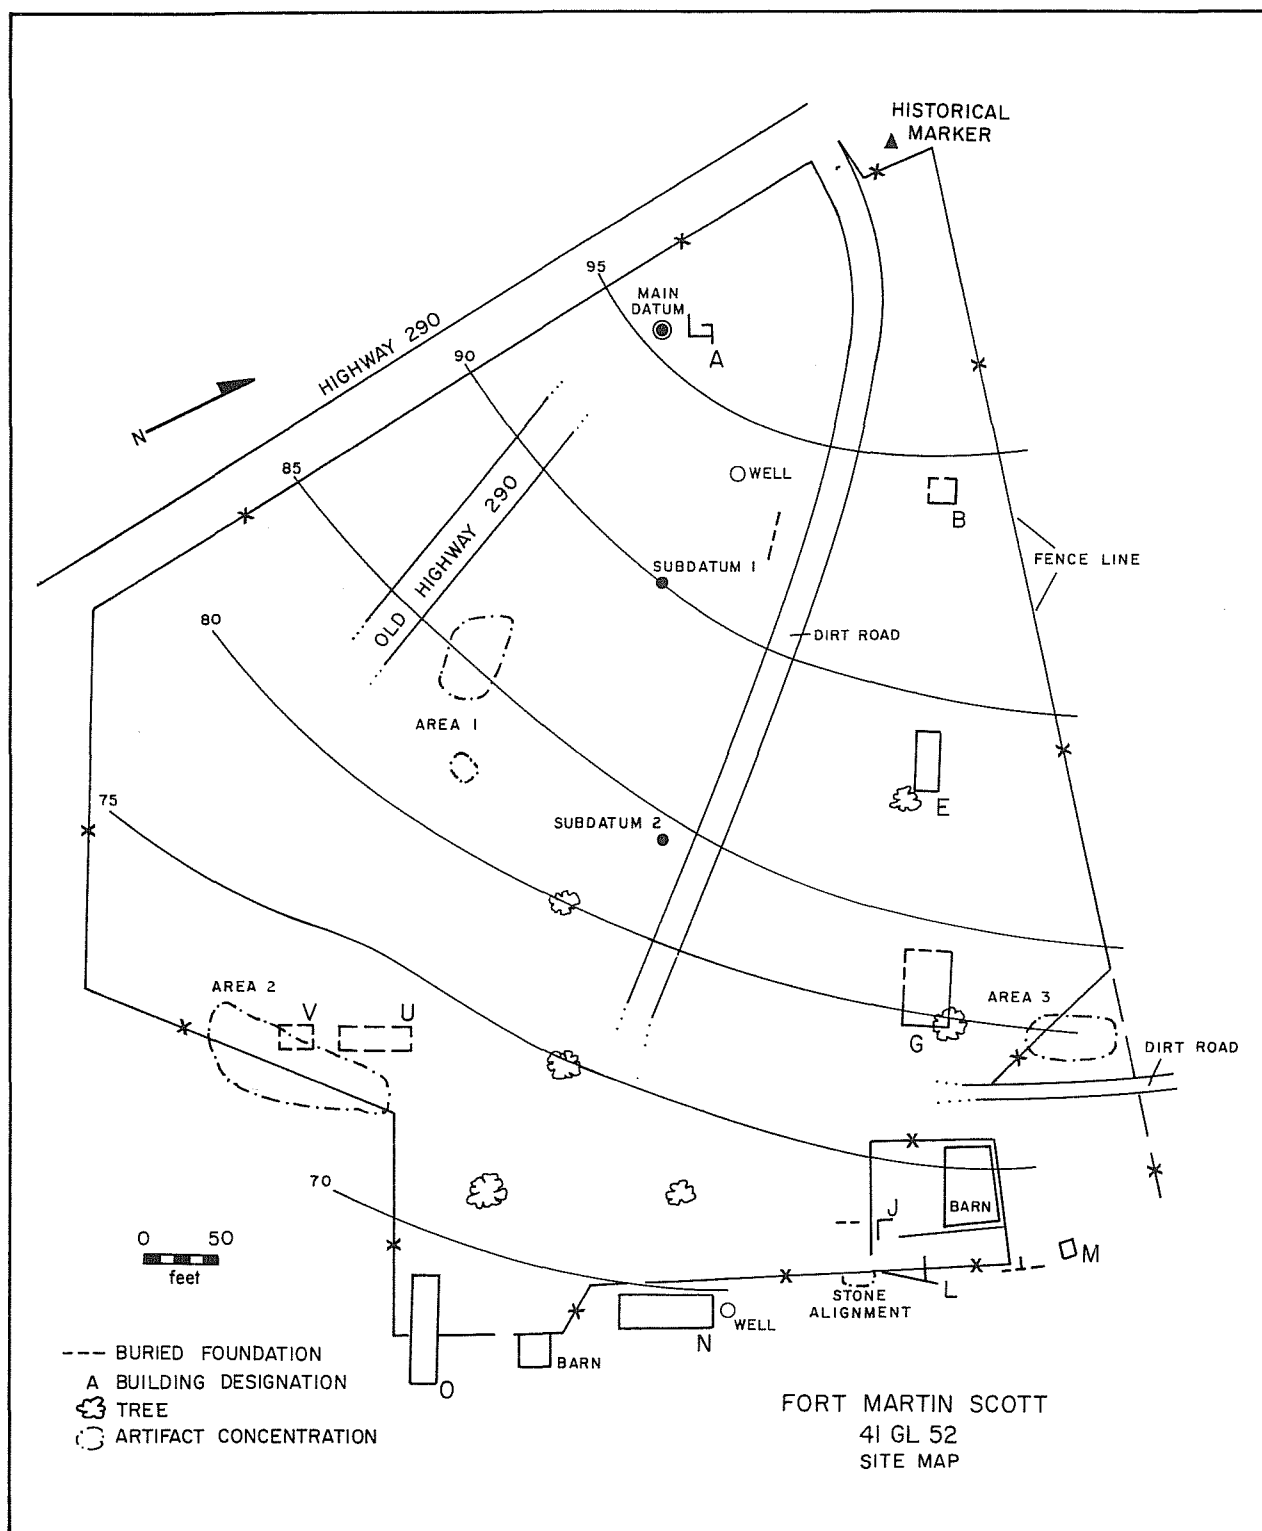
Figure 4. Site Plan Map of Fort Martin Scott (41 GL 52).

The main horizontal system of referencing consisted of a 640-foot east-west base line which extended from the guardhouse (Structure N) to the foundation remnants associated with the former Commanders' House (Structure A; Fig. 4). A main site datum was established near Structure A (1627 feet above Mean Sea Level [MSL]) which also served as the datum for vertical referencing for the entire site. Mapping stations were placed at 100-foot intervals along the primary east-west base line. Structural foundations associated with known historical buildings received an additional temporary datum; a driven 1/2-inch rebar was placed at the southwest corner on the outside wall of Structures E, F, G, and O. The structural datum for Structure A was placed near the outside wall, near the only remaining *in situ* portion. The structural datum was placed near an outside wall for the sutler's store. Several different techniques were used to identify the possible location of structures, as depicted in the 1853 map (Fig. 2), in areas where no modern-day surface evidences existed. These techniques included surface survey, probing, dowsing, the use of a metal detector, and predictive estimating.

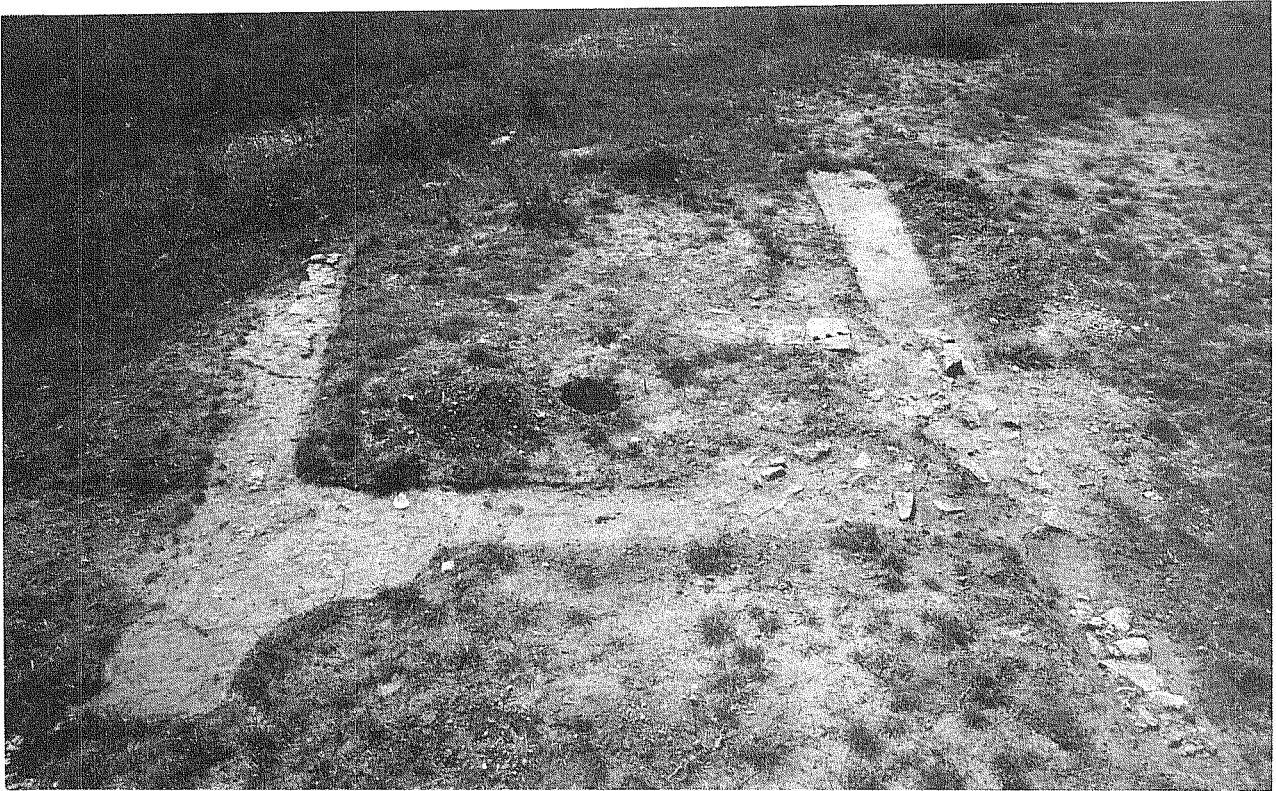
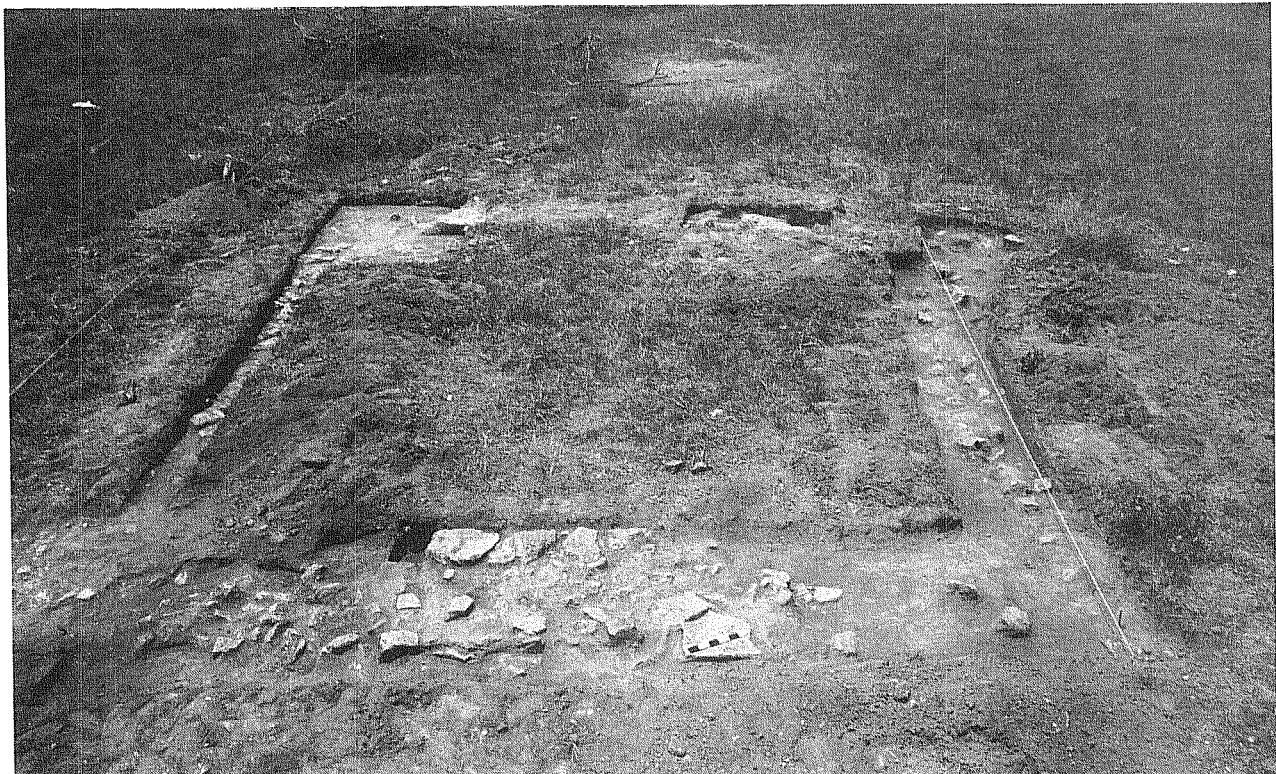
The front of this structure would have faced east towards the parade ground. The exposed short wall section is oriented roughly east-west and represents a remnant of the north wall foundation. Flat shovels were used to scrape off the upper few inches of soil in all directions from the extant wall section. Additional stones, roughly oriented north-south, were found to intersect the short wall section at a 90° angle. These two wall sections appear to represent the northeast corner of Structure A and the foundation footer for the front porch (Fig. 6,a).

Figure 5. Foundation Remnants for Structures A and B. a, Structure A; b, Structure B.

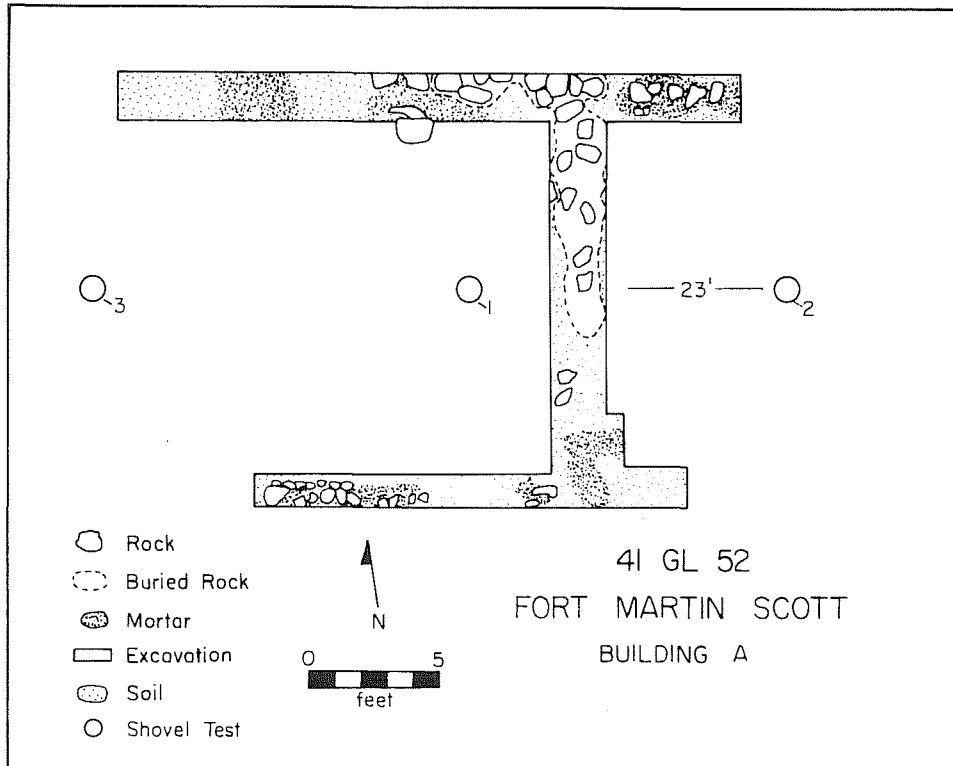
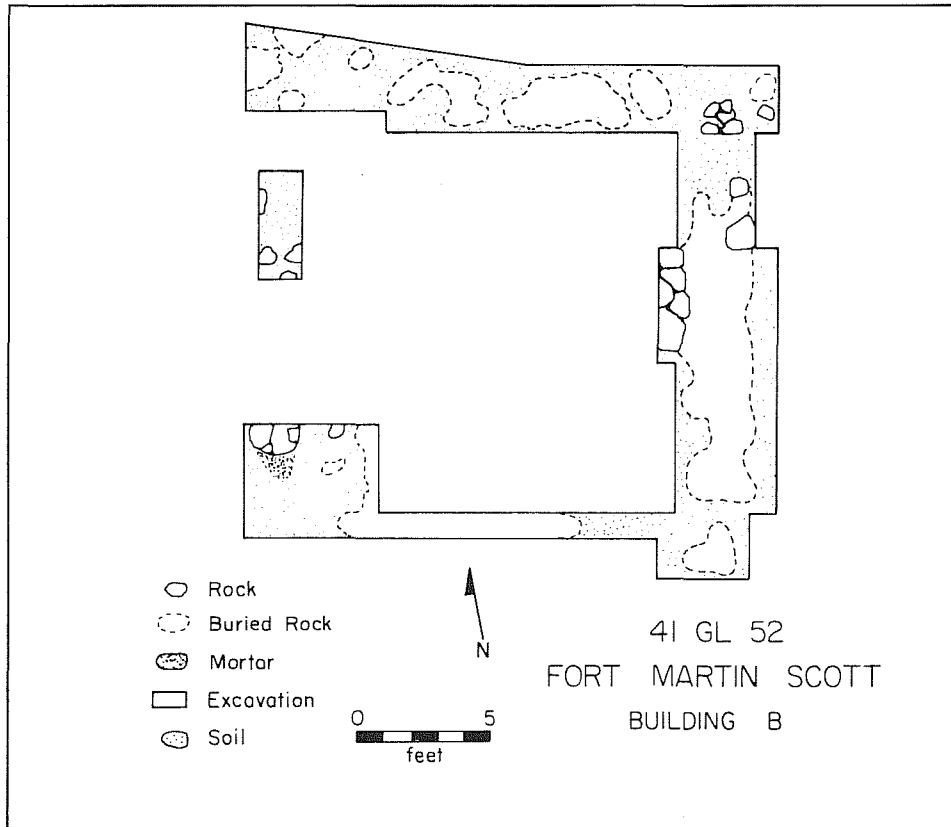
Figure 6. Floor Plan Drawing of Structures A and B. a, Structure A; b, Structure B.

With the aid of the probe, a discrete line of rocks in the center of the building was located ca. five inches below ground surface (Fig. 6,b). This line of rocks eventually turned out to be the foundation for the chimney base. The relative location for the rear (north) wall and front (south) wall was projected from the chimney base. String lines were also established for the suspected locations of the west and east walls. All wall projections were excavated to a depth of ca. 10 inches. The north wall consisted of a scatter of stones and deteriorated mortar (Fig. 5,b). A small piece of finished plaster, finer grained and much whiter than the mortar, was found along the north wall and appears to have been painted or whitewashed on one surface. The south wall projection did not produce any intact portions of a foundation. There is a layer of stone rubble intermixed with deteriorated mortar spread over most of the southern part of the building. Excavation of the west and east wall projections produced similar results.

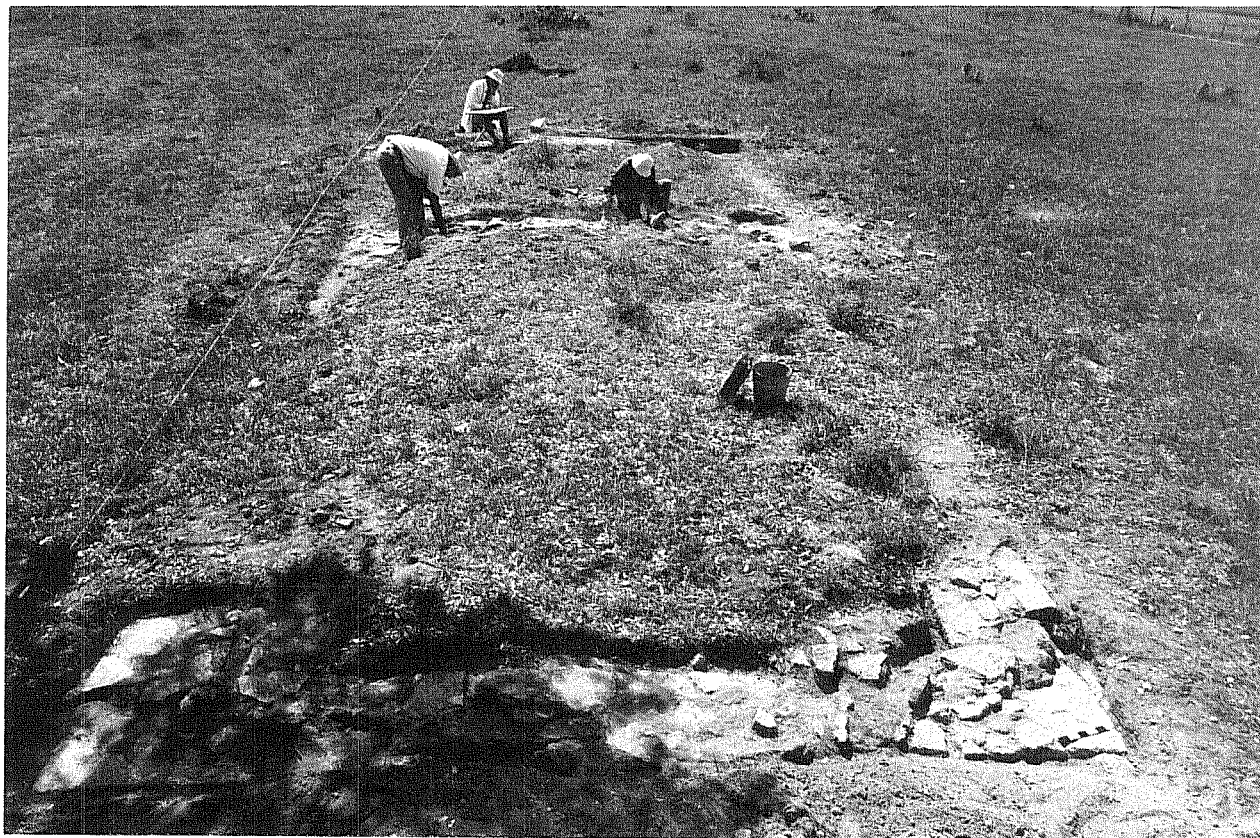
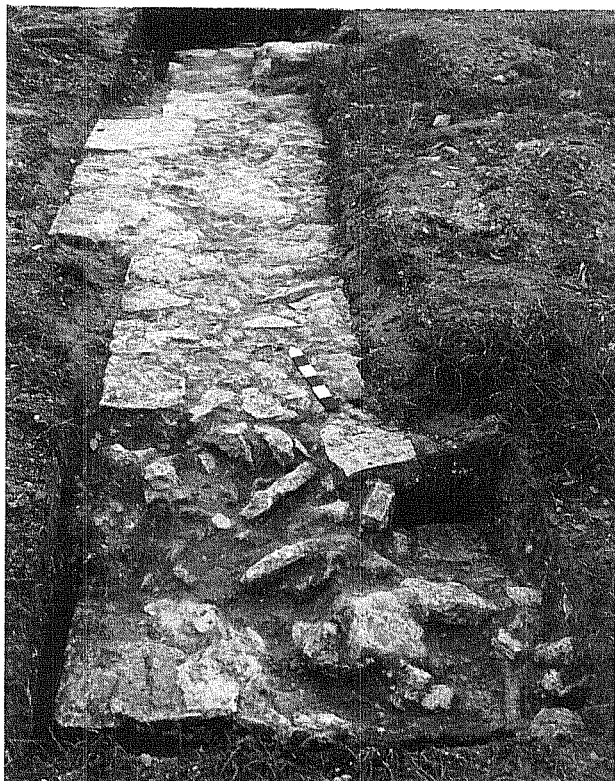
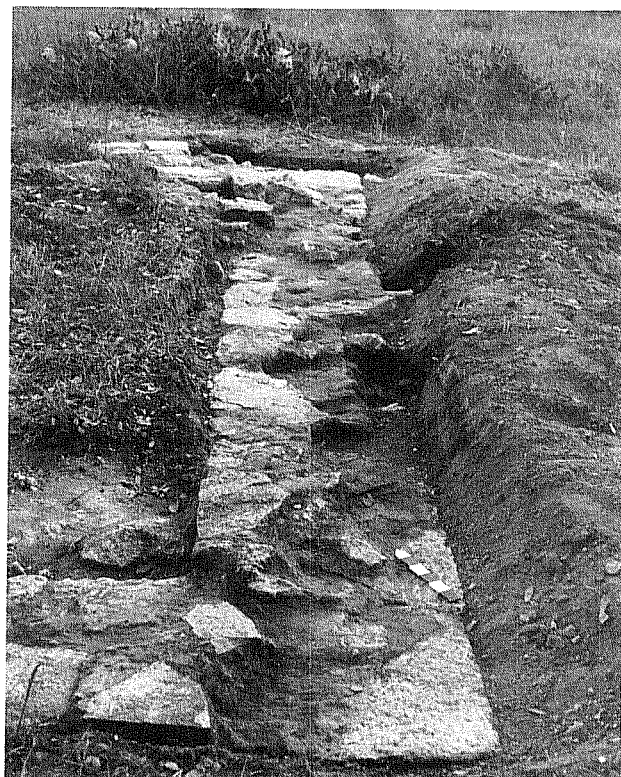
The extant portions of walls were cleaned (Fig. 7,a). Additional trenching and hand excavation were necessary to completely uncover the west (Fig. 7,b) and east walls (Fig. 7,c). Both the east and west walls contained a foundation for a chimney base. Both were located in the center of the walls (Fig. 8,a). Two interior walls, oriented roughly north-south, were also identified and excavated. Only short sections of the front (south) and back (north) walls were cleared.

Figure 7. Foundation Remnants for Structure E. a, foundation cleaning; b, west wall; c, east wall.

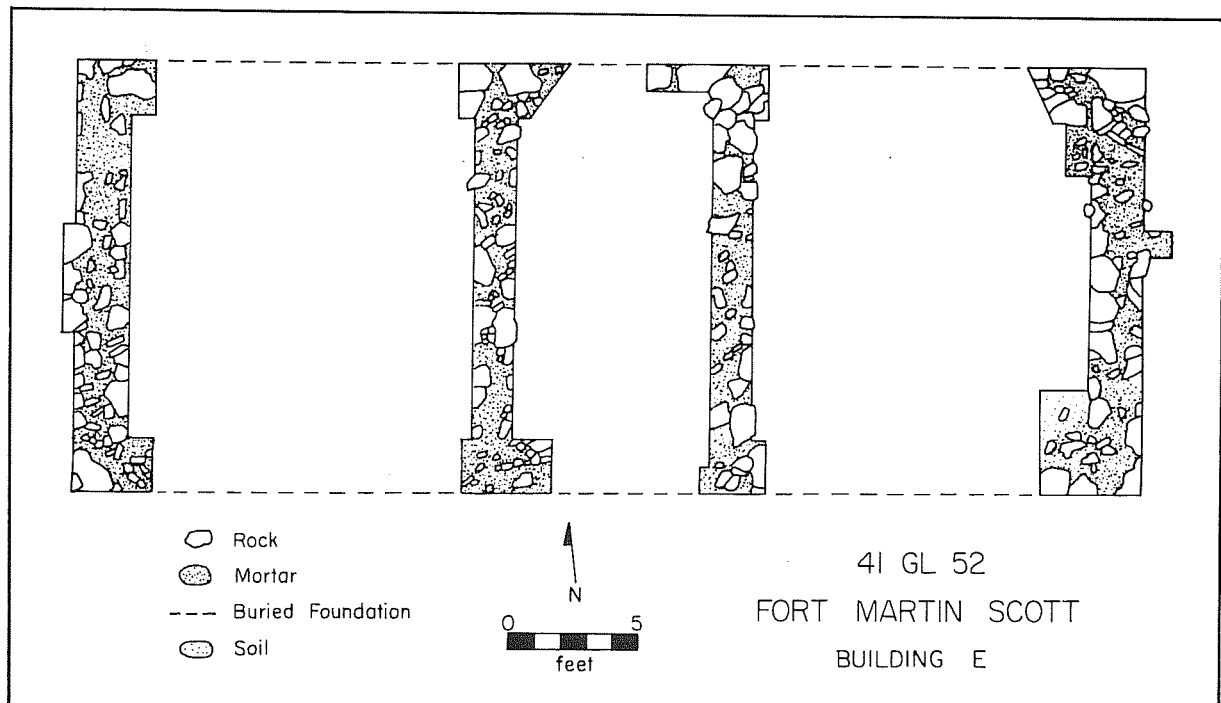
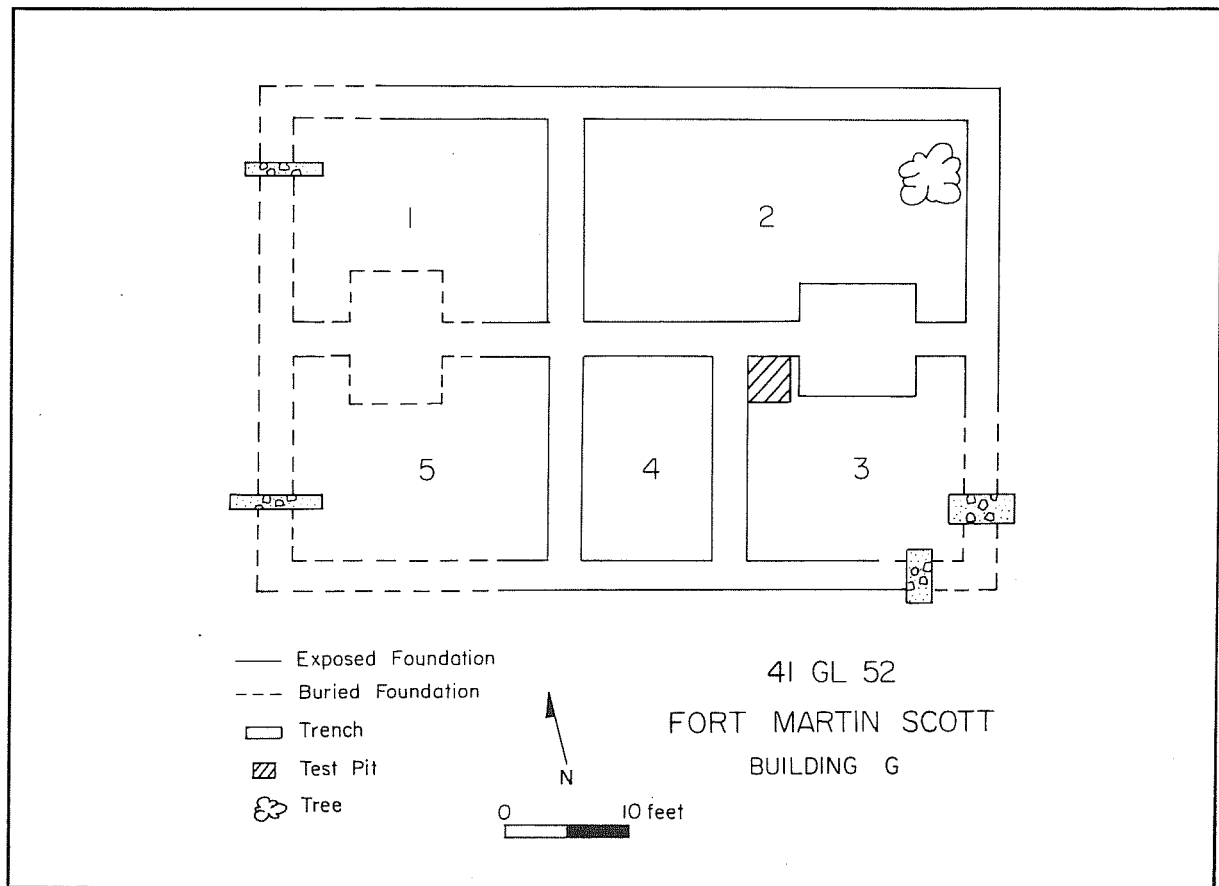
Figure 8. Floor Plan Drawing of Structures E and G. a, Structure E; b, Structure G.

Structure G is the easternmost structure in the north row of officers' quarters (Fig. 4). The 1853 Freeman Inspection Report described this structure as adobe, four rooms with a basement, and 16 x 17 feet in dimensions; there was no mention of porches (Fig. 2). About 75% of the foundation for this former structure was exposed prior to testing (Fig. 8,b).

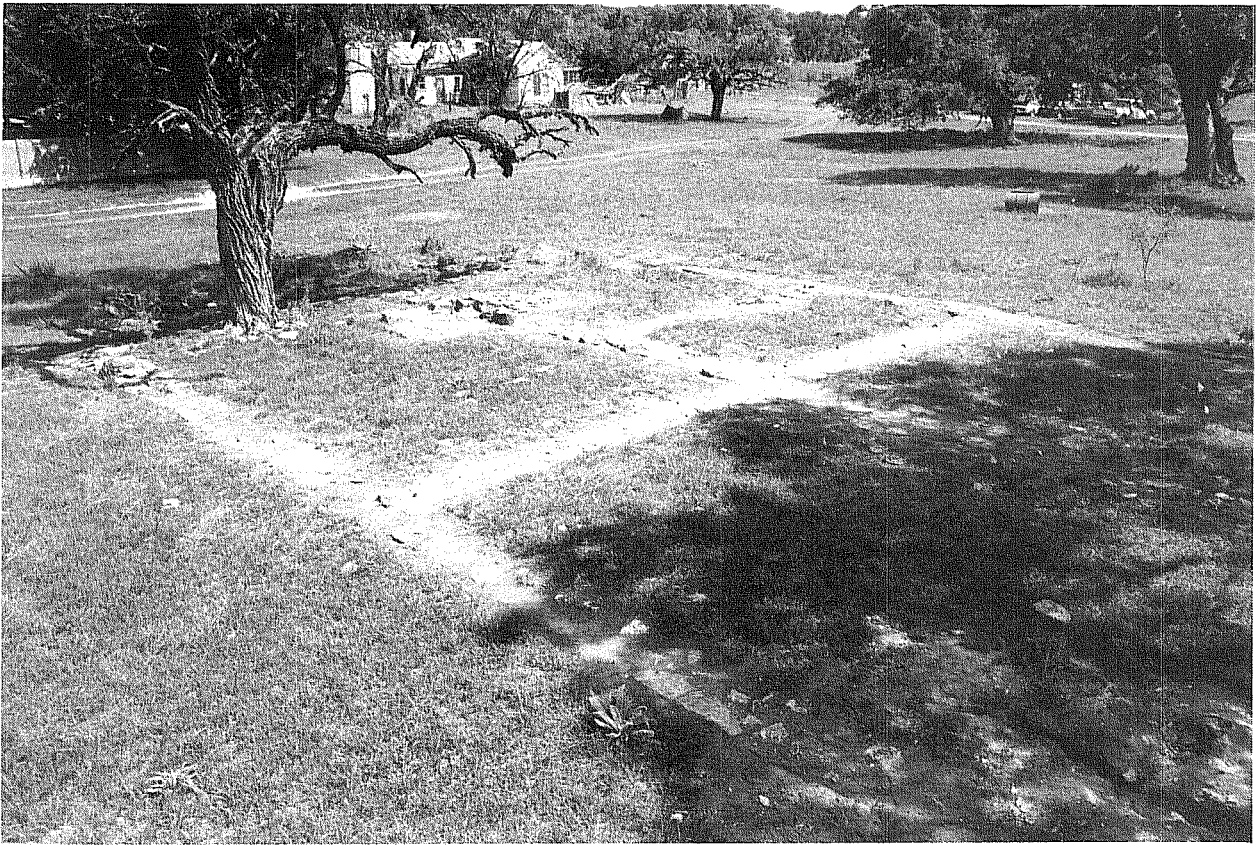
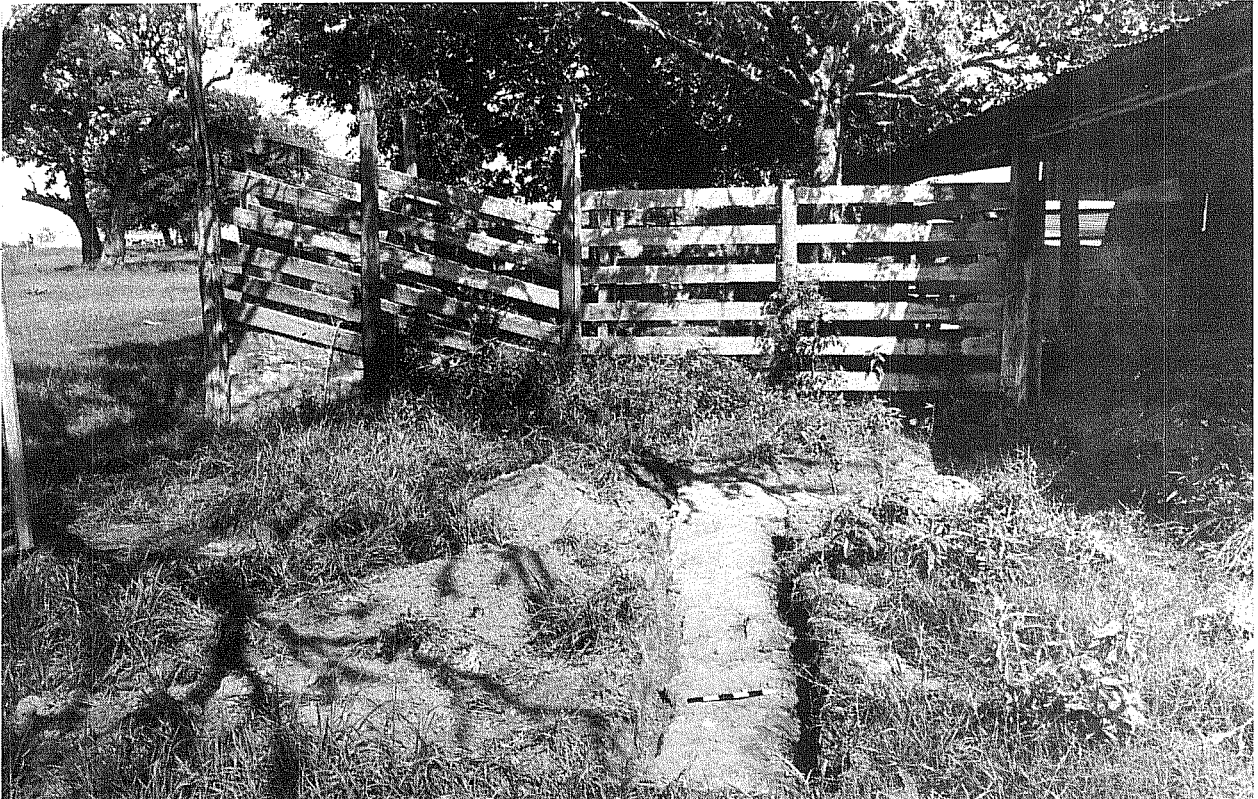
A total of two test trenches was excavated at a 90° angle to the suspected location of the west wall. Both test units evidenced small amounts of mortar and rubble but without any *in situ* sections of wall. Excavation of the western one-third of the south wall produced similar results. Two additional test trenches (ca. 12 inches deep) near the southeast corner of the south wall also produced similar results. The areas currently exposed represent the only sections of foundations remaining from Structure G (Fig. 9,a).

Figure 9. Foundation Remnants for Structures G and J. a, Structure G; b, Structure J.

(Fig. 9,b). The main wall section (outer wall) was ca. two feet thick, while the cross (interior) wall was ca. 18 inches thick. Both walls were composed primarily of rubble and deteriorated mortar (Fig. 10).

Since there is some difference between the 1853 description of Structure G and what was found through our investigation, it might be useful to do a complete excavation of this foundation. This investigation would probably allow confirmation of the actual date of construction and possible later uses of the building after the fort was decommissioned.

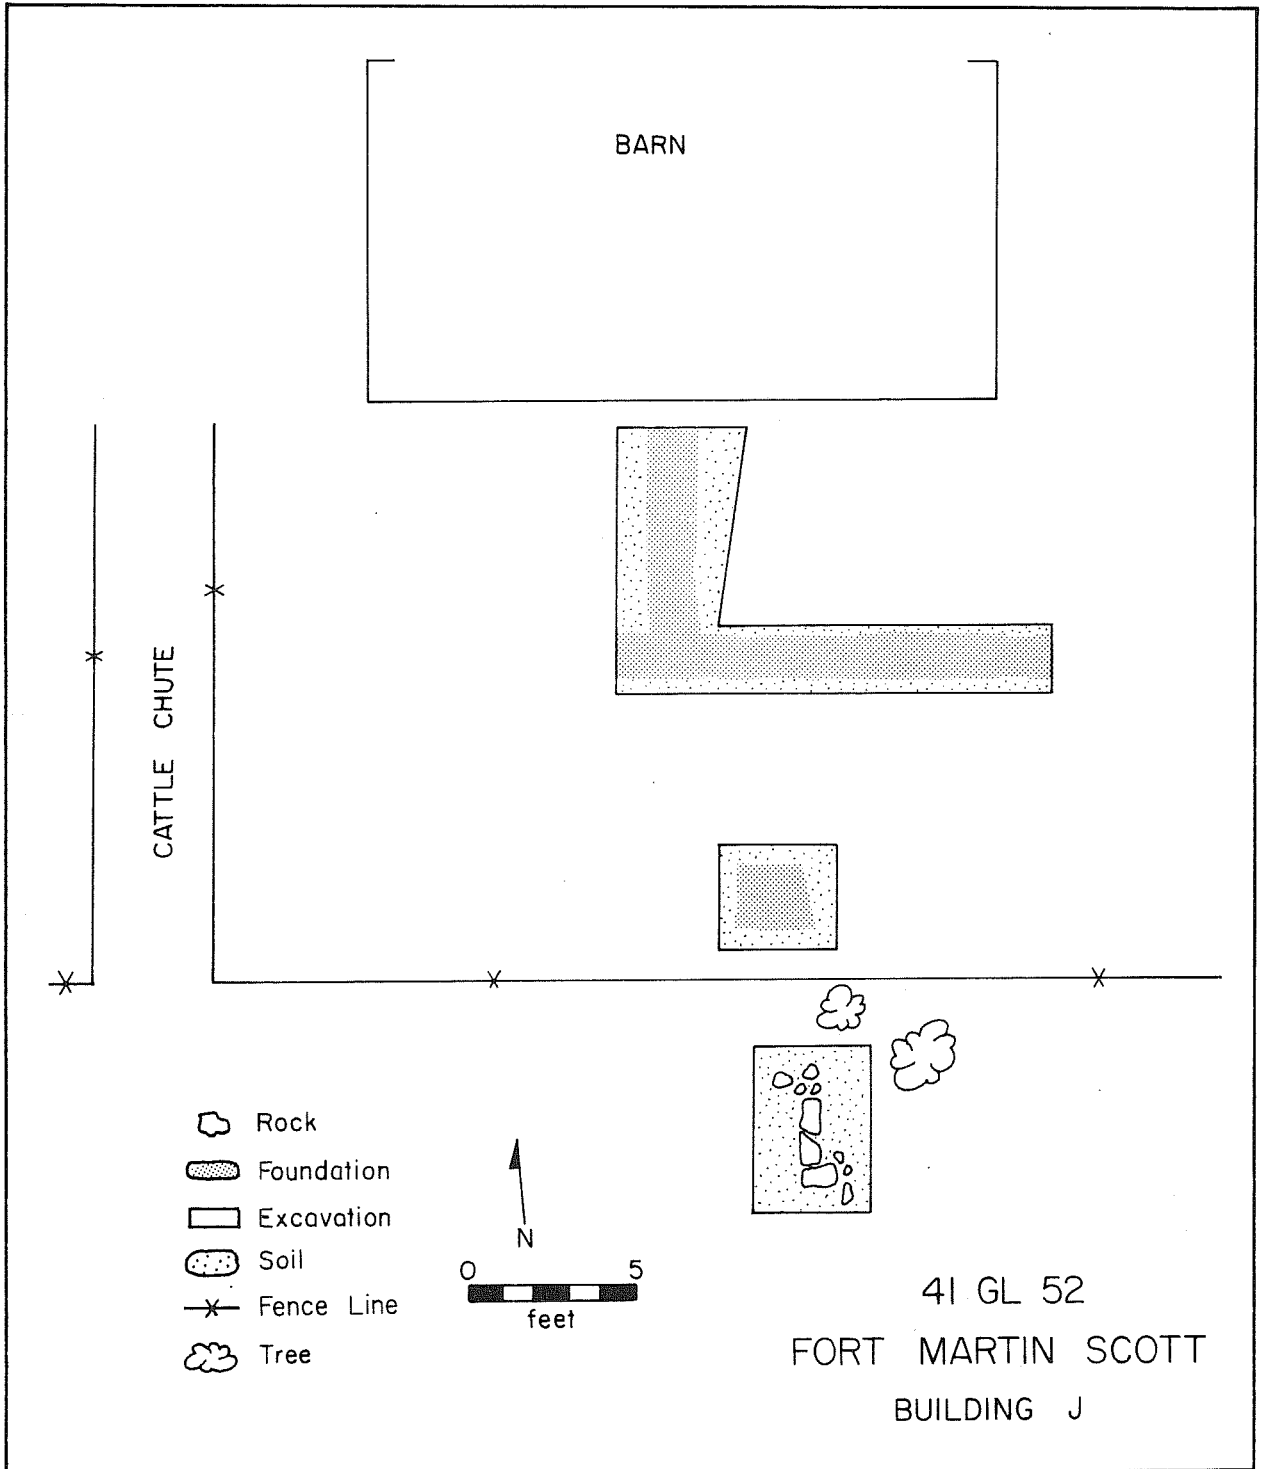
The cross wall was oriented roughly north-south and adjoined the main wall at a 90° angle. The northernmost portion of this wall appears to have been destroyed by the construction of the barn. The main east-west wall remnant extends to the east for at least 15 feet and is buried beneath 6 to 13 inches of earth. The western limits of this wall were not explored. These remnants may represent Structure J; remnants for Structure H are most probably inside the barn. The subsurface soil failed to produce a single artifact.

Figure 10. Floor Plan Drawing of Foundation Remains for Structure J.

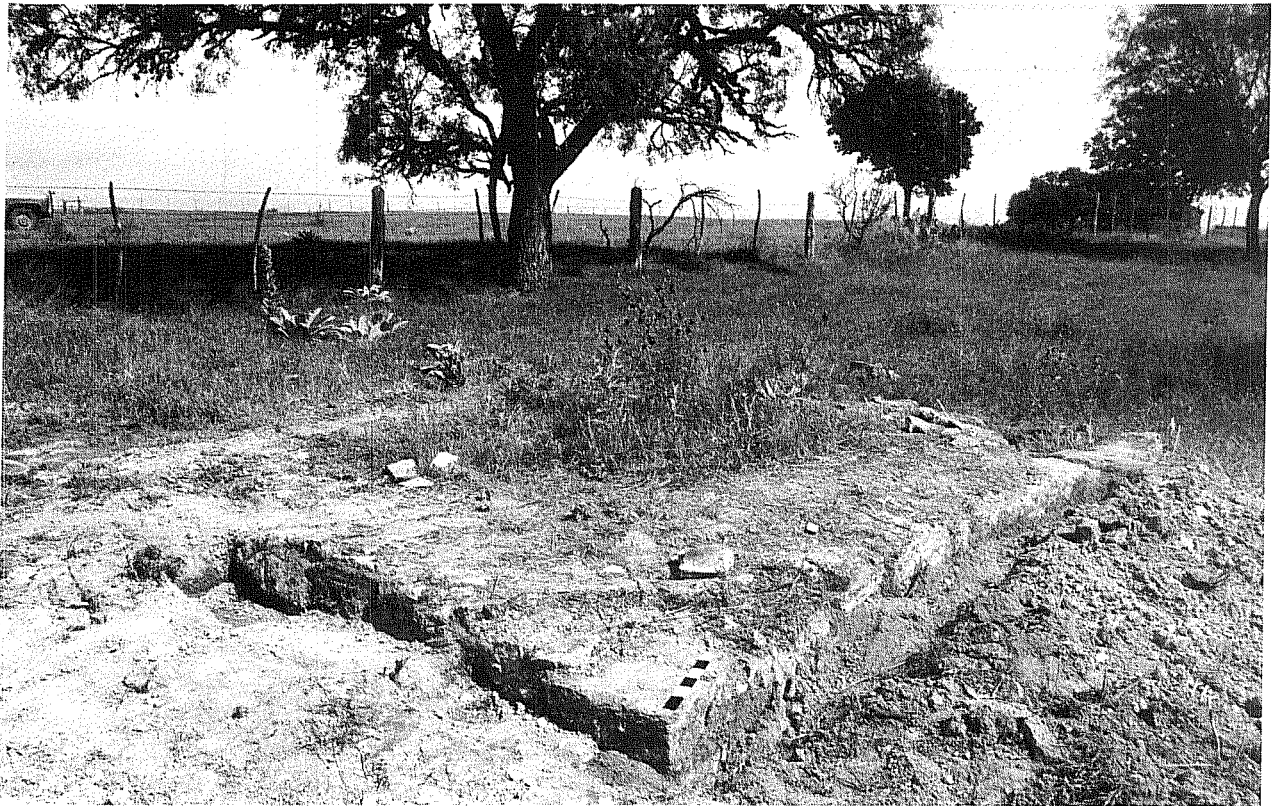
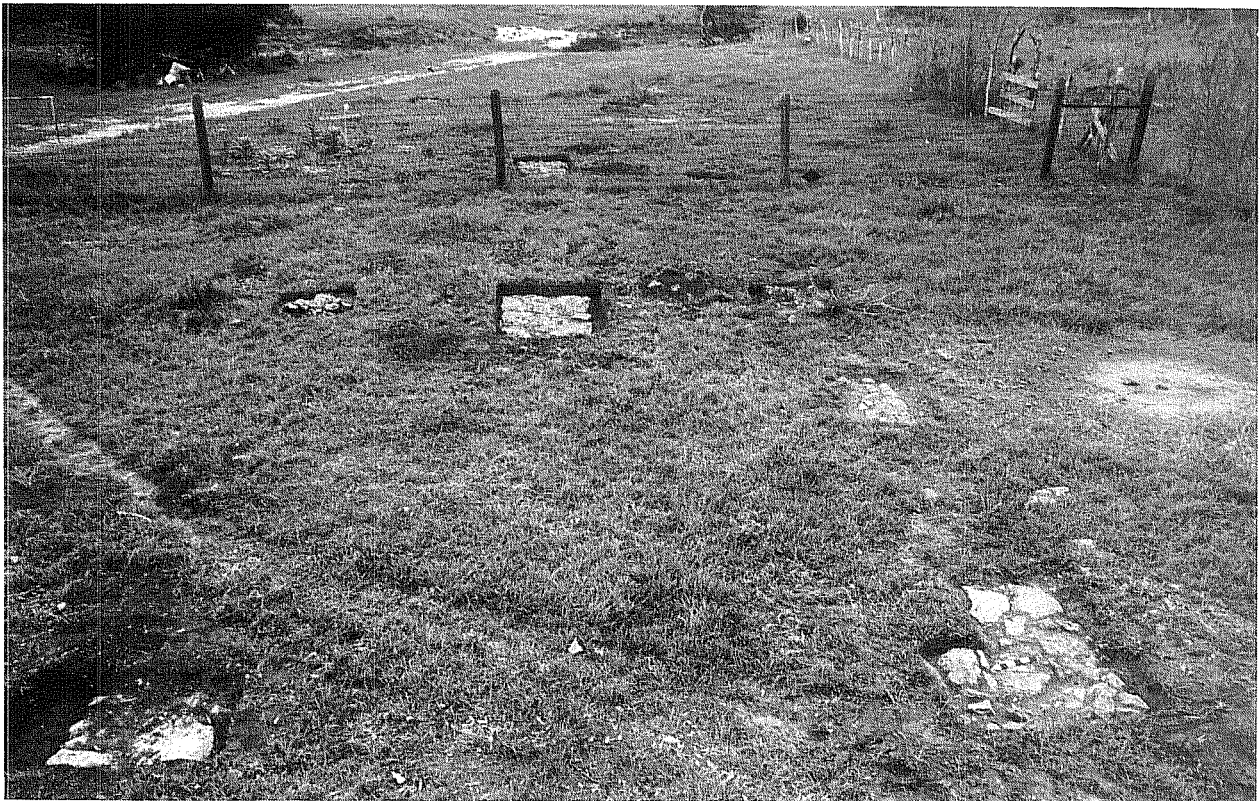
Structure M is located adjacent to Barons Creek and is ca. 50 feet south of the northeast corner of the property leased by the City to the Fredericksburg Heritage Federation (Fig. 4). The 1853 Freeman Inspection Report described the bake house as a log structure with dimensions of 14 x 20 feet (Fig. 2). The only remaining evidence for this structure is the remains of the foundation for a cut-stone bake oven (Fig. 11,a).

Figure 11. Foundation Remnants for Bake Oven and Structure 0. a, bake oven; b, Structure 0.
