ARCHAEOLOGICAL INVESTIGATIONS AT FORT MARTIN SCOTT (41 GL 52) IN GILLESPIE COUNTY, TEXAS

Center for Archaeological Research
The University of Texas at San Antonio
Archaeological Survey Report, No. 169

During May 24-30, 1986, archaeological investigations at Fort Martin Scott (41 GL 52) were conducted by the Center for Archaeological Research at The University of Texas at San Antonio. The fort was established by the U.S. Army in 1848. It was the fifth United States fort in Texas. Only one of the fort's original buildings now exists. The foundations for an additional eight structures were identified and documented by this project. The property on which this old fort is located is owned by the City of Fredericksburg. The Fredericksburg Heritage Federation plans to develop the area as a day-use facility which includes archaeological and historical interpretations of the fort during its tenure (1848-1853) as a military outpost on the western frontier.

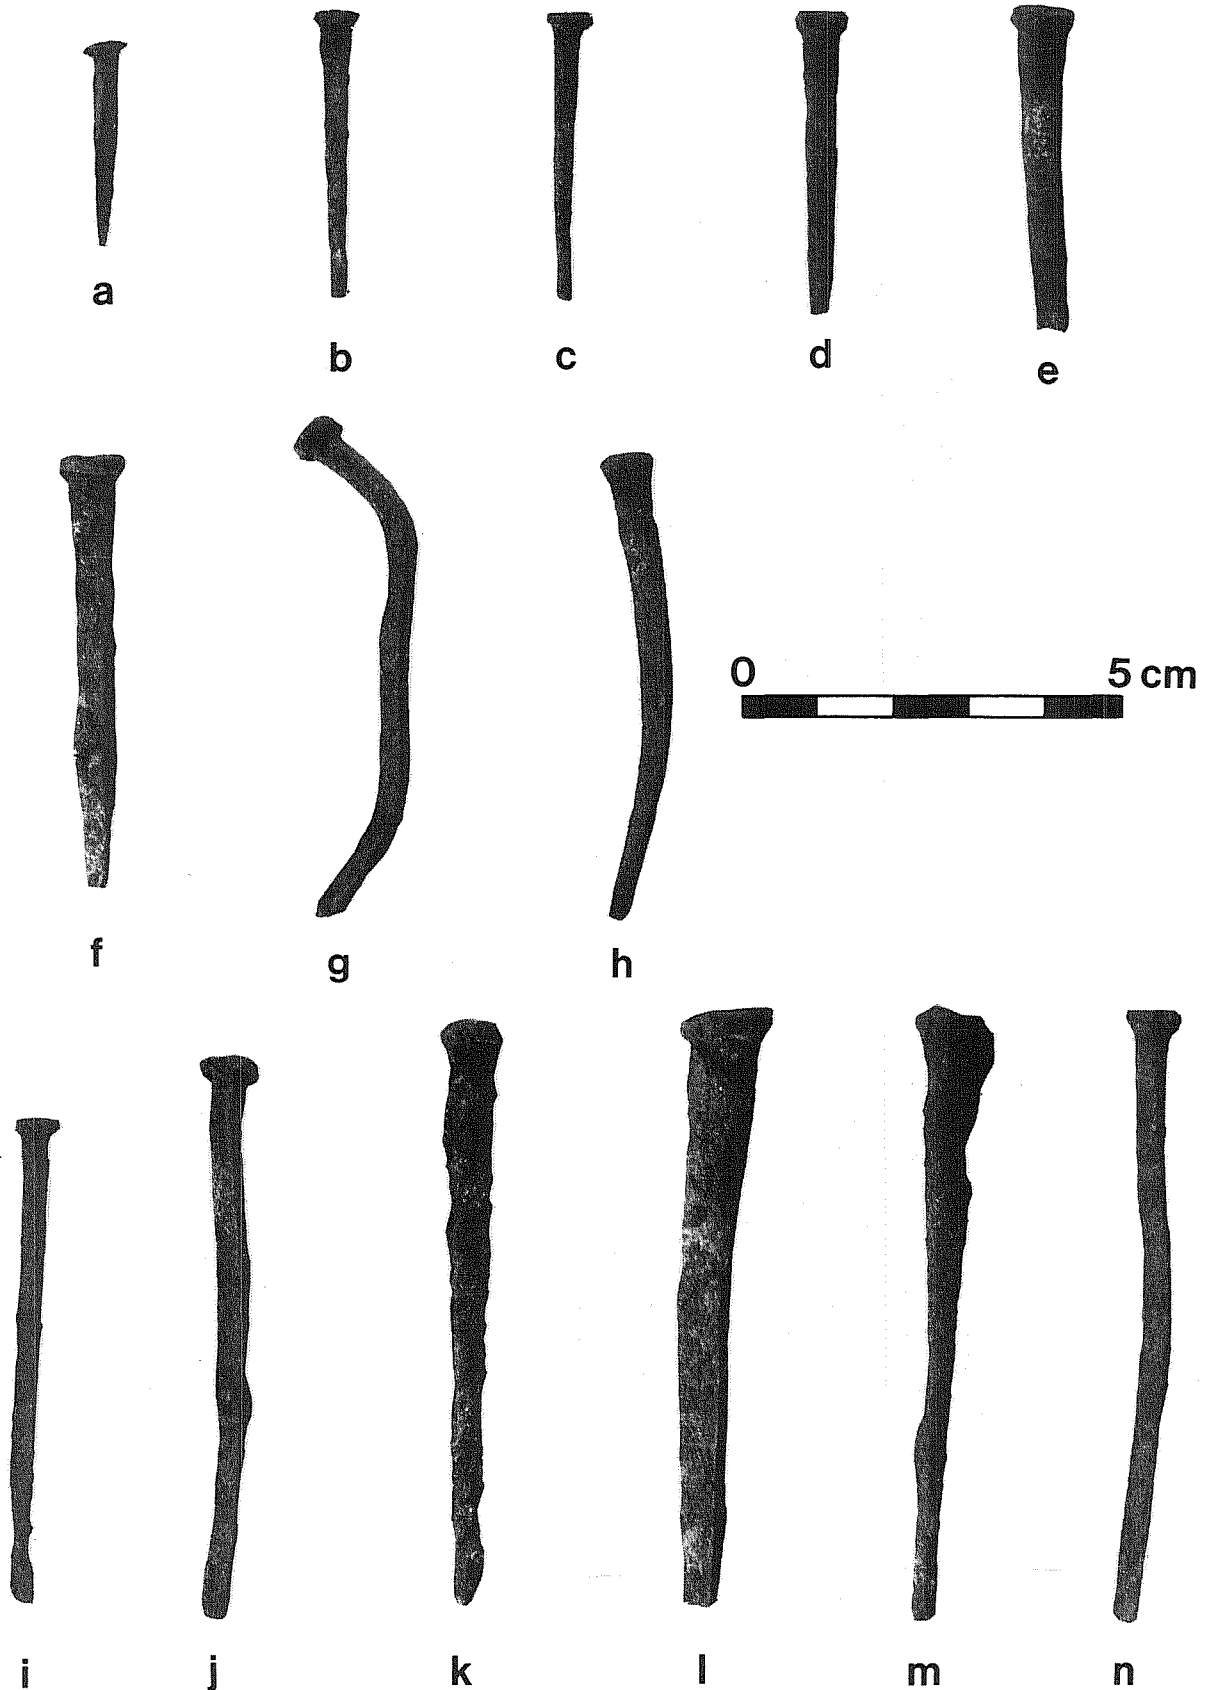
Figure 13. Square-Cut Nails Recovered from Survey Area 1.

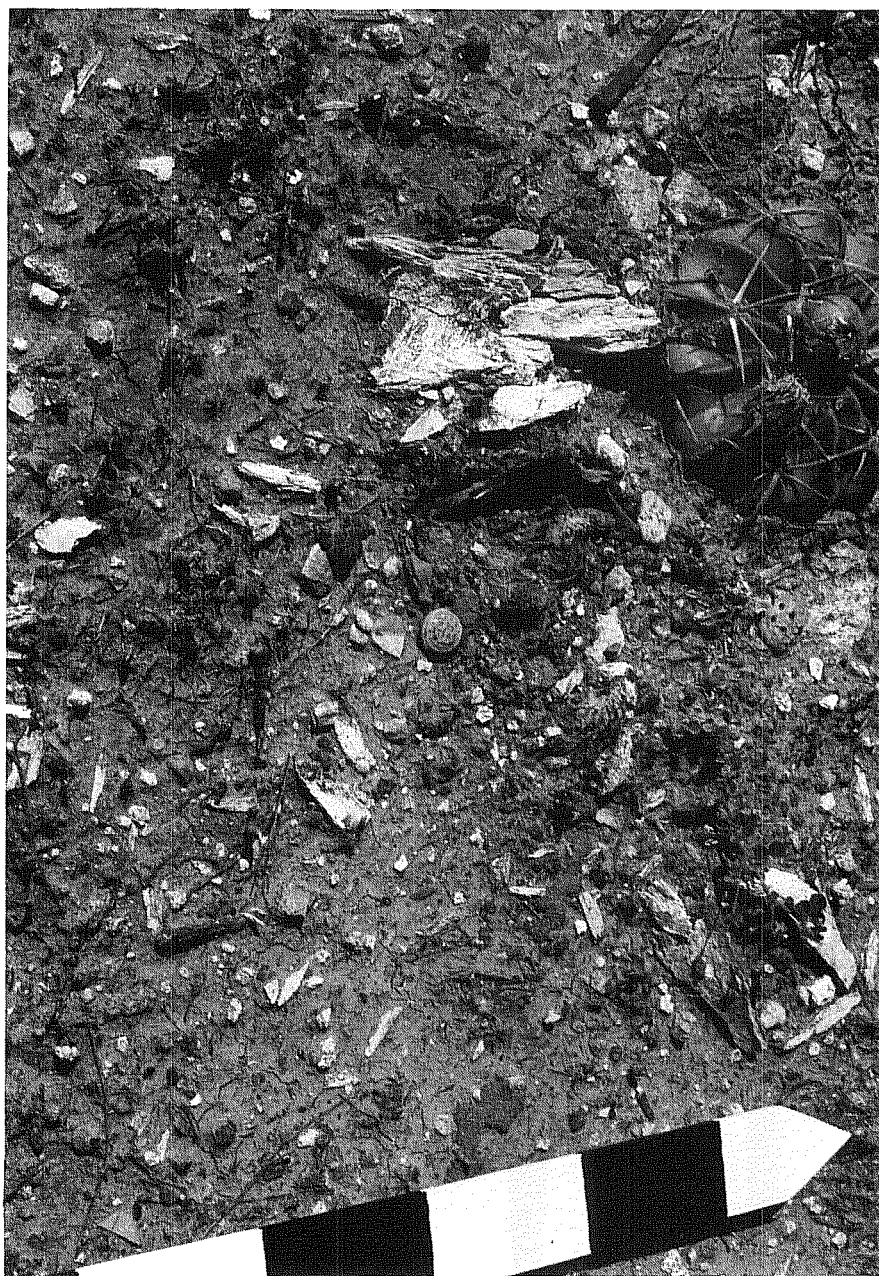
The main artifact scatter was limited to an area ca. 50 feet (east-west) by 40 feet (north-south). The ground surface had little to no vegetation and exhibited numerous erosional rivulets produced by sheet wash erosion. A total of 19 complete square-cut nails (Fig. 13), two pipe fragments, two buttons, one cartridge case, and several glass fragments was found randomly scattered across the area. A second small concentration of artifacts (Fig. 14) was isolated in the western half of Survey Area 1: several square-cut nails, .36 caliber and .44 caliber lead balls (Fig. 16,o,q), a U.S. military button (Fig. 16,d), and two percussion caps for use on military muskets (Fig. 16,l,m).

Figure 14. Artifact Scatter in Survey Area 1.
