# Archaeological and Historical Investigations for the Mission Road Realignment Project, San Antonio, Texas

**ARCHAEOLOGICAL AND HISTORICAL INVESTIGATIONS  
FOR THE MISSION ROAD REALIGNMENT PROJECT,  
SAN ANTONIO, TEXAS**

**Center for Archaeological Research  
The University of Texas at San Antonio  
Archaeological Survey Report, No. 173**

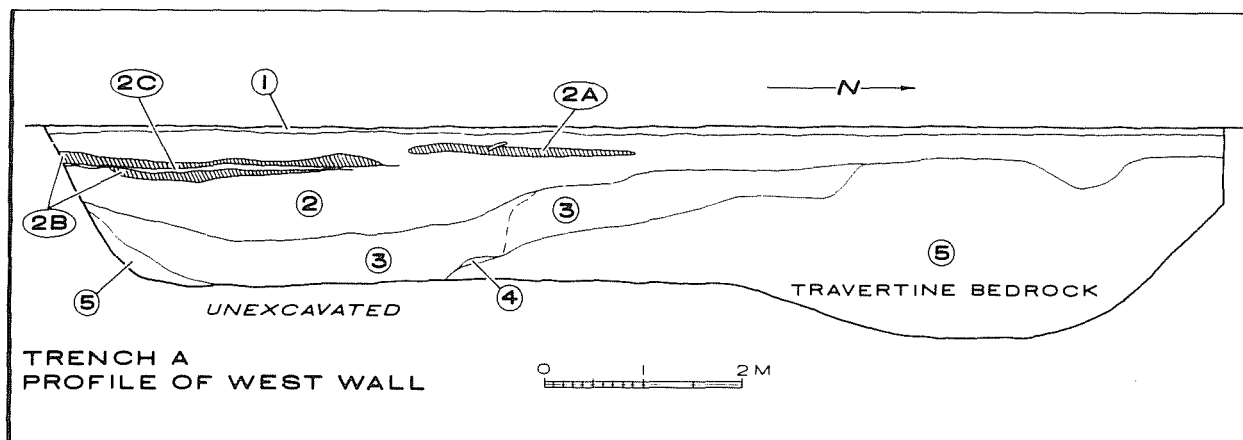
Figure 3. Trench A, Profile of West Wall.

by 0.75-0.80 m in width. A total of five stratigraphically discrete zones (see Fig. 3) was identified.

**Zone 1 (0-0.12 m):** This zone consisted of a black clayey topsoil (10 YR 2/1) and humic layer that included numerous small pieces of land snail shell, travertine, and caliche pebbles. A few modern aluminum pull-tabs and sherds of thin, brown glass (beer bottles) were the only cultural materials noted in the backdirt. The soil contact between Zones 1 and 2 was fairly distinct and occurred at roughly the same depth (0.10-0.12 m) across the length of the trench profile.

**Zone 2 (0.12-1.15 m):** This zone consisted of very dark grayish brown (10 YR 3/2) clayey loam that included proportionately larger chunks of travertine and caliche pebbles. Zone 2 ranged from 0.30 to 1.10 m in thickness. Zone 2 contained several small (0.03-0.15 m thick) unconnected lenses of dark yellowish brown (10 YR 4/4) travertine and one dark black (10 YR 2/1) lens that included large chunks of wood charcoal. Cultural materials within this zone were limited to 20th-century construction debris (iron rebar, red brick, rusty metal and wire, chunks of mortar, and stone copings similar to those used to construct St. Joseph's Orphanage). Zone 2 would appear to be the product of the bulldozing activities during the late 1950s to early 1960s. The soil contact between Zones 2 and 3 was very uneven (0.34-1.15 m below the ground surface) and weakly defined.

**Zone 3 (0.34-1.60 m):** This zone consisted of a yellowish brown (10 YR 5/4) clayey sand that included several localized pockets and chunks of yellowish sand. The thickness of Zone 3 ranged from 0.10 to 0.50 m. The proportion of sand to clay in this zone was much greater than in Zone 2. Small caliche pebbles and chunks of partially consolidated travertine were

evident throughout this zone and provided a somewhat mottled appearance. Cultural materials were totally absent. This zone appeared to be natural and without disturbance from bulldozing. Soil contact between Zones 3 and 4 was distinct and fairly even although restricted to only a portion of the 12 m profile in Trench A. Contact between these zones ranged from 1.30 to 1.40 m below the ground surface.

**Zone 4 (1.30-1.40 m):** Zone 4 consisted of a thin localized layer of dark brown (10 YR 3/3) clayey alluvium that is restricted to about a 1 m section of the overall 12 m profile. This zone is sandwiched between a yellowish sandy soil zone (Zone 3) and partially consolidated travertine (Zone 5). Cultural materials were totally absent as were caliche pebbles and gravels.

**Zone 5 (0.34-2.25 m):** Zone 5 consisted of damp, partially consolidated yellowish (10 YR 7/6) travertine which ranged in thickness from 0.50 to 1.90 m. Cultural materials were totally absent. Zone 5 is best described as a homogeneous zone of travertine without any type of intrusions.

Trench A sought to determine if the acequialike feature noted by Scurlock and Fox (1977) extended to or transected the proposed right-of-way. Trench A (Fig. 2) was excavated to a maximum depth of about 2.58 m. Trench dimensions were about 12 m in length

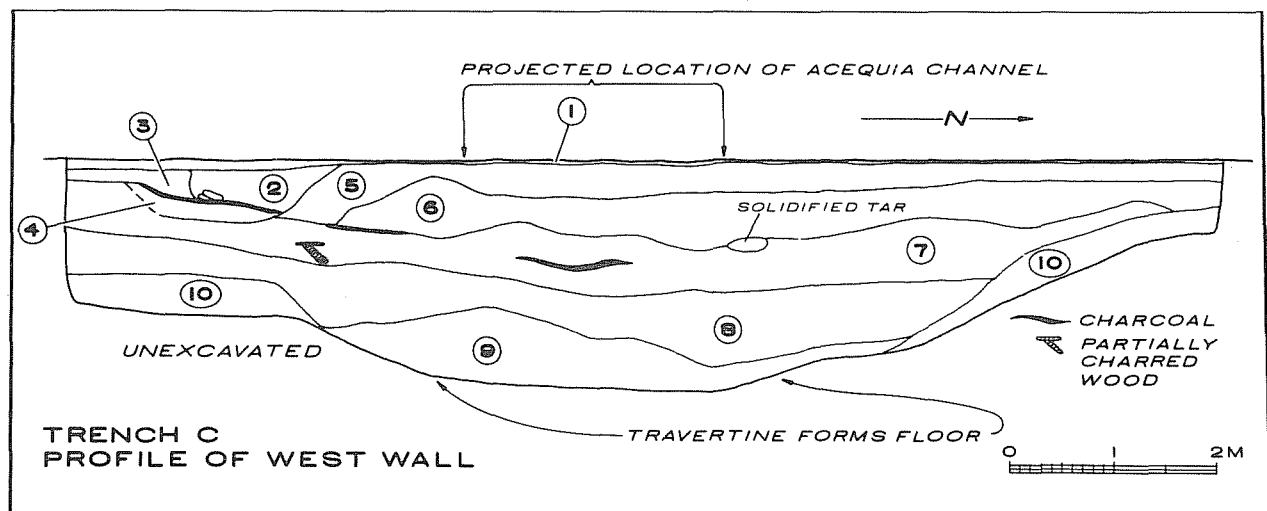
Figure 4. Trench C, Profile of West Wall.

Trench C was excavated to a depth of 2.20 m. The trench was about 11 m in length and ranged from 0.70 to 0.80 m in width. A total of 10 stratigraphic zones was evident in the completed trench profile (see Fig. 4).

**Zone 1 (0-0.11 m):** Zone 1 consisted of a black (10 YR 2/1) clayey soil and humic layer. Brown glass (beer bottle) and light green ribbed glass (Coca Cola bottle) were the only cultural materials identified *in situ*. Zone 1 ranged in thickness from 0.04 to 0.11 m. Contact between Zones 1 and 2 was sharply defined.

**Zone 2 (0.05-0.45 m):** Zone 2 consisted of a localized lens of very pale brown (10 YR 7/3) sand that is most probably the product of bulldozing.

**Zone 3 (0.10-0.40 m):** Zone 3 is also most probably the product of recent bulldozing. This zone consisted of a localized lens of dark reddish brown (5 YR 3/2) loosely compacted soil that included small pieces of wood. Zone 3 ranged from 0.10 to 0.30 m in thickness. Contact between Zones 3 and 4 was clearly defined.

**Zone 4 (0.25-0.60 m):** Zone 4 also consisted of a localized lens that was not represented across the entire profile. Soil matrix consisted of a light tan (10 YR 7/2) clayey loam. Zone 4 ranged in thickness from 0.05 to 0.62 m. Contact between Zones 4 and 5 was clearly defined.

**Zone 5 (0.03-0.62 m):** Zone 5 consisted of a dark reddish brown (5YR 3/2) clayey loam that included numerous small caliche pebbles, gravel, and chunks of weakly consolidated travertine. Cultural materials were few and were mainly limited to construction materials. This zone ranged in thickness from 0.12 to 0.50 m.

**Zone 6 (0.18-0.65 m):** Zone 6 consisted of a very dark grayish brown (10 YR 3/2) clayey loam apparently deposited by bulldozing. Cultural materials were densely compacted throughout the entire zone. Artifacts included a wide range of construction materials (metal, wood, bricks, mortar, window glass, solidified roofing tar) and domestic items (whiteware ceramics, beverage and medicine bottles, children's toys, a leather ball, a leather shoe, and a tricycle frame without wheels). All identifiable items are of 20th-century manufacture and were most probably deposited by the orphanage. Zone 6 ranged from 0.22 to 0.52 m in thickness. Contact between Zones 6 and 7 was weakly defined across the length of the vertical profile.

**Zone 7 (0.20-1.30 m):** Zone 7 also appeared to be the product of bulldozing. It differed from Zone 6 in soil color and artifact density. This zone had relatively few artifacts and consisted of a dark grayish brown (10 YR 2/2) soil matrix that included a higher proportion of sand than was present in Zone 6. Zone 7 ranged in thickness from 0.20 to 0.55 m. Contact between Zones 7 and 8 was poorly defined across the length of the profile.

**Zone 8 (0.65-1.50 m):** Zone 8 appears to be the deepest of the artificial strata created by bulldozing. Soils within Zone 8 consisted of a dark grayish brown

(10 YR 4/2) clayey loam that included small (1-2 cm) gravels. Cultural materials were restricted to the contact between Zones 7 and 8. Cultural materials consisted of concrete and brick rubble intermixed with small amounts of travertine. This zone ranged from 0.20 to 0.70 m in thickness. Contact between Zones 8 and 9 was sharp and well defined across the profile.

Zone 9 (1.40-2.00 m): Zone 9 consisted of a yellowish brown (10 YR 5/4) sandy clay matrix that was culturally sterile. This zone would appear to be naturally formed and ranged in thickness from 0.10 to 0.60 m in thickness. Contact with Zone 10 was readily identifiable.

Zone 10 (1.10-2.20 m): Zone 10 was the lowest stratigraphic unit recognized in Trench C. It consisted of damp, light gray (10 YR 7/2) to light yellowish (10 YR 6/4) partially consolidated travertine. This zone was culturally sterile.

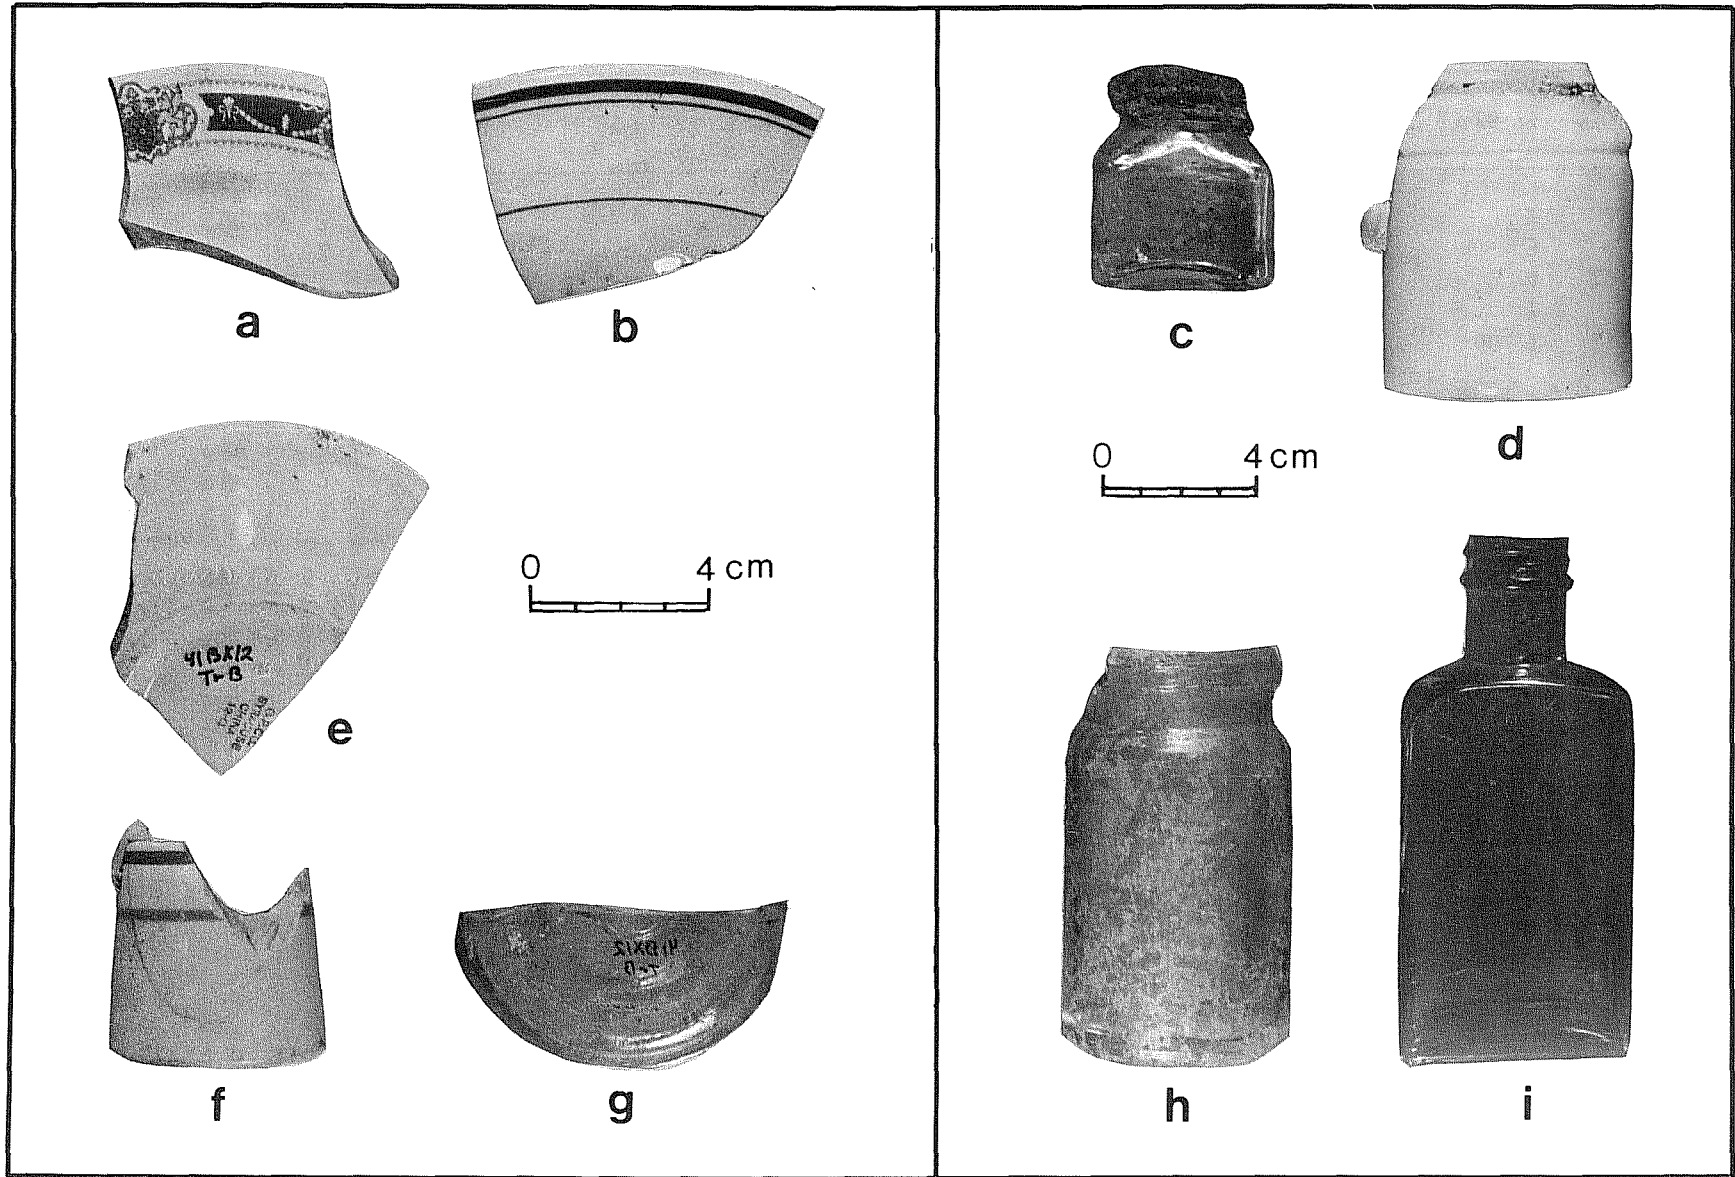
Figure 5. *Selected Artifacts Recovered at Mission Concepción.* a, hotelware, polychrome design; b, hotelware, green bands; c, ink bottle, screw cap; d, white glass ointment jar; e, ironstone bowl, Onandaga China Co., Syracuse, N.Y., ca. 1871-1900; f, hotelware cream pitcher; g, wine bottle base, olive green; h, paste jar, clear glass; i, screw top medicine bottle, brown glass.
