# Archaeological Investigations at the San Pedro Acequia San Antonio, Texas

Center for Archaeological Research  
The University of Texas at San Antonio  
Archaeological Survey Report, No. 103

## ABSTRACT

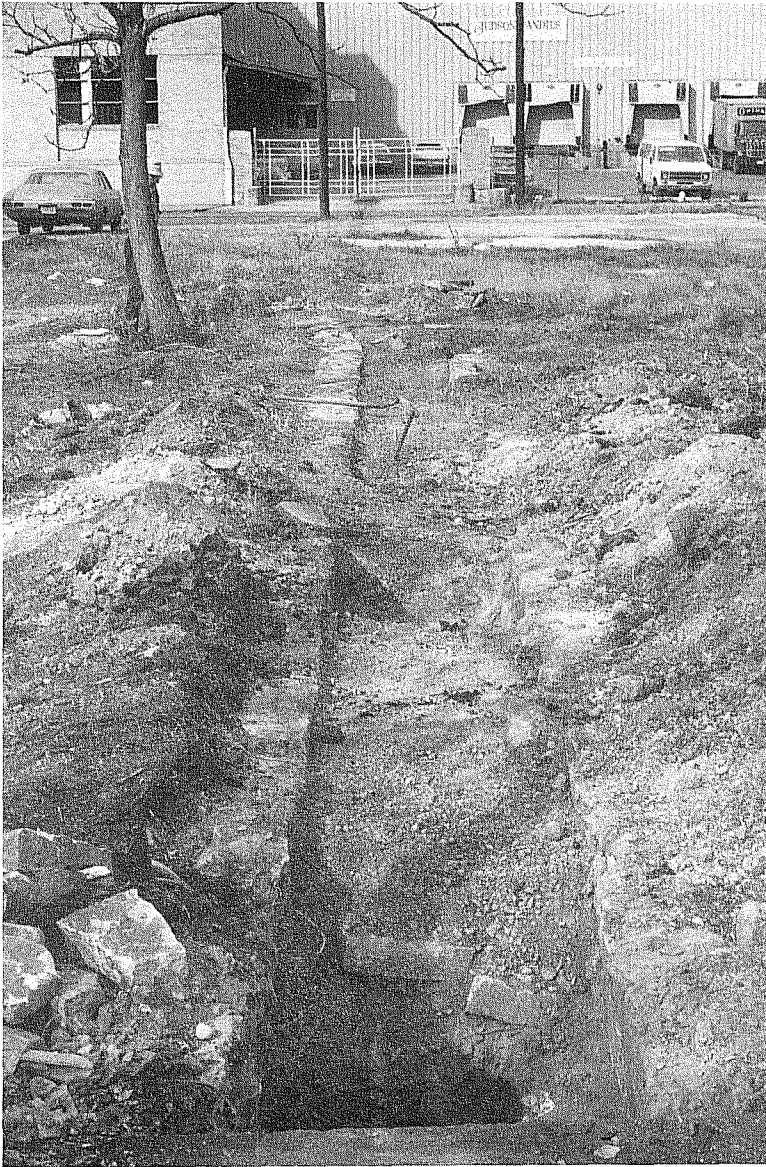
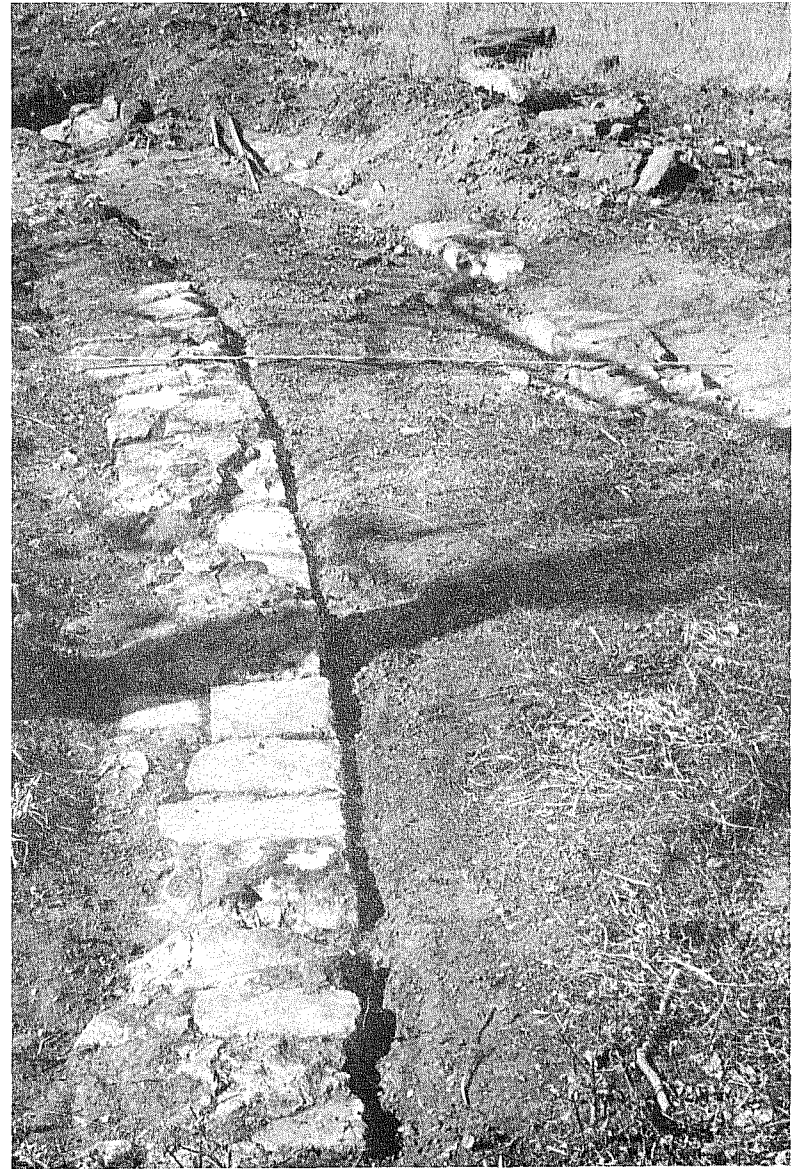
Figure 11. *San Pedro Acequia*. a, stone-lined portion of acequia in excavation Trench F; b, stone-lined acequia in excavation (surface) Trench Q.

photographed (Fig. 11,b), and it was noted that the stone masonry was a different style. A collection of small limestone blocks with occasional clay bricks were mortared together in different localities along the top; this later work could suggest that the wall height was raised to accommodate a higher water level.
