ARCHAEOLOGICAL TESTING OF PROPOSED  
SEWER LINE LOCATION AT  
MISSION SAN JOSE

DAVID HAFERNIK AND ANNE A. FOX

*Center for Archaeological Research  
The University of Texas at San Antonio  
Archaeological Survey Report, No. 138*

Investigations conducted under  
Texas Antiquities Committee Permit No. 411

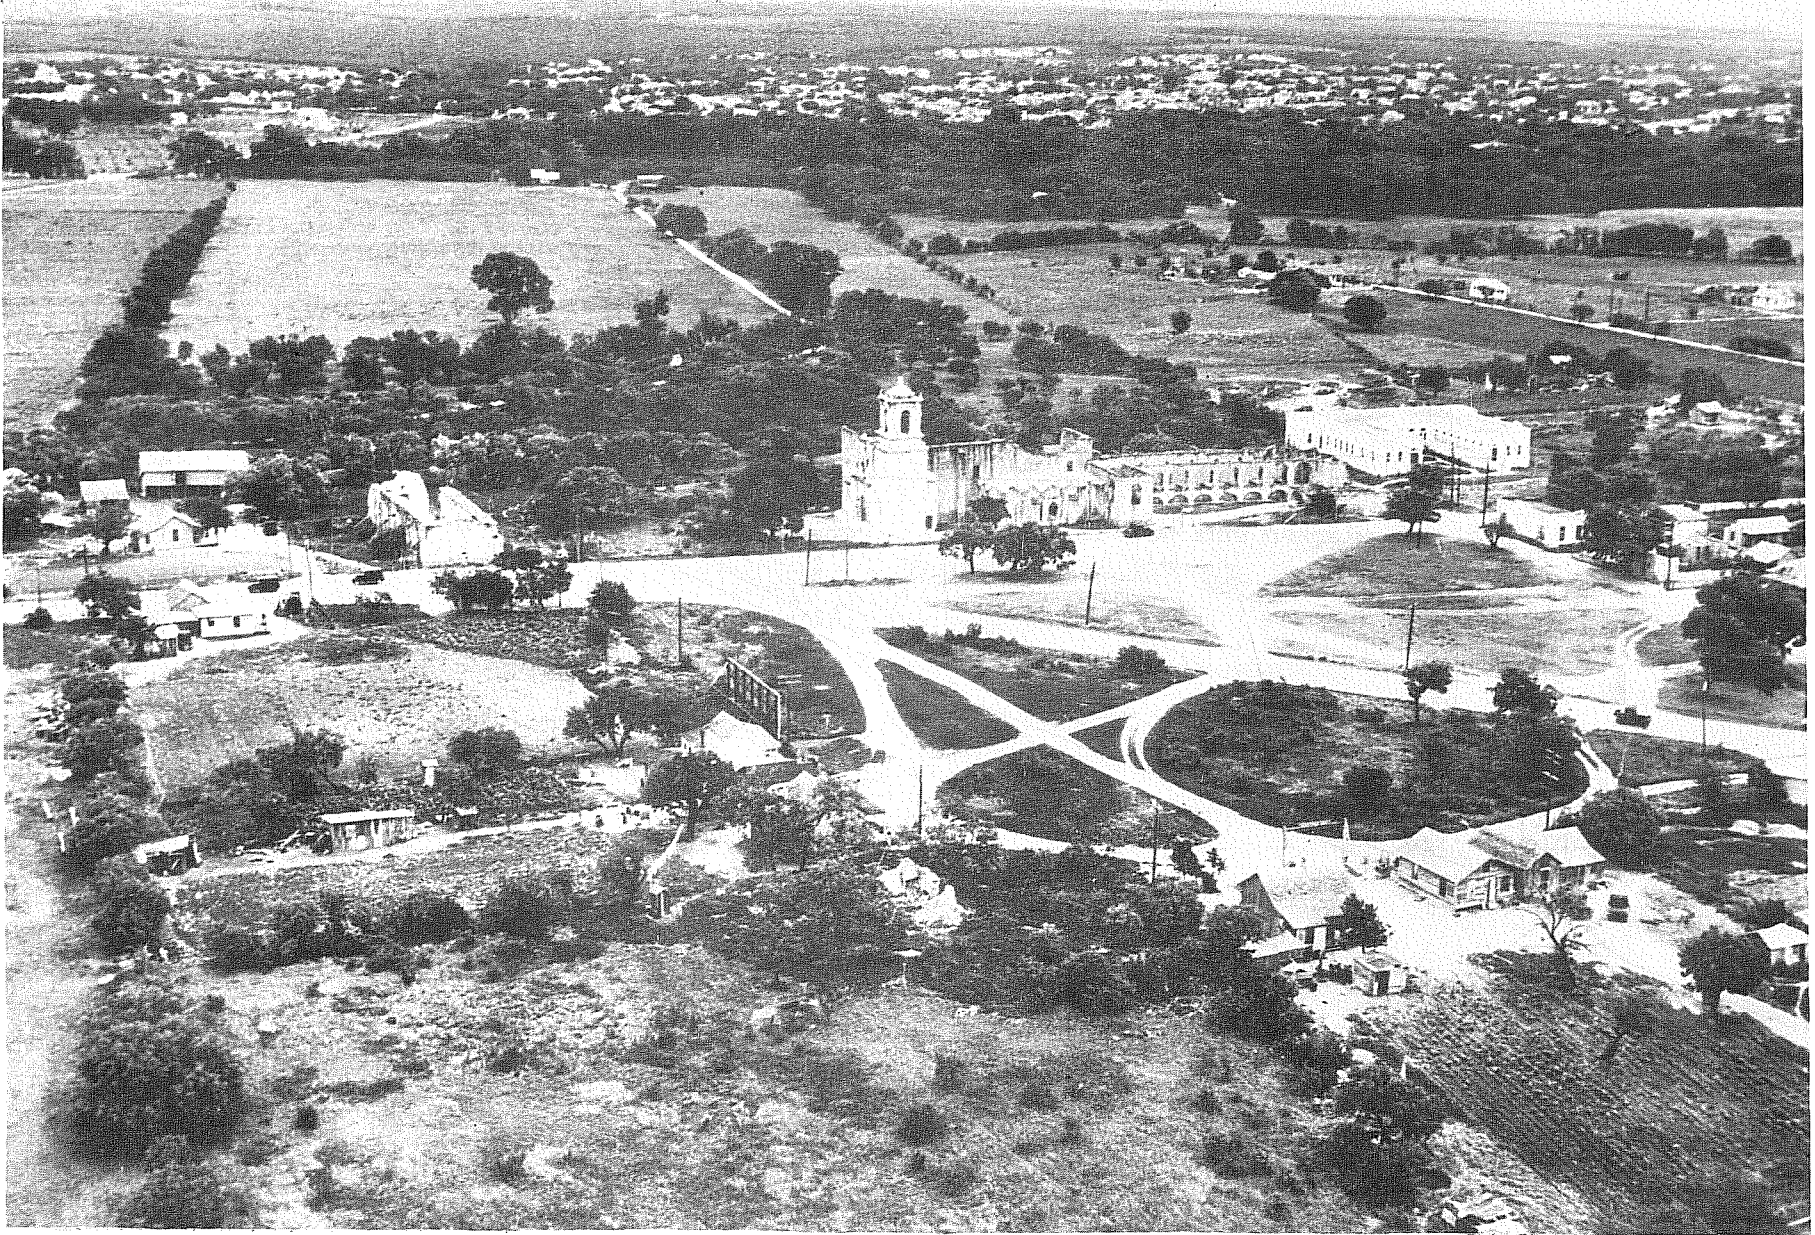
Figure 3. Undated Aerial Photograph of Mission San José Looking North-Northeast ca. 1931-1932. From the files of the San Antonio Missions National Historic Park. Note Schelcher property outlined by trees in lower left quadrant, and privy near the north lot line. For location of backhoe trench, compare with Figure 2.

The general area has been continuously occupied from the 1740s when Mission San José was moved to the site (Habig 1968:45) to the 1940s when reconstruction of the mission began. The property was divided into long, narrow strips running perpendicular to the mission walls at the time of secularization in 1893, and at that time was acquired by various mission Indian families and local Spanish citizens. At first the people lived in the stone buildings on the mission walls. These buildings were gradually modified or replaced by small frame houses, at which time the area to be impacted by the sewer trench would have been in the back yards of these houses and could possibly have been the location of wells, trash dumps, or other features related to these houses. By 1931-1932 (Fig. 3) much of the land had fallen vacant, some ruins of the stone houses remained, and a few frame houses continued to be occupied. Fence lines visible in the area reflect property lines found on a 1941 map in the National Park Service collections (see Fig. 3).
