ARCHAEOLOGICAL INVESTIGATIONS AT THE UNITED STATES ARSENAL SITE (41 BX 622), SAN ANTONIO, TEXAS

Anne A. Fox

Center for Archaeological Research The University of Texas at San Antonio Archaeological Survey Report, No. 137

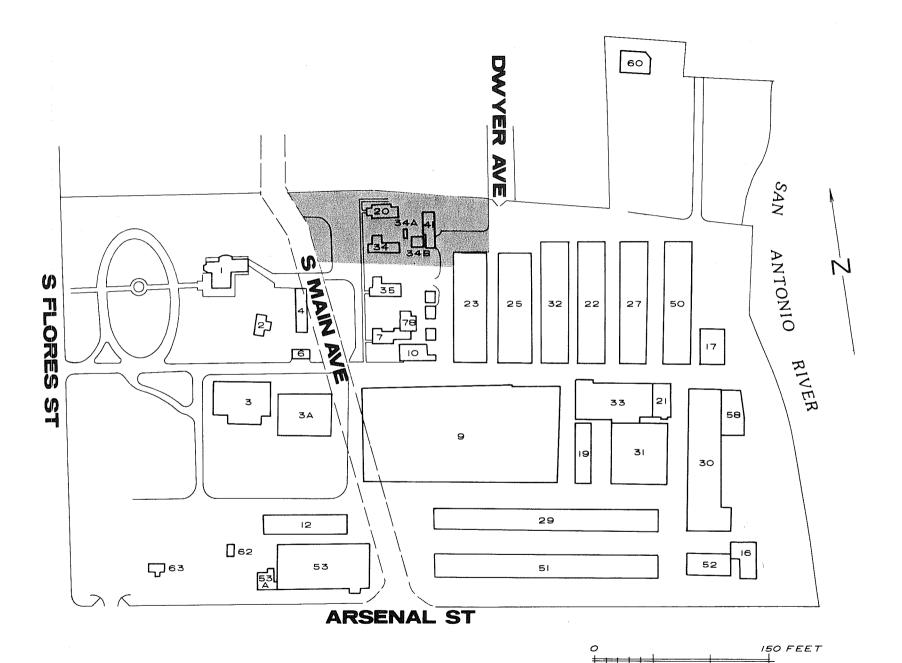
Figure 1. Arsenal Site Plan. Basic data and building identifications from 1946 road map (San Antonio Arsenal, Office of the Post Engineer 1946); location of South Main Avenue from 1961 site plan (General Services Administration 1961). The area investigated by trenching is indicated by darkened area.

In mid-February, the Center was requested to do additional testing at the south end of the old stone stable building (No. 21 in Fig. 1). It was hoped to determine if any indication remained of the location of an outside stairway providing access to the loft above the stable. A test pit measuring ca. $1-1/2 \text{ m} \times 3 \text{ m}$ was excavated. The first level consisted of ca. 15 cm of gravel fill. A $1-\text{m}^2$ concrete slab was found at the west end of the unit at this level, and a pipe trench at the opposite end. Excavation continued through several alternating layers of brown soil and gravel fill until a hard, cobble layer set into caliche at ca. 30 cm below the original ground surface was encountered in the area. No postholes or other traces of support for a stairway were found within this area. A profile of the south wall of this test unit is on file at the Center for Archaeological Research.
