AN ARCHAEOLOGICAL AND HISTORICAL
ASSESSMENT OF THE
VISTA VERDE SOUTH PROJECT,
SAN ANTONIO, TEXAS

Center for Archaeological Research
The University of Texas at San Antonio
Archaeological Survey Report, No. 156

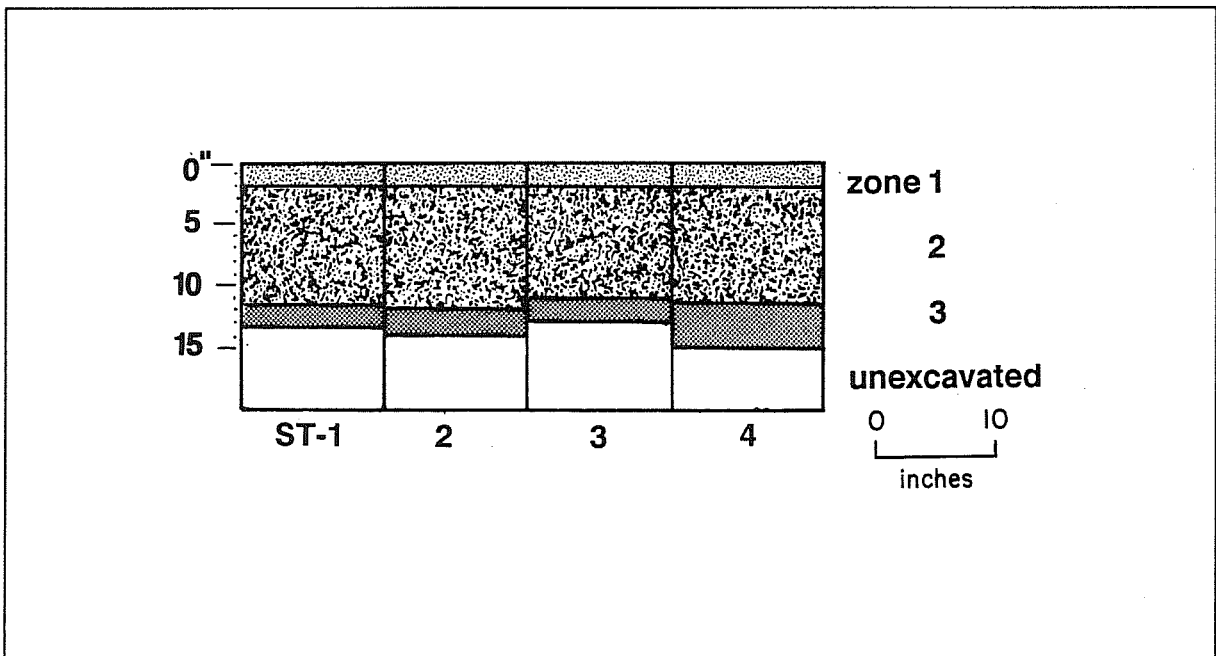
Figure 21. Composite Soil Profile for Shovel Tests 1-4, NCB 280.

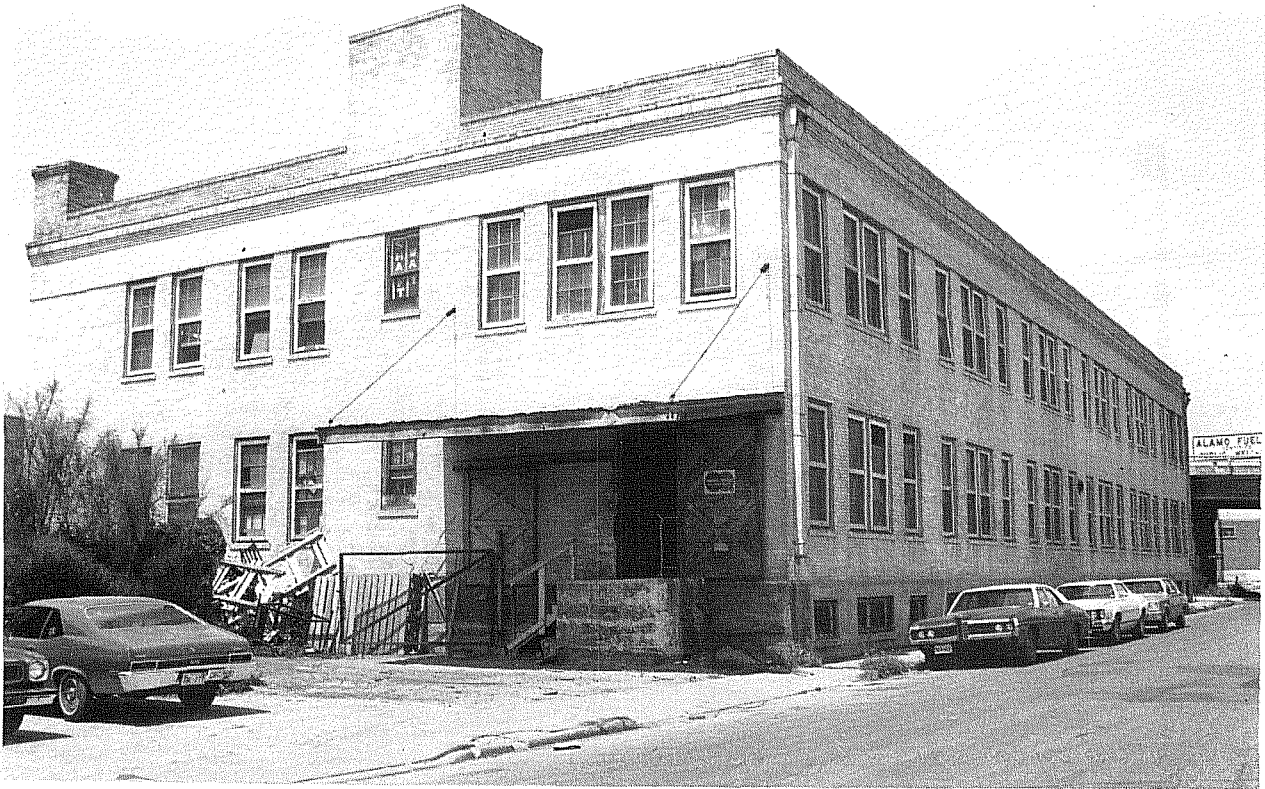
a

Figure 31. Structures at 602 Buena Vista Street and 301-315 South Frio Street. a, 602 Buena Vista Street, Map Reference A (Fig. 14), demolished with SHPO permission; b, 301-315 South Frio Street, Map Reference B (Fig. 14), demolished with SHPO permission.

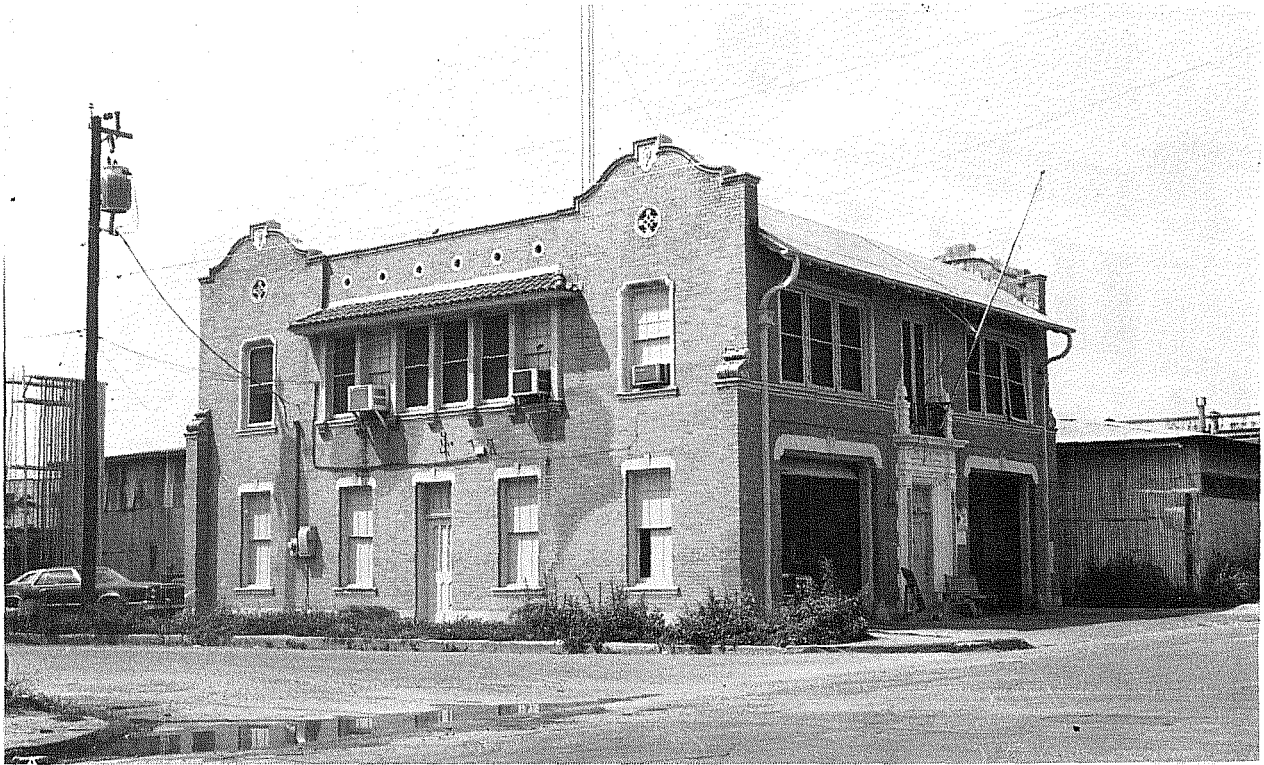
a

Figure 32. Structures at 323 South Frio Street and 427-441 South Frio Street. a, 323 South Frio Street, Map Reference C (Fig. 14), standing August 1, 1985; b, 427-441 South Frio Street, Map Reference D (Fig. 14), demolished with SHPO permission.

French doors above (DeLara-Almond Architects, Inc. 1981). This structure is shown in the appendix (Fig. 32,a). Both of the buildings on NCB 267 had been previously surveyed by the Texas Historical Commission and the City of San Antonio in 1977.

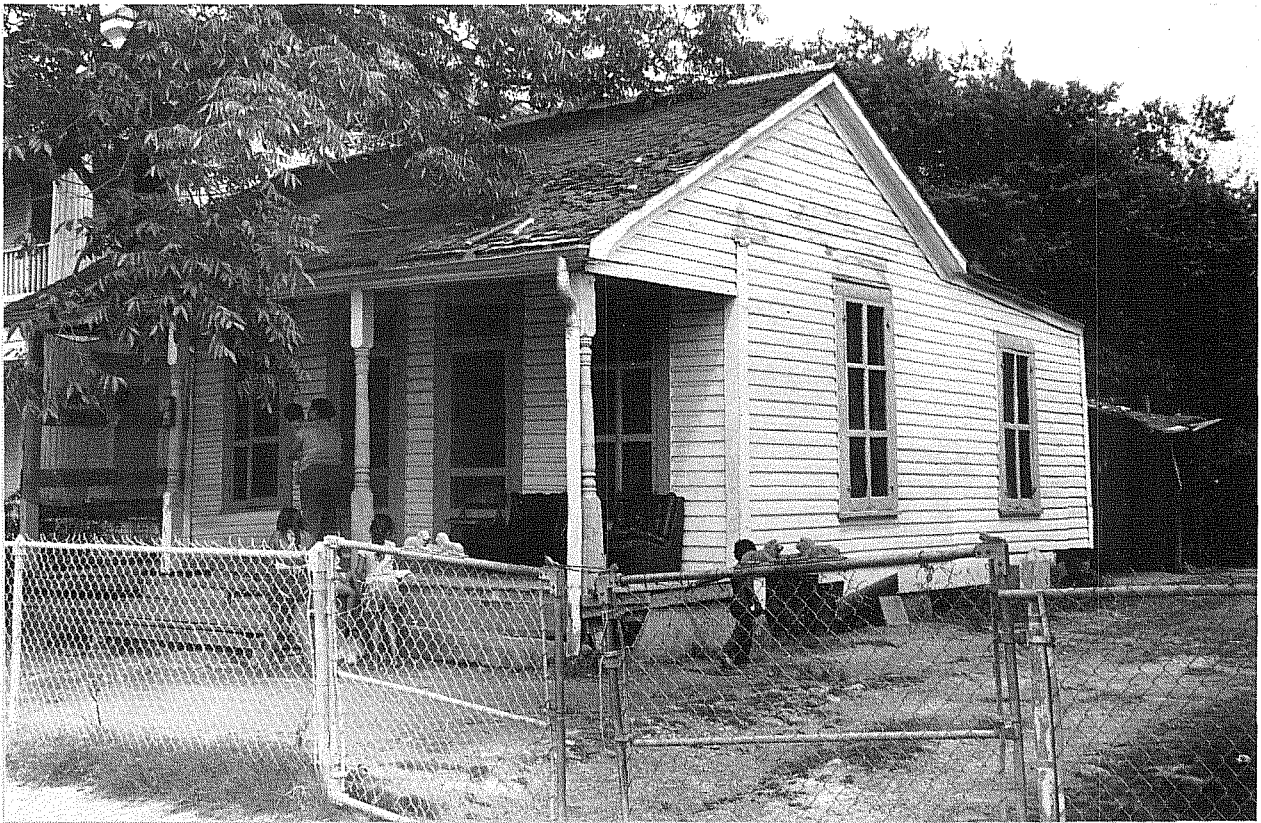
b

Figure 33. Structures at 701 South Leona Street and 514 South Frio Street. a, 701 South Leona Street, Map Reference G (Fig. 14), standing August 1, 1985; b, 514 South Frio Street, Map Reference H (Fig. 14), moved off original site.

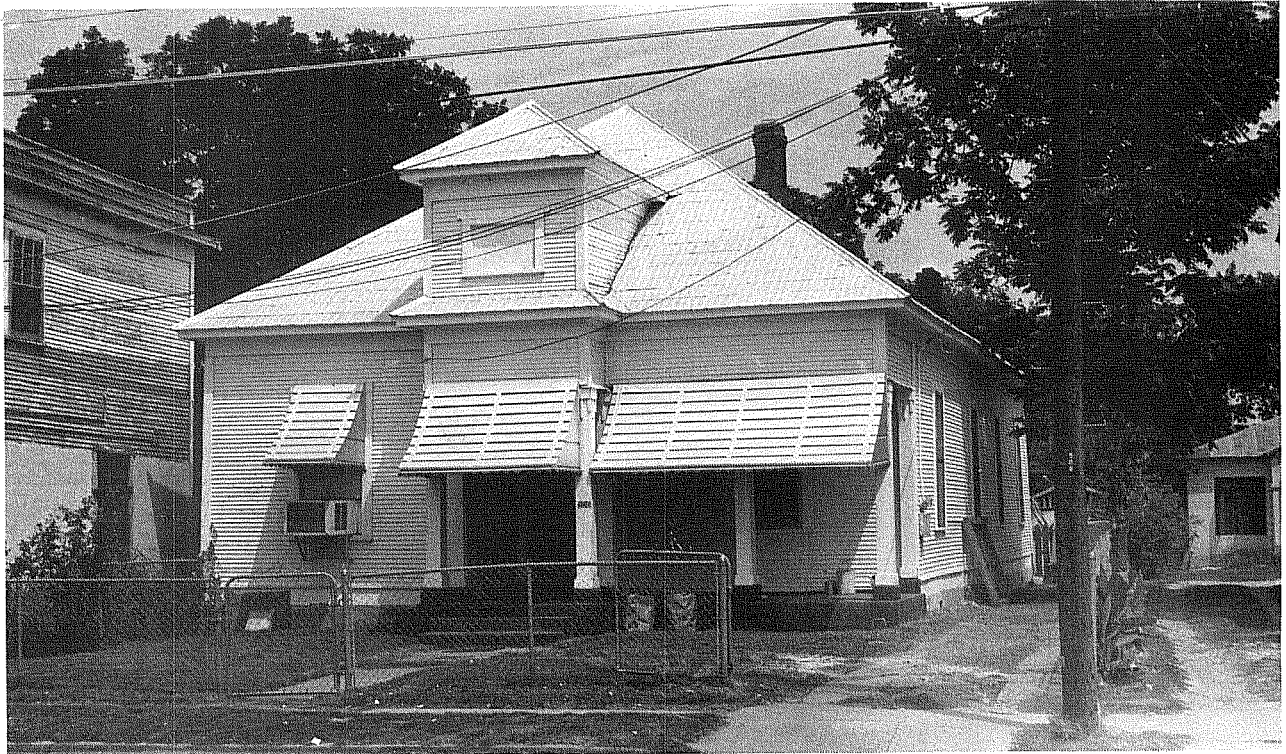
a

Figure 34. Structures at 508 South Frio Street and 208 South Leona Street. a, 508 South Frio Street, Map Reference I (Fig. 14), moved off original site; b, 208 South Leona Street, Map Reference J (Fig. 14), moved off original site.

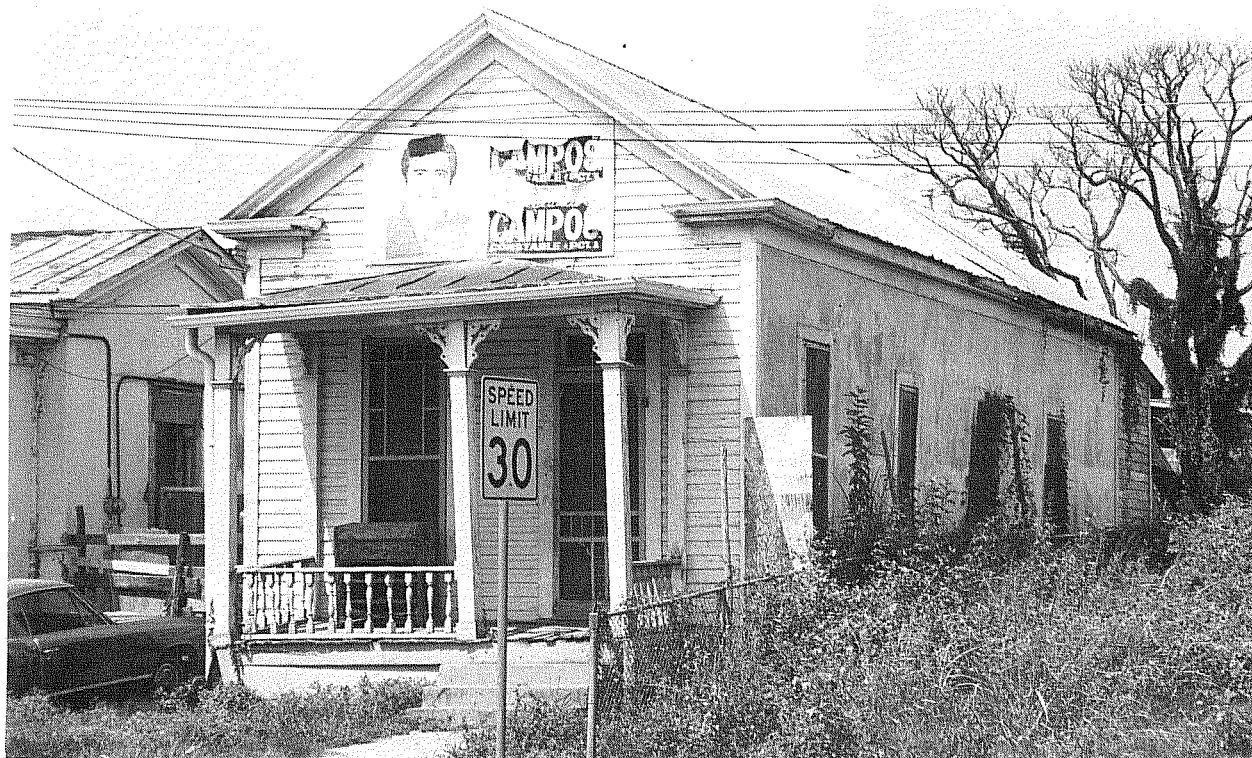
a

Figure 35. Structures at 209 South Pecos Street and 211 South Pecos Street. a, 209 South Pecos Street, Map Reference K (Fig. 14), moved off original site; b, 211 South Pecos Street, Map Reference L (Fig. 14), demolished with SHPO permission, 1983.

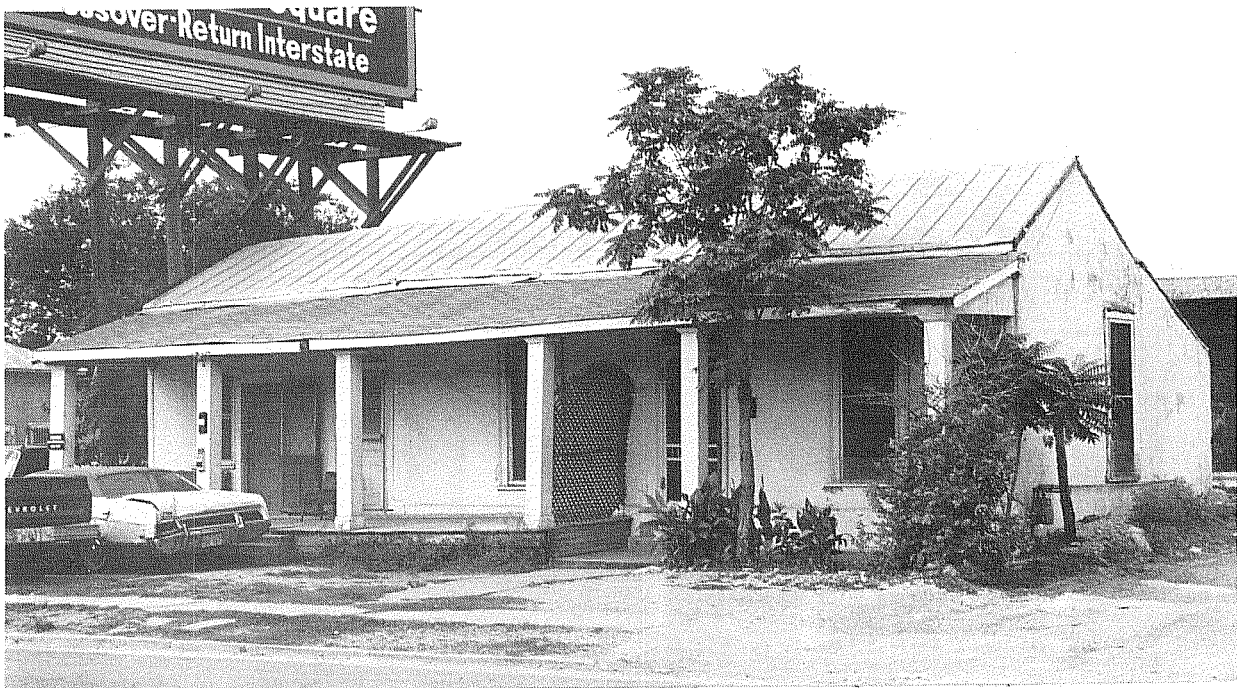
a

Figure 36. Structures at 213 South Pecos Street and 420 Matamoras Street. a, 213 South Pecos Street, Map Reference M (Fig. 14), demolished 1983 with no documentation; b, 420 Matamoras Street, Map Reference N (Fig. 14), demolished 1985 after documentation.

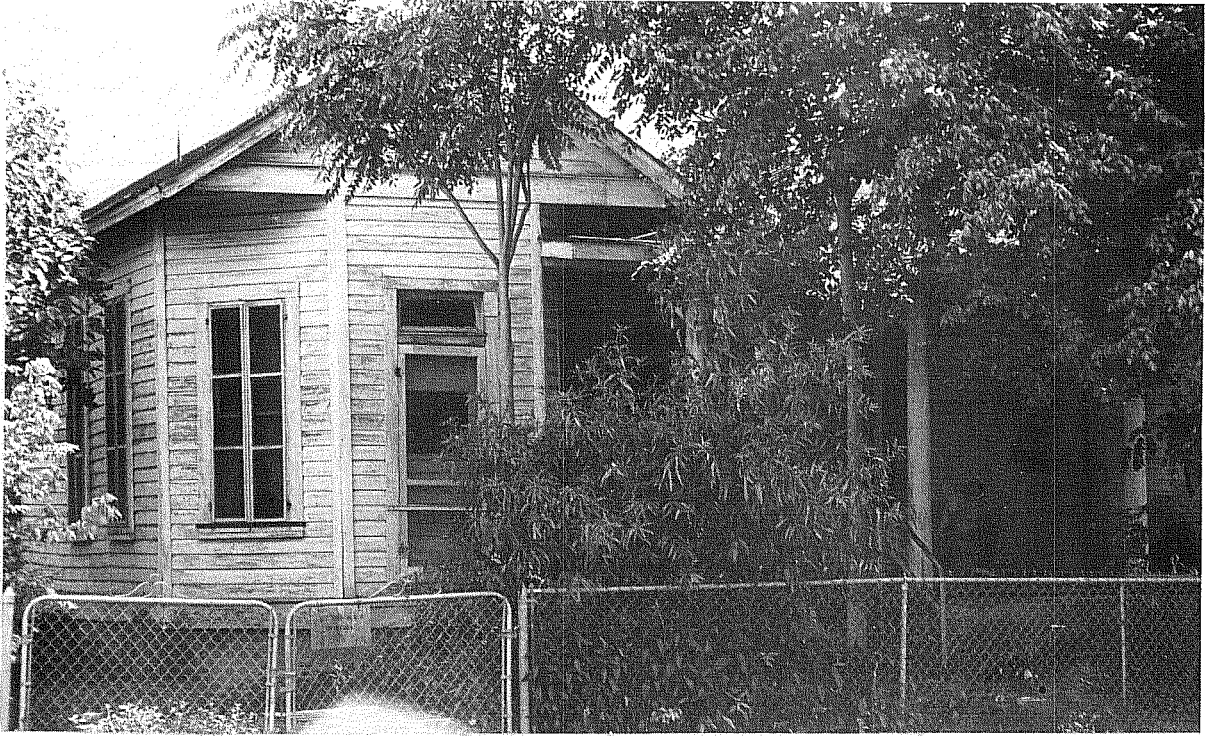
a

Figure 37. Structures at 416 Matamoras Street and 401 South Pecos Street. a, 416 Matamoras Street, Map Reference O (Fig. 14), demolished 1985 after documentation; b, 401 South Pecos Street, Map Reference P (Fig. 14), demolished 1985 after documentation (also listed as 402-1/2 South Pecos Street in DeLara-Almond Architects, Inc. [1981] report).

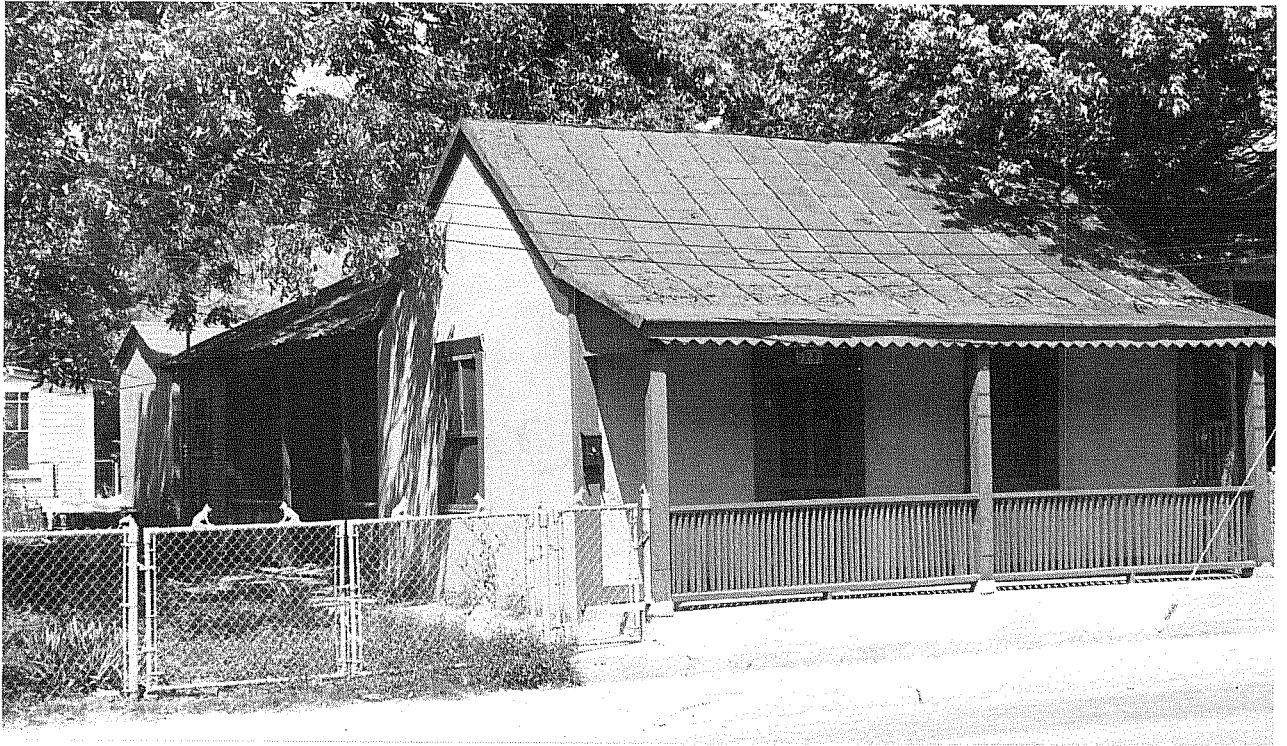
a

Figure 39. Structures at 721 South Pecos Street and 324 El Paso Street. a, 721 South Pecos Street, Map Reference S (Fig. 14), standing August 1, 1985; b, 324 El Paso Street, Map Reference T (Fig. 14), standing August 1, 1985.
