Archaeological and Historical Investigations at the Alamo North Wall San Antonio, Bexar County, Texas

James E. Ivey and Anne A. Fox

Center for Archaeological Research
The University of Texas at San Antonio
Archaeological Survey Report, No. 224

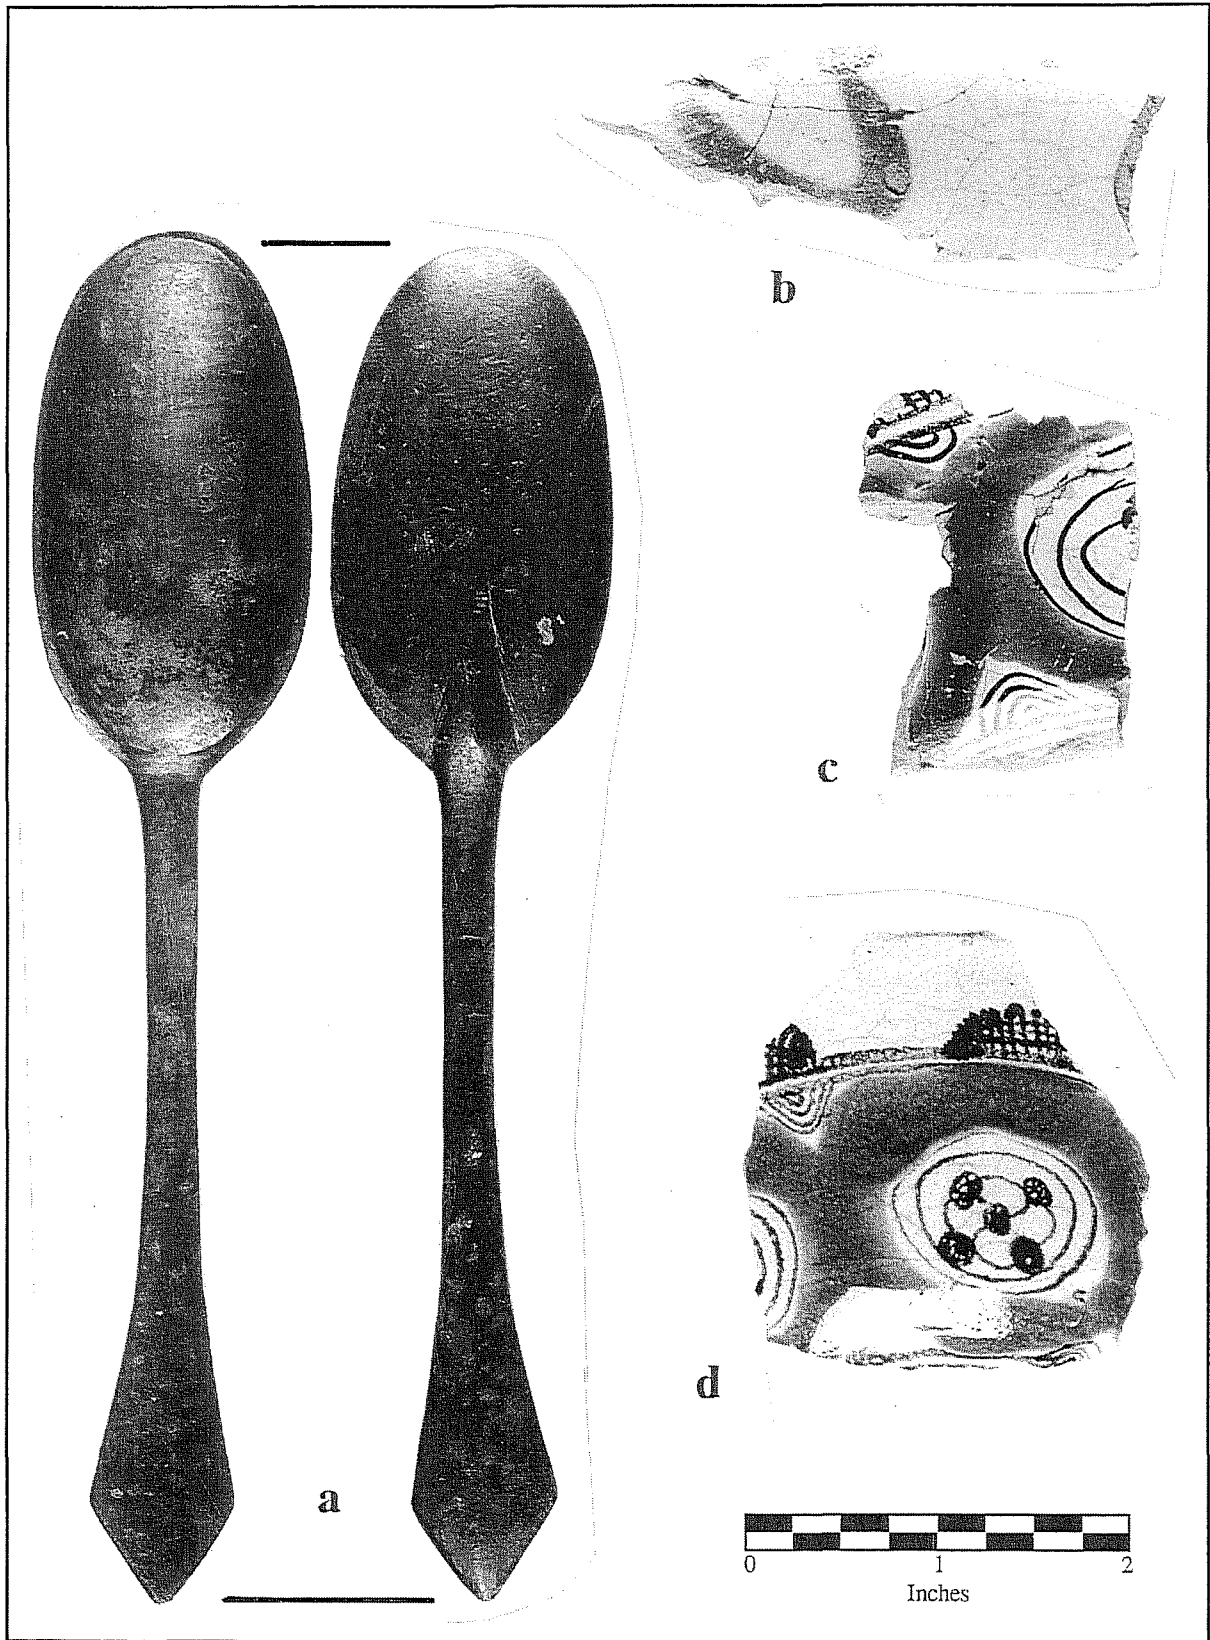
Figure 13. *Artifacts from the acequia.* a-cast copper spoon with pewter plating; b- green-on-cream majolica bowl sherd; c-Puebla Polychrome majolica sherd; d-Puebla Polychrome majolica bowl sherd.

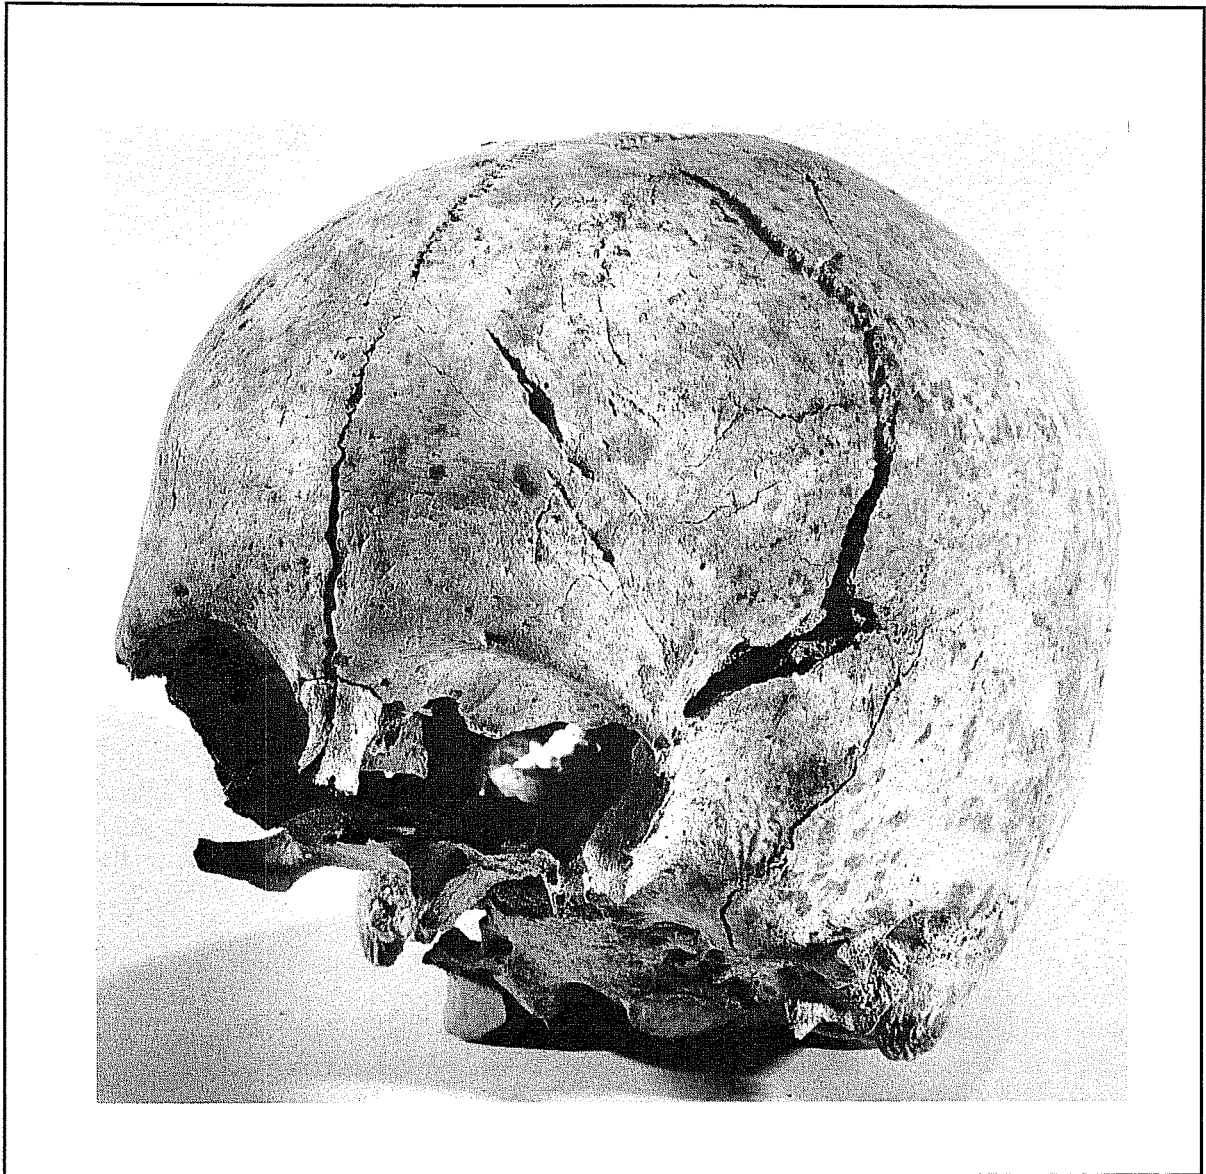
Figure 16. *The Alamo skull*. Shown approximately three-quarter size.

The skull, then, may have belonged to someone who died immediately after being slashed several times by a heavy-bladed weapon a few months before his skull was dumped into a defensive ditch of the Alamo on May 22. From February 23 through March 6, two and a half to three months before that date, a large number of young men of this same age all died violent deaths, many of them the victims of, among other things, heavy-bladed weapons. It would be, we think, an extreme improbability for these two occurrences to have been without connection. As far as we can tell, the skull is that of a participant in the Battle of the Alamo.
