The Alamo Restoration and Conservation Project: Excavations at the South Transept

*Center for Archaeological Research
The University of Texas at San Antonio
Archaeological Survey Report, No. 245*

Texas Antiquities Committee Permit No. 1503

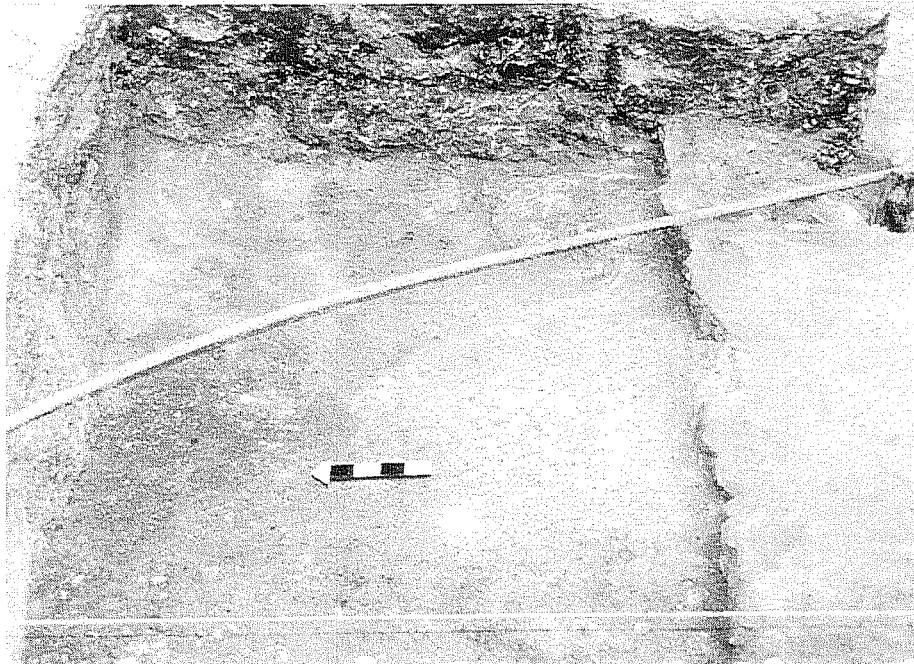
Figure 27. *Area A, looking east, with rubble foundation shown on the right side. The foundation of the west wall of the south transept is at the top.*

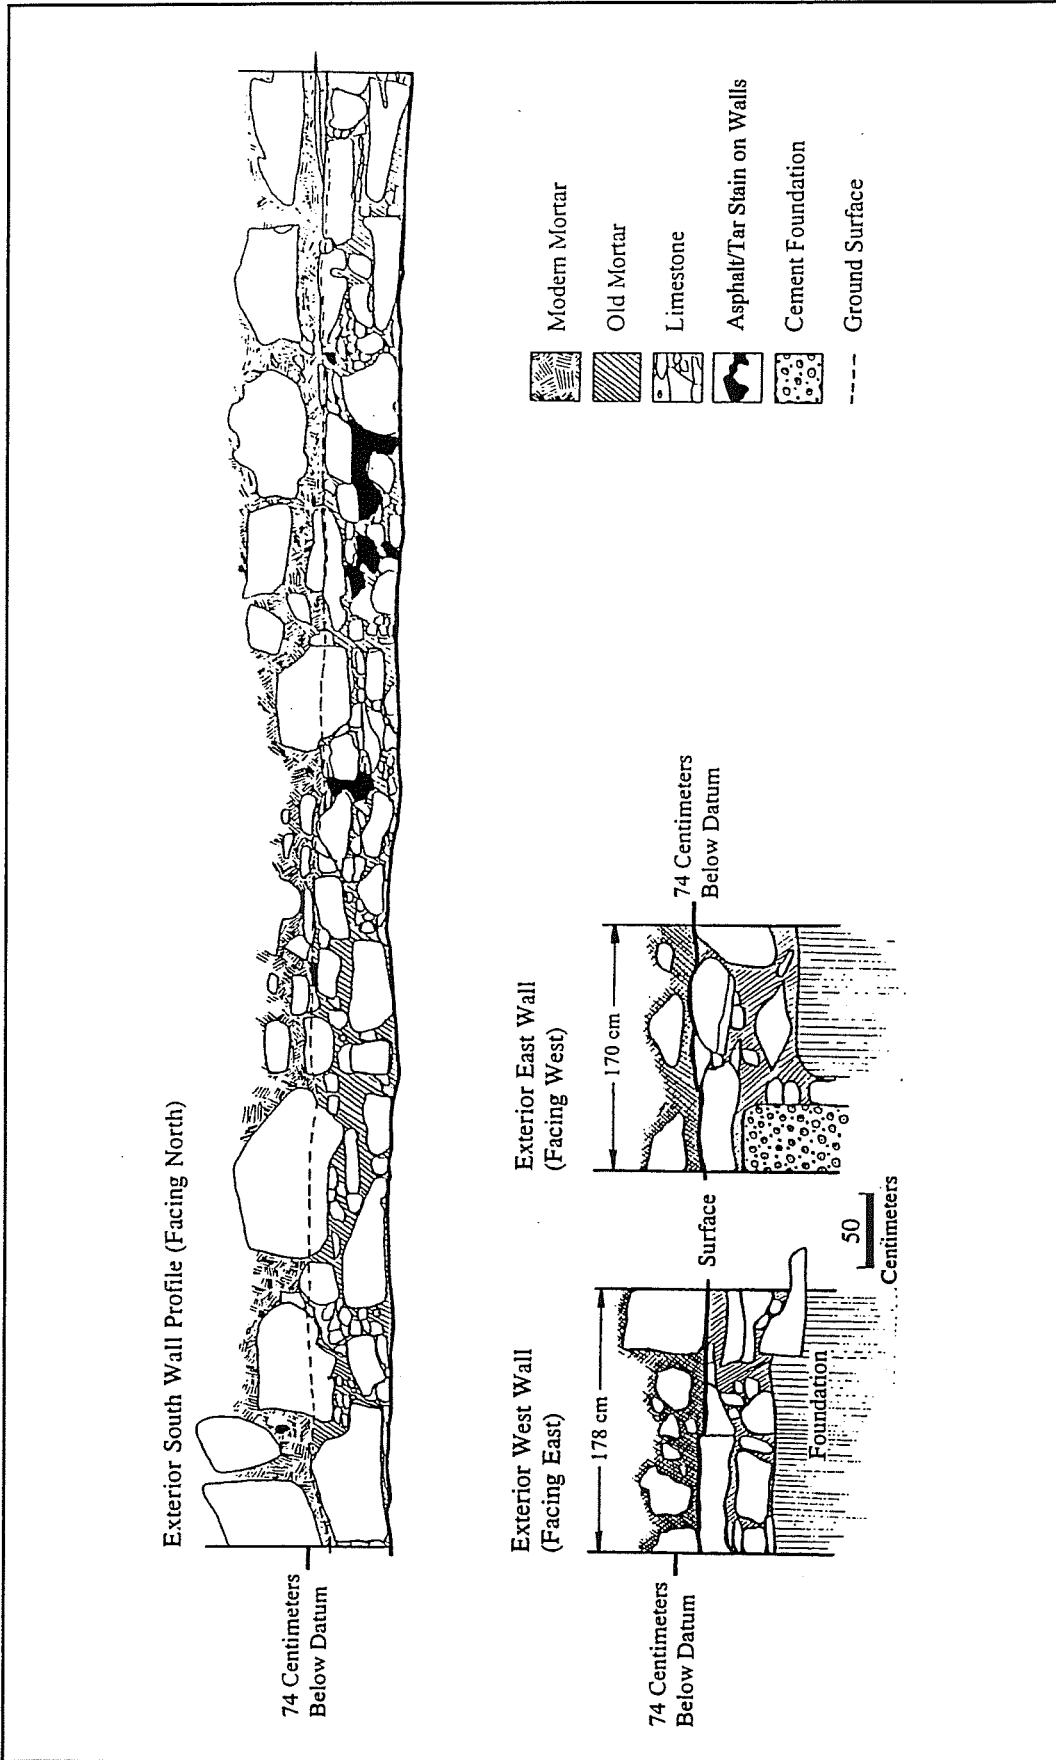
Figure 36. Drawing of the exterior lower walls of the south transept, above the foundation stones.

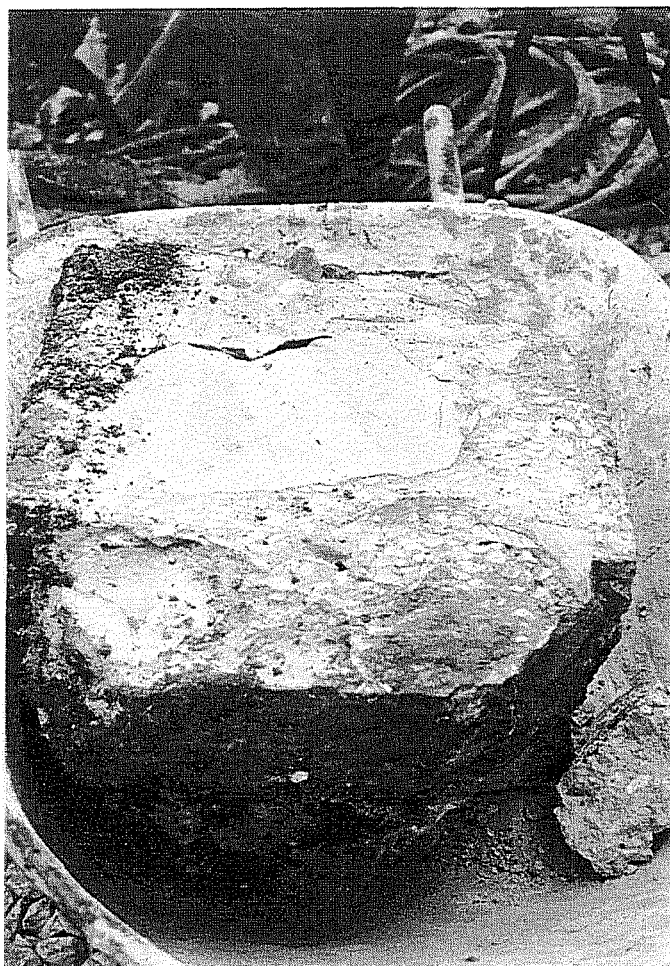
Figure 42. *Portion of concrete foundation in a wheelbarrow, during removal, showing cut face. The foundation was 46 cm across. Note the large chunks of limestone.*

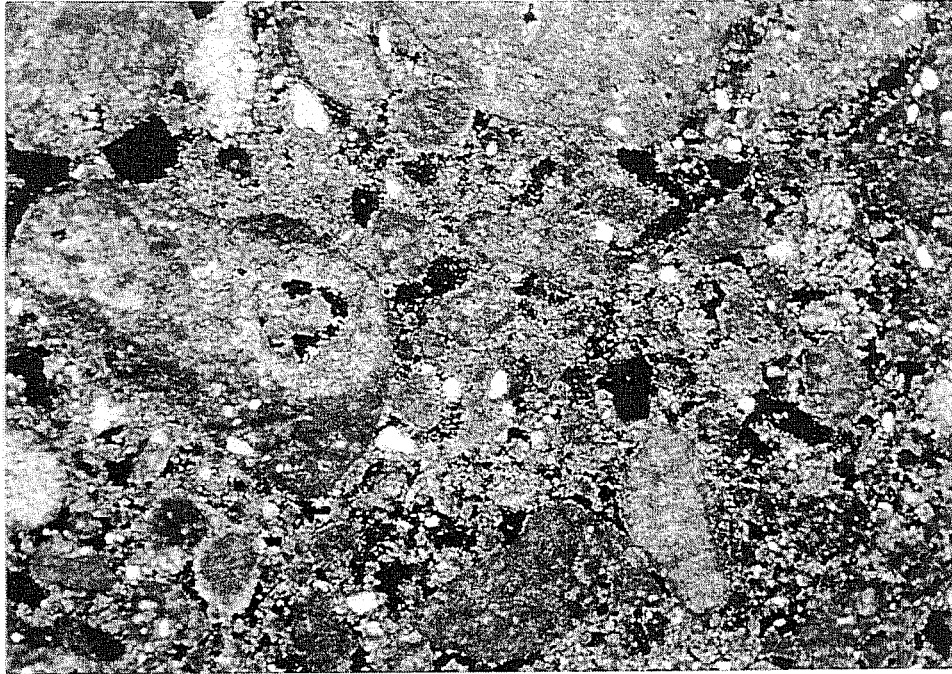
Figure A6. Detail of Figure A5, shows calcined nature of the clasts.
