San Antonio Mission Trails Statewide Transportation Enhancement Project Volume II Construction Packages 2 and 3: Archaeological Testing and Monitoring Construction of the Mission Trails Hike and Bike Trails, City of San Antonio, Bexar County, Texas

**San Antonio Mission Trails
Statewide Transportation Enhancement Project**

Volume II
*Construction Packages 2 and 3:
Archaeological Testing and Monitoring Construction
of the Mission Trails Hike and Bike Trails,
City of San Antonio, Bexar County, Texas*

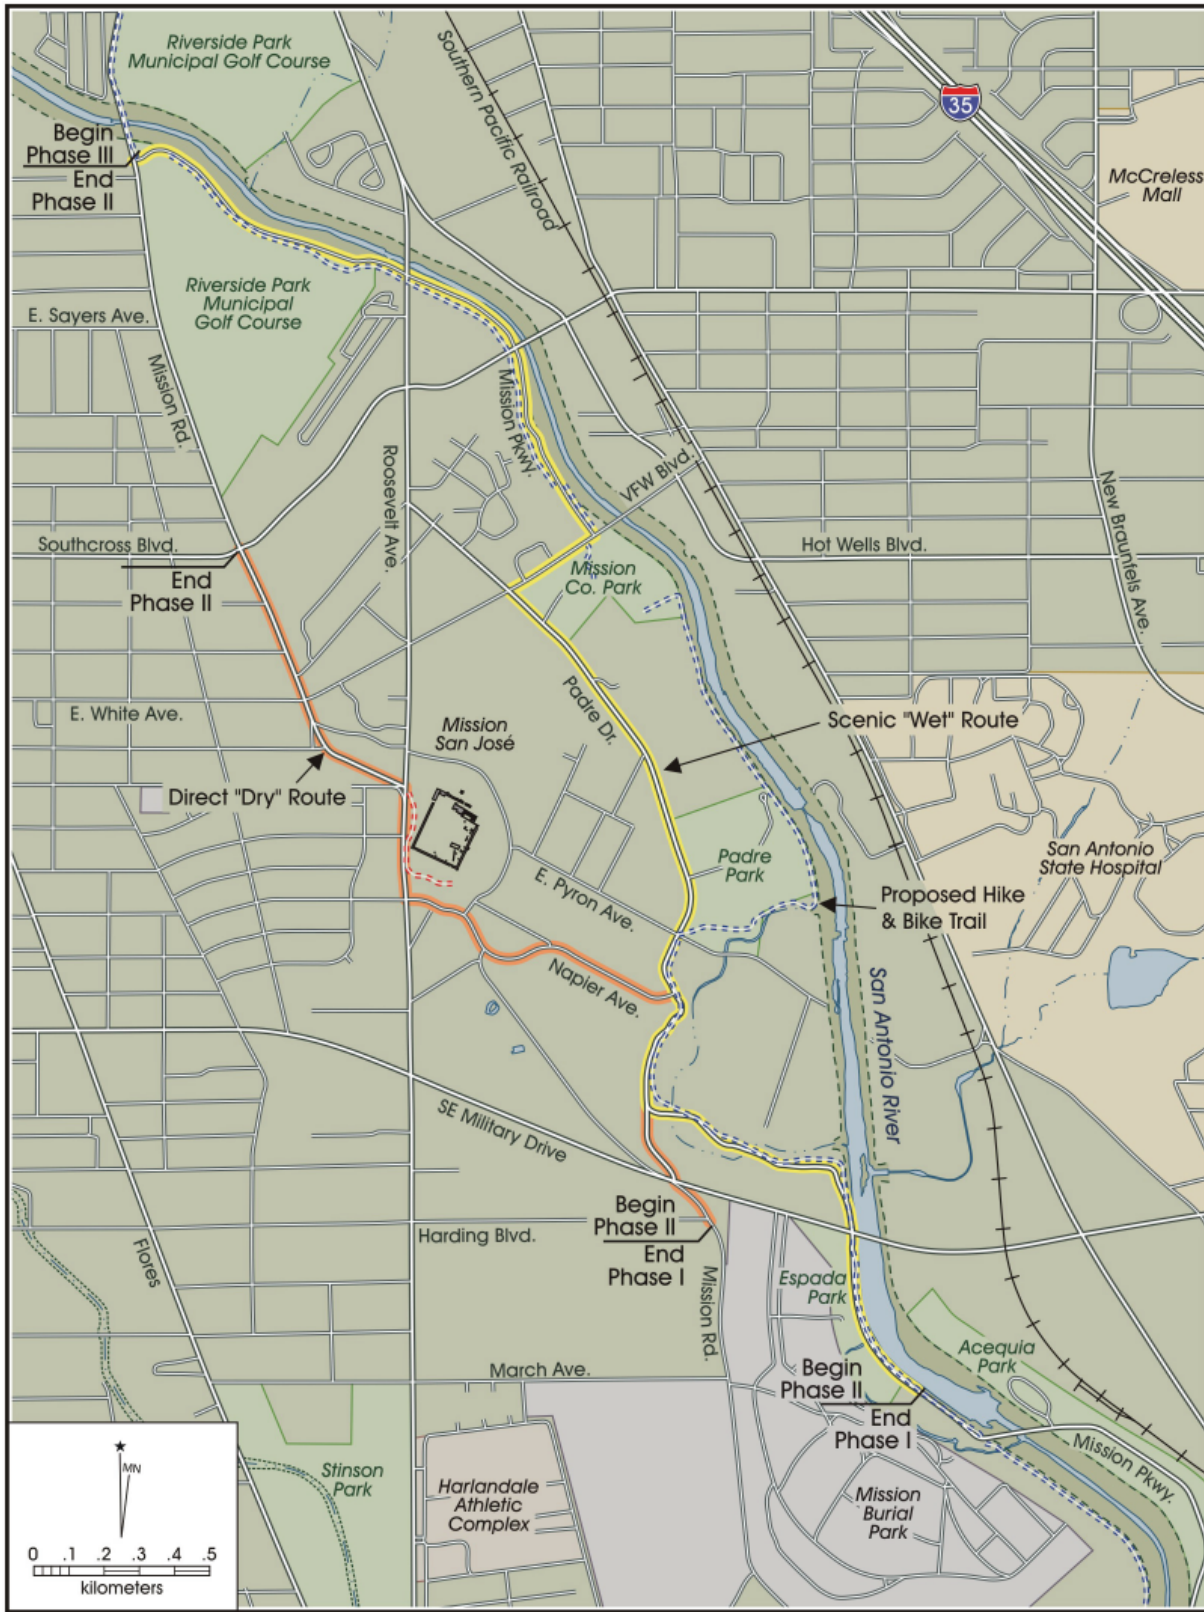
Figure 1-4. Map of Scenic and Direct routes of the Mission Trails project covered by Construction Package 2, showing Areas of Concern.

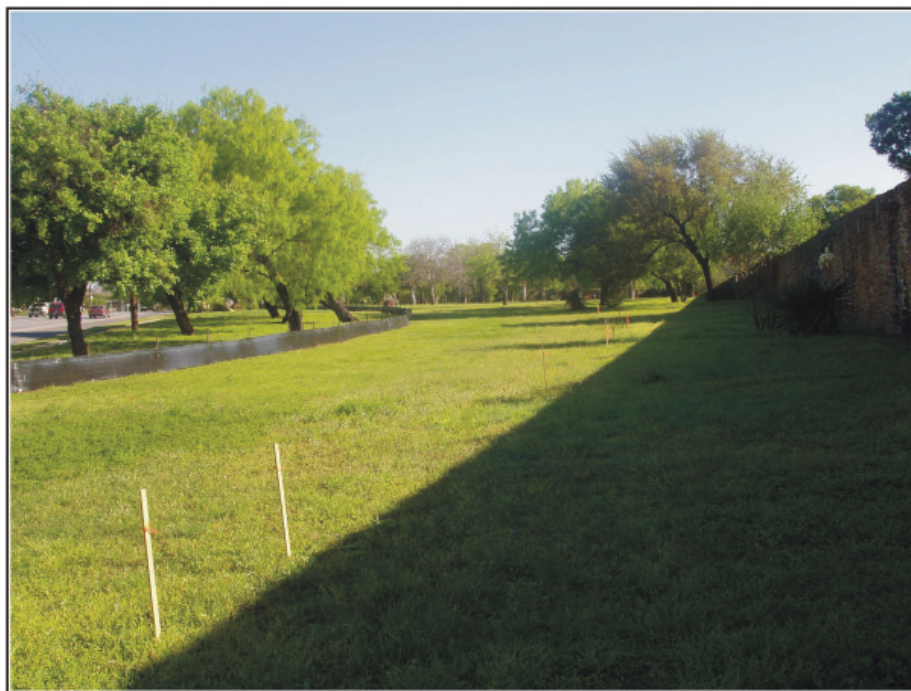
Figure 1-7. View of area between west wall of Mission José and Roosevelt Avenue in 2002, with footprint of new hike and bike trail staked (looking north).

hike and bike trail turns north running for approximately 200 m between the mission’s west wall and Roosevelt Avenue (Figure 1-7). The areas near the south and west walls of Mission San José have been surveyed and tested by

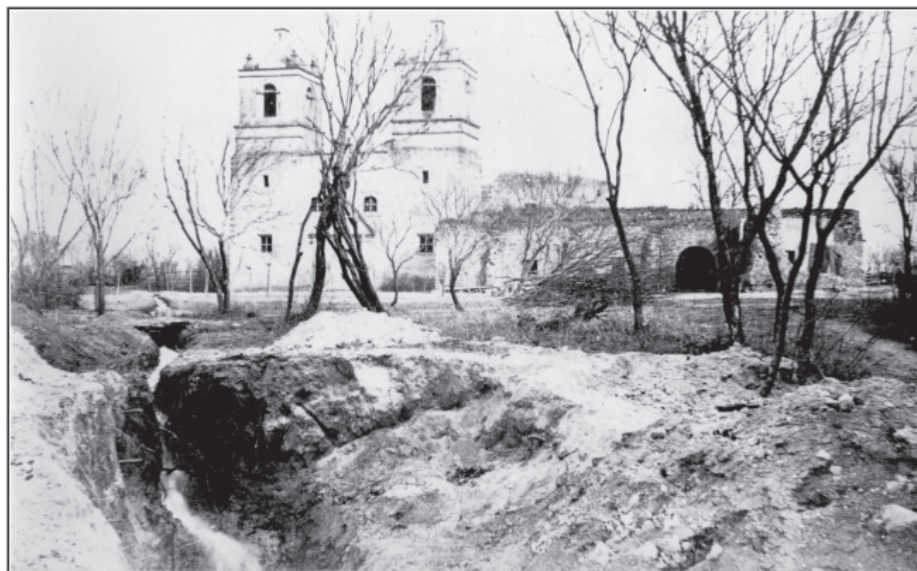
Figure 2-3. Photograph of Mission Concepción probably taken in the late nineteenth century, showing a new acequia crossing the old mission compound.

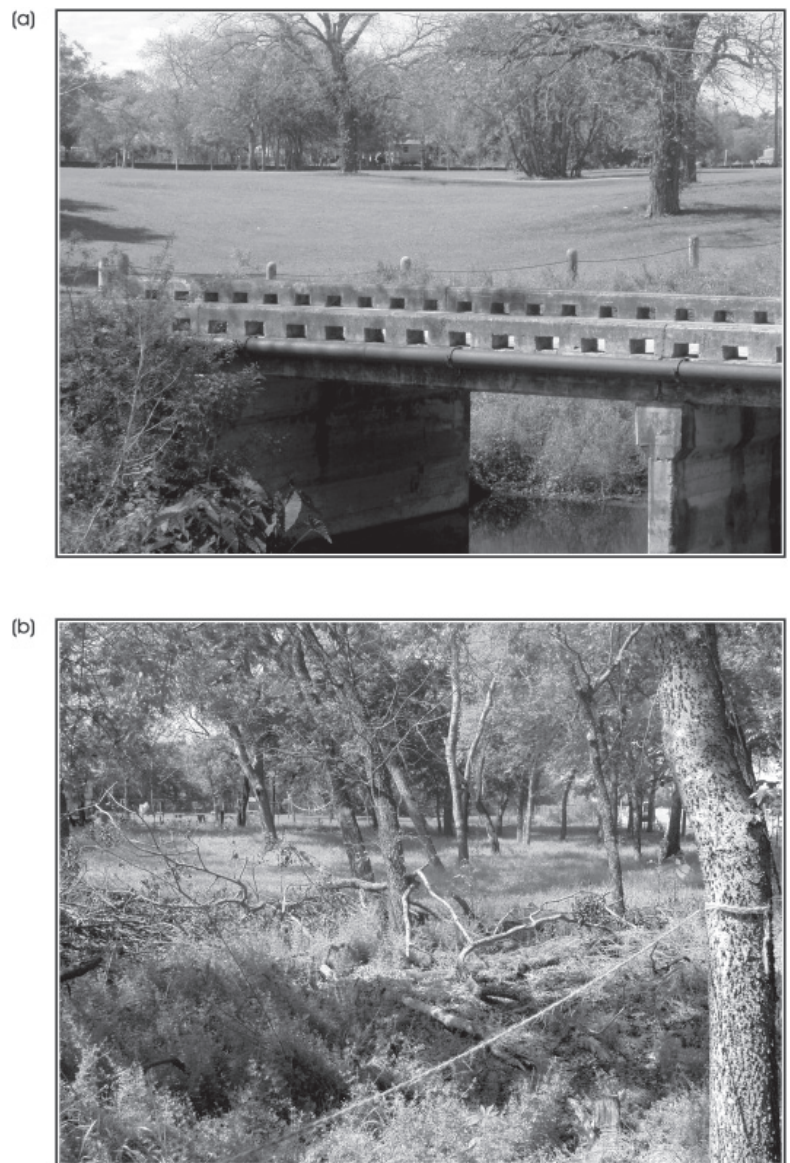
Figure 4-1. *The remnants of the acequia near Padre Drive: (a) the Pyron Avenue bridge, looking northwest, where the acequia can be seen as a swale extending from the old river channel and running just left of the clump of trees in the right middle foreground; (b) The acequia remnant on the west side of Padre Drive as it turns north.*

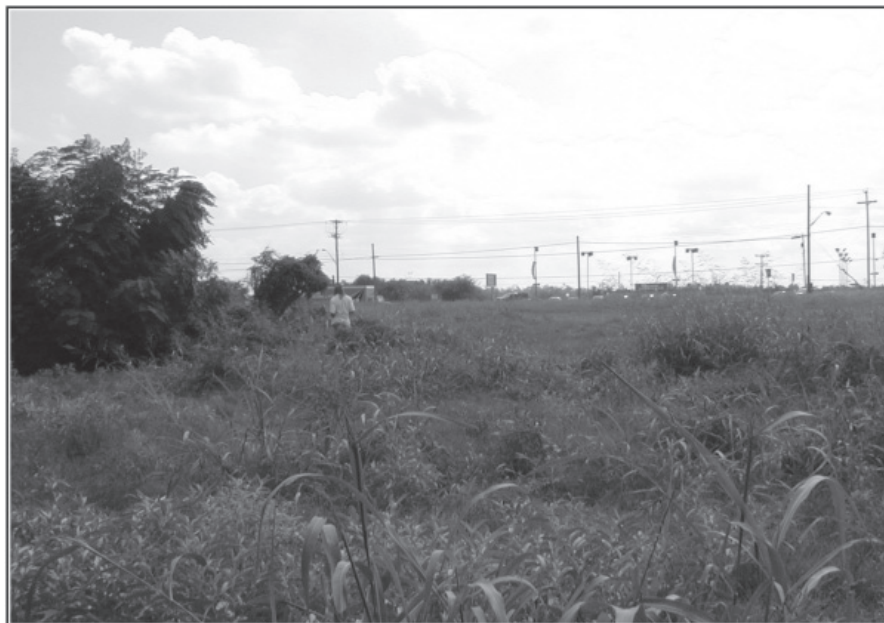
Figure 4-6. *The Pyron Homestead, showing dense vegetation.*

The foundations of the Pyron Homestead are outside the project area. The planned extension of Padre Drive does pass through the homestead property (Cox 1992), however. The ground surface along the ROW was overgrown, decreasing ground surface visibility to zero (Figure 4-6).

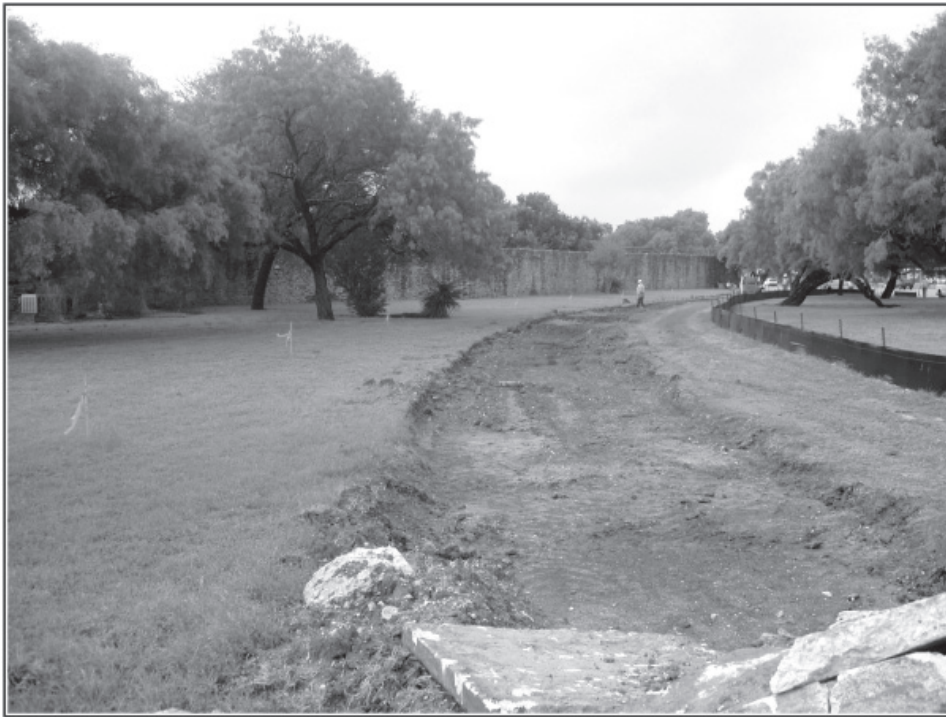
Figure 4-13. Area monitored during construction of the hike and bike trail.

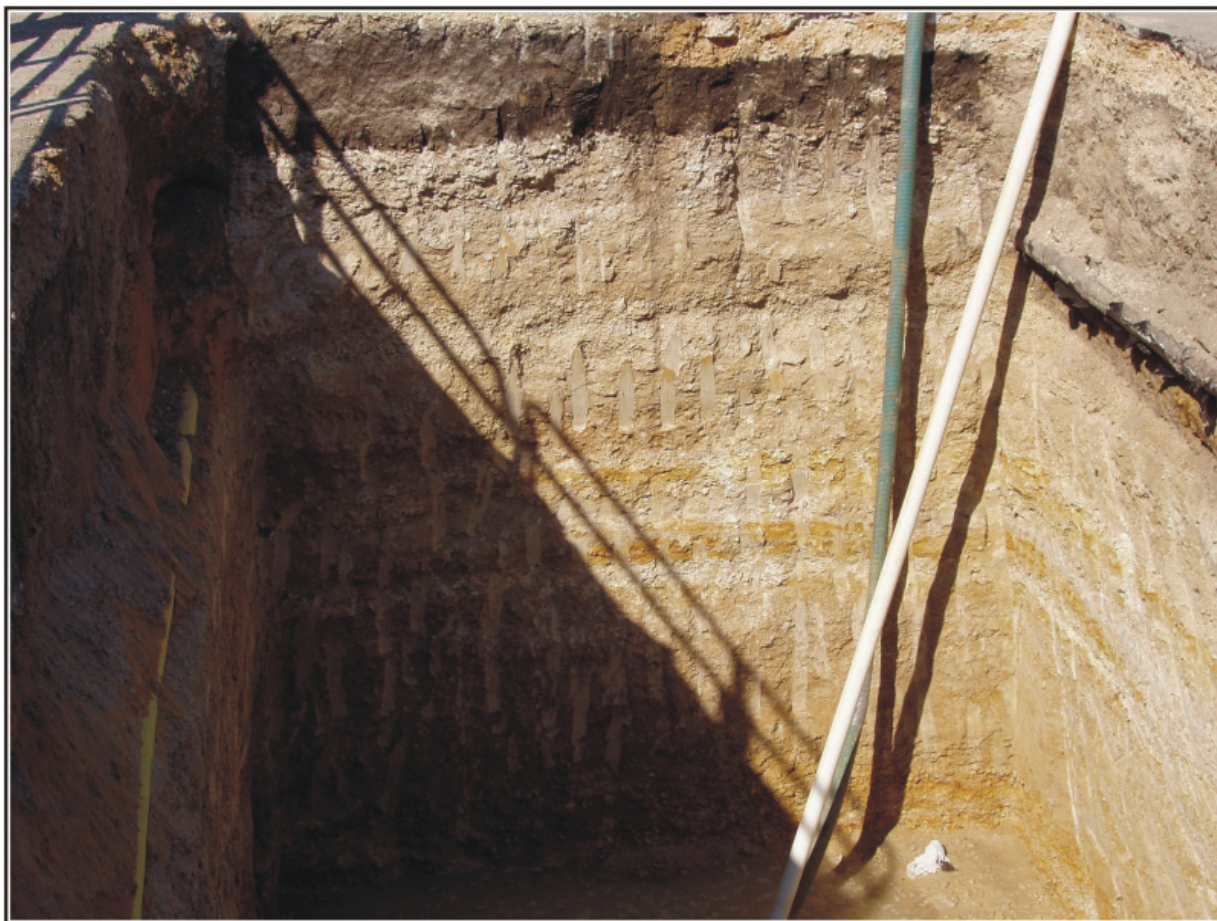
Figure 4-15. Deep pit dug in E. White Avenue west of Mission Road at the time archaeologists arrived at the site.

along both sides of Mission Road to Southcross. Sediments along Roosevelt were generally disturbed from about 0.5 to 1 m below ground surface. All showed a profile very similar to that seen in the large pit on E. White (Figure 4-15), except

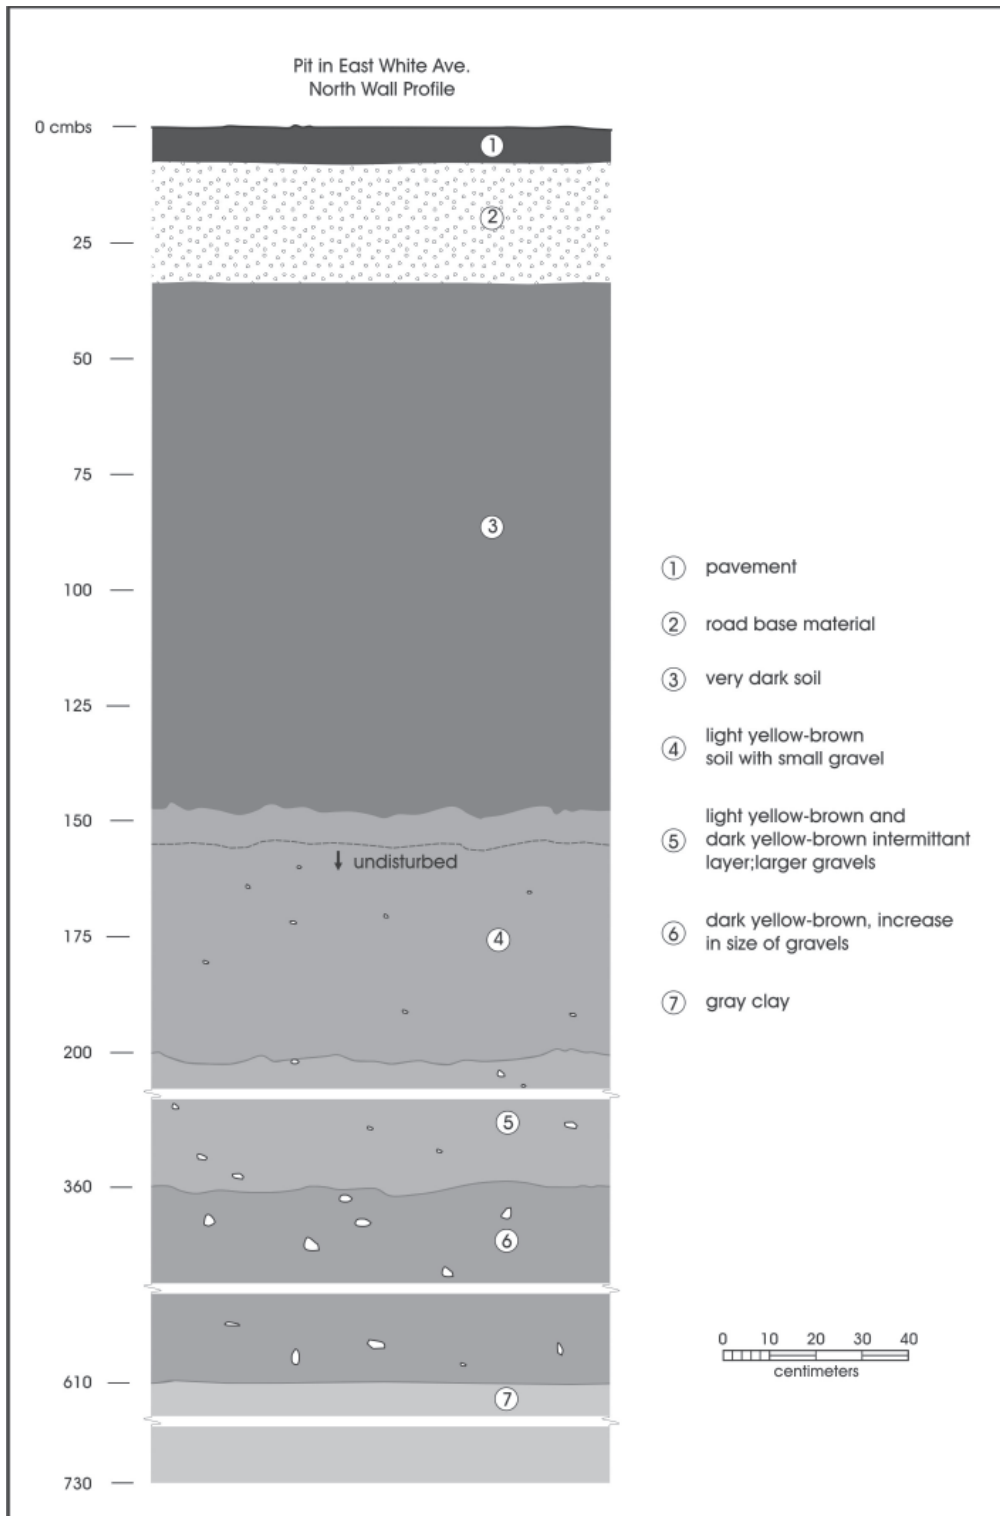
Figure 4-16. Profile of north wall of large pit in E. White Avenue just north of Mission Road.

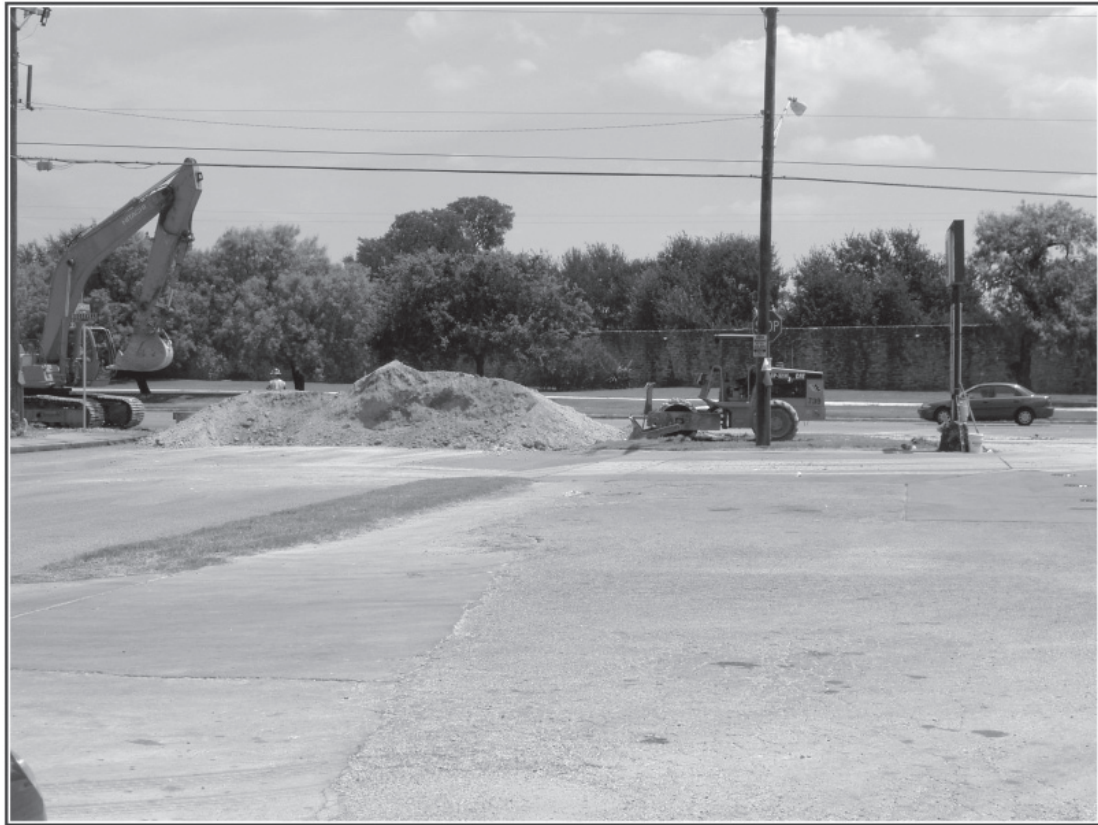
Figure 4-17. Monitoring utility placement on Roosevelt Avenue, looking northeast, with west wall of Mission San José in background.

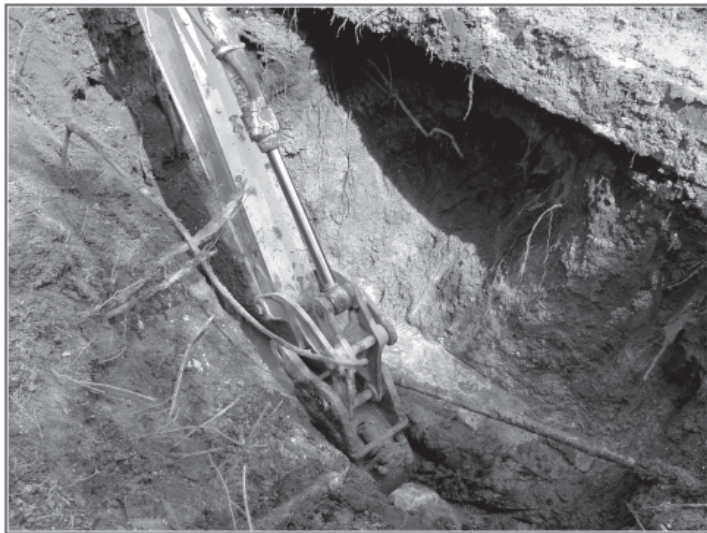
Figure 4-18. Backhoe digging below Mission Road, showing degree of previous disturbance in trench.

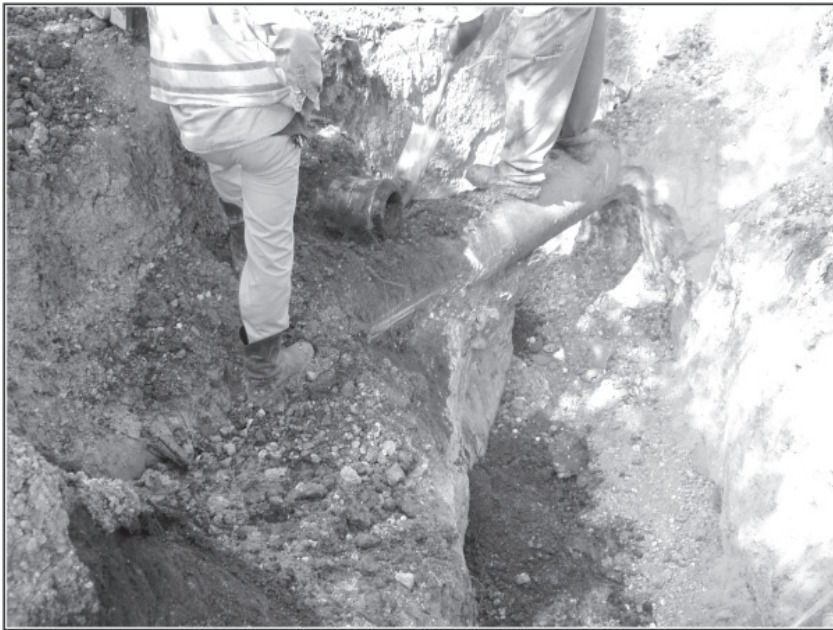
Figure 4-19. Working around old utility lines in a trench on Mission Road near E. White Avenue.

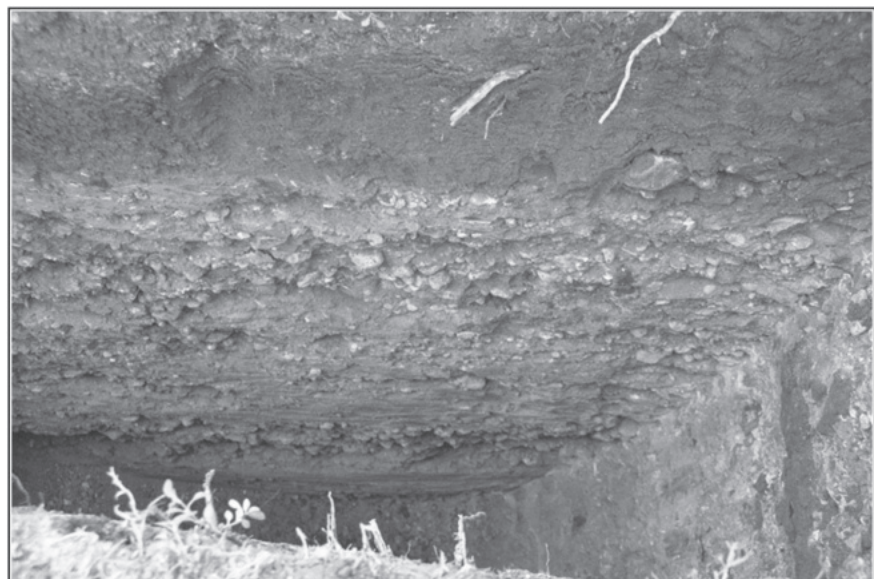
Figure 4-23. Photograph of the south wall of Trench B, showing layers of modern fill.

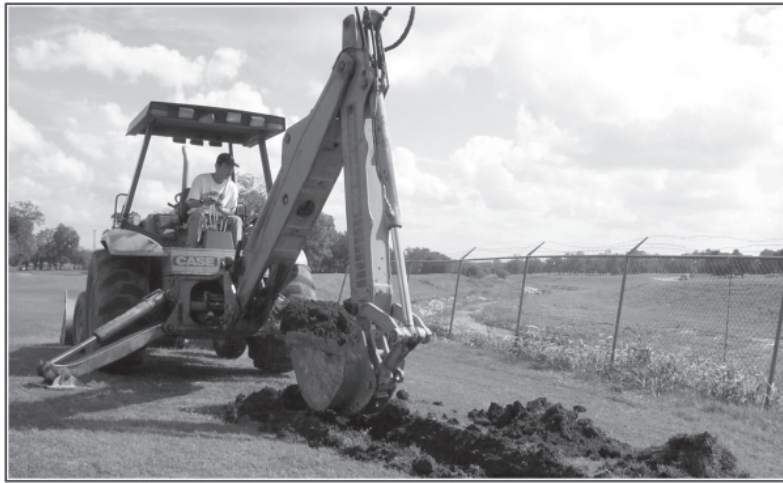
Figure 4-24. Digging Trench C on the north bank of the San Antonio River, near the Mission Road Bridge. Looking southeast.

Trench C was located about 6 m north of the fence that protects golfers from the steep drop to the river (Figure 4-24) above the eighteenth tee. The trench was 3.4 m long and 3.8

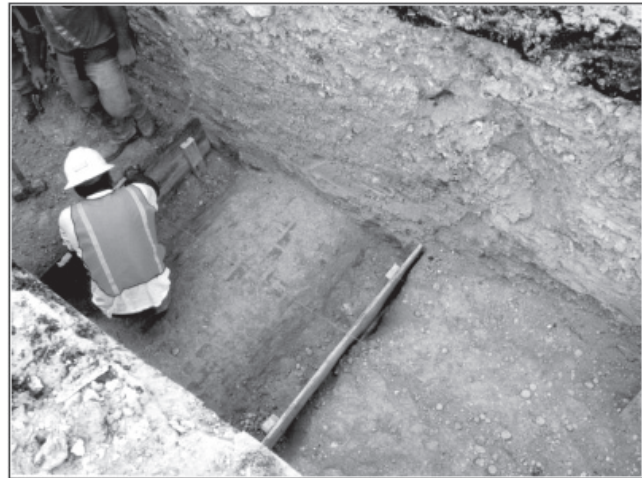
Figure 4-28. Nineteenth century brick sewer line, probably built into the old Concepción/Pajalache acequia ca. 1895-1897.

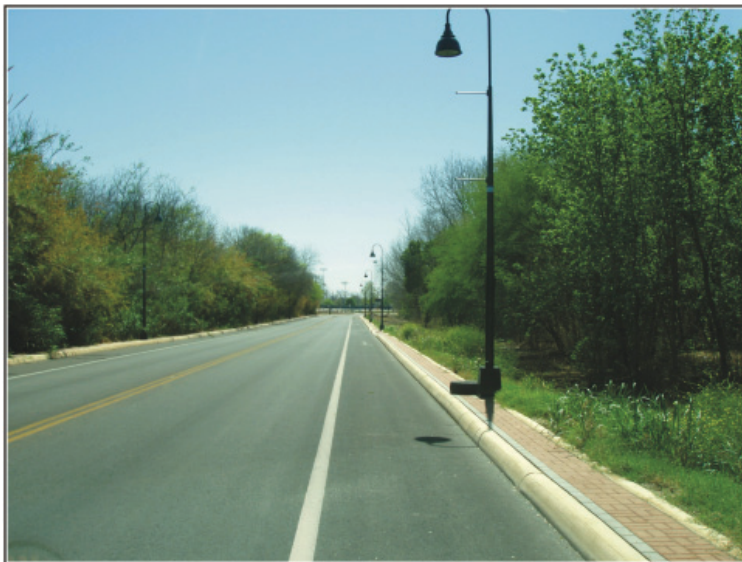
Figure 5-1. The new hike and bike trail along Padre Road.

Beginning in October 1998, the Center for Archaeological Research provided archival research and archaeological services to the City of San Antonio for the Texas Department of Transportation as part of the Mission Trails Statewide Transportation Enhancement Project. The project goals were to create a hike and bike trail system connecting the five Spanish missions in San Antonio and to improve city streets (Figures 5-1, 5-2).

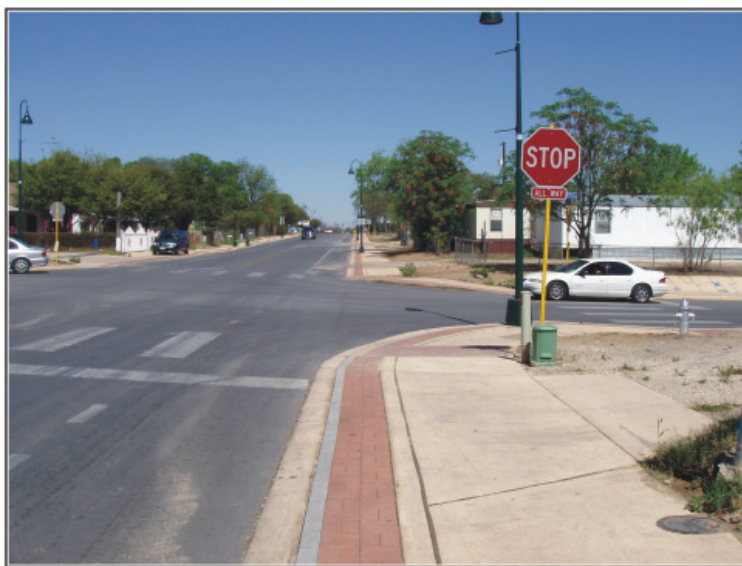
Figure 5-2. The new hike and bike trail at the corner of E. White Avenue and Mission Road.

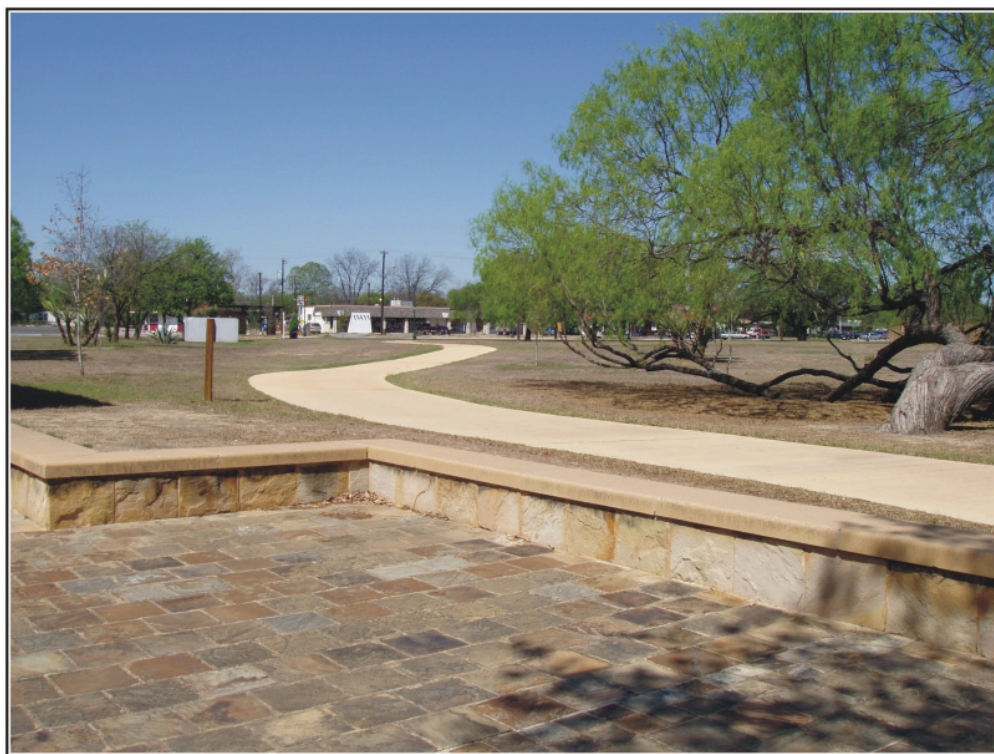
Figure 5-3. The new hike and bike trail south of Mission San José.
