**INTENSIVE LINEAR PEDESTRIAN SURVEY OF CALLAGHAN
ROAD BETWEEN INGRAM AND BANDERA ROADS
AND ALONG ZARZAMORA CREEK,
SAN ANTONIO, BEXAR COUNTY, TEXAS**

ARCHAEOLOGICAL REPORT, No. 372
CENTER FOR ARCHAEOLOGICAL RESEARCH
THE UNIVERSITY OF TEXAS AT SAN ANTONIO
©2007

Texas Antiquities Permit No. 4320

CSJ#s 0915-12-154 and 0915-12-266

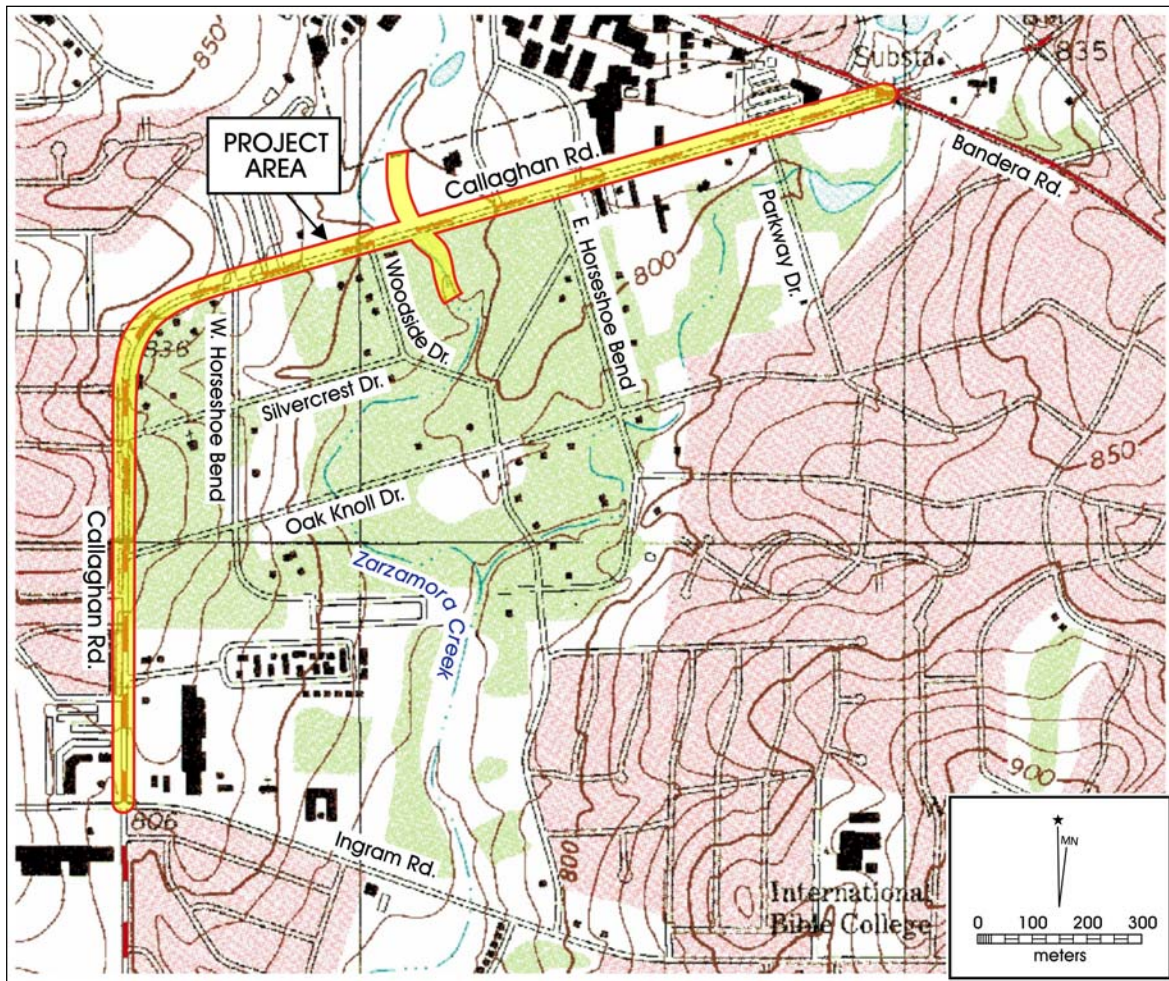
Figure 1. The APE is highlighted on the 1993 San Antonio, West, Texas USGS topographic quadrangle.

The Area of Potential Effect (APE) as described to CAR by HNTB is depicted on the 1993 edition of the San Antonio West, Texas 7.5-minute United States Geological Survey (USGS) topographic quadrangle map (Figure 1). The City of San Antonio plans to add new ROW intermittently to 1.5 miles of Callaghan Road between Ingram and Bandera Roads expanding the existing ROW an additional 1 to 5 m. This primarily concerns the east/south side of Callaghan Road, although plans also show intermittent improvements along the west/north side as well. Construction plans also

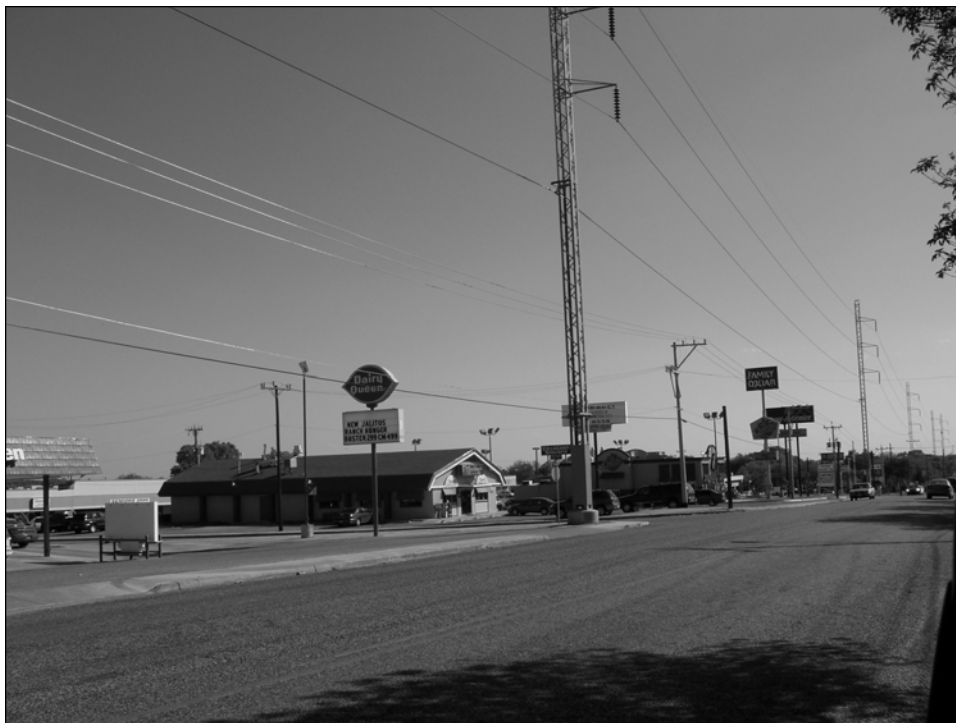
Figure 2. *Between Ingram and Oak Knoll, Callaghan Road is commercially developed and retains little potential for encountering intact cultural or buried deposits.*

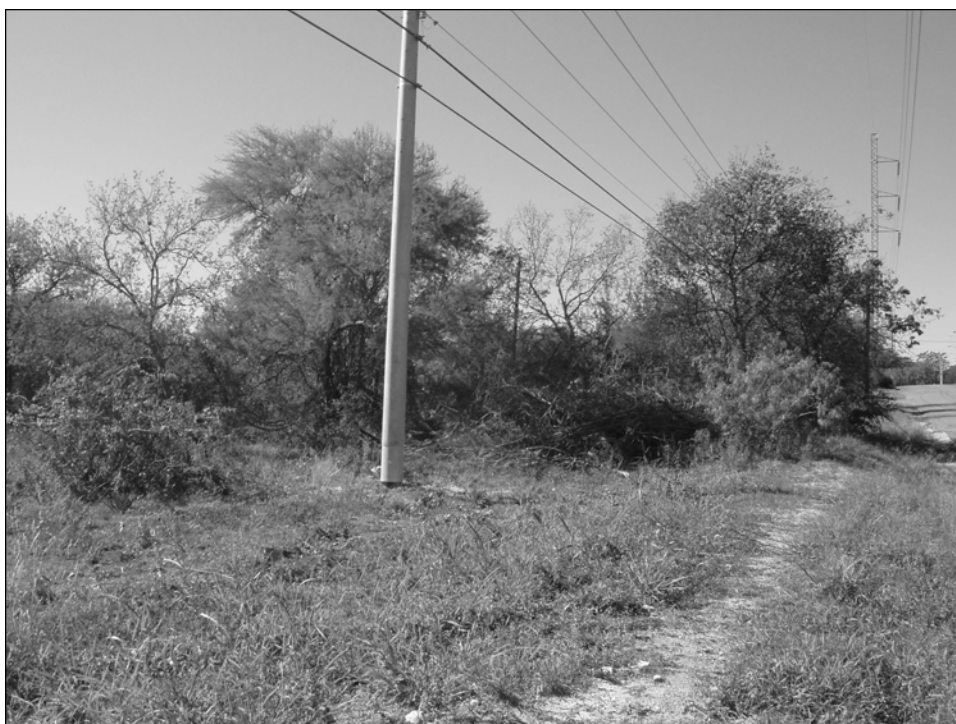
Figure 3. *Sections between Horseshoe Bend East and Oak Knoll have mixed commercial and residential development with more areas available for shovel testing and therefore a greater chance of encountering intact archaeological deposits exists.*

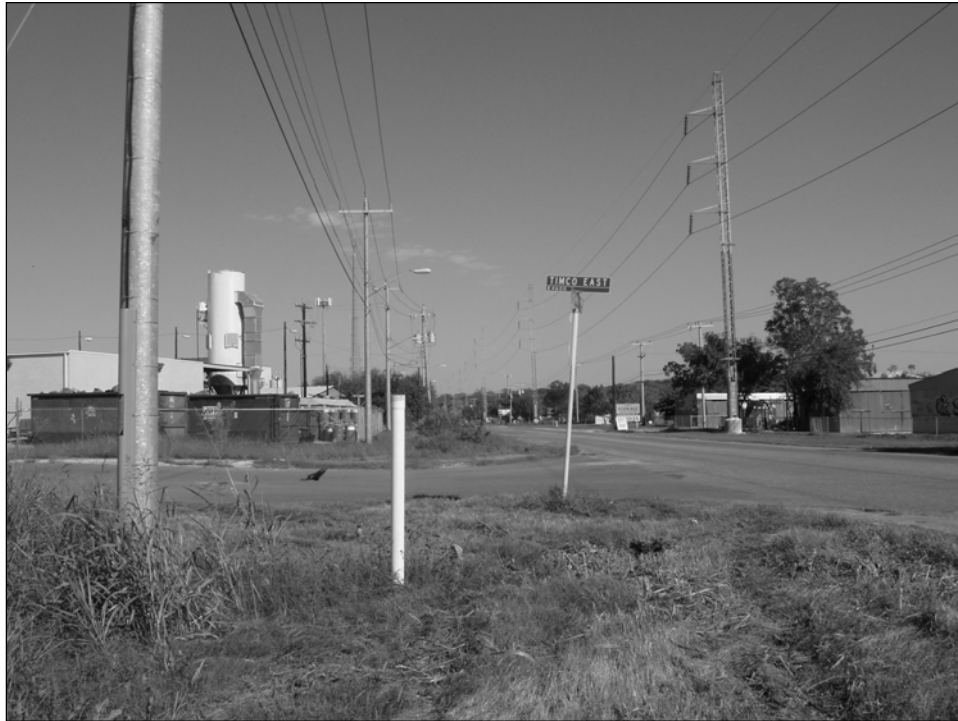
Figure 4. *The eastern end of the APE between Horseshoe Bend East and Bandera Roads has also seen commercial development and retains little potential for encountering intact archaeological deposits due to the amount of paved ground surface.*

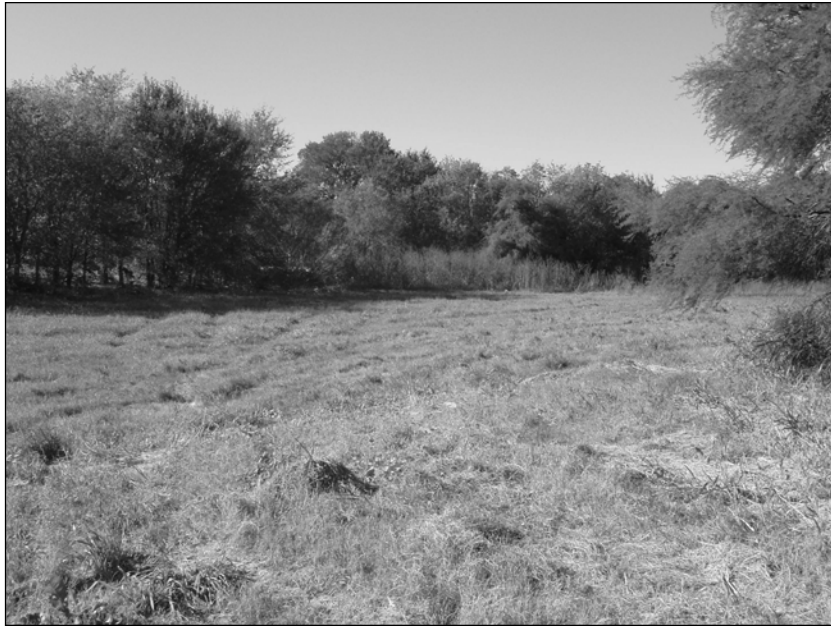
Figure 5. The APE includes areas east of the current location of Zarzamora Creek, encompassing 2.31 acres of floodplain and flood terrace that have the greatest potential for containing archeological deposits.

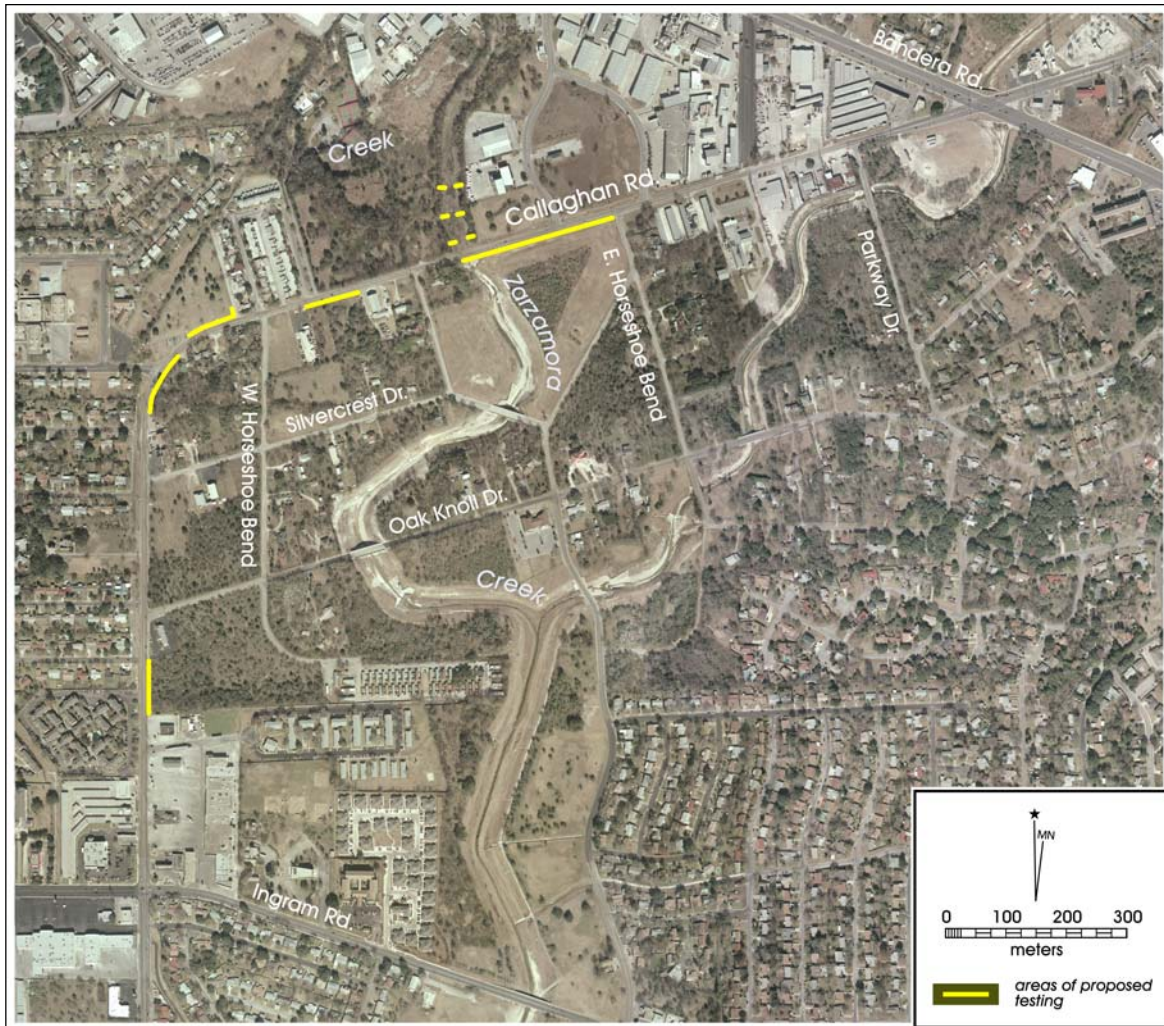
Figure 7. 2006 aerial photograph showing sections along Callaghan proposed for subsurface testing.

The Center for Archaeological Research performed an intensive pedestrian survey along 1.5 miles of Callaghan Road between Ingram and Bandera Roads and along 130 m of Zarzamora Creek north of Callaghan Road that totaled 2.31 acres. Under these project limits, accounting for developed areas where shovel testing could not be performed, CAR proposed to excavate up to six backhoe trenches in each of six defined rechannelization areas, three shovel tests along Zarzamora Creek and six shovel tests in new ROW along .35 miles in vacant lots on Callaghan Road (Figure 7).

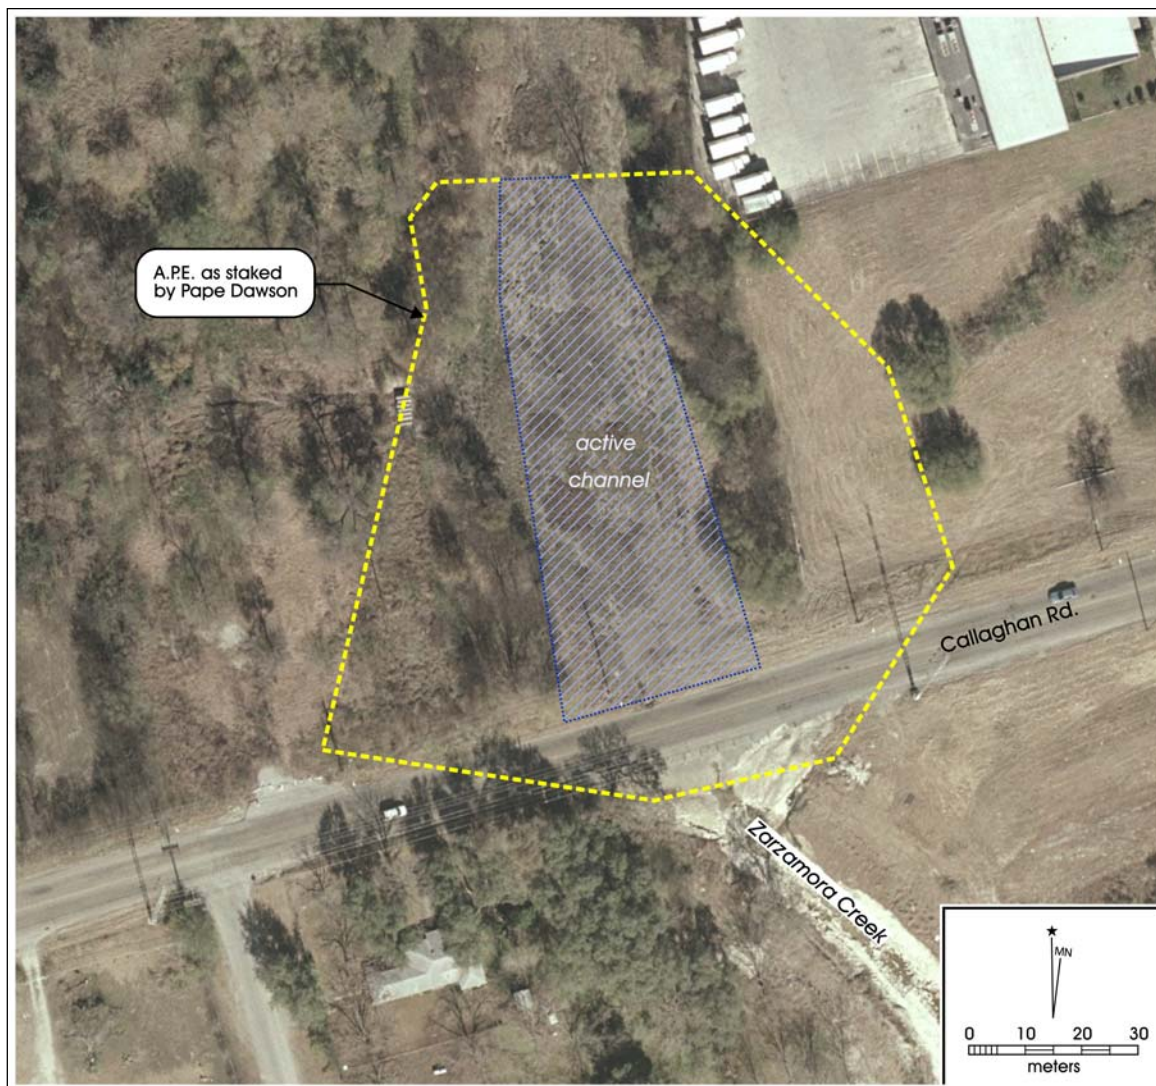
Figure 8. 2006 aerial photograph showing locations of the channel limits as staked by Pape Dawson, Inc. and the originally proposed areas for backhoe trenching.

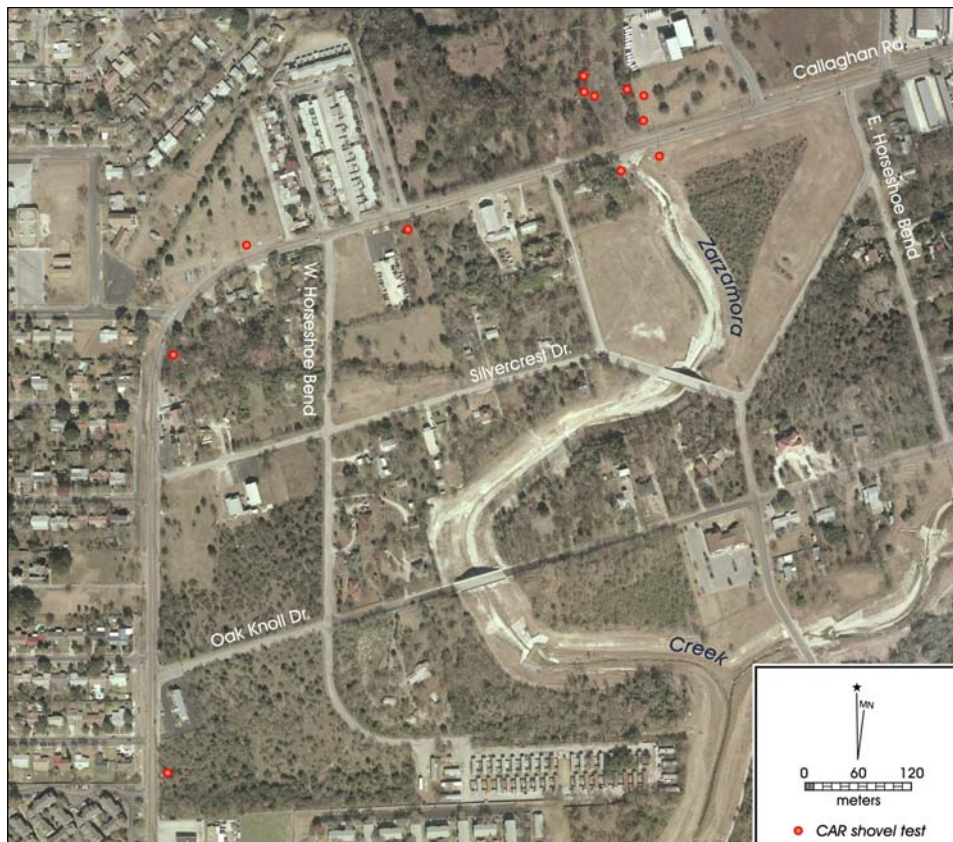
Figure 9. 2006 aerial showing locations of shovel tests along Callaghan Road.

Subsurface shovel testing occurred in five locales along Callaghan Road (Figure 9). Two shovel tests were excavated between East Horseshoe Bend and Zarzamora Creek and one at each of the following locations: between West Horseshoe Bend and Woodside Drive, between Silvercrest

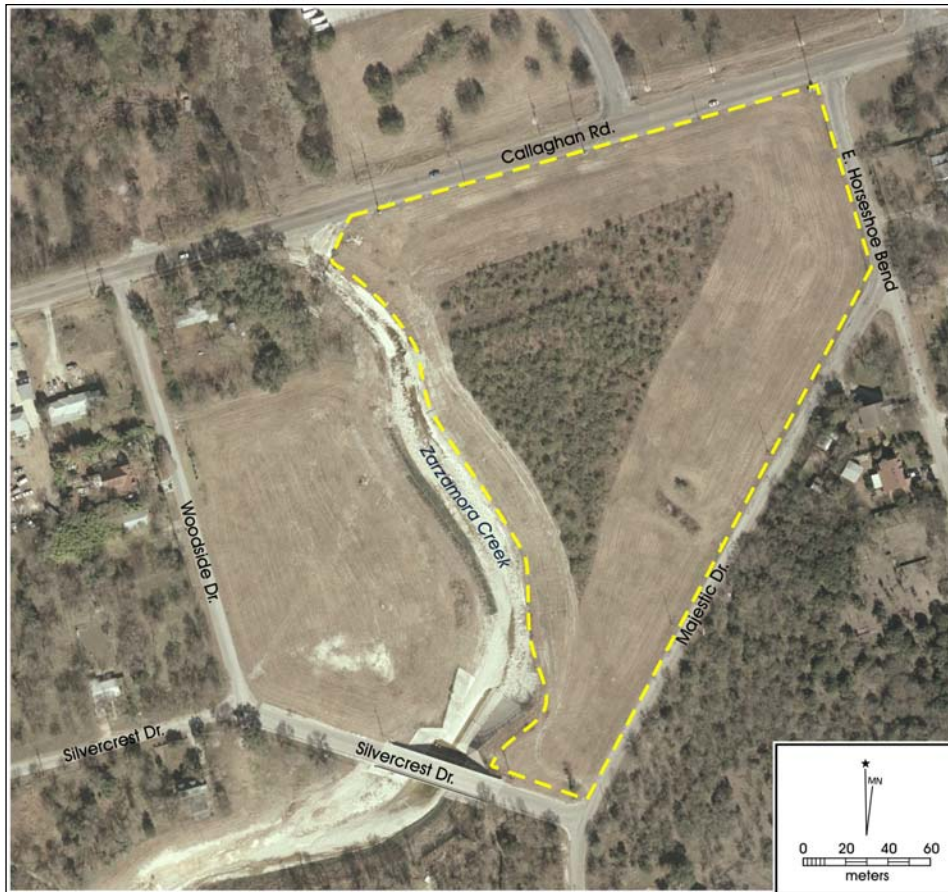
Figure 10. Aerial photograph showing the estimated location of construction dump south of Callaghan between Zarzamora Creek and Horseshoe Bend East.

CAR personnel found no artifacts within the project area along Callaghan Road. Shovel tests revealed shallow bedrock between 30 and 62 cm below surface (cmbs) in the western end of the survey area and a construction dump at the eastern end (Figure 10). A large lot between East Horseshoe Bend and Zarzamora Creek proposed for shovel testing was actually quite disturbed upon closer examination. The eastern edge of the lot is paved and the entire lot littered with construction debris (Figure 11). The landform appears artificially raised. We assume that this is part of the construction dump documented previously by the City of San Antonio Environmental Services Department mentioned above. Our assessment, based on the landform, aerial photographs, and the degree of construction material scattered across the lot inside the APE, is that the construction dump spans 43,138 m² (10.73 acres). All attempts

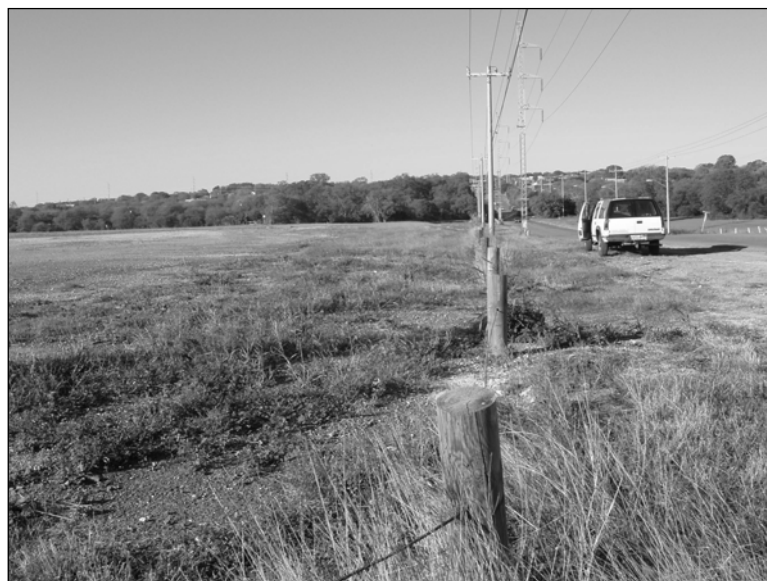
Figure 11. The eastern edge of the lot east of Zarzamora Creek south of Callaghan is paved and the entire lot is littered with construction debris.

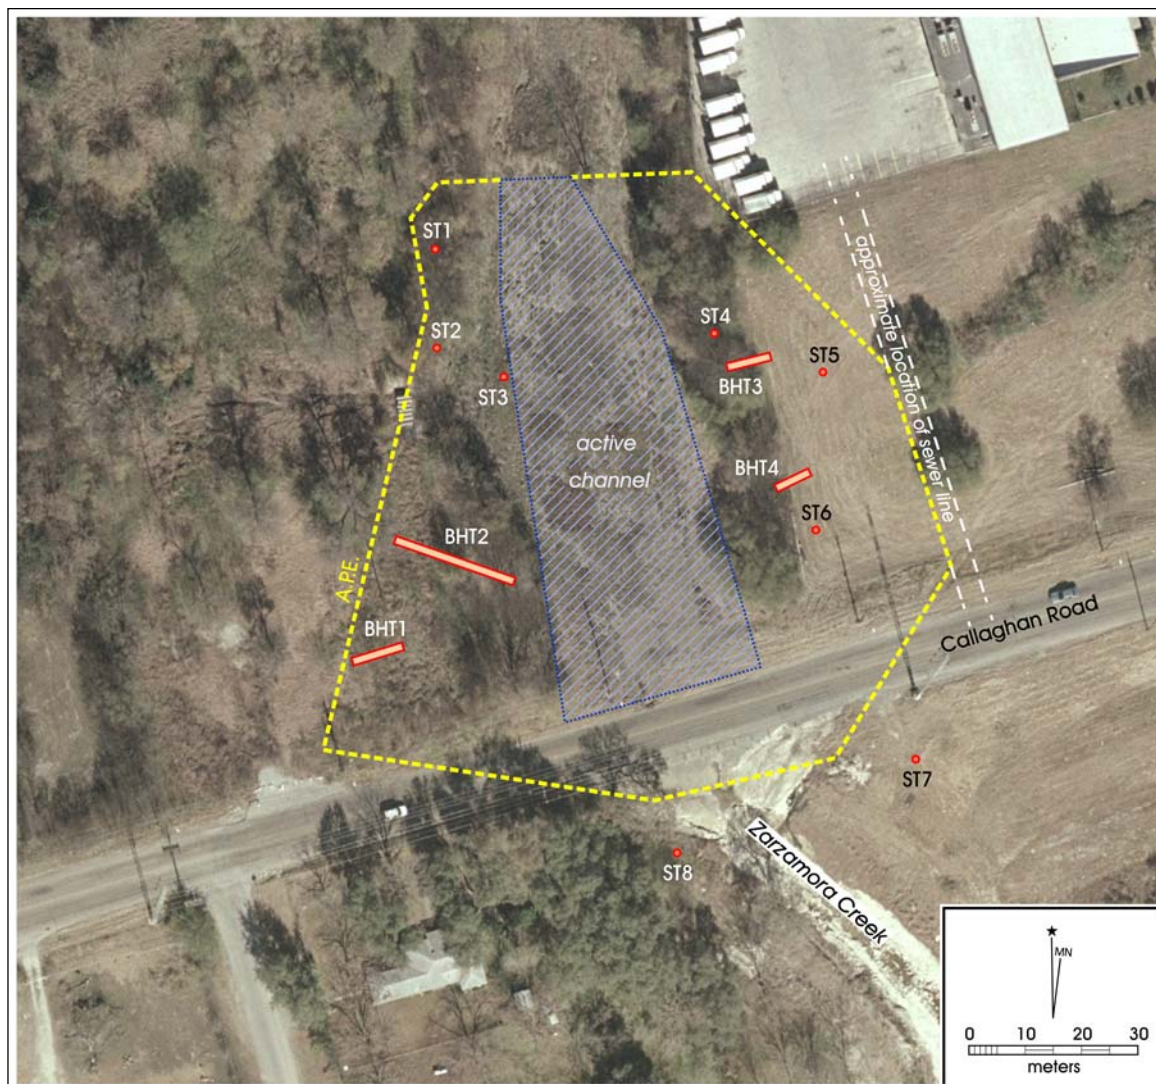
Figure 12. Aerial photograph showing the placement of backhoe trenches and shovel tests near Zarzamora Creek.

Excavations performed at Zarzamora Creek included four backhoe trenches and six shovel tests (Figure 12). The west side of this area is filled by construction dumps as previously

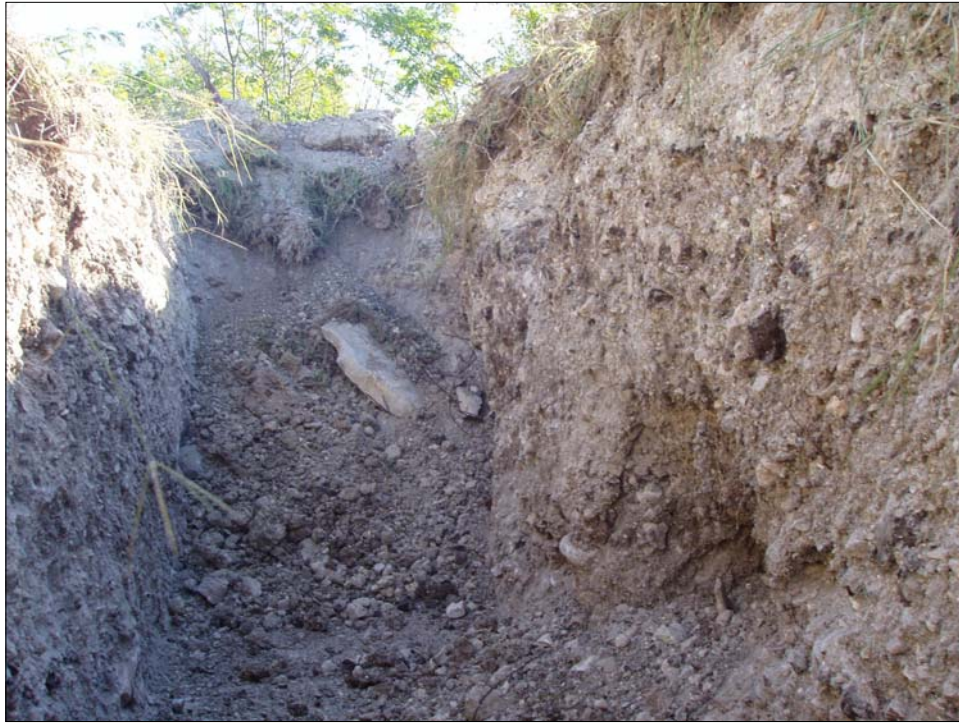
Figure 13. *Photograph of Trench 1 excavated entirely in construction fill.*

Backhoe Trench 1 was excavated on the west side of the creek on a rise above the current floodplain. Excavation occurred entirely within construction fill and revealed no significant archeological deposits (Figure 13). To determine the extent of this construction fill, we excavated a long trench from closer to the active channel west in an attempt to locate the eastern edge of the dump. Backhoe Trench 2 showed the most informative profile spanning 20 m long (Figure 14). The center of the trench exposed the following profile (Figure 15). The top 10 cm of silty loam over 60 cm of fill and gravels likely brought in by owners. Below the modern fill lies 80 cm of alluvial clay with creek gravels and pebbles. Creek channel

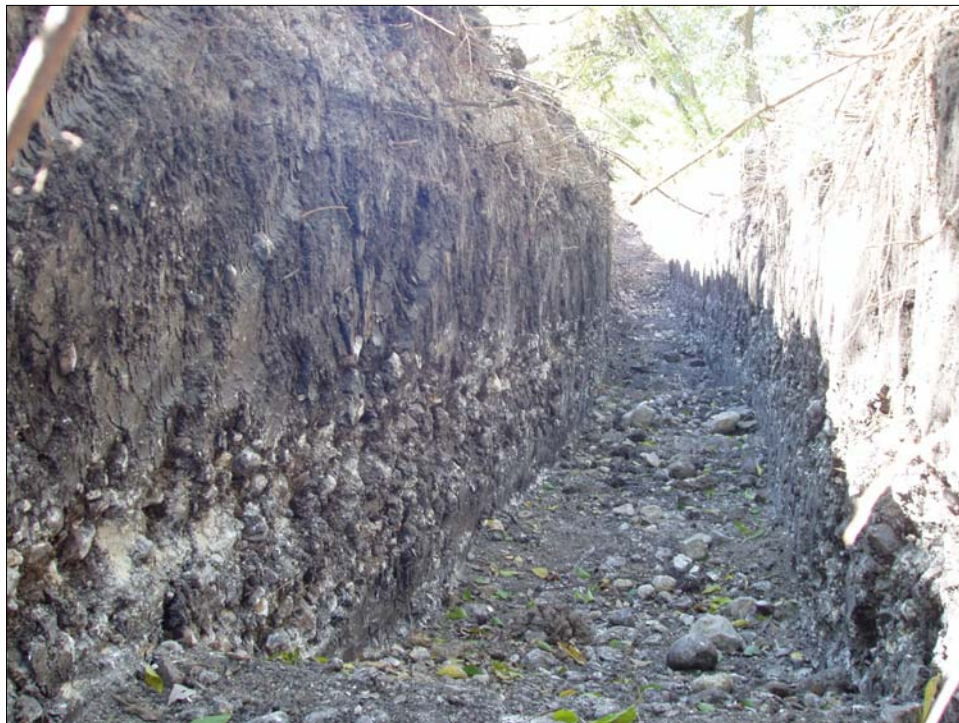
Figure 14. *Photograph of Backhoe Trench 2.*

At the western end of Backhoe Trench 2, a sandy lens was uncovered at 50 cmbs. Above this lens, the same modern fill was exposed. The sandy lens and deposits below appear to be alluvial deposits similar to the previous profile with alternating strata of silty clay and creek gravels (Figure 15).

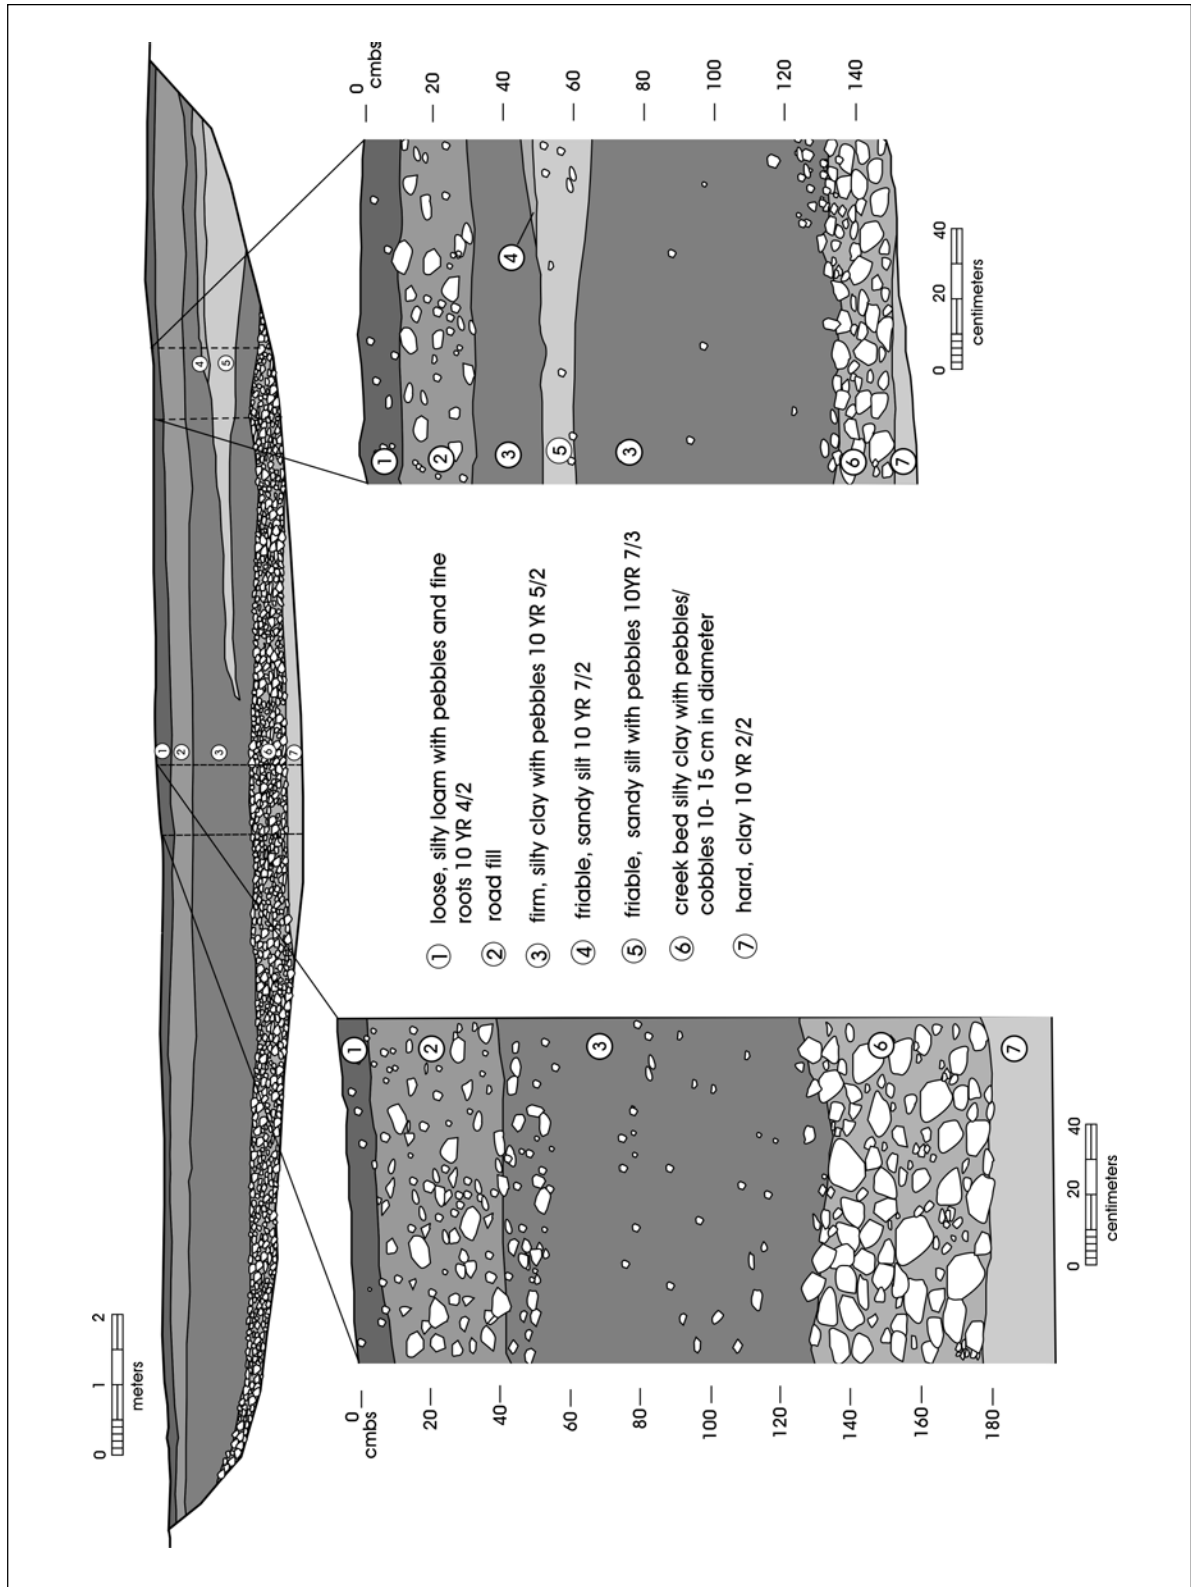
Figure 15. Profile drawing of Backhoe Trench 2.

Backhoe Trench 2 revealed the best profile and encountered alternating strata of silty clay and creek channel gravels up to 2.0 mbs. A single chipped stone tool was excavated from the trench and seen in the backdirt. This is a bifacially flaked expedient tool 15 cm in length with approximately 50 percent cortex remaining. The provenience of this tool is unknown and is the only example of cultural material in the trench. No other cultural items or archaeological deposits were seen in the profile wall. This artifact does not represent a significant archaeological deposit or exhibit any research potential. Fire-cracked rock was recorded from shovel tests on the west side of Zarzamora Creek but these were from the upper levels and associated with modern trash and construction materials. East of the creek, fire-cracked rock was seen above creek gravels in Backhoe Trench 4. This artifact was likely carried in with flood deposits and not in its primary location.

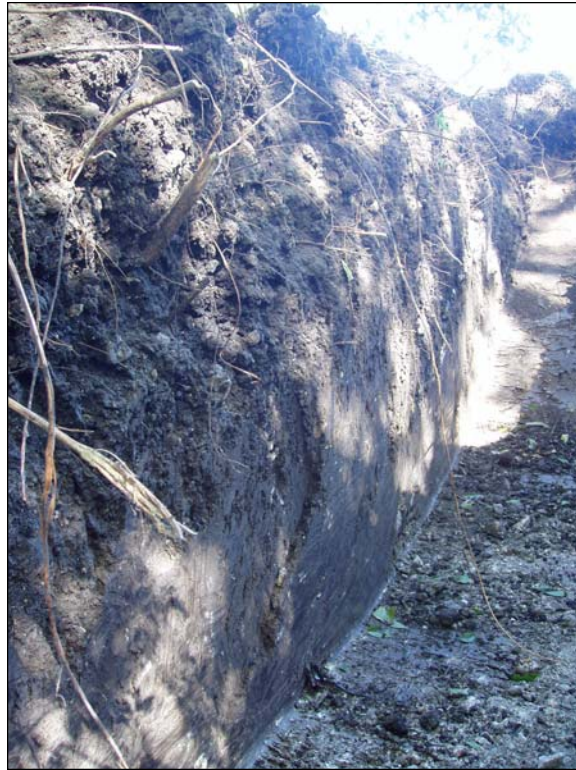
Figure 16. Photograph of Backhoe Trench 3 showing 1.25 meters of silty clay.

Backhoe Trenches 3 and 4 were placed on the eastern side of the Zarzamora Creek flood zone near the sewer line and the Blue Bell Creameries building. Both trenches exposed silty clays. Backhoe Trench 3 exposed silty clay with some gravel inclusions to 150 cmbs (Figure 16). Backhoe Trench 4 reached decomposing bedrock at 125 cmbs (Figure 17). The upper 25 cm showed silty clay loam with roots. Beneath this upper stratum lay compact silty clay with sparse, fine roots. One piece of fire-cracked rock observed in the trench wall lay within this silty clay deposit 25 cm above a stratum of creek gravels. The stratum of creek gravels was approximately 25 cm thick sitting on weathered bedrock in this exposure. Soils in Backhoe Trenches 3 and 4 appear to be unaltered by fill or construction dumps, though the area has seen disturbance with the installation of a 22-in. forced sewer line. We made every effort to place backhoe trenches in undisturbed areas of the APE.

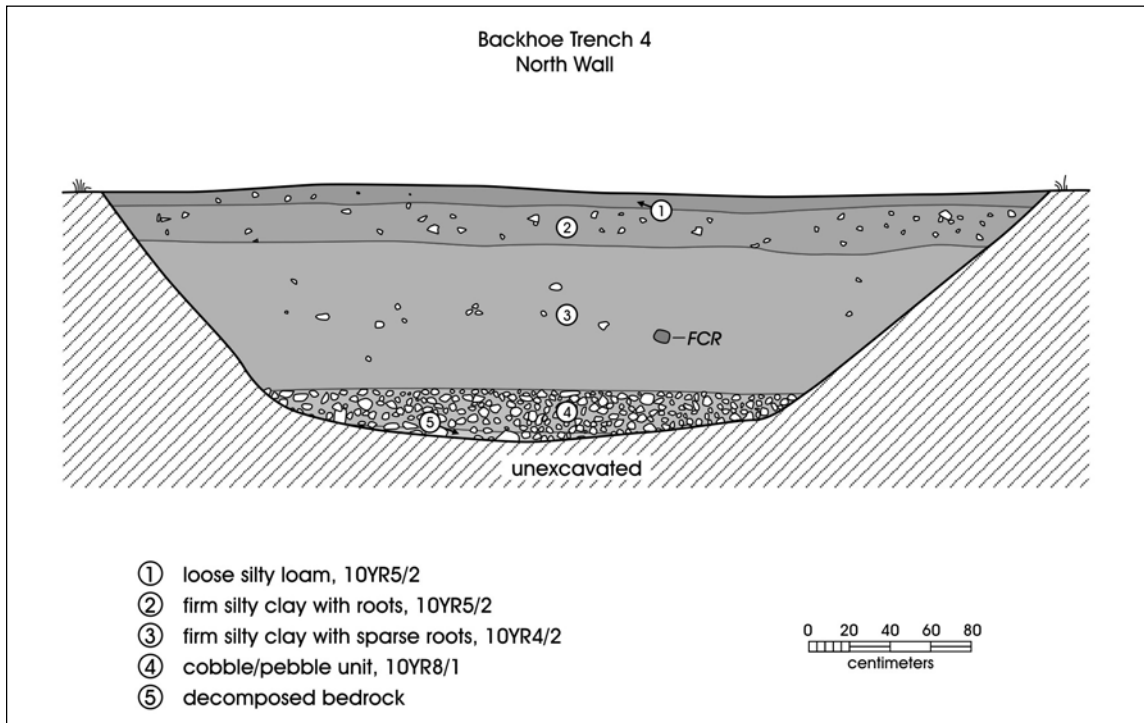
Figure 17. Backhoe Trench 4 was excavated to decomposing bedrock at 125 cms.

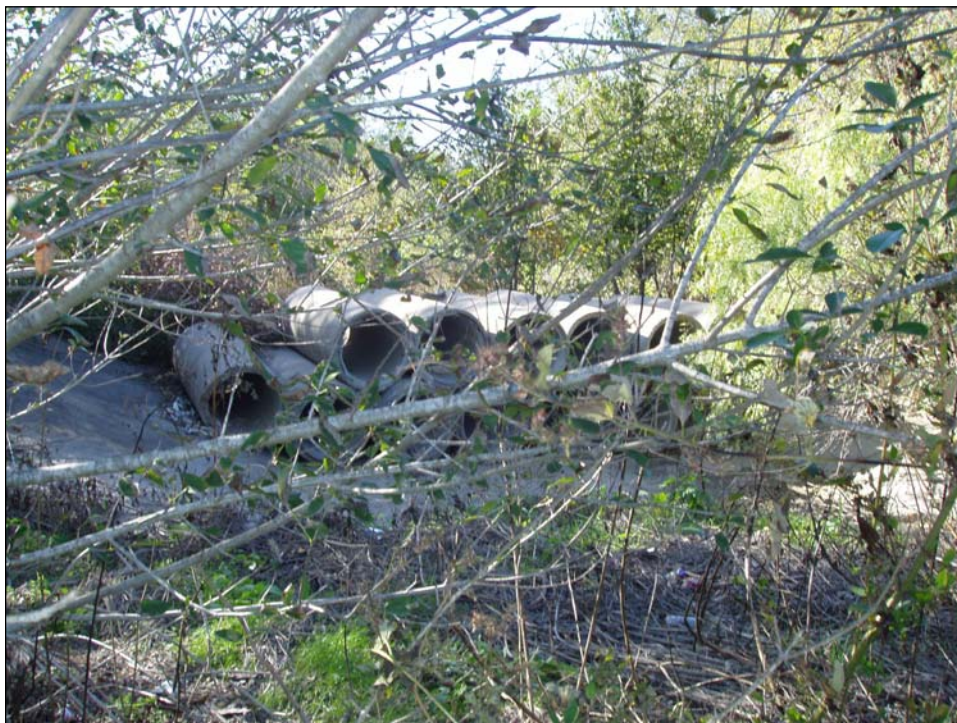
Figure 18. *Culverts were stacked to allow floodwaters to drain while also serving to keep horses out of the creek, according to a former horse caretaker on the property.*

Shovel tests around Zarzamora Creek tested areas inaccessible with the backhoe. These included places crossed by fences or near a culvert barrier on a concrete pad (Figure 18). Shovel tests showed disturbed soils with trash up to 40 cmbs on the west side of the creek. Gravels begin to increase at 30-40 cmbs with no other discernable change in soil texture. The upper 20 cm are soft silty loam and the lower 40 cm are compact silty clays with pebbles. Burned rock was identified in the 30 cm of Shovel Test 1 along with recent trash (plastic grocery bags, machine cut nails, concrete).
