Historical Archaeological Resources of the Choke Canyon Reservoir Area in McMullen and Live Oak Counties, Texas

HISTORICAL ARCHAEOLOGICAL RESOURCES OF THE
CHOKE CANYON RESERVOIR AREA IN
McMULLEN AND LIVE OAK COUNTIES, TEXAS

Report of a project carried out by the
Cultural Resources Institute
Texas Tech University

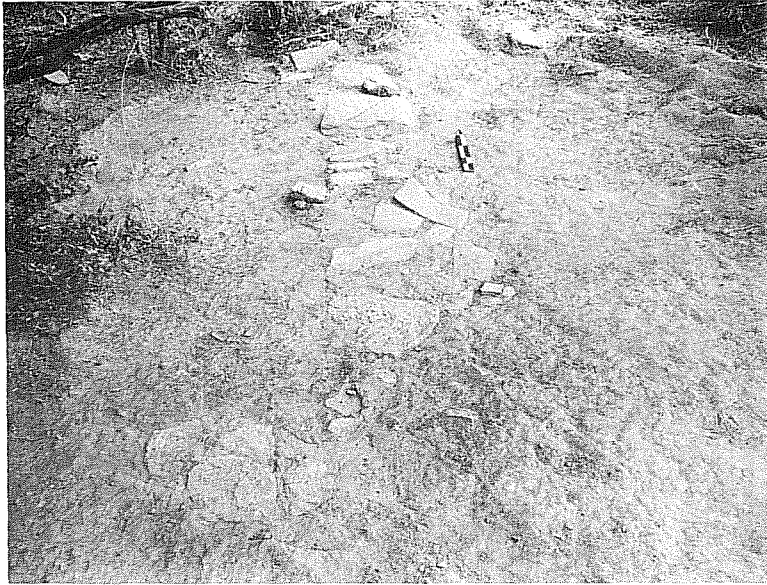
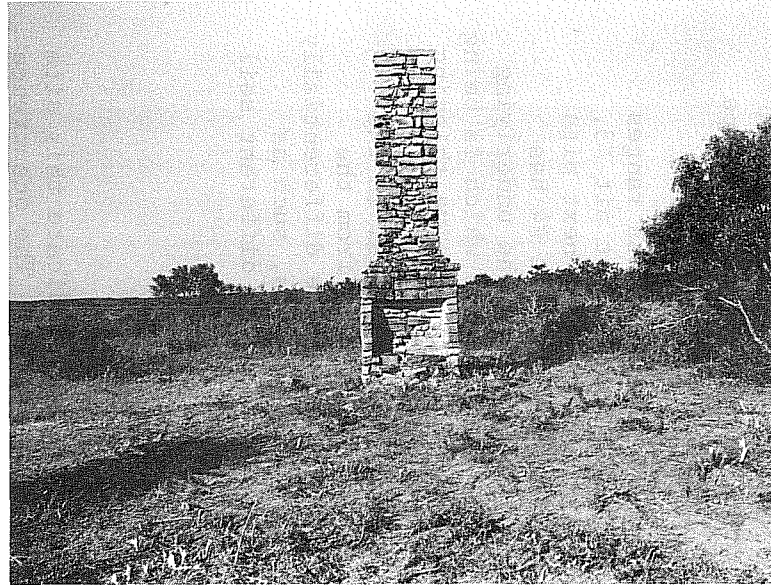
Figure 18. *Photographs of Various Features.* a, sandstone slab alignment, 41MC15; b, sandstone house chimney, 41MC17; c, scattered sandstone rocks and test pits #1 and #3 in front of chimney; d, test trench #1, 41MC74.

This site (Fig. 19) has the most complete older architectural remains in the western part of the reservoir. A well-preserved sandstone chimney (Fig. 18, b), scattered sandstone rocks and various historic occupational debris are evident on the surface in an area about 25m x 30m. Situated about 100m south of the Frio River on a high terrace and slight rise, the site has been damaged by brush clearing except adjacent to and including the chimney. No definite architectural remains were found in association with the chimney. On the north side of the chimney was a group of sandstone slabs (Fig. 18, c) one course thick (on the surface), which could have been a feature similar to that in site 41MC15 (Fig. 18, a). It was not tested.

The stone chimney is constructed of shaped sandstone blocks mortared with lime mortar. The foundation (Fig. 21) extends about 36m below what may have been the ground surface at time of construction and is set on a 4cm thick layer of lime mortar. If the chimney foundation was constructed symmetrically with the stack, the total dimensions would be about 2m². The chimney (Fig. 18, b) stands 5.25m tall and is braced in the top or mantel of the hearth with a flat piece of iron which is apparently a straightened piece of wagon wheel rim. This metal piece is beveled on both edges of one side, is perforated with a hole every 62cm along its length, and measures 1.5cm x 6cm in cross section. Part of the metal brace is visible in the upper left corner of the hearth opening as shown in Figure 18, c.

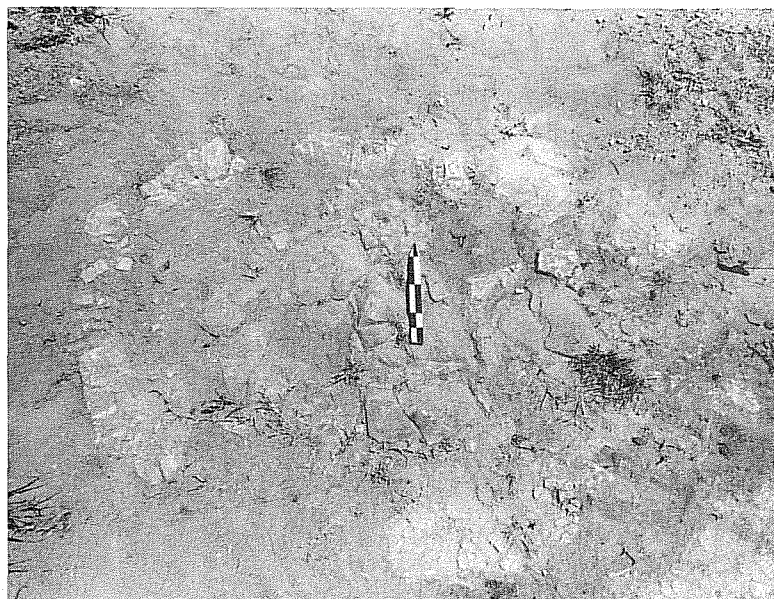
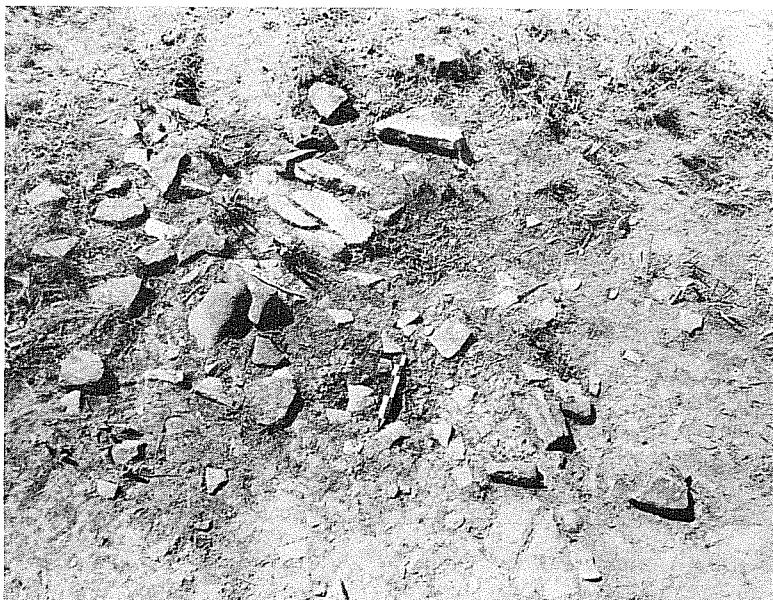
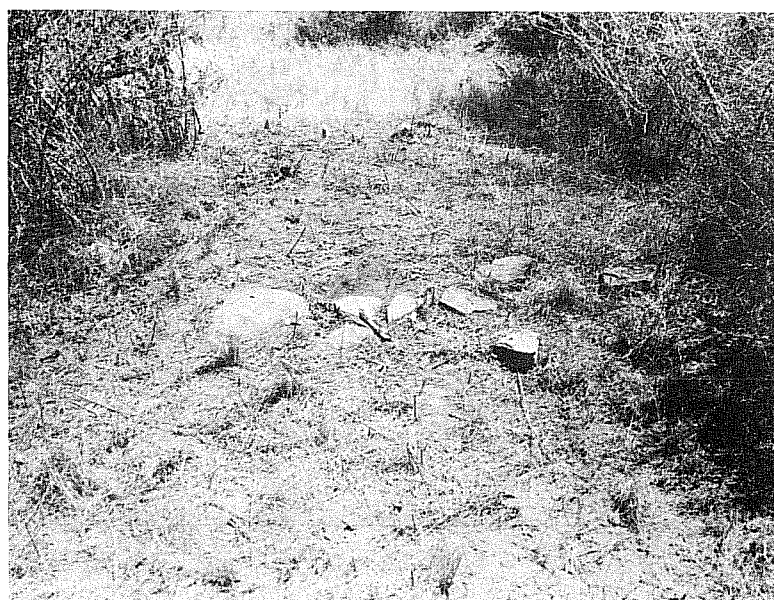
Figure 26. *Photographic Views of 41MC91 and 41MC185.* a, extant house, 41MC91; b, cistern or tank top west of extant house, 41MC91; c, feature 1, badly disturbed chimney foundation, 41MC185; d, feature 2, 41MC185.

This site (Fig. 25) has an extant frame house (Fig. 26, a) with associated scatter of historic occupational debris, water cistern or tank (Figs. 26, b; 27). The site is situated on a ridge top on the edge of the valley wall. The site is 30m from the old river bed of San Miguel Creek, which is presently about 700m to the south. Original investigations by THC questioned the antiquity of the extant house and noted the incongruence of its suspected post-1900 age relative to the late 19th century age of the site as suggested by the artifacts. A chimney foundation remnant, feature 1, was discovered eroding in the road bed in front of the extant structure, indicating the presence of an earlier structure and explaining the earlier incongruence problem. A second sandstone block concentration was noted to the NE of the extant house but is of an undetermined nature. Square cut nails were found in association with this concentration (on the south side), indicating perhaps an outbuilding in association with the earlier 19th century occupation.

A circular stone tank or cistern (Fig. 26, b) was found between the extant house and an associated shed, but the exact relationship of this feature is unknown. The feature is 1.8m in diameter, is filled with rocks and dirt, and is flush with the ground surface. The location of this feature is next to the corner of the extant house and could conceivably be associated with this house, but it is also close enough to the chimney foundation that it could be associated with the earlier structure.

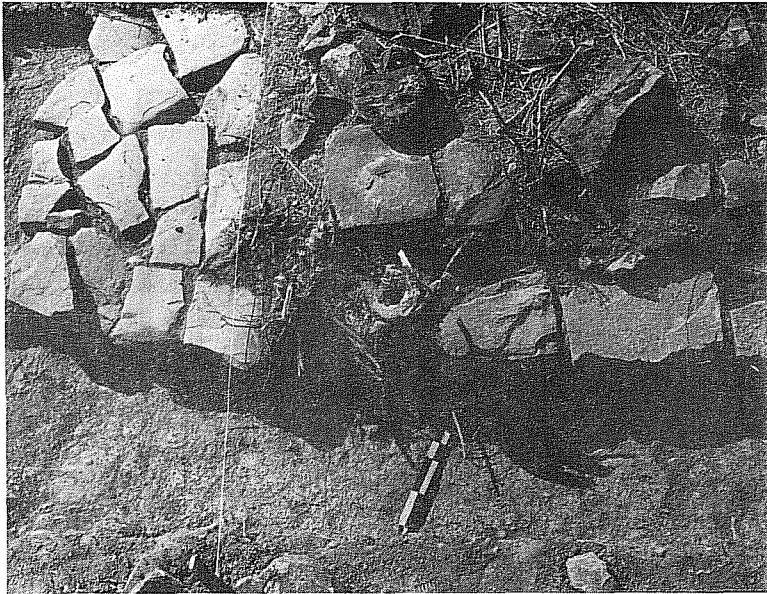
Figure 34. *Photographs of 41MC192.* a, chimney foundation; b, test pit #3, level 1, showing lens feature; c, general view of site; d, test pit #3, level 2, showing stain in floor.

The sandstone rubble is scattered broadly over the site; much of it is surface scatter, but there is some aligned distribution pattern (Fig. 34, a). The chimney foundation is situated in a central part of the east edge of the stone rubble and oriented with a long axis aligned with the rubble. The hearth is about 2m x 3m in size and has two or perhaps three courses of slabs remaining (Fig. 35). If the rectangular stone rubble is representative of the original house dimensions, the chimney would be situated in the middle of the east wall of a rectangular structure measuring about 5m x 15m.

The degree to which the surface rubble represents the actual house architecture is not known except in one test pit, #3, (Fig. 34, b). Situated on the west side of the structure opposite the chimney foundation, the 1m x .75m pit encountered a feature at about 8cm below the ground surface which is apparently some type of wall footing or other architectural feature. The ground surface in this area was littered with sandstone blocks, as can be seen in Figure 34, c. Stone blocks like those outside pit #3 were present within the pit, but were not buried to any depth and were removed prior to the photograph. In the same Figure (34, b), there is visible a clustering of small sandstone rocks in the northwest floor corner of the pit. This is the footing feature which extends outside the pit to the north and west, is relatively circular in outline on the edge excavated, and is about 8-10cm thick. The top surface of the gravel feature increases in height to the NW, which is toward the central area of an extensive sandstone block concentration. The floor of test pit #3, subsequent to excavating to 20cm level, was brushed, troweled, and dampened with water spray, revealing several soil stains which may also be architectural features. One linear dark stain was oriented northwest/southeast across the floor of the pit, parallel in axis to the chimney foundation. Another stain (10-15cm, circular) was located to the west of the linear stain under the edge of the overlying gravel lens feature (Fig. 34, d). These stains may represent a post and wall trench associated with the structure or may be merely a rodent burrow with a fortuitous orientation. The stone scattered on the surface of the site could also have been fortuitously aligned by a bulldozer cut, but the surface features in test pit #3 indicate that this is not the case. More testing should disclose the correct answer.

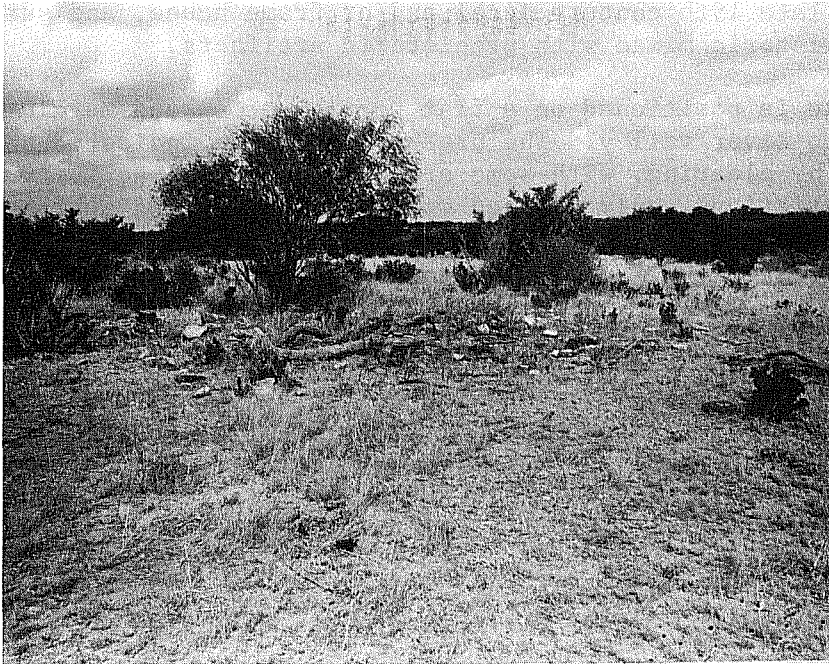
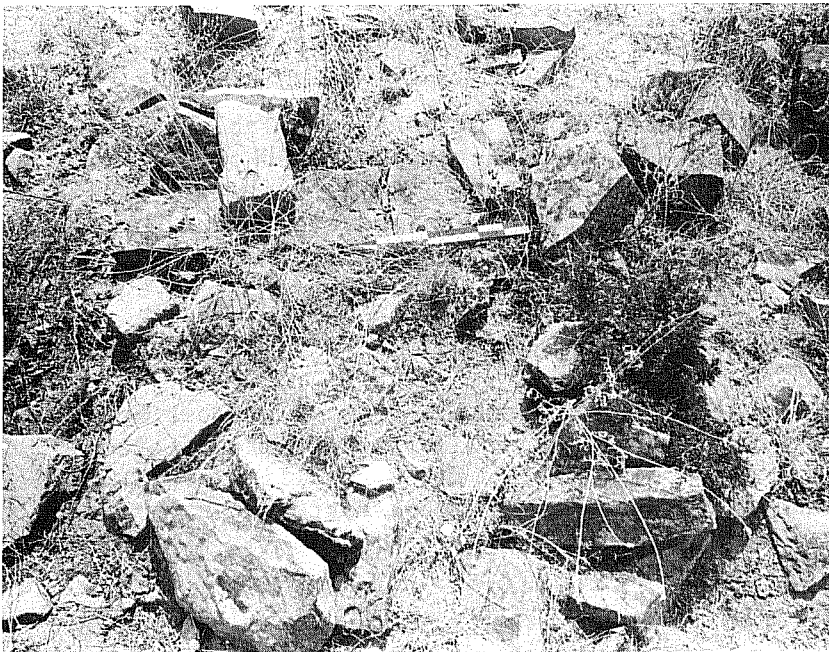
Figure 37. *Site 41MC193.* a, general view of site; b, chimney foundation.

(Fig. 37, a) with sandstone chimney foundation (Fig. 37, b), scattered sandstone, and historic occupational debris, and 2) a small scattering of sandstone which may represent an outbuilding foundation to the west of the house. The habitation structure is rectangular in outline, with remnants of slab alignments. Sheet erosion has been moderate, with probable past disturbance by brush clearing and much recent damage by hog rooting. A sendero crossing the site between the outbuilding and the house was used as a demarcation line to surface collect the site in two areas, A and B. Area B is associated with the outbuilding foundation, and area A is on the south side of the sendero and associated with the habitation site. As at site 41MC192, surface collections were made subsequent to the summer field season, with the collected items incorporated with those previously collected by areas. No test excavations were made, but animal burrow profiles and backdirt indicate this site to be very similar to 41MC192, which is only about 390m to the west.
