**WEAR AND SCUFFING RESISTANCES OF EUTECTIC
Al-Si ALLOYS AND Al-Si BASED COMPOSITES**

A Thesis

Submitted to the Faculty of Graduate Studies and Research
through Engineering Materials
in Partial Fulfillment of the Requirements for
the Degree of Master of Applied Science at the
University of Windsor

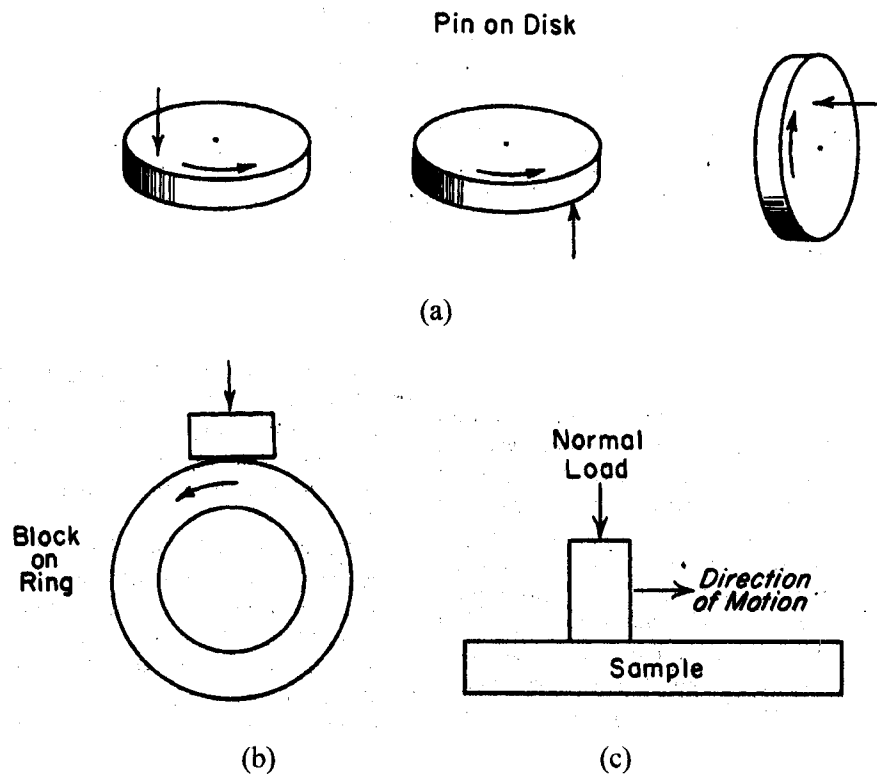
Figure 2.1 The pin-on-disk wear test machine [16]: a) three different arrangements for a simple pin-on-disk wear test machine; b) block-on-ring wear machine; c) reciprocating wear machine.

Various wear set-ups have been developed for tribology research purposes. Pin-on-disk (Fig 2.1a), block-on-ring (Fig 2.1b), and reciprocating wear machine (Fig 2.1c) are commonly used in laboratory [16].

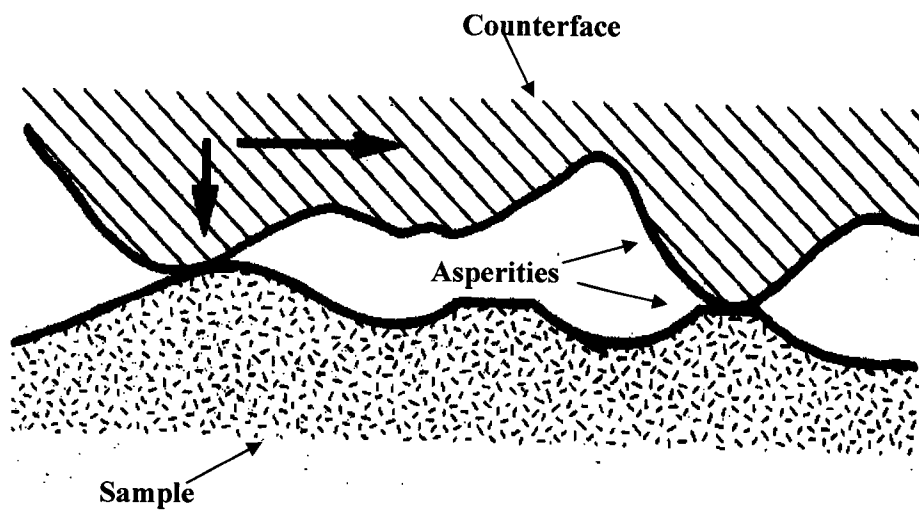
Figure 2.2 Two sliding surfaces contact by asperities. [9]

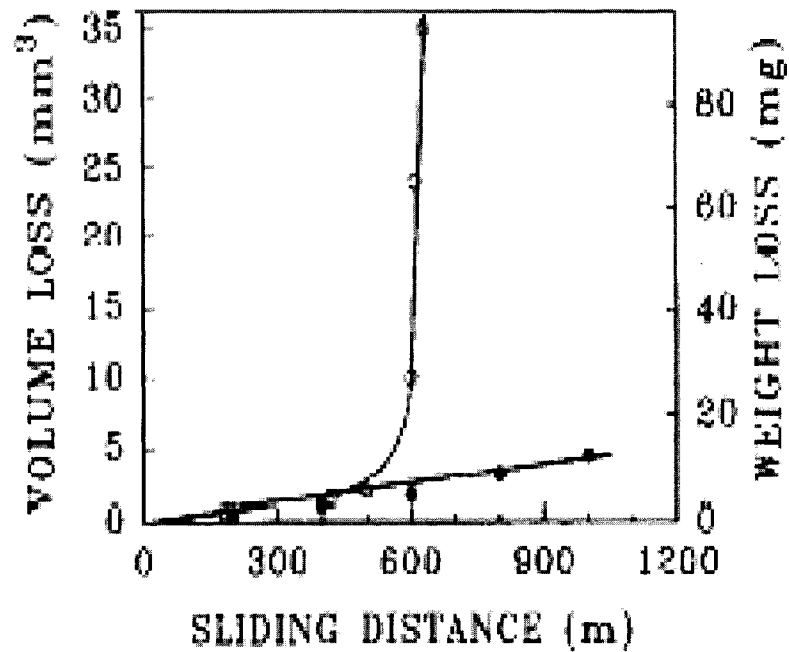
Figure 2.4 (a-b) Effect of forced cooling by chilled water on the mild to severe wear transition in 6061 Al worn against SAE 52100 steel. Without cooling the contact temperature exceeds T_c (395k) leading to severe wear (○). Cooling the system will ensure that the contact surface temperature stays below 395k, thus only mild wear is observed (●). Load =98N, $v=0.8\text{m/s}$. [22]

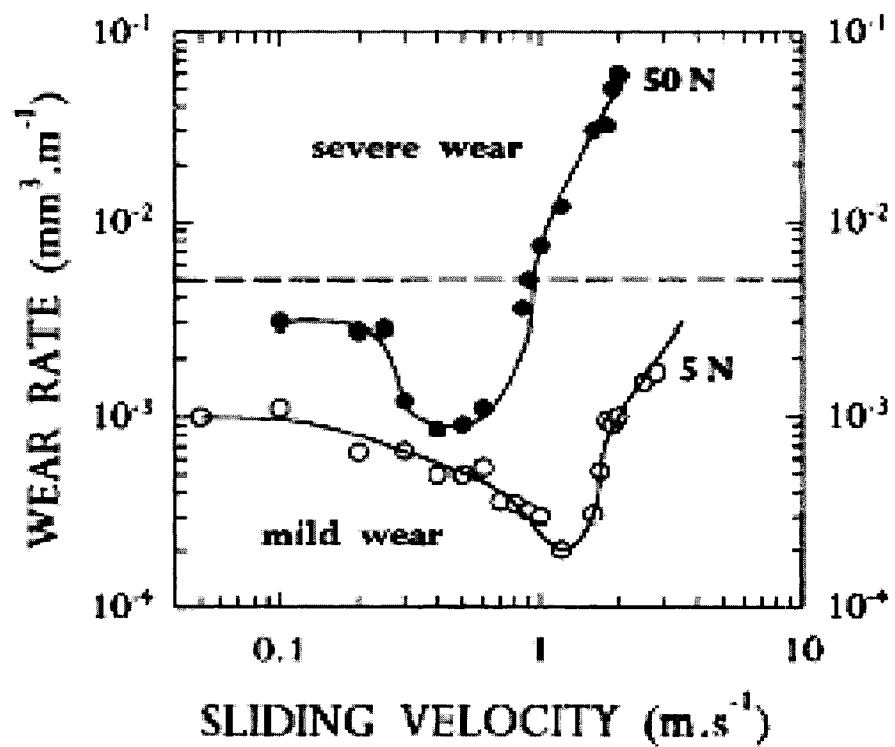
Figure 2.5 Wear rate versus sliding speed diagram for tests performed at two contact loads: 5.0N (\circ) and 50.0N (\bullet). [22]

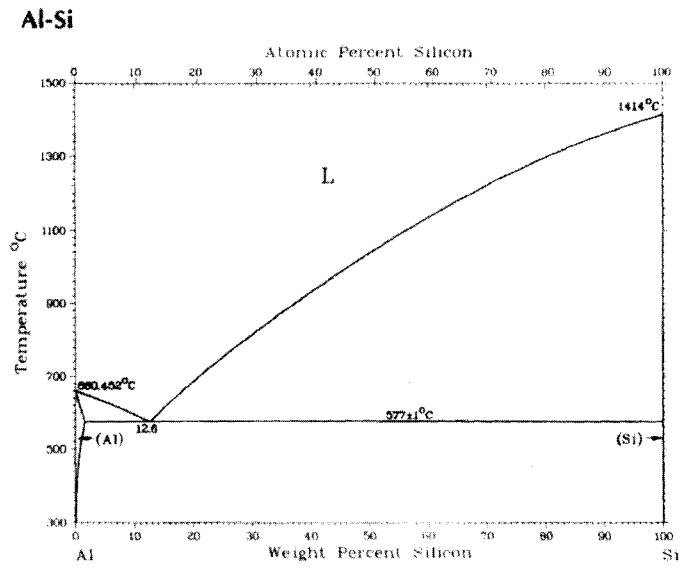
Figure 2.6 Phase diagram of Al-Si alloy system

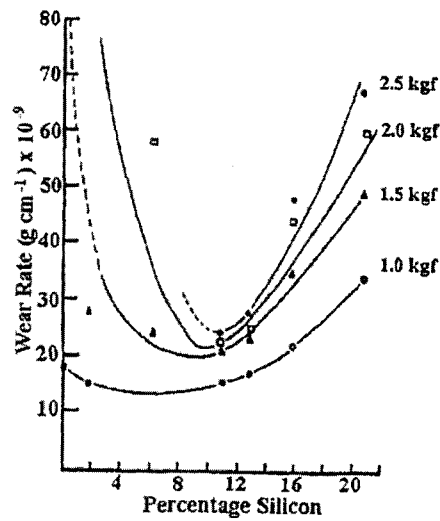
Figure 2.7 Wear rate as a function of Si Addition for Al-Si alloys subjected to dry sliding. [53].

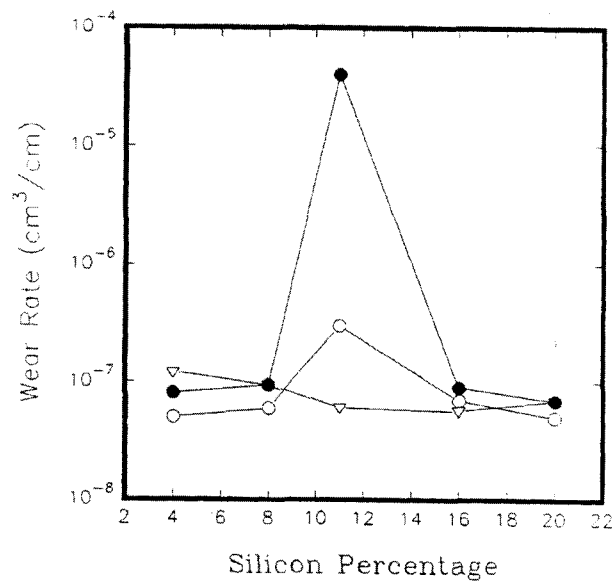
Figure 2.8 Wear rate as a function of Si content worn against steel at 1m/s, 10N (o), 20 N (•) AND 60N (Δ) load [3].

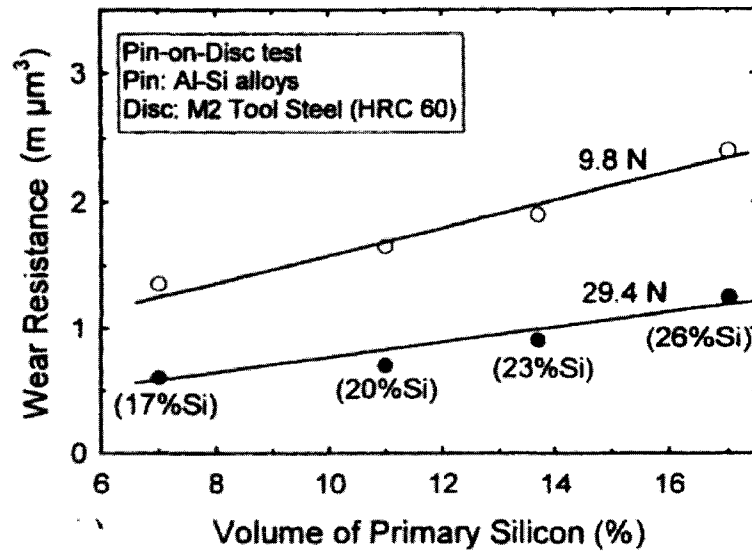
Figure 2.9 Effect of Silicon content in hypereutectic Al-Si alloys on wear, from pin-on-disk tests sliding against hard steel (figures in brackets denote total silicon content) [55].

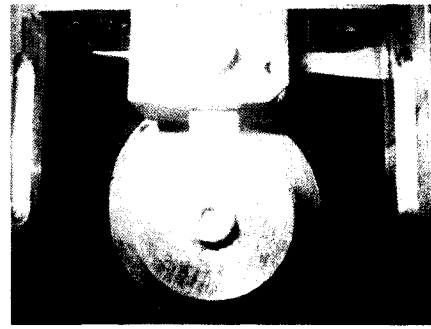
Figure 3.1 The block-on-ring Wear machine. a) A general view of the machine; b) the block-on-ring configuration.

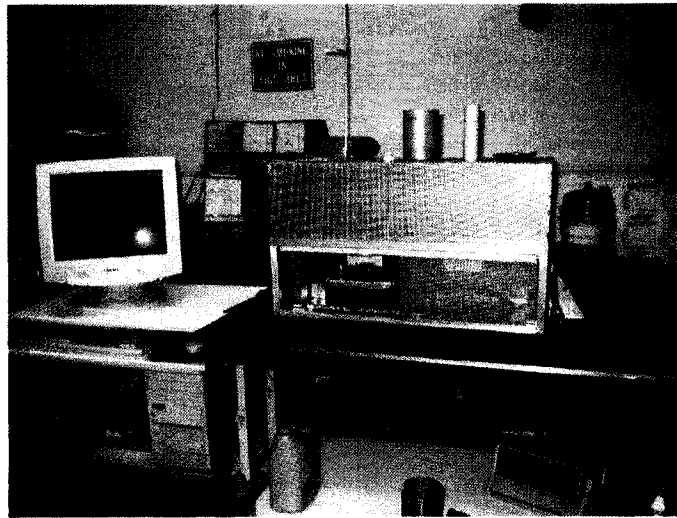
Figure 3.2 The Scratch Tester (1-movable sample; 2-stationary indenter; 3-load cell). a) A general view of the scratch tester; b) a schematic show of the tester.

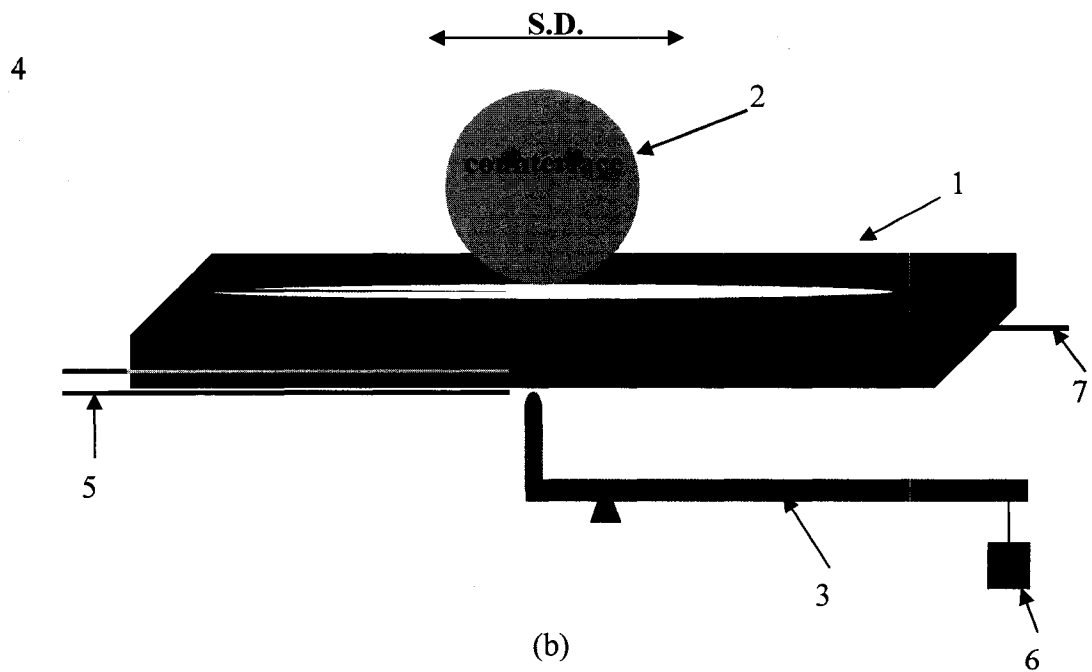
Figure 3.3 The reciprocating wear tester (1-stationary sample; 2-counterface; 3-loading arm; 4-oil reservoir; 5-thermocouple; 6-load; 7-cartridge heater). a) A general view of the reciprocating wear tester; b) a schematic show of the reciprocating wear tester.

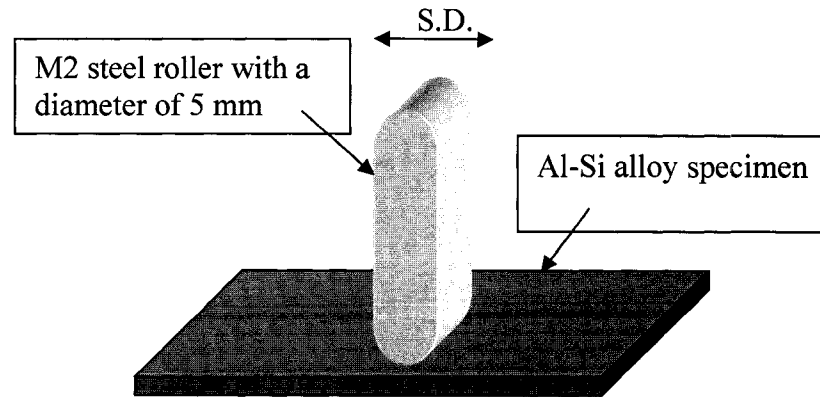
Figure 3.4 Contact configuration of Al-Si alloy scuffing tests

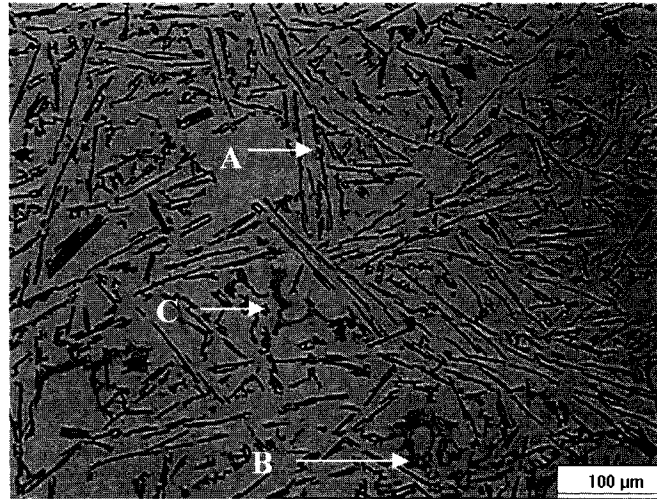
Figure 4.1 General optical image of the microstructure of A13-S alloy [A: Needle-shaped eutectic Si particles, B: $Al_{15}(FeMn)_3Si_2$ phase, C: Al_2Cu eutectic phase]

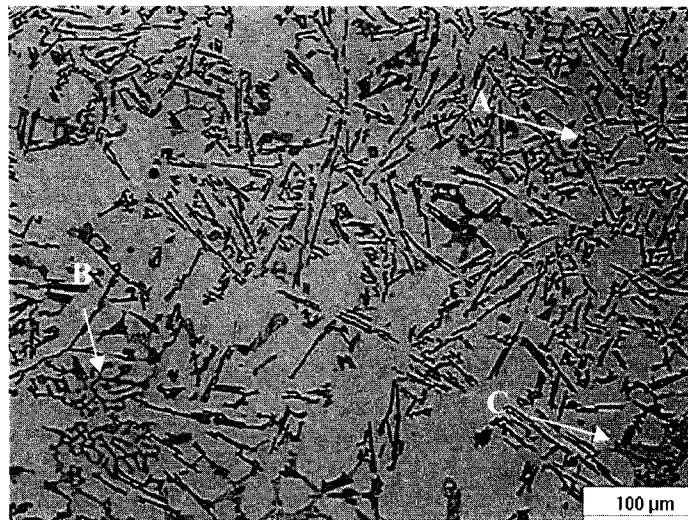
Figure 4.2 General optical image of the microstructure of A13-Z alloy [A: Needle-shaped eutectic Si particles, B: $Al_{15}(FeMn)_3Si_2$ phase, C: Al_2Cu eutectic phase]

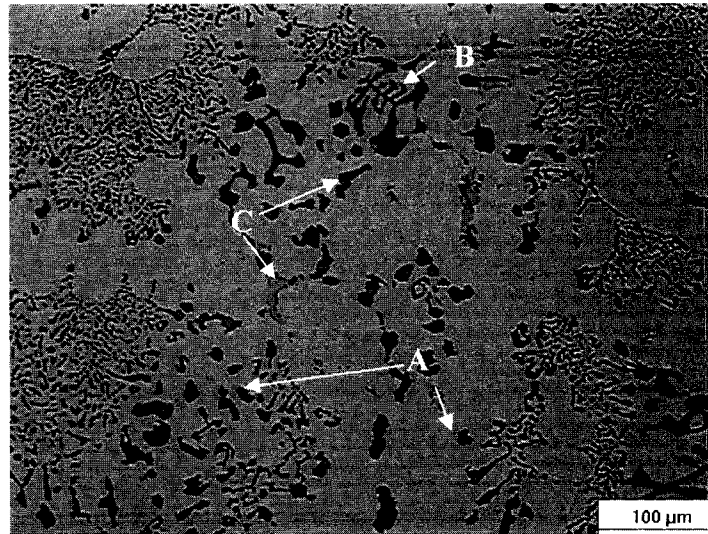
Figure 4.3 General optical image of the microstructure of A13-C-T6 alloy [A: Round-shaped eutectic Si particles, B: $\text{Al}_{15}(\text{FeMn})_3\text{Si}_2$ phase, C: Al_2Cu eutectic phase]

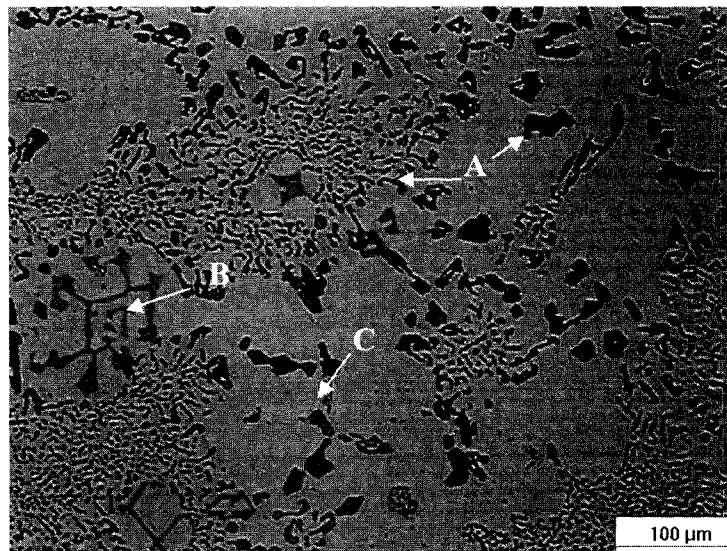
Figure 4.4 General optical image of the microstructure of A13-S-T6 alloy [A: Round-shaped eutectic Si particles, B: $\text{Al}_{15}(\text{FeMn})_3\text{Si}_2$ phase, C: Al_2Cu eutectic phase]

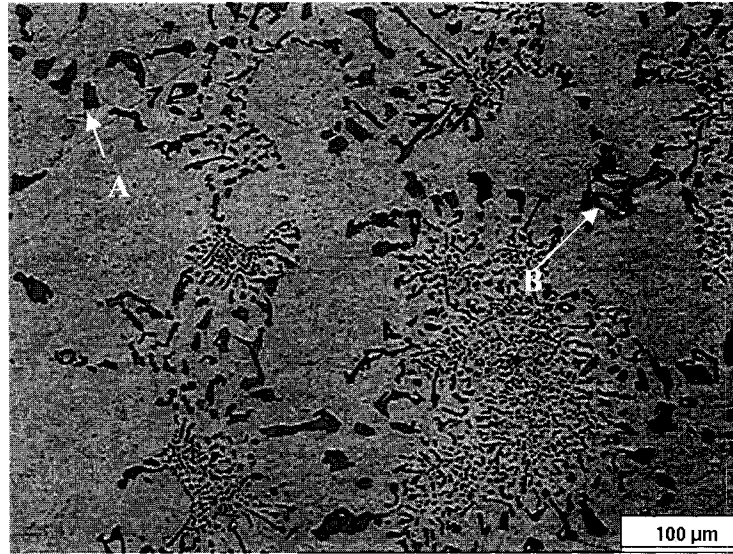
Figure 4.5 General optical image of the microstructure of A13-S-T6-AN alloy [A: Round-shaped eutectic Si particles; B: $\text{Al}_{15}(\text{FeMn})_3\text{Si}_2$ phase]

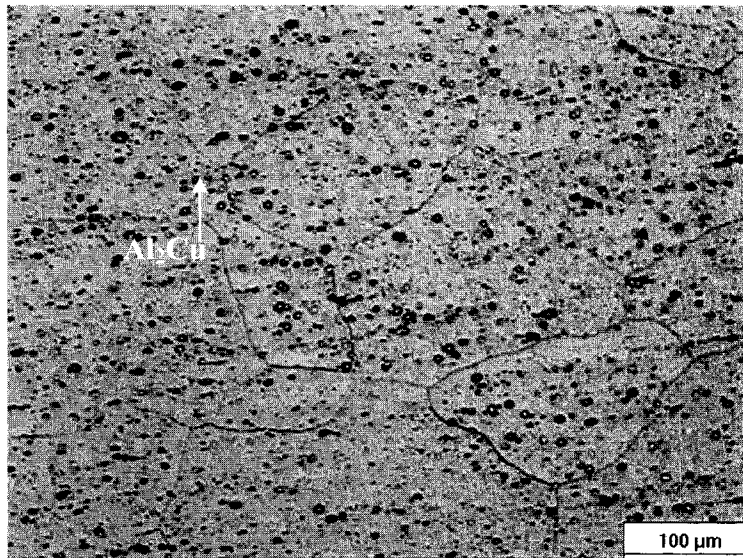
Figure 4.6 General optical image of the microstructure of the wrought 6061 Al alloy. Small particles in the matrix are Al₂Cu phase [large particles were not observed in matrix]

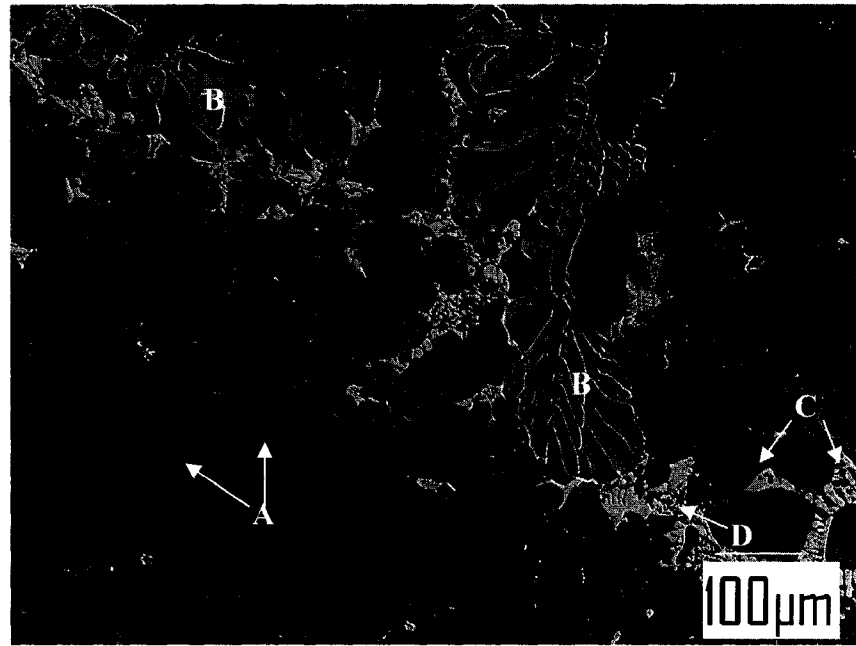
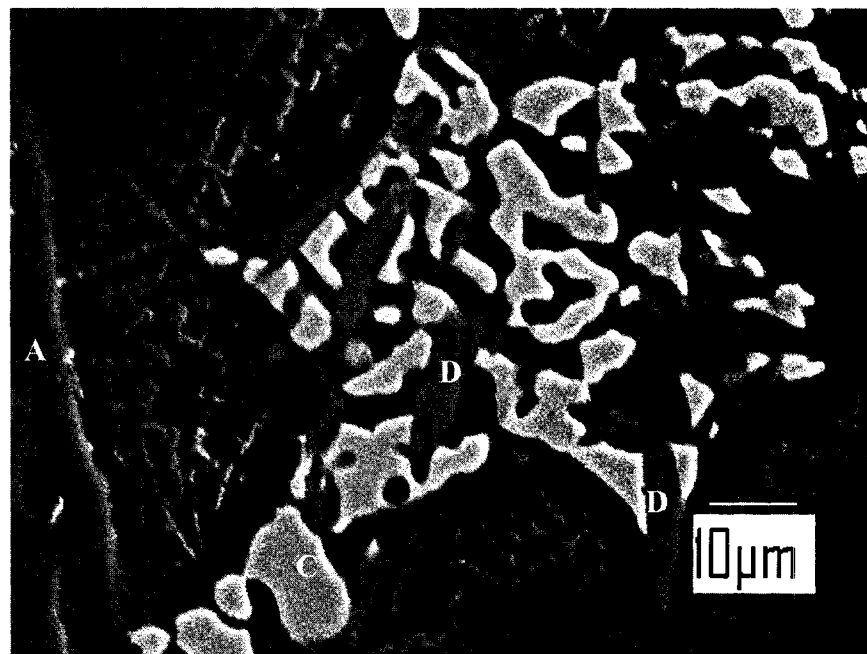
Figure 4.7 SEM microstructure shows various phases in the as-cast A13-S alloy. (a) x 200, (b) x 2000 [A: needle-shaped eutectic Si, B: $\text{Al}_{15}(\text{FeMn})_3\text{Si}_2$ (Chinese script), C: Al_2Cu , D: needle-shaped $\text{Al}_5\text{Mg}_8\text{Si}_6\text{Cu}_2$ plates existed between Al_2Cu phase, F: Cu-Fe-Mn-Si]

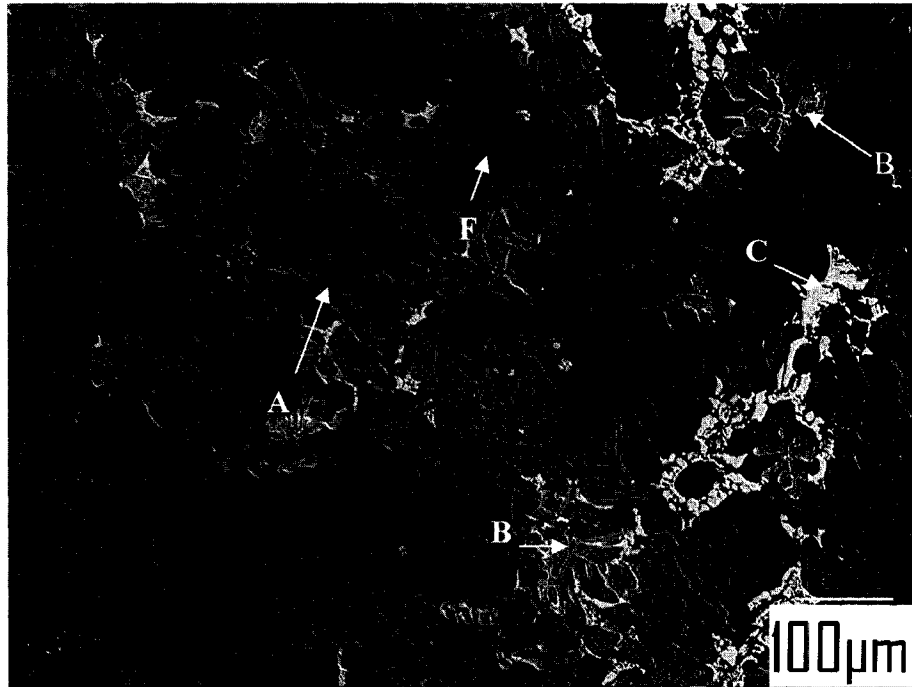
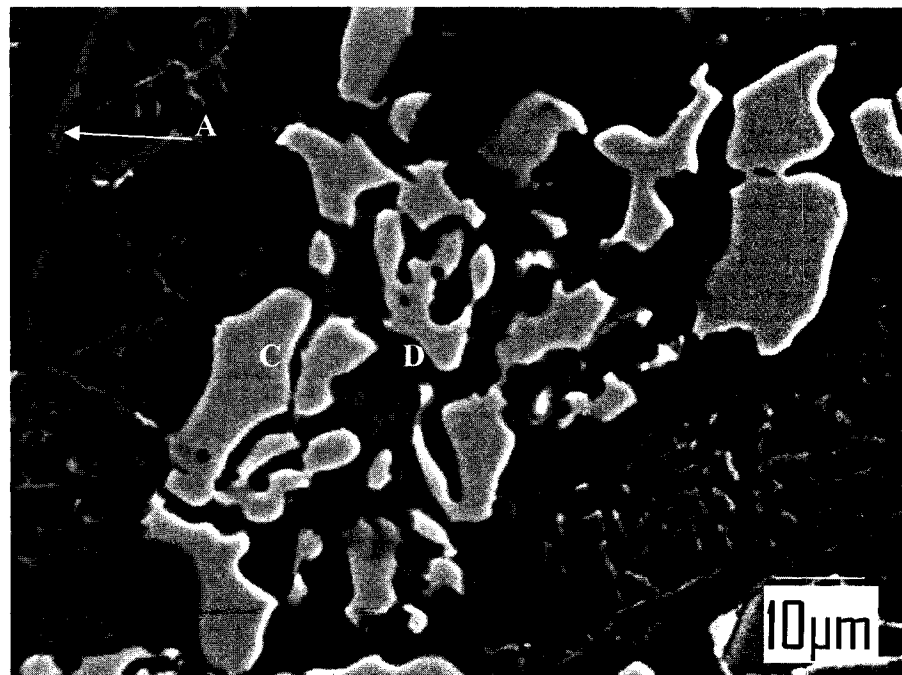
Figure 4.8 SEM microstructure showing various phases in the as-cast A13-Z alloy. (a) x 200, (b) x 2000 [A: Needle-shaped eutectic Si, B: $\text{Al}_{15}(\text{FeMn})_3\text{Si}_2$ phase, C: Al_2Cu phase, D: rounded $\text{Al}_5\text{Mg}_8\text{Si}_6\text{Cu}_2$ plates existed between Al_2Cu phase, F: Cu-Fe-Mn-Si]

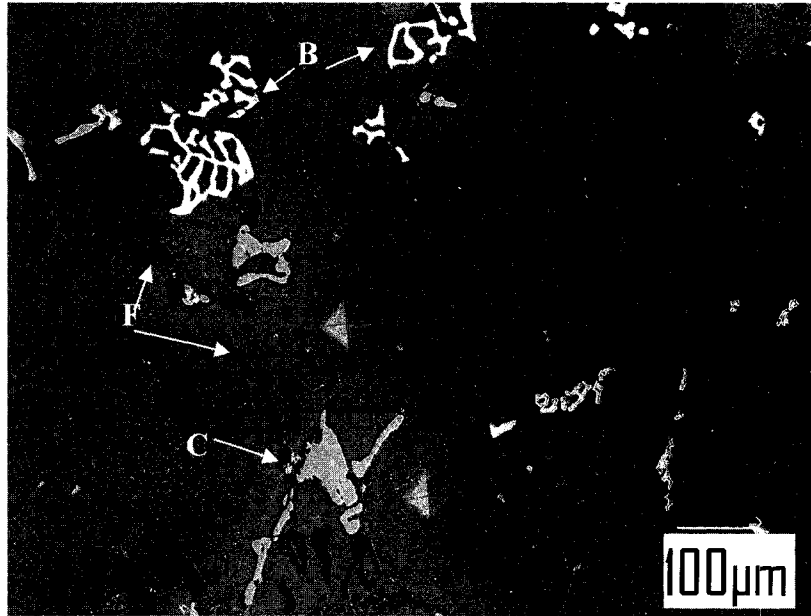
Figure 4.9 SEM microstructure showing various phases in A13-C-T6 alloy [B: $\text{Al}_{15}(\text{FeMn})_3\text{Si}_2$ phase, C: Al_2Cu phase, F: rounded eutectic Si]

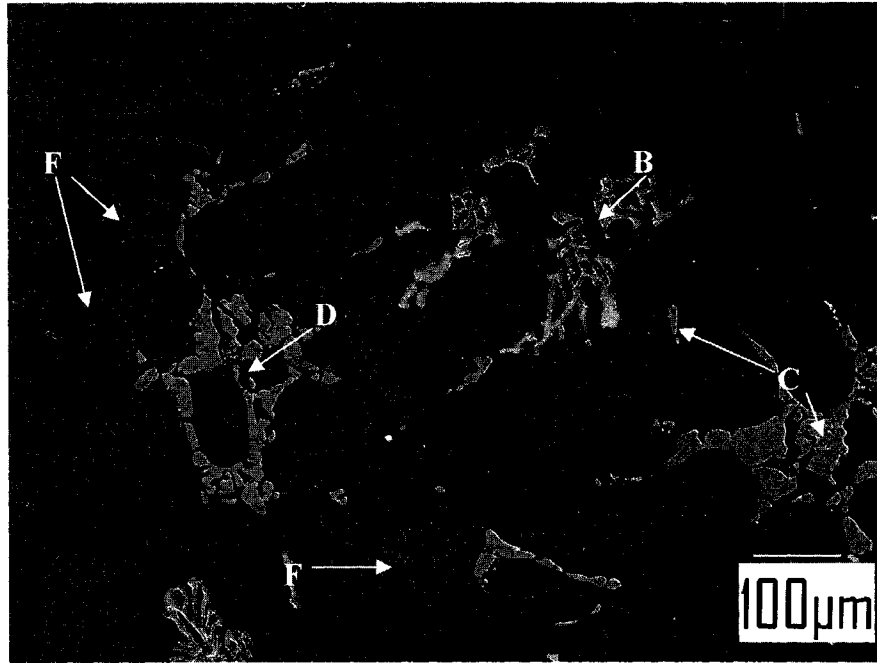
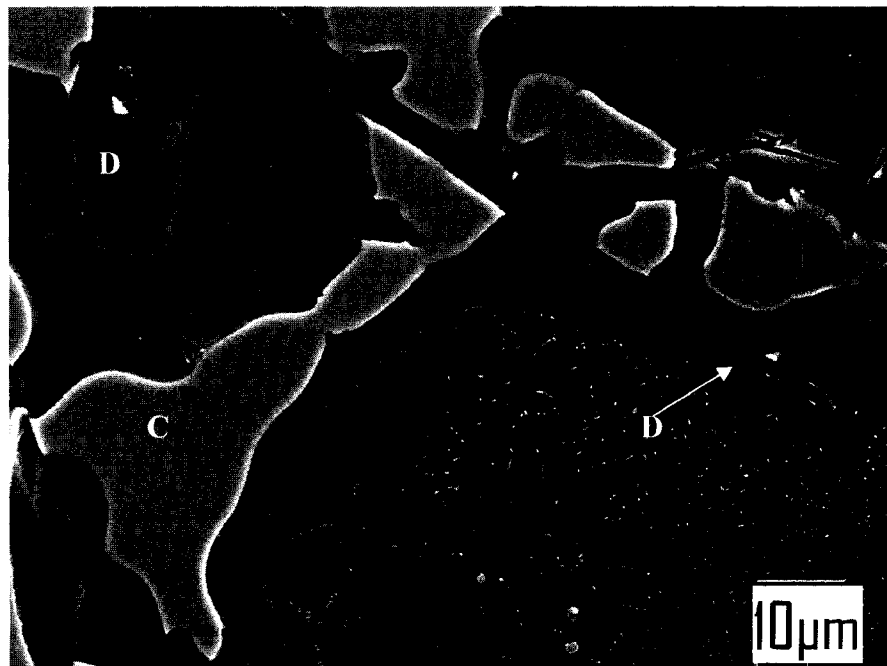
Figure 4.10 SEM microstructure shows various phases in A13-C-T6 alloy. (a) x 200, (b) x 2000 [B: $\text{Al}_{15}(\text{FeMn})_3\text{Si}_2$ phase, C: Al_2Cu phase, D: $\text{Al}_5\text{Mg}_8\text{Si}_6\text{Cu}_2$ phase, F: rounded eutectic Si]

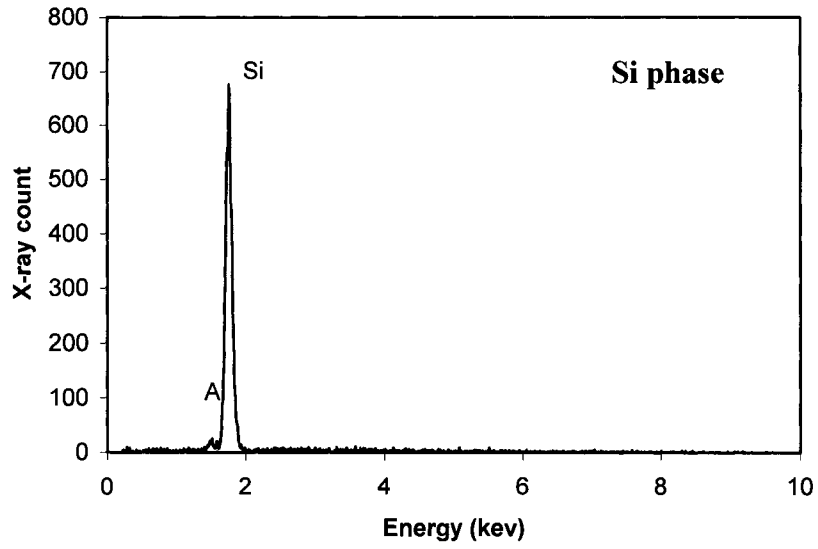
Figure 4.11 EDS spectrum of eutectic silicon (A and F)

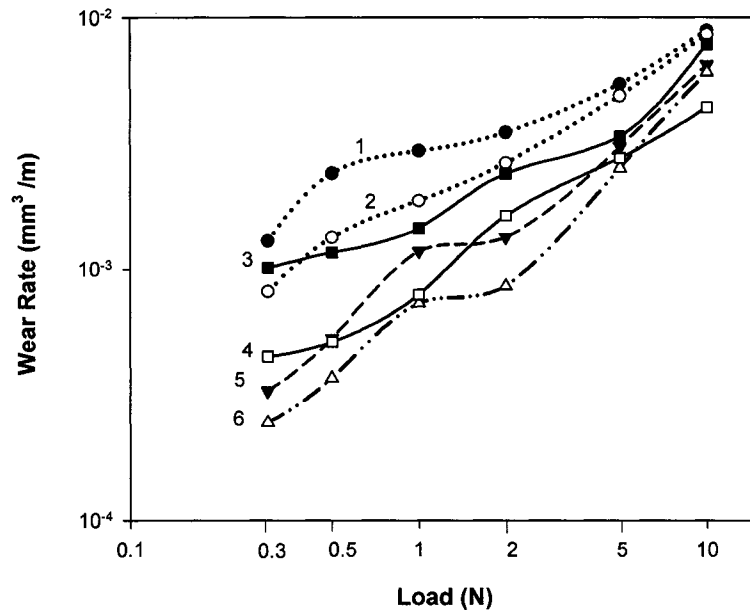
Figure 4.25 (1) Wear rates vs. load at different sliding velocities (1: Al-13-S, 2m/s; 2: Al-13-C-T6, 2m/s; 3: Al-13-S, 1m/s; 4: Al-13-C-T6, 1m/s; 5: Al-13-S, 0.2m/s; 6: Al-13-C-T6, 0.2m/s)

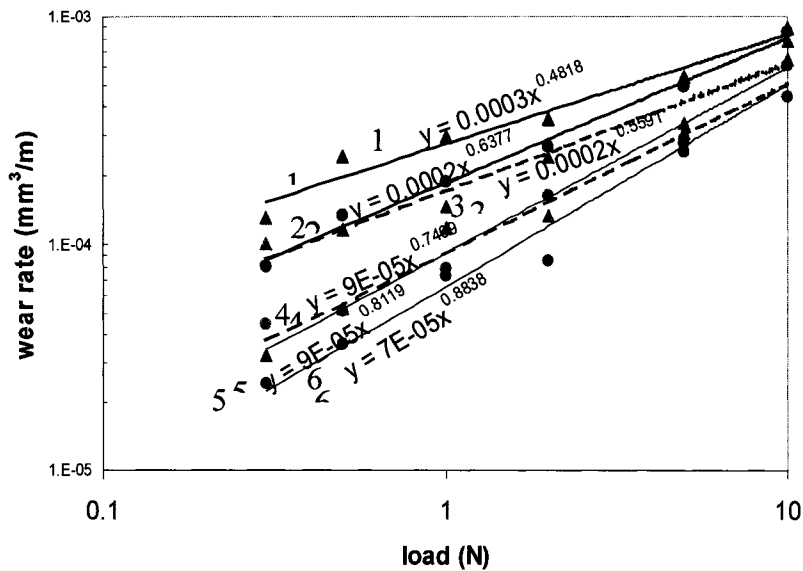
Figure 4.25 (2) Power law of volume loss of the four materials vs. sliding distance in Figure 4.25 (1). (1: Al-13-S, 2m/s; 2: Al-13-C-T6, 2m/s; 3: Al-13-S, 1m/s; 4: Al-13-C-T6, 1m/s; 5: Al-13-S, 0.2m/s; 6: Al-13-C-T6, 0.2m/s)

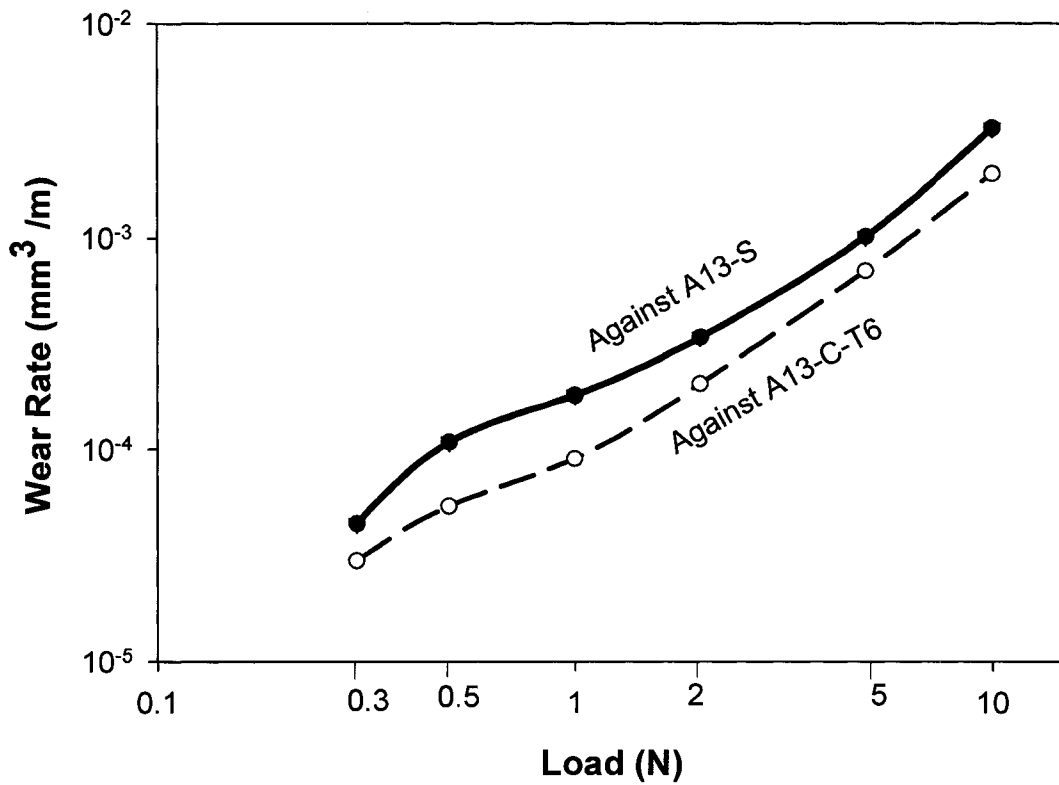
Figure 4.26 Wear rates of AISI 52100 counterface rings against A13-C-T6 and A13-S alloys.

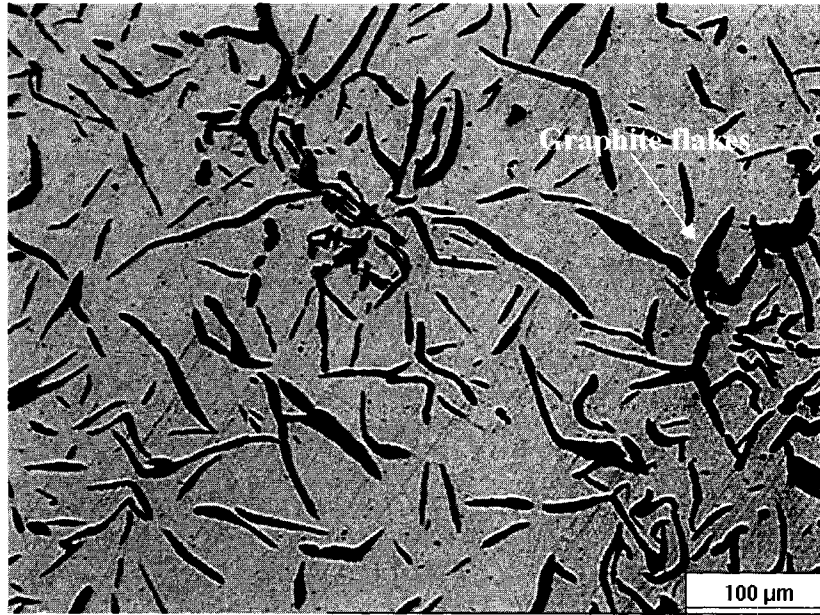
Figure 4.27 Microstructure of the AISI A40 cast iron

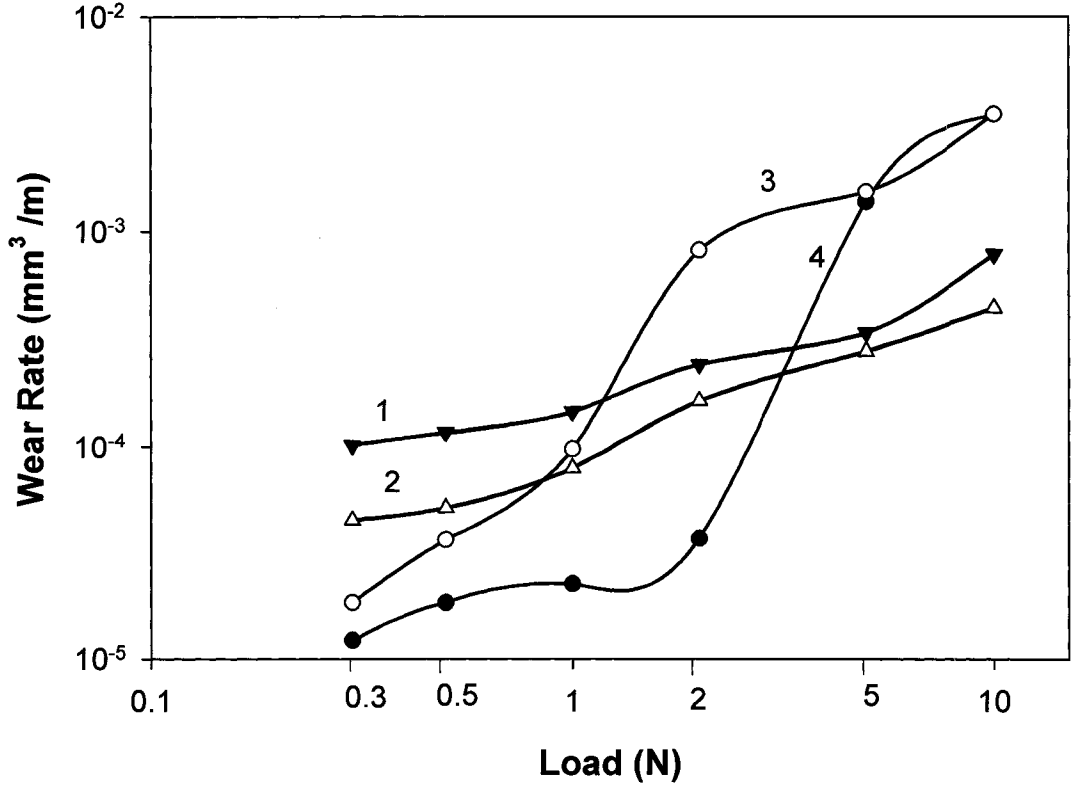
Figure 4.28 Wear rates of A13-C-T6 and A13-S against cast iron rings at 1m/s. (Wear rates against 52100 steel rings at 1m/s were also plotted as a comparison; 1: 52100 steel ring against A13-S sample; 2: 52100 steel ring against A13-C-T6 sample; 3: cast iron ring against A13-S sample; 4: cast iron ring against A13-C-T6 sample)

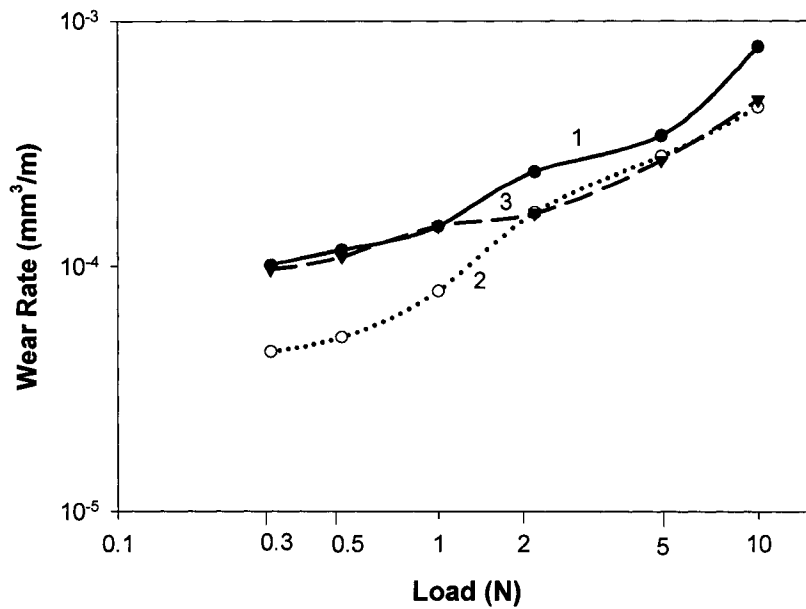
Figure 2.29 (1) Wear rates as a function of load for Al-Si alloys with different matrix hardness (1: A13-S; 2: A113-C-T6; 3: A113-C-T6-AN)

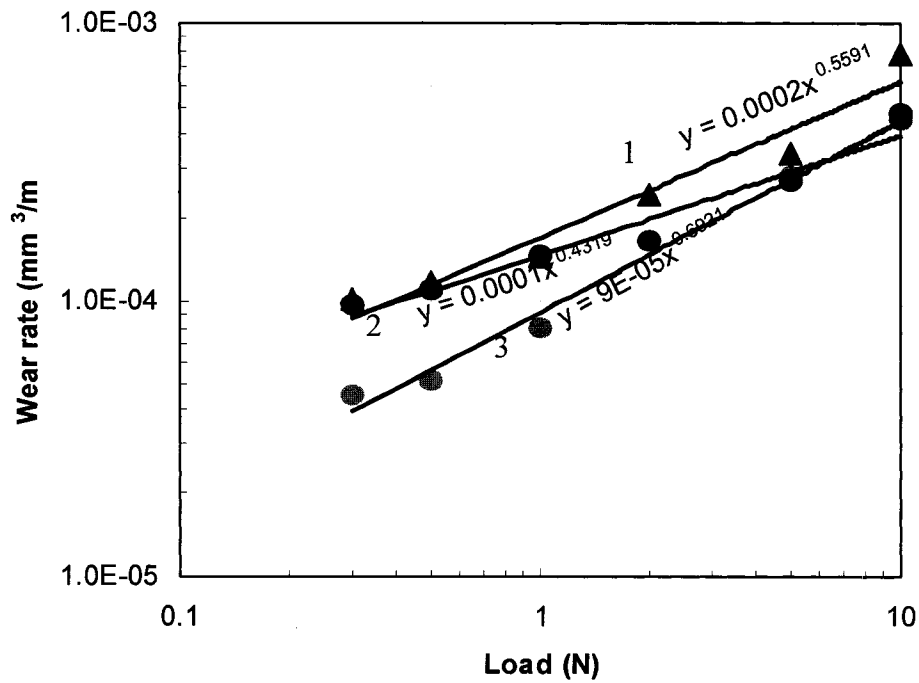
Figure 2.29 (2) Power law of wear rates as a function of load for Al-Si alloys with different matrix hardness (1: A13-S; 2: A113-C-T6; 3: A113-C-T6-AN)

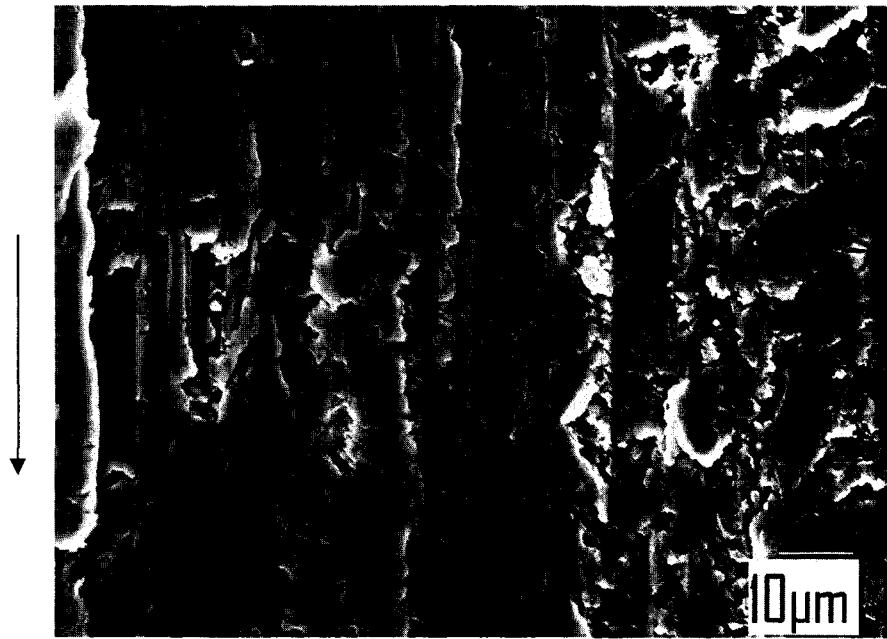
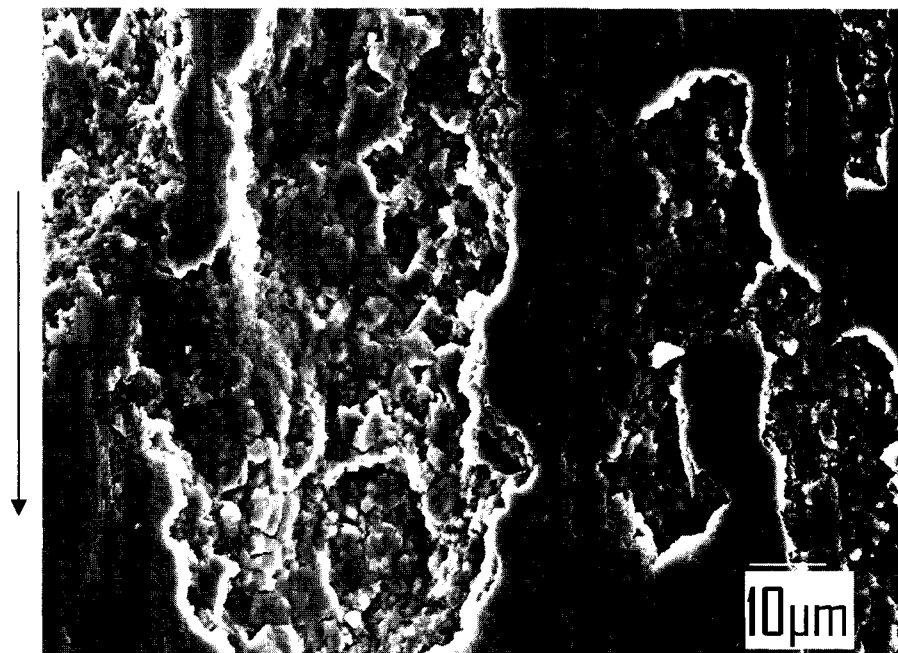
Figure 4.31- a) SEM worn surface micrograph of A13-C-T6 at high magnification; b) SEM worn surface of A13-S at high magnification. (0.3N, counterface AISI 52100 steel ring).

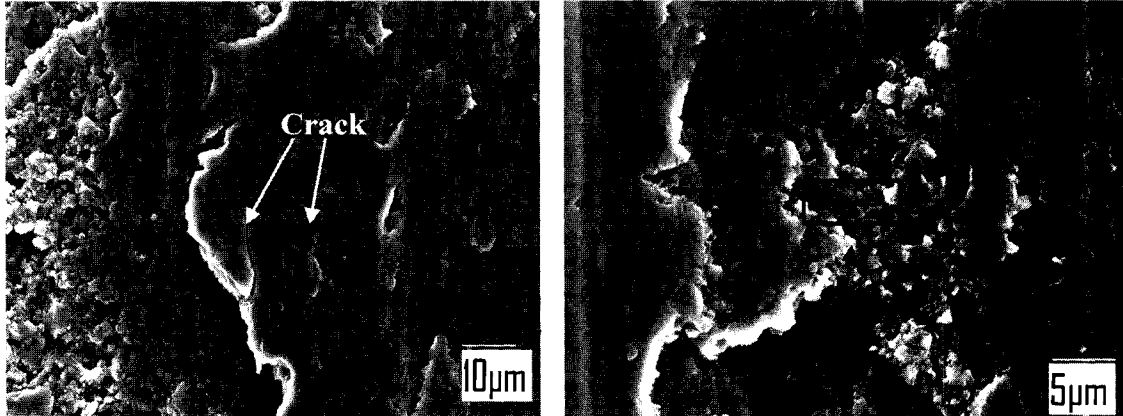
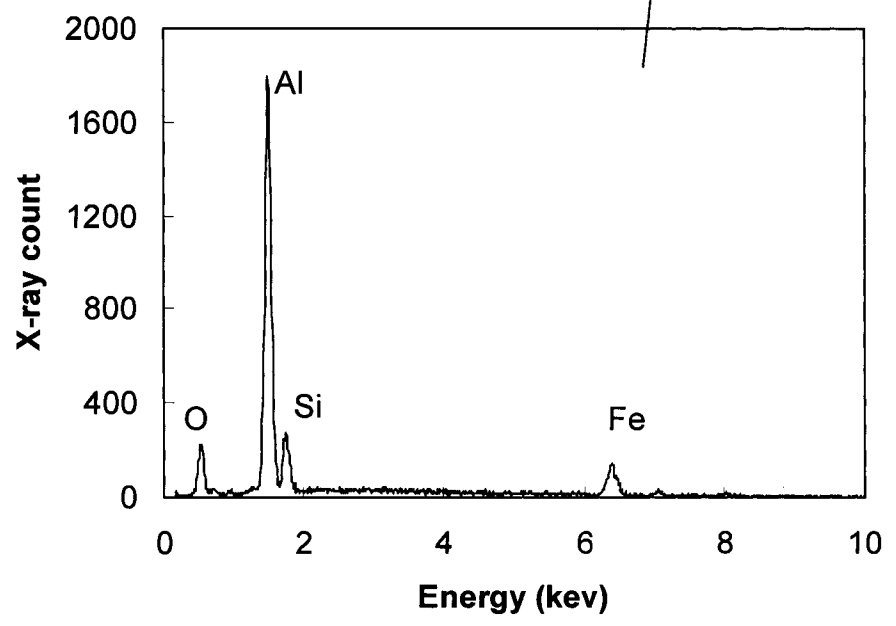
Figure 4.32- a) Arrows on the worn surface at high magnification shows micro-cracks in A13-C-T6 sample (2N); b) Top view of the mechanically mixed layer in a crater (A13-C-T6, 2N); c) EDS spectrum from the area marked by box on the SEM image Figure 4.32 (b) identified large amount of O element.

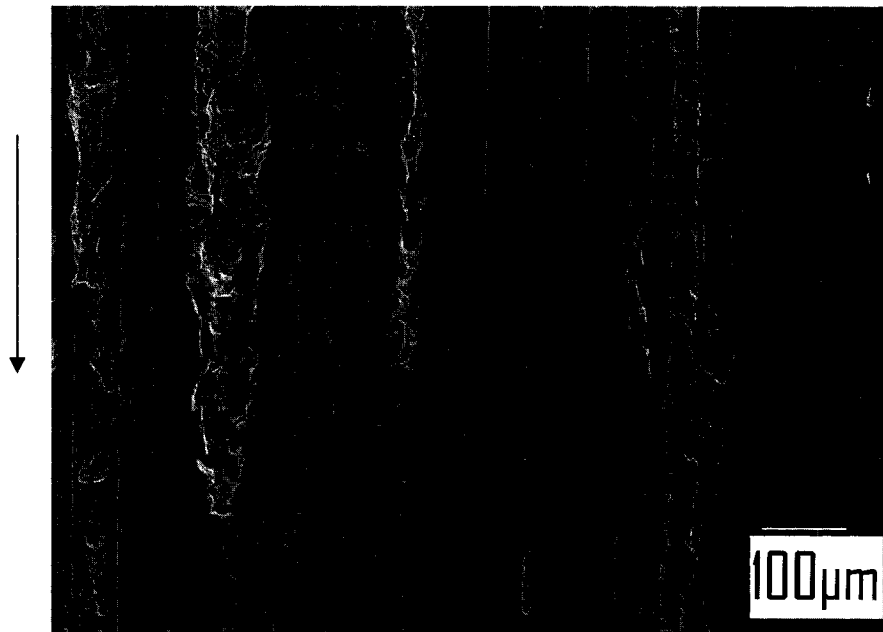
Figure 4.33- a) Worn surface of A13-C-T6 shows polished appearance (2N, counterface A40 cast iron ring); b) Worn surface of A13-C-T6 shows ploughed topographies (5N, counterface A40 cast iron ring).

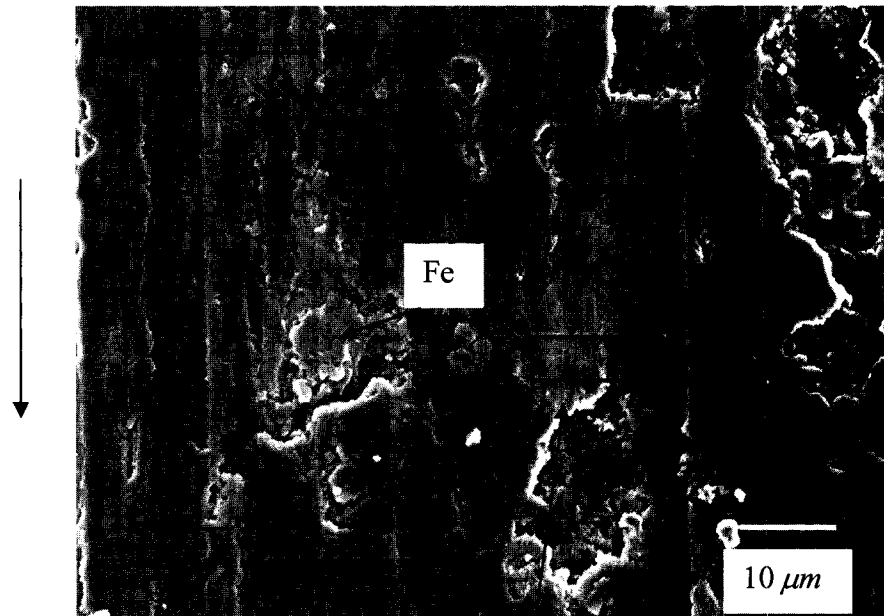
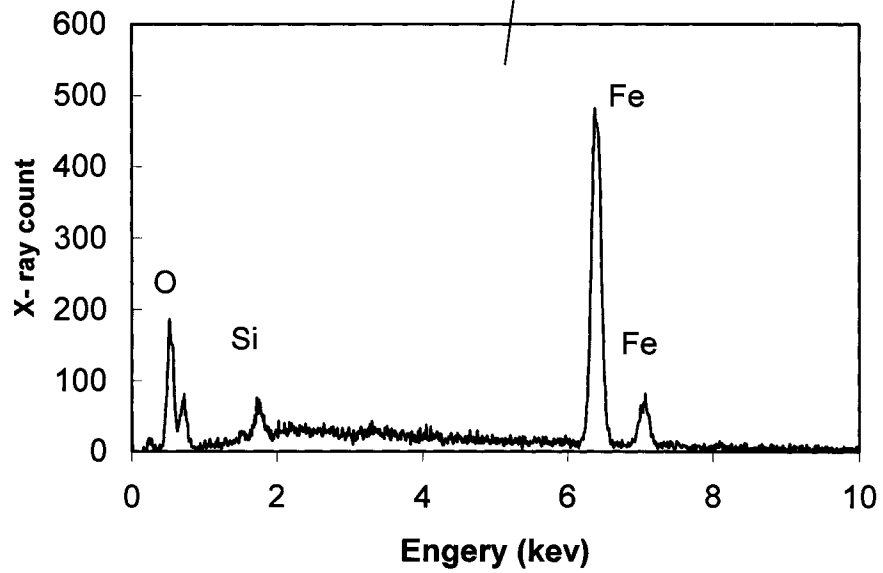
Figure 4.34- (a) Smeared transferred layer on the A13-C-T6 worn surface (5N, 1m/s); b) EDS spectrum identified that this smeared layer in Figure 4.34 (a) was Fe containing large amount of O element.

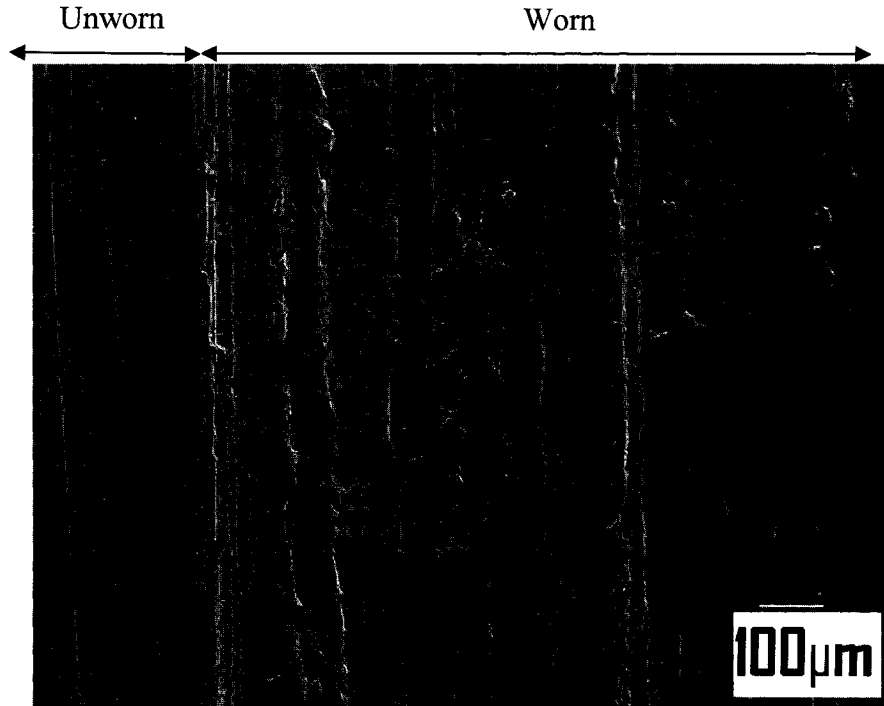
Figure 4.36 Worn surfaces of cast iron rings against A13-C-T6, (a) 5N, (b) 2N
