**WEAR AND SCUFFING RESISTANCES OF EUTECTIC
Al-Si ALLOYS AND Al-Si BASED COMPOSITES**

A Thesis

Submitted to the Faculty of Graduate Studies and Research
through Engineering Materials
in Partial Fulfillment of the Requirements for
the Degree of Master of Applied Science at the
University of Windsor

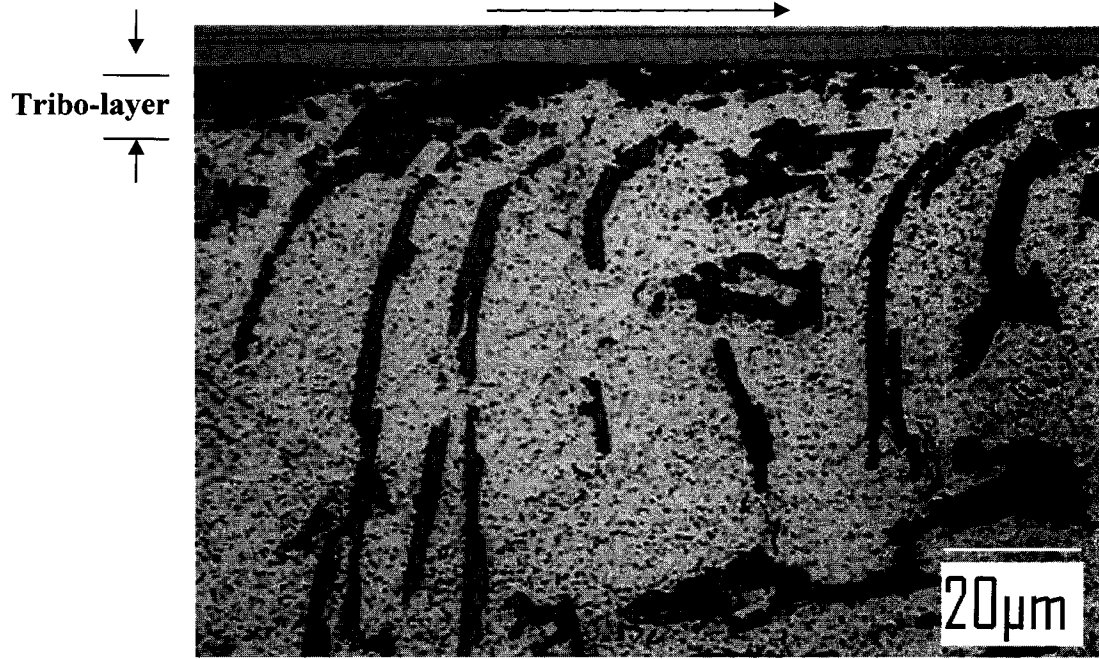
Figure 4.40- a) Secondary SEM image of debris of A13-S (5 N, 1m/s, counterface cast iron ring); -b) Backscattered SEM image Figure 4.40a; c) EDS spectrum from the indicated area in Figure 4.40 (a); EDS spectrum from the indicated area in Figure 4.40 (b).

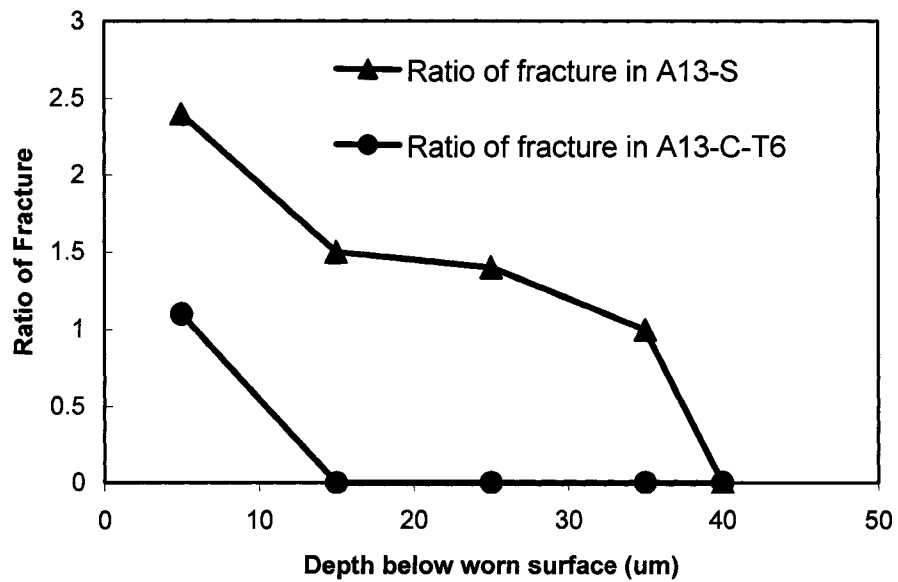
4.43 a) Silicon particle fracture at different depth (10N, 1m/s); b) ratio of Si particle fracture at different depth.

- Fractured Si=Number of fractured Si particles/overall Si particles within the depth.
- Ratio of fracture = Number of fragments of each Si particle/number of fractured Si particles within the depth.

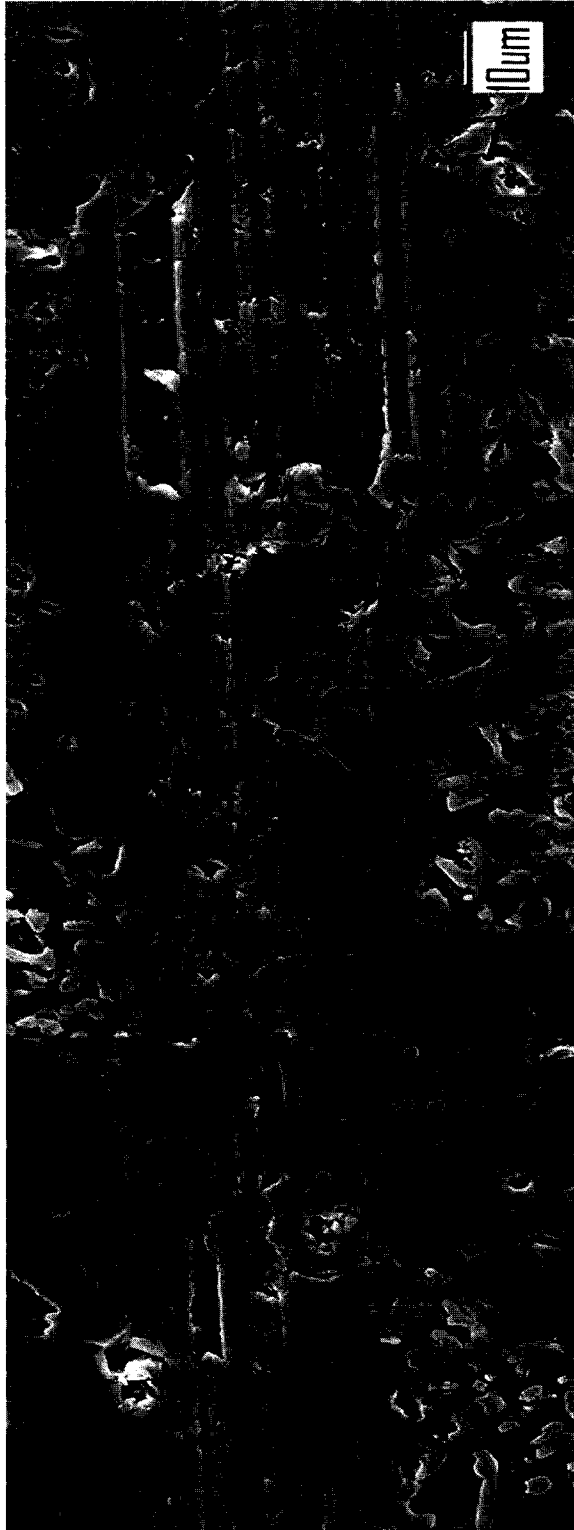
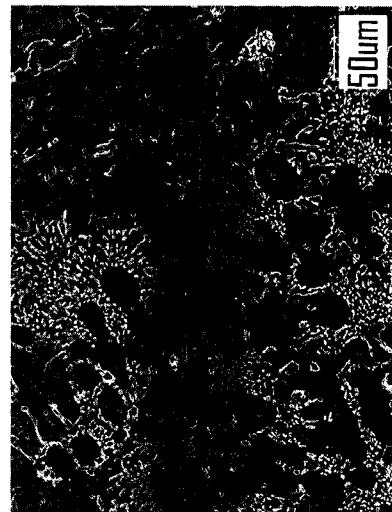
Figure 4.50 Topography of scratched surfaces at 5N, lubricated test. (a) A13-S, (b) A13-C-T6

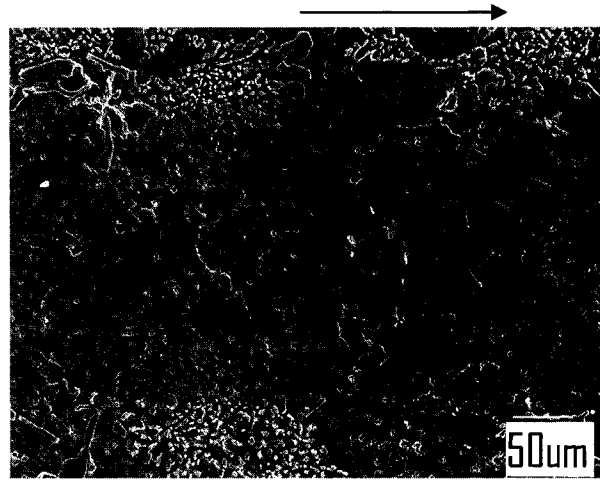
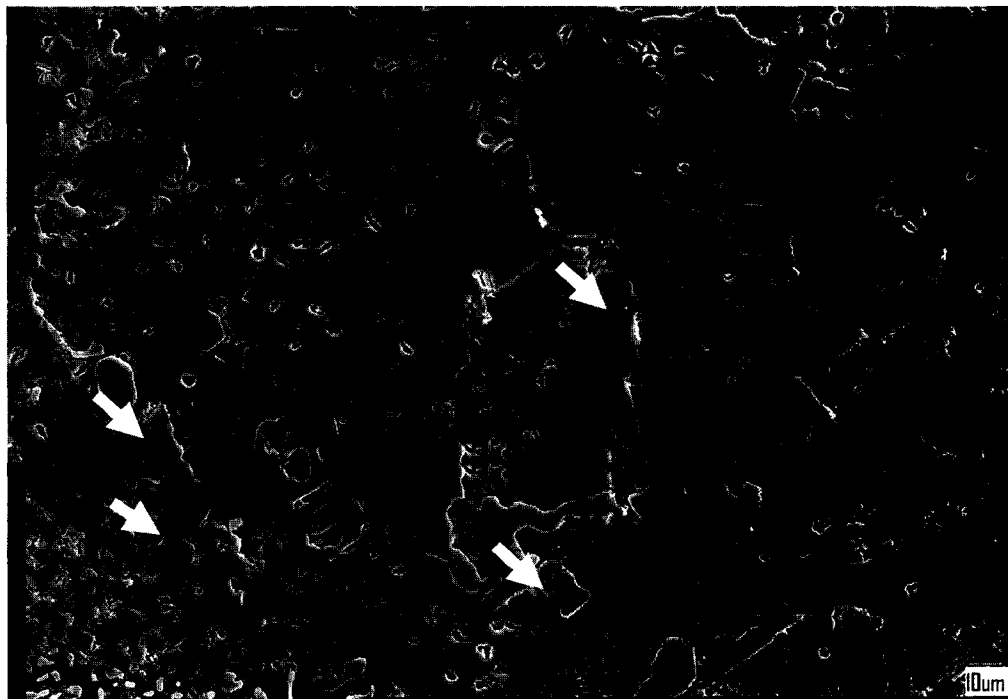
Figure 4.51 Scratch topographies of A13-C-T6-AN (a) dry scratch, (b) lubricated scratch. Arrows in (b) indicated the particle fracture.

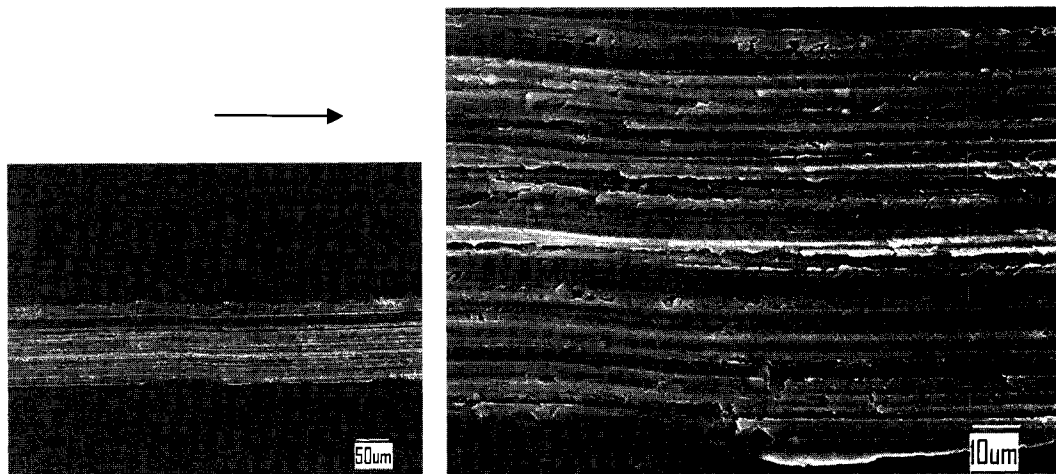
Figure 4.52 Topography of A6061 Al scratch surface. (a) dry scratch at 0.5N, (b) lubricated scratch at 5N.

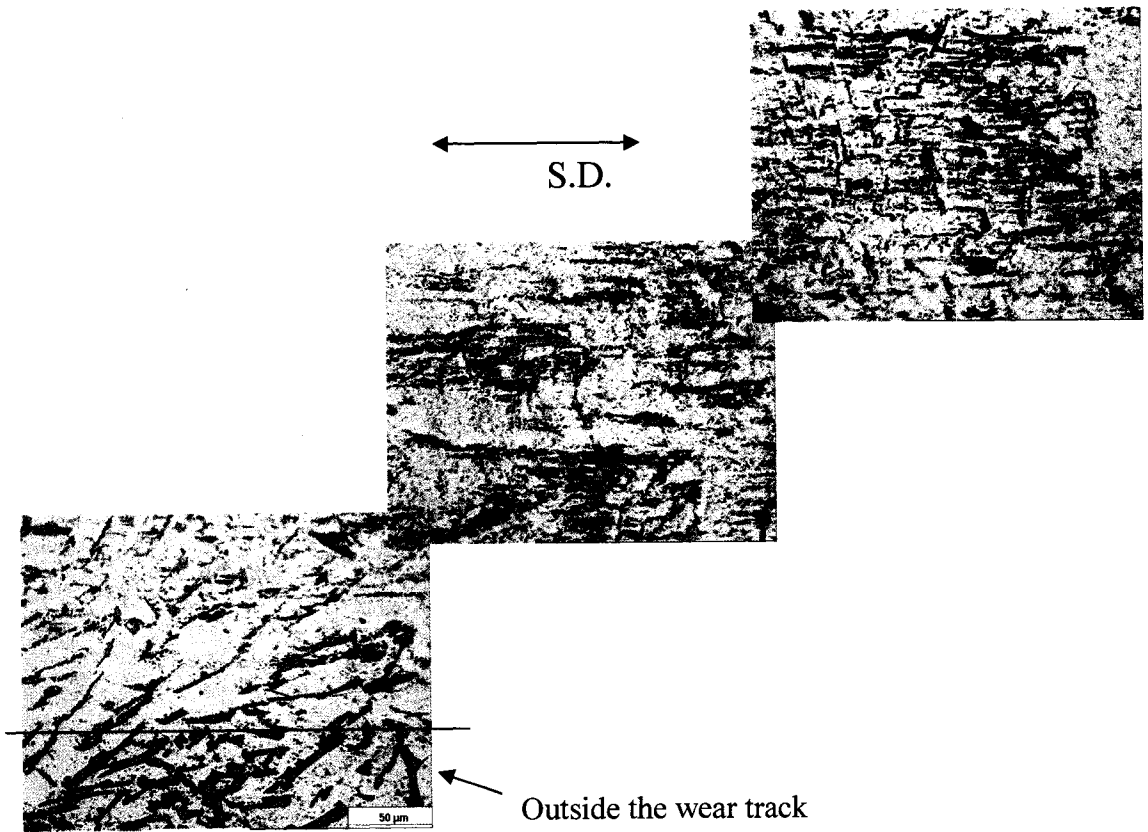
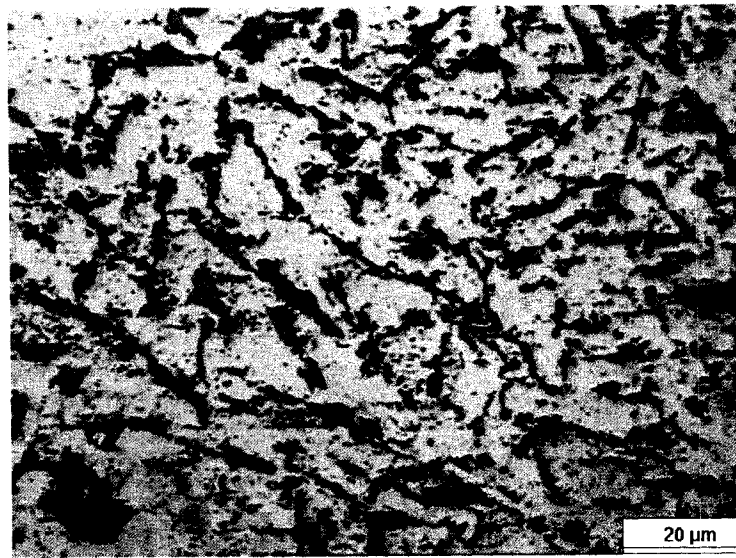
Figure 4.54 Topographies of worn surface of A13-S after 2.16Km reciprocating wear at 0.72m/s velocity, 150 °C. (a) x500, (b) x1000.

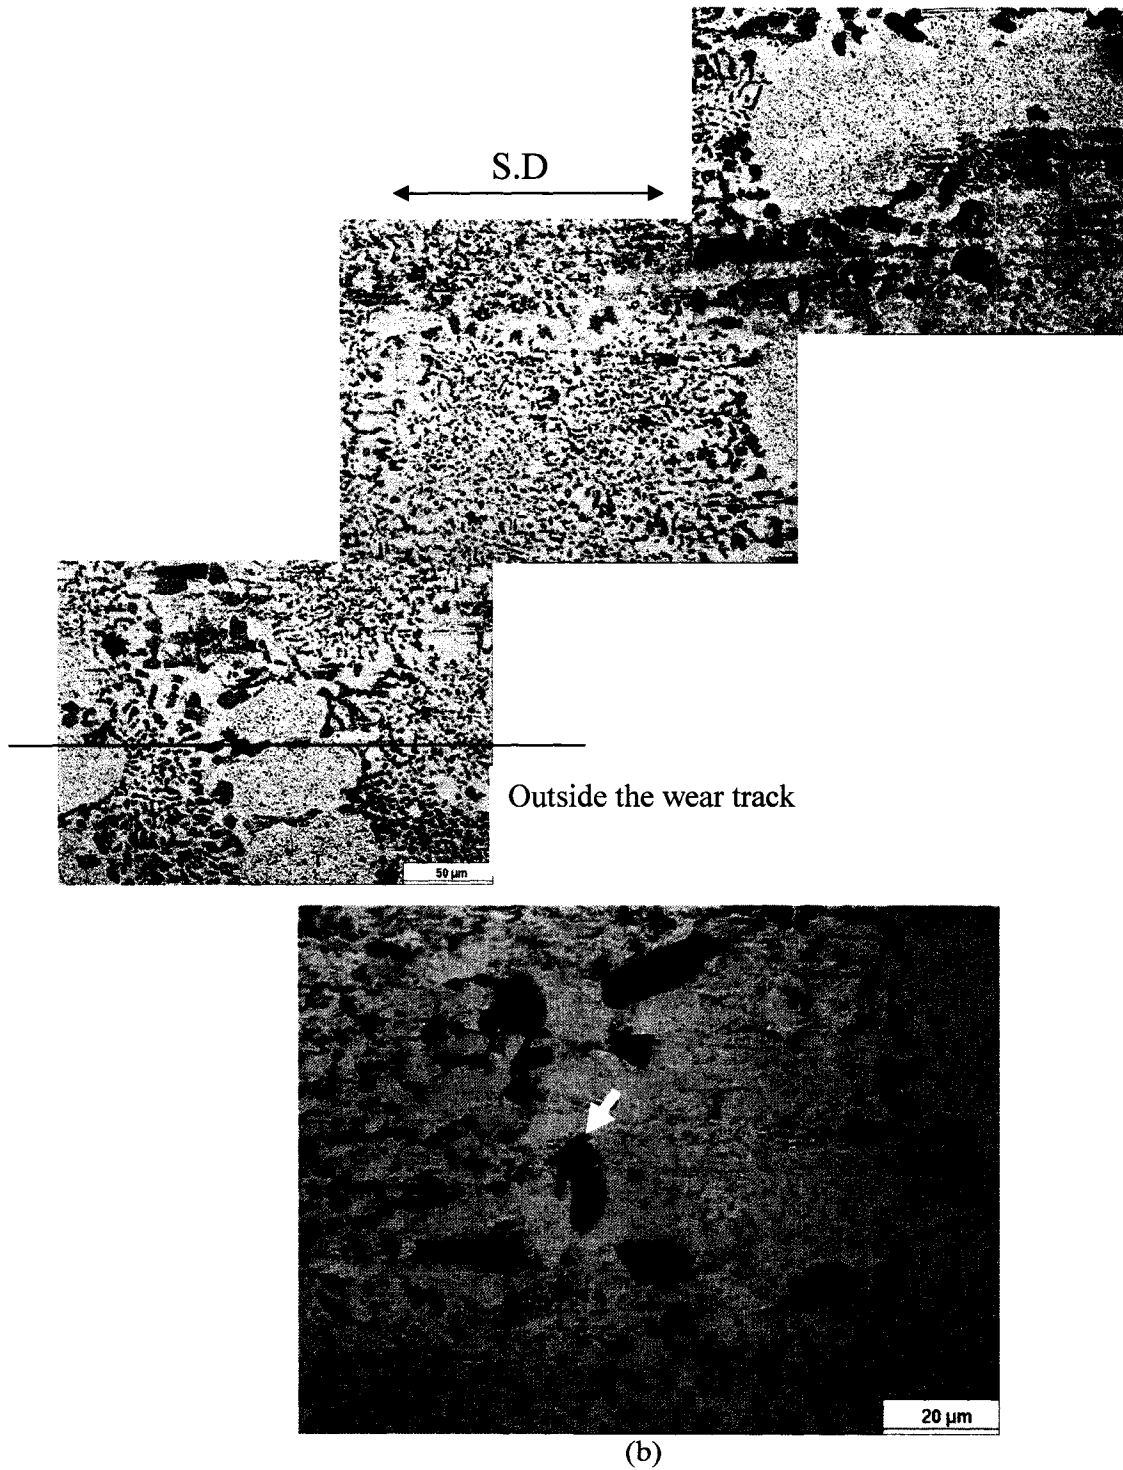
(b)
 Figure 4.55 Topographies of worn surface of A13-C-T6 after 2.16Km reciprocating wear at 0.72m/s velocity, 150 °C. (a) x 500, (b) x 1000. The arrow showed the grooved Si particle.

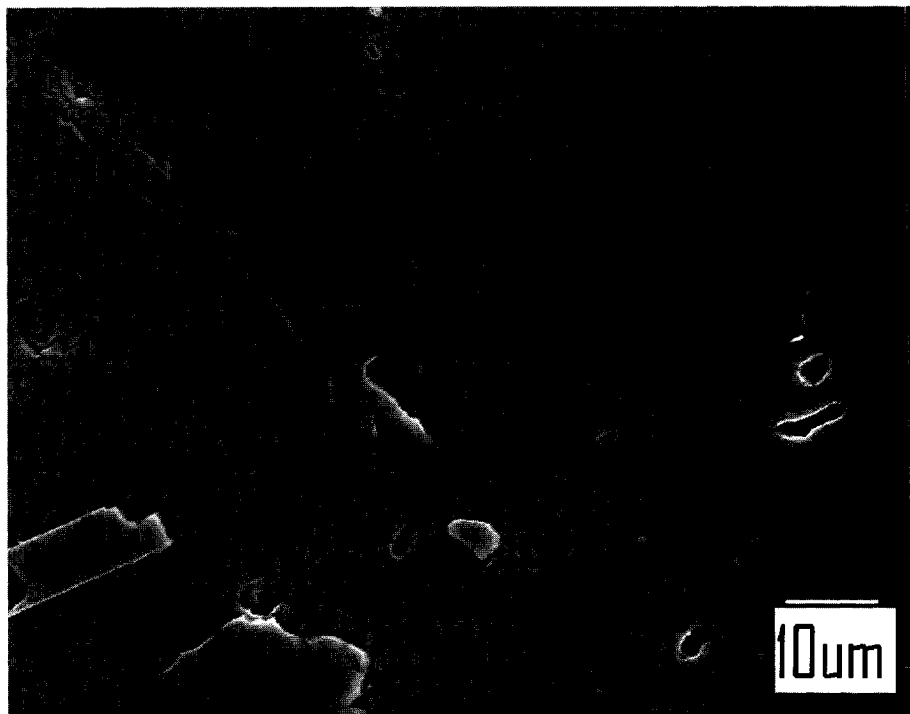
Figure 4.56 SEM morphology of worn surfaces. (a) The needle-shaped Si particles in A13-S are fractured and grinded; (b) The round-shaped Si particles in A13-C-T6 underwent minimal damage with aluminum smeared over the surfaces.

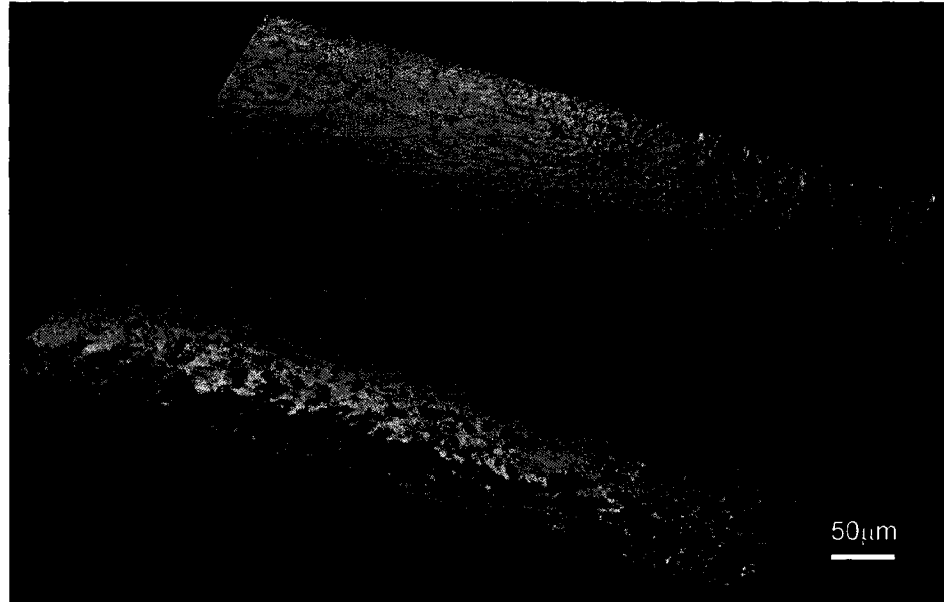
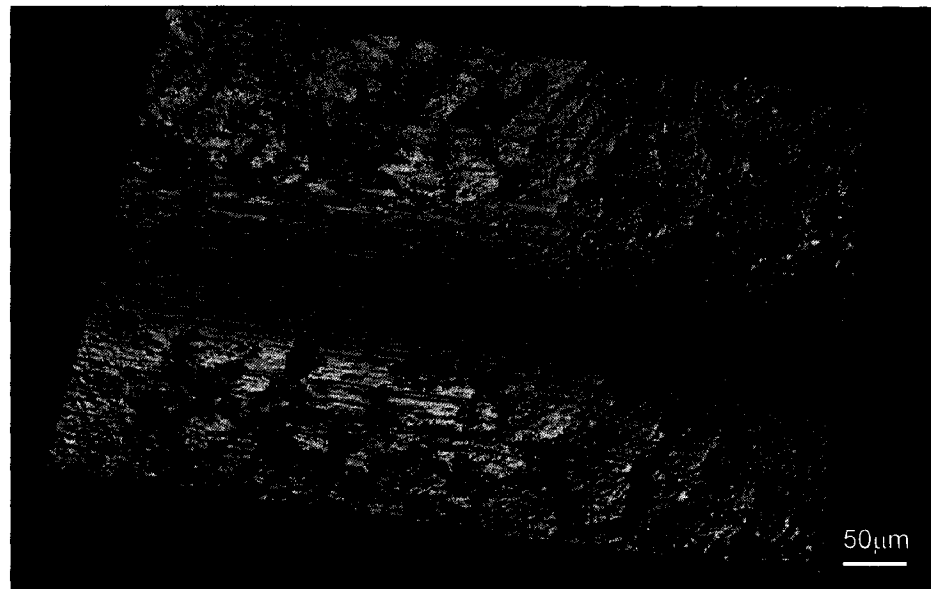
Figure 4.57 WYKO 3D images of scratch tracks. (a) A13-S, (b) A13-C-T6 after 2.16km wear test at 0.72m/s, 150 °C, lubricated condition.

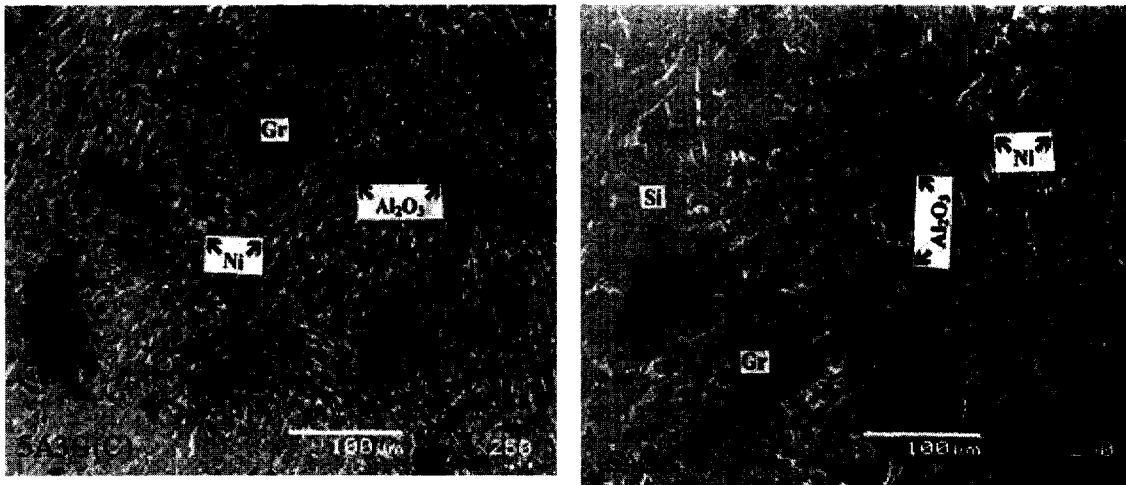
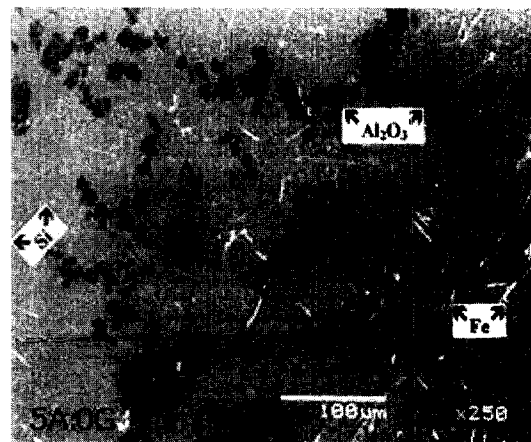
Figure 5.1 Microstructures of the Al-Si based composite materials

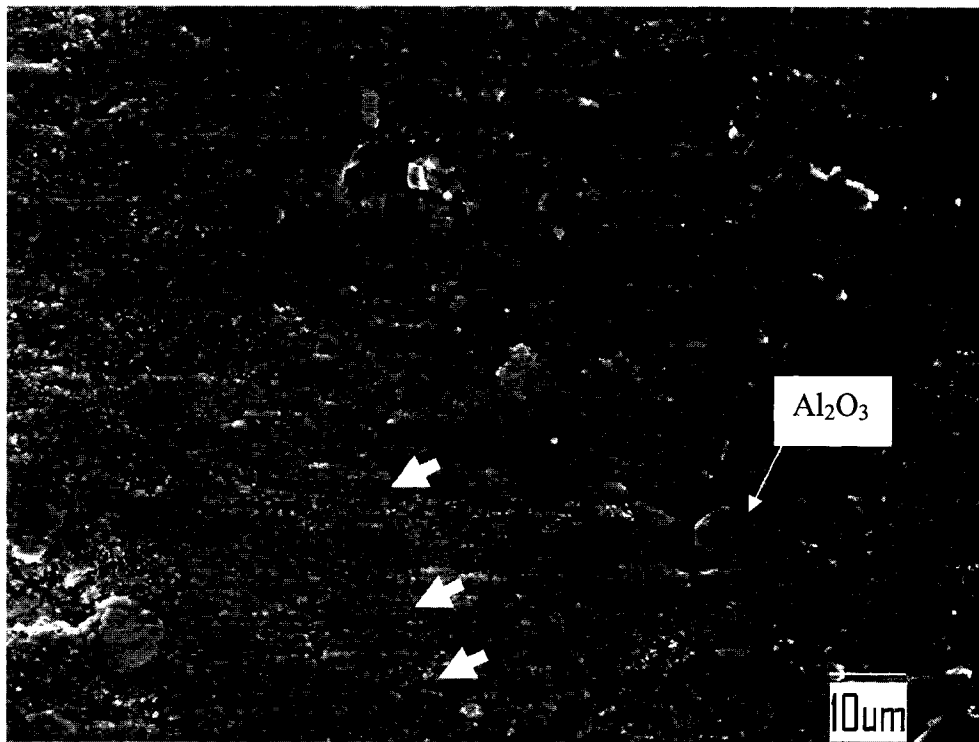
Figure 5.3 Topography of 5A3G(C) in high magnification from A in Figure 5.2 (350N). Arrows showed the deformation zone in the dark area marked A.

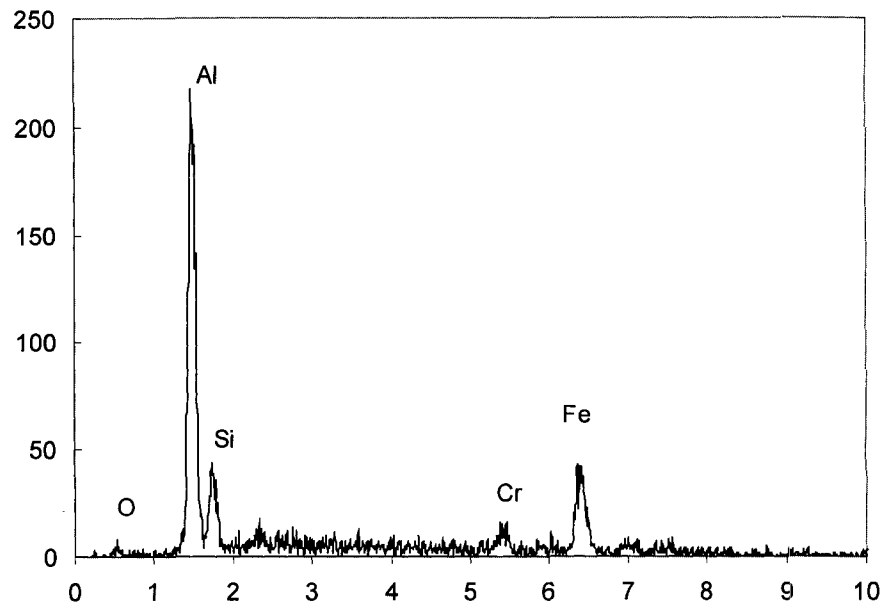
Figure 5.4 EDS from the 5A3G (C) worn surface.

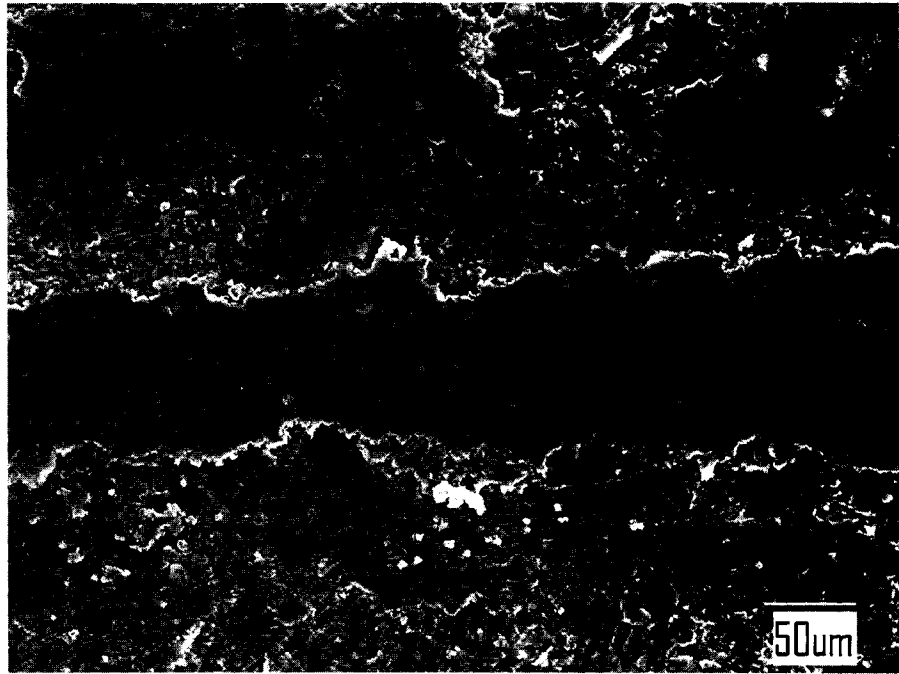
Figure 5.5 Compacted smeared layer from A in Figure 5.2 (350N)

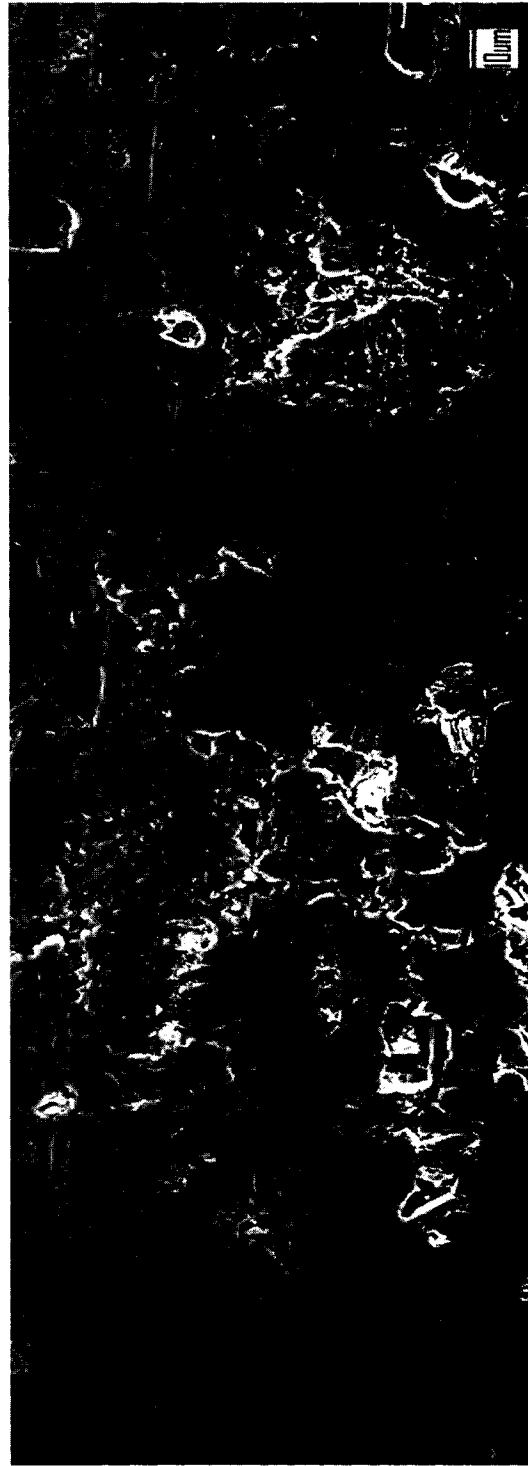
Figure 5.6 High magnification topography of B in Figure 5.2 (350N)

load-step, shiny-metal spots appeared in the darkened areas and eventually some of them advanced and formed a continuously metallic band structure (B in Figure 5.2). Figure 5.6 shows the shiny band structure at high magnification. Light grooving and scratching developed in the polished areas. Normal stresses compressed and flattened the contacting areas. The development of the fresh-metallic zone on one side of the specimen indicated that catastrophic wear would be initiated in this area.

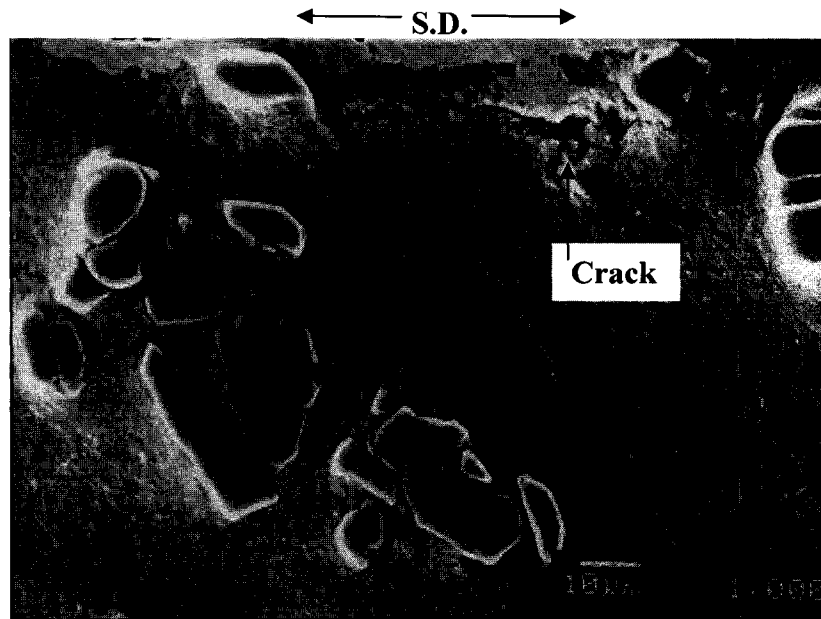
Figure 5.15 Cross section of worn surface: crack under 5A3G (C) scuffed surface.

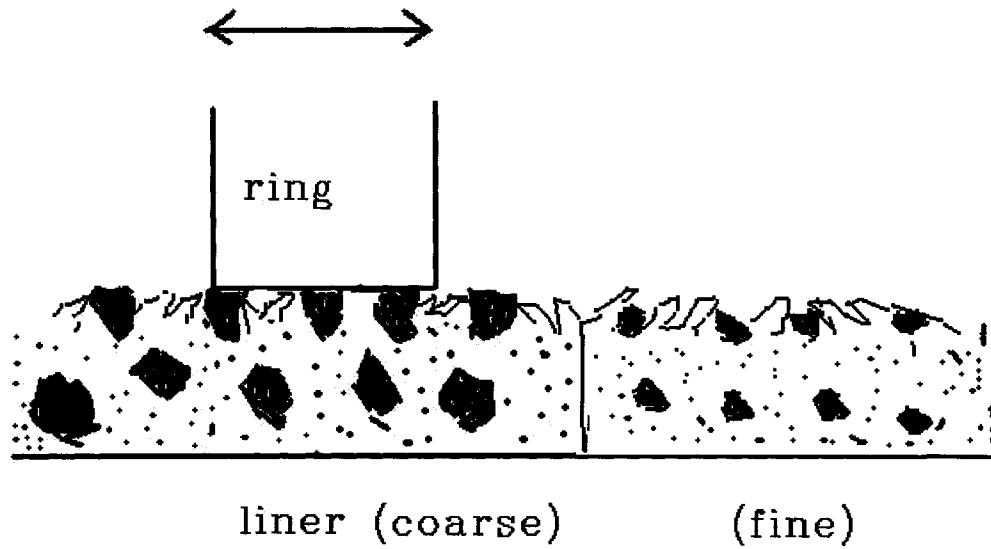
Figure 5.16 Illustration of influence of particle size on scuffing.

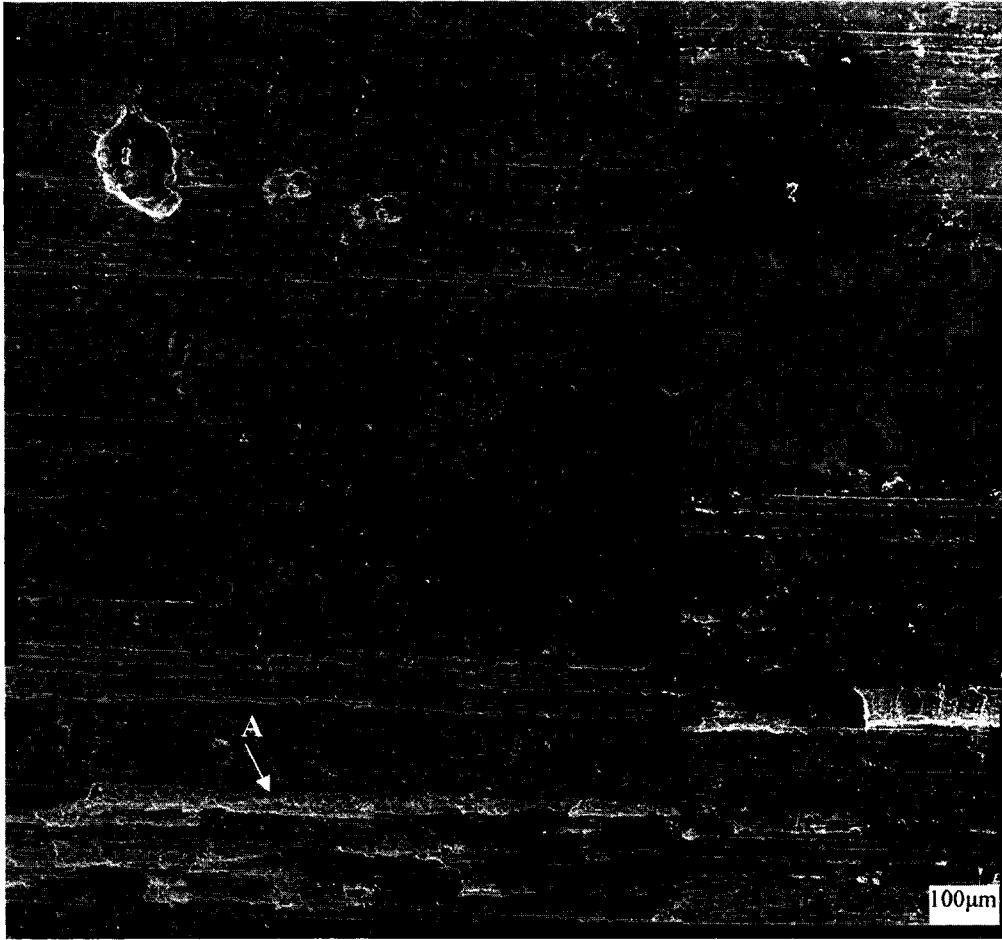
Figure 5.18 M2 counterface against the A13-S specimen (x100). Large amount of transferred aluminum was welded on the top of the counterface area.

Counterface observations have shown that the top area of the M2 roller against A-13-S specimen was flattened. Large amount of aluminum transferred onto the counterface (Figure 5.18). On the surface of the M2 counterface against A13-C-T6 alloy, however, aluminum transfer was minimal (Figure 5.20), although ploughing marks were found on the surface.

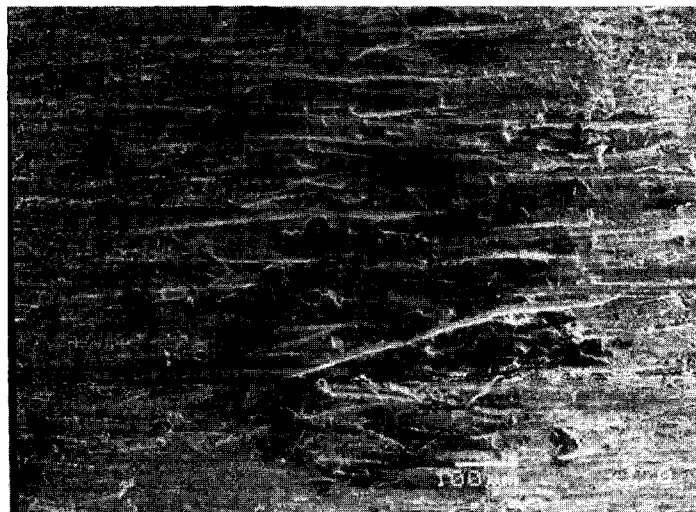
Figure 5.20 Worn surface of the M2 counterface against A13-C-T6 specimen (x100). Small amount of transferred aluminum and debris attached on the scuffed counterface.
