Investigation of wear and scuffing behaviour of ferrous thermal spray coatings for aluminum engines.

**INVESTIGATION OF WEAR AND SCUFFING BEHAVIOUR OF
FERROUS THERMAL SPRAY COATINGS
FOR ALUMINUM ENGINES**

**A Dissertation
Submitted to the Faculty of Graduate Studies and Research
through Engineering Materials in Partial Fulfillment of the Requirements
for the Degree of Doctor of Philosophy at the
University of Windsor**

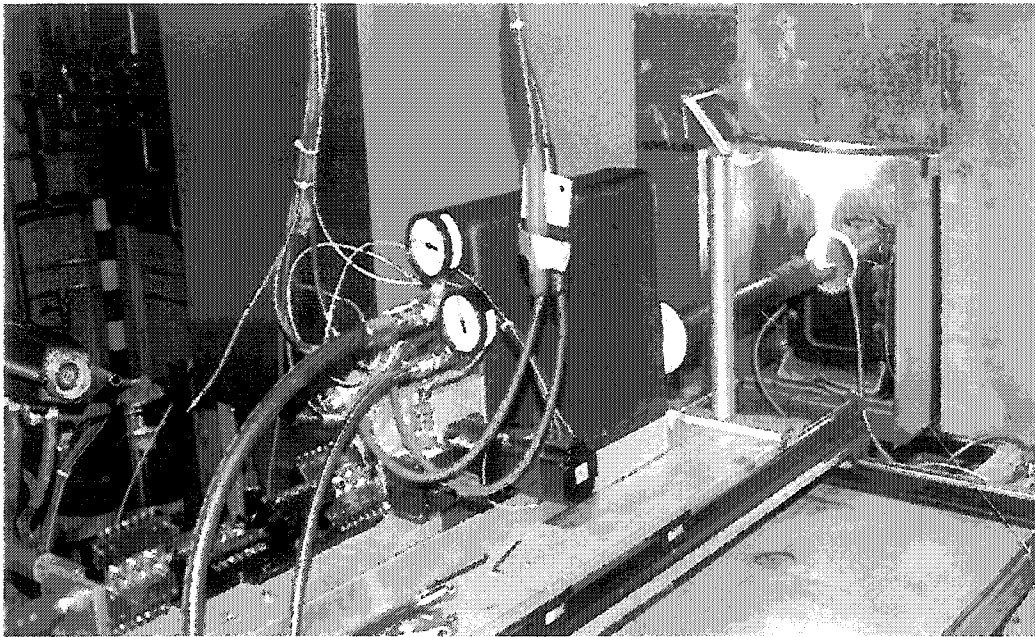
Fig. 3.1- The PTWA set up used to coat inner surfaces of the cylinder bores. This set up is located at the General Motors Research and Development Centre, Warren, MI.

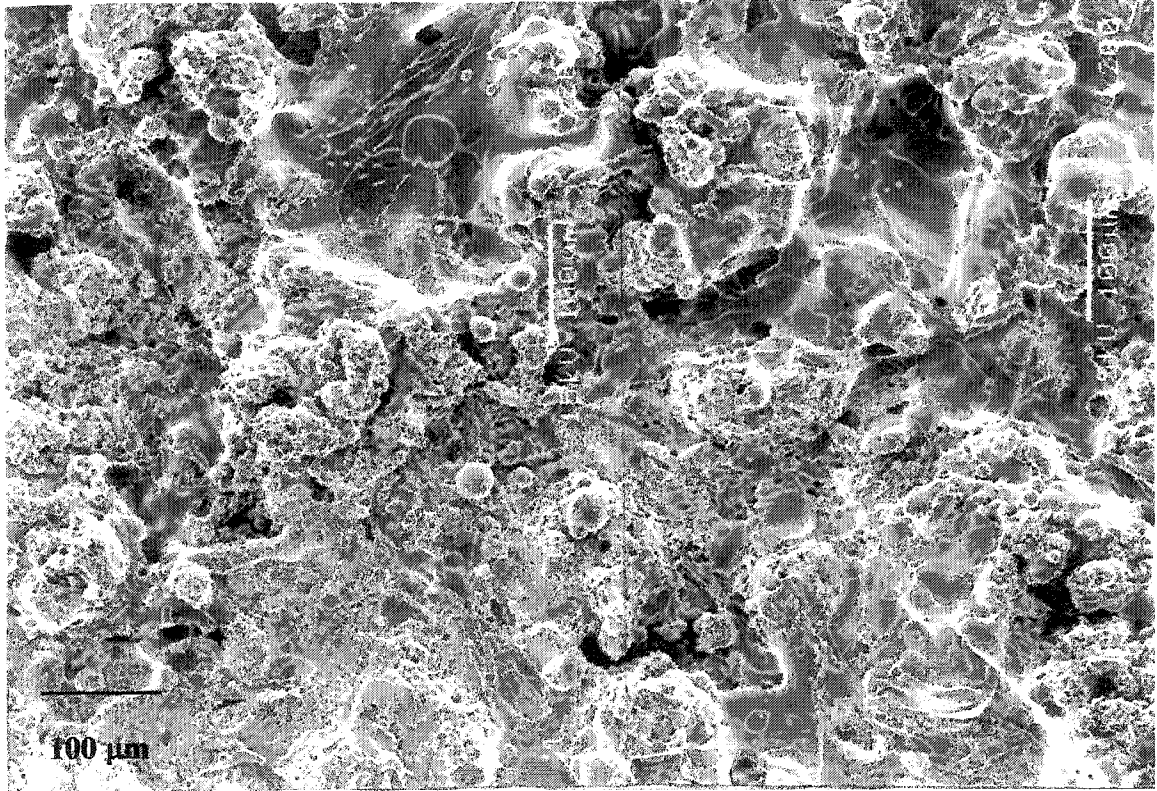
Fig. 4.1- A typical secondary electron SEM image of the surface of the PTWA 1020 coating in the as-deposited condition shows that the surface is very rough after the thermal deposition process.

A typical secondary electron SEM image of the surface of the PTWA 1020 in the as deposited condition shows that the surface is very rough after the thermal deposition process.

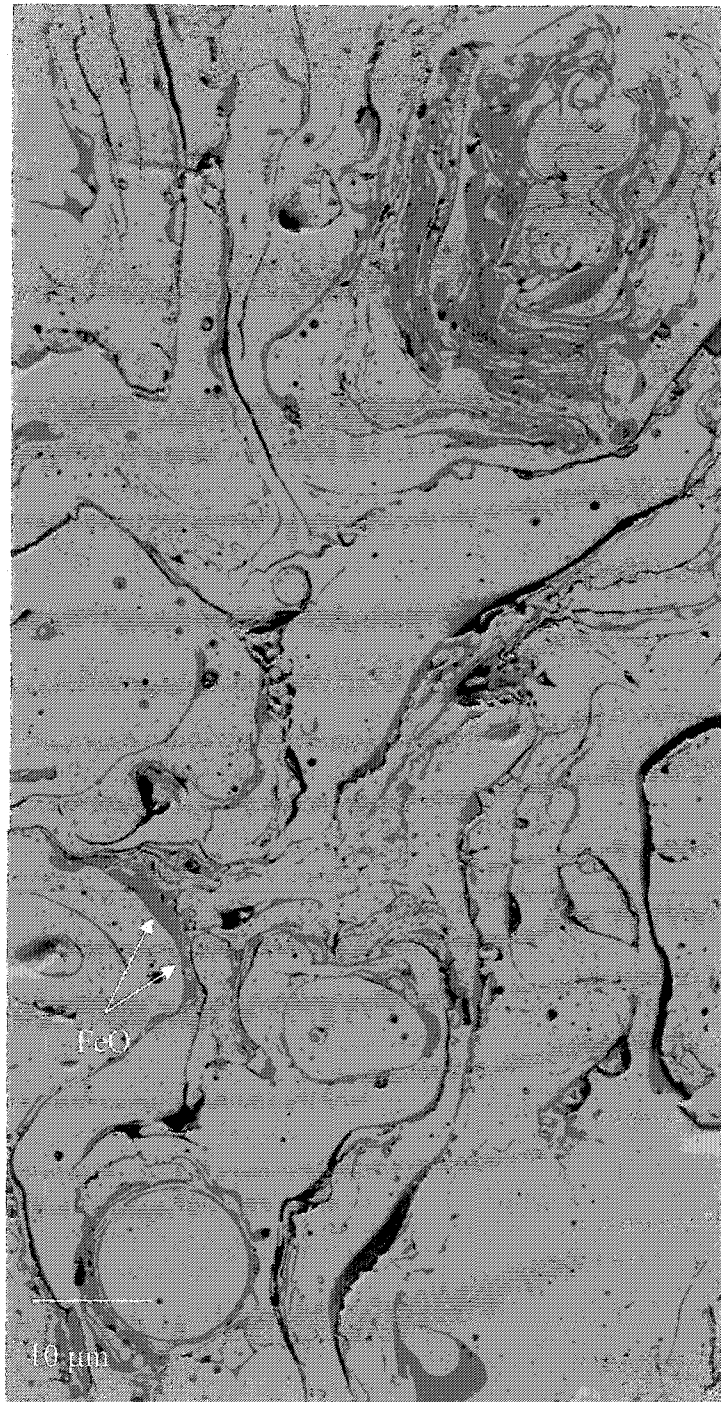
Fig. 4.2- A back-scattered SEM micrograph of the top surface of the PTWA 1020 coating after polishing to an average roughness (R_a) of 0.1 μm.

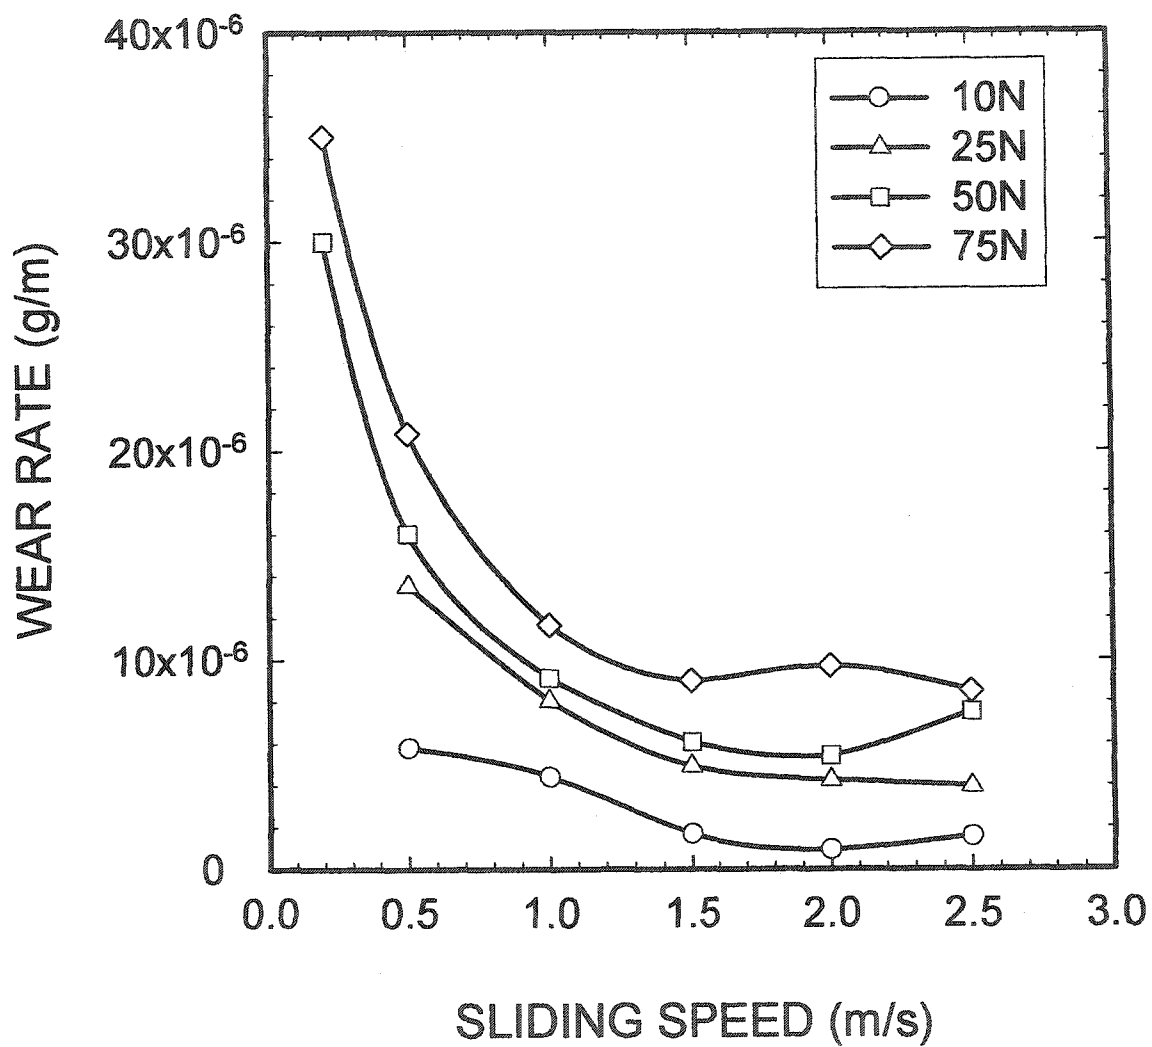
Fig. 4.5- The variation of the wear rates (g/m) of the PTWA 1020 thermal spray coatings plotted versus the sliding speed for four different normal loads. The trend is for decreased wear rates at increased speed.

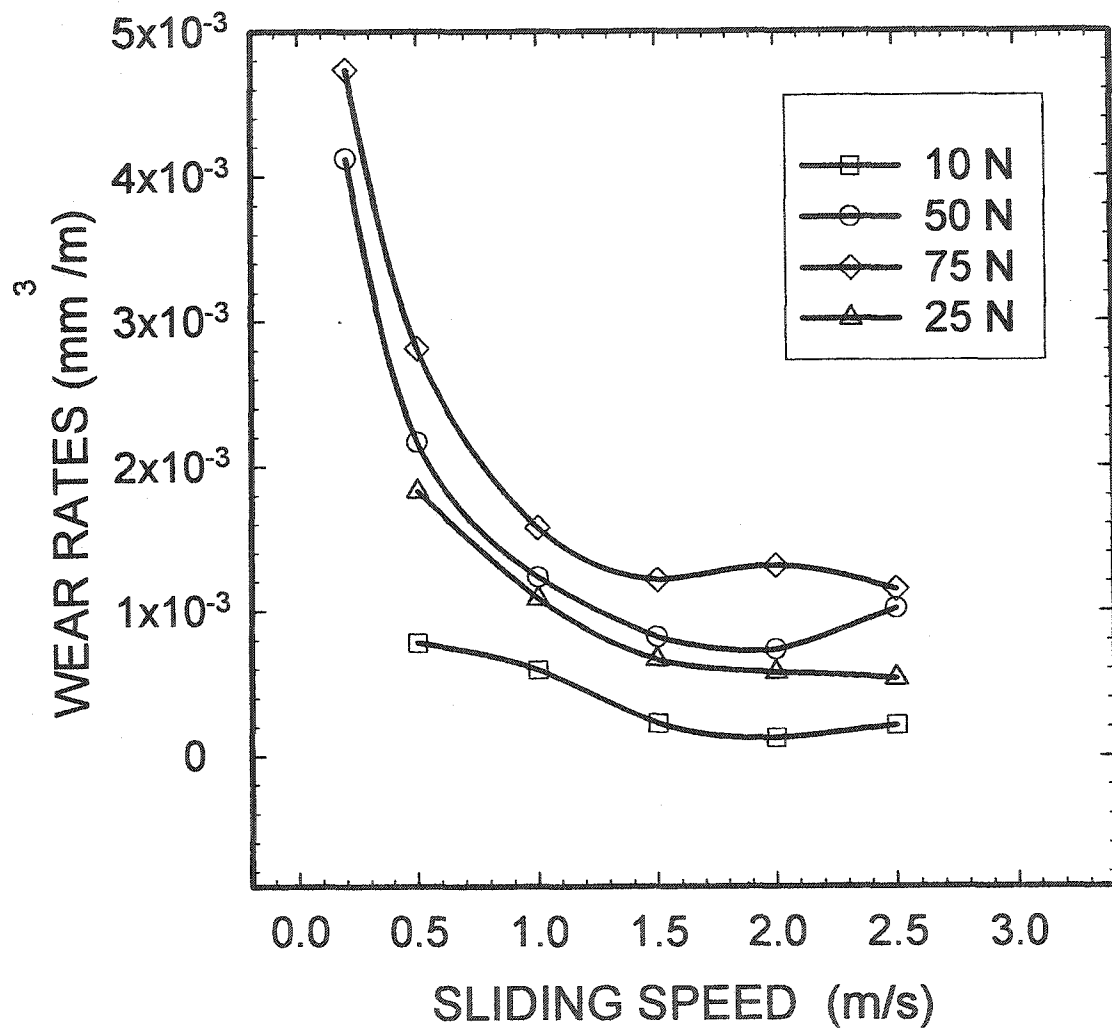
Fig. 4.6- The volumetric wear (mm^3/m) of the PTWA 1020 coatings at four different loads plotted against the sliding speeds.

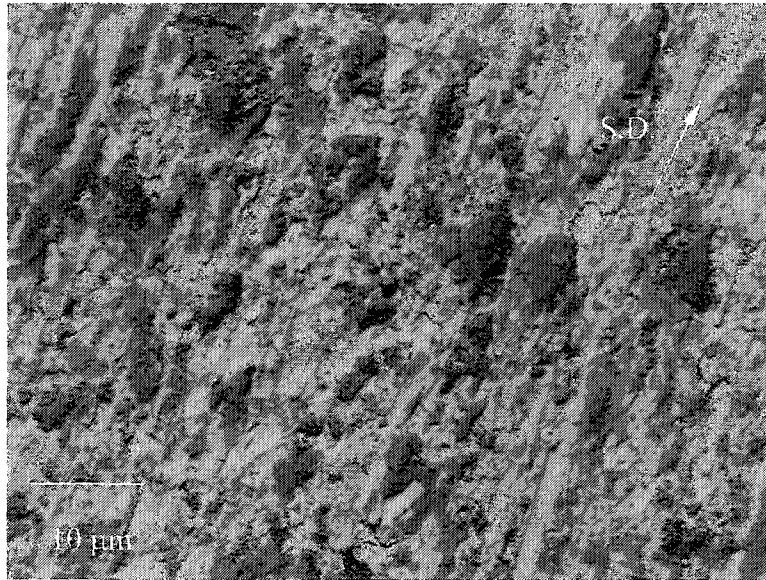
Fig. 4.8- A back-scattered SEM micrograph of the sliding surface of the PTWA 1020 sample worn at 10 N load and 0.5 m/s after 5000 m sliding distance. The micrograph is taken at a tilted angle of 15° to the worn surface to accentuate morphological details.

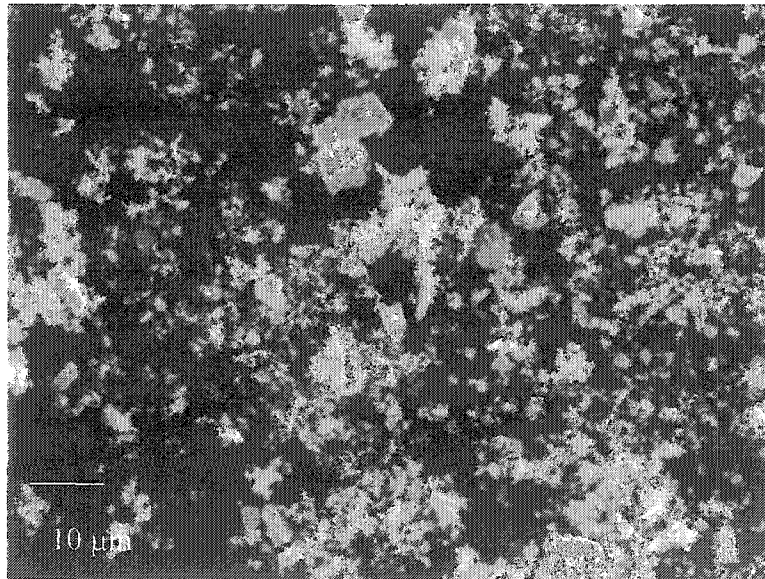
Fig. 4.9- A secondary SEM micrograph of the debris collected from the test performed under 10 N load, and 0.5 m/s showing that the fine particles agglomerated to form oxide aggregates of 2-4 μm.

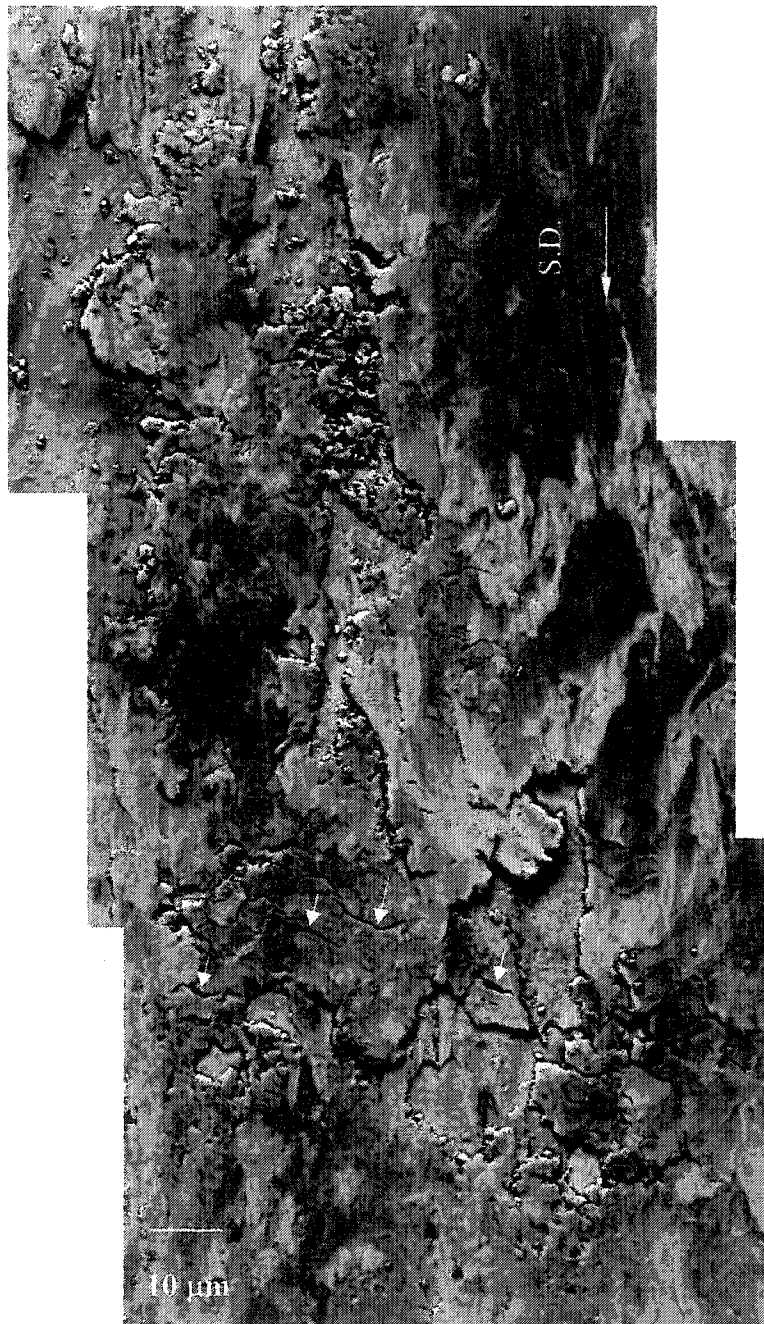
Fig. 4.10- (a) A back-scattered SEM micrograph of a sample worn at 75 N load and 0.5 m/s. The dark grey regions were identified as the oxygen rich film with the aid of EDS. EDS analysis from the medium grey areas shows the presence of elemental Fe. The arrows on the micrograph show cracks on the deformed splats.

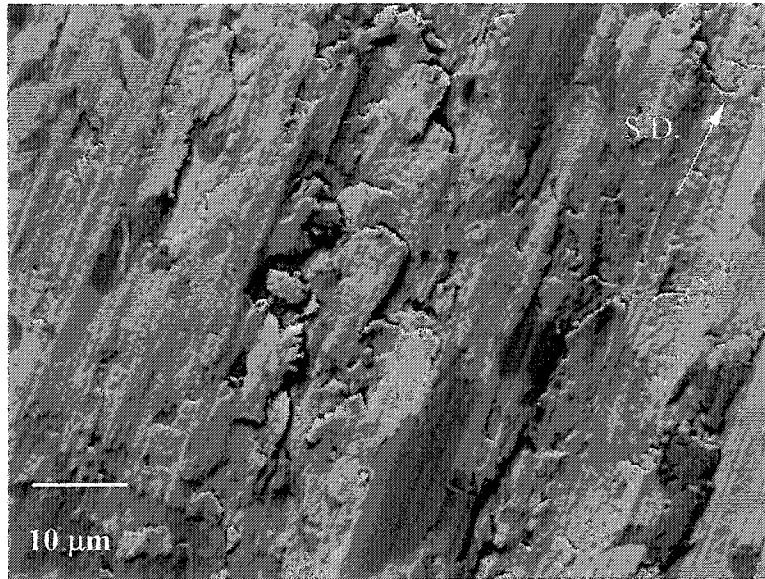
Fig. 4.10- (b) Another example of the deformation and fragmentation processes of the splats at the sliding surface of the PTWA 1020 coating at high loads (50 N) and low speed (0.5 m/s) testing conditions.

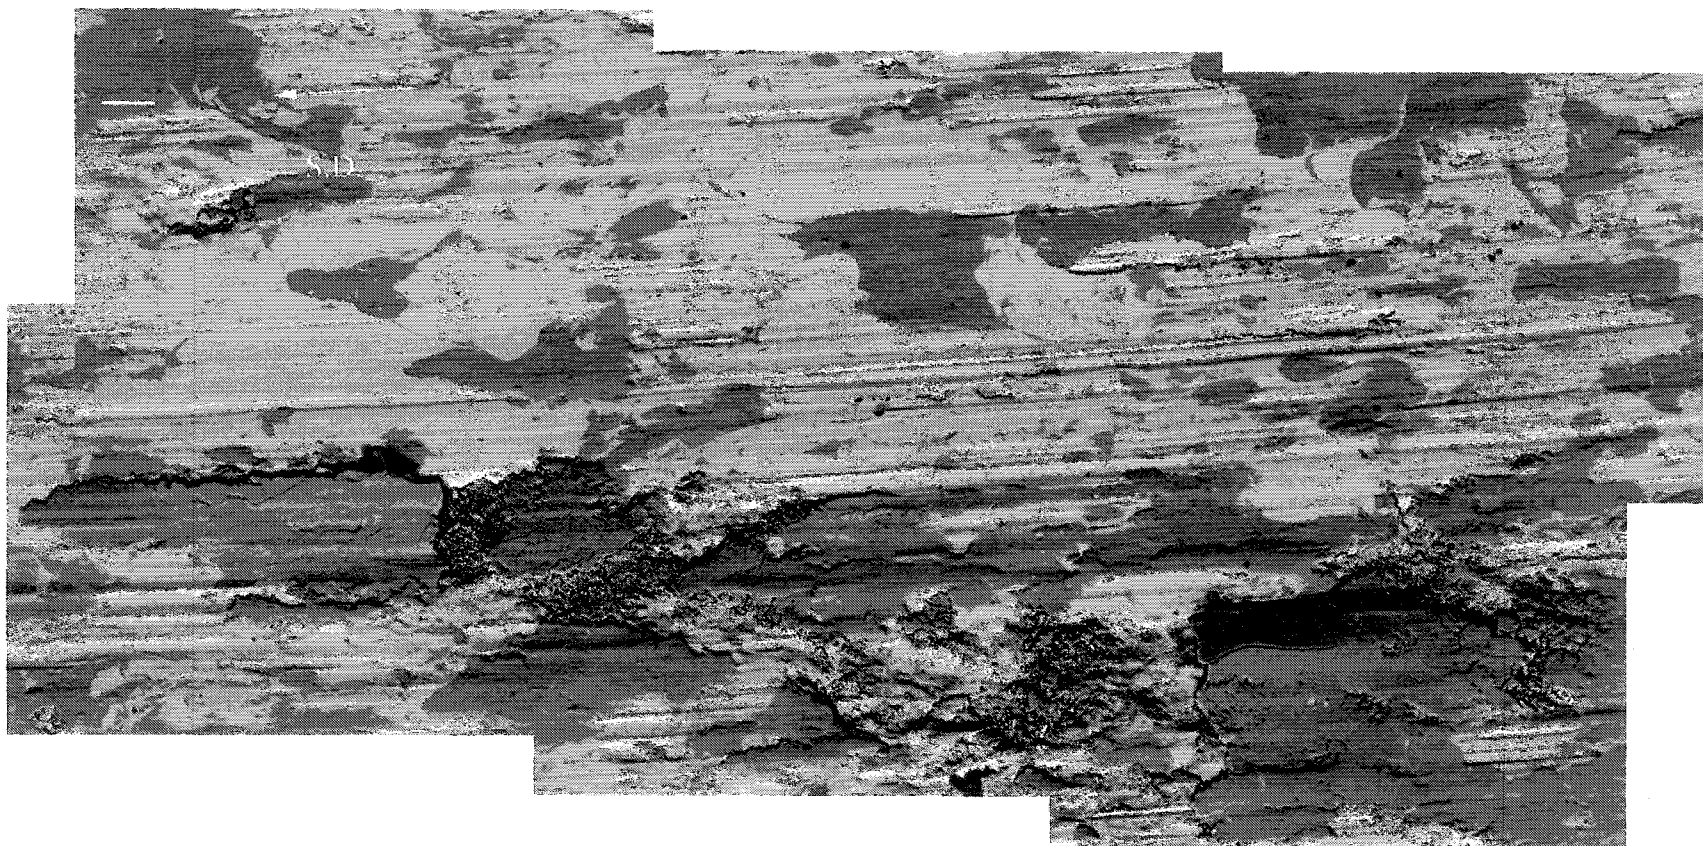
Fig. 4 12- A back-scattered SEM micrograph of a sample worn at 50 N load and 2.5 m/s. The micrograph is taken from a region, which shows evidence for deformation mostly in the form of surface grooving of both the oxide rich layers and the iron splats. (Note the micrograph was deliberately selected to illustrate the deformation pattern and that the area fraction of the oxide rich layers is less than the average coverage).

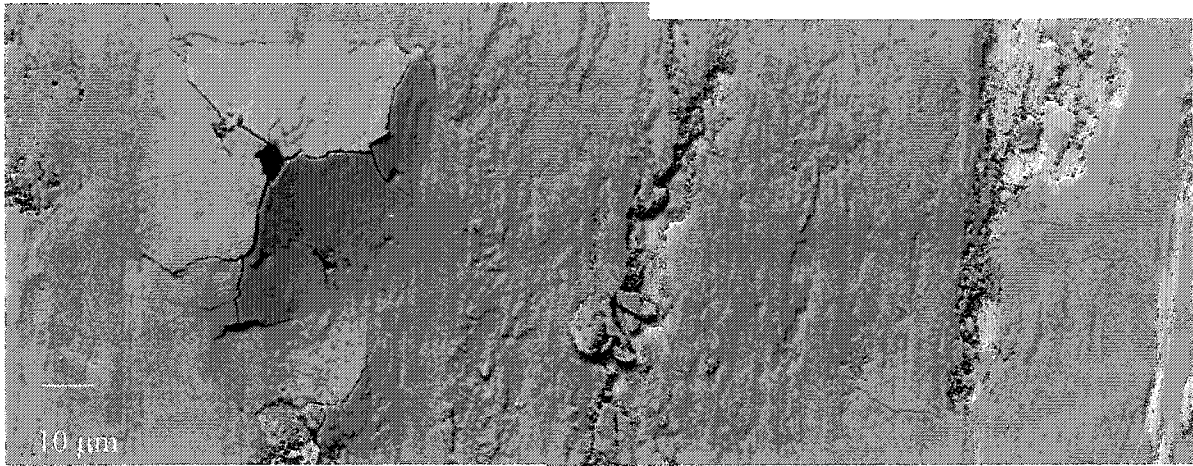
Fig. 4.1- A back-scattered SEM image of the worn surfaces of the PTWA 1020 coating tested at 50 N and 2.5 m/s shows the wear track was covered by an oxide rich film and the micrograph also shows the spallation of the oxide film.

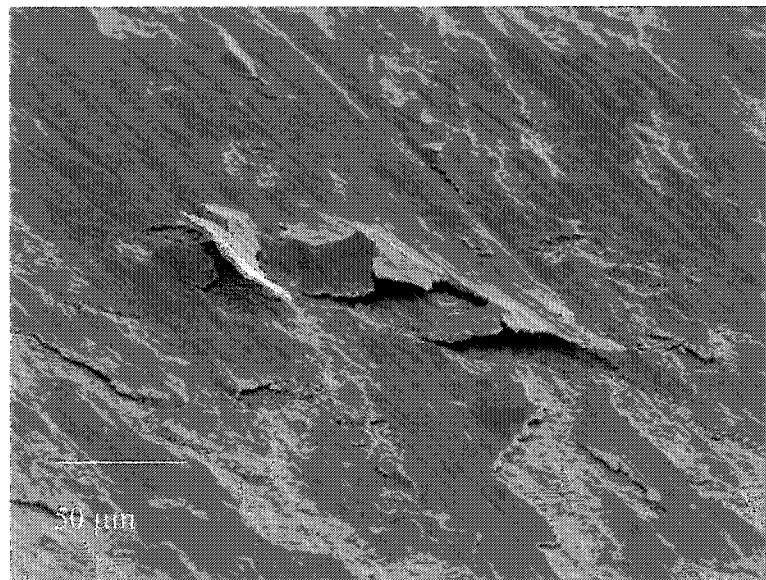
Fig. 4.14- Another example of the spallation of the oxide layers generated during the sliding of PTWA 1020 tested at 75 N and 2.5 m/s. The secondary SEM micrograph also shows the distribution of the oxide layers more accurately (70%).

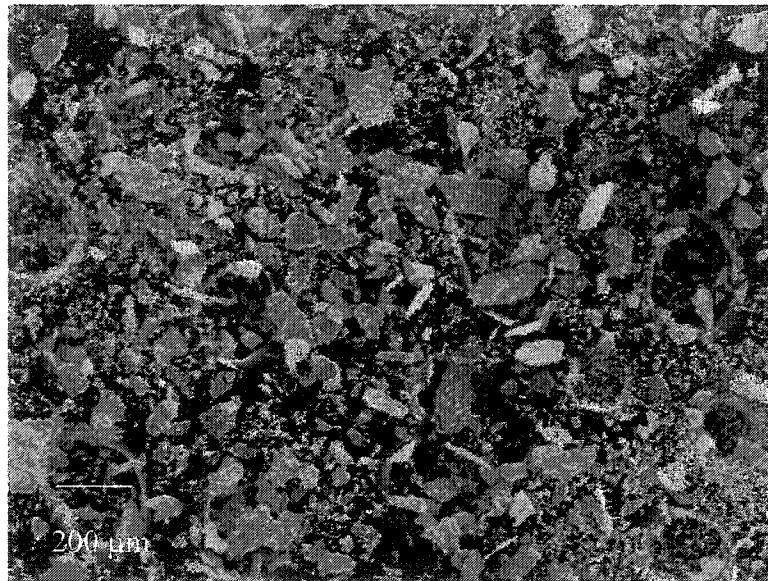
Fig. 4.15- A secondary SEM micrograph of the debris from the test performed on PTWA 1020 at 75N load and 2.5 m/s that shows the plate like oxide particles.

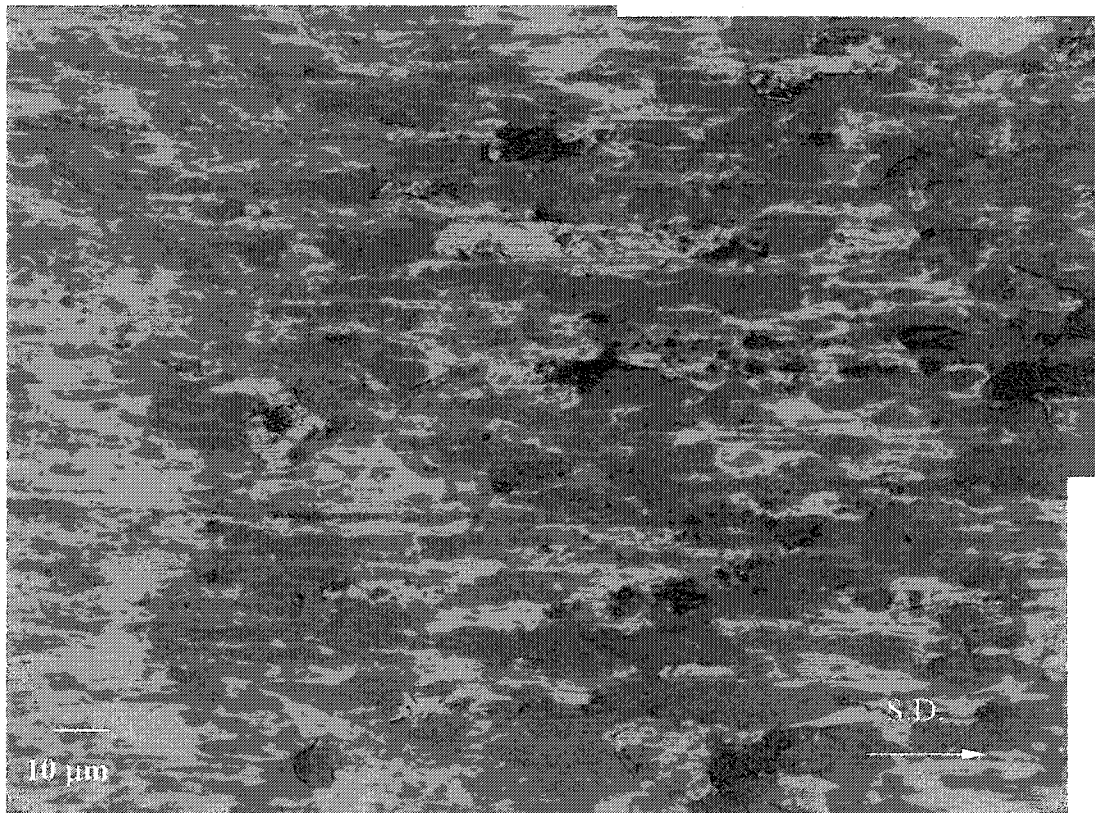
Fig. 4.16- A back-scattered SEM micrograph of a PTWA 1020 sample worn at 10 N load and 2.5 m/s. The dark grey extended regions are an iron oxide film that is smeared over the surface of the steel splats during sliding.

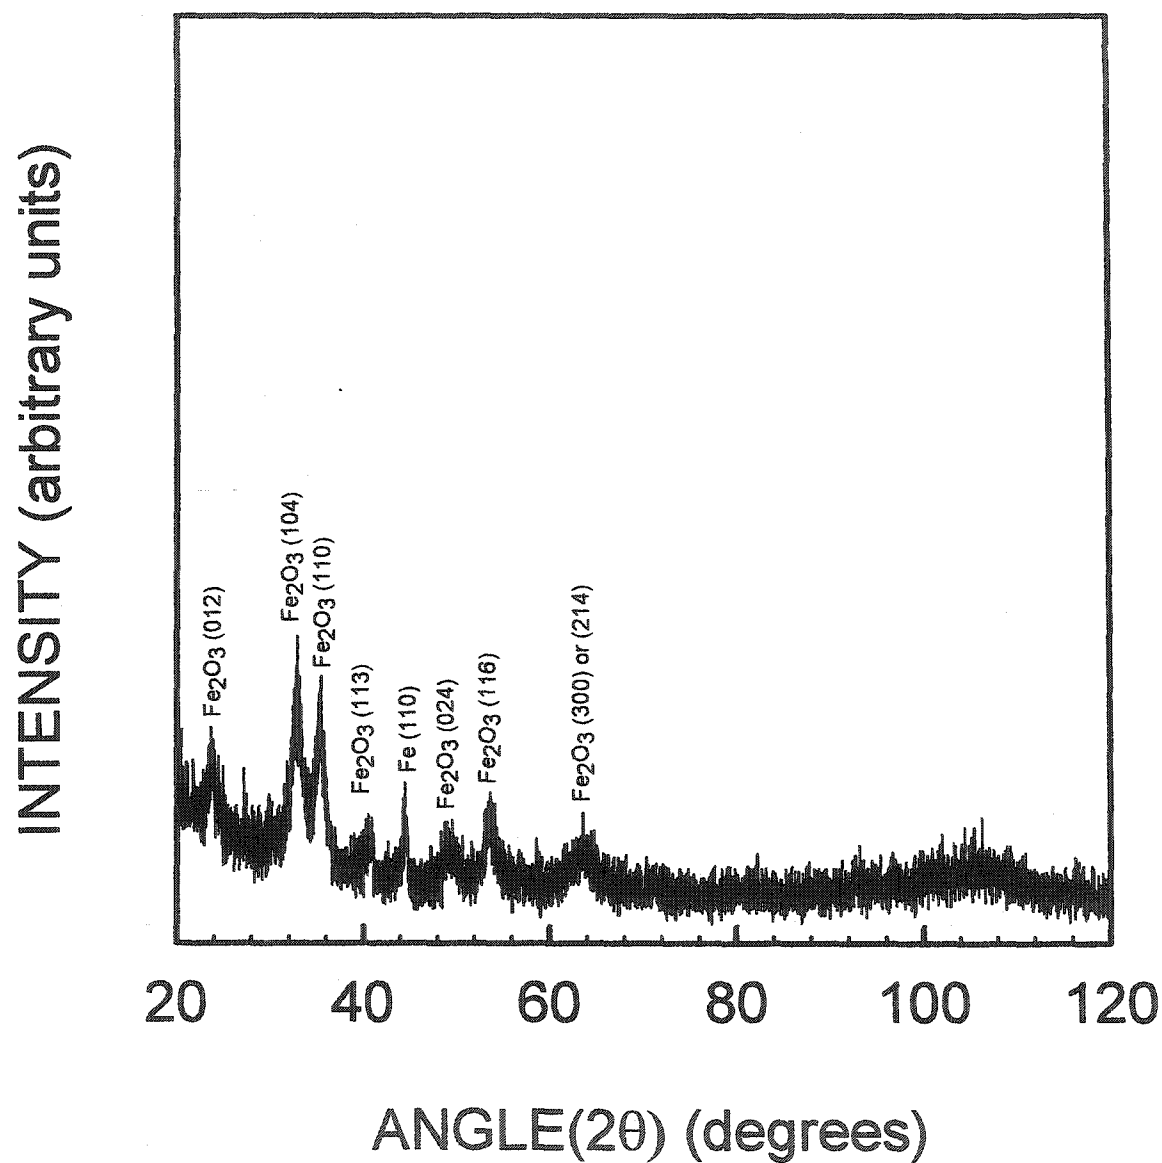
Fig. 4.17- The XRD spectra of the wear debris collected from PTWA 1020 at 10N (low load) and 0.5 m/s (low speed) shows the peaks for hematite (Fe_2O_3), and a few small peaks of ferrite.

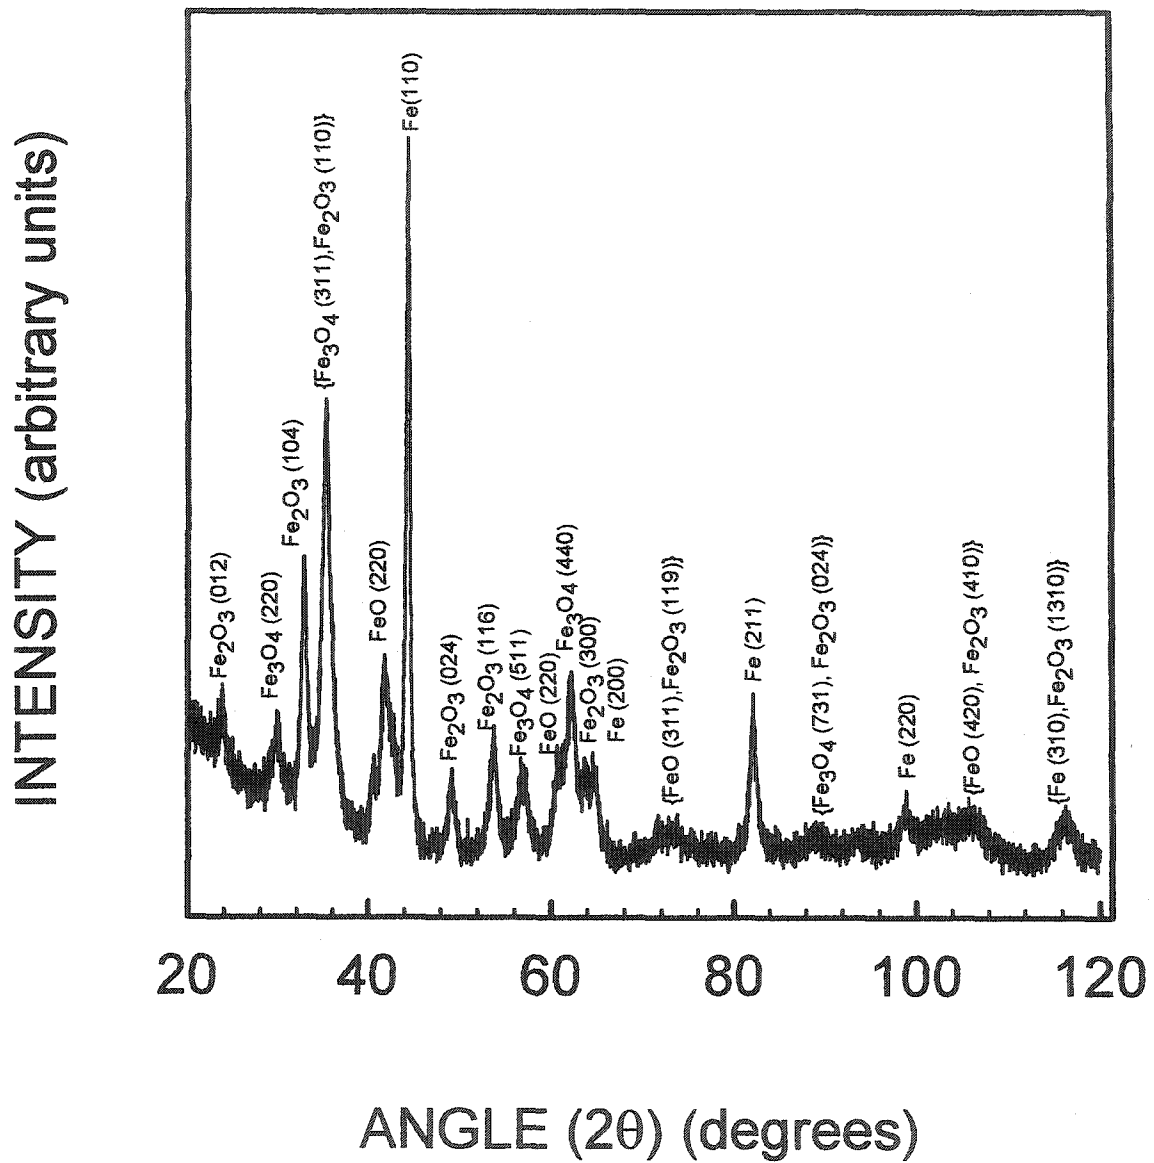
Fig. 4.18- The XRD spectra of the wear debris collected from PTWA 1020 at 50N (high load) and 0.5 m/s (low speed) shows the debris consisted of a mixture of three types of iron oxides: Fe_2O_3 , Fe_3O_4 , and FeO with a significant amount of metallic ferrite in the debris.

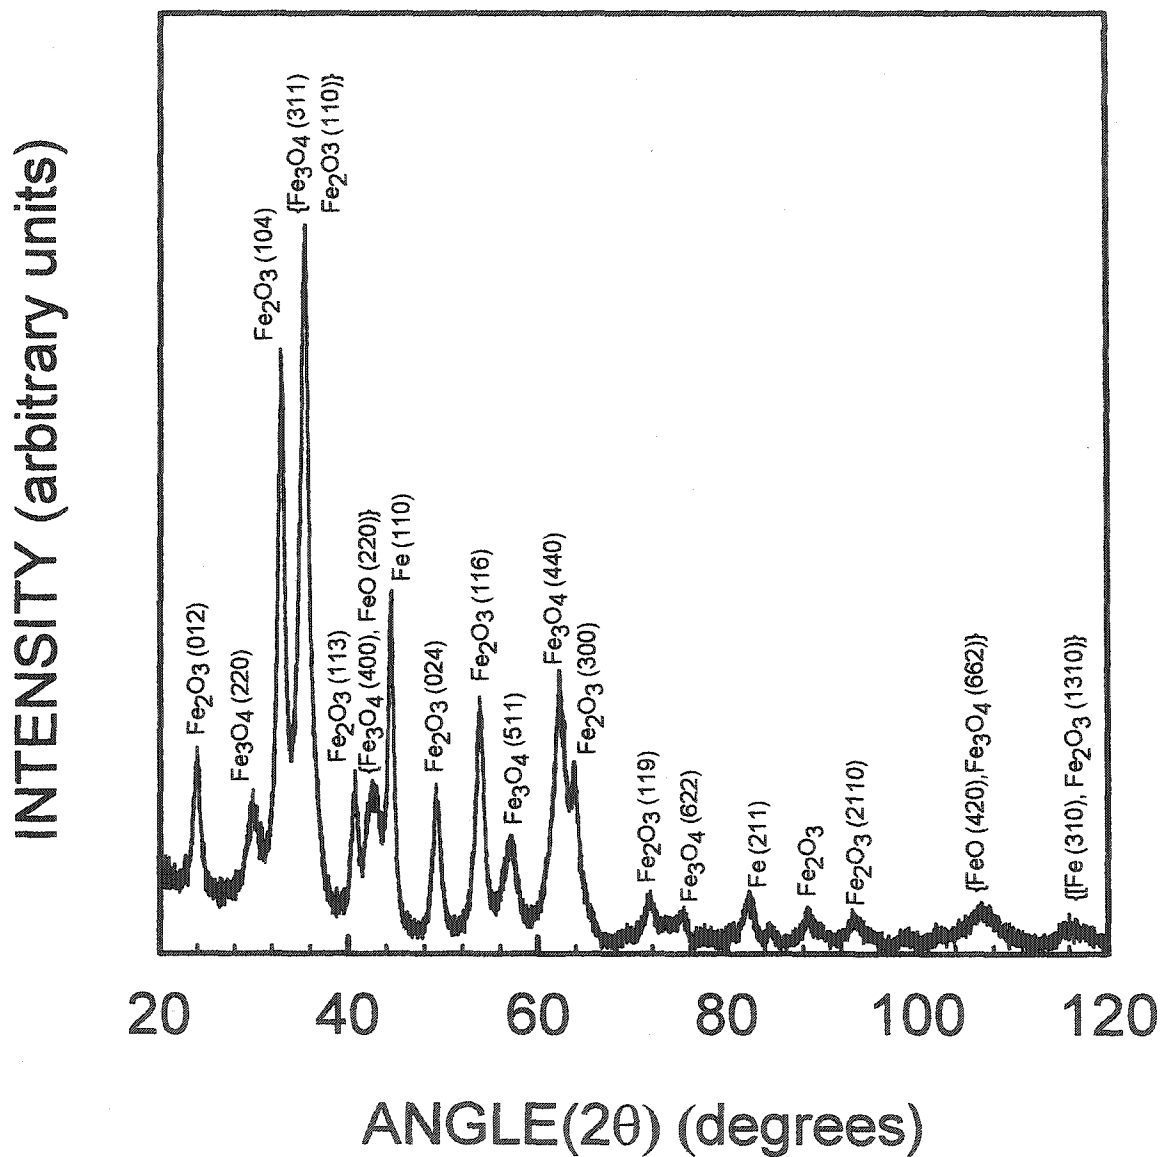
Fig. 4.19- The XRD spectra of the wear debris collected from PTWA 1020 at 50N (high load) and 2m/s (high speed) shows that the debris consists of ferrite, and three types of iron oxides, namely Fe_2O_3 , Fe_3O_4 , and FeO .

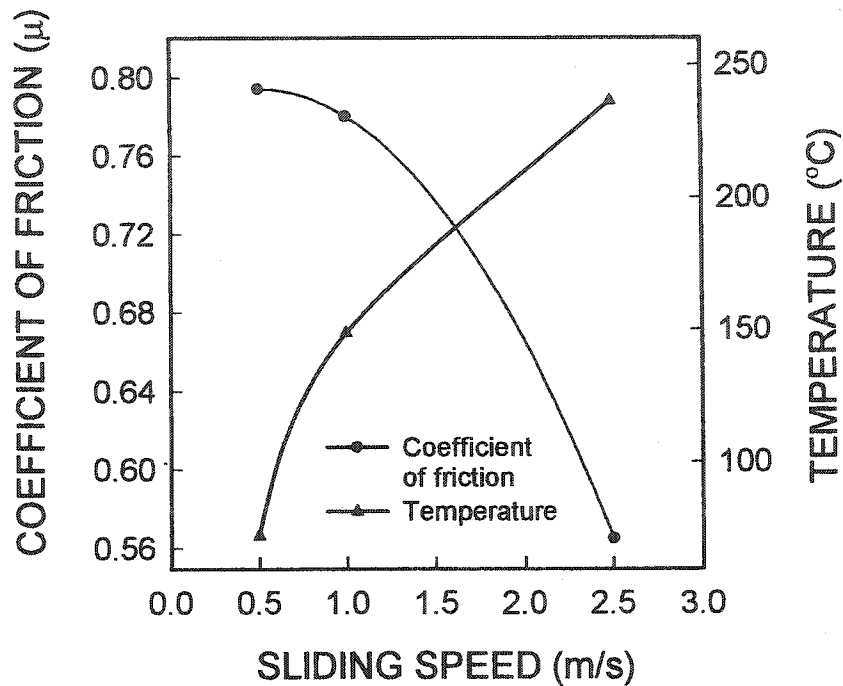
Fig. 4.22- The variation of the friction induced temperature rise of the pin, and the coefficient of friction with sliding speed for PTWA 1020 samples tested at a constant load of 50 N.

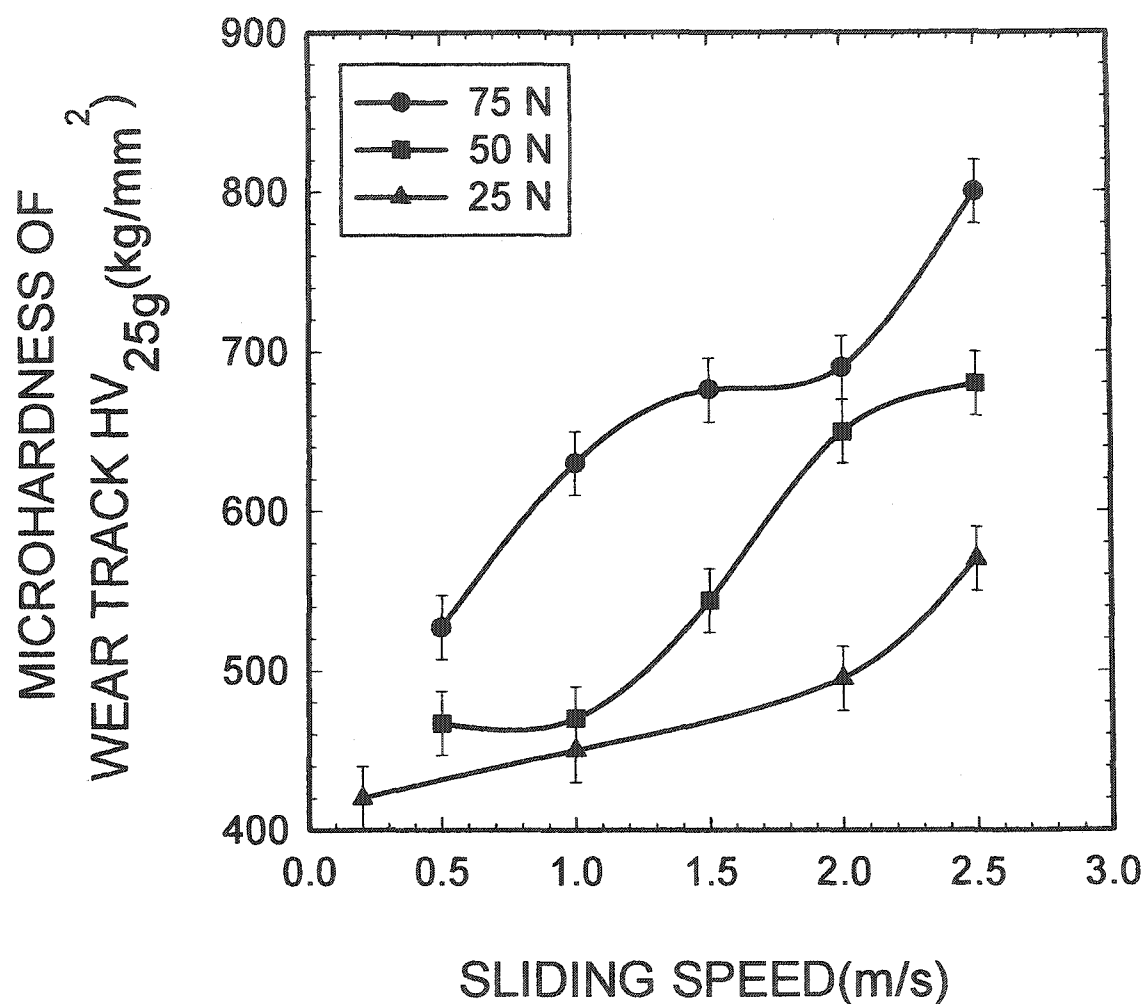
Fig. 4.24- The variation of hardness with sliding speed for high loads. The hardness measurements were taken from regions of the wear track where the PTWA 1020 coating was exposed through oxide deposit.

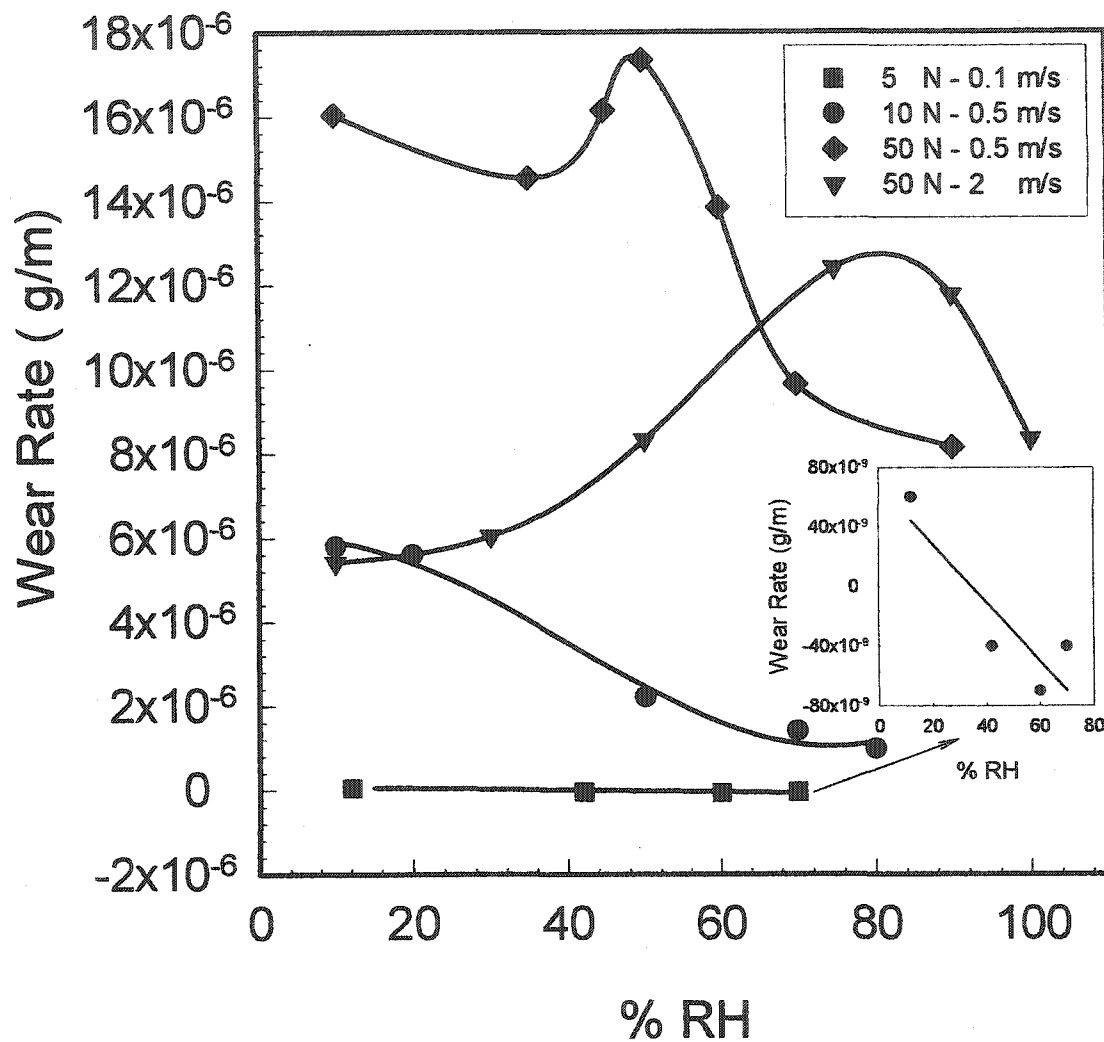
Fig. 4.26- Variation of wear rates of PTWA 1020 coatings with the relative humidity for four different testing conditions. The insert shows wear rates for tests at 5 N and 0.1 m/s at different humidity levels.

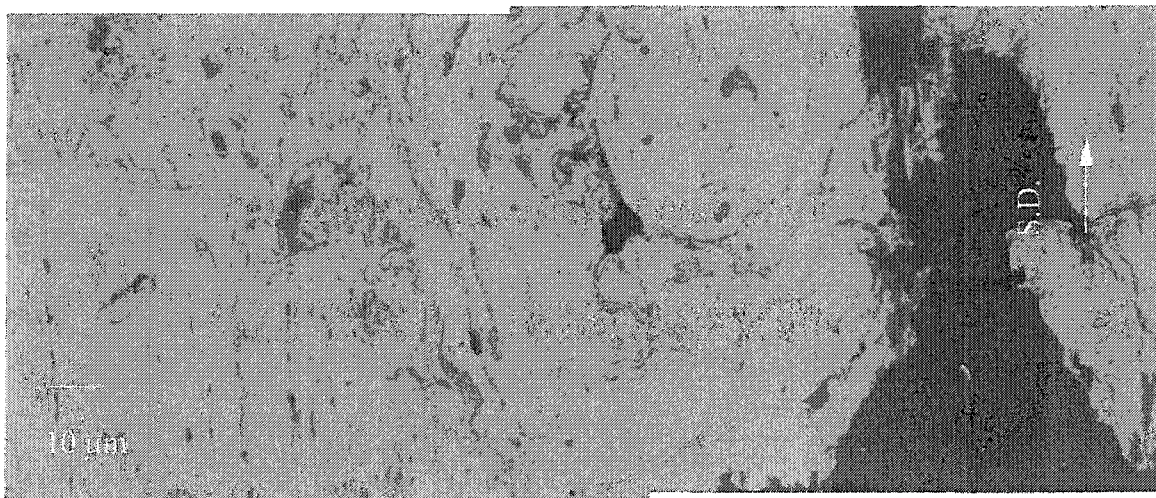
Fig. 4.28- A back-scattered SEM micrograph of a PTWA 1020 sample worn at 5 N load, 0.1 m/s sliding speed and 80% RH. The metallic parts are highly polished, and the oxide layers between the splats (dark grey veins) are noticeable. The porosity and the space between the contact areas are filled by the oxide layers, which were removed from the contact surfaces (dark grey regions).

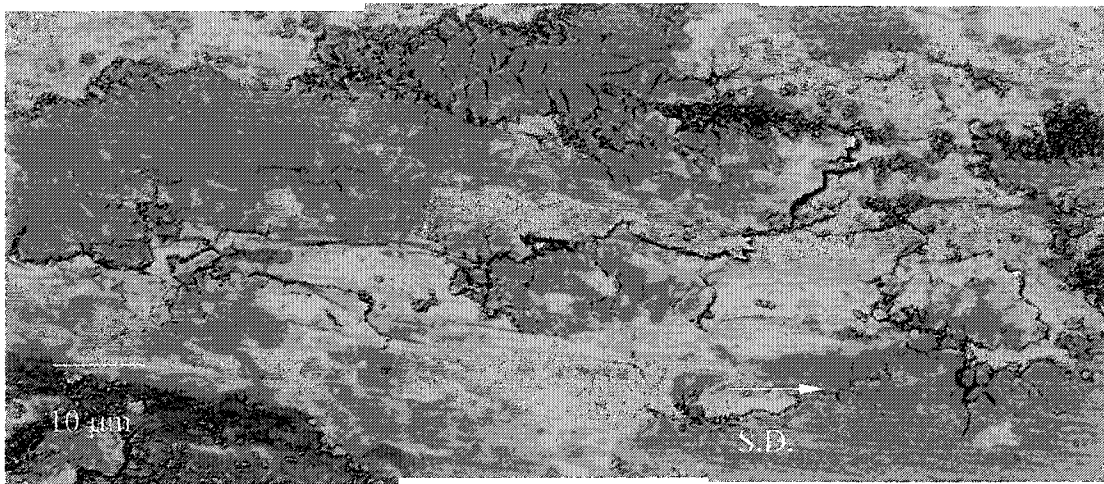
Fig. 4.29- A back-scattered SEM micrograph of a PTWA 1020 sample worn at 50 N load and 0.5 m/s and 50% relative humidity. The edges of the deformed steel splats show fracture and fragmentation.

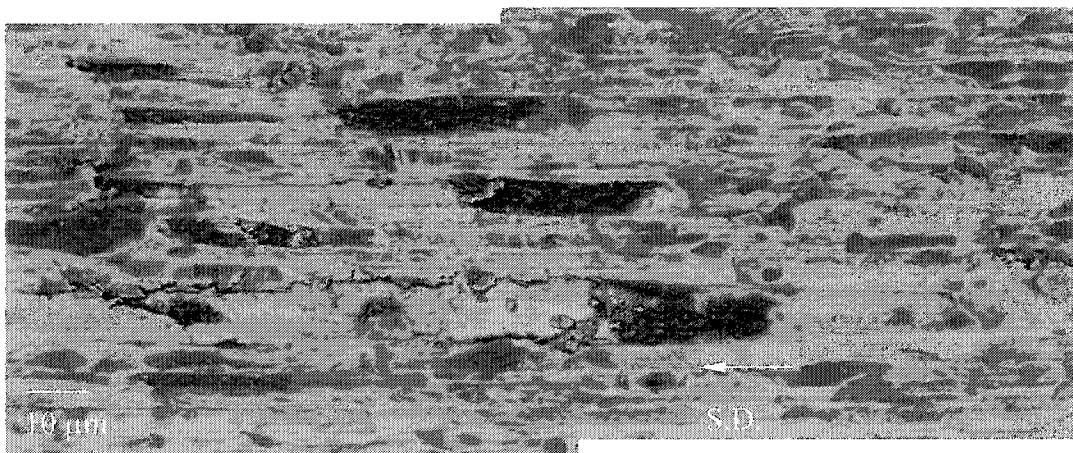
Fig. 4.30- A back-scattered SEM micrograph of a PTWA 1020 sample worn at 50 N load and 0.5 m/s and 90% relative humidity. The polishing wear mechanism is active at this relative humidity level, but there is still evidence of fracture.

Fig. 4.30	116
A back-scattered SEM micrograph of a PTWA 1020 sample worn at 50 N load and 0.5 m/s and 90% relative humidity. The polishing wear mechanism is active at this relative humidity level, but there is still evidence of fracture.	
Fig. 4.31.a	117
A variation of the coefficient of friction with the sliding distance at different humidity levels for the PTWA 1020 coatings tested at 5 N - 0.1m/s.	
Fig. 4.31.b	118
Variation of the coefficient of friction with the sliding distance at different humidity levels for the PTWA 1020 coatings tested at 50 N - 0.5m/s.	
Fig. 4.32	119
The average coefficient of friction of PTWA 1020 coatings for the wear tests performed under 50 N, 0.5 m/s loading condition as a function of humidity.	
Fig. 4.33	120
The XRD spectra of the PTWA 1020 wear debris collected from a constant load and a sliding speed of 50 N and 0.5 m/s, and different humidity of 50% with high wear rate, and 90% with low wear rate.

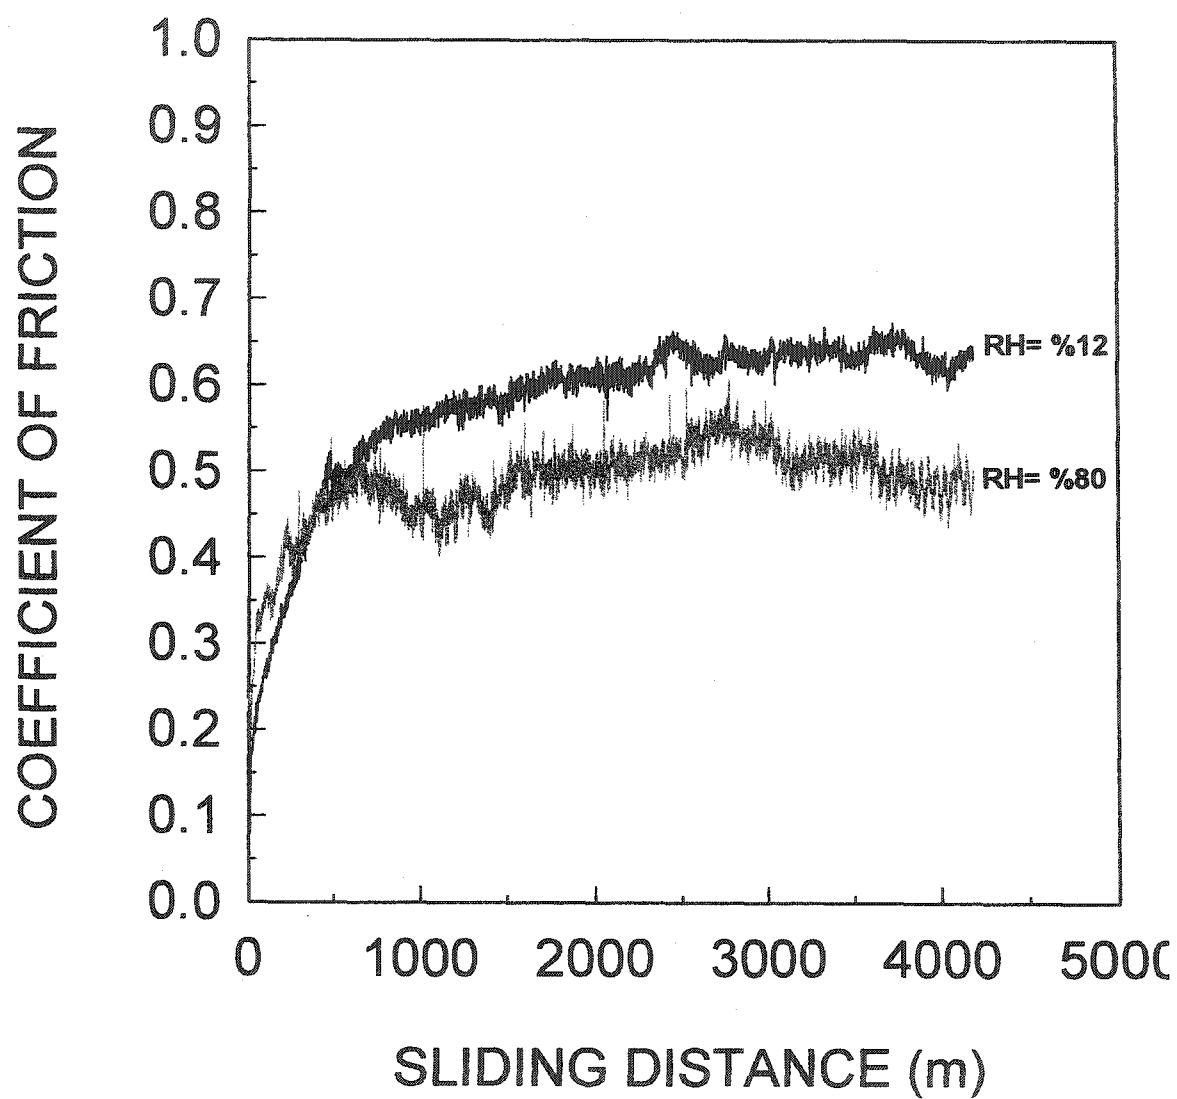
Fig. 4.31.a- A variation of the coefficient of friction with the sliding distance at different humidity levels for the PTWA 1020 coatings tested at 5 N - 0.1m/s.
