Investigation of wear and scuffing behaviour of ferrous thermal spray coatings for aluminum engines.

**INVESTIGATION OF WEAR AND SCUFFING BEHAVIOUR OF
FERROUS THERMAL SPRAY COATINGS
FOR ALUMINUM ENGINES**

**A Dissertation
Submitted to the Faculty of Graduate Studies and Research
through Engineering Materials in Partial Fulfillment of the Requirements
for the Degree of Doctor of Philosophy at the
University of Windsor**

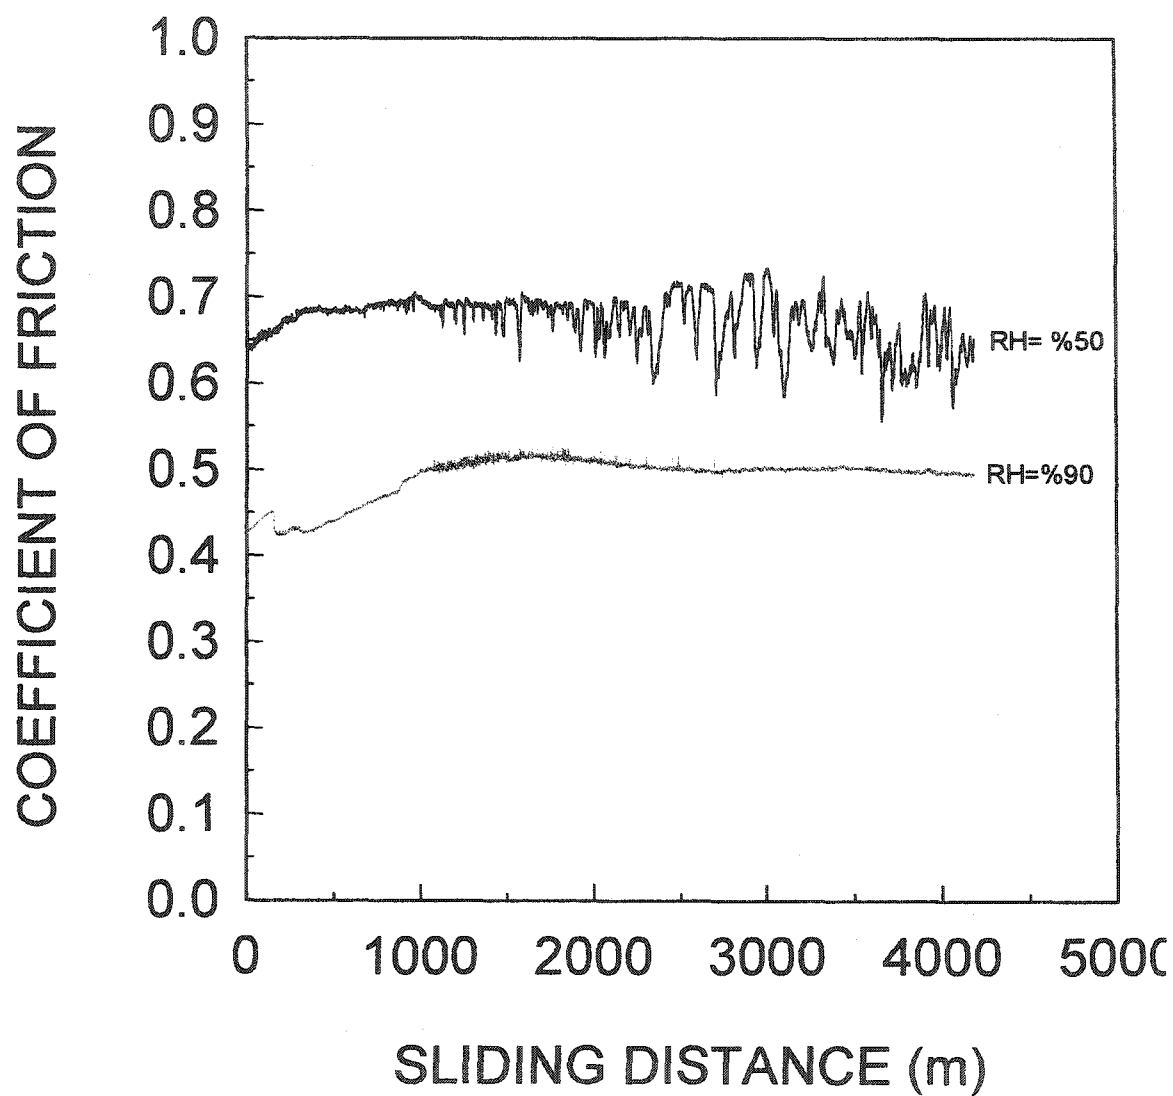
Fig. 4.31.b- Variation of the coefficient of friction with the sliding distance at different humidity levels for the PTWA 1020 coatings tested at 50 N - 0.5m/s.

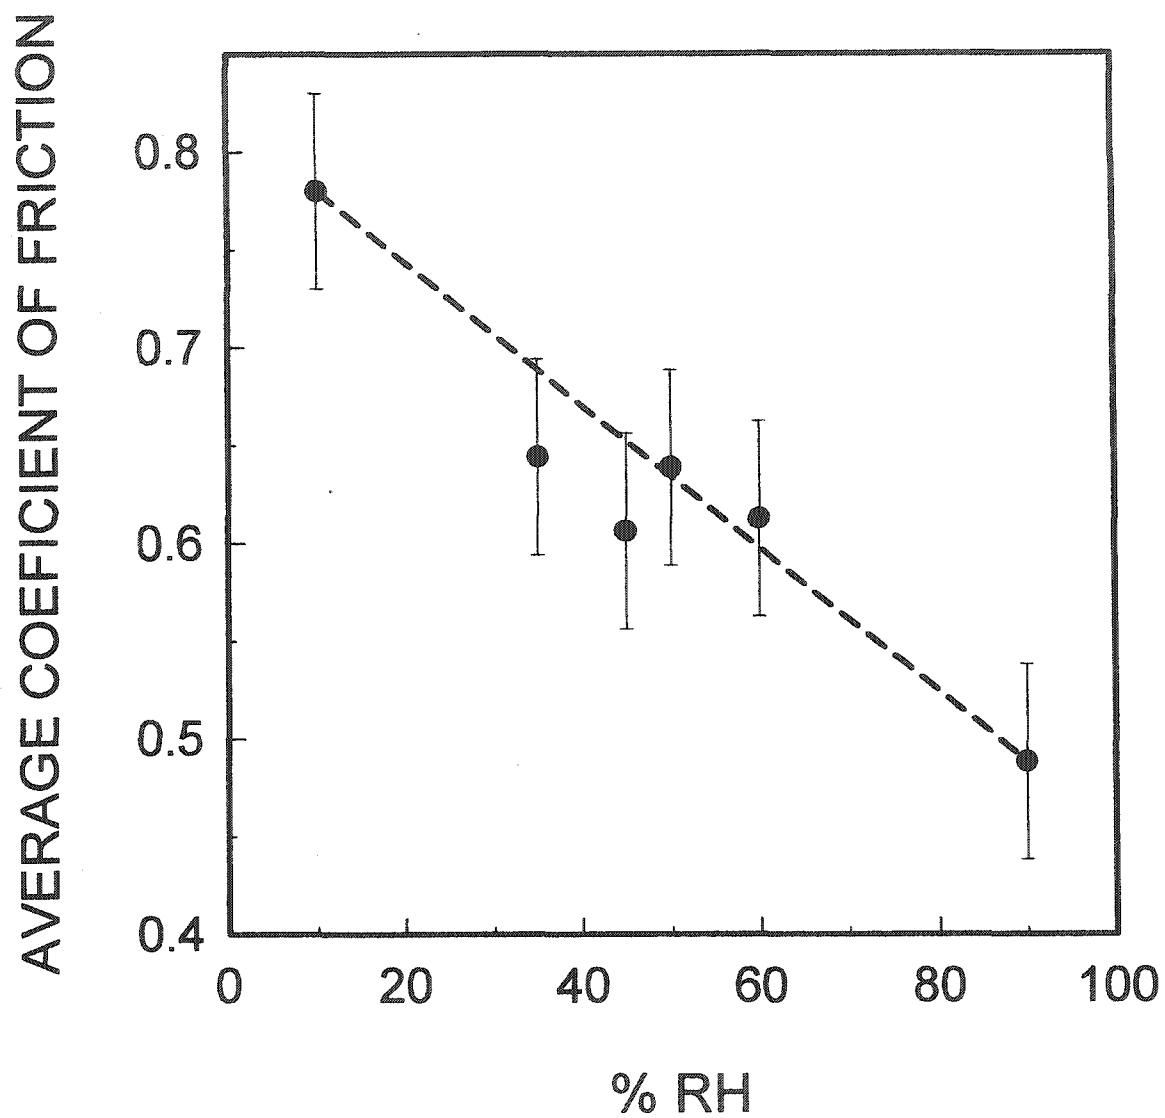
Fig. 4.32- The change in the average coefficient of friction of PTWA 1020 coatings for the wear tests performed under 50 N, 0.5 m/s loading condition as a function of humidity.

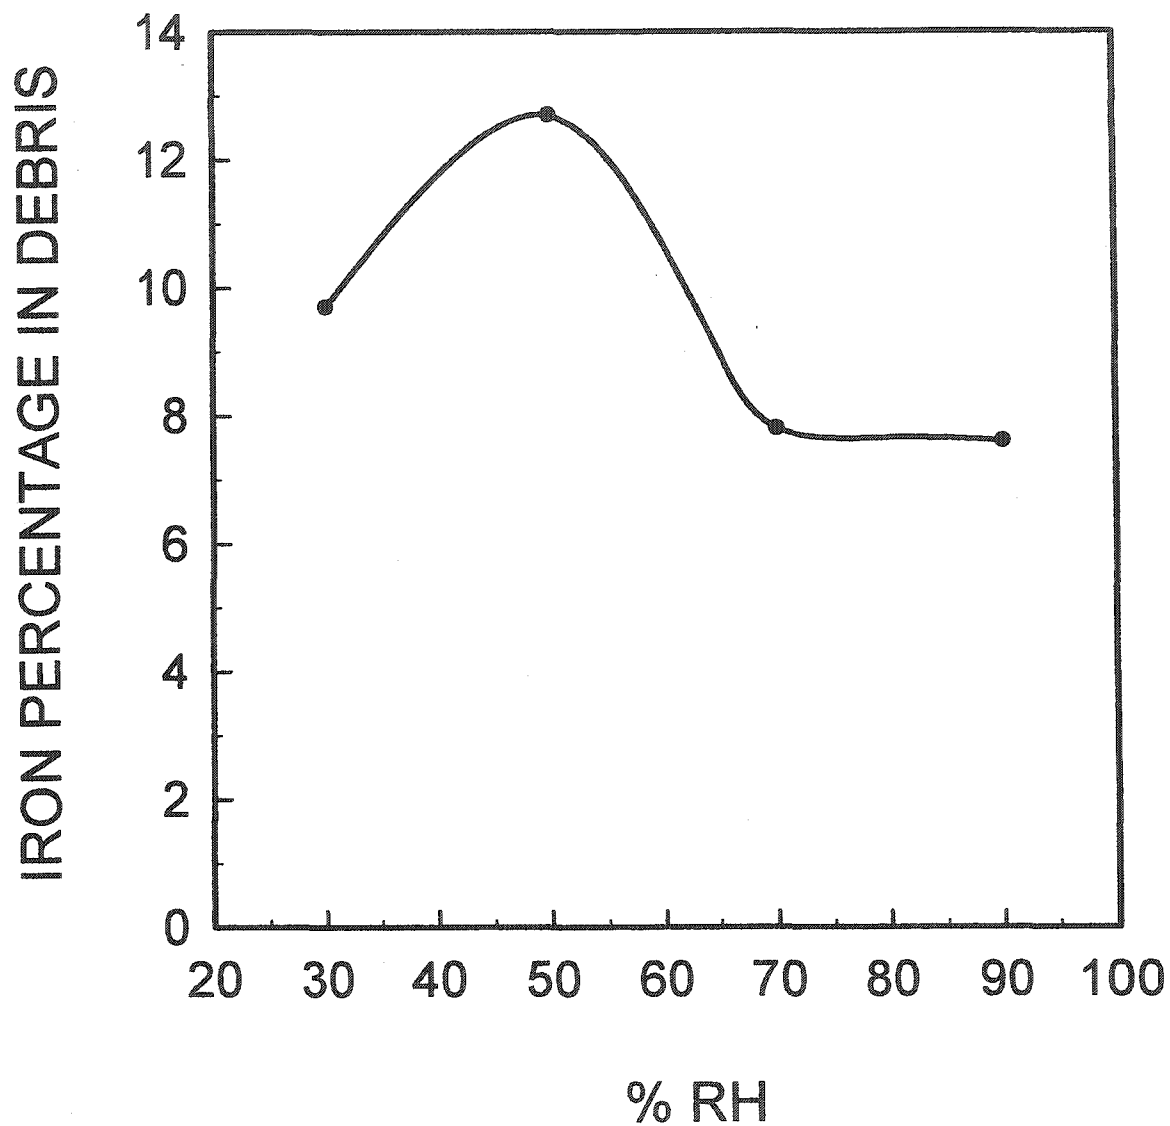
Fig. 4.34- The fraction of the elemental iron content of debris of PTWA 1020 obtained from wear tests performed at 50 N and 0.5 m/s as a function of the relative humidity of the wear environment. The quantitative phase analysis was obtained from the Rietveld analyses with an accuracy of $\pm 0.5\%$. The iron content follows a similar trend as the wear rate.

Fig. 4.34	121
The fraction of the elemental iron content of debris of PTWA 1020 obtained from wear tests performed at 50 N and 0.5 m/s as a function of the relative humidity of the wear environment. The quantitative phase analysis was obtained from the Rietveld analyses with an accuracy of $\pm 0.5\%$. The iron content follows a similar trend as the wear rate.	
Fig. 4.35	122
Microstructure and composition of HVOF 1020 coatings: (a) is a back-scattered SEM micrograph showing the cross-sectional microstructure. The light areas labelled (b) in the micrograph are the steel splats, (see the EDS spectrum of (b)); the dark grey regions labelled (c) consist of Fe and O as shown in the EDS spectrum of (c); the black regions labelled (d) are the pores. Figure 4.35 (d) XRD spectrum of HVOF 1020 confirming the presence of iron and (FeO).	
Fig. 4.36	124

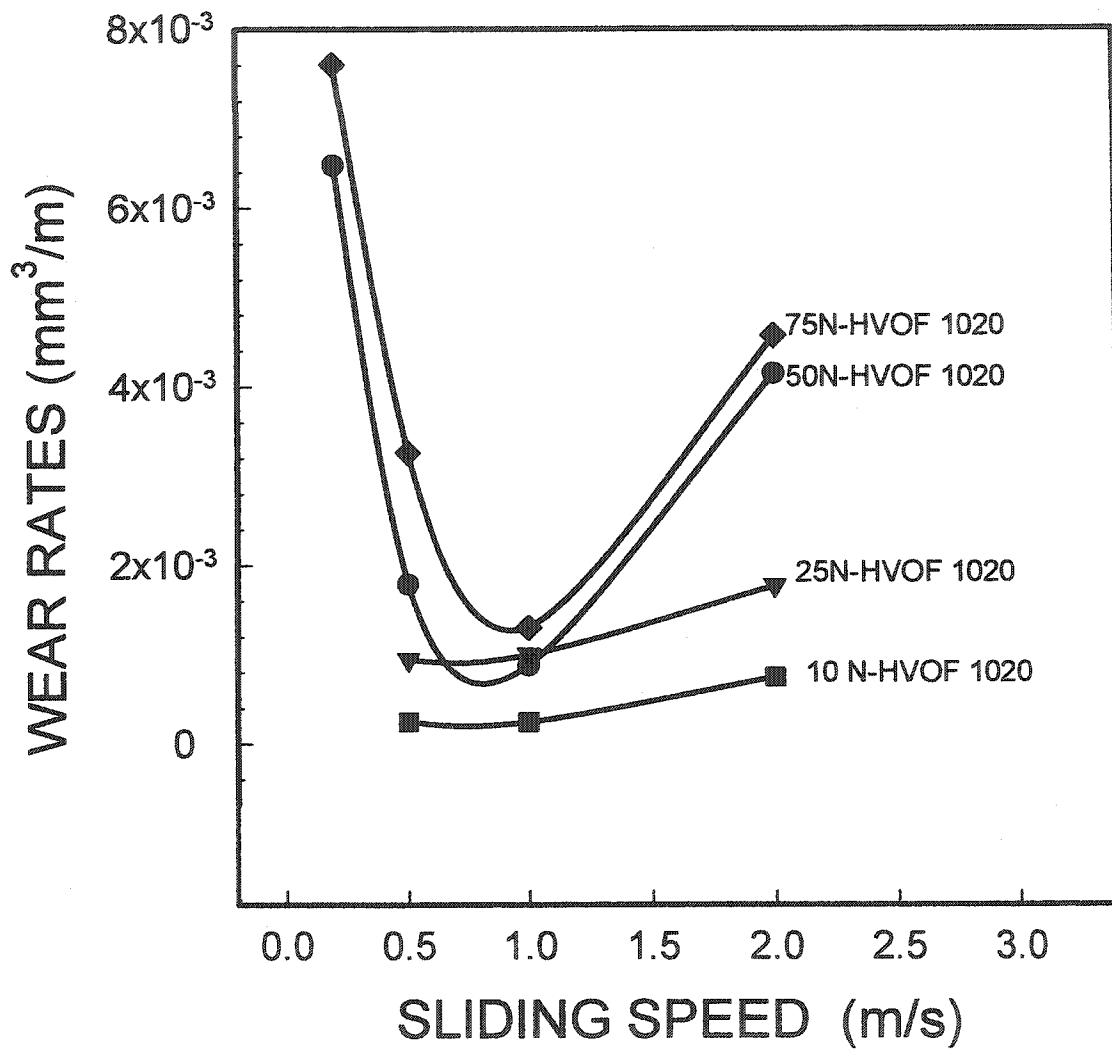
Fig. 4.36- Variation of wear rates (mm^3/m) of the HVOF 1020 coatings is plotted as a function of sliding speed at several load levels of 5 N, 10 N, 25 N, 50 N and 75 N.

A variation of wear rates (mm^3/m) of the HVOF 1020 coatings is plotted as a function of sliding speed at several load levels of 5 N, 10 N, 25 N, 50 N and 75 N.

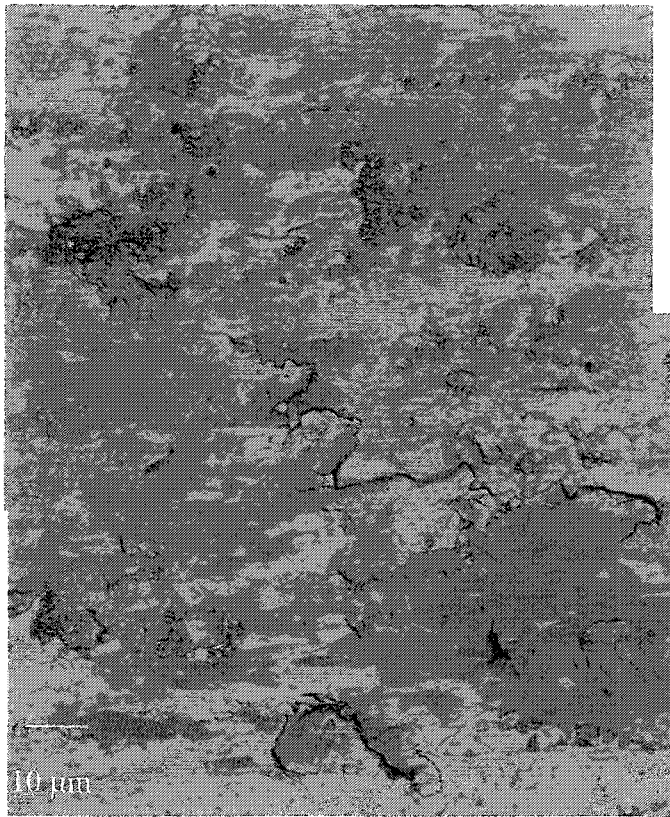
Fig. 4.38- A back-scattered SEM micrograph of the worn surface of the HVOF 1020 coating tested at 75 N load and 0.5 m/s shows severe plastic deformation on the sliding surfaces.

A back-scattered SEM micrograph of the worn surface of the HVOF 1020 coating tested at 75 N load and 0.5 m/s shows severe plastic deformation on the sliding surfaces.

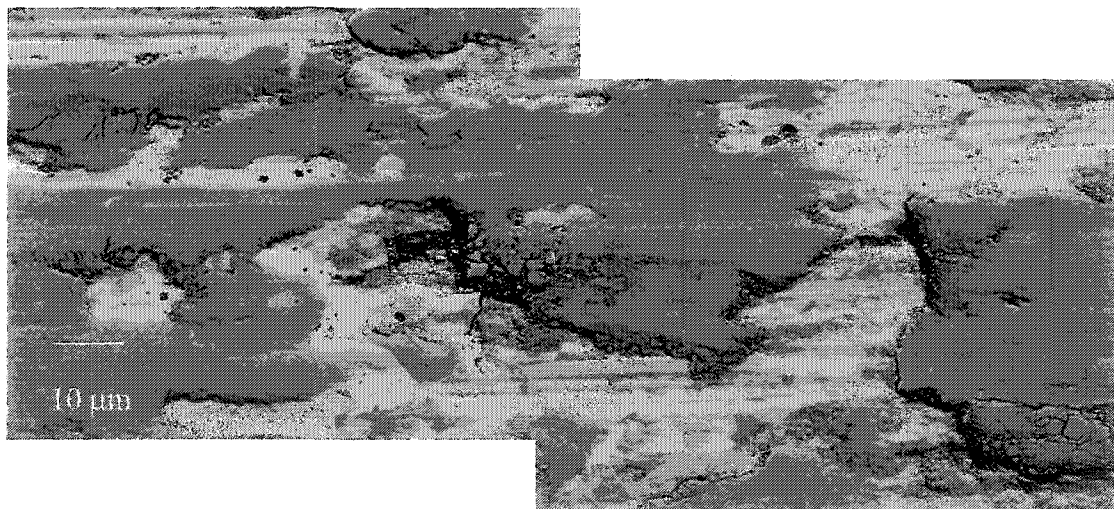
Fig. 4.41- A back-scattered SEM micrograph of the HVOF 1020 coating tested at 50 N load and 2 m/s. The micrograph was taken from a region on the wear track, which shows evidence for surface oxidation during sliding.

A back-scattered SEM micrograph of the HVOF 1020 coating tested at 50 N load and 2 m/s. The micrograph was taken from a region on the wear track, which shows evidence for surface oxidation during sliding.

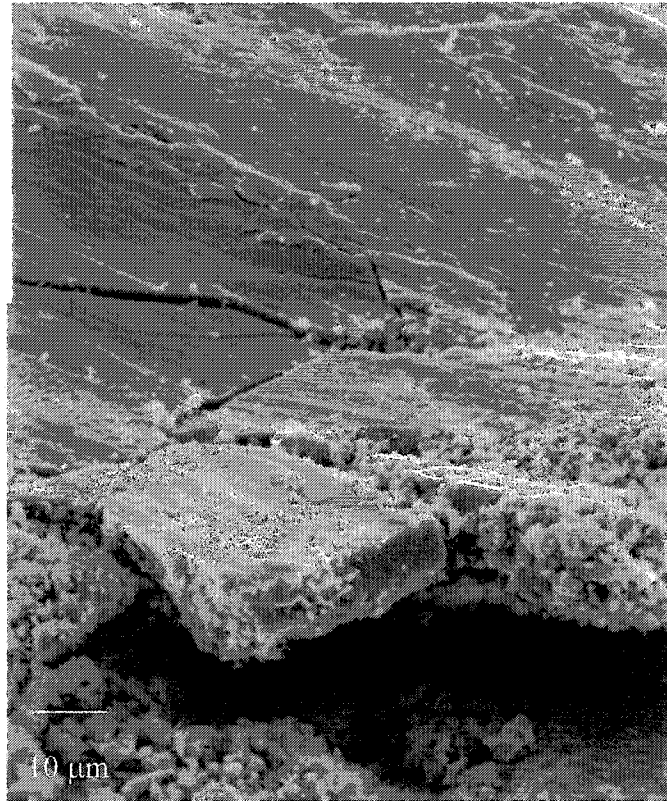
Fig. 4.44- Another example of the formation of the thick oxide layers of the HVOF 1020 during sliding at high loading conditions. The figure also shows cracking in the oxide film.

Fig. 4.44	129
Another example of the formation of the thick oxide layers of the HVOF 1020 during sliding at high loading conditions. The figure also shows cracking in the oxide film.	
Fig. 4.45	130
A secondary electron SEM image from the debris gathered from the HVOF 1020 tested under 75 N and 2.5 m/s shows the plate-like iron oxide debris.	
Fig. 4.46	131
Microstructure and composition of HVOF 1020-2.5% Al coatings: Figure 4.46.a is a back-scattered SEM micrograph showing the cross-sectional microstructure. The light areas labelled (b) the steel splats (see EDS spectrum of Figure 4.46.b); the medium grey regions labelled (c) are the iron oxide veins that consists of Fe and O as shown in the EDS spectrum of Figure 4.46.c ; the dark grey regions labelled (d) are inclusions consisting of Al, Fe and O as shown in the EDS spectrum of Figure 4.46.d ; the black regions labelled (e) are the pores.	
Fig. 4.47	133

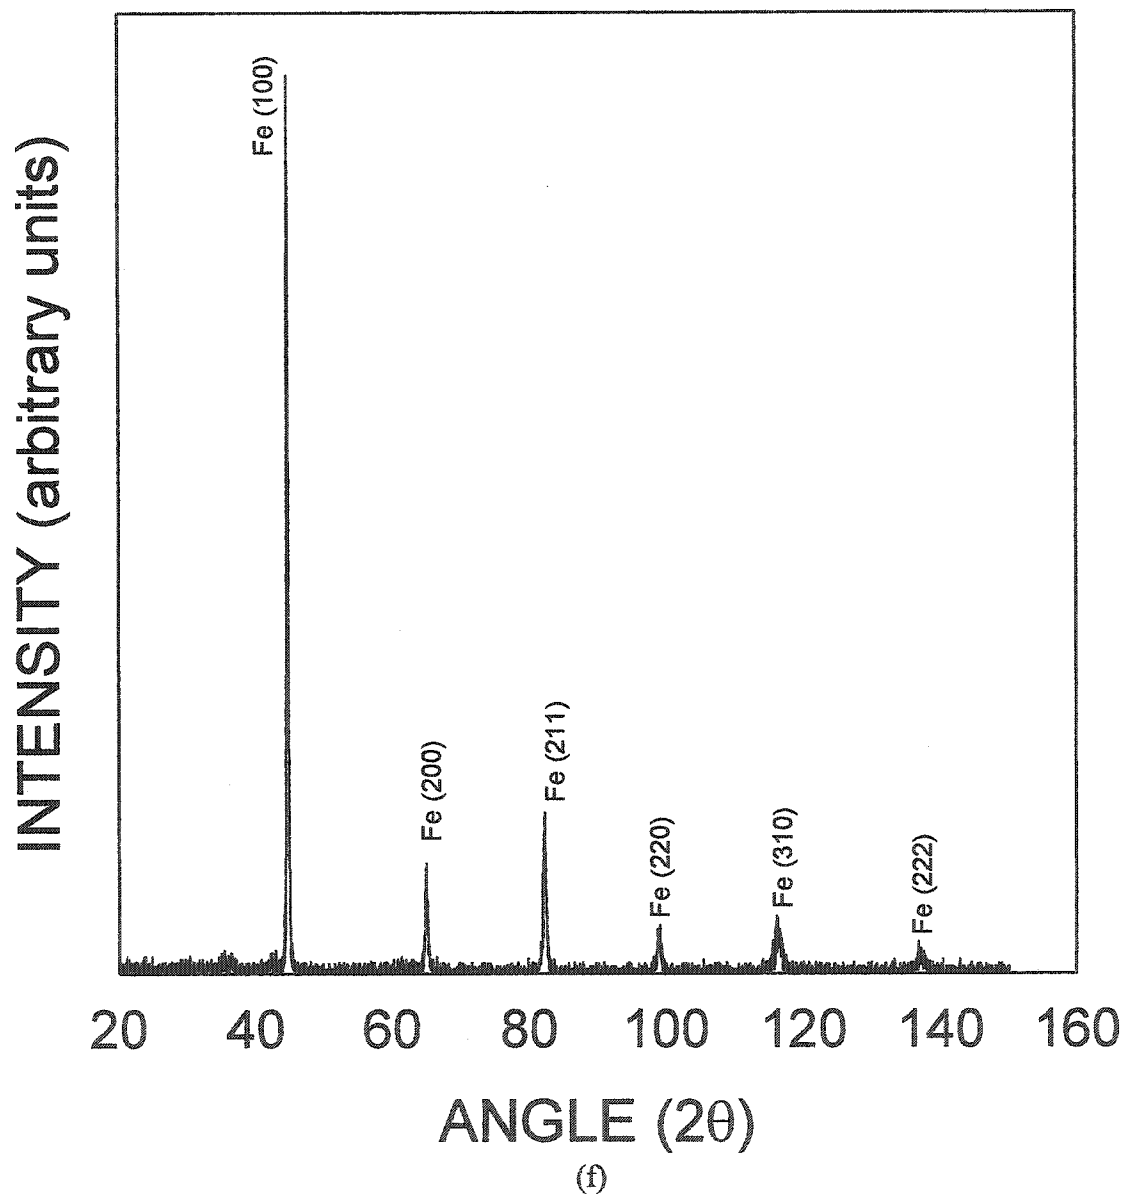
(f)
Fig. 4.46- Microstructure and composition of HVOF 1020-2.5% Al coatings: Fig. 4.46.a is a back-scattered SEM micrograph showing the cross-sectional microstructure. The light areas labelled (b) the steel splats (see EDS spectrum of Fig. 4.46.b); the medium grey regions labelled (c) are the iron oxide veins that consists of Fe and O as shown in the EDS spectrum of Fig. 4.46.c; the dark grey regions labelled (d) are inclusions consisting of Al, Fe and O as shown in the EDS spectrum of Fig. 4.46.d; the black regions labelled (e) are the pores. Fig. 4.46 f is the XRD spectrum of this coating.

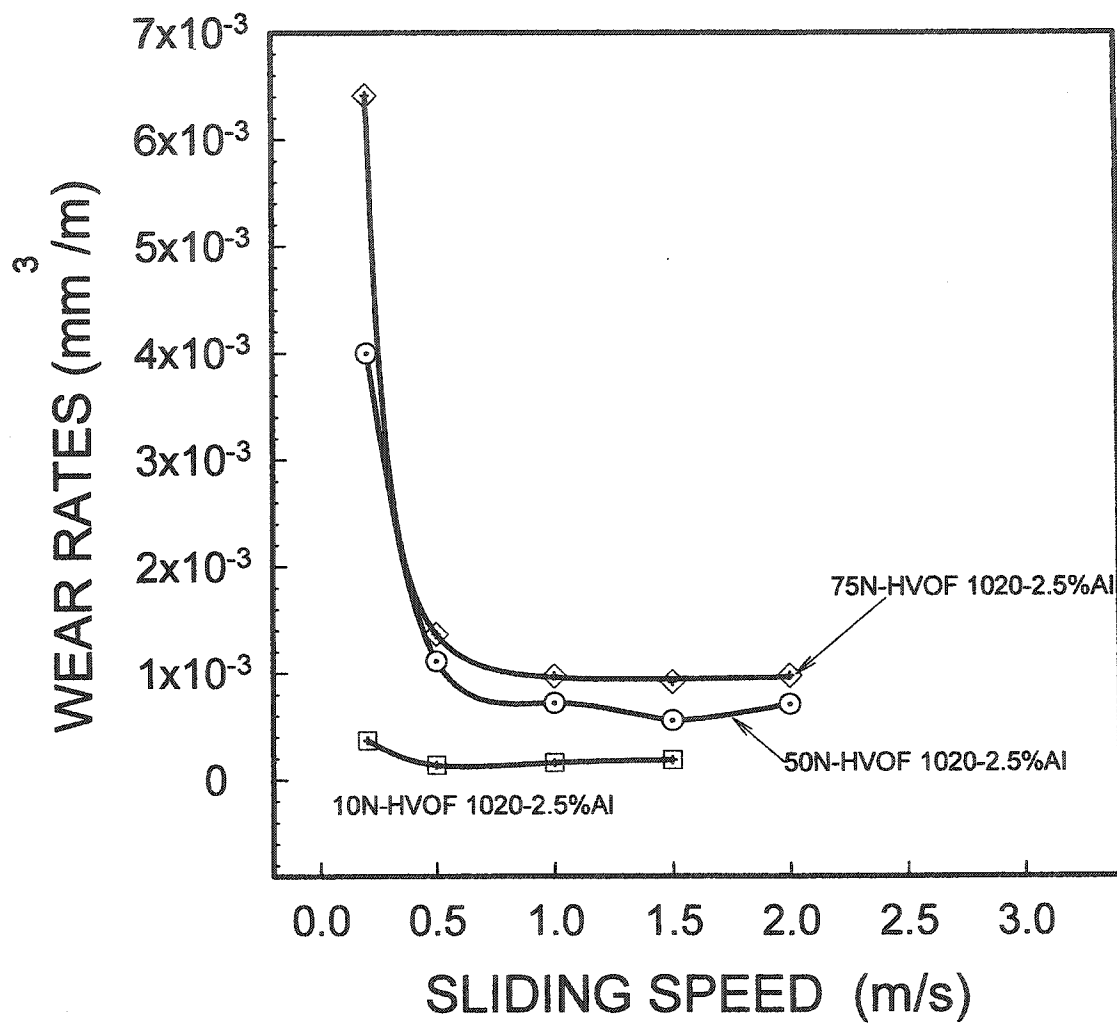
Fig. 4.47- The variation of the wear rates (mm³/m) of the HVOF 1020-2.5% Al coatings is plotted as a function of sliding speed at load levels of 5 N, 10 N, 25 N, 50 N and 75 N.

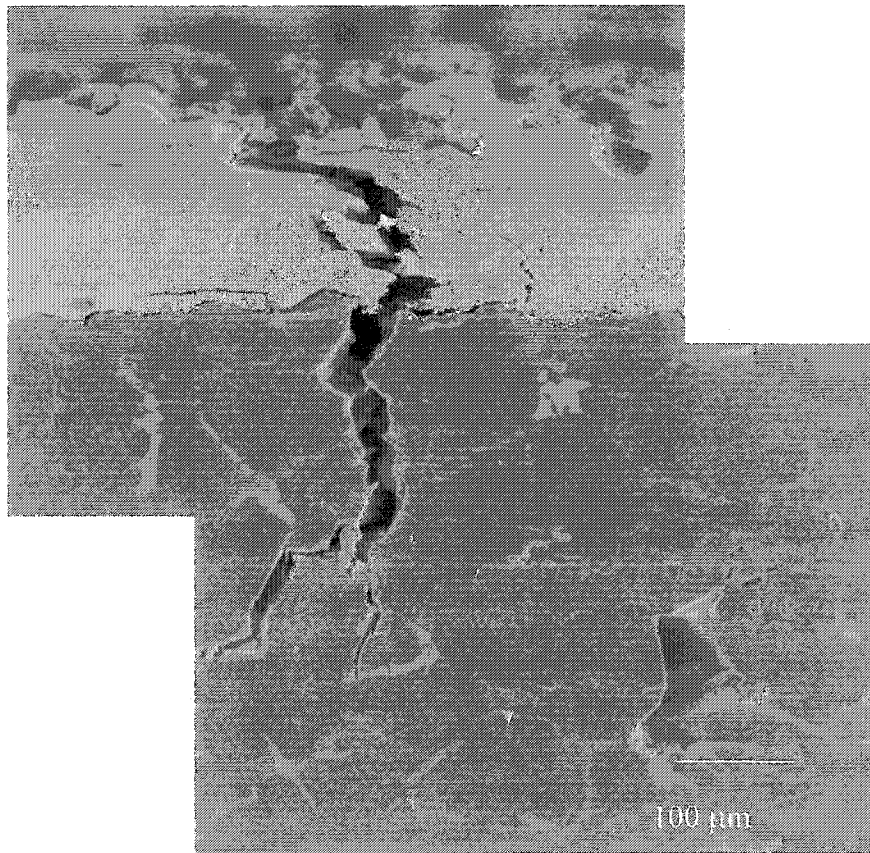
Fig. 5.4- A high magnification micrograph of the cross section of the PTWA 1020 presented in Fig. 5.3.

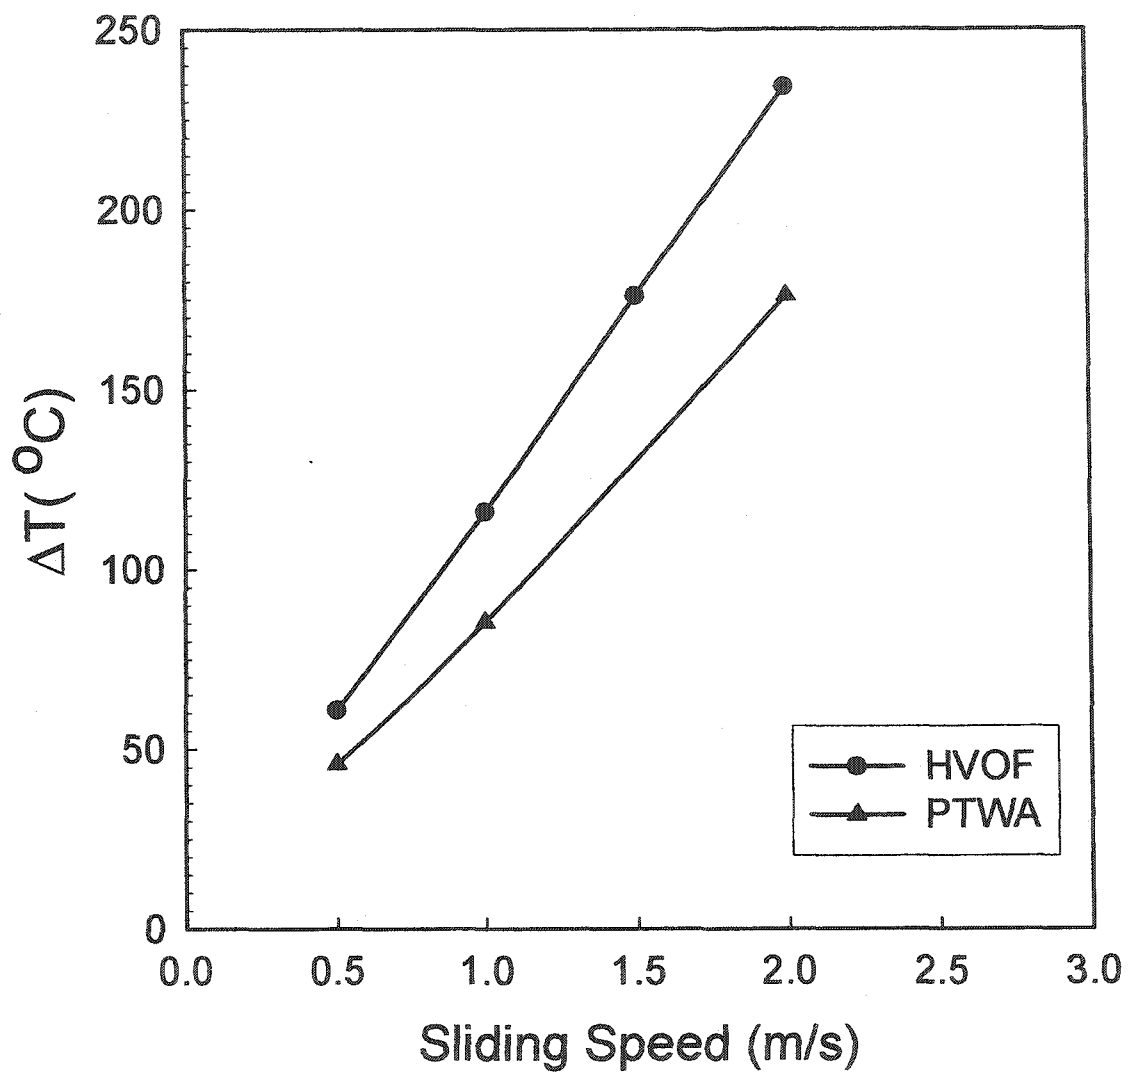
Fig. 5.6- Comparison of friction induced surface temperatures for PTWA 1020 and HVOF 1020 at different sliding speeds at 75 N load.

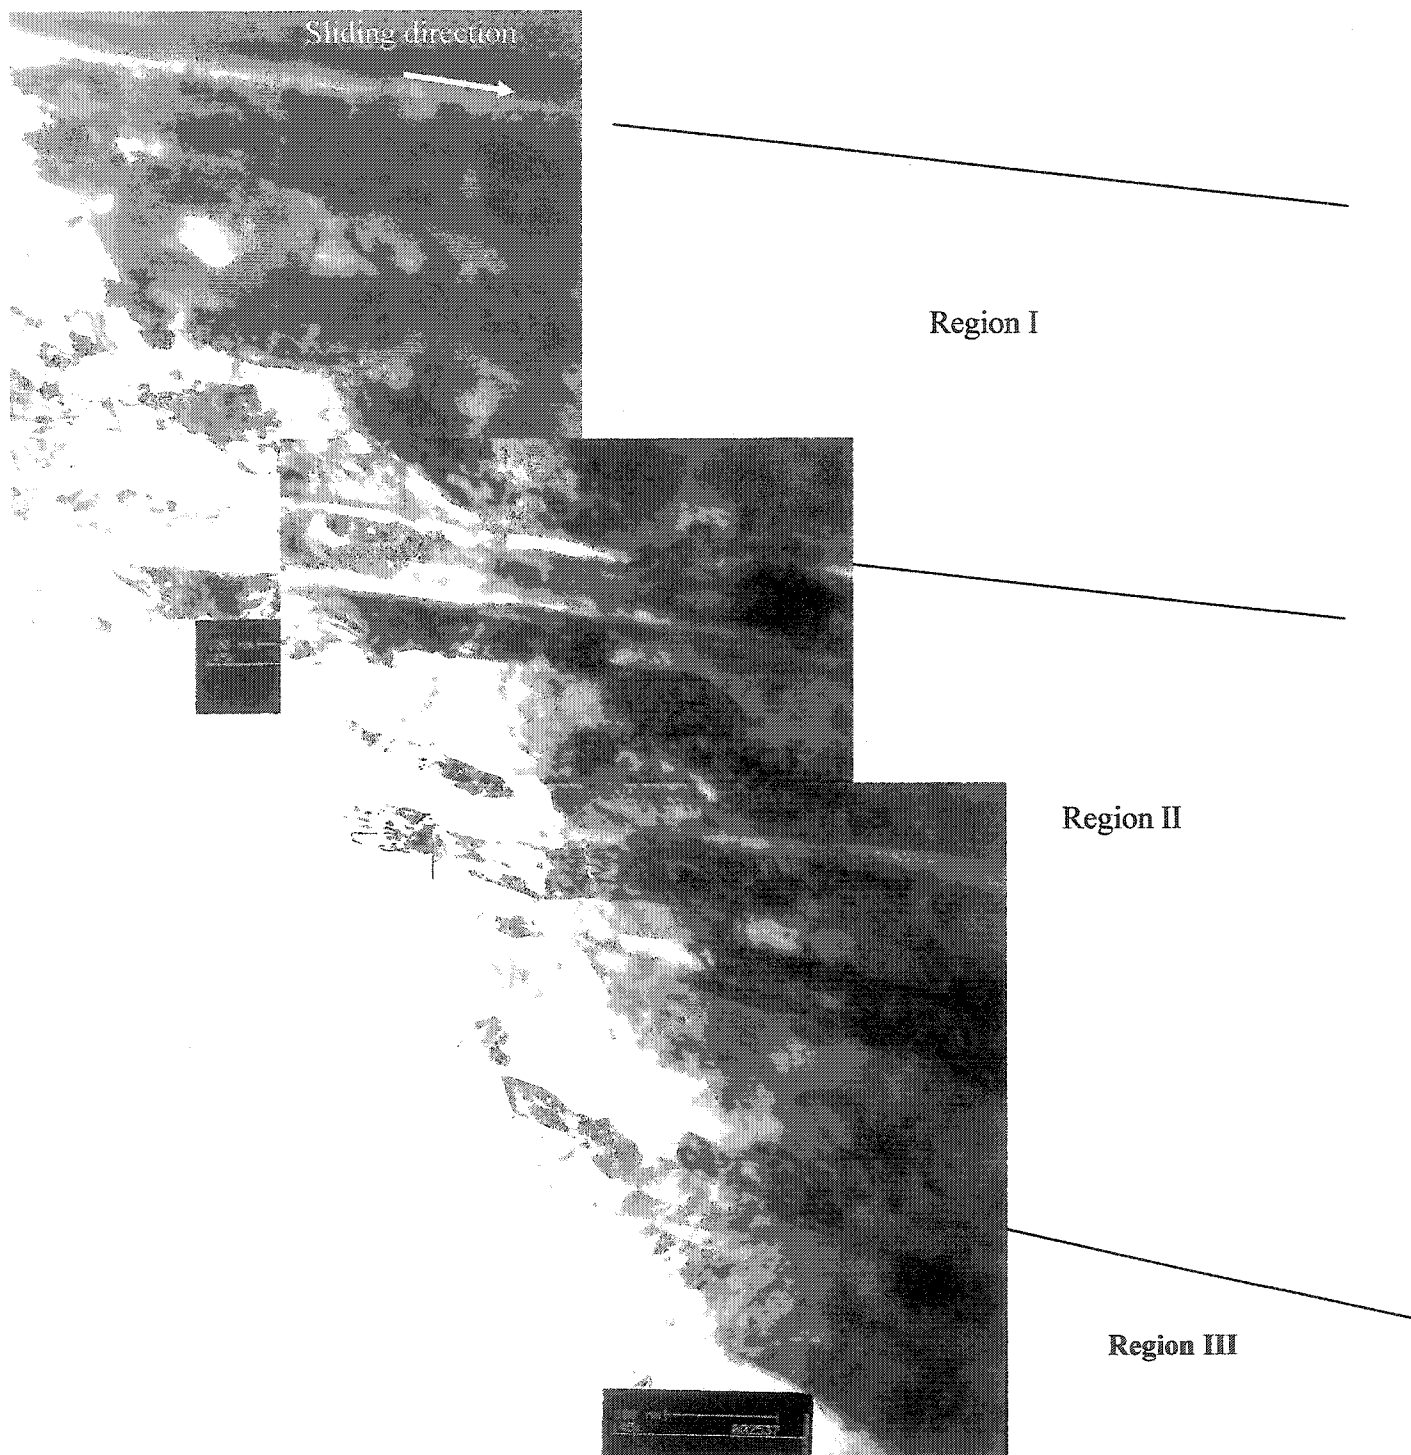
Fig. 5.7- TEM metallographic investigations on the longitudinal sections of the PTWA 1020 sample tested at 75 N and 2.5 m/s which showed surface hardening after wear. The microstructure is divided into three distinguished layers: 1) on the contact surface where the grain size is about 50 nm, and 2) adjacent to the layer where there is a substructure consisting of an elongated sub-grain and 3) undeformed coating.

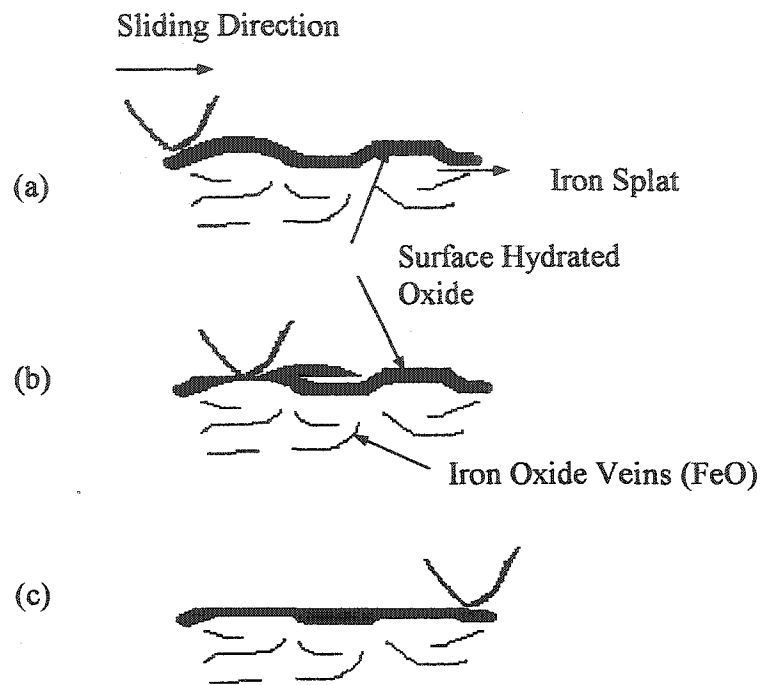
Fig. 5.8- Schematic diagrams illustrating a mechanism for polishing wear by chemical and mechanical mechanisms. **a)** a cross-section of the coating and the formation of the oxide film at high humidity. **b)** the detached hydrated iron oxide by counterface becomes entrapped in the spaces between the actual contact areas. **c)** The crests of asperities are removed and the surface becomes flat.

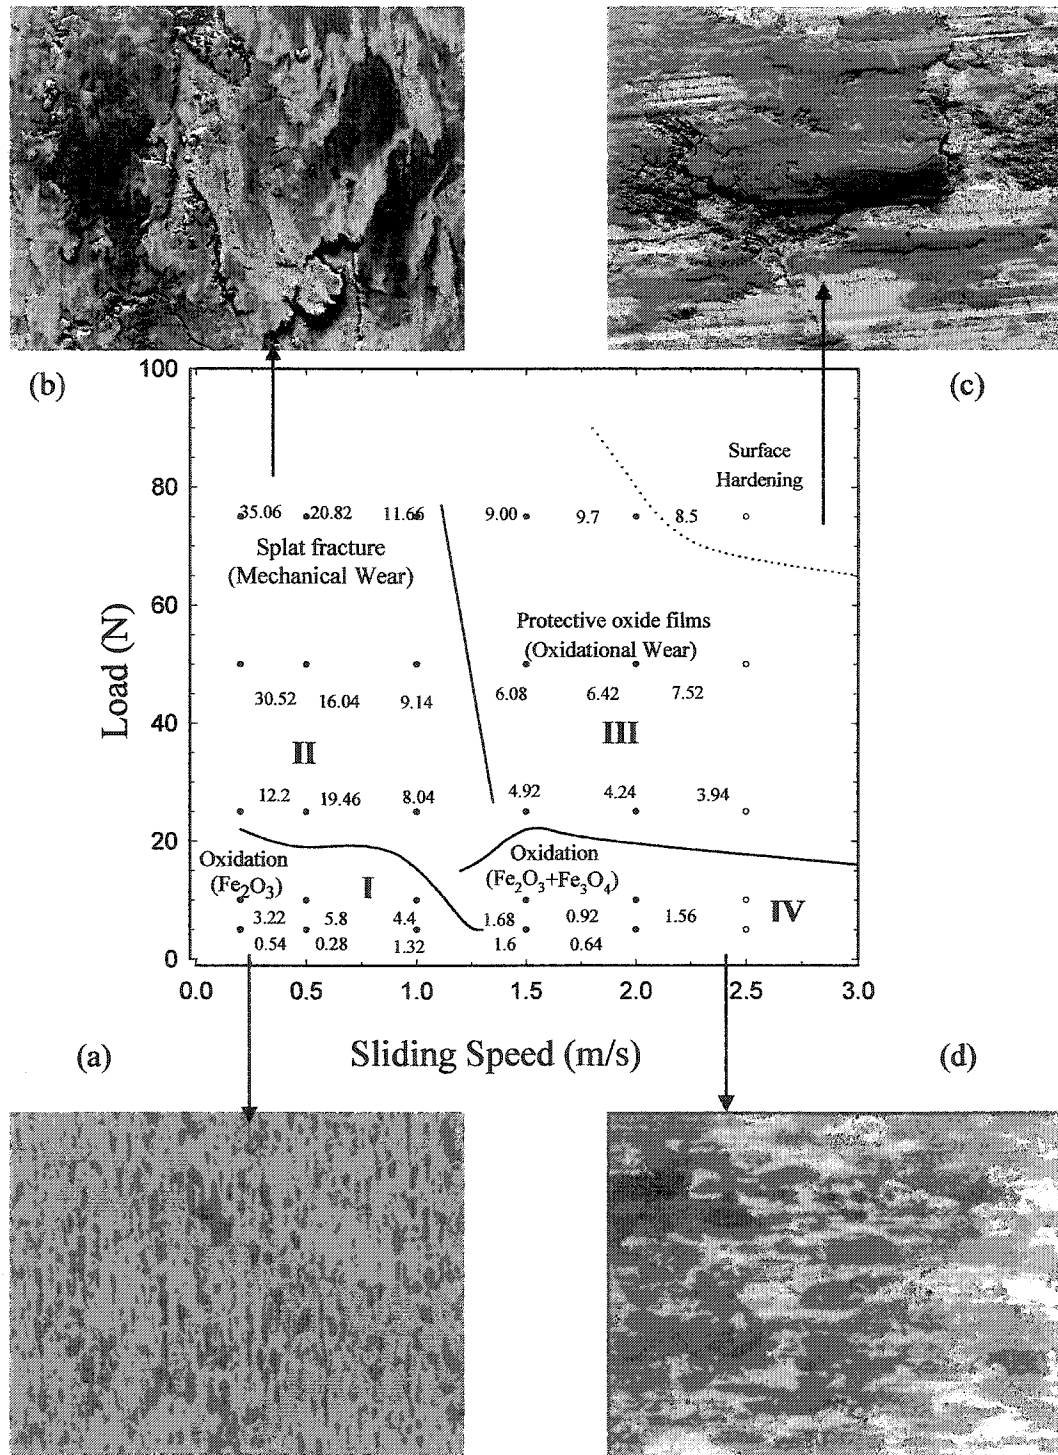
Fig. 5.9- Wear map showing wear rates and mechanisms for PTWA 1020 thermal spray coatings in dry sliding against tool steel pin material. The coatings wear rates have units of 10^{-6} g/m. Experiments were conducted using the pin-on-disc geometry, at room temperature in air (RH=10%). (a-d) Typical SEM micrographs (backscattered electron (BSE)) of worn surface morphologies from Regimes I-IV.

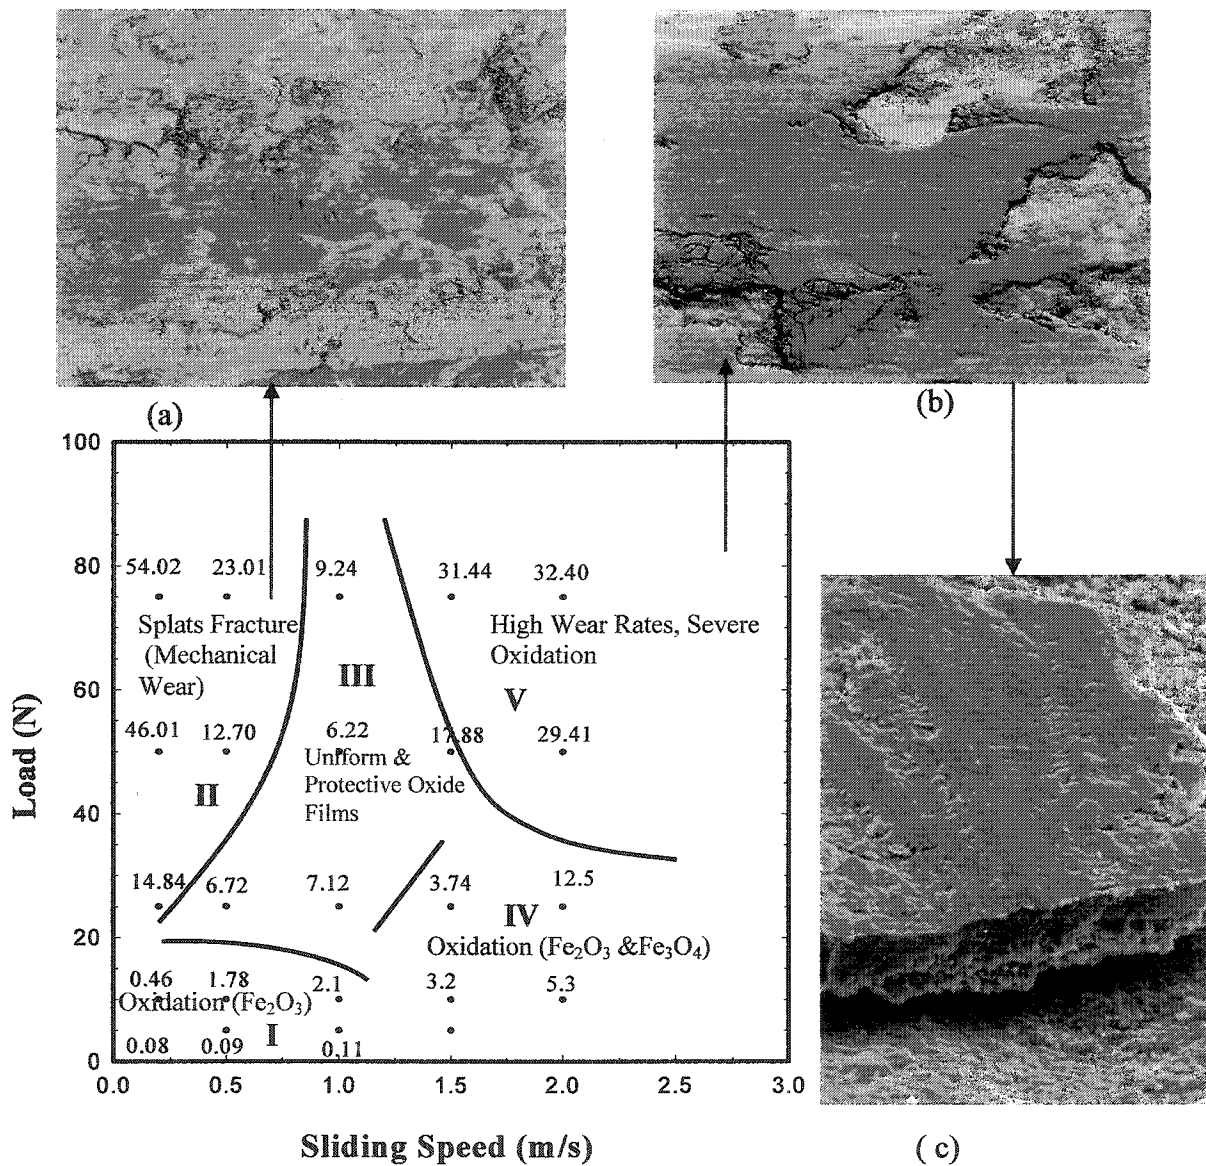
Fig. 5.10- Wear map showing wear rates and mechanisms for HVOF 1020 thermal spray coatings in dry sliding against tool steel pin material. The coatings wear rates have units of 10^{-6} g/m. Experiments were conducted using the pin-on-disc geometry, at room temperature in air (RH=10%). (a-c) Typical SEM micrographs of worn surface morphologies.

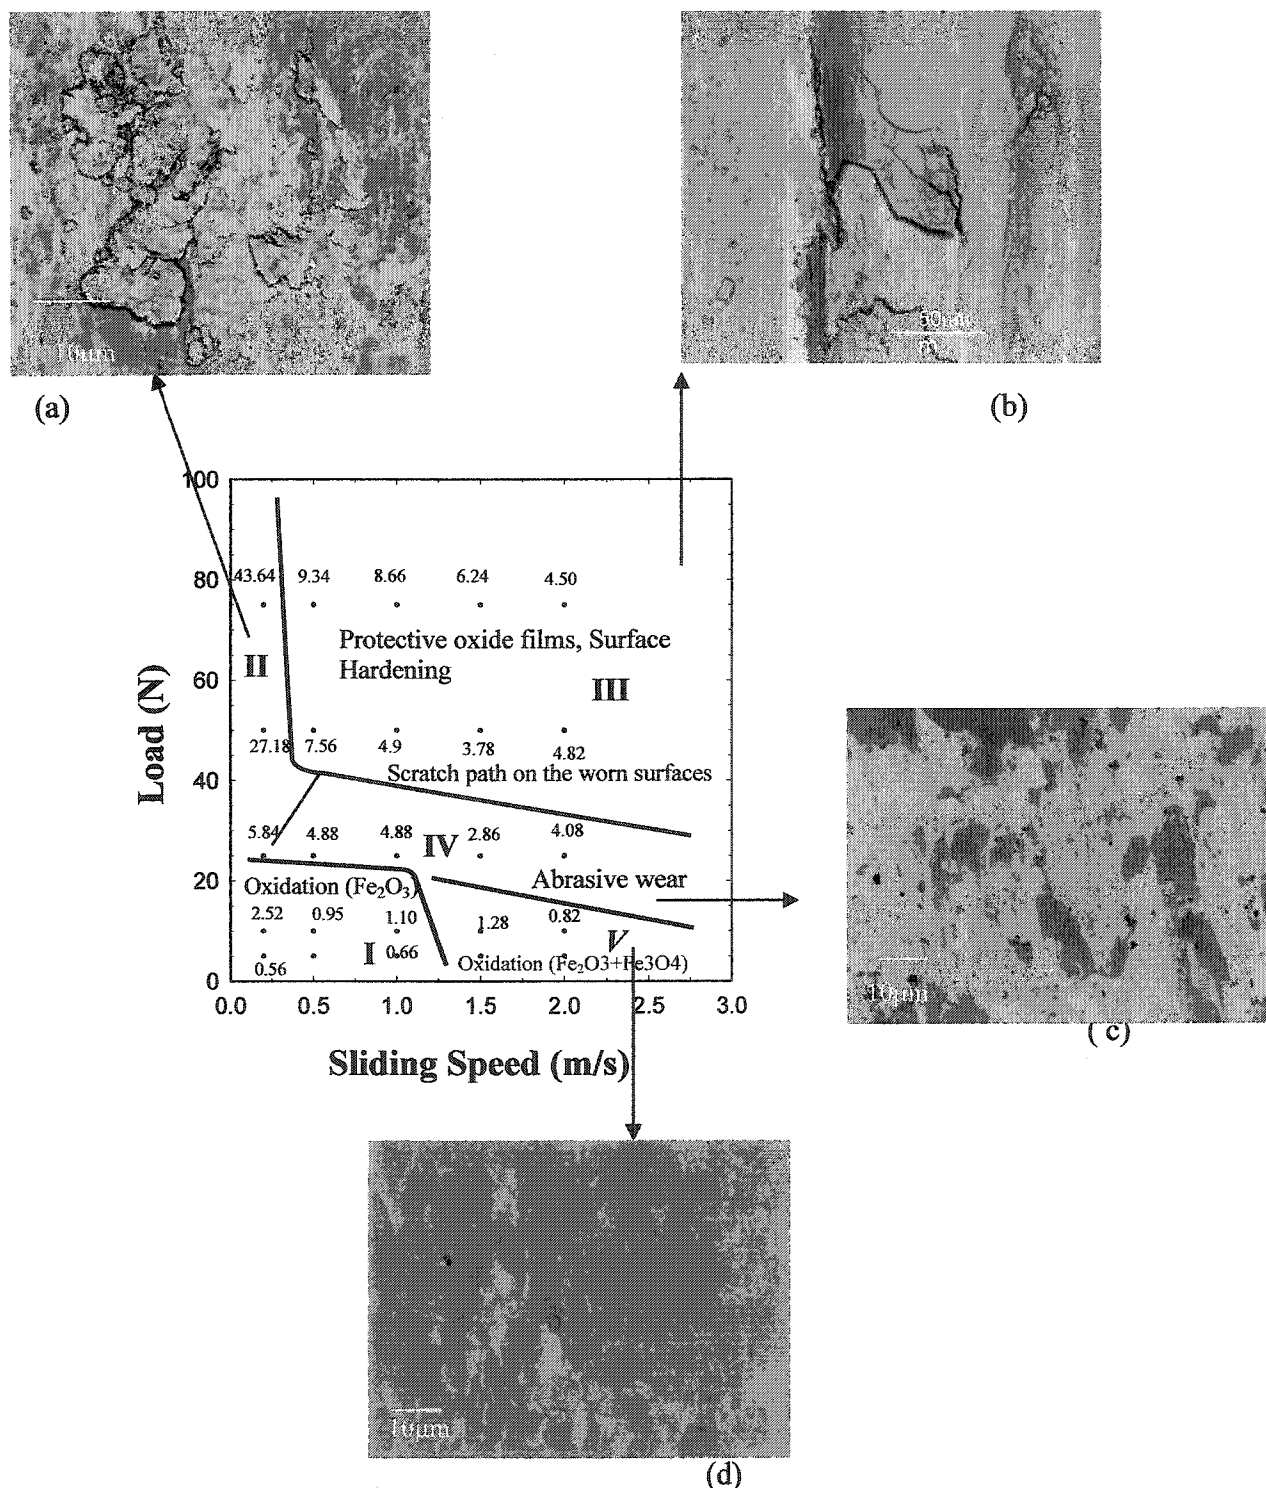
Fig. 5.12- Wear map showing wear rates and mechanisms for HVOF 1020-2.5% Al thermal spray coatings in dry sliding against tool steel pin material. The coatings wear rates have units of 10^{-6} g/m. Experiments were conducted using the pin-on-disc geometry, at room temperature in air (RH=10%). (a-d) Typical SEM micrographs of worn surface morphologies.

Wear map showing wear rates and mechanisms for HVOF 1020-2.5% Al thermal spray coatings in dry sliding against tool steel pin material. The coatings wear rates have units

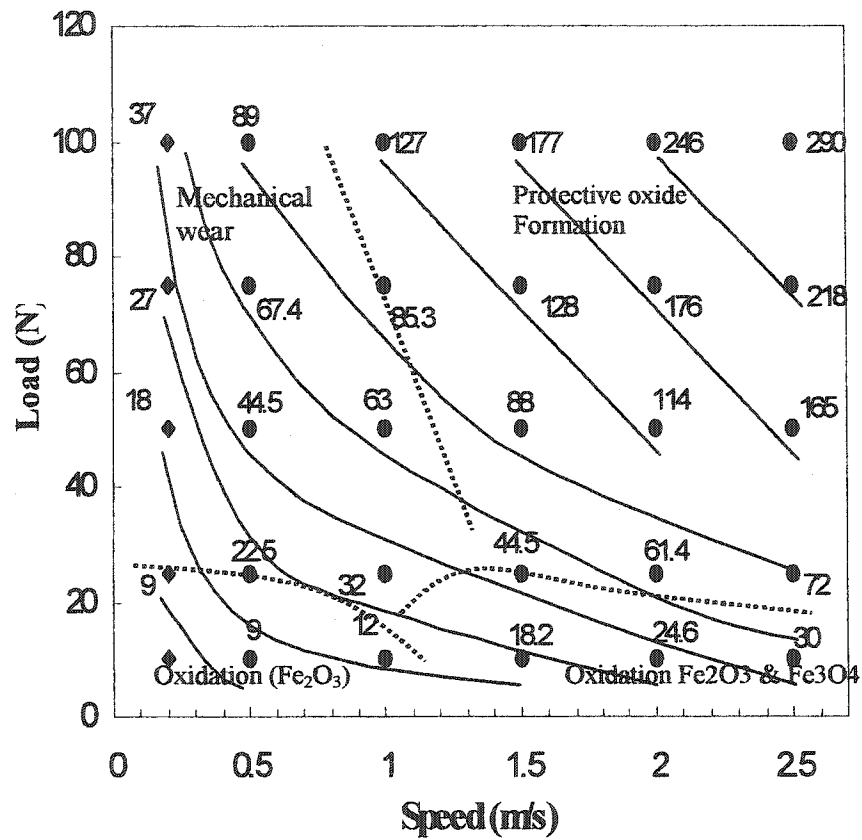
Fig. 5.13- The surface (bulk) temperature map for the PTWA 1020 constructed on load vs. speed axes. The temperature map shows the temperature increase (in °C) on the sliding surface during the sliding at various combinations of load and velocity. The wear regimes are superimposed on the temperature map.

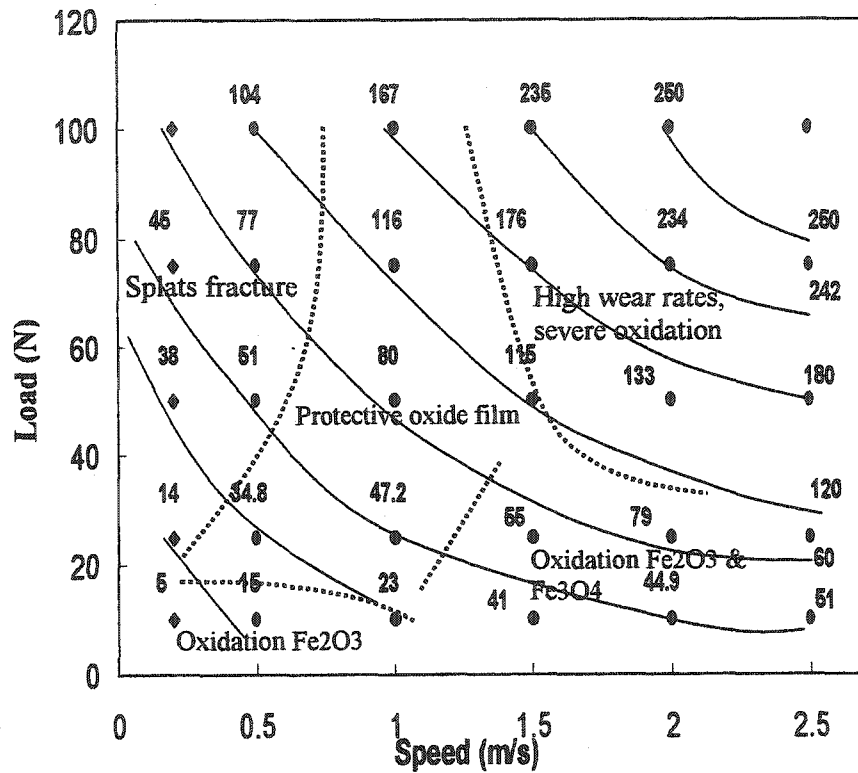
Fig. 5.14- The surface (bulk) temperature map for the HVOF 1020 constructed on load vs. speed axes. The temperature map shows the temperature increase (in °C) on the sliding at the various combinations of load and speed. The wear regimes are superimposed on the temperature map.

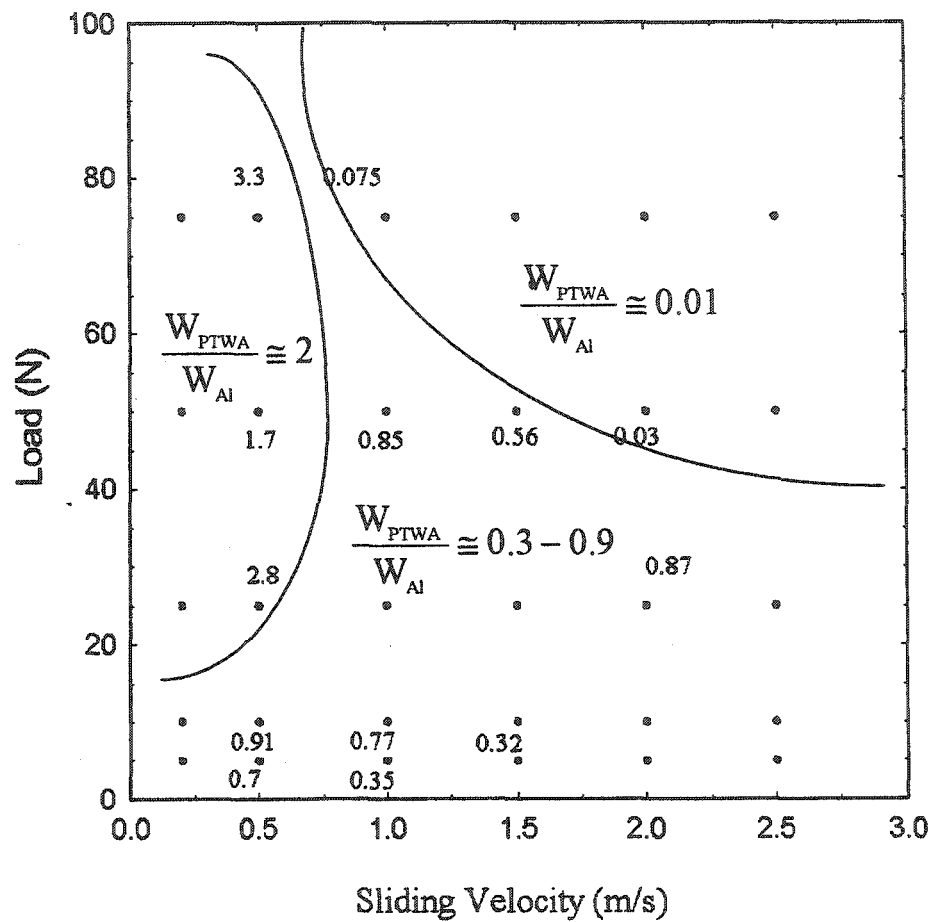
Fig. 5.15- The comparative wear map of the PTWA 1020 coatings and the 356 Al alloy showing the degree of protection provided by the coatings to the aluminum surfaces. The numbers on the map are the ratios of the wear rates of PTWA 1020 to the wear rates of 356 Al alloys at the same loading conditions.
