Investigation of wear and scuffing behaviour of ferrous thermal spray coatings for aluminum engines.

**INVESTIGATION OF WEAR AND SCUFFING BEHAVIOUR OF
FERROUS THERMAL SPRAY COATINGS
FOR ALUMINUM ENGINES**

**A Dissertation
Submitted to the Faculty of Graduate Studies and Research
through Engineering Materials in Partial Fulfillment of the Requirements
for the Degree of Doctor of Philosophy at the
University of Windsor**

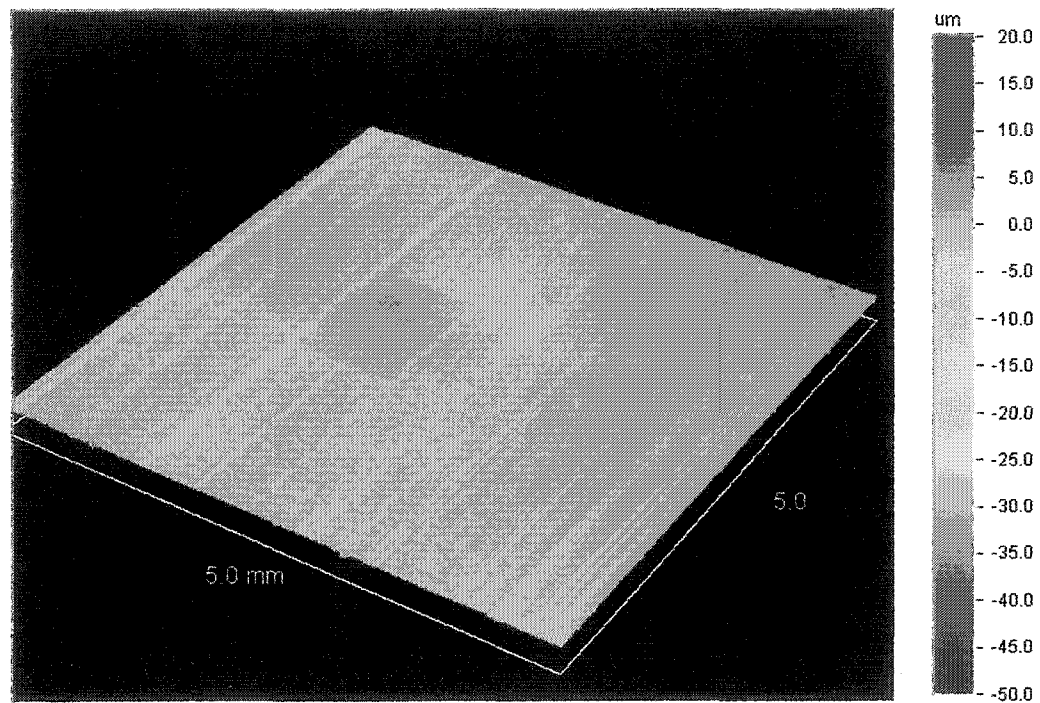
Fig. 6.4- Surface profilometry image from the minor face of the scuffed corvette engine, which shows that the hone marks are completely removed. Scratches and wear scars appeared on the surface of the HVOF 1020-2.5% Al coating.

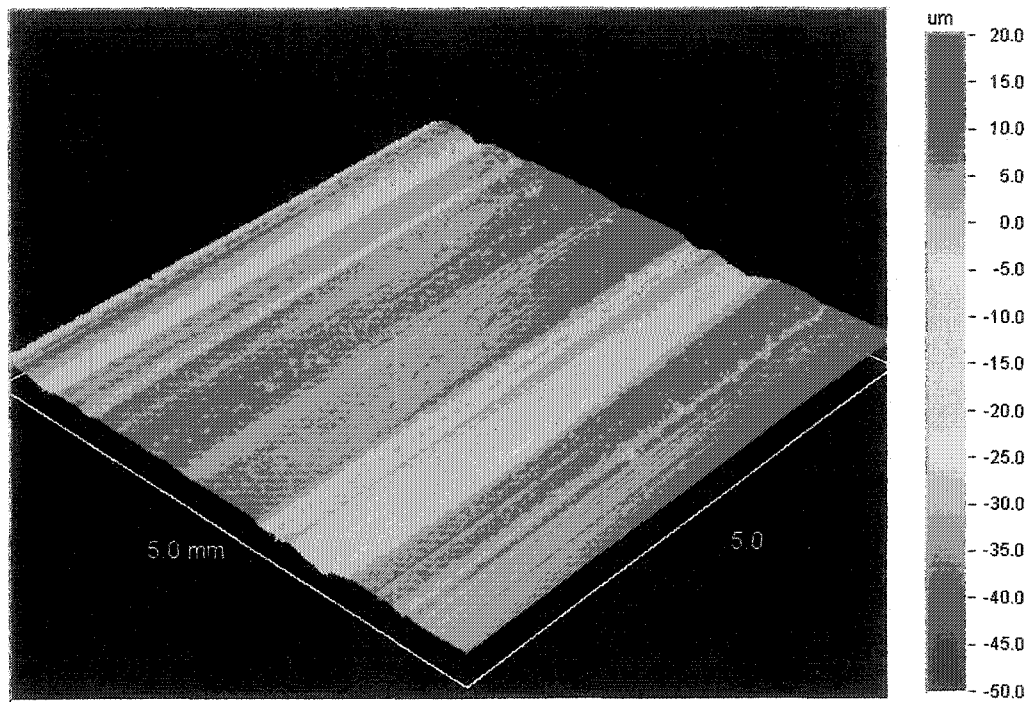
Fig. 6.5.a- Surface profilometry image from the major face of the scuffed Corvette engine. The rough surfaces associated with deep scratches and deep wear scars are clearly seen.

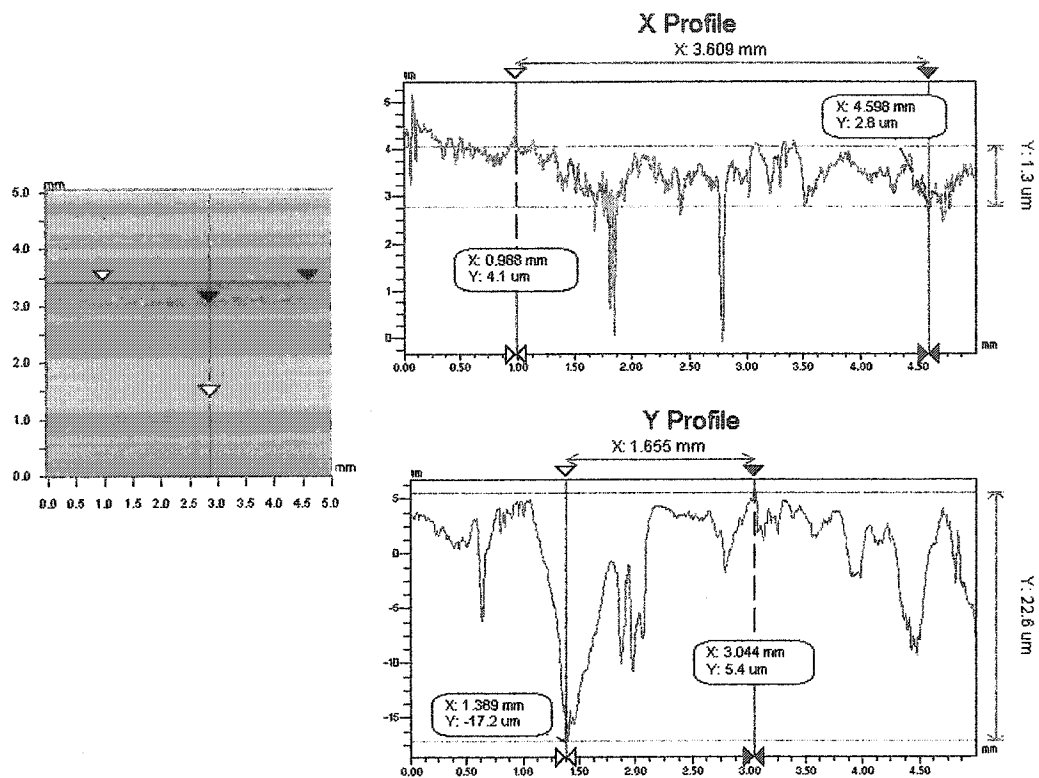
Fig. 6.5.b- Plan view WYKO image of the major face, along with Y and X profiles of selected points as marked on the image.

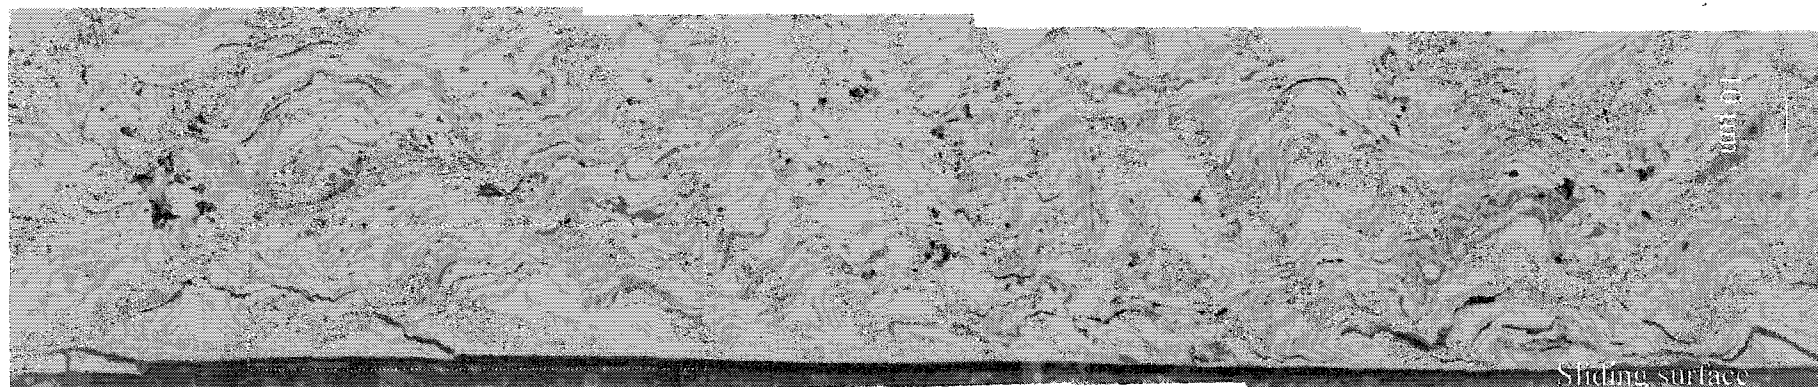
Fig. 6-7.a- Cross-sectional micrograph taken from the same area on the major thrust face (middle part of the bore), the micrograph shows 2-5 μm tribolayer thick on the sliding surface and extensive sub-surface cracking. Fig. 7b High magnification of the back-scattered SEM image of the damaged surface region (area inside the rectangle) in Fig. 7a shows a mechanically mixed tribolayer, evidence of plastic deformation and flow beneath the tribolayer more clear.

(a) Cross-sectional micrograph taken from the same area on the major thrust face (middle part of the bore). The micrograph shows 2-5 μm thick tribolayer on the sliding surface and extensive subsurface cracking. (b) High magnification of the back-scattered SEM image of the damaged surface region (area inside the rectangle) in Fig. 7.a shows a mechanically mixed tribolayer, evidence of plastic deformation and the flow beneath the tribolayer.

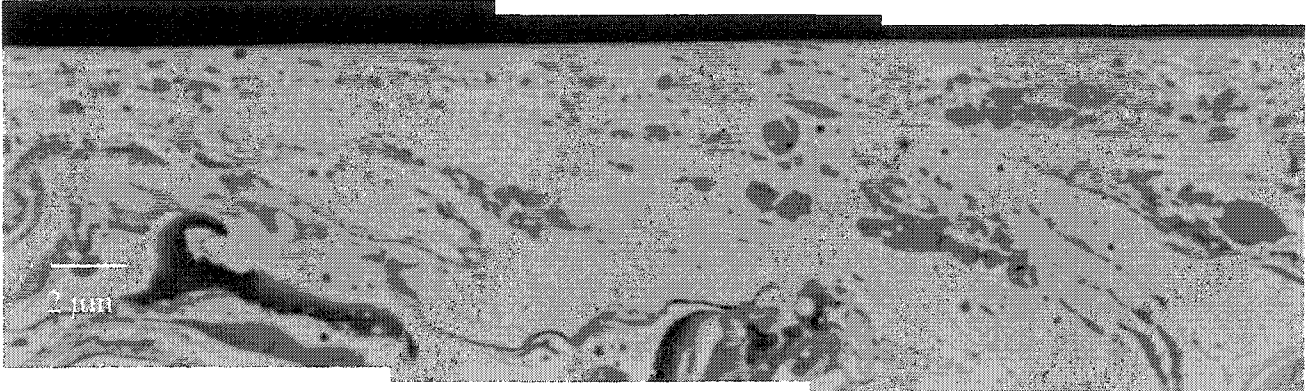
Fig. 6.8- Secondary SEM micrograph taken from the major face of the Corvette engine shows that the shear stress from sliding of the rings or piston induced subsurface plastic deformation and a net flow of the relatively soft matrix. This shear stress also fractured the oxide particles in the tribolayer, reducing their size and dispersing them in the matrix.

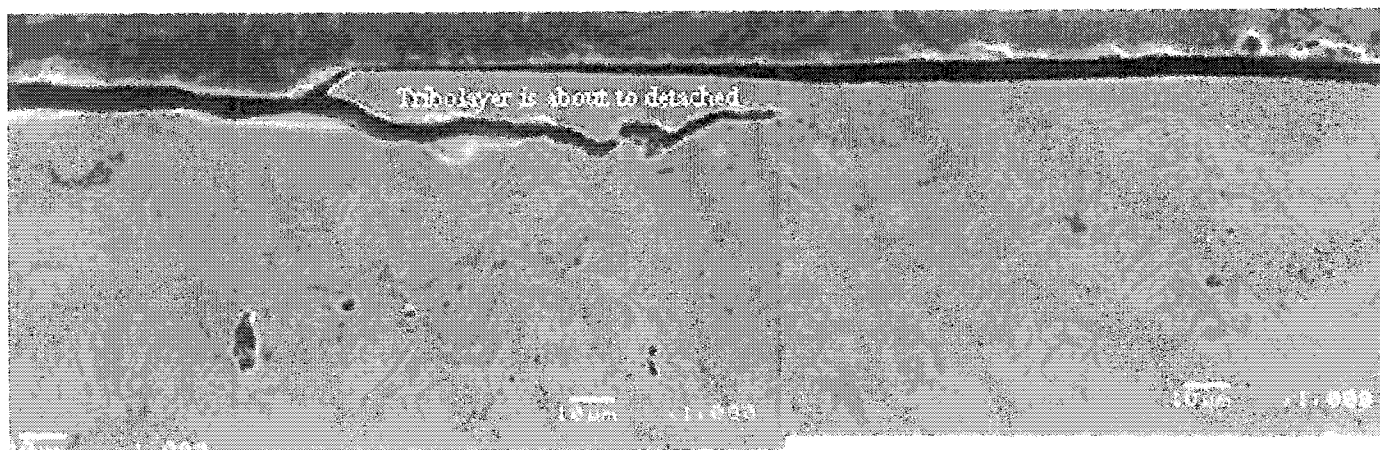
Fig. 6.10- Secondary electron SEM image of the longitudinal cross section from the major face of the Corvette engine shows how the surface layers were detached from sliding surfaces.

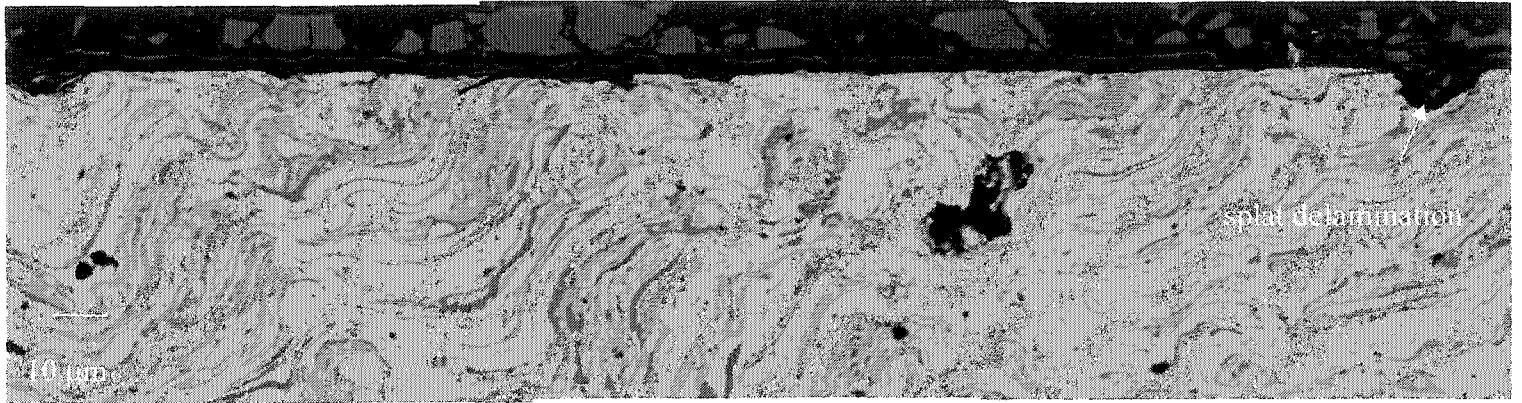
Fig. 6.11- Cross-sectional secondary SEM image taken from the minor face 45 mm below the deck face shows the surface damages in the form of splat delamination. There is no evidence of the tribolayer.

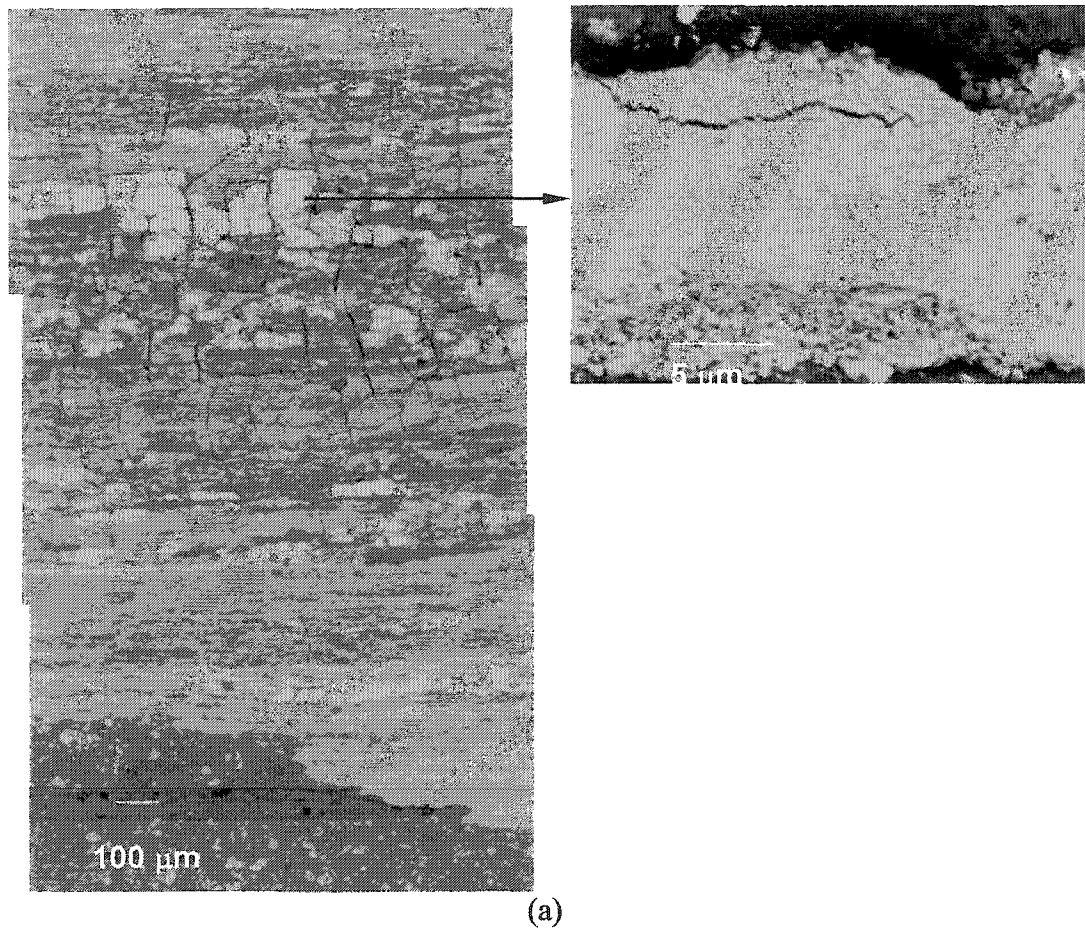
Fig. 6.13- (a) Back-scattered electron SEM image taken from the side of the piston skirt in contact with the major face of the bore with the greatest damage; (b) High magnification micrograph that shows iron patches (light grey area) transferred from the HVOF 1020-2.5% Al coating on the cylinder bores.

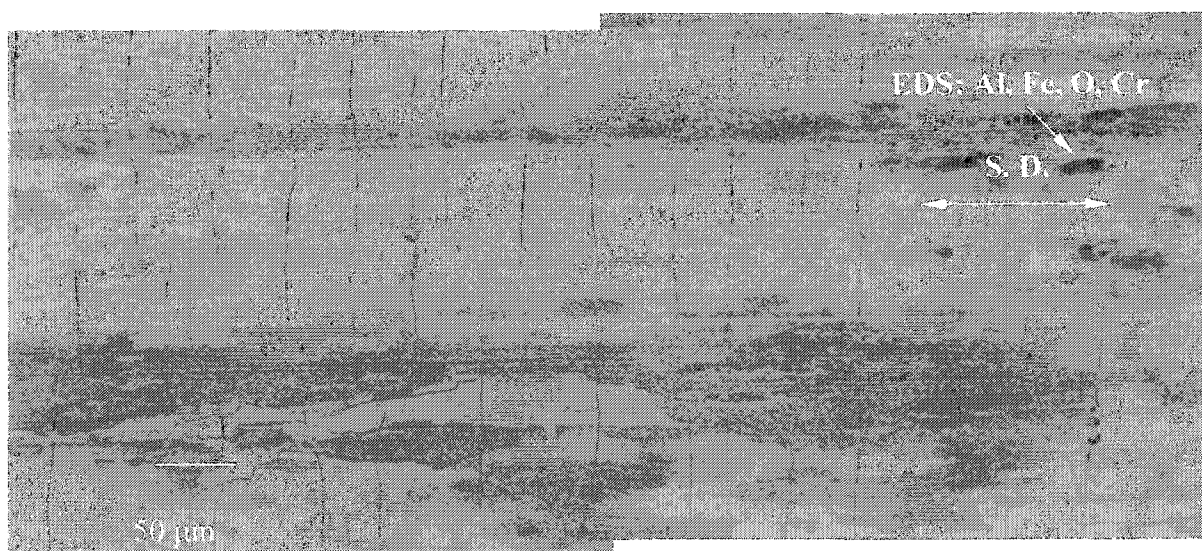
Fig. 6.15- Back-scattered SEM micrograph of the centre of the damaged area of the ring shows that the surface is cracked along a direction perpendicular to the sliding direction with scratches parallel to the sliding direction. There is also evidence of material transfer (dark region) to the surface of the ring.

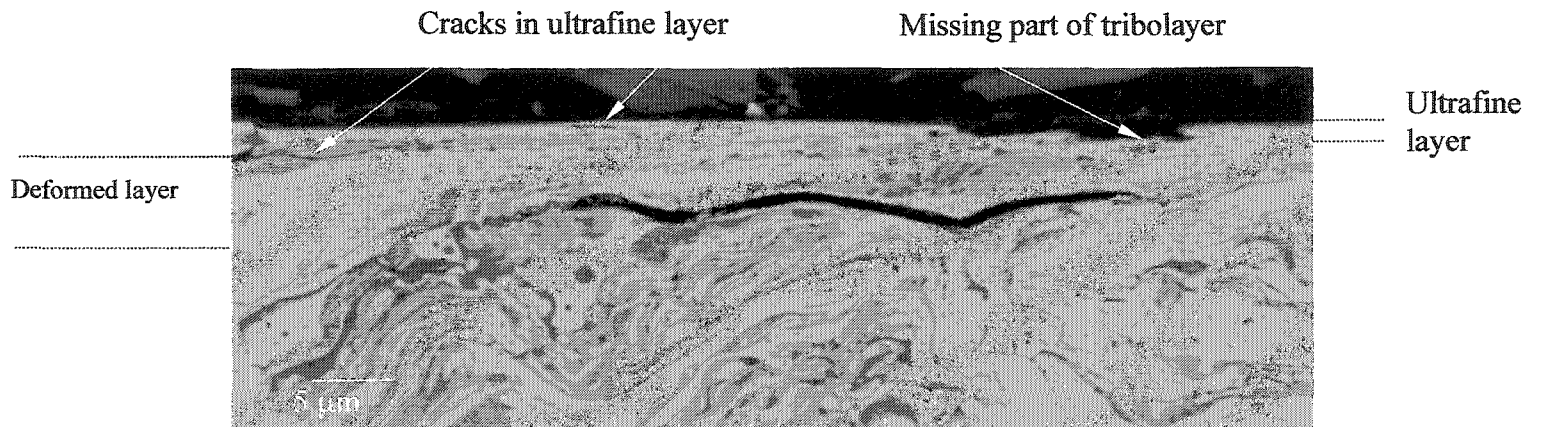
Fig. 6.18- Back-scattered SEM micrograph from the cross section of the major side of the scuffed Saturn engine bore that shows subsurface cracks parallel to the surface.

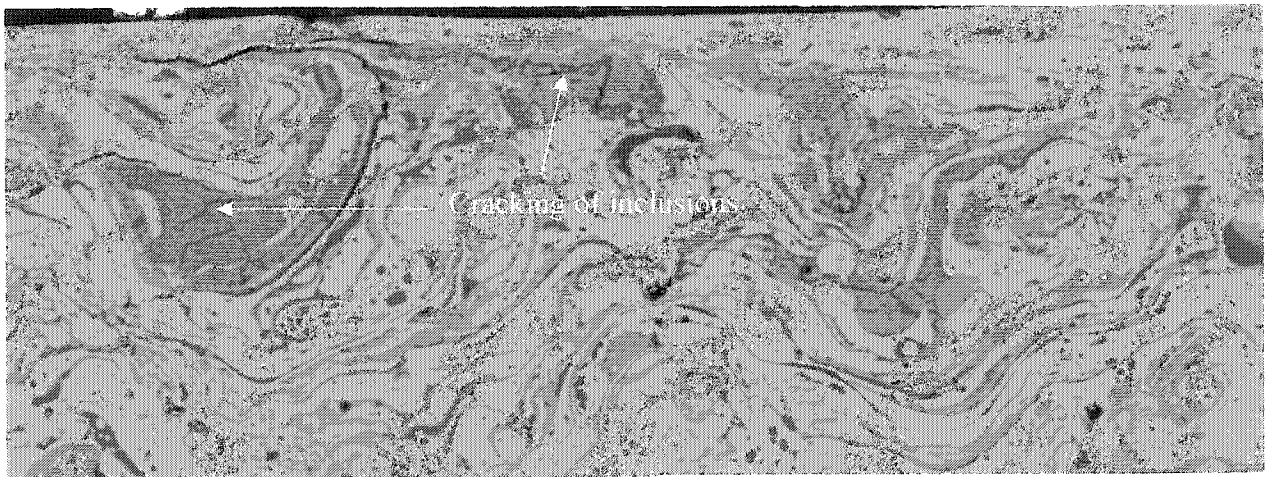
Fig. 6.20- Back scattered SEM image from the cross section of HVOF 1020-2.5% Al tested at 100 N load and 0.2 m/s speed under Ar atmosphere and boundary lubricated condition to 15,000 m using pin-on-disc tribometer that shows formation of deformed layer and cracks in the inclusions.

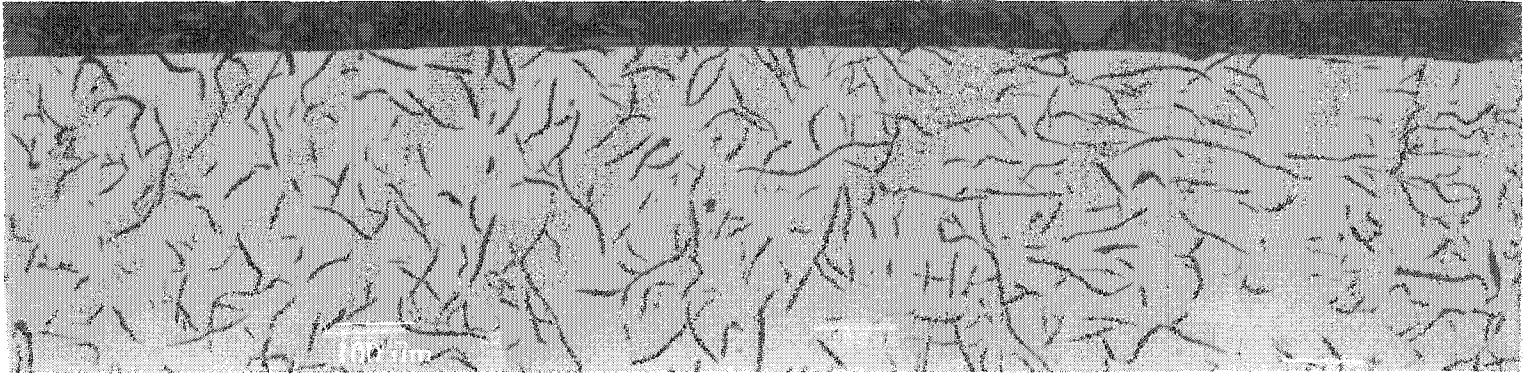
Fig. 6.23- Back-scattered SEM image from the cross section of cast iron tested at 100 N load and 0.2 m/s speed under Ar atmosphere and boundary lubricated condition to 15,000 m using pin-on-disc tribometer that shows no visible damage and deformed layer at the contact surface.
