Repair of corroded steel beam using CFRP

**A Thesis
Submitted to the Faculty of Graduate Studies
through
the Department of Civil and Environmental Engineering
in Partial Fulfillment of the Requirements for
the Degree of Master of Applied Science at the
University of Windsor**

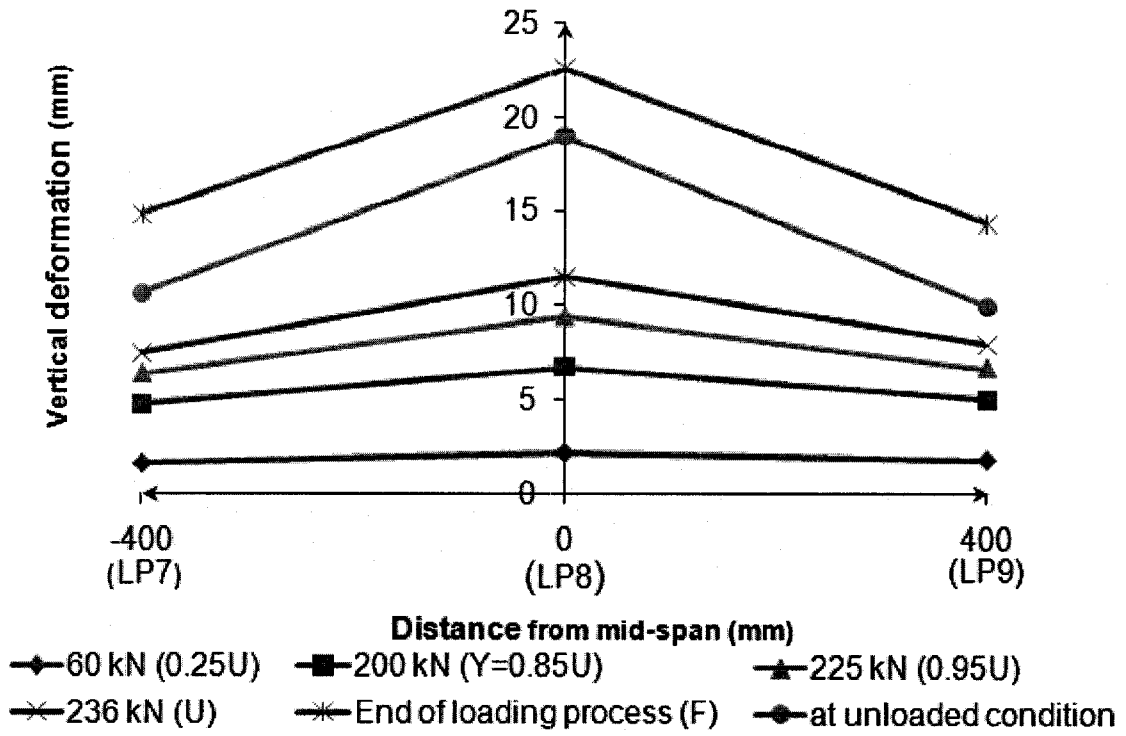
Figure 4.11: Vertical deformation response for RC-W67-T2.4-G1

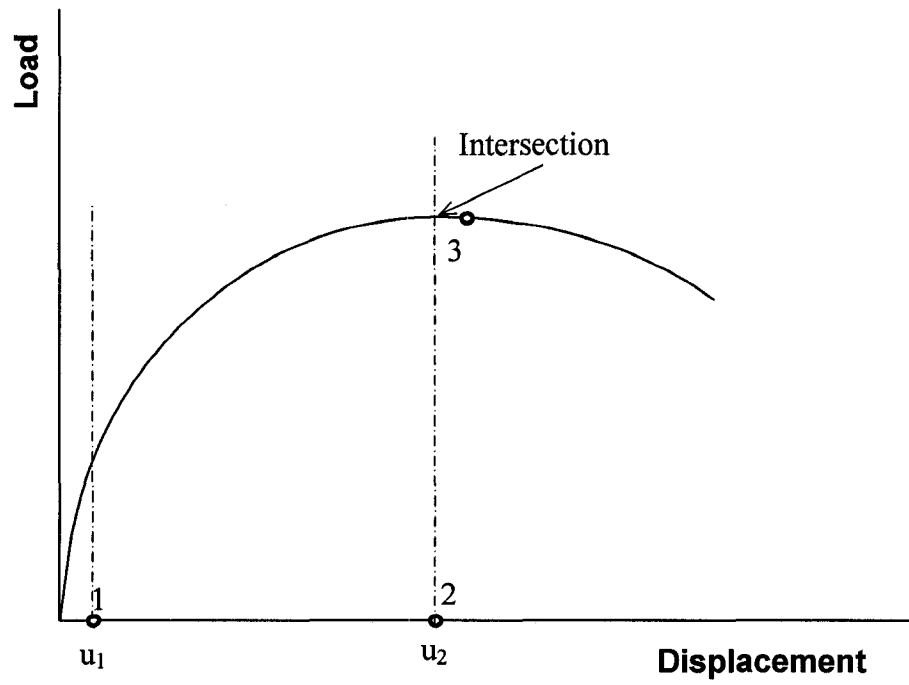
Figure 5.14: Displacement control process
