Effect of ESD on Complex Programmable Logic Device and Field Programmable Gate Arrays

Abstract— Complex electronics devices are becoming more sensitive to electrostatic discharge (ESD). These components are being developed with higher density (extra memory bits per unit volume) and are becoming faster (MHz, GHz, THz, etc.). These upgrades in technology do not come without a “technological price”. By enhancing the products’ performance to meet the users’ demands and requirements, one drawback is the reduction in the ESD sensitivity voltage levels. Indirect and direct air/contact discharge test has been conducted on the ALS-SDA-CPLD/FPGA trainer kit linked to the digital to analog converter (DAC) module. The Field Programmable Gate Arrays (FPGA) and Complex Programmable Logic Devices (CPLD) are found to be very ESD sensitive. The FPGA 3s50 IC was affected during the contact discharge to the input pin. There was damage to the bond pad as well as the metal top layer was damaged. The DAC ICs were affected during the ESD discharge - one due to direct ESD effects and the other due to indirect ESD effects. There was dielectric breakdown damage observed in the CPLD 9572 IC.

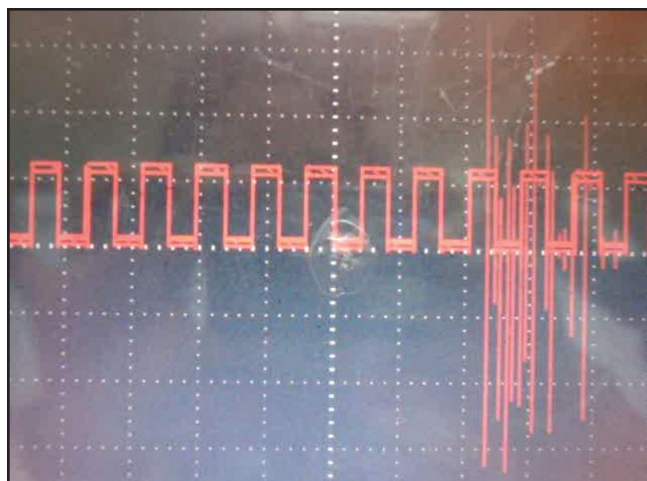
Fig. 8 DAC output for a 8kV discharge

When air discharge of 2kV was given on the DAC FRC no effect was observed. For a 4kV air discharge small transients were seen in the DAC output. For an 8kV air discharge on the FRC connected to seven segment data had no impact on the seven segment output but DAC output had transients. When the 8kV air discharge was given on the DAC FRC huge transients were observed in the DAC output as shown in the Fig. 8.

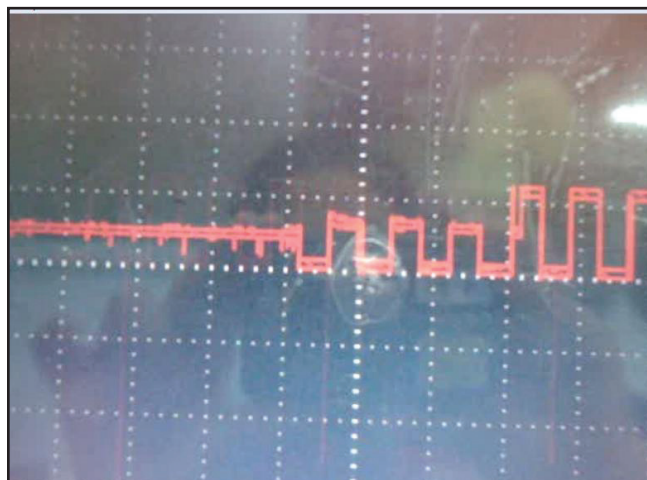
Fig. 9 DAC output for 15kV discharge on FRC

When 15kV discharge was given on DAC FRC, initially large transients were observed in the DAC output and the amplitude of the DAC output became zero, then recovered to half of its initial value and finally recovered back to original value of 5V as shown in the Fig. 9. When 15kV air discharge was given on the FRC connected to the seven segment display, one of the segments in the display momentarily turned off.
