§17. Thermal Loads Effects on Erosion Processes of Helium Irradiated High-melting PFMs

Miyamoto, M. (Dept. Mater. Sci. Shimane Univ.), Tokitani, M., Masuzaki, S.

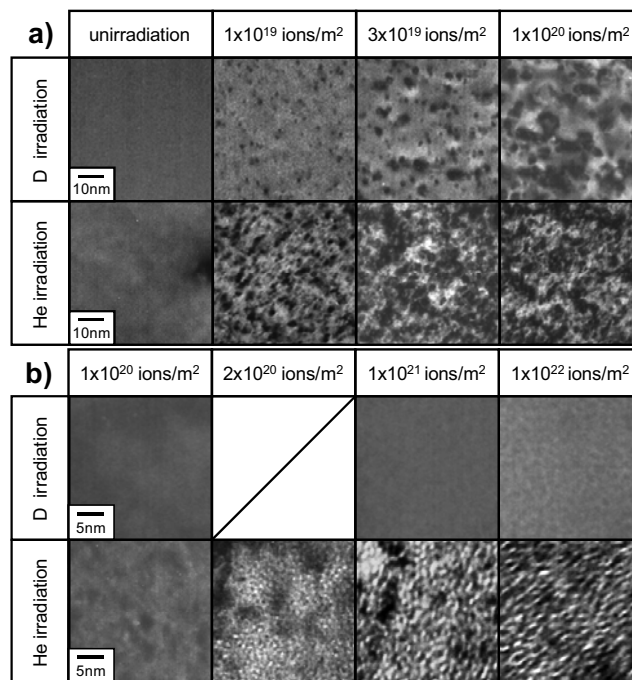
Fig. 1 Microstructure evolutions in Mo irradiated with 5 keV- D^+ or He^+ at R.T. Black dot images (a) and circular white images (b) indicate radiation-induced dislocation loops and helium bubbles, respectively.

Fig.1 shows TEM micrographs of Mo irradiated with 5 keV D^+ or He^+ at R.T. For the He^+ irradiated sample, comparatively high density of dislocation loops and helium bubbles were formed while no visible bubbles were observed even in the sample irradiated with deuterium ions to a fluence of $1 \times 10^{22} \text{ ions/m}^2$. For optical measurements, rather large changes were similarly observed in the He irradiation sample. Fig. 2 shows refractive index, n , and extinction coefficient, k , for the virgin sample and irradiated samples with 3 keV D^+ or He^+ as a function of a photon energy. These results indicate that a helium irradiation has a larger impact on properties change of PFMs than a hydrogen isotope irradiation. A strong helium effects on surface morphology were also observed after the thermal loading. Fig.3 shows the SEM image of He^+ pre-irradiated W surface after the thermal loading of $\sim 0.4 \text{ MW/m}^2$ in ACT. While D^+ pre-irradiation sample shows smooth surface after the similar thermal loading, large roughness and many holes are observed for the He^+ pre-irradiation sample. It should be noted that existence of helium causes stable defects such as helium bubbles and the influence of the helium related defects remains even at a very high temperature.

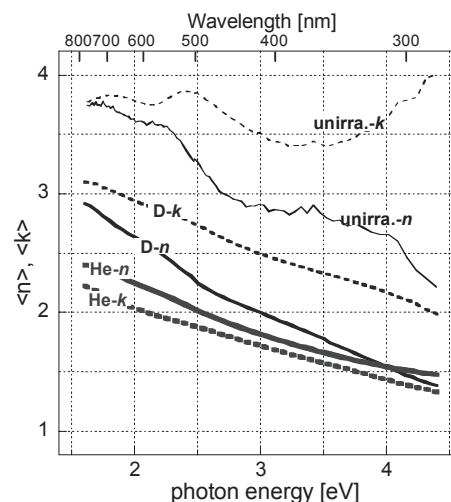
Fig. 2 Optical constants, n and k , measured with ellipsometer, in the Mo samples before and after the irradiation with 3keV- D^+ or He^+ .

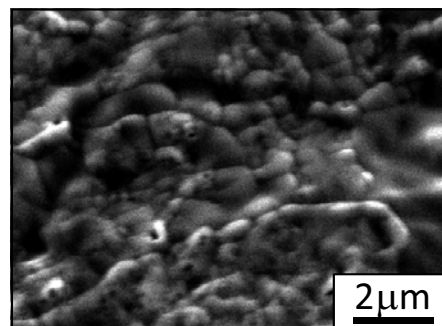
Fig.3 Surface morphology after the thermal loading of $\sim 0.4 \text{ MW/m}^2$ experiments in W pre-irradiated with 5keV- He^+ to a fluence of 10^{23} He/m^2 .
