Journal of the Arkansas Academy of Science

Geologic Hazards Associated with Shale Strata and Swelling Clays within Fayetteville Quadrangle, Washington County, Arkansas

Maria E. King, Jack T. King, and Stephen K. Boss*

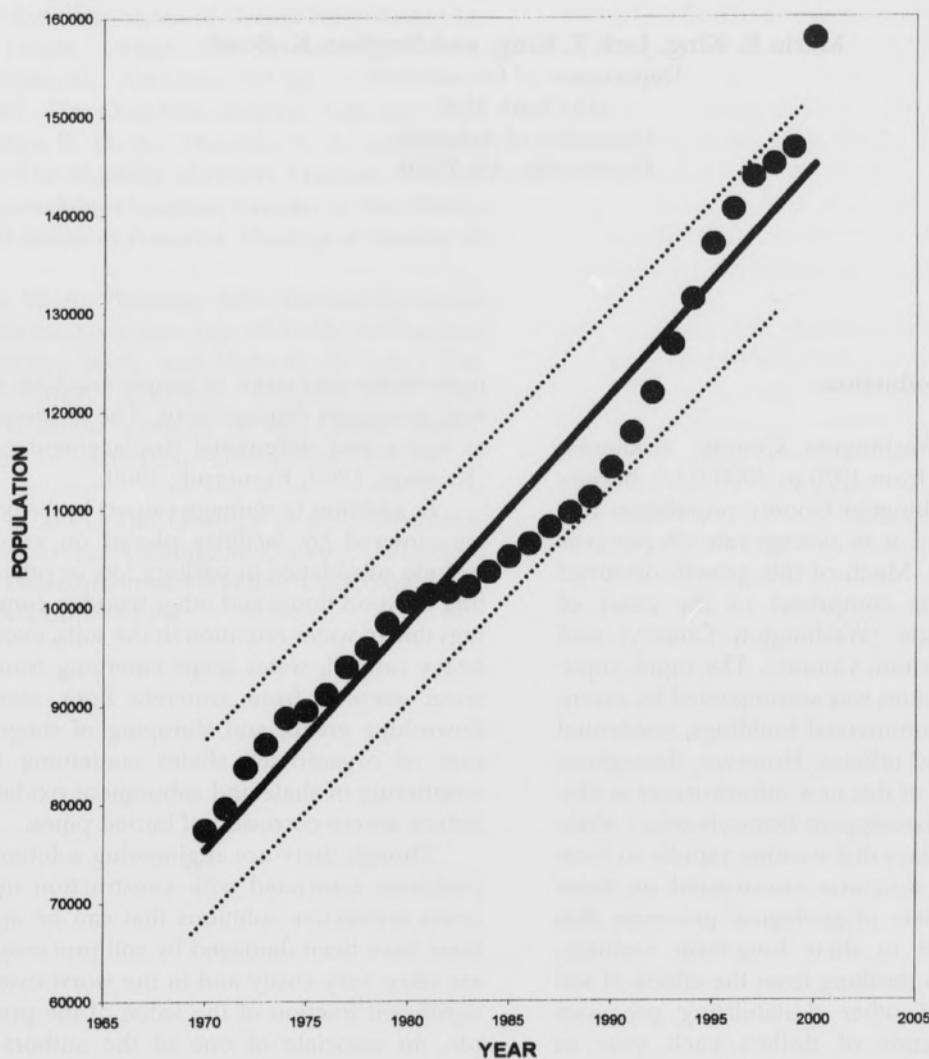
Fig. 1. Population trend for Washington County, Arkansas, 1970 - 2000. Graph shows relatively rapid growth of Washington County over the last 30 years. Note that total population increased 100% (77,370-157,715) from 1970 to 2000. Also note outlying nature of 2000 census result. Solid line indicates best-fit linear regression through data up to 1999 (excluding 2000 data as outlier). Dotted lines represent 95% confidence limits of regression line. Linear regression indicates average annual growth of 3% during the last 30 years. Data obtained from U. S. Census Bureau Arkansas State Data Center, University of Arkansas-Little Rock, Little Rock, Arkansas. URL: (<http://www.aiea.ualr.edu/csdc/PopEstimates.html>).

The population of Washington County, Arkansas, increased more than 100% from 1970 to 2000 (U.S. Bureau of the Census, 2000). Washington County population was 77,370 in 1970 and increased at an average rate 3% per year to 157,715 in 2000 (Fig. 1). Much of this growth occurred within the urban corridor comprised of the cities of Fayetteville and Springdale (Washington County) and Rogers and Bentonville (Benton County). The rapid population growth within these cities was accompanied by extensive new construction of commercial buildings, residential areas, streets, highways, and utilities. However, throughout Washington County, much of this new infrastructure is situated on late Paleozoic (Mississippian-Pennsylvanian) shale strata containing swelling clays that weather rapidly to form expansive soils. As such, structures constructed on these strata are subject to a variety of geological processes that pose a significant hazard to their long-term viability. Damage to these structures resulting from the effects of soil expansion/contraction and other destabilizing processes cost hundreds of thousands of dollars each year in Fayetteville alone.

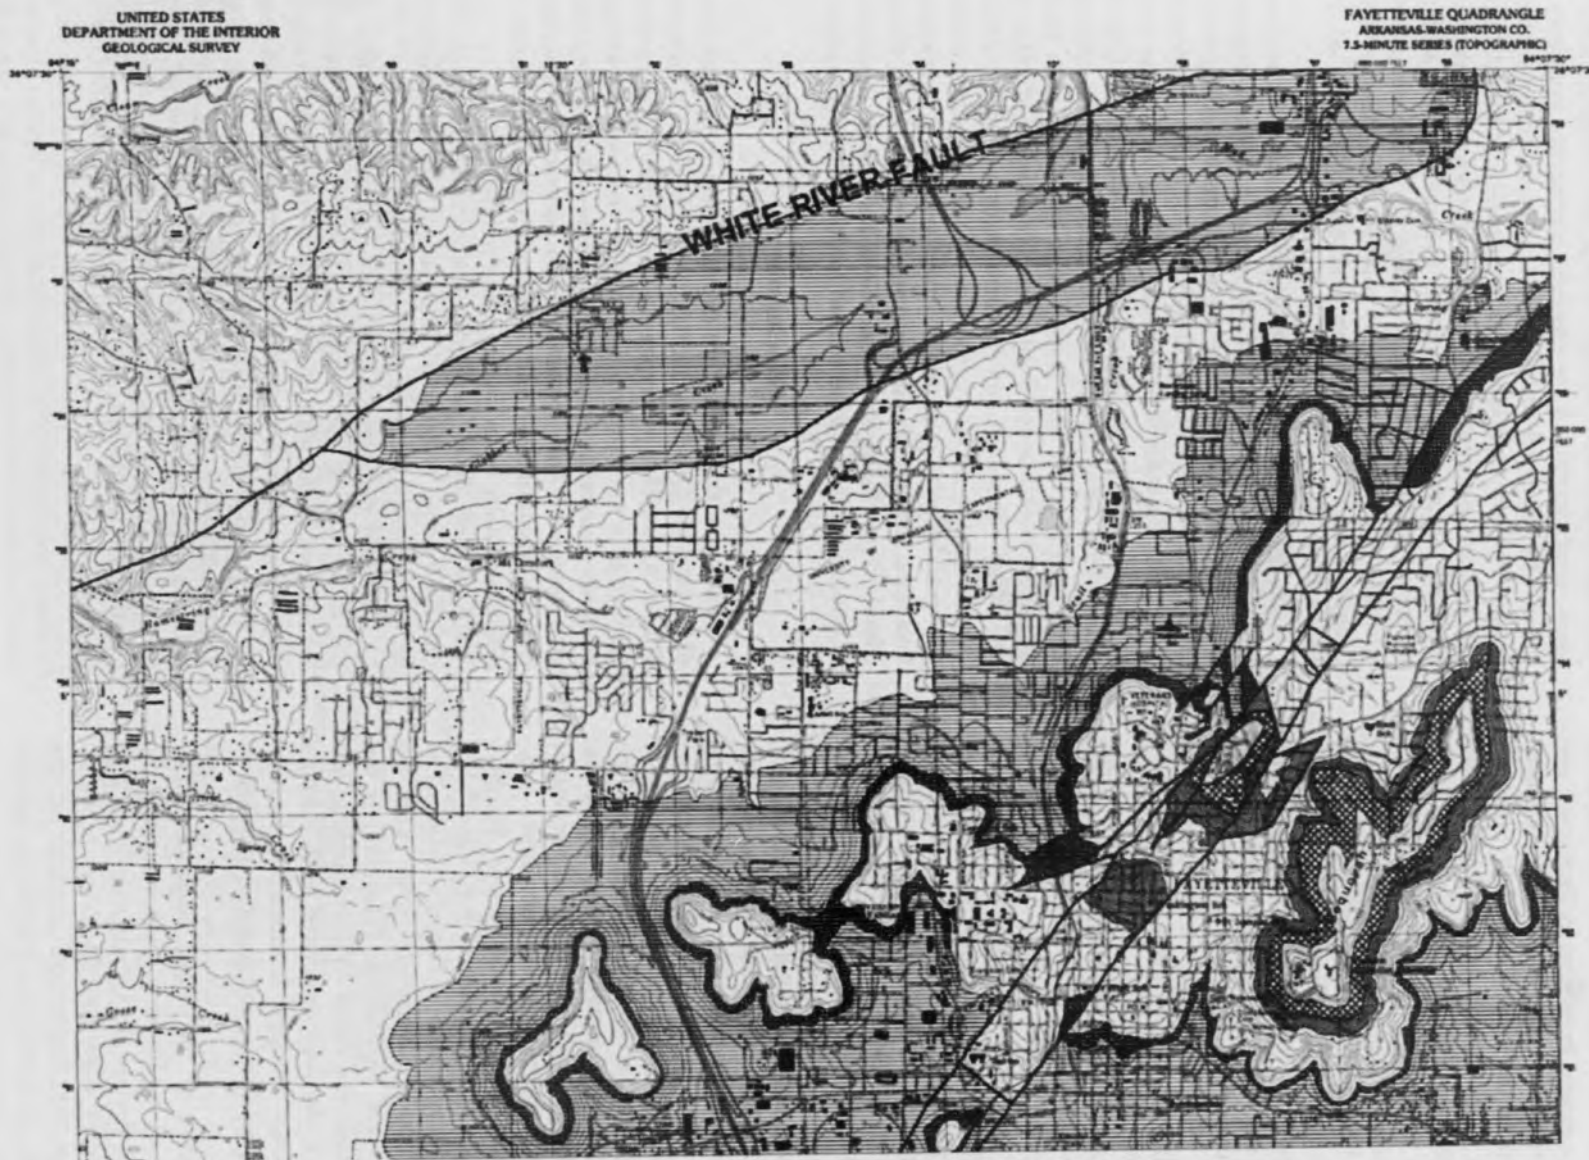
Fig. 2. Map of northern half of Fayetteville 7.5-Minute Quadrangle, Arkansas showing outcrop extents of shale strata containing expansive soils and known to weather to expansive soils.

The lower Fayetteville Shale of the Fayetteville Formation covers an extensive area (45.5%) of the Fayetteville Quadrangle (Figs. 2, 3). The city of Fayetteville is expanding rapidly with residential subdivisions, city streets, utilities, and business complexes into areas underlain by this unit. Indeed, most of the flat and gently sloped land in the Fayetteville Quadrangle is underlain by the lower Fayetteville Shale. Thus, the topography of the lower

Woolsey-Dye Members of the Bloyd Formation.--The Woolsey-Dye Members of the Bloyd Formation cover 2.3% of the surface area of the Fayetteville Quadrangle (Figs. 2, 3) (King et al., 2001). The Woolsey-Dye Members occur on moderate slopes above the Brentwood Member of the Bloyd Formation. The Woolsey-Dye Members weather quickly into soft gummy clay. Much of the outcrop area of

Trace Creek Member of the Atoka Formation.--The Trace Creek Member of the Atoka Formation is a black, organic-rich shale at the base of the Atoka Formation (King et al., 2001). The Trace Creek Member has an outcrop extent of 1% in the Fayetteville Quadrangle (Figs. 2, 3). The only inhabited area on the Trace Creek Member in the City of Fayetteville is a residential neighborhood on Mount Sequoyah (Fig. 2). The Trace Creek Member forms steep slopes between a bench formed from the Kessler Member of the Bloyd Formation and the first sandstone of the Atoka Formation. On exposure, the Trace Creek Member weathers quickly into expandable clay subject to slumping. Problems associated with construction on the Trace Creek Member are cracking of foundations and lateral separation of outside walls of houses related to down slope processes.

Paleozoic shale strata are exposed over more than 50% of Fayetteville Quadrangle (Figs. 2, 3). These shale units are known to weather to expansive soils, creating numerous problems for construction. Damage to structures (dwellings, business complexes, streets, sewers, sidewalks, parking lots, etc.) associated with expansion and contraction of weathered clays within these units costs hundreds of thousands of dollars annually to an unsuspecting public. Many of these costs (particularly those related to repair of damaged home or business foundations) are not protected by homeowners' or businesses' insurance.

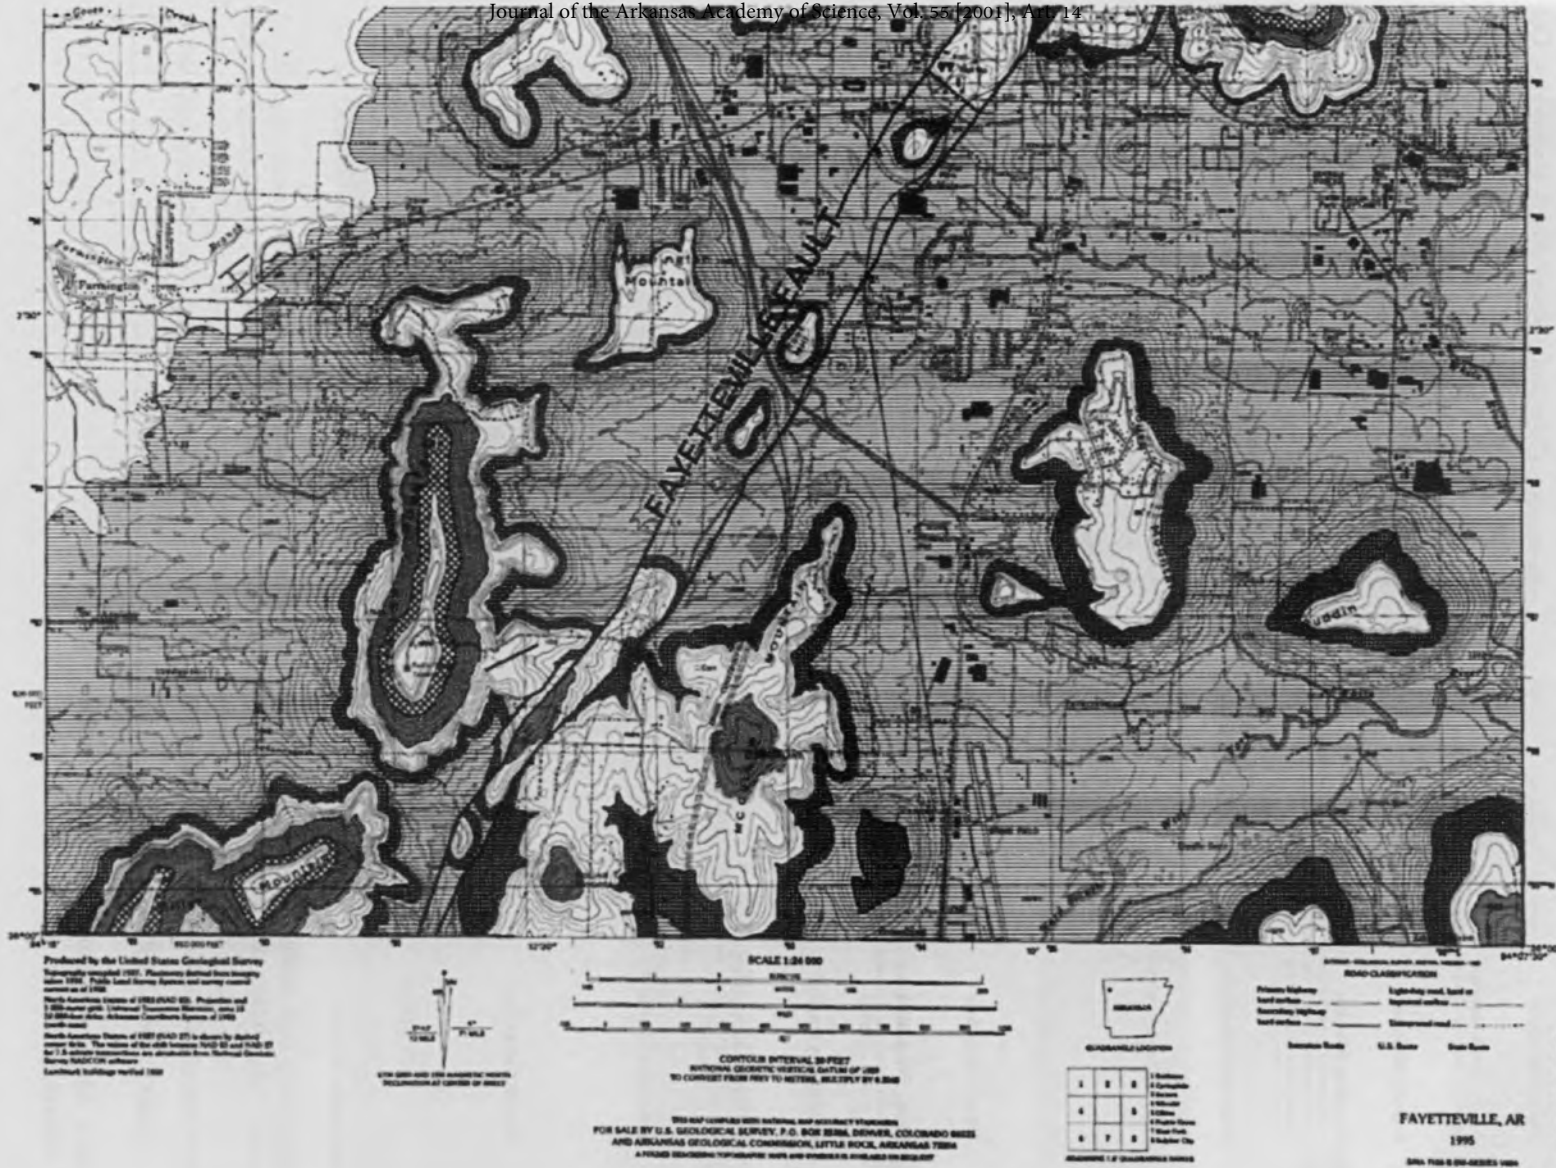
Fig. 3. Map of southern half of Fayetteville 7.5-Minute Quadrangle, Arkansas showing outcrop extents of shale strata containing swelling clays and known to weather to expansive soils.

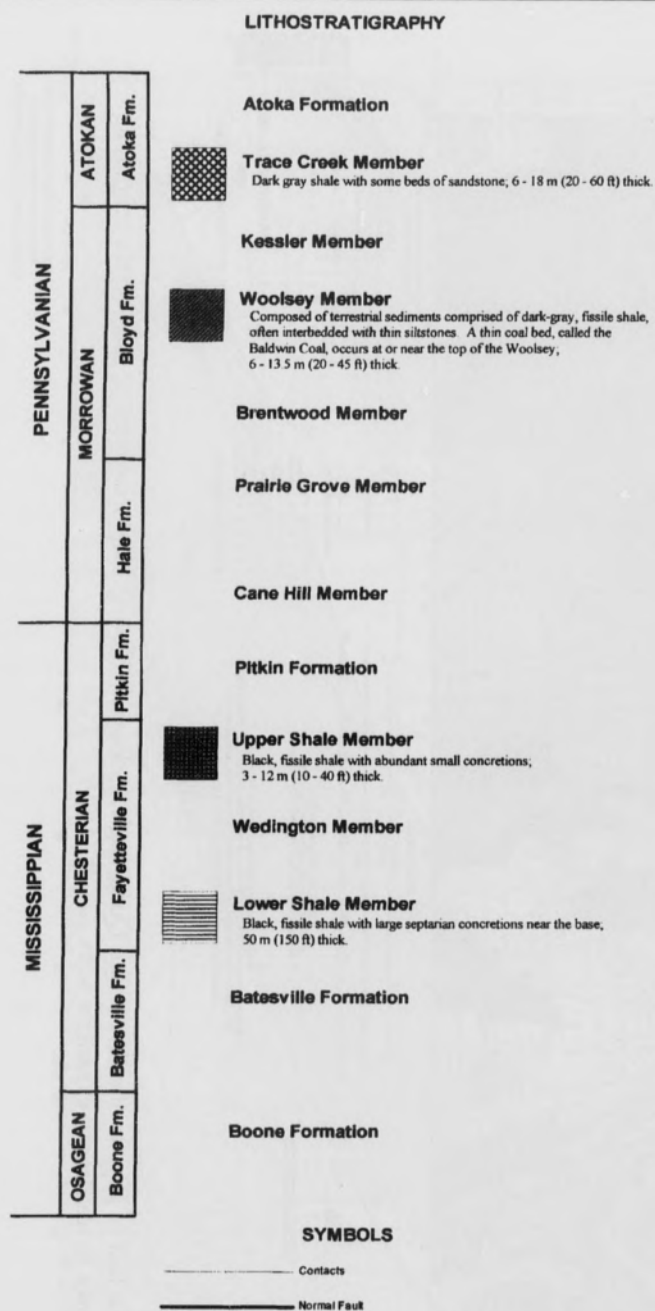
Fig. 4 Legend to accompany Figs. 2 and 3 showing schematic stratigraphic chart of shale strata in Fayetteville Quadrangle.

McFarland, 1998), and 4) the Trace Creek Member of the Atoka Formation (Taff and Adams, 1900; Henbest, 1953; McFarland, 1998)(Figs. 2-4). Detailed descriptions of the geology, composition, and depositional environments of these strata can be found in King et al. (2001). These units pose common hazards to construction, but also have unique hazards related to their geological constitution and geomorphology. Observed hazards associated with each of these units are considered in turn below.

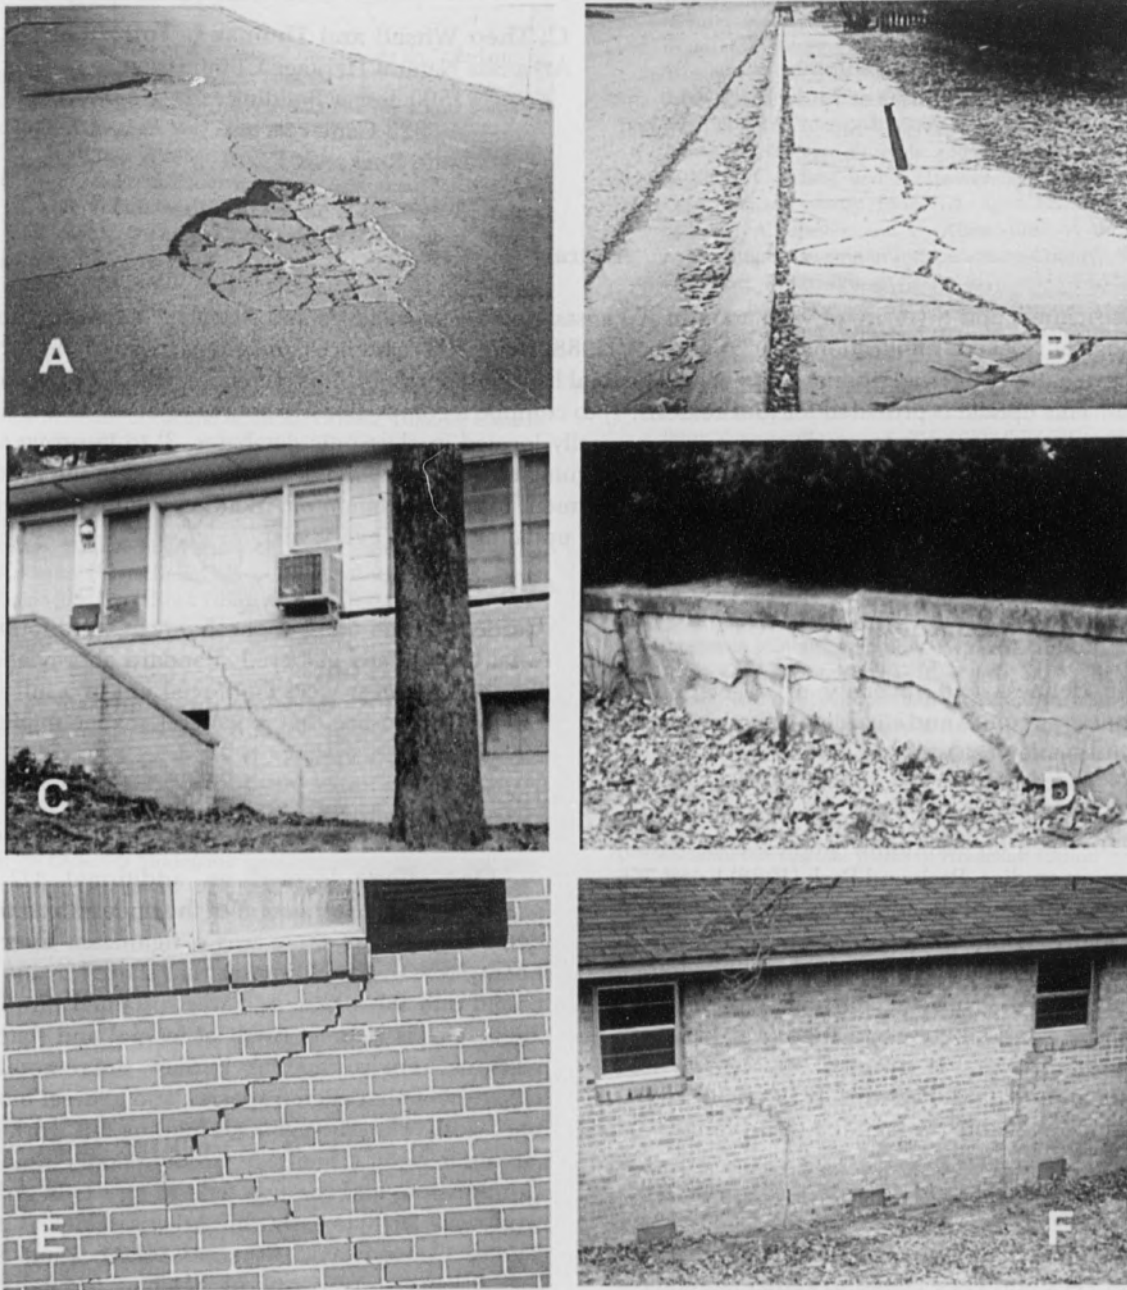
Fig. 5 Images illustrating examples of most common effects of expansive soils on pavements and buildings throughout the Fayetteville Quadrangle. A) Differential subsidence and cracking of pavement; B) Differential subsidence and downslope creep with associated buckling of a sidewalk; C) Cracked masonry foundation of a single-family dwelling; D) Severe cracking and horizontal displacement of a small retaining wall; E) and F) cracking of masonry above foundation of single-family dwellings.
