# IMPROVING THE DAMAGE TOLERANCE OF COMPOSITE JOINTS WITH TUFTING

**Keywords:** 3D reinforcement, Damage tolerant joints, Automated manufacturing, Tufting

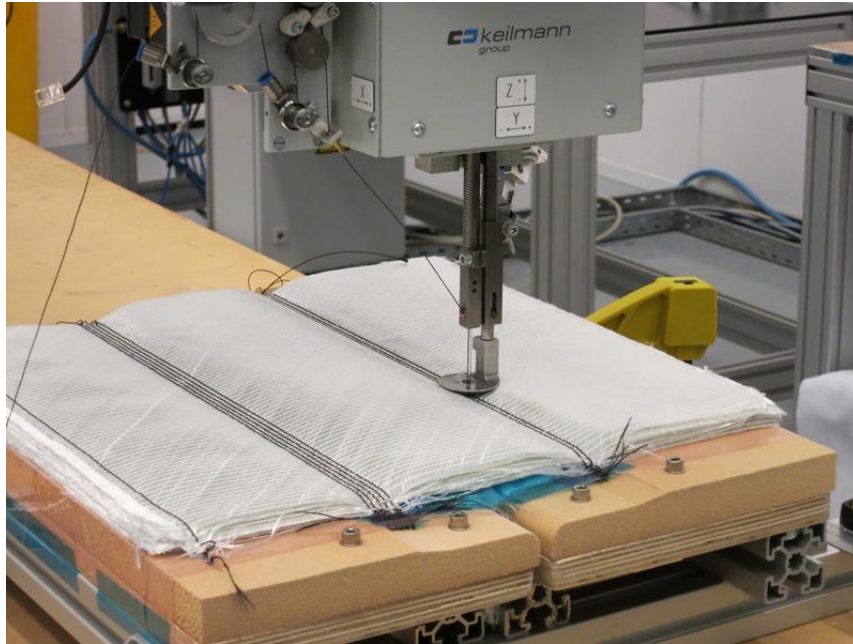
Figure 3: Tufting glass skin-stringer panel with carbon thread

The skin-stringer run-out panels were tufted, using a KSL RS522 tufting head, shown in Figure 3, mounted to a Kuka robot, located at the National Composites Centre. The preform was held securely during tufting using an aluminium extrusion framed fixture clamped to a table. A foam backing was machined with the profile of the skin-stringer from Airex R63.80 foam. This specific foam was previously identified as suitably rigid for supporting a preform during tufting and suitable compliant to allow the tufting needle to penetrate [6]. This foam was covered in a single layer of low temperature vacuum bagging film, to aid in the retention of the tufts when the preform was removed from the foam backing.

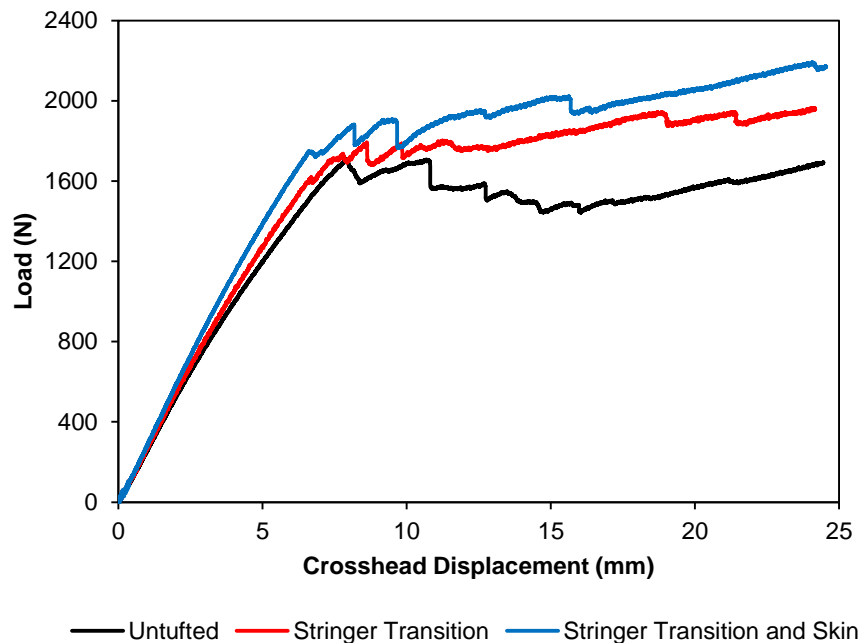
Figure 6: Typical load-displacement plot for the tufted skin-stringer bending tests.

Three specimens were tested for each tufting configuration. One specimen was tested until the joint was about to contact the baseplate of the flexural test fixture, meanwhile, the other two were tested to the first load drop to identify the crack initiation mechanisms. The results of the full-stroke bending test are shown in Figure 6. The untufted control specimen showed the lowest peak load before the onset of delamination. Tufting the stringer transition increased the stiffness of the skin-stringer joint, the onset delamination load, and the sustained damage load. Additional tufts inserted in the adjacent skin to the stringer tip had a similar improvement on performance compared to only tufting the stringer transition. Inserting the tufts clearly improved the damage tolerance as seen by the higher load levels required to propagate damage in the joint.

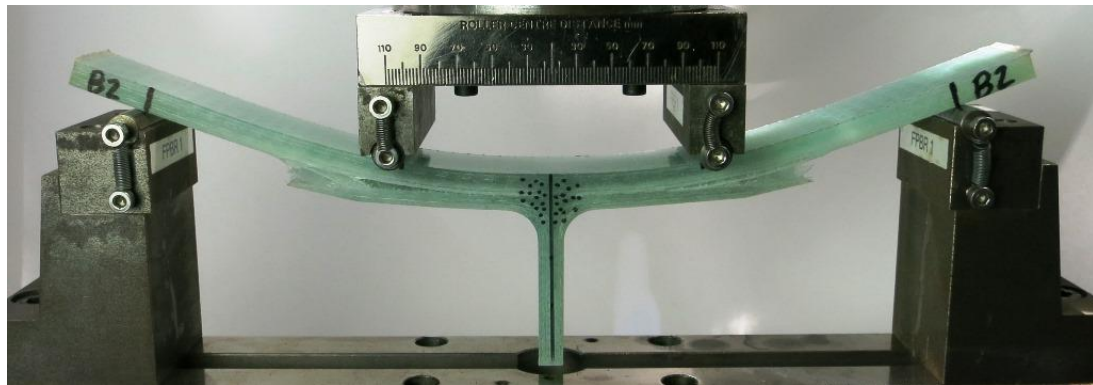
(a) Control

Figure 7: Final failure modes observed in the skin stringer panels: (a) delamination originating from the stringer tip in the control specimen, (b) web-splitting and delamination in stringer flange, and (c) reduced web-splitting but delamination in stringer flange.

Photographs of the skin-stringer specimens at the end of full-stroke testing are shown in Figure 7. The untufted control specimen shows separation of the stringer from the skin. Once the peak load was reached, the stringer flange delaminated from the stringer tip, peeling towards the web as the crosshead continued to travel. The web remained intact as the damage is located between the stringer flange and skin of the joint. Delamination was again observed in the tufted specimens, but the failure mode was altered. Inserting tufts into the stringer transition prevented the flange from separating from the skin, but delamination was observed between the skin and stringer as a white crack in Figure 7b-c. Since the tufts retained contact between the skin and the stringer flange after delamination, the joint remained in contact and able to sustain load, as measured in Figure 6. Both tufted configurations change the failure mode from stringer tip separation from the skin to web splitting in the stringer. While tufting does increase the damage tolerance of the structure, identifying the trigger mechanisms that initiate delamination, and successful mitigation of these, was of greater interest.

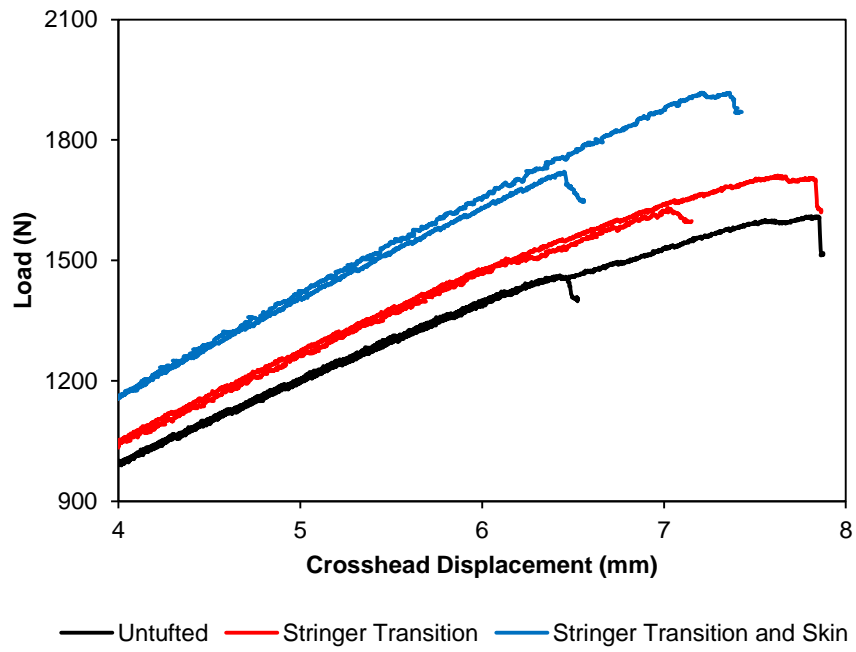
Figure 8: First failure load-displacement plot for skin-stringer tests.

The results of the bending tests that were stopped after first load drop are shown in Figure 8. Askin to the curves observed in Figure 6, increased tufting correlated to an increased joint stiffness and higher failure initiation loads. Averaging the peak loads of these curves shows that tufting the flange to skin transition (Figure 2b) resulted in an 8 % increase in peak load, further increasing to 16 % when tufting the stringer flange transition and adjacent skin to the stringer tip (Figure 2c). The performance increase from tufting is encouraging, but could be improved. Photographs of an untufted and tufted joint are shown in Figure 9. They reveal that inserting the tufts in the stringer to skin transition was successful at mitigating delamination at the stringer tip, but had no influence on the delamination that initiated in the flange to web transition of the stringer.
