**Implementation of a solution to the problem of dry-band arcing on  
ADSS cables**

# IMPLEMENTATION OF A SOLUTION TO THE PROBLEM OF DRY-BAND ARCING ON ADSS CABLES

**Abstract**—The all-dielectric self-supporting (ADSS) cable offers many advantages when installing an optical fibre network on high voltage overhead lines. Generally the use of ADSS cables is confined to system voltage levels well below 275 kV because of the threat of dry-band arcing on the cable sheath. This limit is somewhat arbitrary since in polluted conditions cables can fail at much lower system voltages, and in some higher voltage installations no problems have been witnessed. A solution to the problem of dry-band arcing on ADSS cables has been proposed previously, whereby 50 m resistive rods are attached to the self-supporting cable after installation. The first large-scale installation of this system has been successful, and the first six years' operation is reviewed. The installation is in a particularly aggressive situation and a high level of maintenance has been found to be necessary.

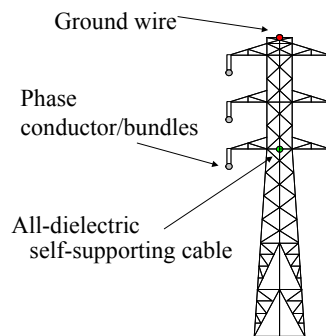
Fig. 1. Typical location of ADSS cable on the lower cross arm of a twin circuit tower.

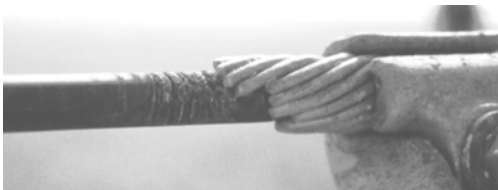
Fig. 3. Damage on a polyethylene sheathed cable in Chile on a 100 kV line. The metallic wires are part of the clamping system and the galvanised clamp around those wires attaches the vibration damper.

The damage seen here may be compared to that reported on ADSS installations in Israel [7] and other sites [9,10]. The environmental similarity between the sites in Israel and Chile are clear. It was also noted that in England the worst case activity occurred at the end of a prolonged dry period in the summer months.

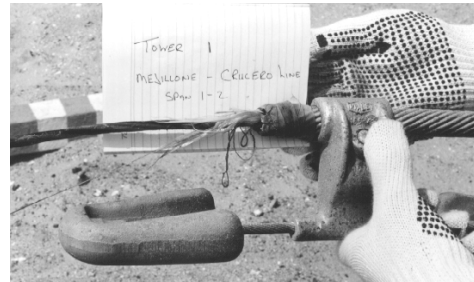
Fig. 4. Complete failure of the cable sheath and exposure of the strength member.

A method for classifying the dry-band arcing damage into four grades has been adopted to record the level of damage on the cables. This grading method is listed in Table I. Prior to the AAS being installed, and within six months of the ADSS cable being installed, damage up to grade 3 could be seen on many cable spans adjacent to the towers (Fig. 6). In these cases self-amalgamating, semi-conductive tape was applied over the damaged section of the cable and up to 3 m from the tower, and non-conducting, arc-resistant tape applied beyond these points to cover the damage. However, some damage of grade 4 level had been seen. In the example shown in Fig. 7, the grade 4 damage has occurred after the semiconductive tape was applied, and the tape can be seen on the left-hand side of the cable. Grade 4 damaged cable had to be replaced. The resistivity of the contaminants on the ADSS cable at such locations was crudely measured to be approximately 500 k $\Omega$ /m. At some towers the sheath had been penetrated and retracted revealing the aramid yarn, the aramid yarn strength member being completely destroyed, exposing the PBT tubes containing the optical fibres (Fig. 4).

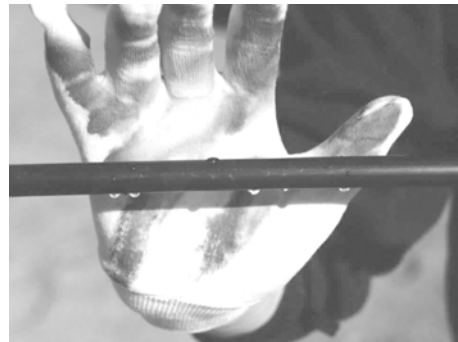
Fig. 5. Wiping the cable with a white glove gives some idea of the level of

solid pollution on the cable in Chile.

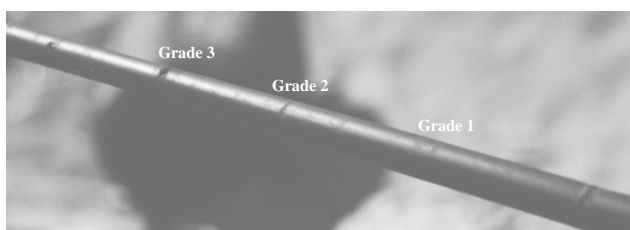
| Grade | Description (see also Figs. 6 and 7) | Radial Depth |
|---|--|---|
| 1 | The surface of the sheathing material is discoloured (this effect is called "chalking", possibly due to the fillers leaching to the surface, and is indicative of low level electrical activity) | < 0.1mm |
| 2 | Material is partially eroded from the sheath due to dry-band arcing | < 0.5 mm |
| 3 | Material is substantially eroded from the sheath due to dry-band arcing | < 1.0 mm |

Fig. 6. The first three grades of damage.

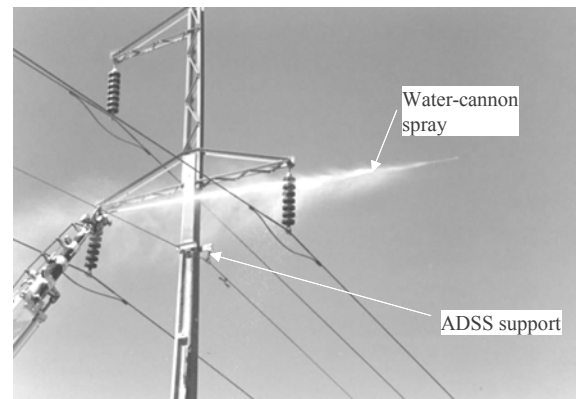
Fig. 8. A 110kV single circuit line supporting an ADSS cable. The water canon is washing the insulators.

values of 7 kV and 11 kV were predicted. All of these values could have been reduced by repositioning the cable or changing the relative sags between the conductors and the ADSS cable, however, because the risk was not appreciate at the time of installation, the ADSS cables had not been installed in the optimum position to reduce induced currents. Fig. 8 shows a steel-reinforced concrete support, and the location of the attachment of the ADSS cable to the tower is highlighted. Fig. 8 also shows the insulator washing in progress.

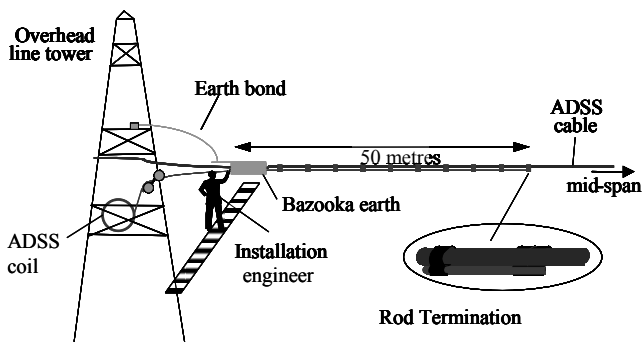
Fig. 9. Schematic of the rod installation.

The resistive rods are normally fitted onto the ADSS cable in situ, by installation crews standing on ladders alongside the ADSS cable on the tower. Alternatively this can be done from a cherry picker on LV routes. Each rod is manually pushed towards mid-span, and clips are applied. The rods are sufficiently stiff to allow well over 50 m to be pushed into the span. They are pre-cut to length and supplied to site in coils. Because the ADSS cable is tensioned before the rod is attached, the majority of health and safety issues are easily overcome and live-line installation is not inhibited. However,

an earth is required on the resistive rod during installation. If the rod is not efficiently earthed at the tower end during installation, it will float to a substantial potential and may deliver up to a few milliamps at several kV, to installation personnel. To overcome this, a split open-ended tube forms a running installation 'bazooka' earth, as shown in Fig. 9. This running earth is designed so that three of the conducting clips are in contact with the earth at all times. Any exposed ADSS cable within reach of an operator from the tower will be wrapped in earthed metallic spiral guard wire, which is an inherent part of the ADSS clamp. The 'bazooka earth' must also be used when the product is removed from service, but it is not required during the operational life of the cable; nor is it required if the rod is installed or removed with the circuits switched out. The installation process is shown on a 400 kV line in the UK in Fig. 10. Fig. 11 shows the process preferred in Chile using a cherry-picker.

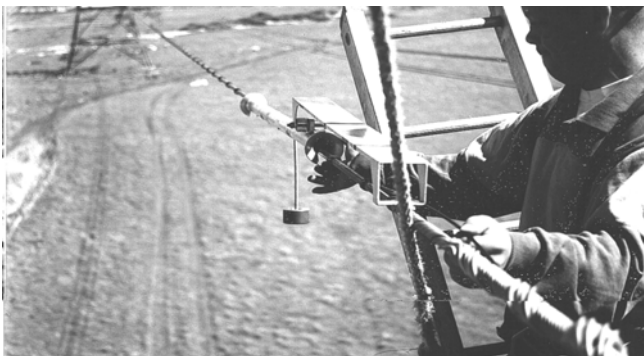
Fig. 10. An installation on a 400 kV tower in the UK. The linesman's right hand is touching the split-tube running earth, his left hand is pushing the rod into the span; he attaches clips between these positions.

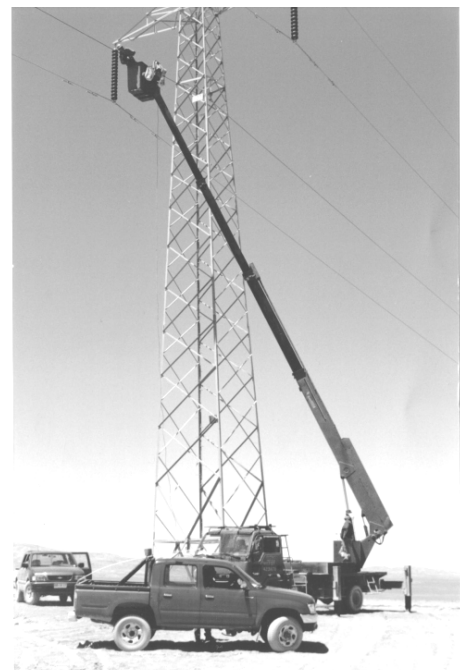
Fig. 11. An installation in Chile using a cherry-picker. This approach was used on all lattice towers.

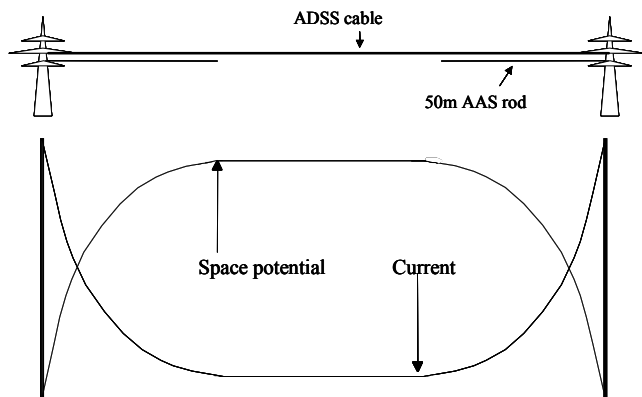
Fig. 12. A schematic of the distribution of voltage over the cable and rod system. Also shown is the cumulative current over the cable surface, which is maximum at the tower. The conductors are not shown in the figure.

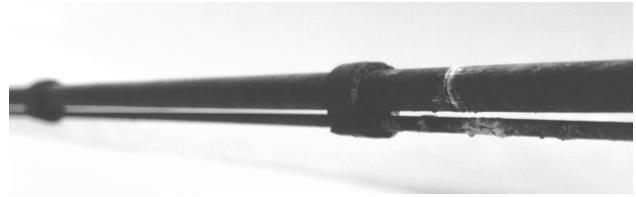
Fig. 13. Damage can be seen on the cable to the right-hand side of the right cable clip.

The installations have been inspected routinely. At the time of writing, over six years have passed since the original installation, and the system is still running. Inspections at the tip of the rod have shown no evidence of dry-band arc activity. However, close to the towers there are clear visual indications that the rod is not performing as expected. In many cases arcing is occurring after a period of time close to the towers. Figs. 13 and 14 show the form of damage seen. It can be seen that the semiconductive sheath of the rod is becoming aged, and in Fig. 13 clear evidence is seen of dry-band arc activity at such a location. The closer inspection of Fig. 14 shows classic dry-band arc degradation patterns on the cable sheath.

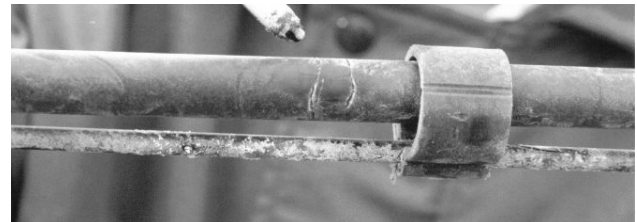
Fig. 14. Damage on the cable and rod can be seen. The clip used here is for a larger sized cable, and is too loose on the ADSS cable.

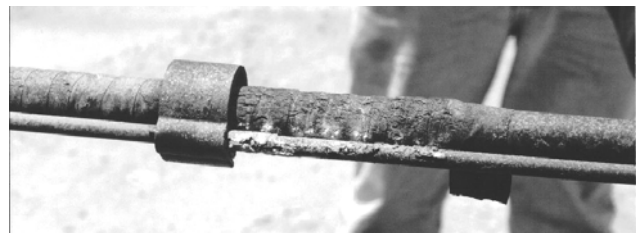
Fig. 15 shows damage that has occurred as a result of arcing between a rod and a previously applied repair sleeve. This has resulted because the rod and semiconductive tape repair have only been electrically connected at the cable clamp, and so a potential difference can occur between the two where the tape ends, because of their different linear resistances. This can be prevented by binding the rod to the semiconductive tape at the span-side end of the taped region.

Fig. 15. Damage to the rod which is running over a wrapped semiconductive repair sleeve.

The rod is clearly ageing close to the clamp much faster than was predicted, although it does continue to protect the cable for long periods of time. As a result the AAS system remains the only known way to protect the cable in these circumstances. A regular inspection and maintenance schedule is now in place for the installed system. Any visual evidence of ageing of the rod close to the tower, or evidence of arc activity on the cable sheath now results in the section of rod closest to the tower being cut back and the rod re-terminated.
