# EVALUATION OF CAUSES OF BLEEDING OF FREE WATER FROM A BENTONITE SLURRY

This paper describes an investigation into the bleeding behaviour of bentonite slurry observed on a trial diaphragm wall panel. The bleeding is thought to be due to the bentonite experiencing a chemical reaction leading to settlement of the solids within the fluid, possibly as a self-weight consolidation process. The trial panel was constructed in a busy airport environment where many different chemical products are used for de-icing the aeroplanes, runways, apron areas, vehicle access and pedestrian routes. The relationships between slurry contamination, bleeding, bentonite hydration time and filter loss behaviour were examined as no relevant published literature could be found. The results show that the amount of bleed strongly depends on both the degree of contamination and the hydration time. It is concluded that bentonite fluids should be allowed to sit in the storage tank for at least 24 hours after mixing, and that the filter loss test is a quick and effective method to determine the potential for bleeding of contaminated slurries.

Balfour Beatty Ground Engineering (BBGE) completed the construction of

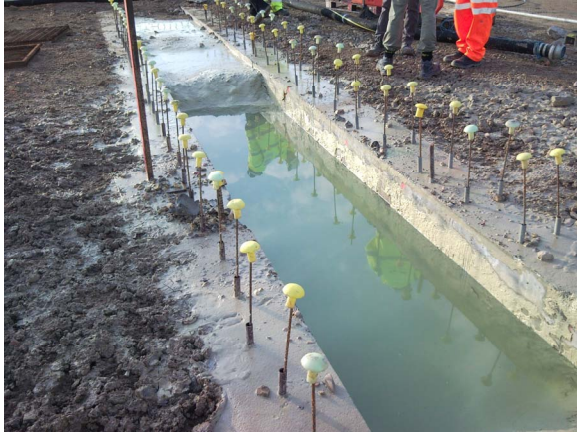
Figure 1 Bleed water in trial panel

To achieve this, the trial panel was excavated on a Friday and was left open over a weekend. On the following Monday morning BBGE personnel observed that approximately 800 mm (32 in) of free water had collected at the surface of the slurry most probably as a result of bleeding, i. e. separation of free water from the bentonite slurry.

Figures 1 and 2 are photographs of the panel trench showing the clear bleed water region at the top of the slurry column. Figure 3 shows the diaphragm wall rig used and Appendix A briefly summarises the chronology of construction events.

Since the bottom of the bleed water region was lying close to the base level of the concrete guide wall, this raised concerns within BBGE that if this reoccurred during the construction of the working panels then their stability would be compromised. This is because if the bleed water region fell below the base of the guide walls, it would drain relatively freely into the underlying ground as little filter cake may have formed. This would reduce the hydrostatic pressure from the slurry which is essential to the stability of the panels.

Monday – upon returning to work it was observed that up to 800 mm (32 in) of water had separated with the bottom of the bleed water region lying close to the base level of the concrete guide wall. The surface of the fluid in the trench remained 200 mm below the top of the guide wall. The second bite at the opposite end of the panel was then excavated, again 3.1m x 1m x 15m depth, with the bleed water from the first bite intermixing with the bentonite slurry within the second bite as the slurry surged over the intervening soil column between the two bites.

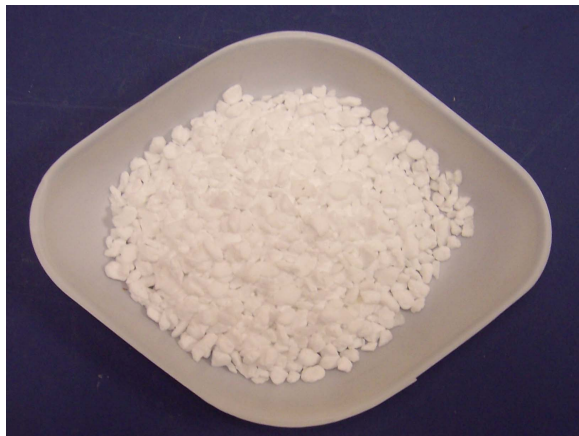
Figure 4 Solid de-icer Clearway 6S

The solid de-icer Clearway 6S was supplied by Kemira ([www.kemira.com](http://www.kemira.com)). According to the supplier, this de-icer is based on the chemistry of sodium acetate trihydrate and magnesium acetate. If it is allowed to intermix with the bentonite fluids, the free magnesium ions might prevent the swelling and hydration of the bentonite particles and convert some of the sodium activated bentonite into magnesium bentonite. This would change the properties of the slurry and so increase the likelihood of settlement of the solids within the slurry, i. e. bleeding. Figure 4 shows the de-icer in its dry as-supplied form.

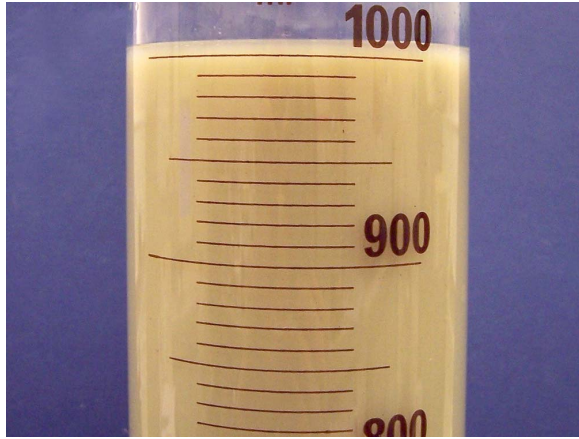
Figure 5 Bleed test result - 5-min hydration and no contamination

Figures 5 to 9 show the test samples for the 5-min hydration case after standing in the cylinders for 72 hours. Figure 10 also plots the relationship of bleed volume with time for these samples. The photographs of the 24-h hydration case samples are not shown since none of them showed any bleed.

As can be seen in these figures, the amount of bleed volume increases with the de-icer concentration, and at the end of the 72-h period the bleed was still continuing especially in the highly contaminated samples. This sort of behaviour is actually expected since high concentrations of magnesium ions have been associated with high bleed (Jefferis, 1992). However, what is unexpected is the complete absence of bleed shown by the 24-hr hydration samples. This is probably because the extra waiting time allowed the bentonite particles to swell and hydrate producing a slurry of finely dispersed bentonite platelets. Therefore if viscometer tests were also carried out, we would expect to see higher gel strength in the samples

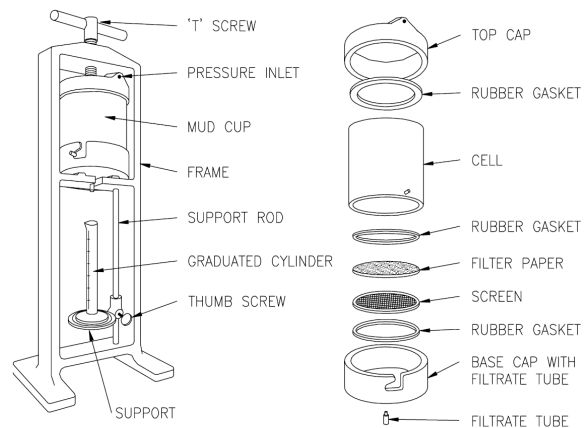
Figure 11 API filter press (after Federation of Piling Specialists, 2006)

The test measures the amount of filter loss when the slurry is subjected to a pressure of 100 psi (690 kPa) for 30 minutes in a standard API cell. Since the filtrate volume normally shows a linear relationship to the square root of time for which the sample is under pressure, the test can be terminated at 7.5 minutes and the filtrate loss reported as twice the 7.5-min value. This is a useful feature for sites with tight schedules although it does involve some potential inaccuracy as the filter loss versus square root time plot may not pass through the origin (see, for example, Figure 12). However, for this laboratory investigation the tests were run for the full 30 minutes and the amount of filtrate was logged continuously with an electronic balance. Figure 11 shows the exploded view of the API filter press.

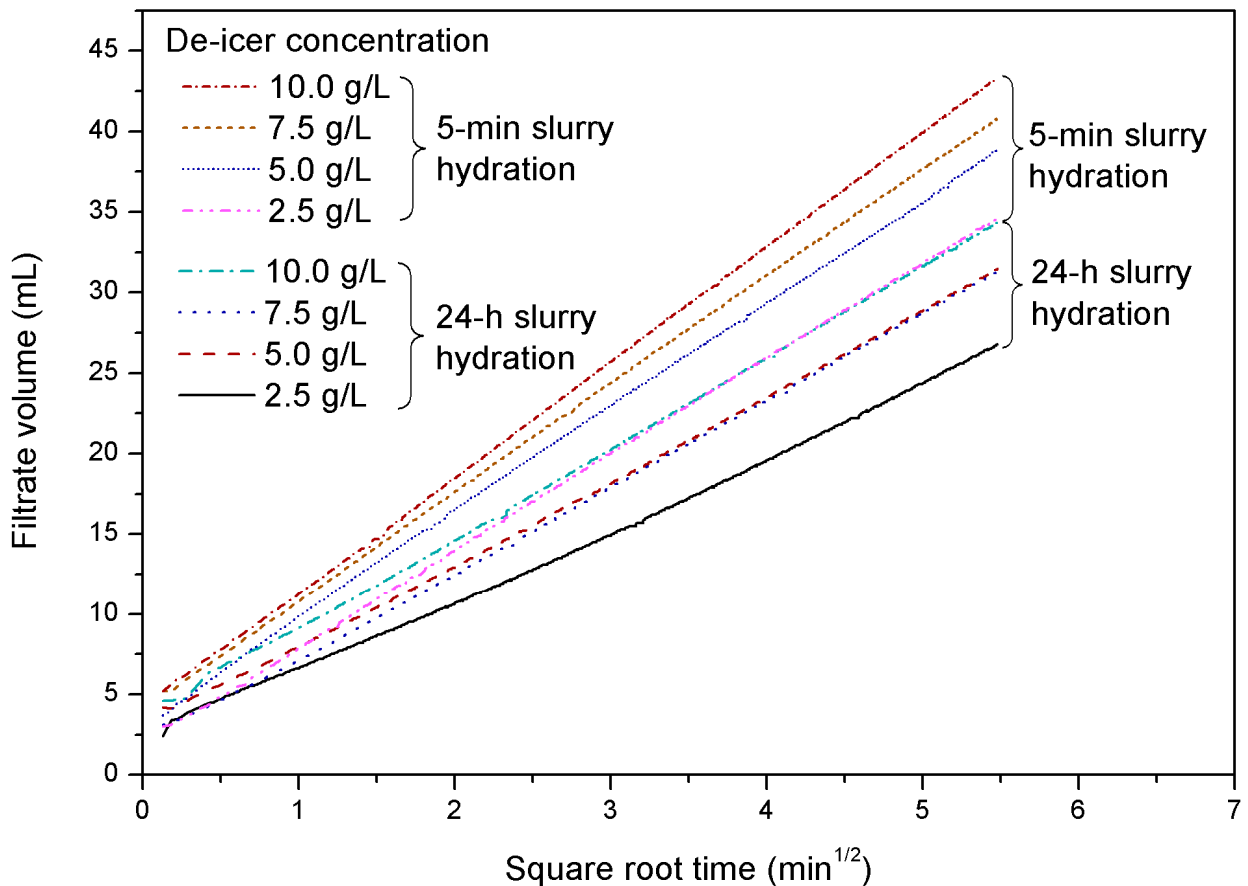
Figure 12 Filtrate loss of bleed test samples

Figure 12 shows the effect of de-icer contamination and hydration time on the filtrate volume from the filter loss testing. As can be seen, all the samples showed the expected linear relationship to the square root of time but their filtrate volumes varied considerably. The 5-min hydration samples generally showed much higher fluid loss than the 24-h hydration samples and within each group the more contaminated samples also showed higher loss. The ability of the filter loss test to detect contaminated slurries

is very good indeed since it could even show the difference between the four 24-hr hydration samples when the bleed test could not (no bleed was found in any of them).

When considering the bleed and filter loss results together (Figures 5 to 12), it would appear that the 30 mL limit specified by the Federation of Piling Specialists (FPS) on filtrate loss after 30 minutes is a good guideline for site use as those samples with > 30 mL are more likely to bleed – though the actual indicator figure may depend on the type of bentonite used. This finding suggests that the filter loss test is a quick and effective indicator of damage to a bentonite slurry and the potential for bleeding on site. To our knowledge, the usefulness of the filter loss test for this purpose is not thought to have been reported previously.
