Fracture Behaviour and Damage Characterisation in Composite Impact Panels by Laboratory X-ray Computed Tomography

Arthur Wilkinson¹, Jasmin Stein^{1,2}, Philip J. Withers², and Fabien Léonard²

Thermosets 2013
September 18th – 20th , Berlin

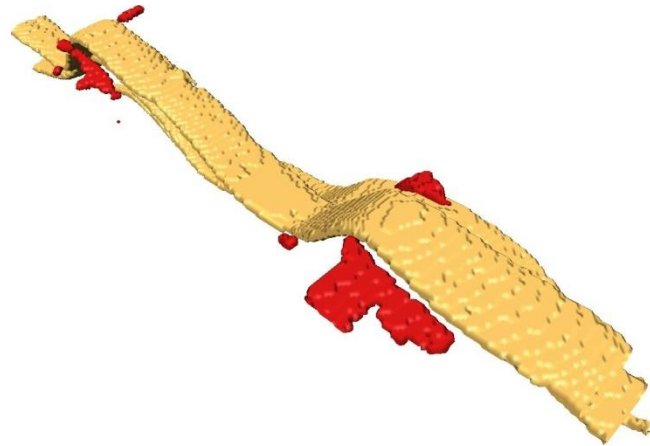
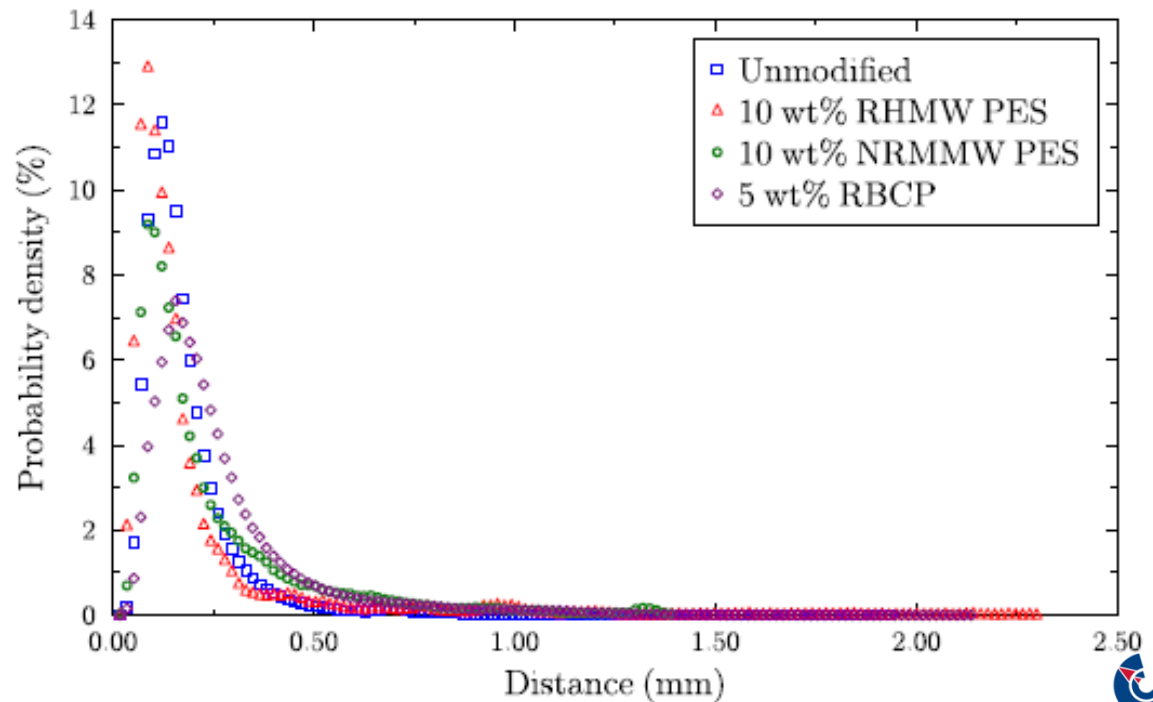
XCT statistical analysis of void positions

Probability density - void to yarn distance

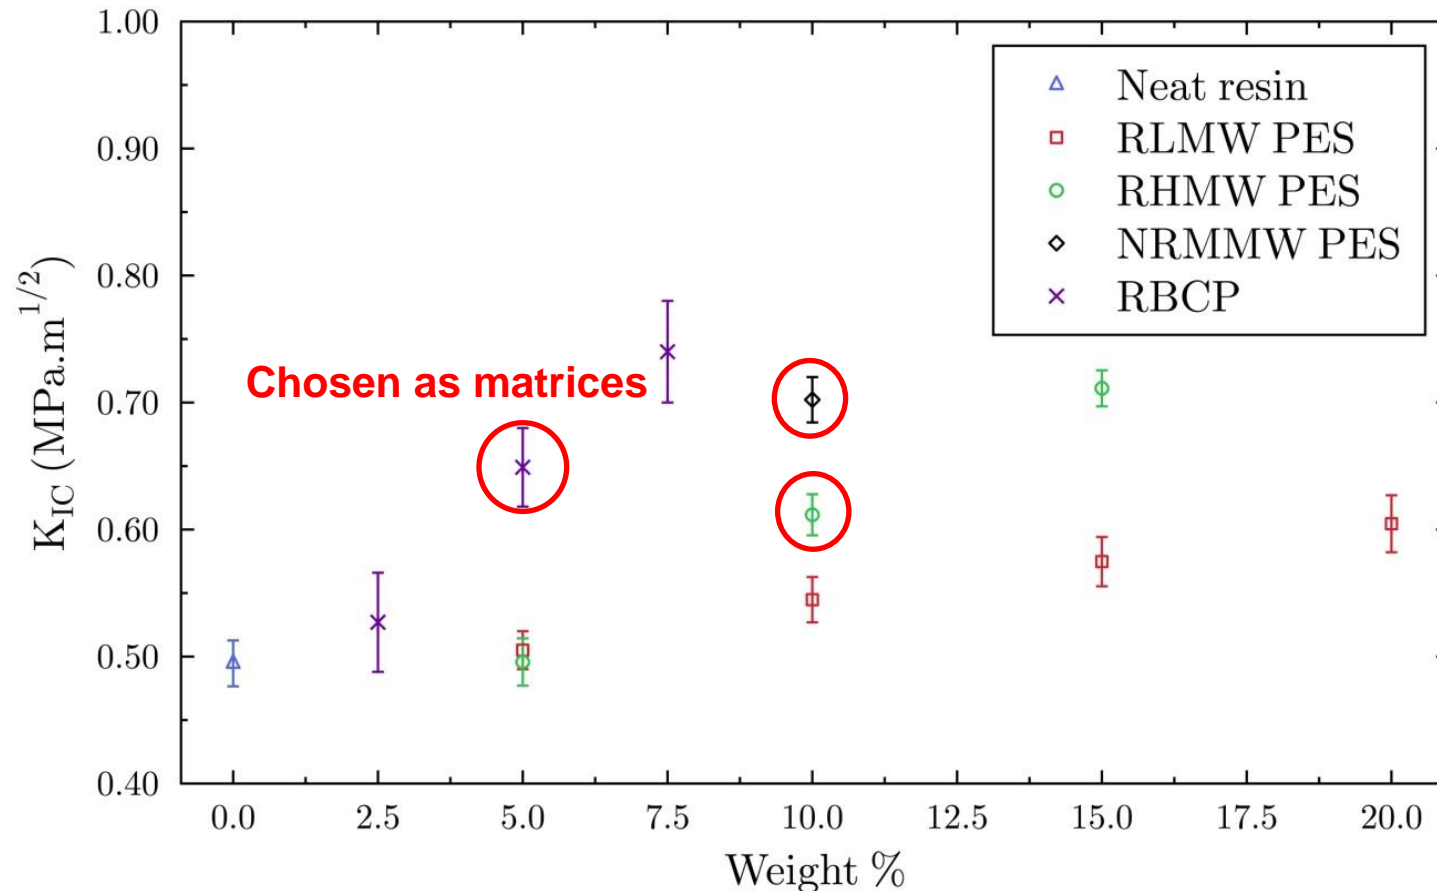
Plane-Strain Fracture Toughness of Bulk Matrices - K_{IC}

- Molecular weight ↑ - toughening effect ↑
- Reactivity - toughening effect ↓
- Tri-block copolymer has the **greatest** effect

- XCT can provide extension information on voids in as-prepared composites and on damage in impacted composites.
- In the bulk matrix systems, FBCP imparted superior toughness than PES.
- In interlaminar fracture and impact testing differences due to matrix fracture toughness become less clear.

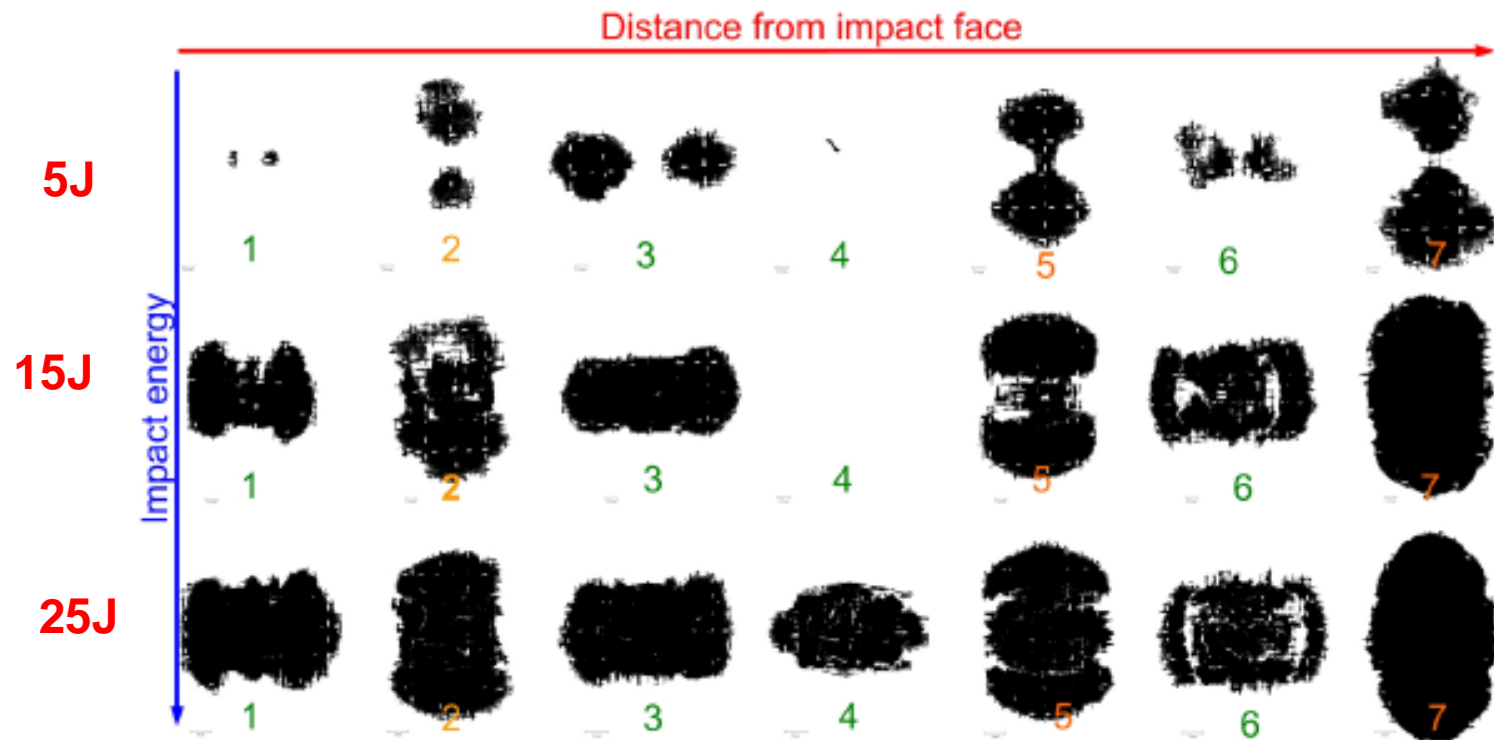
Interfacial damage area progression with impact energy. The numbers indicate the interlaminar regions below the impacted face – unmodified resin system

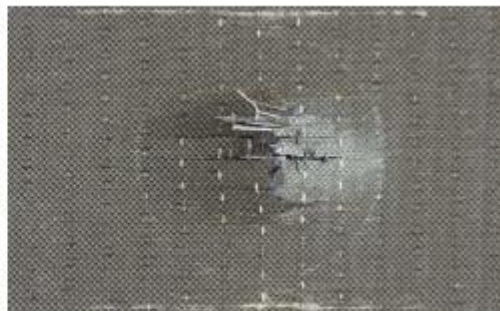
(b) Back unmodified

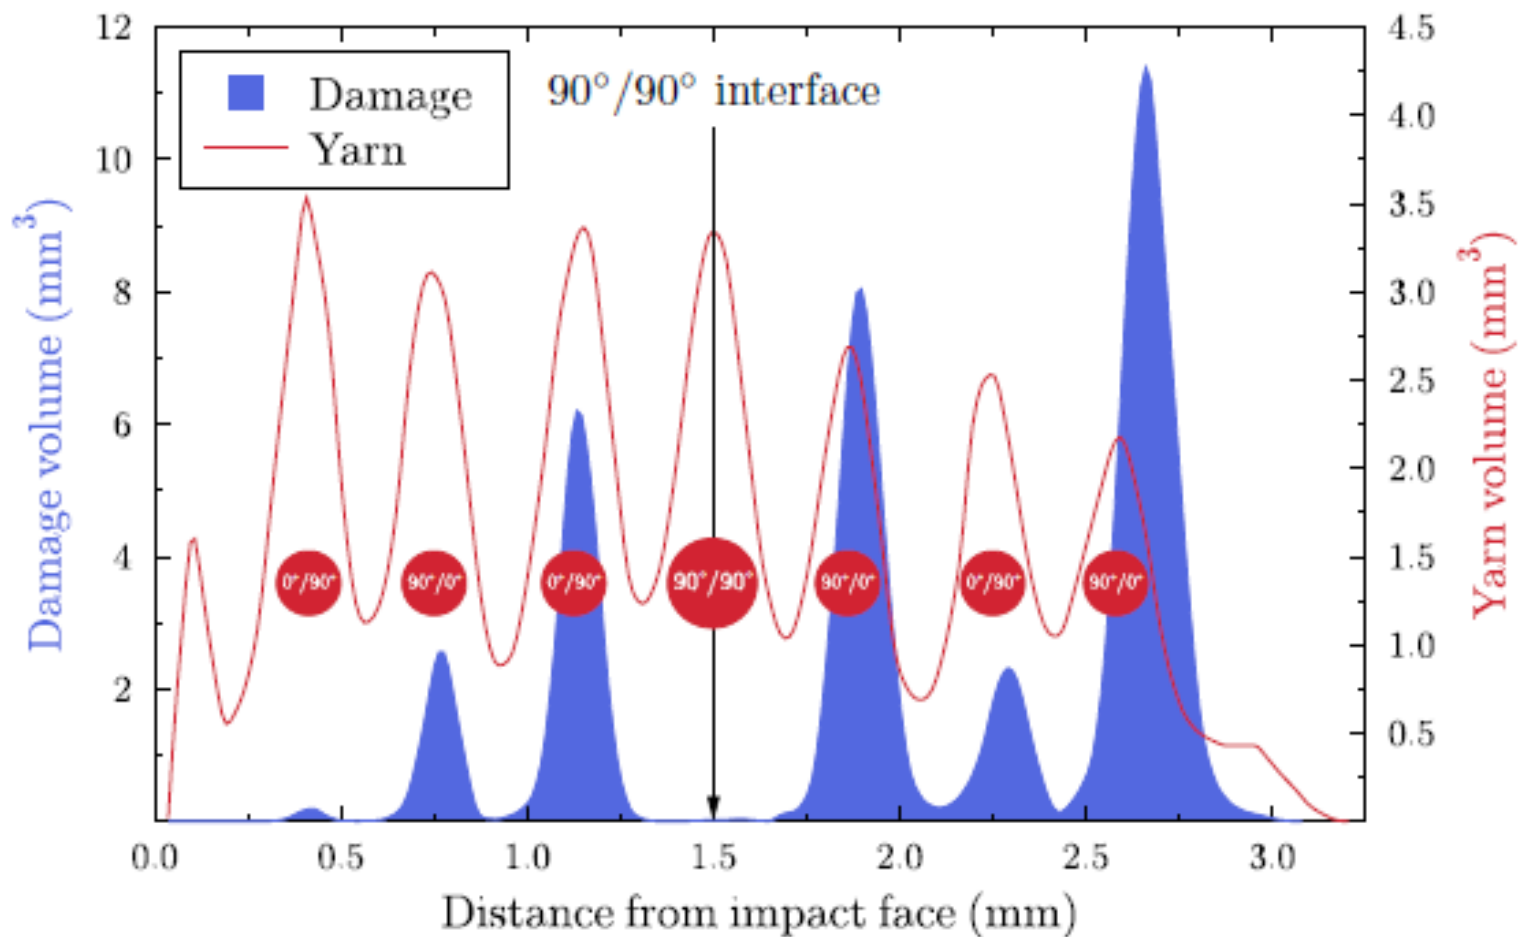
Damage volume vs. distance from impact face - unmodified resin 15J

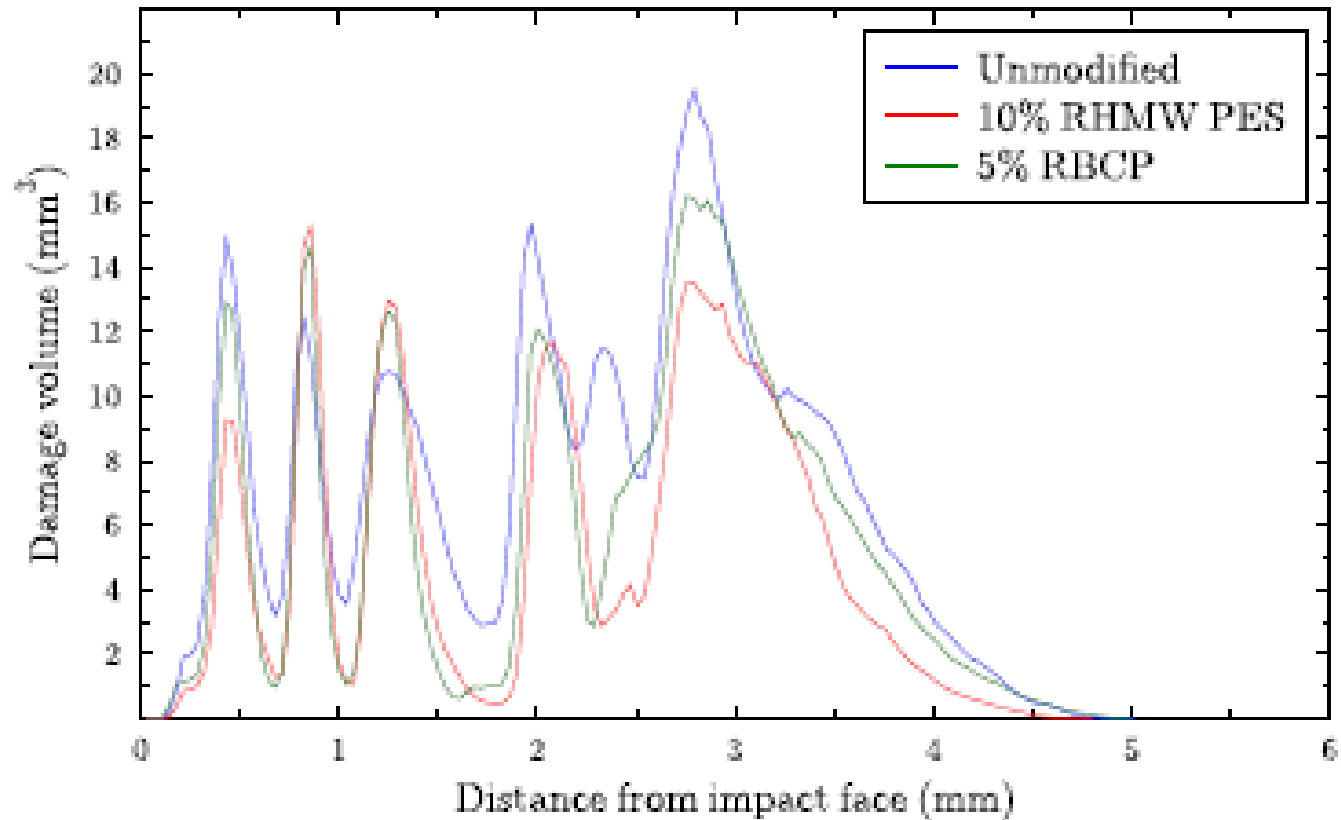
Damage volume vs. distance from impact face - different matrices 15J
