Use of Digital Image Correlation (DIC) for detection of defects and monitoring of structural integrity in the nuclear industry

Fabio Scenini^{1*}, Feridoon Azough¹, Matthew C L Read-Jennings², Paul Waterfall² and John P. Shoesmith³

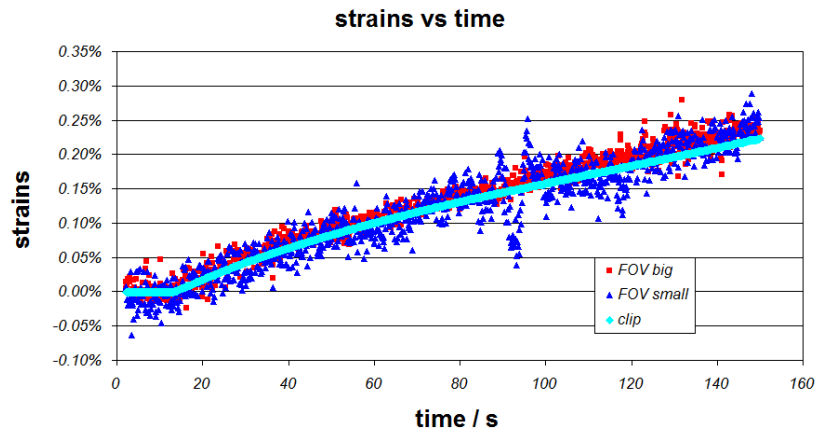
Figure 2 Strain against time measured with a clip gauge, a large and a small field of view optics.

The test conducted for the stainless steel samples (1200 grit marking in both oxidised and non-oxidised state and 600 grit marking) showed that the software can accurately track the surface movement. The comparison of strain measured by strain gauge and large and small field of view is shown in **Error! Reference source not found.** where strain measured in three different ways is plotted as a function of time.

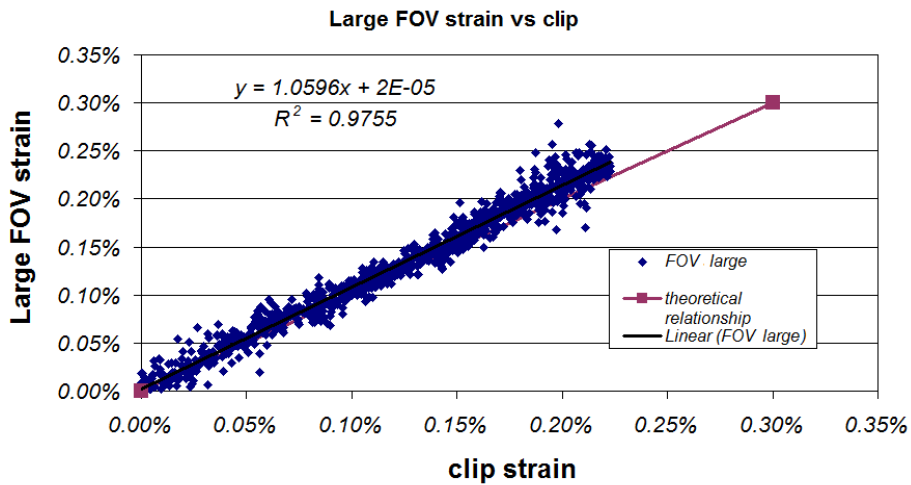
Figure 3 Strain measured with a LFOV plotted as a function of the strain measured using a clip gauge.

A more accurate comparison is obtained by plotting the strain measured optically with the reference strain measured via conventional methods (clip gauge) so that it is possible to obtain more quantitative data. The strain measured by LFOV (Figure 3) lens correlates quite well with the reference strain measured via a clip gauge and the R^2 of the best fit line is 0.97. However the SFOV correlates less well with the strain measured by the extensometer and the R^2 of the best fit line is 0.907 (Figure 4).

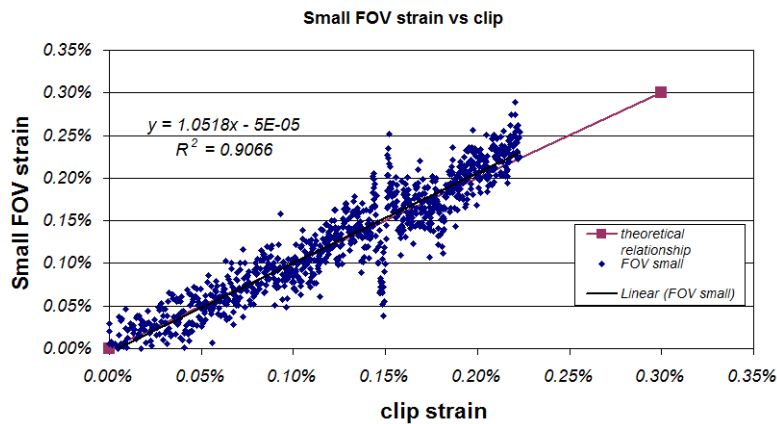
Figure 4 Strain measured with a SFOV plotted as a function of the strain measured using a clip gauge.

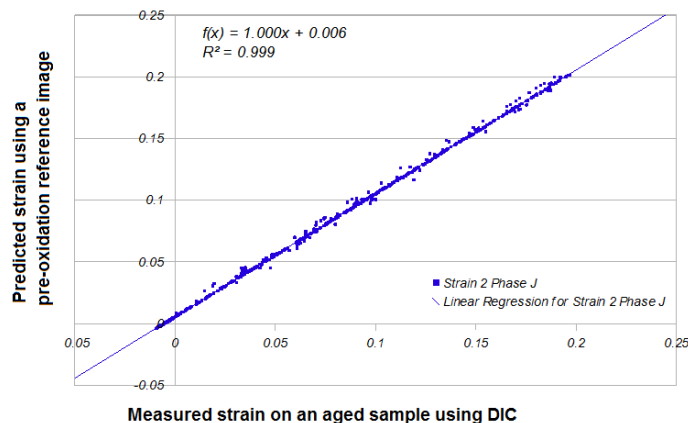
Figure 5 Strain predicted using a reference image collected before the re-oxidation (finger print) and the measured strain on an aged sample using DIC.

The strain predicted using a reference image collected before the re-oxidation (finger print) and the measured strain on an aged sample using DIC is shown in Figure 5. These results suggest that it is possible to use a fingerprint image for the determination of strain on a component that is aged by oxidation and deformation. Potential applications include the detection of in service creep, environmental assisted cracking and crack extension.

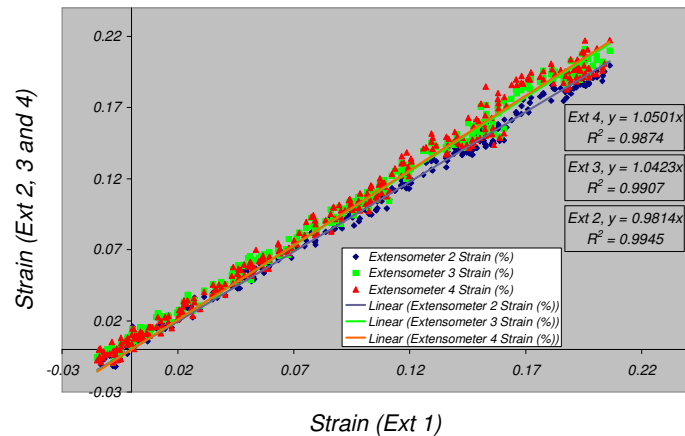
Figure 7 Strain for extensometer 1 against the rest in the sample without hole and without slot.

Figure 6 (a) shows the strain against time for samples with no defect and no slot. As expected, the amount of the strain is similar for the extensometers selected along the defect. By introducing the defect in one side the sample, it was expected that the amount of strain would increase from extensometers far from the defect to the extensometers close to the defect (Figure 6 (b)). This trend was observed for all the samples. As it can be seen in the graphs of extensometers against time is a qualitative observation and because the small changes in the strain, it is difficult to appreciate the differences between strain gauges. Therefore it was decided to plot strain from the extensometer that does not lie on the defect along with the rest of the extensometers. This is presented in Figure 7 and Figure 8. For the sample without a hole or slot, the m and R^2 values are close to the ideal value of 1. This clearly indicates that the amount of strain is the same from one side of the sample to the other side. Slight deviation is due to scattering in the data as it can be seen in the related graphs of extensometers against time.

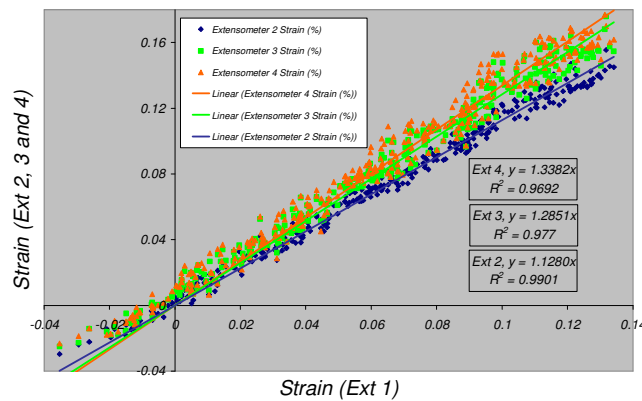
Figure 8 Strain for extensometer 1 against the rest in the sample with 0.3mm hole and with slot.

Figure 8 shows the data for the sample with 0.3mm hole and slot, the m values are significantly greater than 1 and increases as the extensometer moves to the other side of the sample where the defect has been introduced. This deviation from linearity means that the extensometer 1 is probably in elastic region whereas the rest of the gauges are in plastic region thus indicates the presence of a defect.
