Virtual Archaeology Review, 7(15): 1-8, 2016

TECHNICAL STUDY OF GERMOLLES' WALL PAINTINGS: THE INPUT OF IMAGING TECHNIQUES

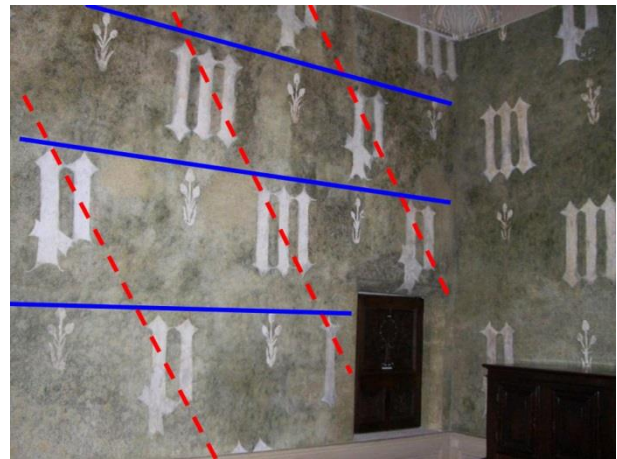
Figure 2: Wall paintings decoration of Countess of Nevers' dressing room after conservation work (1989-1995). The red dashed lines and the blue lines illustrate the geometrical repetitive pattern of the decoration © Germolles.

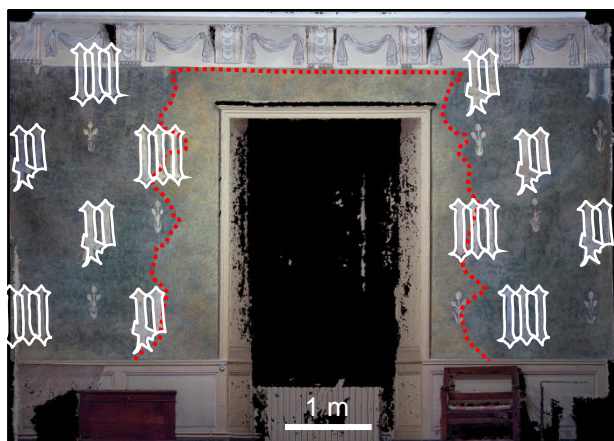
Figure 3: Orthophotograph of room dn south wall. The opening of a window in the 19th century caused loss of original decoration. The red dotted lines mark the edge of original plaster. The profile of "P" and "M" letters is indicated in white, photograph © Guery and outlines © Germolles.

A photogrammetric campaign using a Canon EOS 6D digital camera equipped with a 16-35 mm stabilized zoom lens set at 16 mm, was performed to obtain orthophotographs that were used as basemaps for documentation. Tracing manually the outline of letters over these digital basemaps showed that all "M" letters have the same form (Fig. 3) while "P" letters were further decorated with arabesques at their bottom parts (Fig. 5).

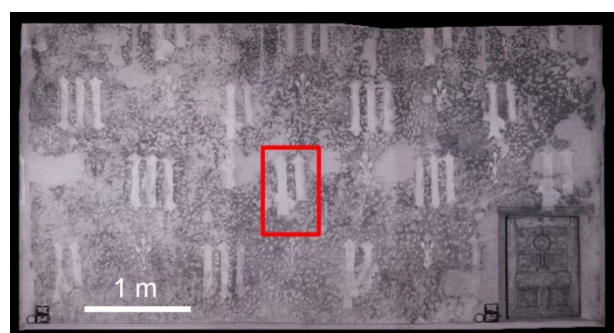
Figure 4: IR photographic image (approx. 830-1000 nm) of room dn west wall with location of the letter "P" further examined in Fig. 5 © Piqué.

Infrared (IR) pictures (approx. 830-1000 nm) of the walls obtained with Canon EOS 5D Mark II digital camera and halogen Lowel V (500 W) light were effective in revealing the extension of 20th century conservation

work. This intervention consisted in filling the holes left by the keying process before the application of a concealing stucco plaster. The missing decoration was recreated over these fills by repainting with material transparent to IR (Fig. 4). On the contrary, the original green used to paint the background is opaque to IR and appears dark grey. Due to this optical behaviour difference, IR pictures clearly showed areas original and not original. Hyperspectral imaging was used to investigate further the embellishments at the extremities of the "P" letters. The CCD camera (HS-XX-V10E), developed by SPECIM provides a 1600 x 840 pixel resolution, a spectral resolution of 2.8 nm and a wavelength range between 400 to 1000 nm. The wall paintings were illuminated by two halogen lamps oriented to 45°. The data processed with ENVI 5.2 + IDL software allowed to obtain an RGB image (R=650 nm; G=540 nm; B=450 nm) and greyscale images at wavelengths ranging from 500 to 1000 nm. These pictures were used as basemaps to indicate specific features such as the original profile of the "P" letters (Fig. 5, picture at 1000 nm) and their embellishment by medieval artists (Fig. 5, RGB picture). It appears that the addition of the arabesques was done over the original green background making each letter "P" appear a little different in visible light.

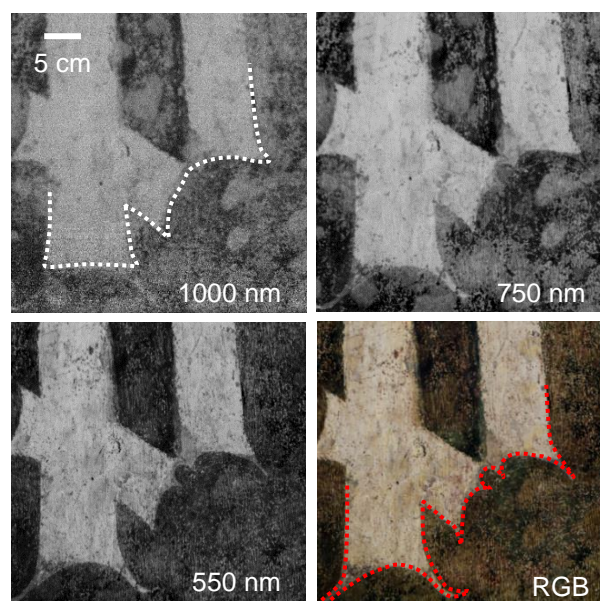
Figure 5: Hyperspectral imaging of the lower part of the letter "P" shown in Fig. 4. The white dotted line on the "P" photographed at 1000 nm shows the original profile of the letter while the red dotted line on the RGB picture shows the profile of the letter after embellishment © Mounier.

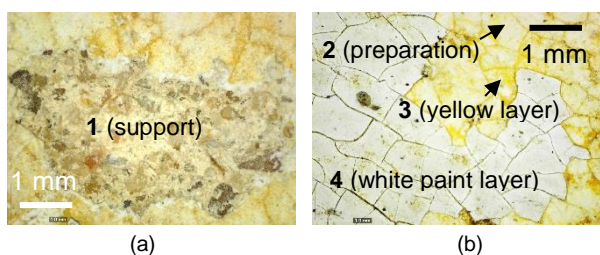
Figure 6: Micro observation of an "M" letter with Dinolite® microscope: a) support material; b) preparation, yellow and white paint layers b) © Papiashvili.

The mural decorations were studied by visual examination with the help of good lights, portable microscopy and micro technical photography using Dino-lite digital microscope AD4113T (Fig. 6). The painting technique used to create the "P" and the "M" letters is the same and results in the following stratigraphy: the white preparation layer (2, Fig. 6b) applied on the

support (1, Fig. 6a) is covered with a yellow underlayer (3, Fig. 6b) and the letters are executed with a white paint layer that appears heavily cracked (4, Fig. 6b).

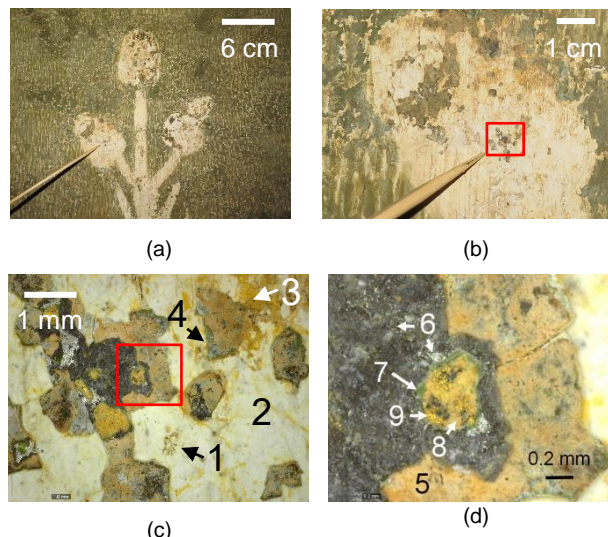
Figure 7: Macro (a and detail b) to micro (c and detail d) observation of a thistle with Dinolite® microscope. The stratigraphy comprises the underlayers (support material (1), preparation with regular strokes (2) and yellow layers (3), the green background (4) and the finishing metallic layers (5 to 9) © Papiashvili.

The technique used to paint the thistles in between the letters is different and the stratigraphy examined is indicated on Fig. 7 showing the detail of one of the flowers. Currently, most of the thistles appear white because only the white Ca-based preparatory layer remains (Figs. 2 and 7a). Green paint layers as well as isolated black remnants of paint are visible in small amounts (Fig. 7b) and were sometimes toned down by white repainting applied during 1989-1995 conservation campaign.

Visual examination of the paint remains, documented with portable microscope shows above the yellow underlayer (3 on Fig. 7c, similar to 3 on Fig. 6b) a green layer (4, Fig. 7c) that corresponds to the background of the wall decoration. Over this green background layer, the thistles were made with a complex stratigraphy comprising metallic foils applied as finishing layers (Fig. 7d). We find successively a silvery layer (6) on an orange layer (5) covered with a transparent green layer (7) and a gilded layer (9) on another orange layer (8).

The analysis of these metallic remains by XRF revealed the presence of tin (Sn) and gold (Au), while copper (Cu) and Pb were identified on the green background layers. LIBS confirmed these results. Tin (silvery layer) oxidises with time and turns black as shown on Figs. 7c and 7d.

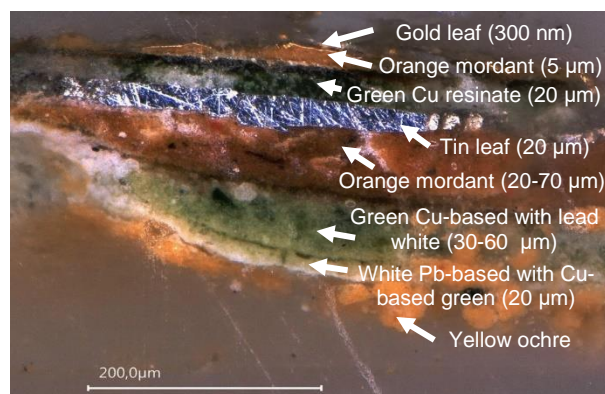
Figure 8: Cross-section of a fragment from a thistle observed in visible light under optical microscope. The identification of the material was carried out combining FTIR and SEM-EDS analyses © Piqué & Martos-Leviv.

A fragment of a thistle stratigraphy was mounted in cross-section and examined under optical microscope. The complete stratigraphy of layers with their respective thickness could be visualised from the yellow underlayer to the upper gold leaf (Fig. 8). Energy Dispersive Spectroscopy associated to Scanning Electron Microscopy (EDS-SEM) using JEOL JSM-5600LV at low pressure (17 Pa) and voltage of 15 kV as well as Attenuated Total Reflectance - Fourier Transformed Infrared (ATR-FTIR) spectroscopy using PerkinElmer spectrum 100 equipped with deuterated-triglycine sulfate (DTGS) detectors (4000 at 400 cm^{-1}) allowed to further characterize each layer. The yellow underlayer contains both Fe, aluminium (Al) and silicium (Si) and is probably a yellow ochre rich in clays. The green background is made by two layers both containing Cu and Pb, the first layer is whiter and contains mainly lead white (PbCO_3) $_2$ Pb(OH)_2 while the second is greener and is richer in Cu-based green. The binder of these Cu and Pb based layers is probably linseed oil, as seen by FTIR.

The orange layers under the metallic leaves have a variable thickness and act as mordants for these layers. The orange layer below the tin foil contains an ochre, Pb and linseed oil. The green layer on top of the tin is a copper resinate, as seen by FTIR. The orange layer supporting the gold foil is composed of ochre and Pb mixed with linseed oil similar to the layer under the tin foil.

Another important question is the surface rendering of the metallic decorations. The presence of metallic remains with the stratigraphy described in Fig. 8 and found on different parts of the thistles (flowers, leaves and stems) seems to indicate that they were completely gilded over the green tin and further decorated on top with black paint or glaze.

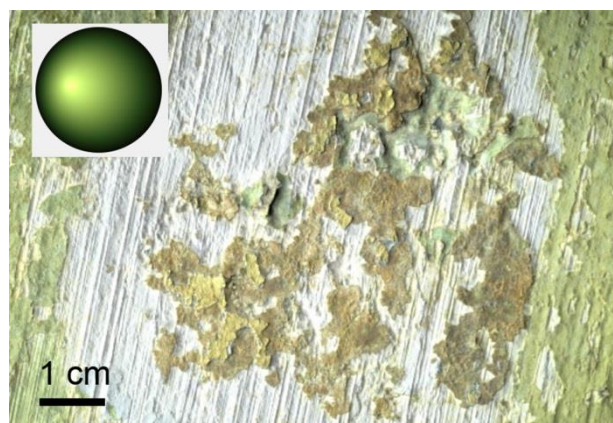
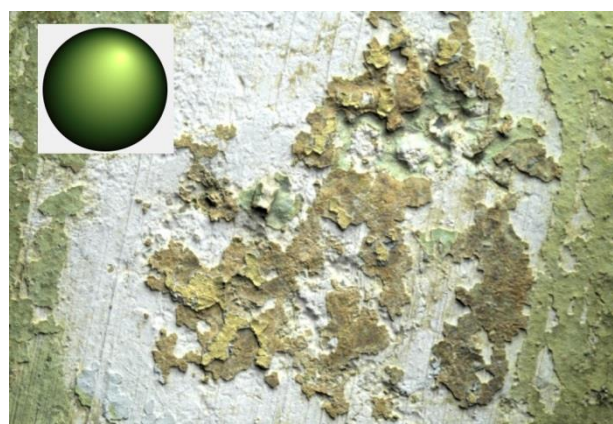
Figure 10: H-RTI snapshots under different illumination angles and application of diffusion gain. Gold remains are evident on picture a) but not so much the stratigraphy of layers. The reverse is observed when the surface is illuminated from the opposite direction b) © Germolles.

Raking light is certainly one of the best way to observe the stratigraphy of layers on the thistles. However, shadows are problematic and difficult to avoid. Therefore Highlight-Reflectance Transformation Imaging (H-RTI) using a Nikon D 7100 digital camera equipped with a variable focal (DX-VR, AF-S 18-140) used with maximum magnification (140 mm), at a working distance of approximately 25 cm, was tested as an alternative to raking light to better visualise details and stratigraphies of these paintings illuminated with a torch equipped with a LED of a power of white light (XM L2) (Duffy, 2013).

H-RTI data processing can be done with open source softwares available to end-users (RTIBuilder® and RTIViewer®), making this imaging technique a low-cost accessible one. Fig. 10 shows two snapshots of an H-RTI recording of a thistle. The remains of the gold foils are clearly visible on Fig. 10a while the layers' stratigraphy is more legible on Fig. 10b.

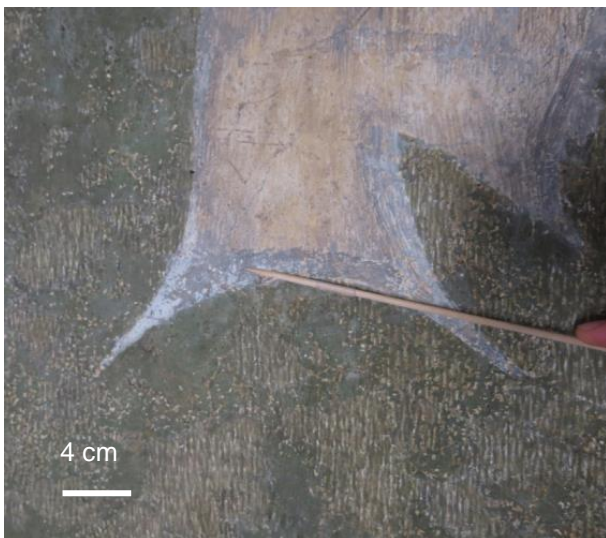
Figure 11: Alteration of lead white creating a shadow effect observed on the edges of a “P” letter © Piqué.

The white paint layer of the letters has a greyish colour in some areas along their profile (particularly the “P”, see Fig. 11). This seems to be related to the well-known lead white alteration process (Giovannoni, Matteini, & Moles, 1990). It is noteworthy that this alteration seems to be limited to areas where the lead white is covering the Cu-based green background.

New questions have come up and would require further investigation such as the “shadow effect” on the edges of the same “P”. We made the hypothesis that it might be due to an alteration of the paint layer but LIBS analyses of hatchings in these areas (that look very different from the retouching technique used during the conservation campaign of the 1990s) revealed the presence of silver.

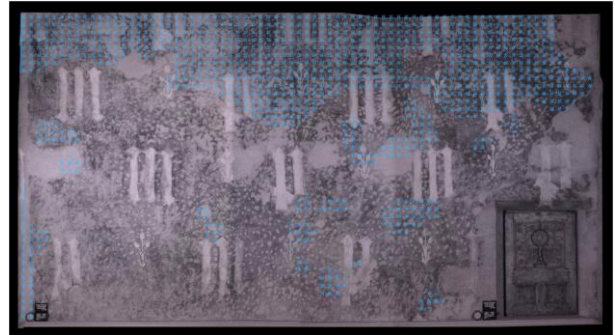
Figure 12: Graphical representation (over IR image) of areas of detachment in blue as recorded by tactile assessment (knocking method) on room dn west wall © Papiashvili.

Investigation with IR Thermography (IRT) using a thermocamera testo 890 equipped with IR-FPA (focal-plane array) detector was carried out to assess large cracks observed on the 19th century cornice of the room. IRT was accompanied by tactile assessment to detect delaminated areas. Fig. 12 shows (on the IR basemap of Fig. 4) the location of detachments perceived by touch (knocking tests). As shown on Fig. 13, the results obtained by IRT and by knocking were similar.

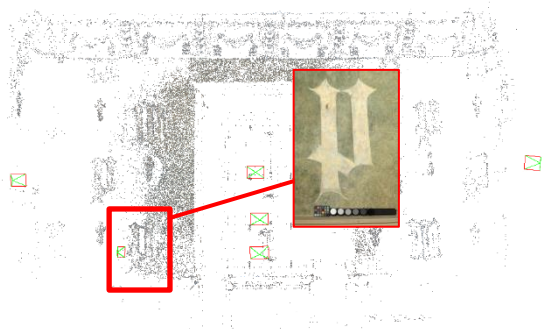
Figure 14: Tie points between the point cloud of room dn south wall and a technical picture of one of the “P” of the same wall © Pamart and Piqué.

Fig. 14 shows for instance how from a photogrammetrically-based point cloud of room dn south wall, tie points were searched and found with other pictures having different resolutions and taken with another camera. This alignment process brings new

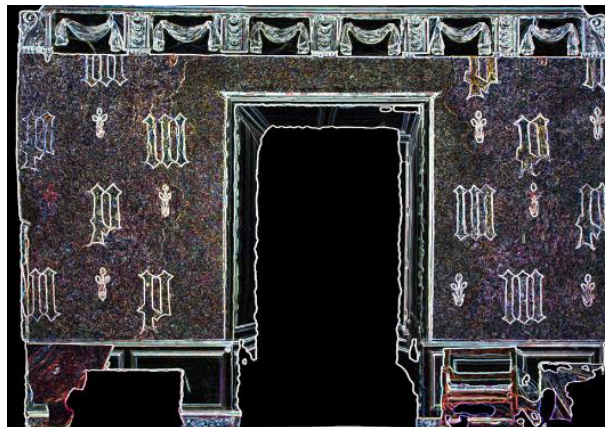
Figure 16: Snapshot from the SIVT application tested on Germolles case study data. Edge filter applied on the registered orthophotograph of room dn south wall ©Wefers and Reich.

All data integrated in SIVT can be analysed using the functionalities “water-filling”, “colour mapping”, “moveable virtual light source”, and “edge filter”. Functions such as layer-structure and transparency functionality allow a combined analysis. Especially the “edge filter” e.g. applied on the orthophotograph supports the analysis of the painting technique as stencils of each letter can be easily created for comparison (Fig. 16).
