ARTICLE

Exceptional river gorge formation from unexceptional floods

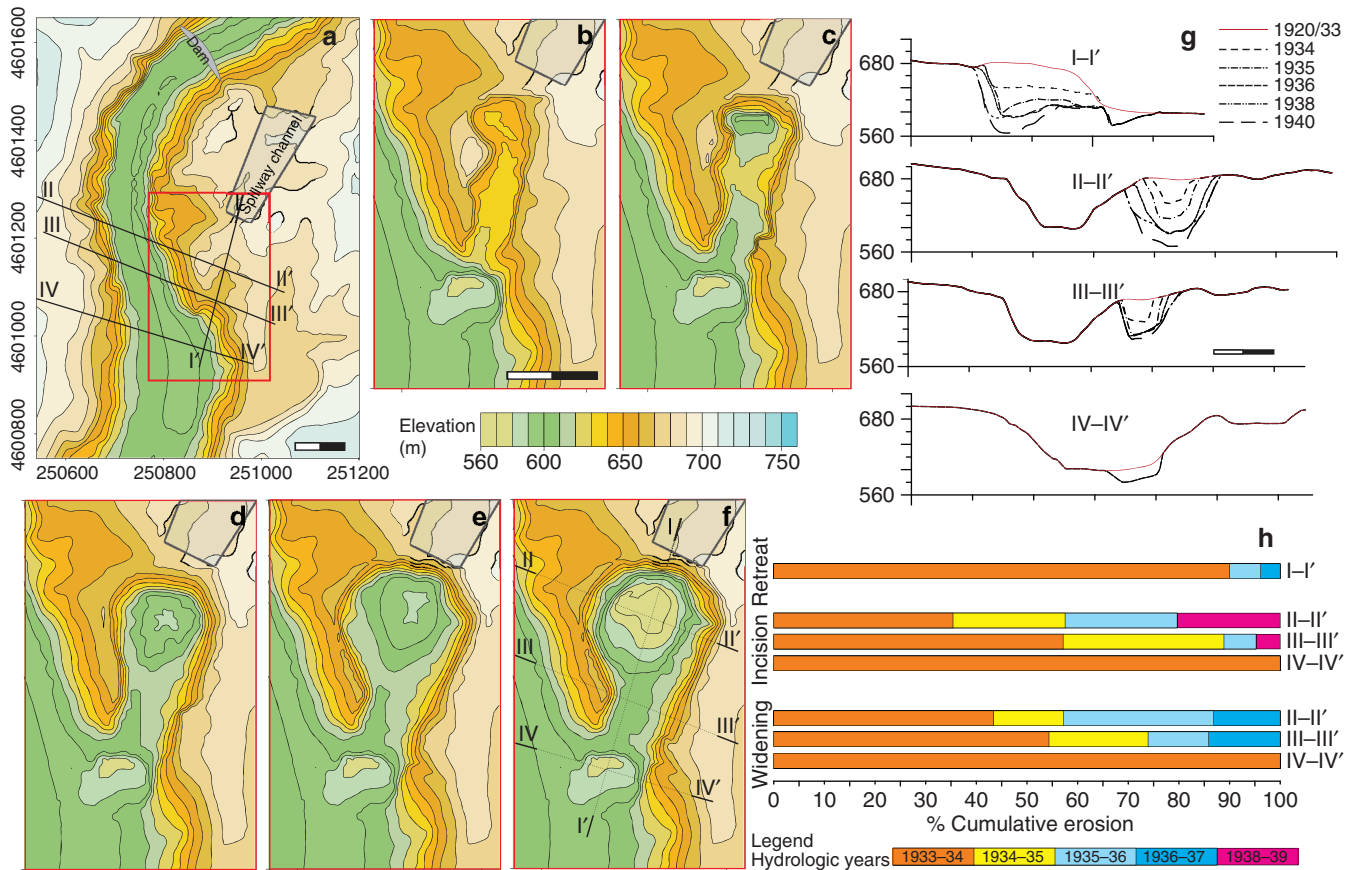
Figure 5 | Contour maps of the spillway topography showing the erosion sequence. Contour lines = 10-m intervals. Map dates: (a) 1920; box = area represented in b-f; Dam and present location of the spillway channel represented. (b) 1934 (after scour events 1–3); (c) 1935 (after scour event 4); (d) 1936 (after scour event 5); (e) 1938; (f) 1940; (g) sections of spillway site in successive years (see a for location). Scale bar, 100-m long. (h) Plot of cumulative percentage of retreat, incision and widening along different gorge sections. Upper reach (II–II’), middle reach (III–III’) and lower reach (IV–IV’).

during the erosion events (1934–1940) was performed through analysis of historic topographic maps^{28,29} (Methods). Digital elevation model (DEM) generation illustrates the former topography of the spillway site and how the bedrock erosion proceeded (Fig. 5). Comparison of successive DEMs enabled spatial and temporal erosion patterns to be quantified for successive stages and allows the calculation of erosion rates (incision, widening, retreat and eroded volume; Fig. 6).

Before the erosion events dam workers established a low gradient (<1°) unlined rock spillway channel. The channel, 400-m long, was inset ~20 m into the bedrock on a topographic high (~70 m above the riverbed; Figs 3i and 5a). The downstream boundary of the spillway was formed by a high angle (~30°) knickpoint lip perpendicular to flow that had been artificially created in the spillway mouth (Figs 3 and 5a,g).

depth increased in the plunge pool with successive outflow discharges and progressive scour formation, the water jet energy focused on the developing plunge pool water body^{41,42}. Over this time bedrock scours occurred predominately at the base of the plunge pool and incision in the middle reach was minimal (Figs 5g,h and 6). Subsequently, as the channel was deepened and enlarged, the rim of the headwall and the gorge sides became unstable and the canyon began widening. Thus, while headwall retreat moved as a wave of erosion upstream creating the canyon, the slowdown in retreat rate promoted a persistent vertical headwall, allowing incision and widening to progress (Fig. 7) and eventually forming the present amphitheatre-headed valley with a 40 m water depth plunge pool (Figs 5 and 6).
