著者	Higuchi Ryo, Suzuki Tamaki, Shibata Mina, Taniguchi Yoko, Gulyaz Murat
journal or publication title	Virtual Archaeology Review
volume	7
number	14
page range	31-42
year	2016-05
権利	(C) UPV, SEAV, 2015
URL	http://hdl.handle.net/2241/00144764

DIGITAL NON-METRIC IMAGE-BASED DOCUMENTATION FOR THE PRESERVATION AND RESTORATION OF MURAL PAINTINGS: THE CASE OF THE ÜZÜMLÜ ROCK-HEWN CHURCH, TURKEY

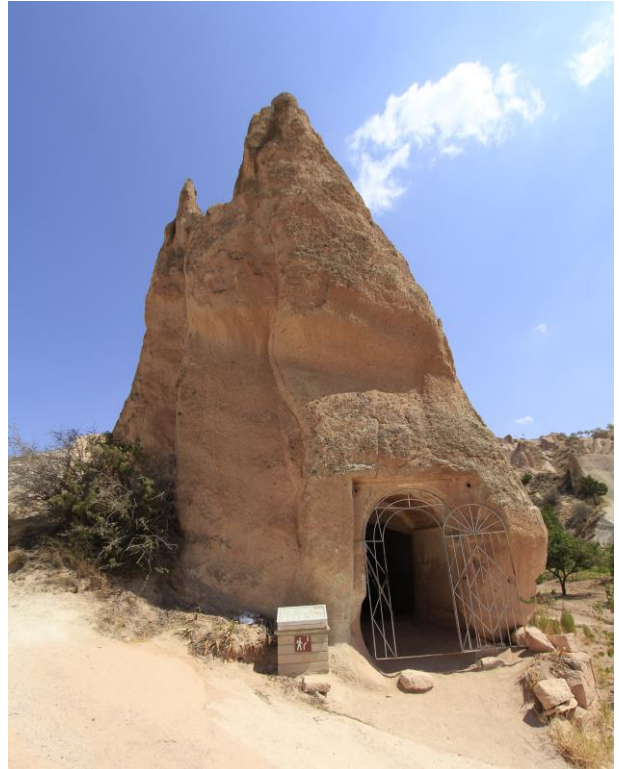
Figure 1: West façade of the Üzümlü Church

The structure of the Üzümlü Church is a solitary cone that is approximately 12 m in the east–west direction and approximately 8 m in the north–south direction. The entrance to the church is a cut on the western façade of the rock. In the past, another entrance was on the southern side; however, this entrance is now filled. Although the church comprises two stories, the upper floor was already inaccessible in the 1960s (Schiemenz,

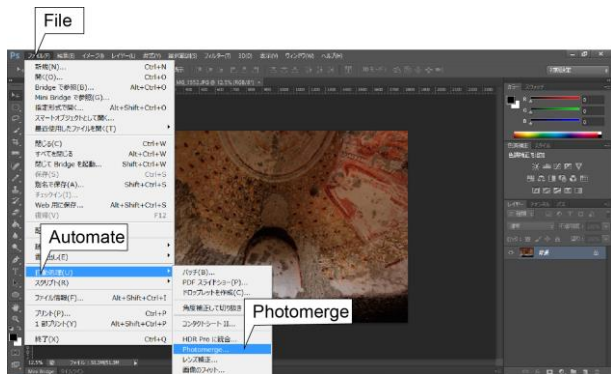
Figure 6: 'Photomerge' on the menu.

1) Read files (Fig. 6): Read the files to merge. Then select <Automate> in the <File> menu. Click <Photomerge> and select <Add Open Files>.

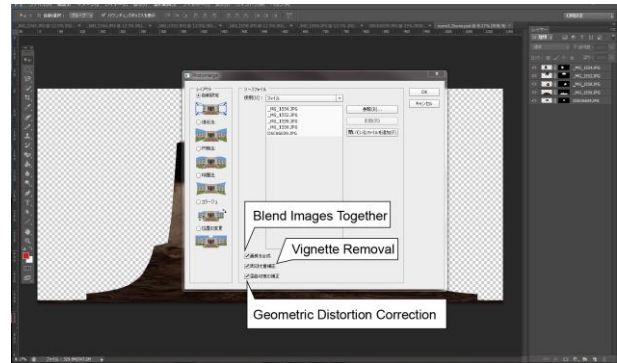
Figure 7: Choosing files to combine.

2) Merge files (Fig. 7): Check <Blend Images Together>. Also check <Vignette Removal> and <Geometric Distortion Correction> to reduce morphing time after merging as we do not intend to make a metric image. Click <OK>.

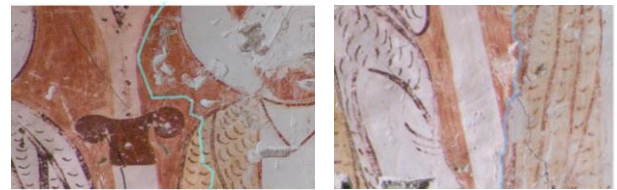
Figure 8: Photomerge examples: a) Successful implementation; b) failed photo combination.

3) Check the edge of each of the images (Fig. 8): Upon correct execution of the preceding steps, we checked each end of the reading photographs. If it was wrong, morphed images would not fit each other (such as in Fig 8b). Lack of overlapping images usually induced this error.

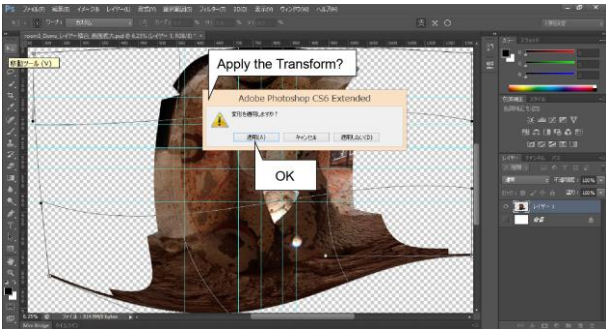
Figure 11: Applying the 'warp' tool.

7) Apply the transformation (Fig. 11): After completing the transformation, click <Apply> in the window <'Apply the transform?>

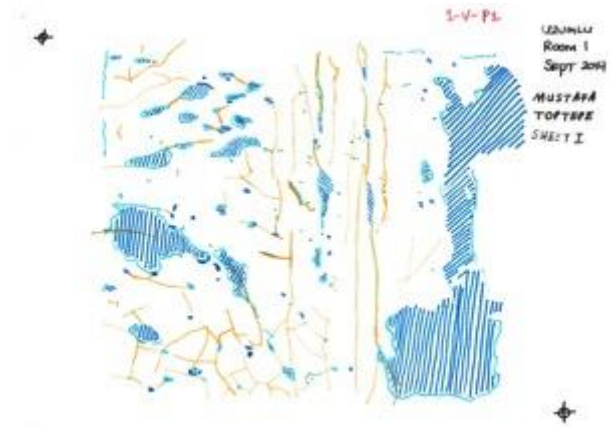
Figure 16: Scanned OHP sheet of plaster deterioration on the ceiling in narthex.

After the state of layer deterioration was documented, an OHP sheet was scanned to create a digital mural condition sheet (Fig. 16). In cases where the number of items was too large for these to be recorded on an OHP sheet, we used more than two OHP sheets to document one layer. Using Adobe Illustrator, we traced the scanned data with a pen tool. The traced deterioration sites were divided into different layers according to each item of deterioration. Therefore, each mural condition sheet can show the deterioration sites of selected items when a pdf file is created and viewed via pdf viewer software. The approximate scale of the mural condition sheets was then adjusted to 1/10, 1/15, 1/20 and 1/25. As we checked the deterioration of each layer of the mural paintings, we produced 39 mural condition sheets and 13 image mosaics of the mural paintings for the digital heritage inventories. An example is Fig. 17, which shows the paint layer deterioration of the ceiling in nave. All the digital inventories of the printed versions (Taniguchi 2015) that we created are available for viewing in Appendix 3 at the following webpage address: http://rcwasia.hass.tsukuba.ac.jp/kaken/contents/content%20images/0_20150723_uzumlu_2014_final_s.pdf.
