Pushover Analysis of Historical Elti Hatun Mosque

Keywords: historical heritage; mosque; pushover analysis; finite element method; seismic performance.

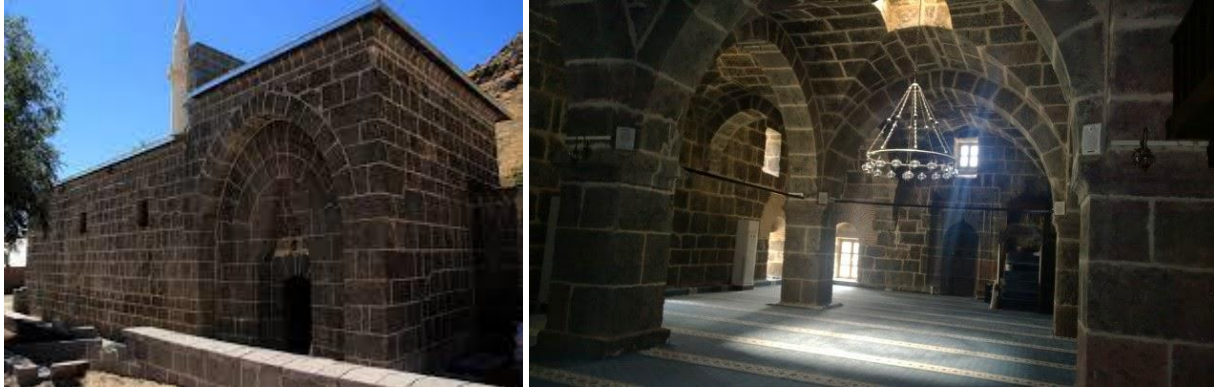
Figure 2: Outside and inside of the Elti Hatun Mosque

was composed of many vaults and arch systems. During the construction phase of the mosque, Horasan mortar was used. Horasan mortar is composed of lime and brick powder. The mosque was restored in the end of July in 2014. Figure 2 shows the views of Elti Hatun Mosque after restoration.
