*Brick and Block Masonry – Trends, Innovations and Challenges – Modena, da Porto & Valluzzi (Eds)*  
© 2016 Taylor & Francis Group, London, ISBN 978-1-138-02999-6

## Out-of-plane response of masonry infilled RC frames: Effect of workmanship and opening

F. Akhouni, G. Vasconcelos, P. Lourenco & L. Silva  
*University of Minho, Portugal*

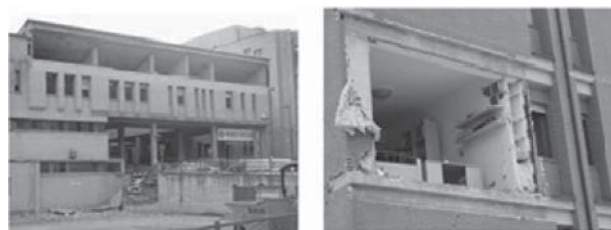
Figure 1. Damage in non-structural elements (Braga et al., 2011).

Out-of-plane collapse of masonry infills within concrete frames has been observed in most of the earthquakes (Braga et al., 2011). Although the infill panels are assumed as non-structural elements, their damage or collapse is not desirable, given the consequences in terms of human life losses and repair or reconstruction costs. In addition, this type of damage can limit the immediate occupancy after the earthquake event. Aforementioned earthquakes such as L'Aquila earthquake (Braga et al., 2011), highlights the damages developed in the infill walls in relation to the minor cracks observed in the structure. In these cases, it was observed that no immediate occupancy was possible due to the generalized damage in the masonry infills. As it is observed in Figure 1 the ground motion was not strong enough to cause structural damage but due to improper anchorage and interaction of the infill walls and surrounding frame, the exterior walls damaged and fell outside and the concrete beam and columns were exposed.

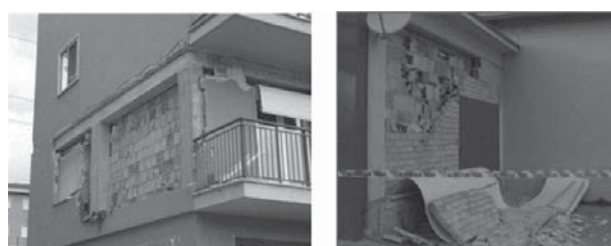
Figure 2. Detachment of the leaves in multi leaf walls (Braga et al., 2011).

Out-of-plane failure of the infills can be observed in dividing walls and also in multi-leaf walls when there is no proper transversal connection between the leaves as it is shown in Figure 2.

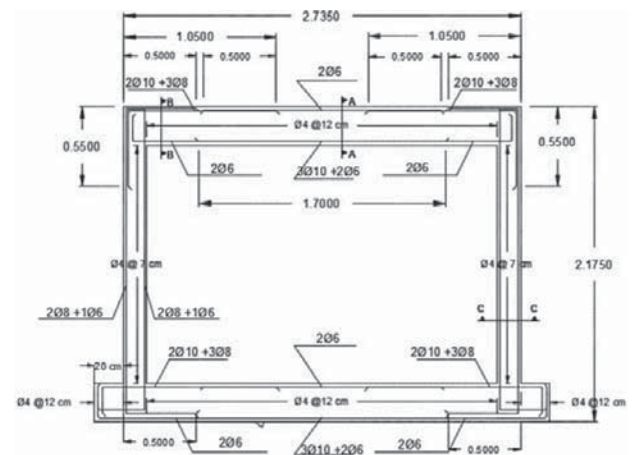
Figure 3. Geometry and reinforcement scheme of the reduced scale specimens.

typical of South European countries and described in this research were categorized in (Furtado et al., 2014). For the design of reduced scale specimens, an allowable stress design approach was followed. In the first step, sections of the columns and beams of prototype were analyzed based on ACI 318-08 guidelines to obtain the maximum allowable forces and flexural moments of each section. Then Cauchy's similitude law was applied to the allowable forces and flexural moments of real scale sections obtained in the first step to calculate the maximum allowable forces and flexural moments of reduced scale sections. In this step each mechanical or geometrical parameters of sections of the prototype was calculated based on Table 1. Finally, cross-section and reinforcement of the reduced scale sections were designed based on the same allowable stress design approach; see Figure 3 and Figure 4.

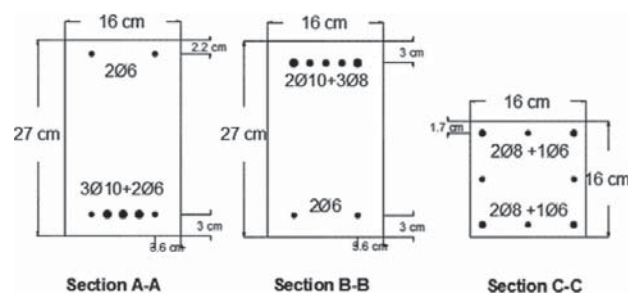
Figure 4. Cross-sections of columns and beams in reduced scale specimens.

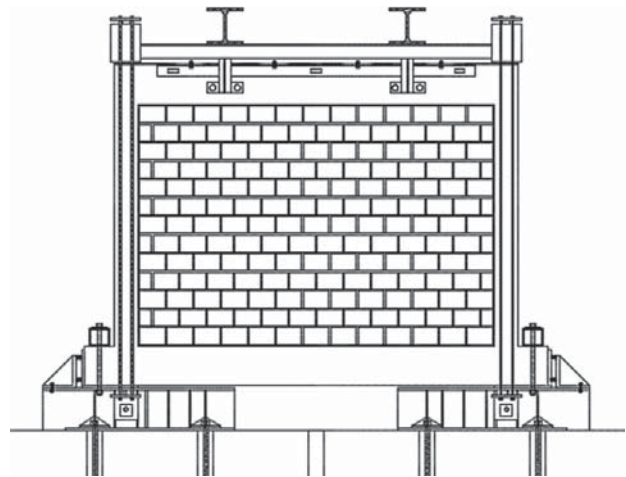
Figure 5. Test setup for out-of-plane testing.

The test setup for out-of-plane loading is shown in Figure 5 and Figure 6. As it is shown in Figure 5, the infilled frame was placed on the same steel profiles of in-plane testing setup. All the test setup for out-of-plane testing is as same as the in-plane test setup but the only difference is providing more out-of-plane resistance of the upper beam by putting four steel rods of M40 to prevent out-of-plane movement of the surrounding frame.

Four rollers were mounted in the bottom part of the supporting frame to ease its moving along the direction of applied load. The supporting frame was also kept in touch with four loadcells to measure the load that is applied by airbag which their contact points are shown in Section A-A. The supporting frame of the loadcells was firmly connected to the strong floor and reaction wall to completely prevent its uplifting and sliding on the floor.

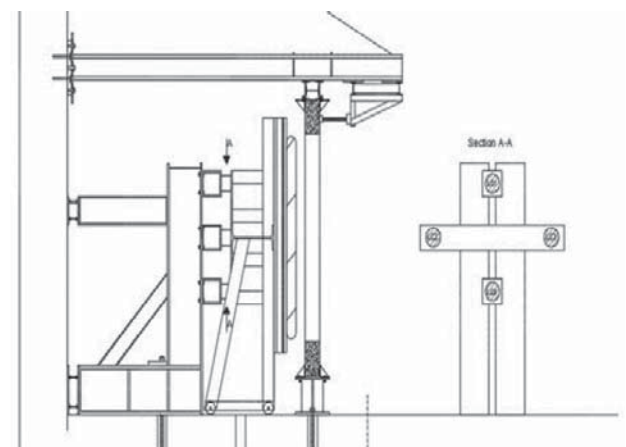
Figure 6. Test setup for out-of-plane testing.

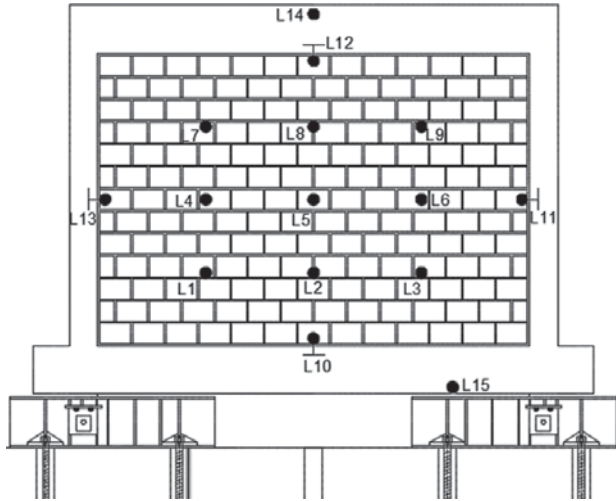
Figure 7. Instrumentation of the infilled frame without opening.

The instrumentation plan for the out-of-plane testing of solid infilled frame is shown in Figure 7 and for partially infilled frame is shown in Figure 8. In the specimen without opening, total number of fifteen LVDTs were mounted on the specimen to monitor its deformation while the out-of-plane load is applied. From them, nine LVDTs record the displacement history of the infill panel during loading (L1 to L9). Four LVDTs measure the relative displacement between infill and its surrounding frame (L10 to L13) and two LVDTs measure the out-of-plane movement of the upper and bottom reinforced concrete beam (L14 and L15).

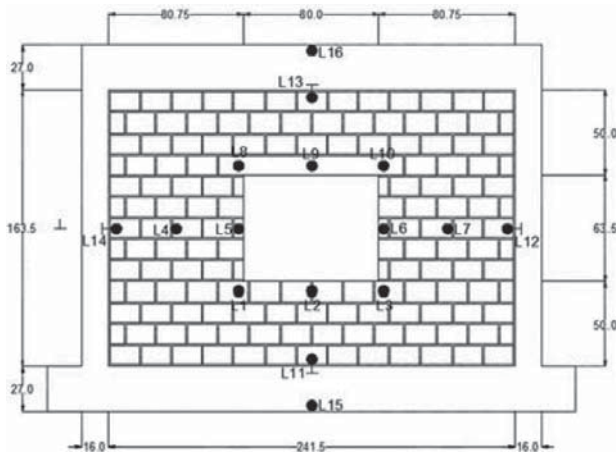
Figure 8. Geometry and instrumentation for specimen with central opening.

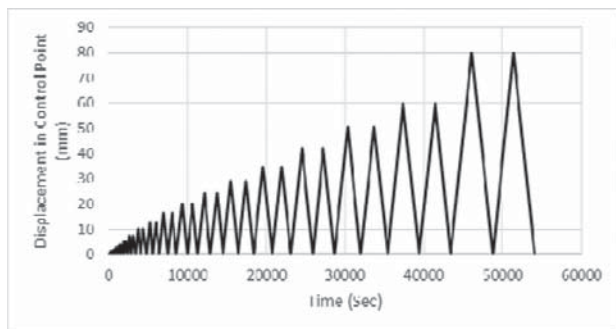
Figure 9. Loading protocol for out-of-plane testing.

Figure 9 shows the defined loading pattern for quasi-static cyclic testing of the specimens in the developed software for out-of-plane testing. It is composed of twenty different amplitudes applied for the control point of each specimen in which for solid infilled frame is assumed as central point (L5) and for partially infilled frame is assumed

as central point of the infill in the upper part of opening (L9). The first amplitude repeated for six times and the others repeated two times to investigate the strength degradation of the specimen at each displacement. This loading protocol is compatible with FEMA461 (FEMA461, 2007). The loading was performed in one direction to monitor the deformation of the infill, propagation of the cracks and performance of the interfaces between infill and reinforced concrete frame during out-of-plane loading.

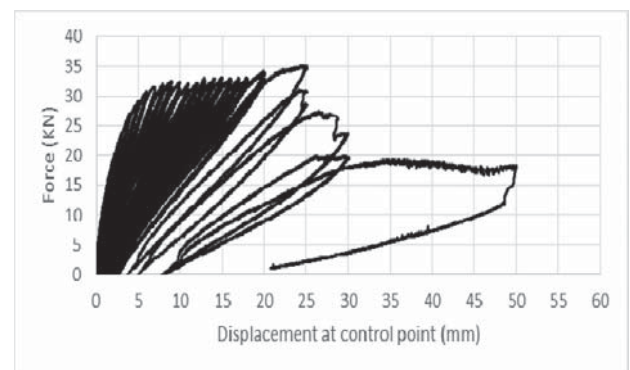
Figure 10. Hysteresis force-displacement diagram of SIF-A.

Force-displacement diagram of the specimen is shown in Figure 10. It is observed that by applying lateral displacements up to 4 mm in the control point no cracks were formed in the specimen. The first cracking of the specimen was observed at lateral displacement of 5 mm corresponding to lateral force of 28.6 kN by formation of horizontal cracks in the center part of the infill. After this point, initial stiffness of the specimen decreased significantly until it reaches the peak force of 34.9 kN at lateral displacement of 25 mm. After peak lateral force, by applying further displacement, sudden drop in lateral force was observed. 20% decrease in the maximum force was observed to reach the lateral force of 27.6 kN corresponding to displacement of 28.1 mm. Further displacement led to further decrease in the lateral force. The specimen was collapsed at lateral displacement of 50 mm corresponding to lateral force of 19.4 kN. Because the specimen collapsed at the first cycle of the amplitude of 50 mm, the second cycle was not performed.

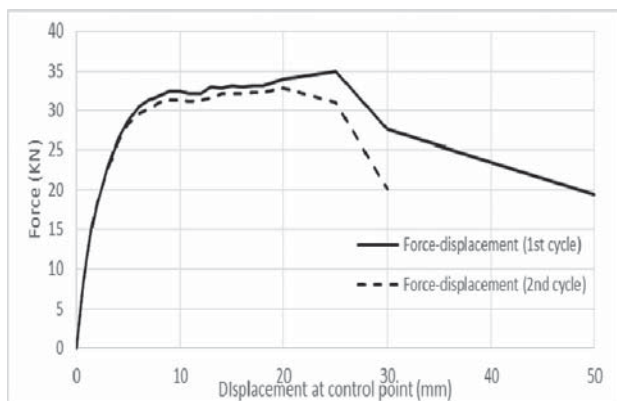
Figure 11. Monotonic force-displacement diagram of specimen SIF-A at each successive cycles.

The monotonic curve of the force-displacement diagram at the first and second cycles of each step is shown in Figure 11. It seems that strength degradation of the specimen at two successive cycles is negligible until lateral displacement of 25 mm in

which the upper interface moved in out-of-plane direction and the maximum force of 34.9 KN was achieved. Strength degradation in the specimen could be considered as a contribution of the crack propagation. Because by increasing the number of cracks in the specimen, strength degradation increases. The degradation amount of 13% was observed at the peak point of the force-displacement diagram. At lateral displacement of 30 mm which infill was cracked totally, the strength degradation of 37% was observed.

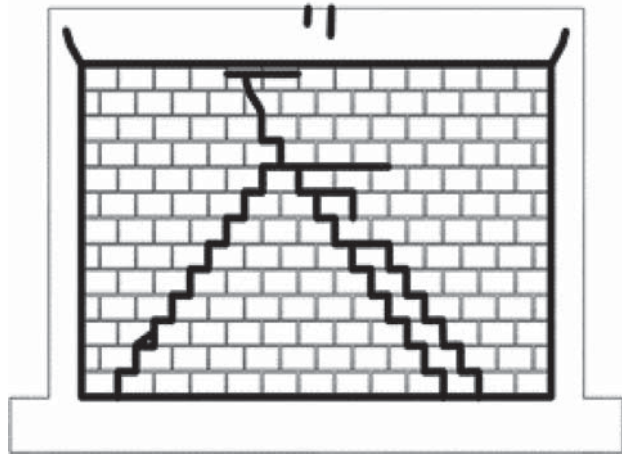
Figure 12. Failure pattern of the specimen SIF-A.

Final cracking pattern of the specimen is drawn in Figure 12. It was observed that at the first levels of loading until displacement of 25 mm the two-way arching mechanism was formed in the specimen but at the second cycle of the amplitude 25 mm, the upper interfaces cracked and bulged outside. This cracking of upper interface change the total cracking pattern of the specimen as shown in Figure 12. In this case, the cracking pattern of the specimen is compatible with the yield line theory of the slabs that have one free edge at their top part.

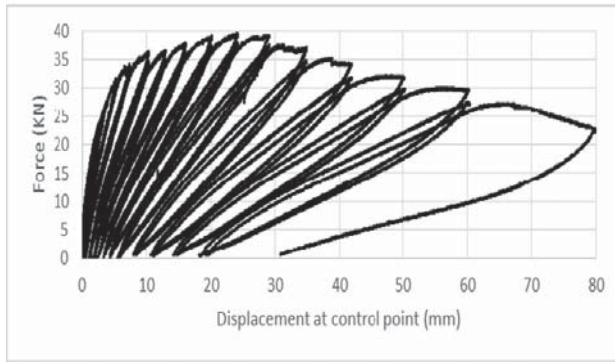
Figure 13. Hysteresis force-displacement diagram of SIF-B.

Force-displacement response of the specimen is shown in Figure 13. It is observed that at displacement of 3.76 mm the cracking in the infill was initiated by forming the horizontal cracks in the mid part of the infill. Significant decrease in the initial stiffness could be observed after displacement of 5.27 mm related to out-of-plane force of 30.9 KN which could be related to the formation of diagonal step cracks. This means that by imposing higher displacement at the control point, force increases slowly until it reaches 39.7 KN at displacement of 24.21 mm. After the peak point, softening branch could be observed which increasing displacement leads to decrease in out-of-plane force to the extent that at displacement of 80 mm the residual strength of 22.4 KN corresponding to 56% of the peak force

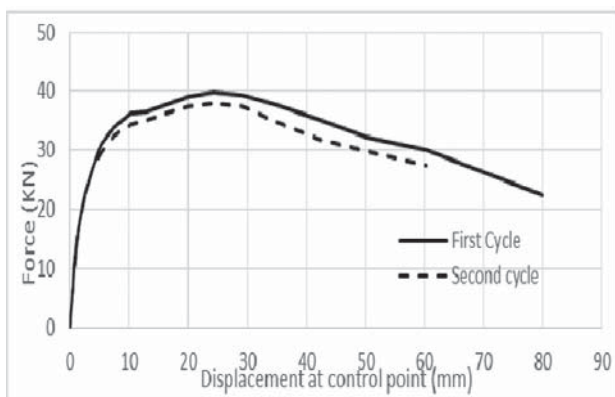
Figure 14. Monotonic force-displacement diagram of specimen SIF-B at each successive cycles.

The monotonic curves of the force-displacement diagram for each cycle is shown in Figure 14. It is observed that by applying more displacements in the specimen which lead to the formation of more cracks, the amount of strength degradation increases. The increasing of the strength degradation in the specimen is assumed as insignificant because maximum amount of 10% was observed at lateral displacement of 60.5 mm.

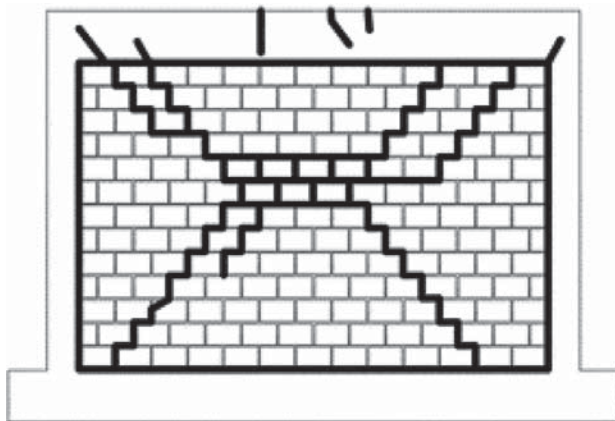
Figure 15. Failure pattern of the specimen SIF-B.

The final cracking pattern of the specimen is shown in Figure 15. In this specimen the cracking pattern is compatible with the yield line theory of the slabs that have four supports. In this case, in the first stages of loading a horizontal crack initiated at the mid-part of the specimen and by applying further displacements to the control point, some diagonal cracks formed at the end part of the horizontal crack trying to reach the corners of the infill. The failure pattern of the specimen exhibits that the two-way arching mechanism that was formed in the initial stages of the test, remained unchanged until the end of the test.

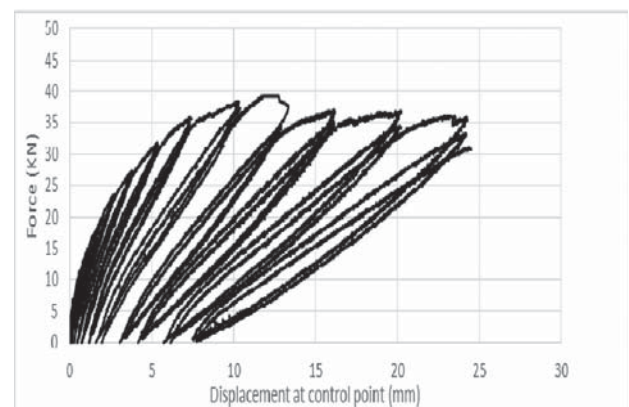
Figure 16. Hysteresis force-displacement diagram of PIF-B.

Force-displacement diagram of the specimen at control point is shown in Figure 16. It is observed that the first cracking initiated at displacement of 3.76 mm corresponding to the out-of-plane force of 26.6 KN. Nonlinearity in the force-displacement diagram was observed before observing the cracks in the specimen. By applying further displacement to the control point, the out-of-plane force was increased until it reached to 39 KN at displacement of 12.91 mm. After this point, increasing the displacement in control point resulted in small decrease in out-of-plane force. Finally the specimen was collapsed at displacement of 24.46 mm corre-

responding to the force of 31.1 kN by out-of-plane failure of the right side of the opening in the infill. Right part of the infill experienced more damage with respect to the other parts of the infill. This could be related to the position of the valves of input air in the airbag that were placed in its right side. It seems that this issue have led to asymmetric loading of the infill.

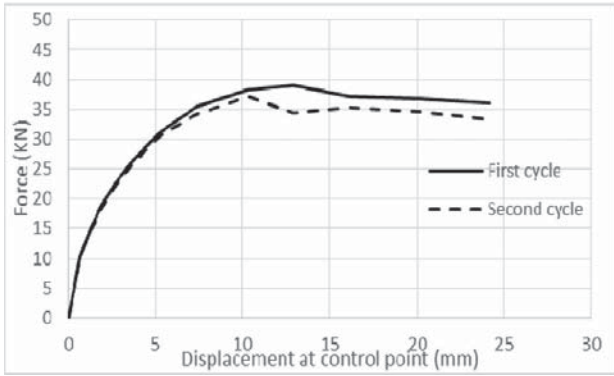
Figure 17. Monotonic force-displacement diagram of specimen PIF-B at each successive cycles.

The monotonic force-displacement diagram for each successive cycles are shown in Figure 17. It is observed that strength degradation in the specimen starts by formation of cracks in the specimen which is similar with the other tests. The maximum strength degradation of 12% was happened at lateral displacement of 12.91 mm corresponding to the peak load of 39 kN while for other displacements the amount of strength degradation is less than 10%.

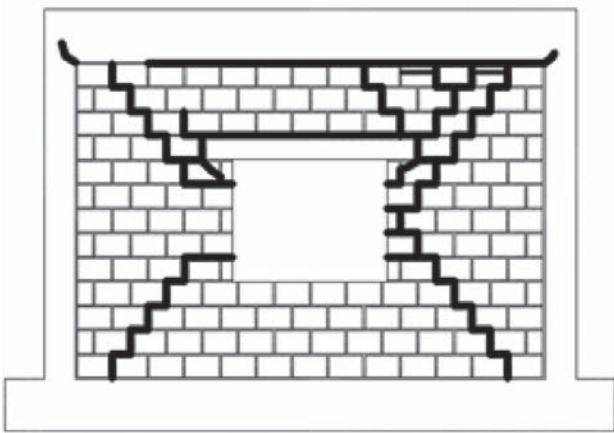
Figure 18. Failure pattern of the specimen PIF-B.

The final cracking pattern of the specimen is shown in Figure 18. It is observed that the cracking of the specimen initiated at the corners of the opening by formation of some diagonal cracks trying to reach the corners of the infill. Increasing the displacement at the control point lead to formation of some horizontal crack in the top part of the infill and finally the specimen failed as shown in Figure 18. It seems that the two-way arching mechanism is also formed in this specimen to resist the out-of-plane loading and remained unchanged until the failure of the specimen.

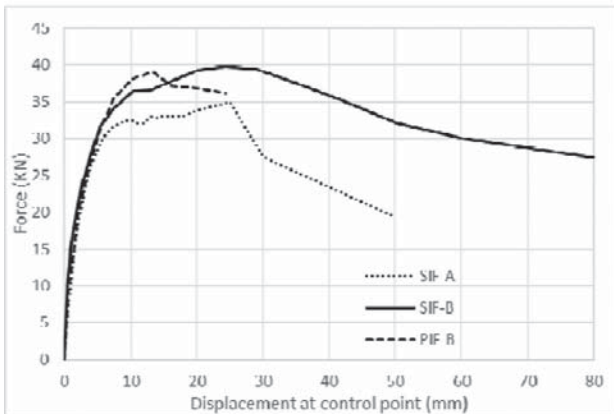
Figure 19. Force-displacement diagram of the specimen.

The force-displacement diagram of the specimens are shown in Figure 19. It is clear that the force-displacement diagram of the specimen constructed with group of mason "A" is totally different with experience group of mason "B". The parameters related to the out-of-plane behaviour of the specimens namely initial stiffness measured as the slope of the force-displacement diagram at 30% of maximum force and the out-of-plane resistance of the specimens are represented in Table 2. It seems that the boundary conditions of the specimen totally affect the out-of-plane behaviour of the specimen. Workmanship as observed in the test results of SIF-A could affect those boundary conditions. It is clear that in the specimen SIF-A, the upper interface lost its functionality due to

It is also concluded that presence of small central opening (13% area of infill) did not result in decrease of the out-of-plane resistance of the specimen while 12% decrease in the initial stiffness was observed. Based on Figure 19 and comparing the force-displacement diagram of the specimens SIF-B and PIF-B, it could be observed that presence of even small percentage of opening in the infill results in decrease in the deformation capacity of the specimen while it does not lead to any significant decrease in the lateral strength of the specimen.
