Evaluation of Concrete and Mortars for Partial Depth Repairs

Eshan V. Dave, Principal Investigator
Department of Civil Engineering
University of Minnesota Duluth

Research Project
Final Report 2014-41

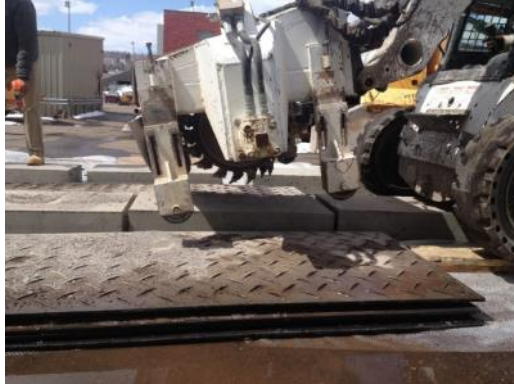
Figure 17: Pavement milling machine used to groove test slabs.

The pop-out bond test involved the casting of representative pavement slabs. The data collected during the test was empirical and was used for comparison purposes only. The slabs were 45 X 24 X 7 ½ inches in size. Once the slabs had cured completely a partial-depth repair milling machine was used to make a groove in the center of each slab (Figure 17).

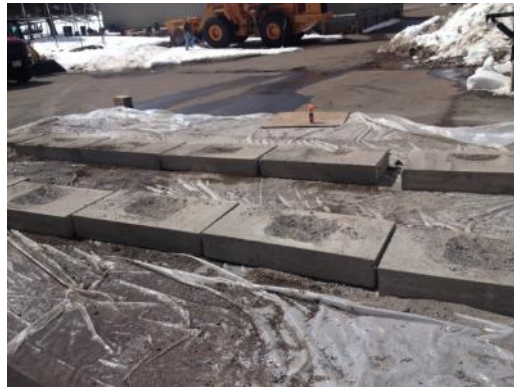
Figure 18: Test slabs containing partial-depth simulated repair areas.

The grooved areas were approximately 18 X 15 X 2 ¾ inches in size (Figure 18). The grooving head produced a hole with a sidewall that measured between 70 and 90 degrees, steeper than is allowed. A 15 pound jack hammer was used to slope the sidewalls to fall into MnDOT patching specifications, 30-60 degrees. The patch area preparation then followed current construction guidelines and were sandblasted to create a micro textured surface.

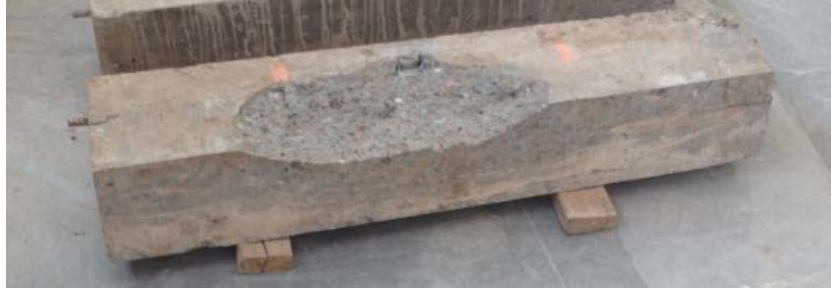
Figure 19: Slab after being cut longitudinally to expose the patch material edge.

After the grooving and sandblasting operation was complete a walk behind concrete saw was used to cut the slabs into two pieces longitudinally. This was done so that there would be an exposed edge of the patching material; this simulated the condition of actual patches in the field (Figure 19).

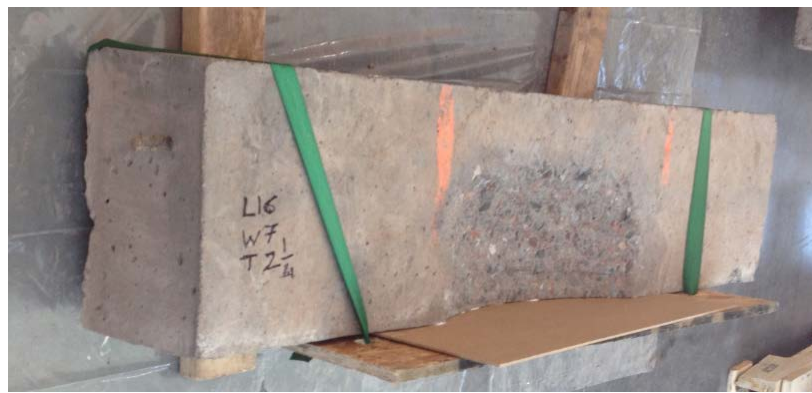
Figure 20: Half slab ready to have patching material added.

Prior to casting the patch material the slabs were set up with a bond breaker similar to what is used in the field (Figure 20). This was done to simulate field conditions as closely as possible.

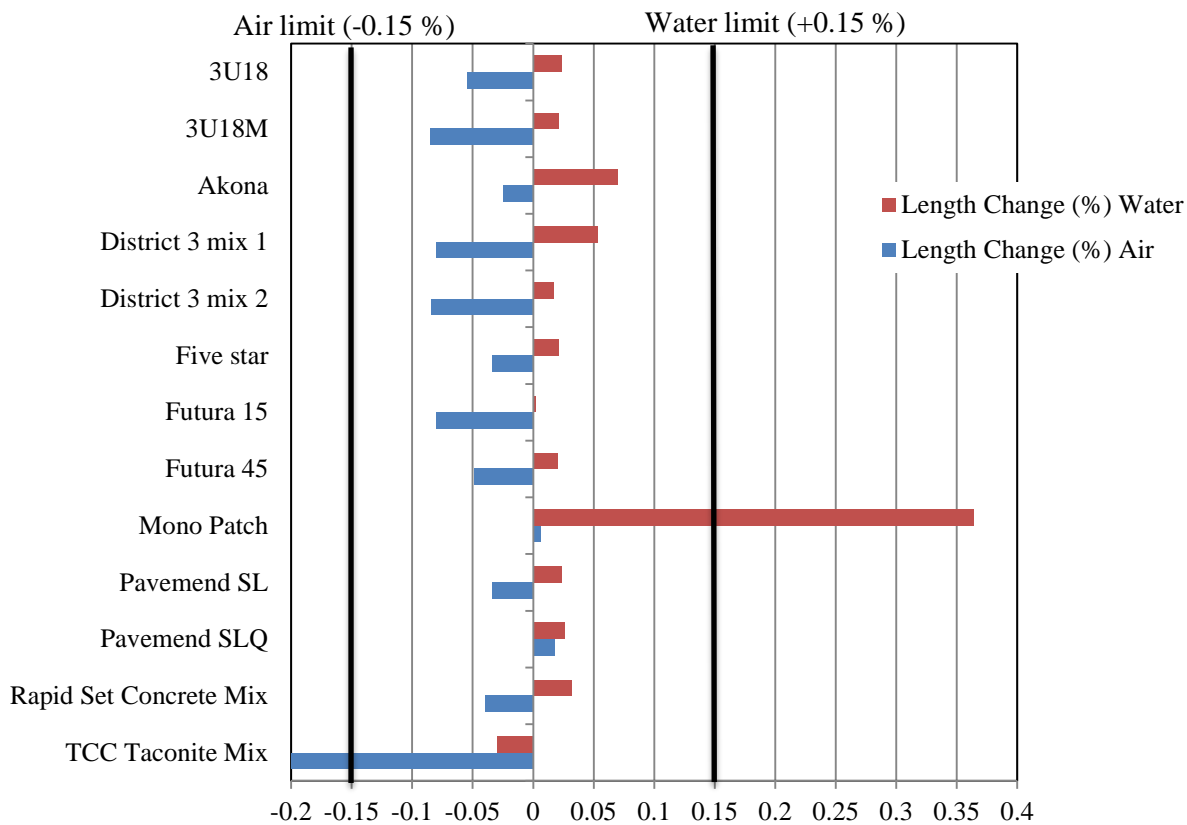
Figure 33: Length change in air and water at 28 days

Length change yielded two unique results. There are two products that expanded while curing in air. Both of those products are magnesium phosphate based. Magnesium Phosphate has been used to accelerate set times and lower the permeability of the concrete (Cervo and Schokker, 2008). There were two products that failed to meet the ASTM C928 specification; Mono Patch and the TCC Taconite mix. Mono Patch expanded in water beyond the limit, which is shown as the black line on Figure 33. The TCC Taconite mix exhibited shrinkage in both air and water. The excessive shrinkage of TCC Taconite mix is partly due to thermal contraction of the specimen as the material hardened at relatively high temperature (approximately 130 °F). The length change in water was within the limit for this material; however the shrinkage in air could not be accurately measured due to the fact that it was no longer within the limits of the testing apparatus.

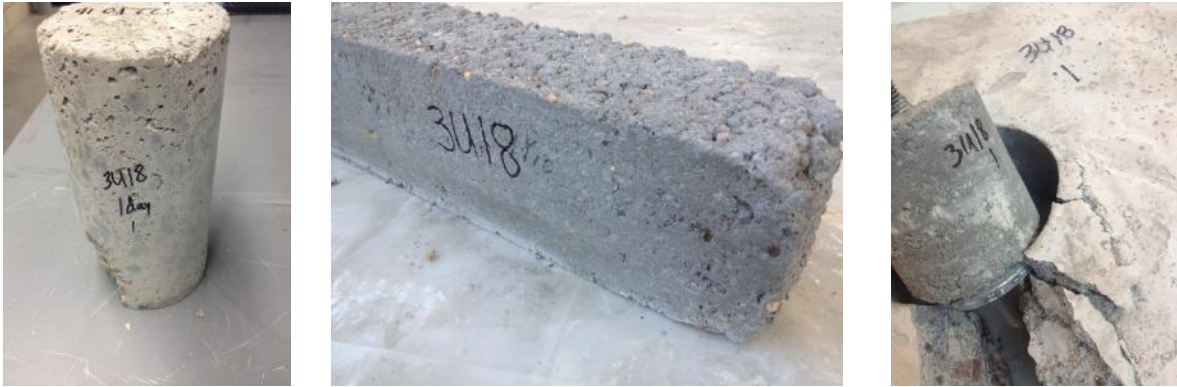
Figure 35: 3U18 compression, freeze thaw and pull out specimens

This mix fails to meet the compressive strength and slump requirement set forth by the ASTM C928. The flexural strength was the lowest of the products that could be measured. Freeze thaw durability ranked the third lowest among all products.

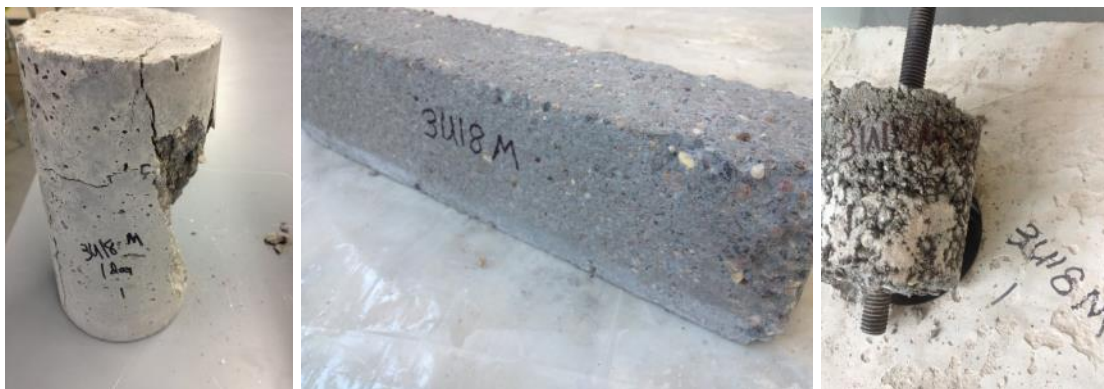
Figure 36: 3U18M compressive, freeze-thaw and pull out specimens

There are similar failures of the ASTM C928 spec, compressive strength and slump. The formed beam specimen for flexural strength was unable to support its own weight at four hours.

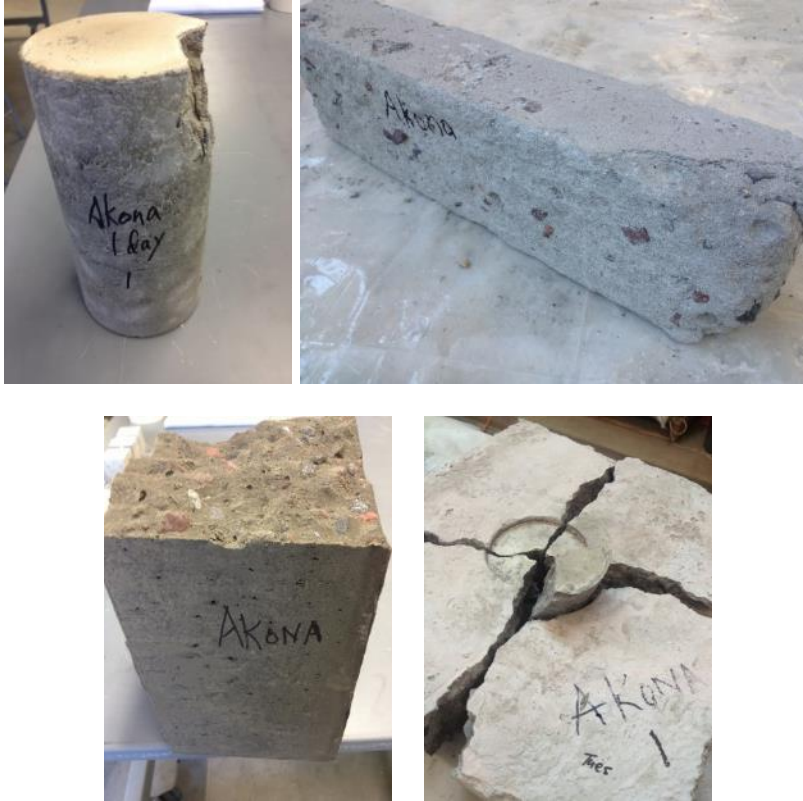
Figure 37: Akona compressive, freeze-thaw, flexural and pull out specimens

Compressive strength at three hours was negligible as the molded cylinders could not carry load. The flexural test did yield results; however, the interior of the beam specimen was still moist. The freeze thaw durability was the lowest among all products.

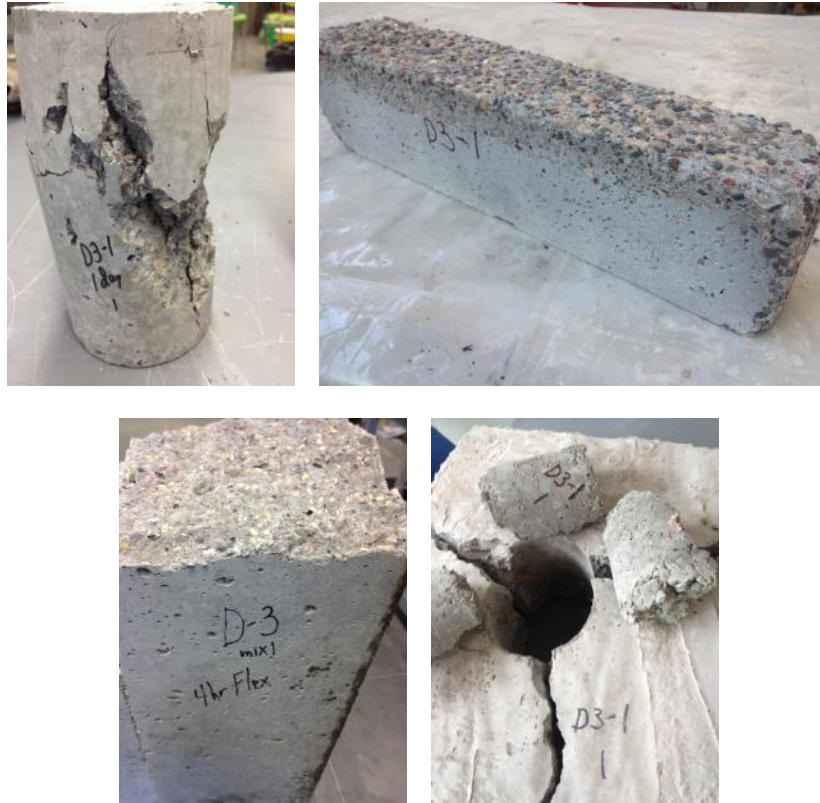
Figure 38: District 3 Mix 1 compressive, freeze-thaw, flexural and pull out specimens

The mix did not achieve ASTM C928 specified strength requirements. When broken during the flexural test there was sufficient internal bond developed to break individual aggregate pieces even though the interior was still moist.

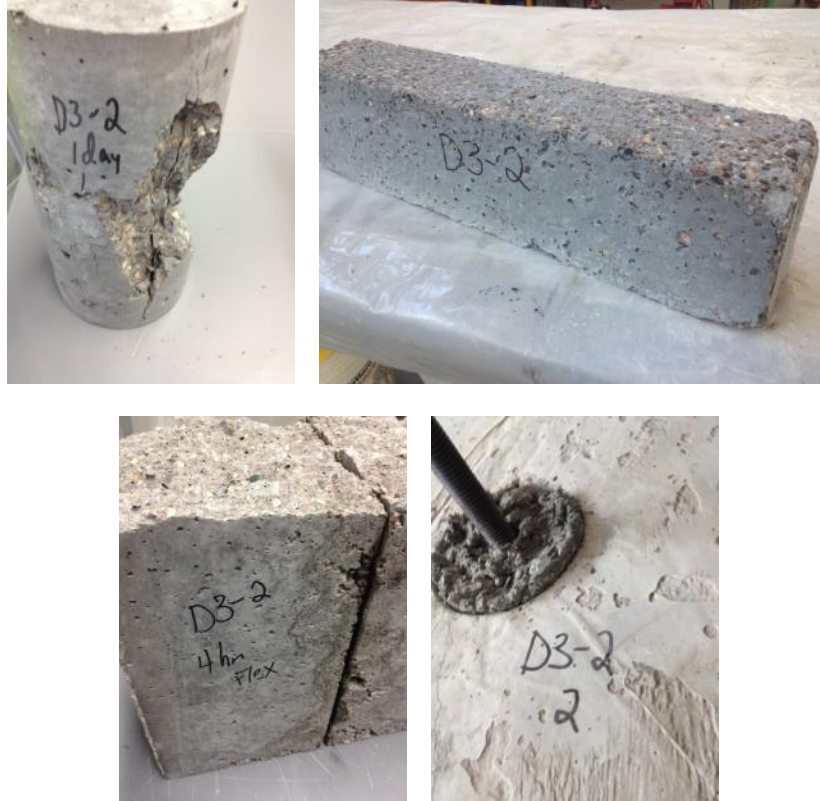
Figure 39: District 3 Mix 2 compressive, freeze-thaw, flexural and pull out specimens

Once again the compressive strength was insufficient at three hours. This mix did achieve the highest overall compressive strength at twenty eight days, over 11,000 psi. At four hours the flexural strength test proved that the internal bond was present and aggregate was broken. The interior as well as the exterior was moist at the time of the flexural test.

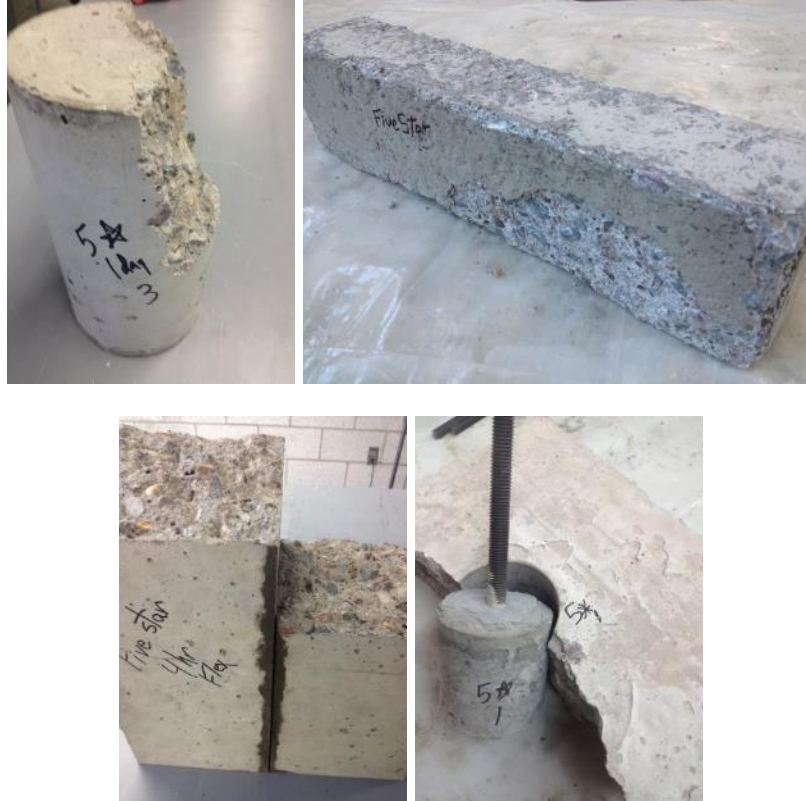
Figure 40: Five Star compressive, freeze-thaw, flexural and pull out specimens

Strength gain at three hours was the highest among all products. Five Star also possessed the highest modulus of rupture at four hours. When broken for the flexural test the interior was completely dry and set. The resistance to freeze thaw was the second lowest of the group.

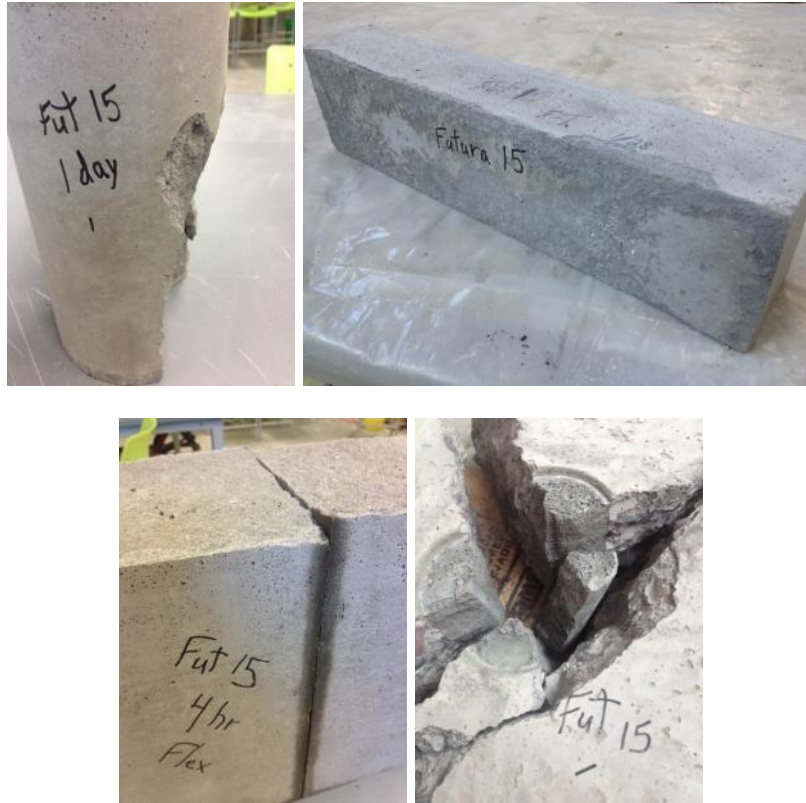
Figure 41: Futura-15 compressive, freeze-thaw, flexural and pull out specimens

Three hour compressive strength was among the top performers of the group. Even though it had achieved over 3,000 psi at three hours the interior of the cylinder molds was moist. It also displayed great compressive gains at 28 days. The modulus of rupture was the highest of the group and contained broken aggregate with a dry interior. Freeze thaw durability factor was below twenty.

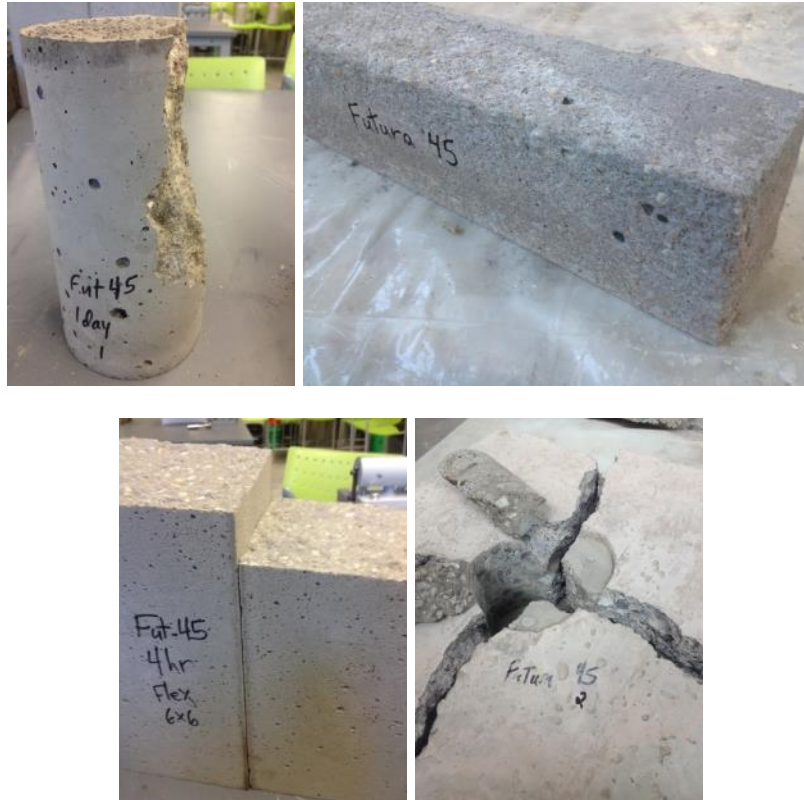
Figure 42: Futura-45 compressive, freeze-thaw, flexural and pull out specimens

Compressive strength gain was virtually identical to the Futura-15. The modulus of rupture was among the top performers. What set this apart was a large durability factor associated with freeze thaw resistance.

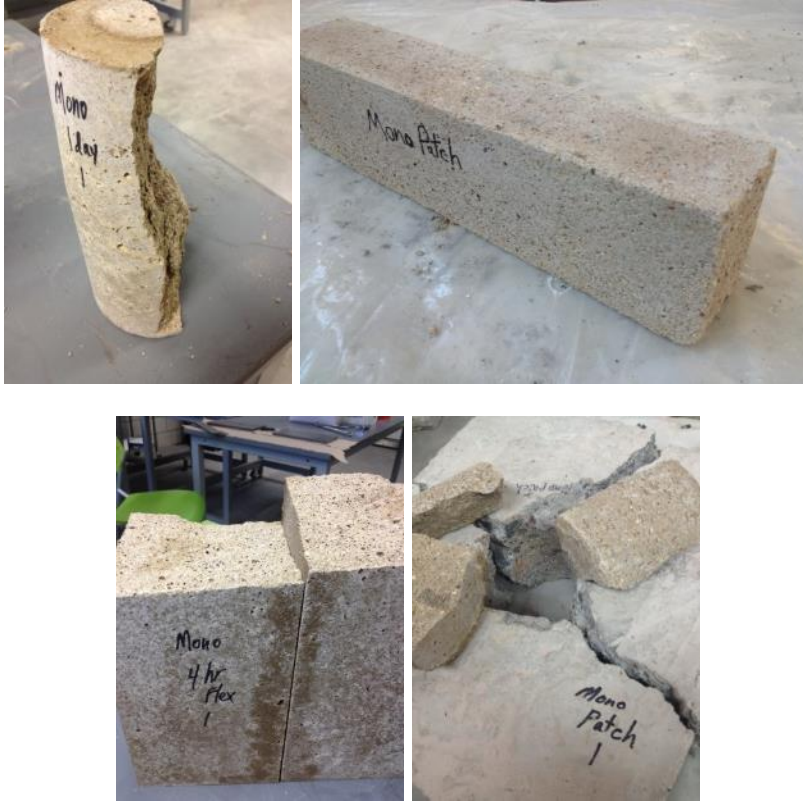
Figure 43: Mono Patch compressive, freeze-thaw, flexural and pull out specimens

Compressive strength at three hours was below the ASTM C928 specification. Modulus of rupture was on the higher end of the overall group. When the flexural test was complete the interior of the beam was dry and set but the product contained several spherical voids ranging from 1/16 to 1/8 inches in diameter. This may have contributed to the higher freeze thaw durability. However this product exhibited a failure during the length change specification. It showed high amounts of expansion in water as well as slight expansion in air.

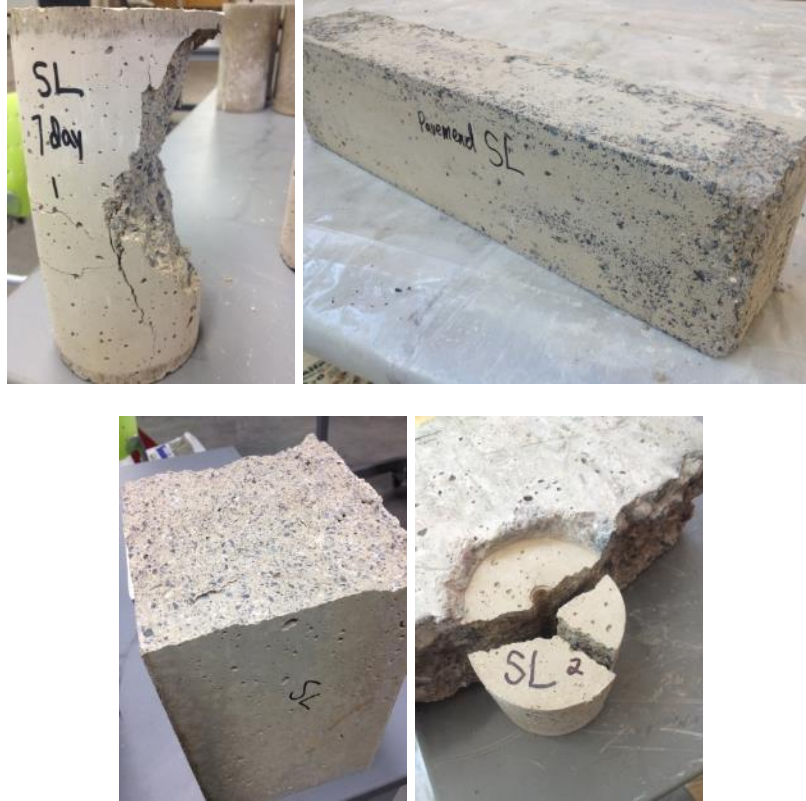
Figure 44: Pavemend SL compressive, freeze-thaw, flexural and pull out specimens

The compressive strength at 3 hours was above the 3,000 psi mark. There was a great increase in the compressive strength at 28 days, it attained over 9,000 psi. This mix had the third highest modulus of rupture and was dry and set on the interior of the flexural beam. Freeze thaw durability was on par with most others which were below twenty.

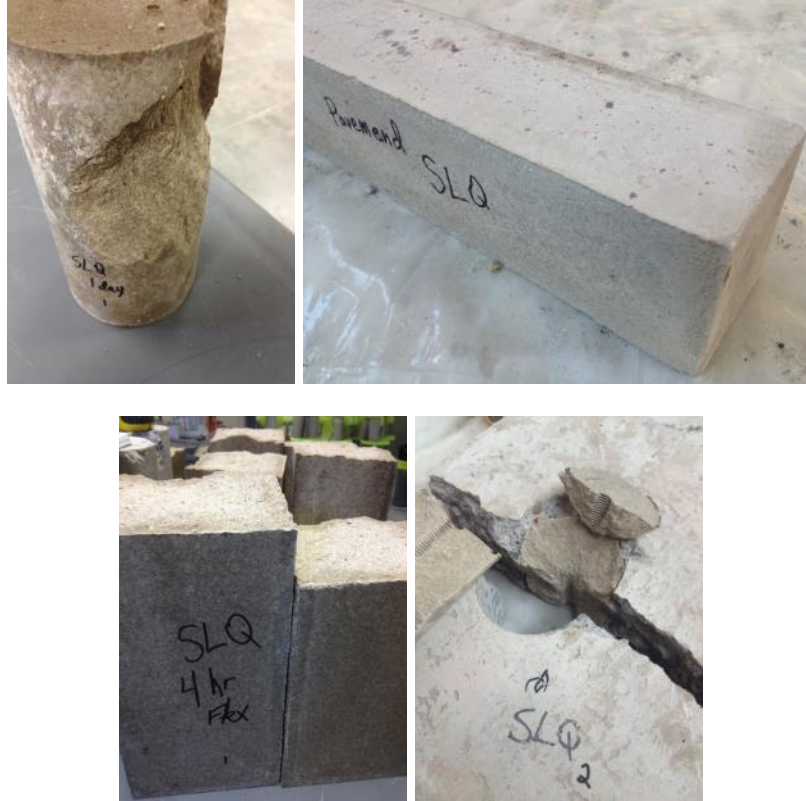
Figure 45: Pavement SLQ compressive, freeze-thaw, flexural and pull out specimens

Three hour compressive strength was below the ASTM C928 specification. It did exceed the 3,000 psi level at one day. This product has high freeze thaw durability with a durability factor above 100. The flexural strength was in the middle of the range for the group, when the beam was broken the interior was found to be dry and set. Like the Mono Patch, which was also magnesium phosphate based, this product expanded while curing in air as well as in water.

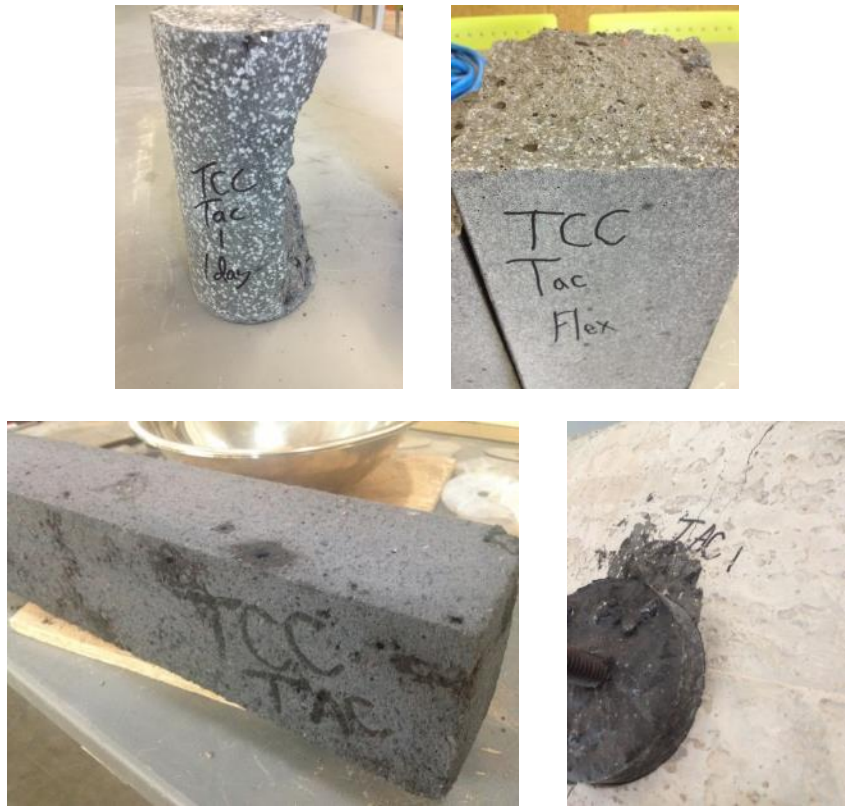
Figure 48: TCC taconite mix compressive, freeze-thaw, flexural and pull out specimens

Compressive strength at three hours was below the ASTM C928 specification. The 7 day strength was just above the MnDOT required minimum of 3,000 psi. Modulus of rupture was comparable to most of the other products. The interior of the flexural test beam contained several clay balls which were comprised of the taconite tailings aggregate. These clay balls ranged from 1/8 to 1/4 of an inch and can be observed in Figure 48. The TCC Taconite Mix had the highest freeze thaw durability.

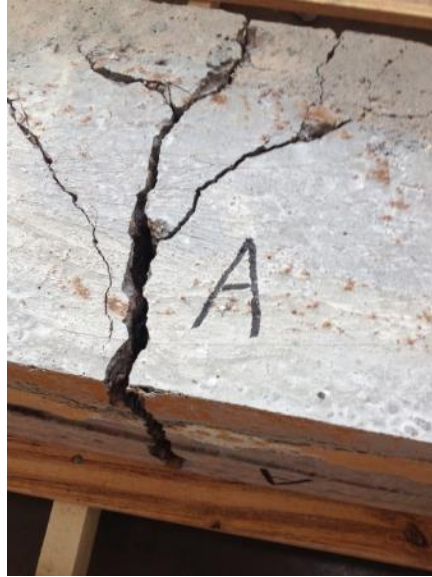
Figure 64: Specimen “A” (D3-2-W) exhibiting central crack propagation.

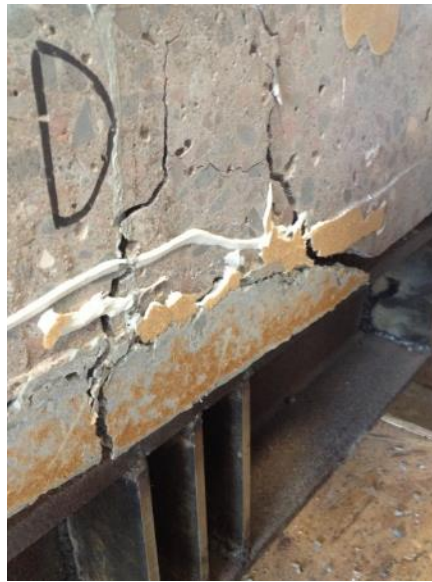
Figure 65: Specimen “D” (D3-2-G) started cracking at the edge of the patch, the bond held and the slab failed in two locations.

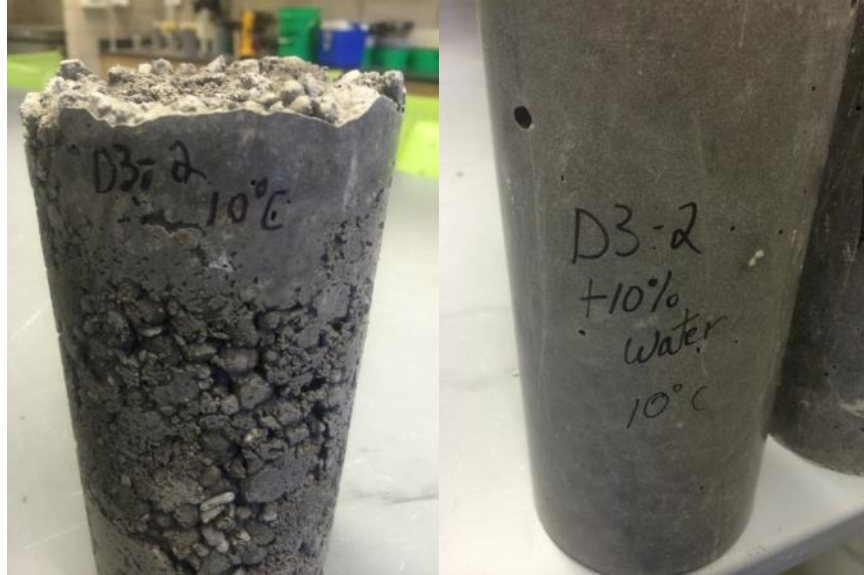
Figure 67: D3-2 mixed as per specified and mixed with 10% additional water.

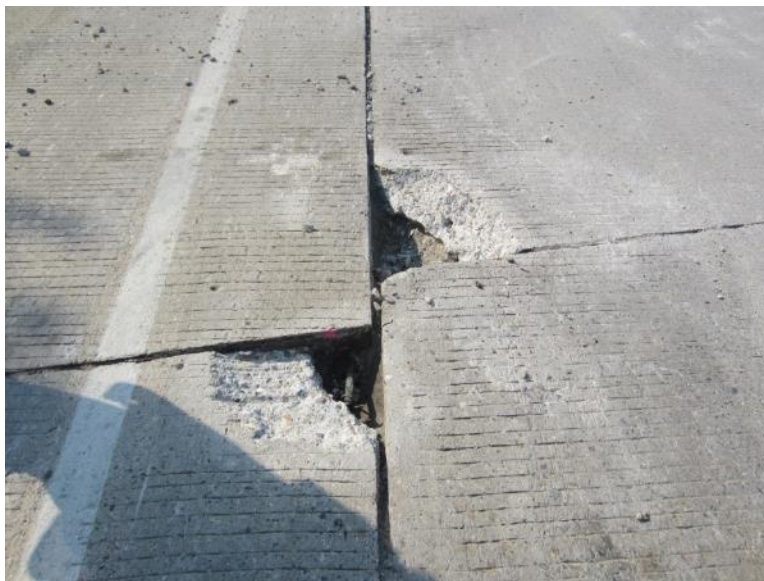
Figure 75: Tapered edges of two opposing corner partial-depth repairs

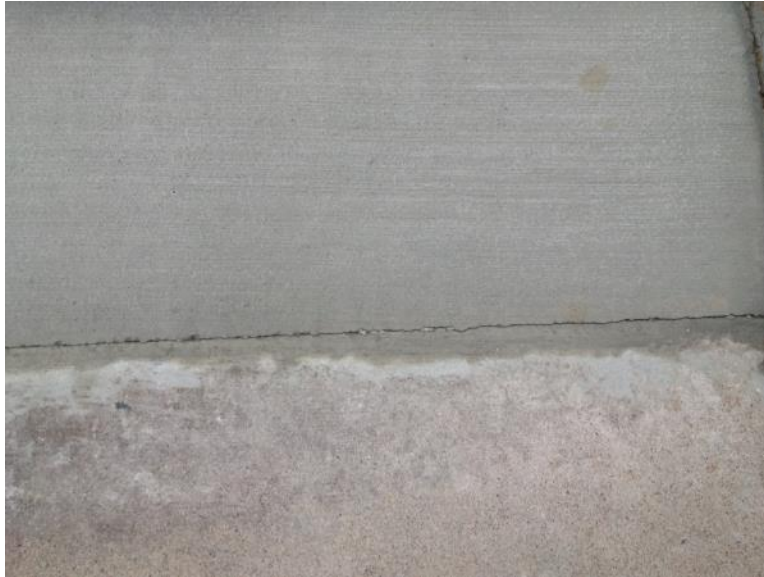
Figure 76: Edge de-bonding due to shrinkage along a saw-cut patch area

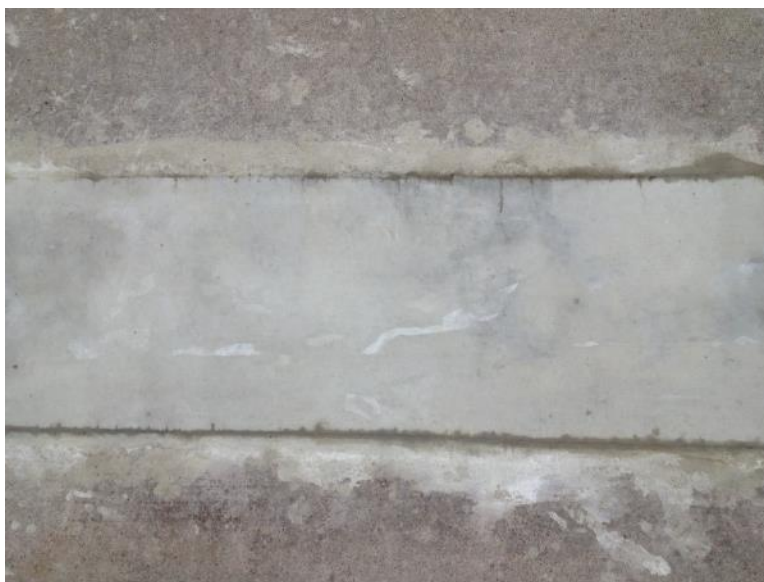
Figure 77: Wetted and covered curing method result

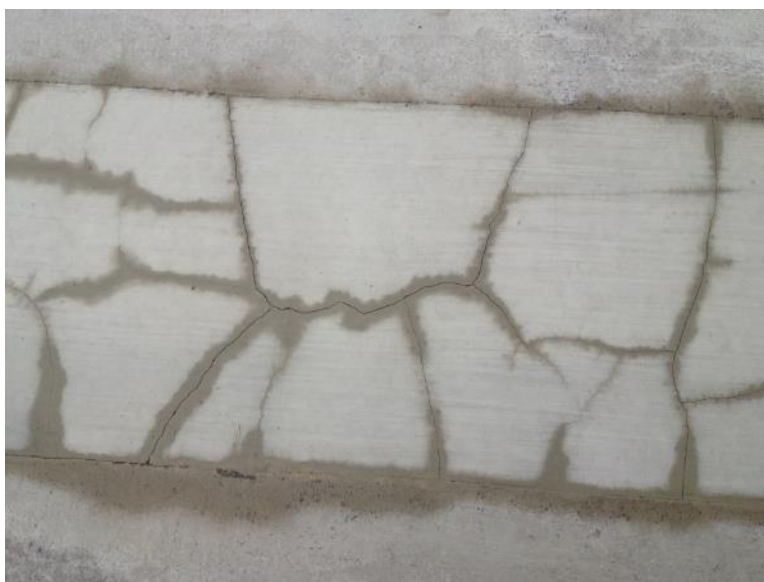
Figure 78: Cracked patch that was placed with no curing

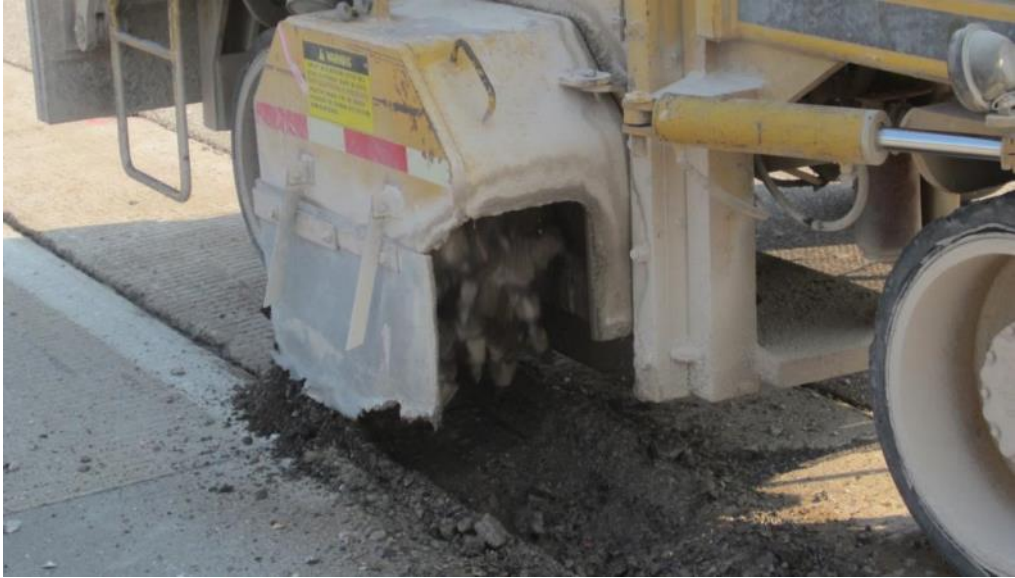
Figure 79: Milling machine grinding a spalled section of concrete

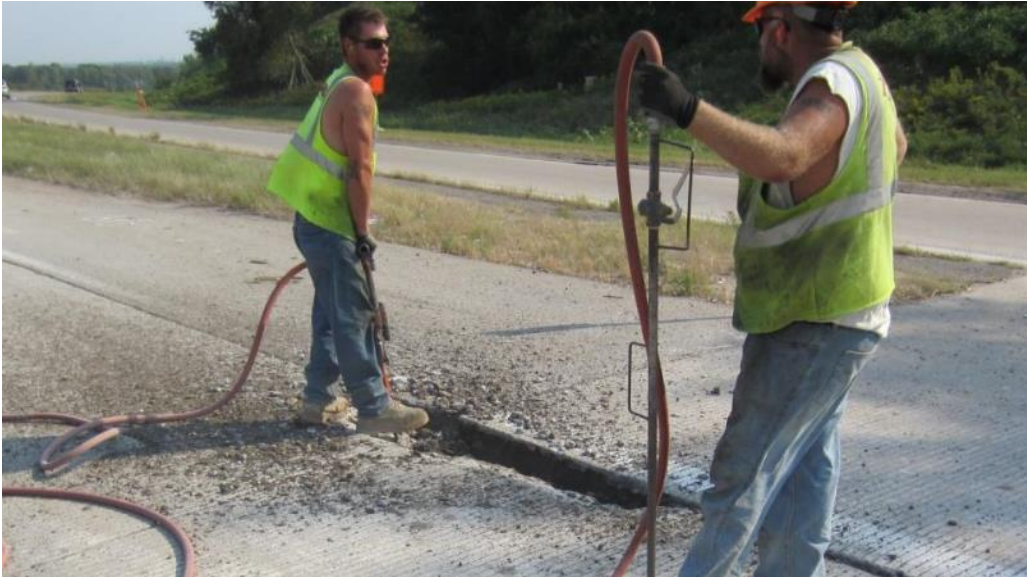
Figure 80: Chipping the edges to meet MnDOT specifications

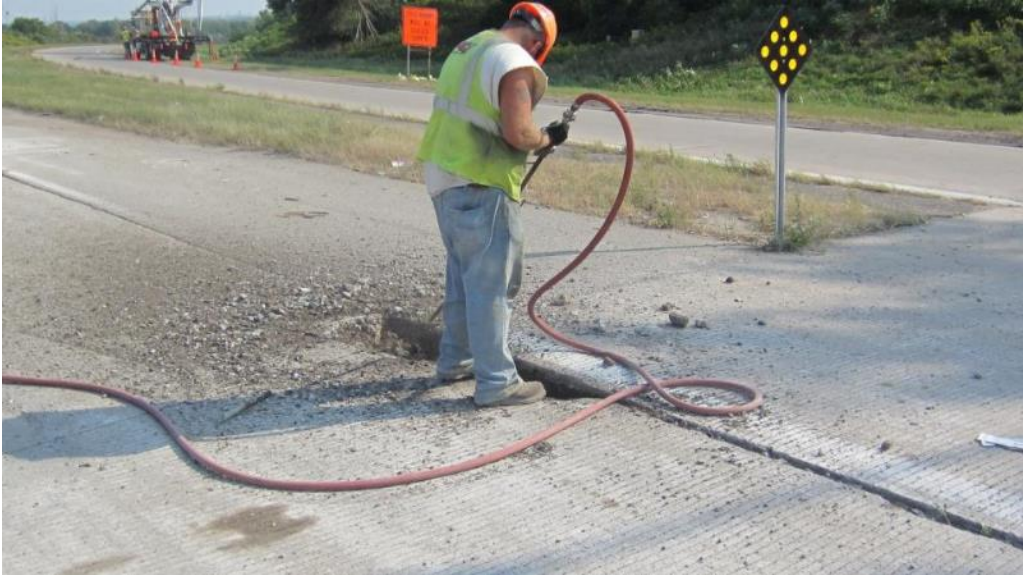
Figure 81: Air blasting the hole to remove excess loose material

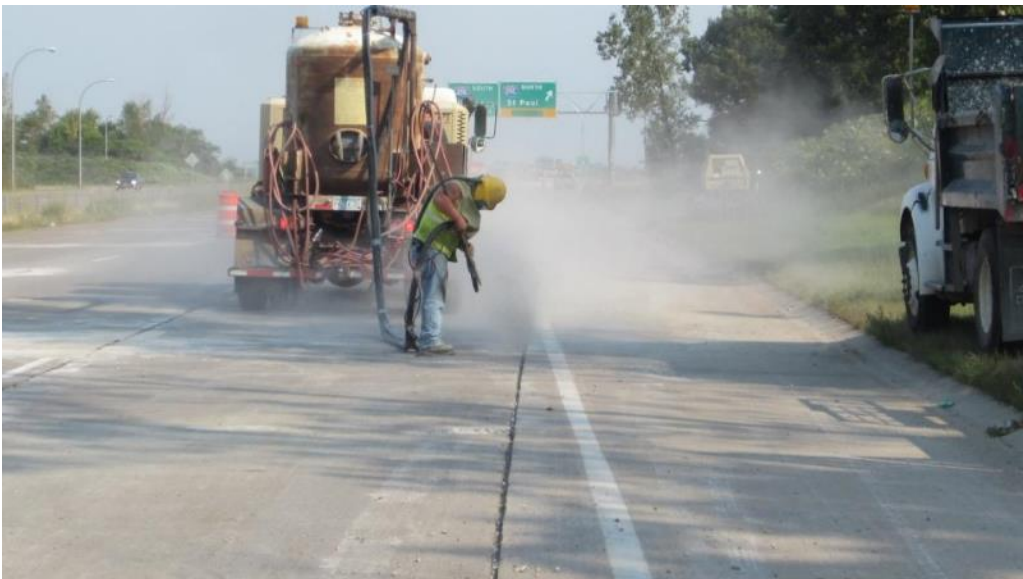
Figure 82: Sandblasting the patch area prior to being filled

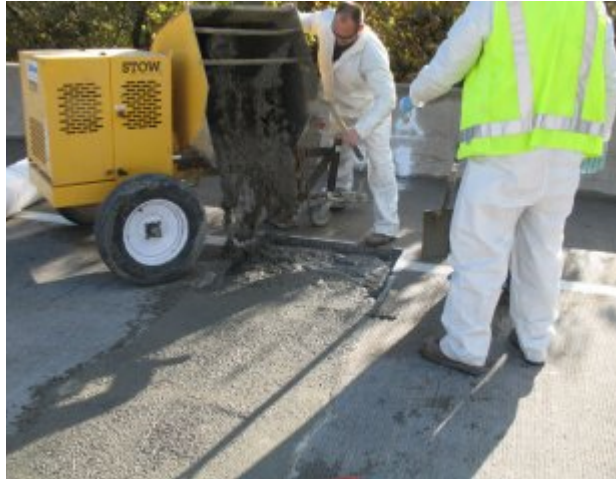
Figure 1-1 Futura-45 bag mix being placed in the field (<http://www.wrmeadows.com/futura-45-horizontal-repair-mortar/>)

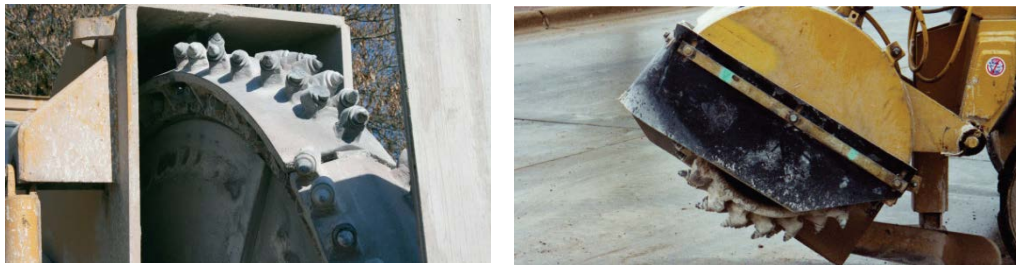
Figure 1-2 Examples of milling machines used to remove deteriorated concrete (Frentress & Harrington, Guide for Partial-Depth Repair of Concrete Pavements, 2012)

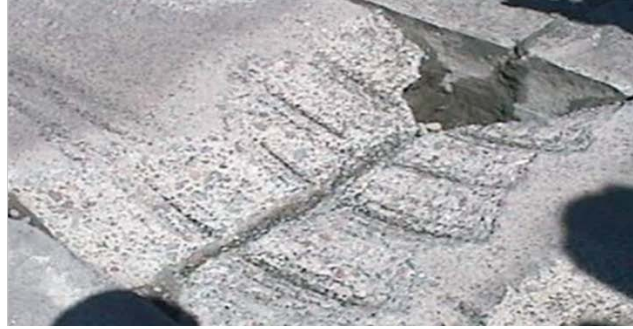
(b) Milled patch area

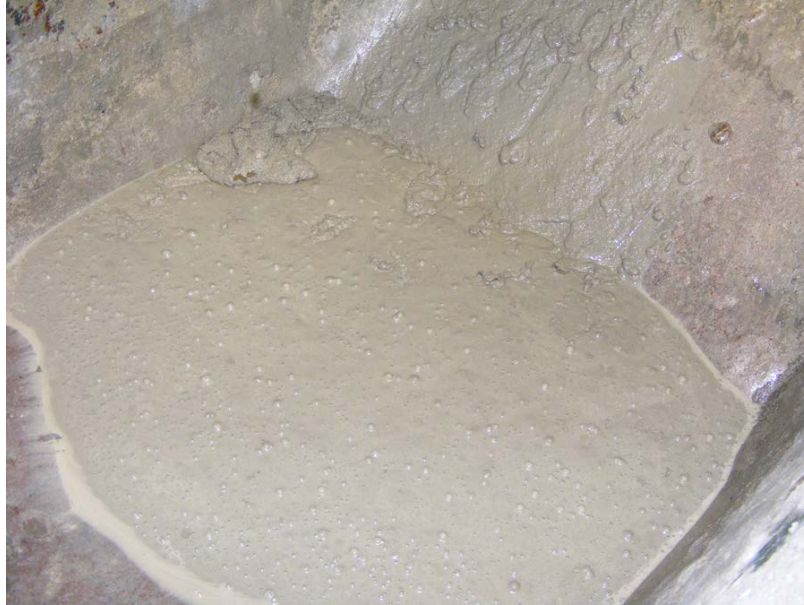
Figure 3-3 Fresh Futura-45 patching material before placement

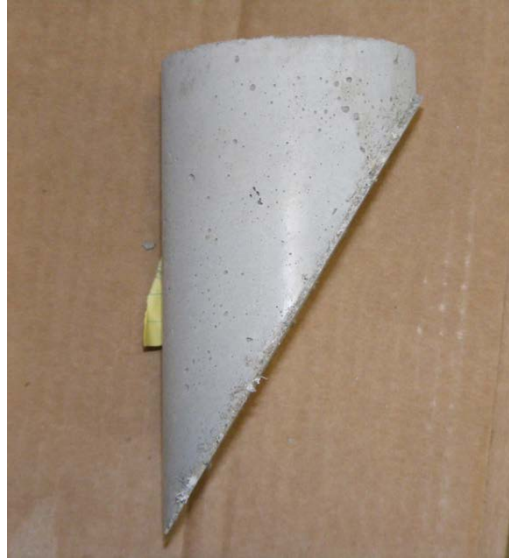
Figure 3-5 Mortar half-cylinder

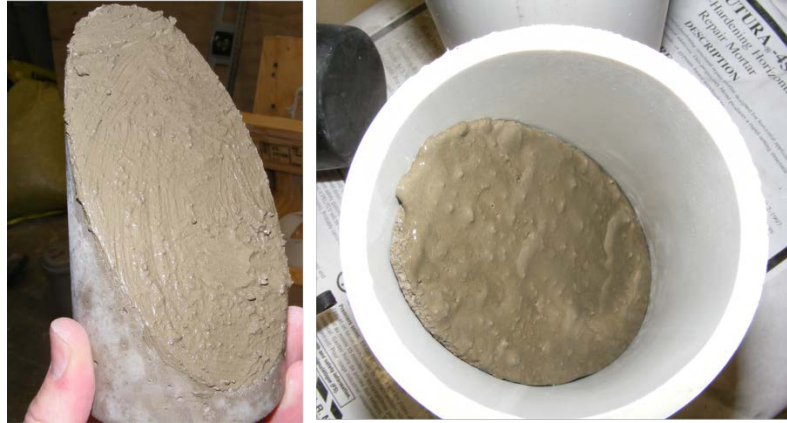
Figure 3-6 Mortar half-cylinder with cement paste applied and placed in PVC mold

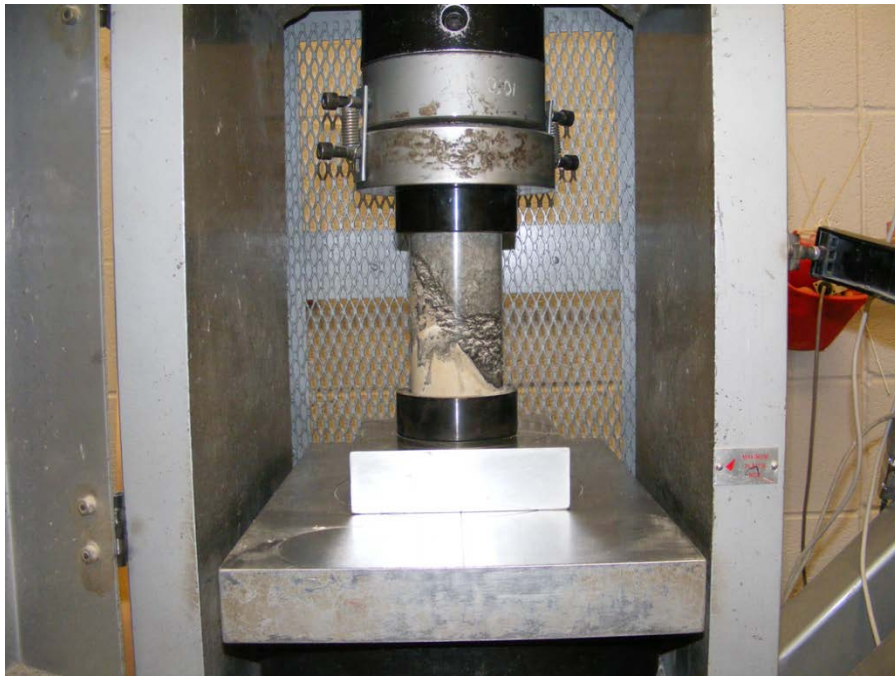
Figure 3-8 Slant shear specimen in Forney compression testing machine

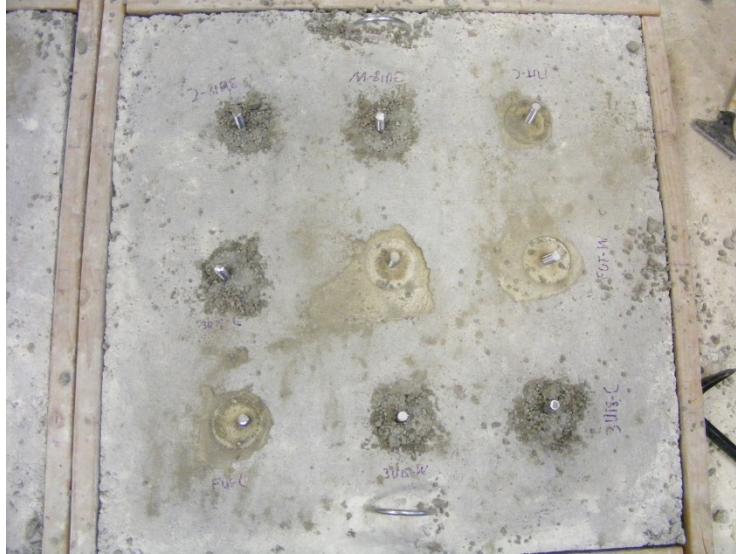
Figure 3-9 Pullout slab filled with core pullout specimens

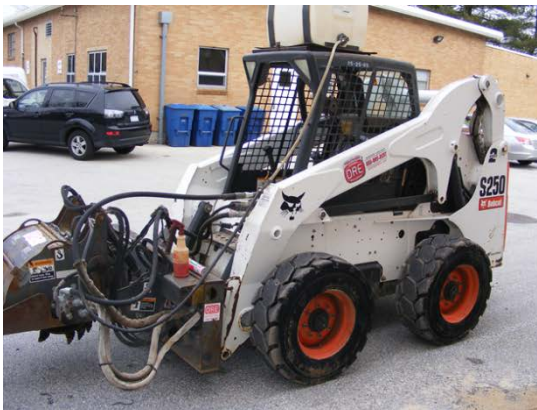
(a) Miller attached to Bobcat loader

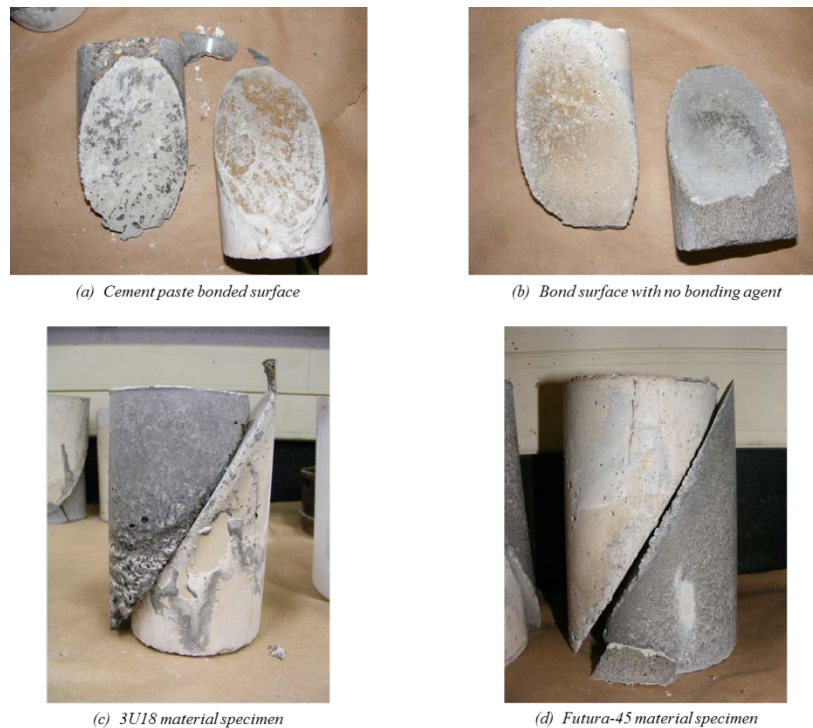
Figure 4-1 Photographs of slant shear specimens after failure

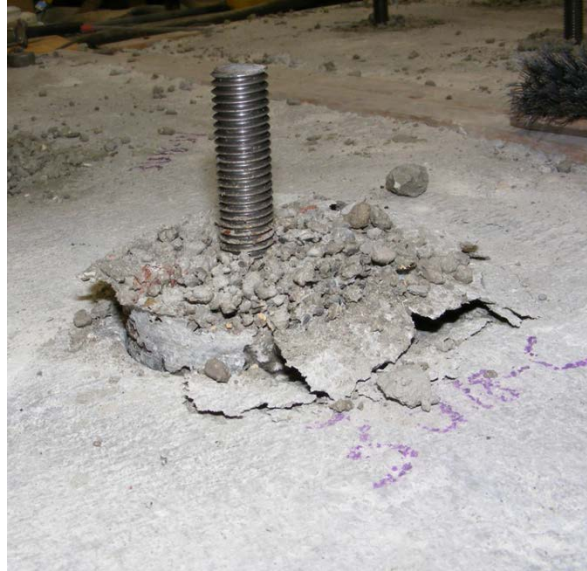
Figure 4-3 Failed core pullout specimen

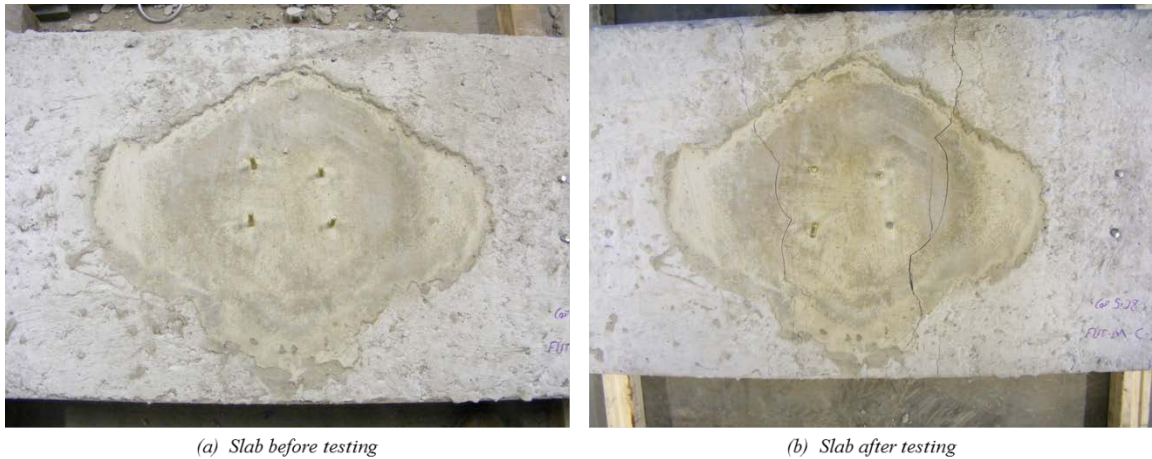
Figure 4-7 Photos of Fut M C 2
