Evaluating the Threat of Environmental Change on Historic Resources: A Case Study and Assessment of Tools

A thesis in Historic Preservation Presented to the Faculties of the University of Pennsylvania in Partial Fulfillment of the Requirements of the Degree of Master of Science in Historic Preservation 2007.

4.3 Existing Conditions	56
4.3.1 Site Observations and Building Context	56
4.3.2 Description of the Cellar's Existing Conditions	59
4.3.3 Regional Characteristics	63

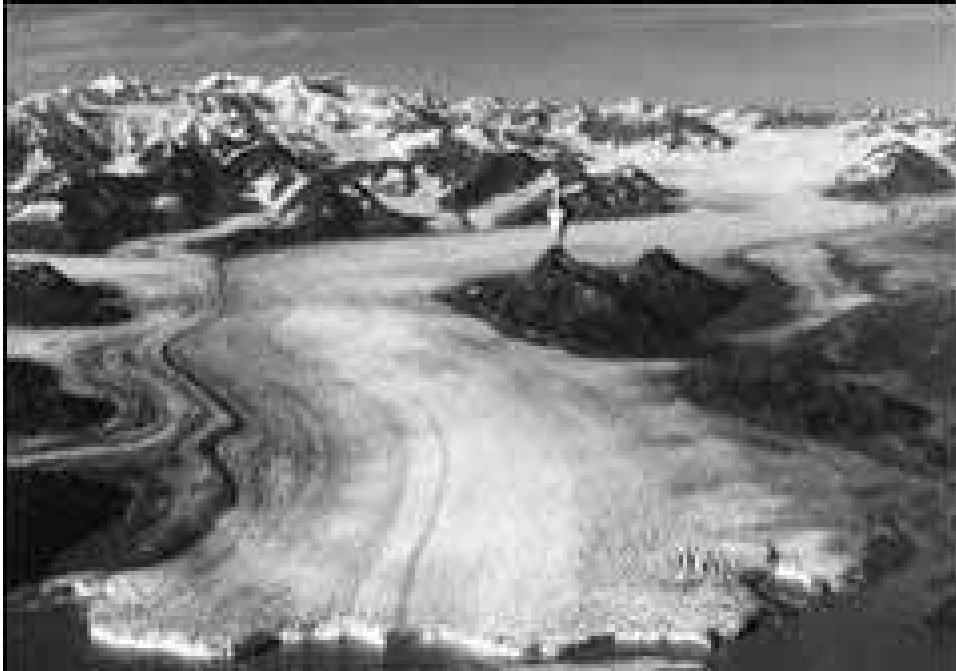
Figure 3. Photograph taken of the Columbia Glacier in 1980. Note the arrow that marks the same location found in the following photograph. (Source: National Aeronautics and Space Administration website: www.nasa.gov)

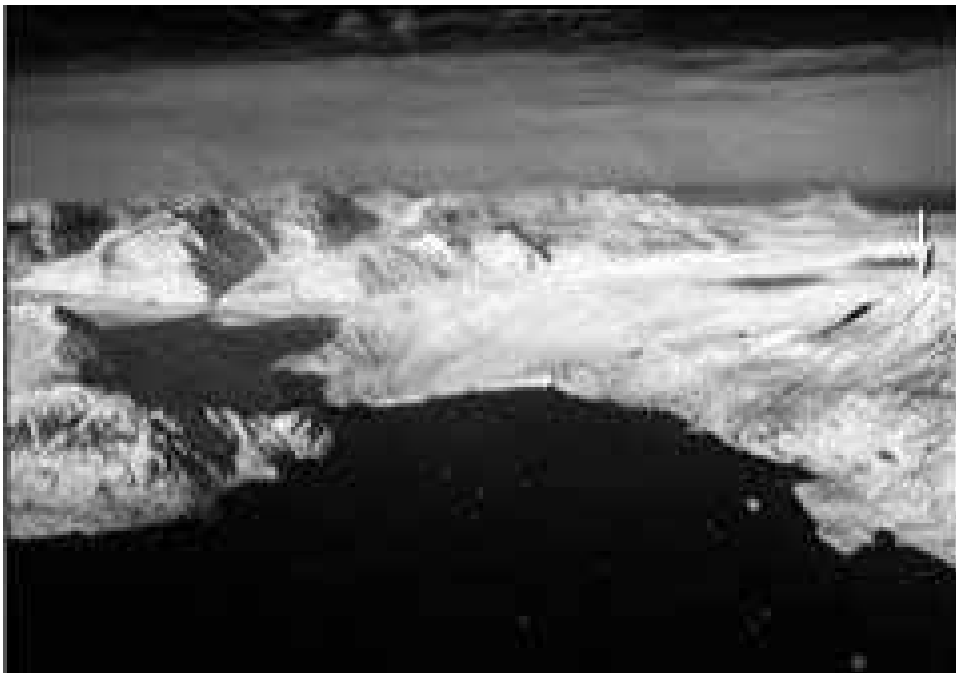
Figure 4. Photograph taken of the Columbia Glacier in 2005. Note the arrow that marks the same location found in the previous photograph. (Source: National Aeronautics and Space Administration website: www.nasa.gov)

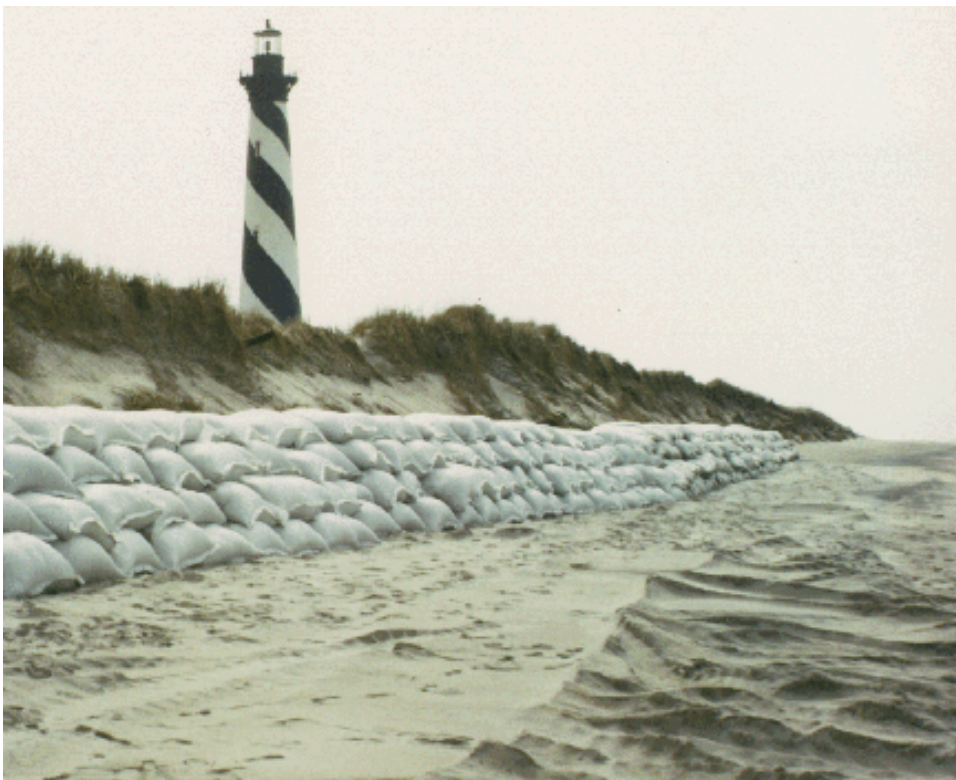
Figure 6. Photograph of the Cape Hatteras Lighthouse and the nearby beach. The sandbags are there to prevent further beach erosion. (Source: United States Geological Survey: pubs.usgs.gov/circ/c1075/images/lighthouse.gif)

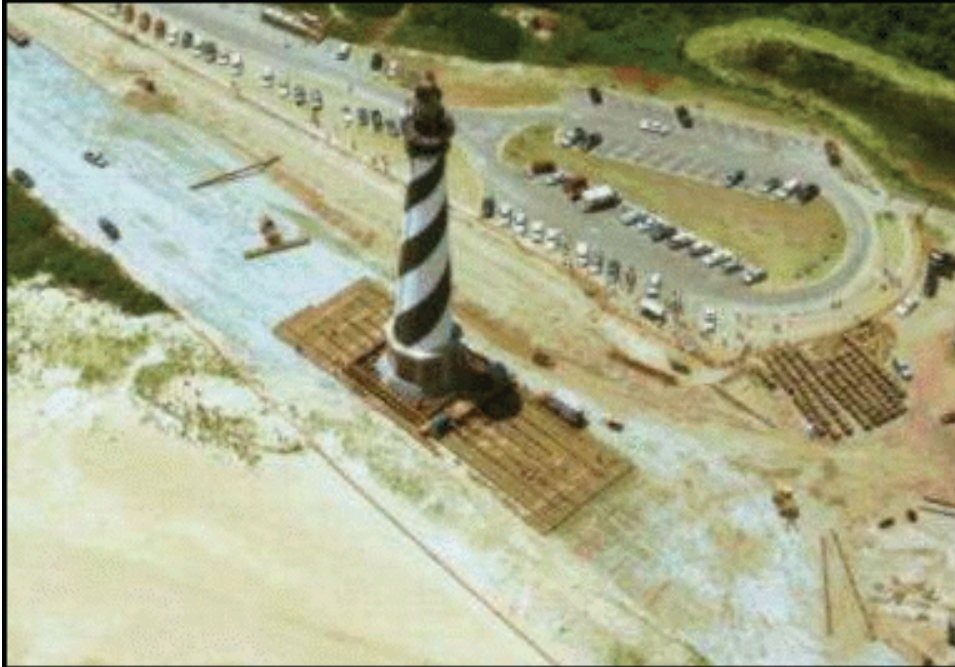
Figure 7. Photograph of the Cape Hatteras Lighthouse and the moving apparatus. (Source: National Park Service Photo: <http://www.nps.gov/archive/caha/views.htm>)

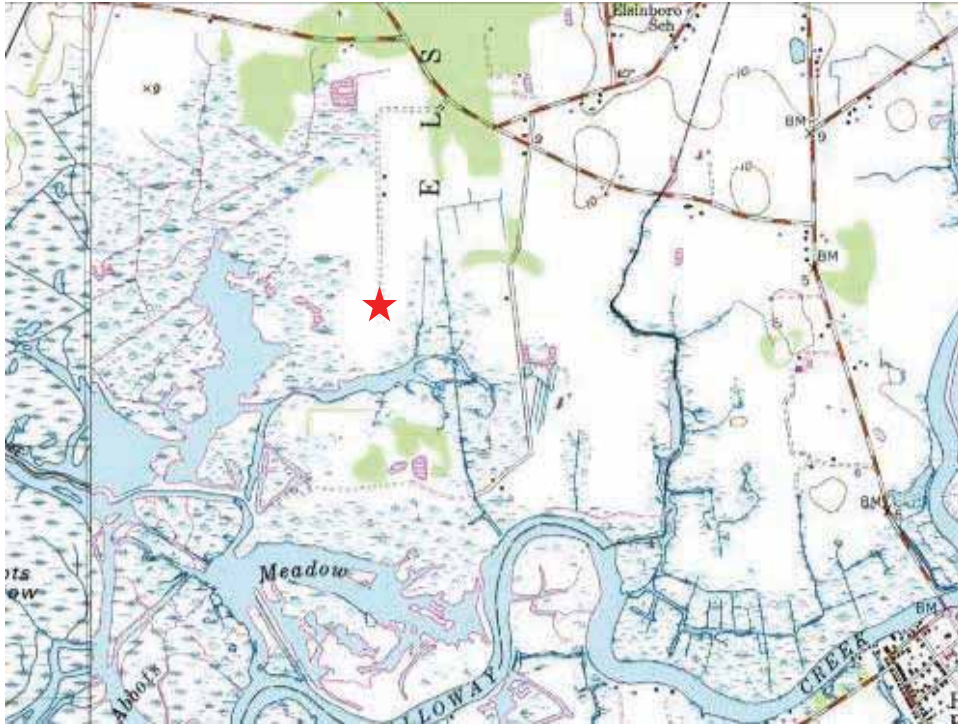
Figure 14. Area topographic map showing the location of the Abel and Mary Nicholson House (red star.) (Source: USGS quad map from www.maptech.com)

depth to the saturated zone, as indicated by the highlighted red area in the map from the National Soil Survey in (Figure 64).²⁰⁸ The USGS quad map was obtained using maptech.com (Figure 14). As shown in the close up view of the quad map (Figure 15), the entire site is relatively flat and lies less than 10 feet above sea level. The Nicholson house site is represented by the two dots located at the end of the dashed line, which represents the access path. The major county roads are represented in red and white, while other alternative access-ways are outlined in solid lines most likely indicating a more developed road that provides access to more than just a single residence. The USGS quad map also shows the neighboring marshland and vegetation in the area and where the water bodies and courses lie in relation to the site. Based on the quad map, it appears that the marshland and water bodies lie very close to the house, which is especially disconcerting given its relatively flat terrain.

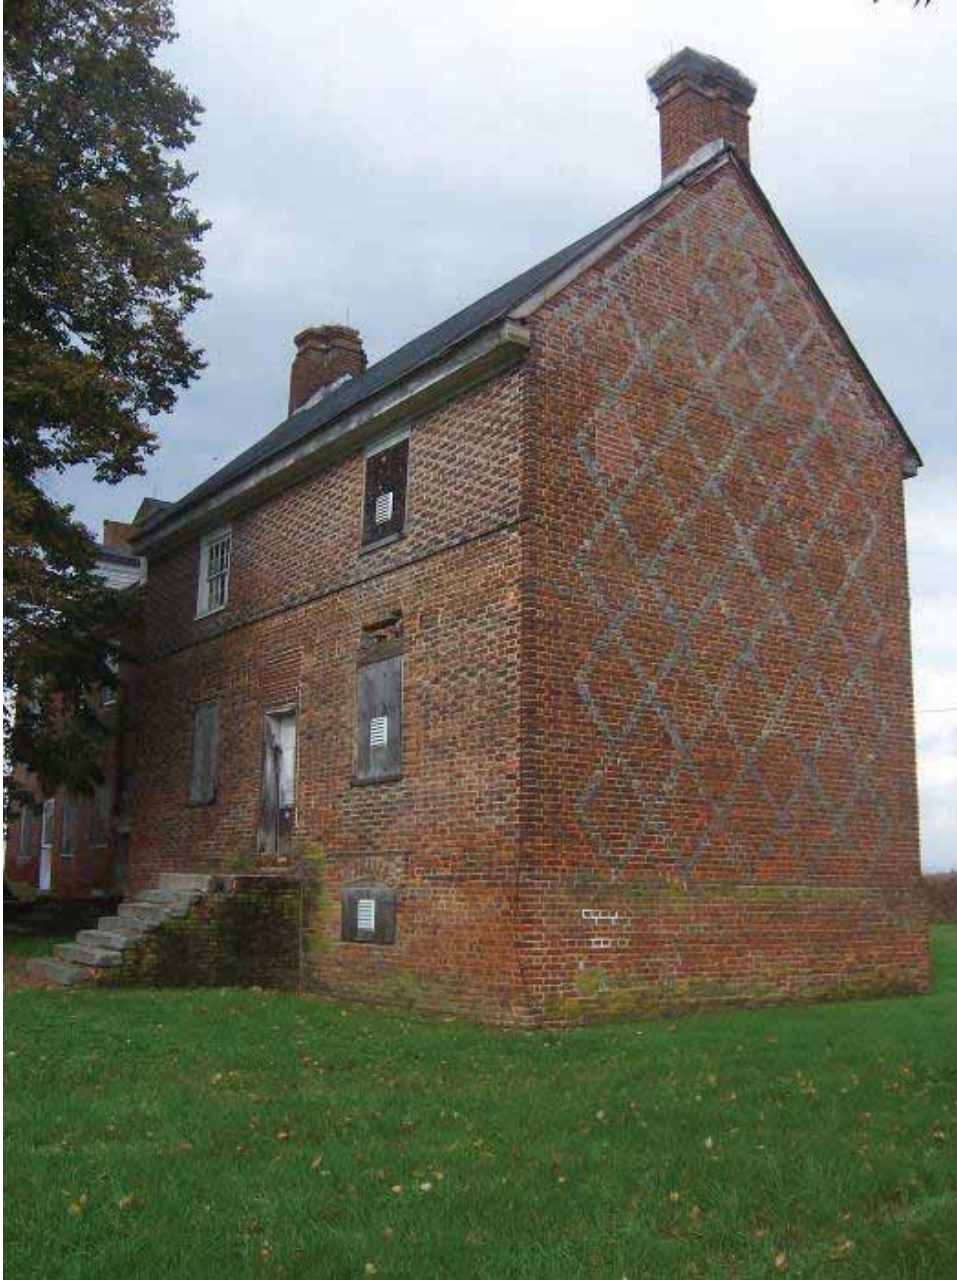
Figure 20. Photograph of the notable diapered-pattern brick end on the east façade of the Abel and Mary Nicholson house. (Source: A. Aiken; taken 10/12/2006.)

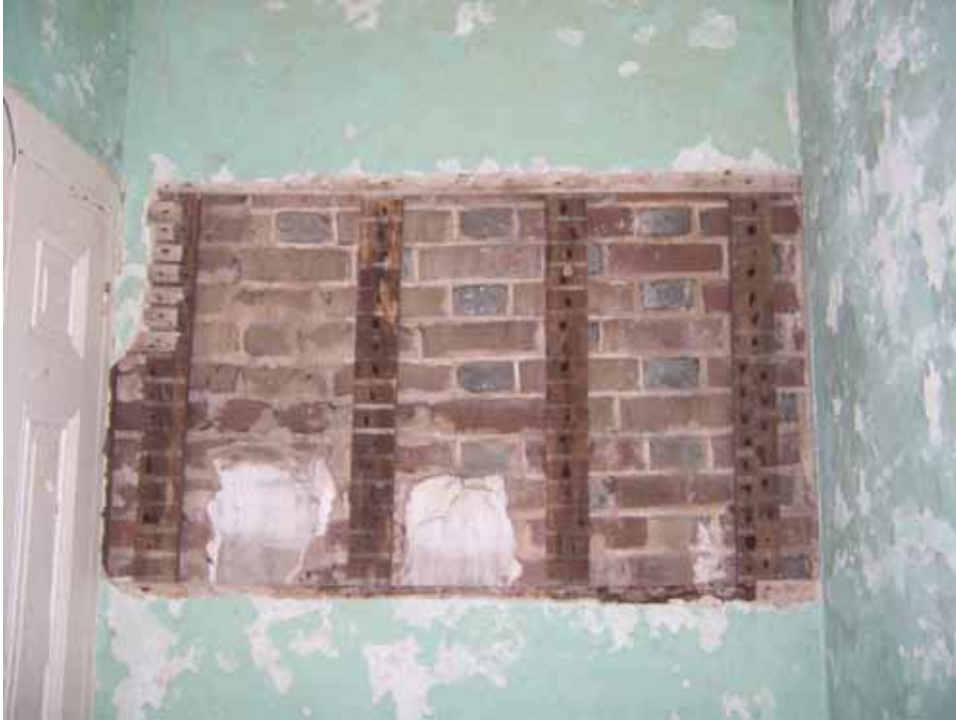
Figure 23. Photographic evidence of earlier attached kitchen addition on the west façade of the original building. (Source: A. Aiken; taken 10/12/2006.)

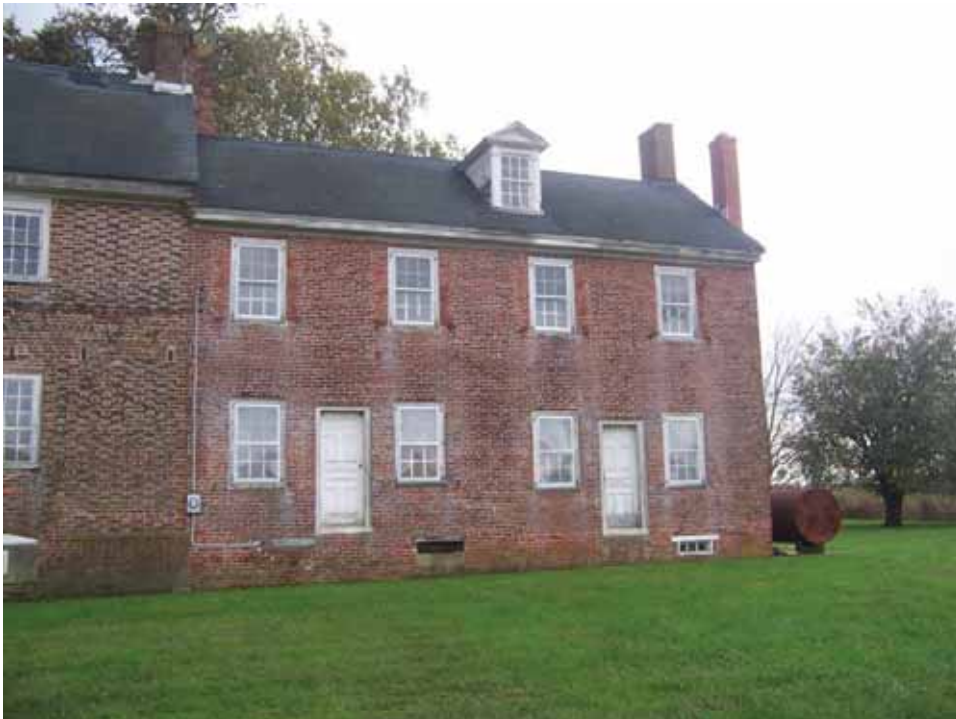
Figure 24. Photograph of the north façade of the 1859 addition block of the Abel and Mary Nicholson house. (Source: A. Aiken; taken 10/12/2006.)

There is no drainage system for surface water, or any means of deflecting precipitation away from the building, on the roof, on the ground, or on the building itself. The rain falls from the roof directly to the ground and as a result the building exhibits drip lines along the north and south elevations (Figure 24) and (Figure 26), respectively. The entire site gradually slopes to the southwest as indicated by the topographic maps and survey performed by Gleissner Associates P.C. in 1998. Since the site has a slight slope and is relatively flat, it most likely does not effectively drain surface water away from the house.¹³⁶ Moreover, in the Nicholson house's preservation plan, Watson & Henry Associates qualified the site as in poor condition with respect to surface water drainage. The lack of drainage for rain and surface water may explain why the basement is so prone to flooding after a rainstorm.

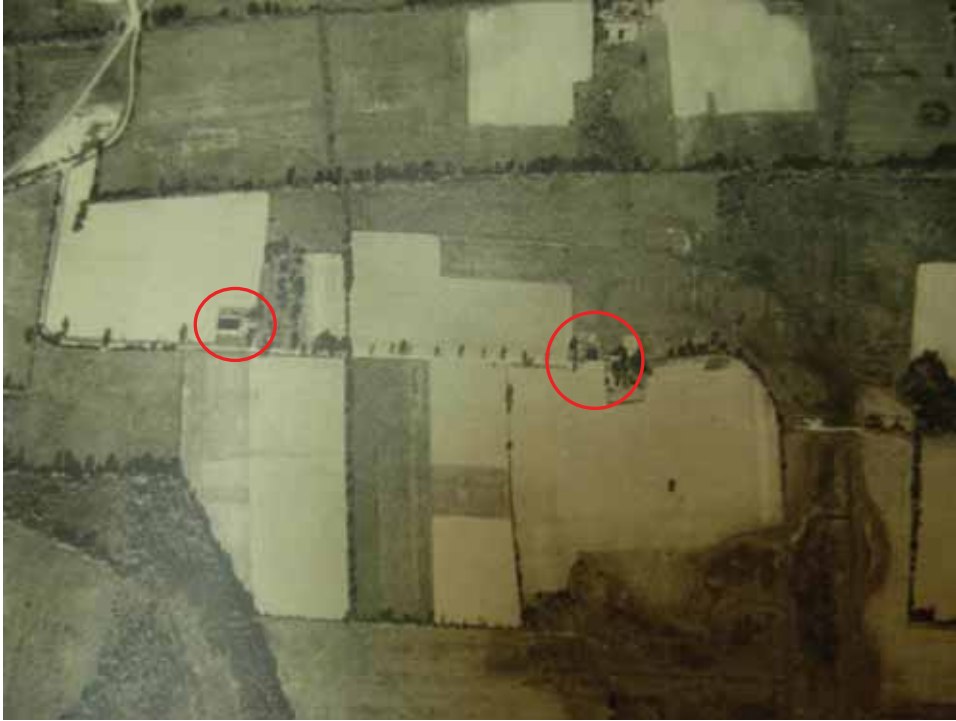
Figure 28. Photograph of 1932 aerial photograph of the site showing the other farm buildings, which no longer exist, located near the Nicholson house. The larger circle contains the Nicholson house while the smaller circle contains farm buildings along its access path (Source: New Jersey Department of Environmental Protection; taken 3/14/2007.)

The Abel and Mary Nicholson house was not always the only structure on the site. There were three other farms buildings built near the house and more along the access path, as shown in earlier aerial photographs (Figure 28). All of the other buildings on site have since burnt down.¹³⁰ Some of the building's foundations can still be seen today according to Ronald Magill, president of the Salem Old House Foundation, the owner of the site. If the farm building held any livestock for an extended period of time, there may be possible contamination of the soil in the area surrounding the house. Contamination of the soil in the immediate vicinity of the house is also possible if there is any leakage of the existing above-ground oil storage tank on the west façade (Figure 29). The oil storage tank rests on a concrete pad that is experiencing major cracking (Figure 30). There could also potentially be unknown stores of oil underground within the area of the site. The oil storage tank supplied oil to be used as fuel to heat the house but may also lead to oil and hydrocarbon contamination of the soil nearby. In either case, soil contamination could result by heating oil leaching into and tainting the groundwater.

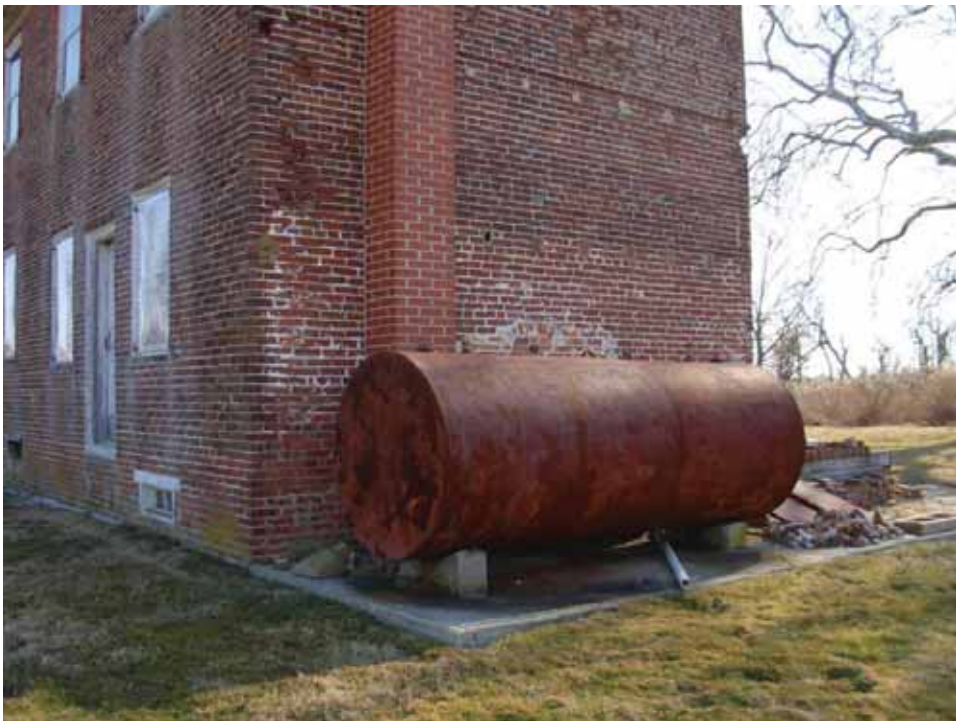
Figure 29. Photograph of the oil storage tank on the west façade of the Nicholson house. (Source: A. Aiken; taken 2/23/2007.)

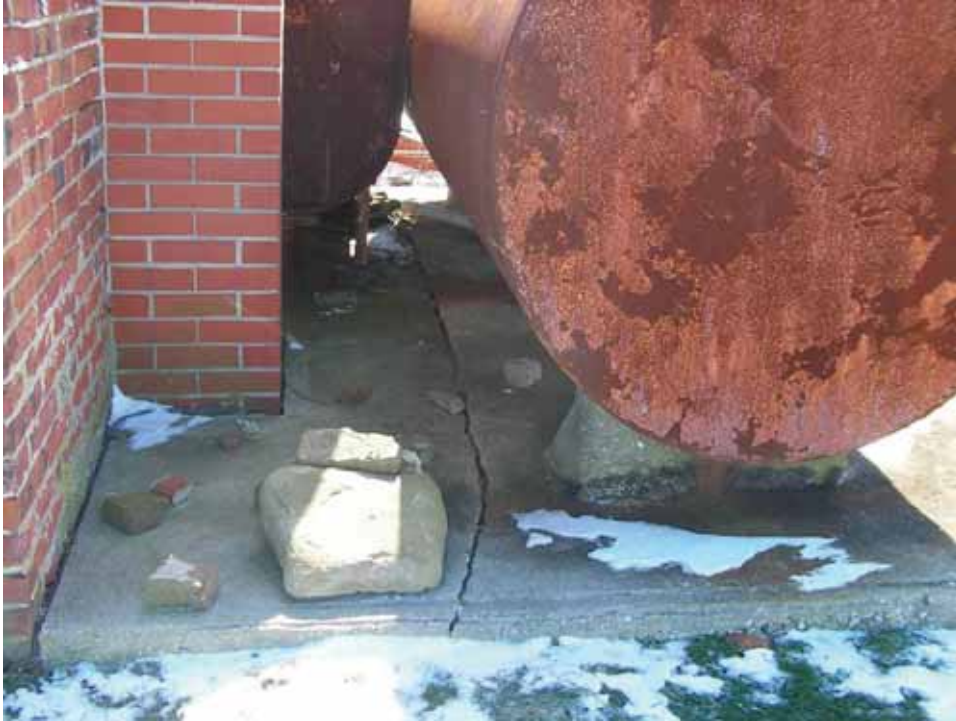
Figure 30. Photograph of the major crack in the concrete pad supporting the oil storage tank on the west façade of the Nicholson house. (Source: A. Aiken; taken 2/7/2007.)

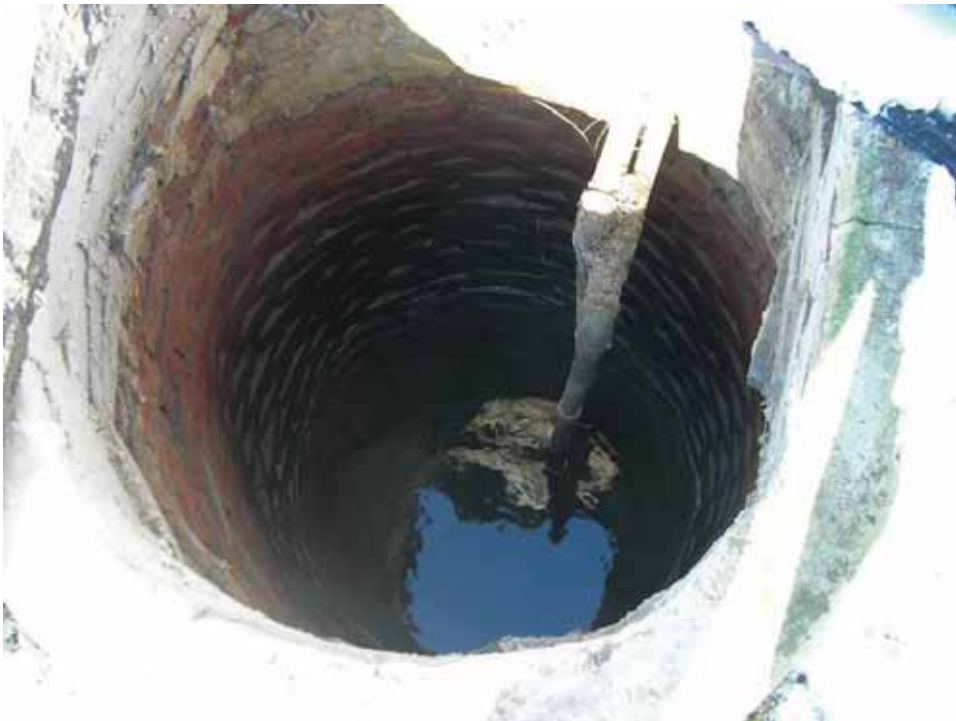
Figure 31. Photograph of the existing drinking well and pump located a few feet from the south façade of the Nicholson house. (Source: A. Aiken; taken 2/7/2007.)

There is an existing drinking well on the site that was hand dug, 30 - inches in diameter, and has a built-in pump that enters the house through the cellar's south wall (Figure 31). The water is pumped into a 12-gallon storage pressure tank in the cellar (Figure 32), where water is drawn in from in the plumbing and to the various normal fixtures

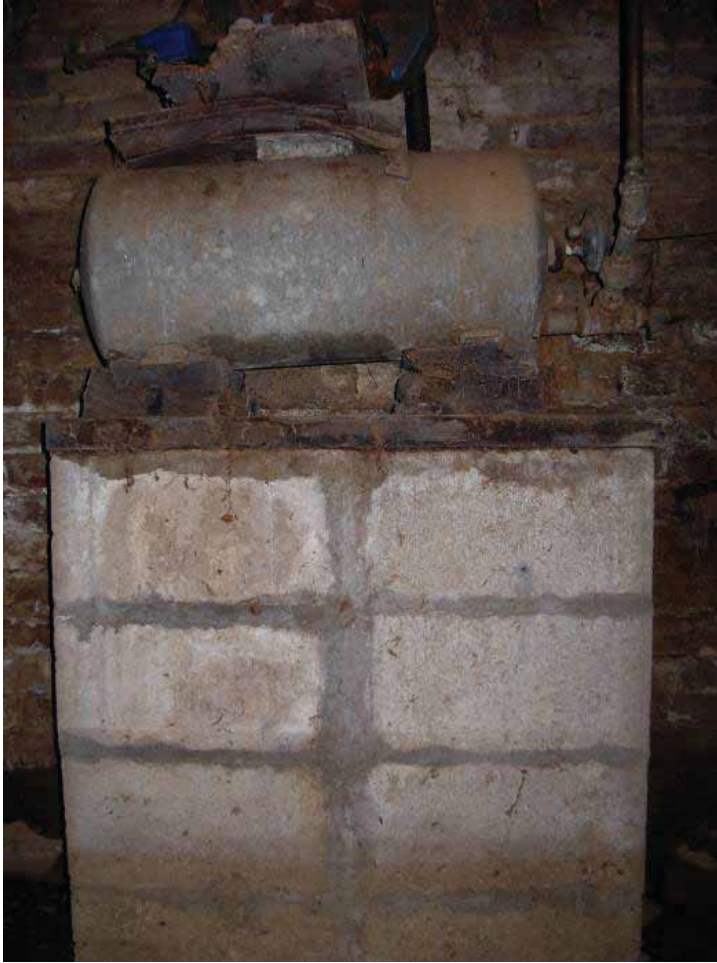
Figure 32. Photograph of the 12-gallon storage pressure water tank located on the south wall of the west cellar room in the 1859 block of the Nicholson house. (Source: A. Aiken; taken 2/23/2007.)

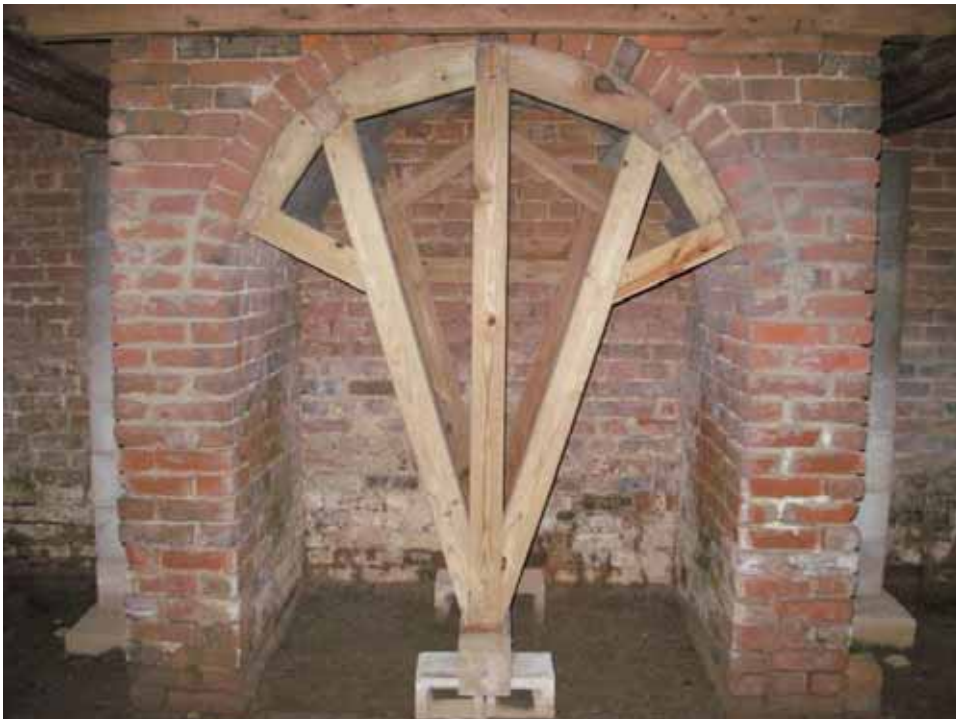
Figure 36. Photograph of the east room wooden reinforced arched brick chimney support on the east wall of the 1722 block of the Abel and Mary Nicholson house. (Source: A. Aiken; taken 2/23/2007.)

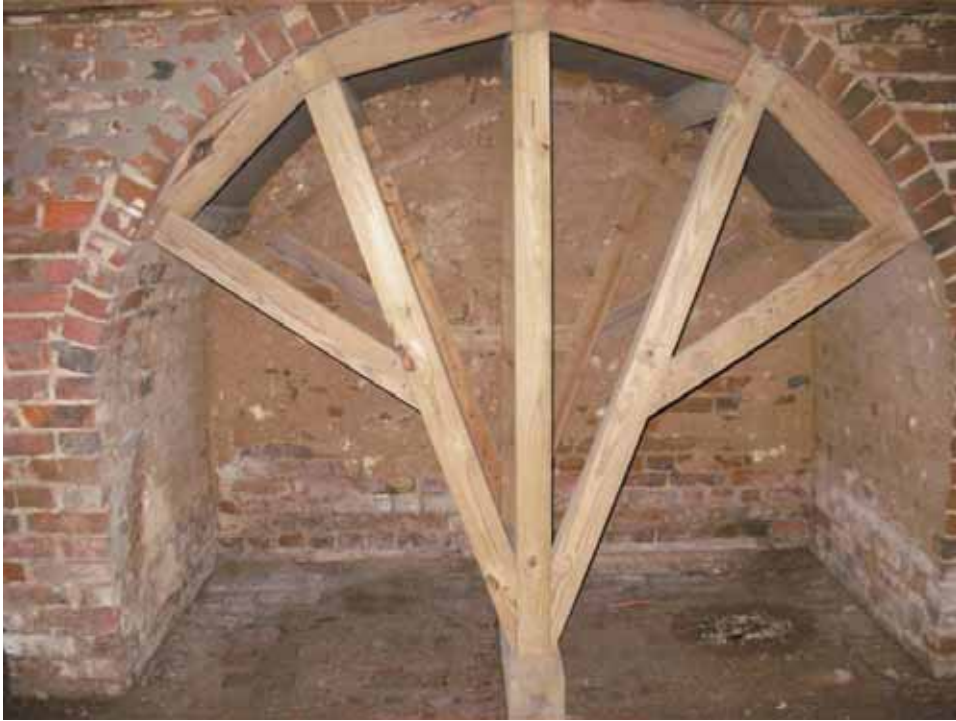
Figure 37. Photograph of the west room wooden reinforced arched brick chimney support on the west wall of the 1722 block of the Abel and Mary Nicholson house. (Source: A. Aiken; taken 2/23/2007.)

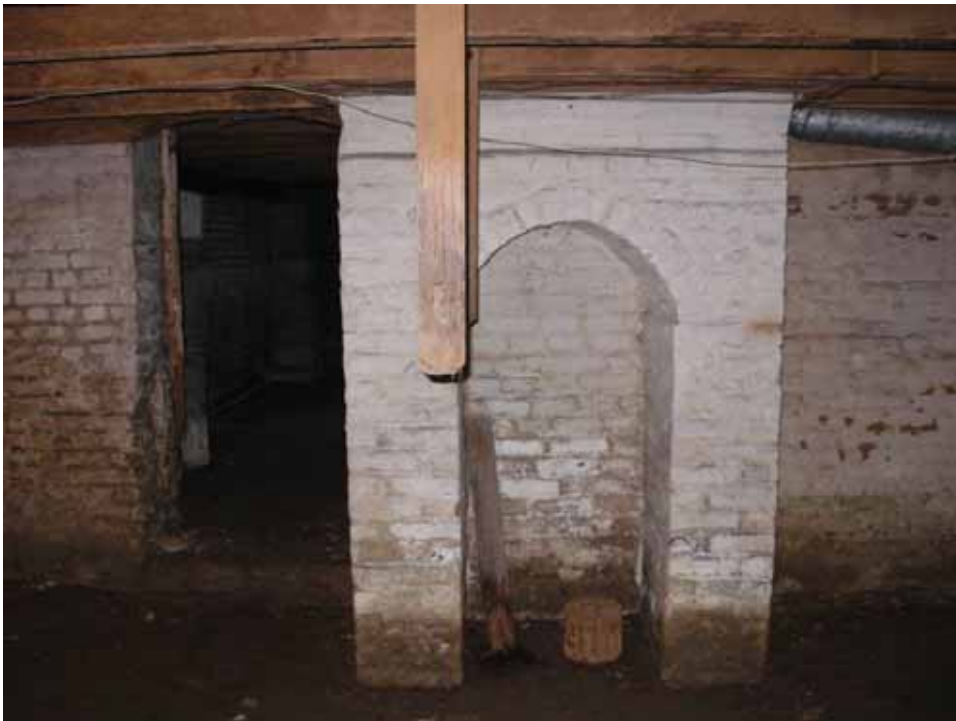
Figure 38. Photograph of the east room arched brick chimney support on the east wall of the 1859 block of the Abel and Mary Nicholson house. (Source: A. Aiken; taken 2/23/2007.)

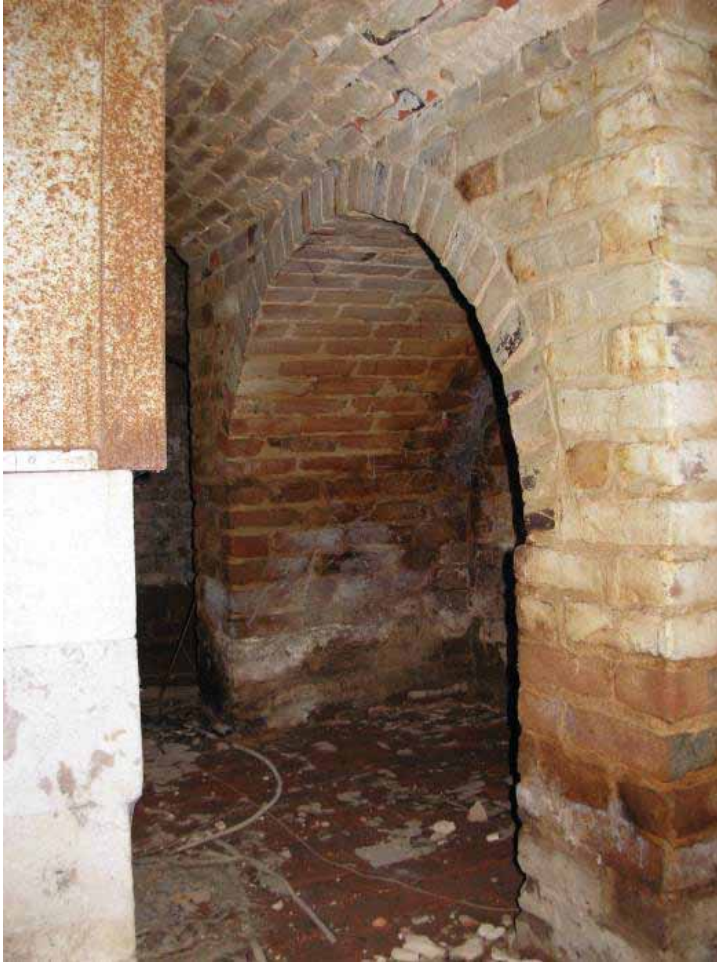
Figure 39. Photograph of the west room arched brick chimney support on the west wall of the 1859 block of the Abel and Mary Nicholson house. (Source: A. Aiken; taken 2/23/2007.)

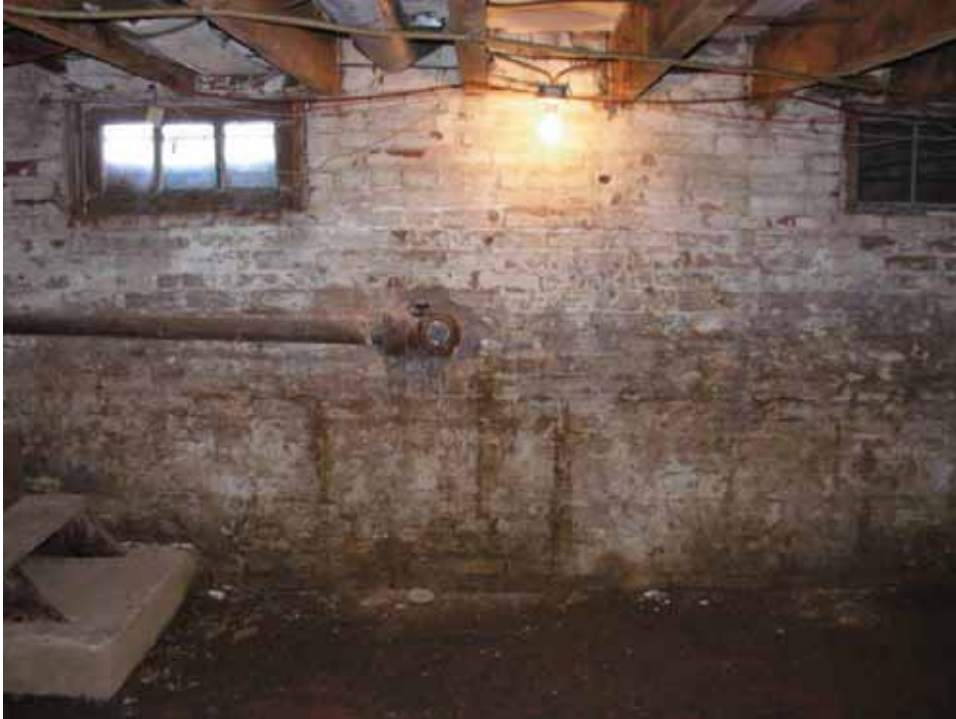
Figure 40. Photograph of the fading whitewash coating on the north wall of the 1859 block east room of the Abel and Mary Nicholson house. (Source: A. Aiken; taken 2/23/2007.)

(Figure 40). This white coat has faded in some areas of both building campaigns. It is believed that the depth of the building foundations, although presently unknown, may lie relatively close to the water table, since historically builders tended to start constructing the building's foundations right above the water table level.

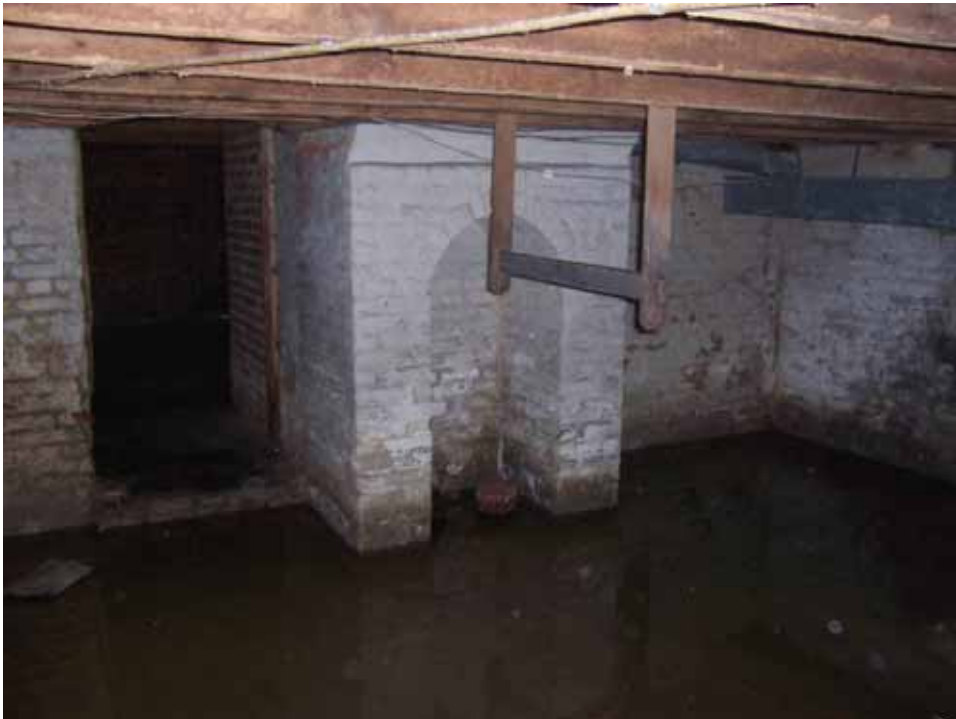
Figure 41. Photograph of the flooded cellar from the cellar staircase, looking into the 1859 block east room of the Abel and Mary Nicholson house. (Source: A. Aiken; taken 10/12/2006.)

The cellar is in poor condition overall. Although the brickwork appears to be very durable with time, the cellar walls still have significant evidence of deterioration. On a site visit in mid-October 2006, following a heavy rainstorm, the basement was found flooded (Figure 41) and the sump pump was not working, although it has since been replaced. The cellar is apparently prone to flooding due to poor surface water drainage. On a site visit in early February 2007, following a snowfall, the basement was not flooded but instead was experiencing below-freezing temperatures that froze the exposed soil and left several small blocks of ice on the material fabric. On another site visit at the end of February 2007, a pool of water was found in the interior southeast corner of the 1722 building (Figure 42). The brick courses at the bottom of the cellar walls were typically damp to touch, laden with heavy water staining (Figure 43), and were typically more friable and deteriorated than any other parts of the walls. On the exterior wall near the ground level the mortar joints are typically eroded and cracked and the bricks are often broken and experiencing green staining (Figure 44). A typical condition that is found in the basement is the dark or white discoloration of the brick in the lower part of the wall near the ground, which is found in both building campaigns (Figure 45) and (Figure 46). In some cases a distinguished, horizontal line of white deposits that runs along the entire width at about mid-height of the interior cellar (Figure 47). The line of

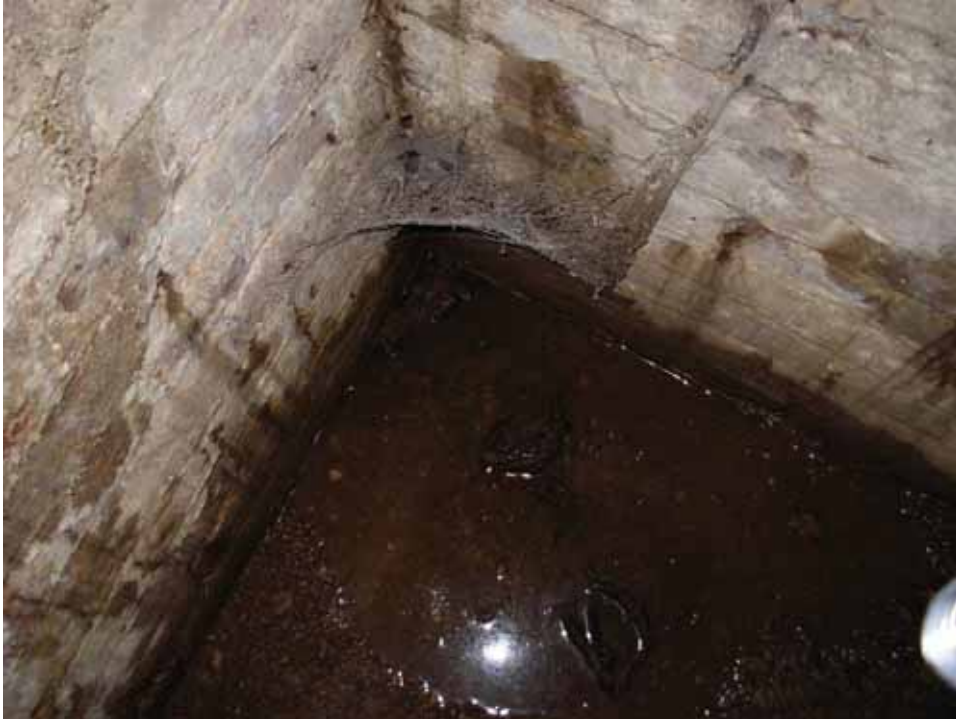
Figure 42. Photograph of the pool of water found at the southeast corner of the 1722 block east room of the Abel and Mary Nicholson house. (Source: A. Aiken; taken 2/23/2007.)

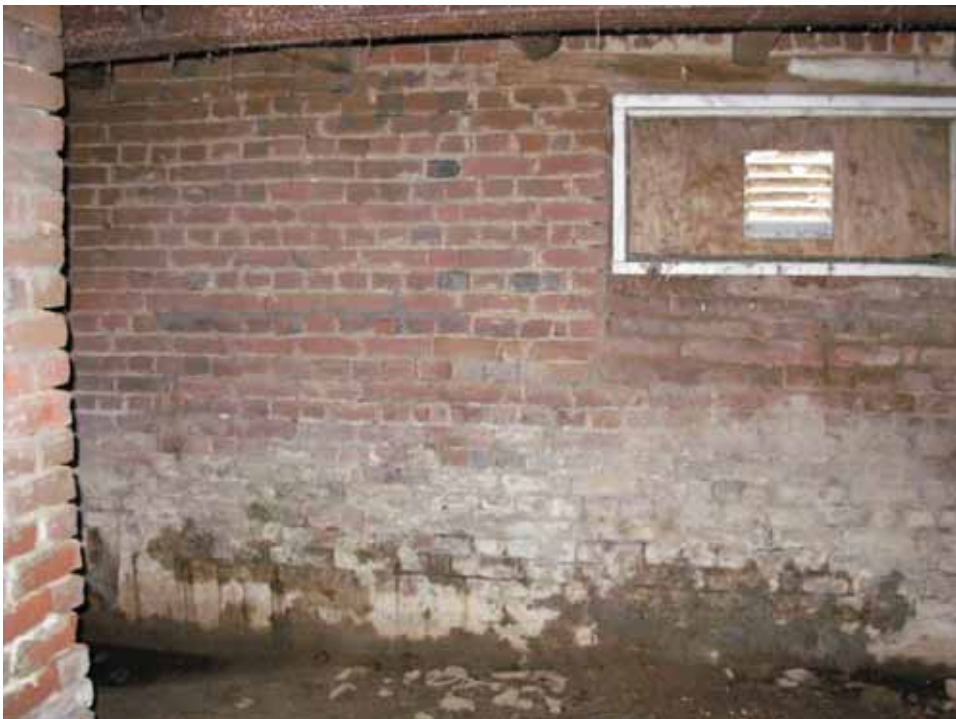
Figure 43. Photograph of the damp water staining at the bottom of the south wall of the east room in the 1722 block of the Abel and Mary Nicholson house. (Source: A. Aiken; taken 2/23/2007.)

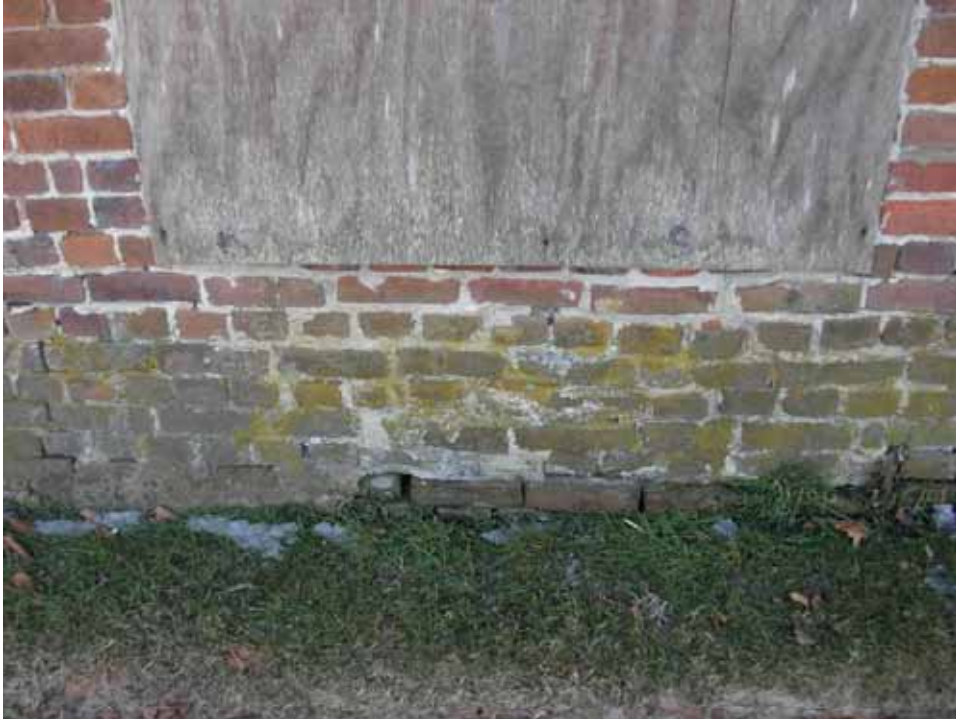
Figure 44. Photograph of the green staining and poor brick and mortar conditions at the bottom, east corner of the north facade of the 1722 block of the Abel and Mary Nicholson house. (Source: A. Aiken; taken 2/23/2007.)

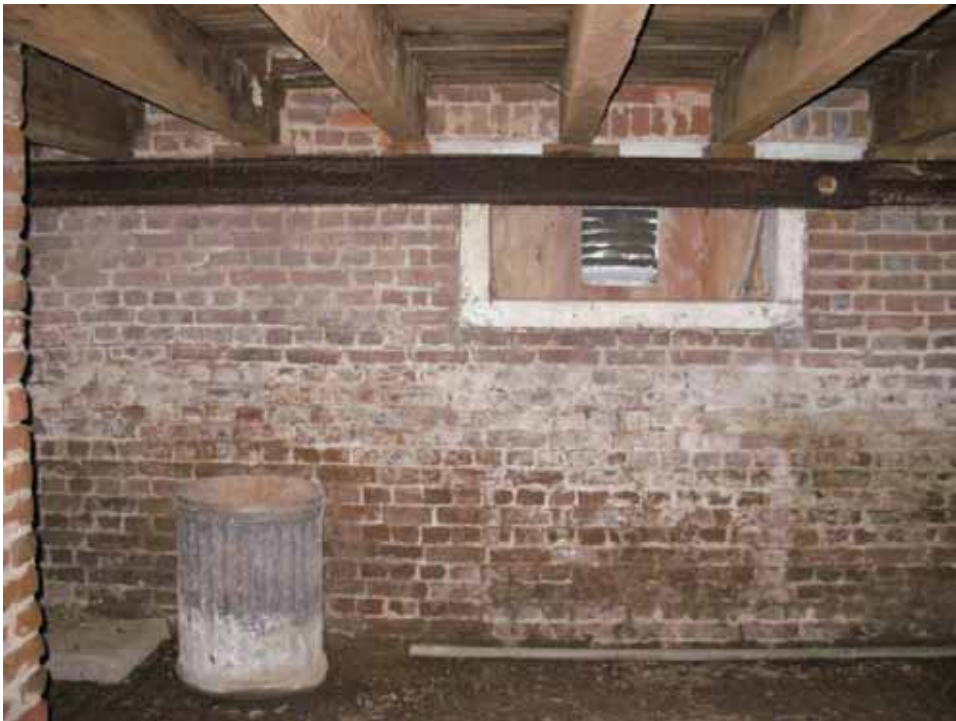
Figure 45. Photograph of the dark discoloration of the north brick cellar wall near the ground of the 1722 block west room of the Abel and Mary Nicholson house. (Source: A. Aiken; taken 2/23/2007.)

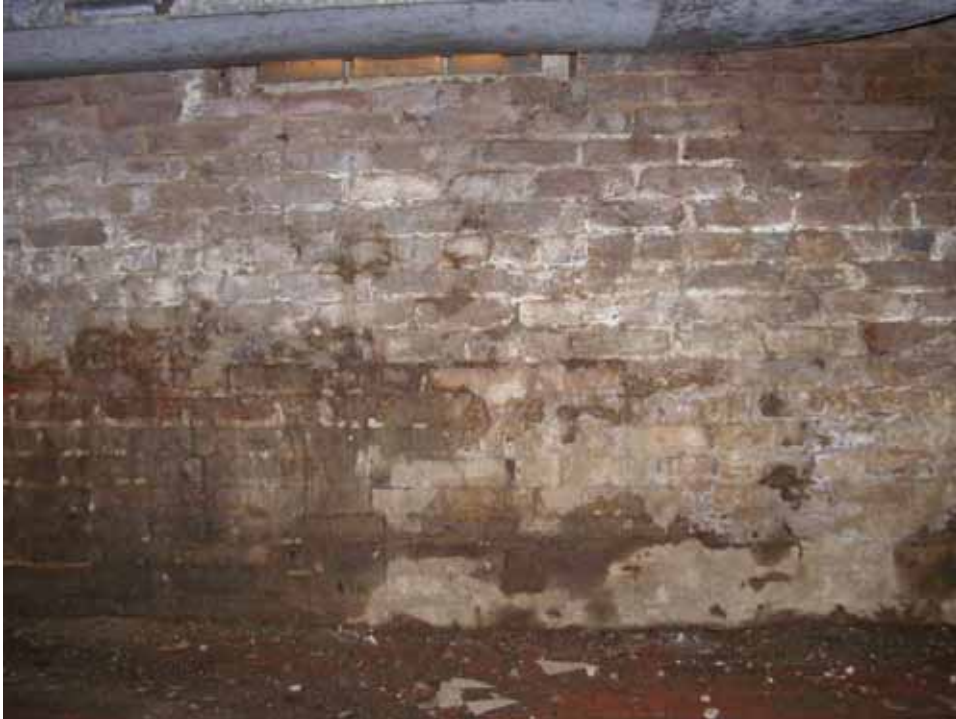
Figure 46. Photograph of the discoloration of the south brick cellar wall next to the water staining, near the ground of the 1859 block west room of the Abel and Mary Nicholson house. (Source: A. Aiken; taken 2/23/2007.)

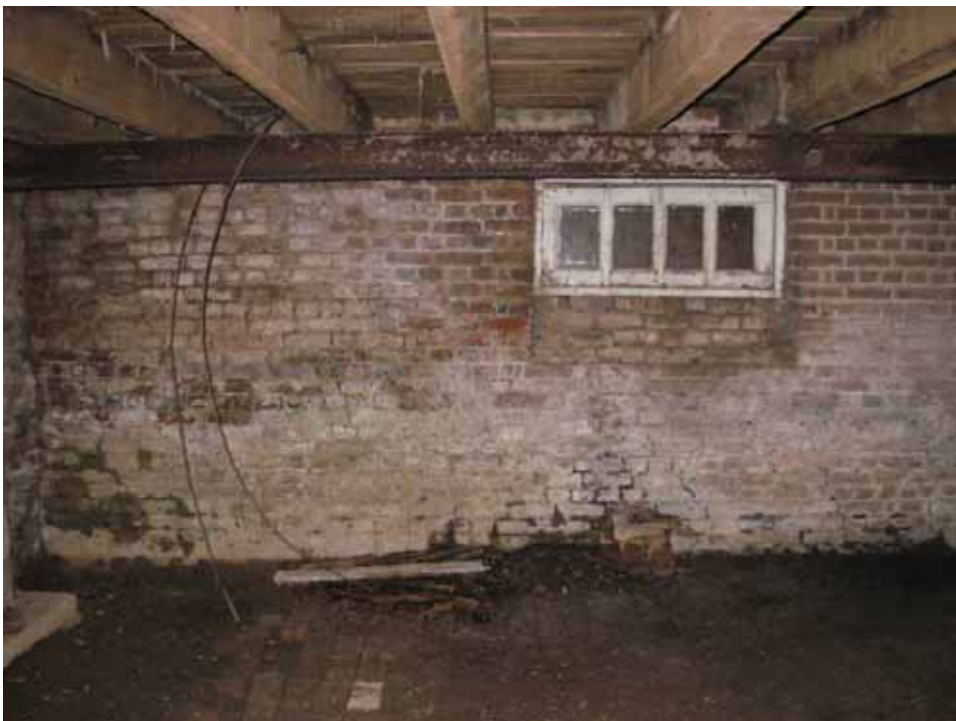
Figure 47. Photograph of the white discoloration of the south brick cellar wall near the ground and under the window of the 1722 block west room of the Abel and Mary Nicholson house. (Source: A. Aiken; taken 2/23/2007.)

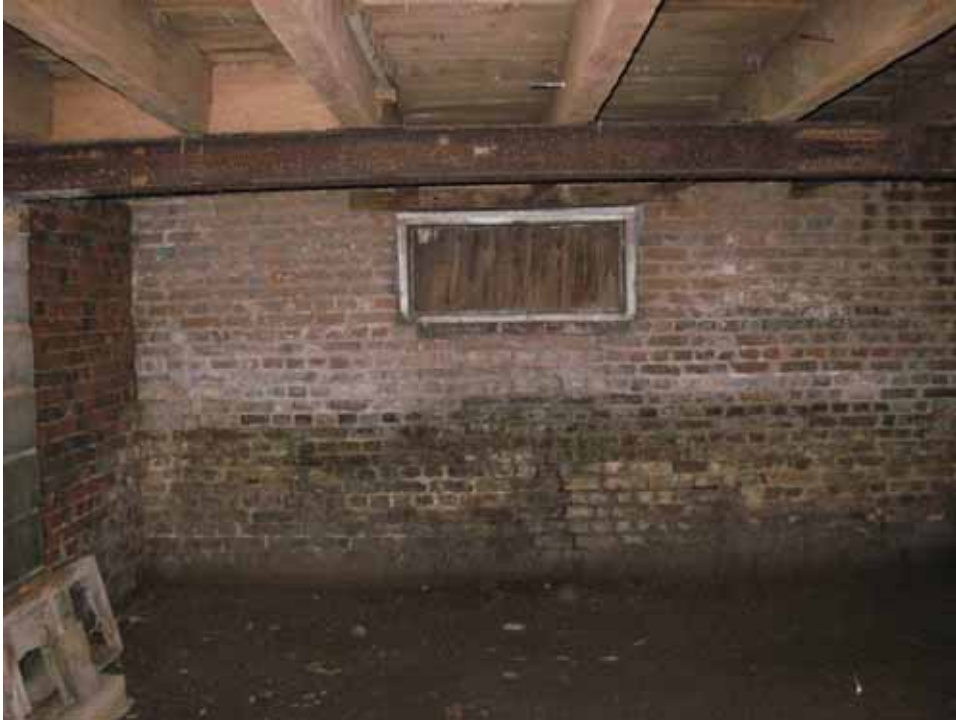
Figure 48. Photograph of the north cellar wall in the east room of the 1722 block of the Abel and Mary Nicholson house. (Source: A. Aiken; taken 2/23/2007.)

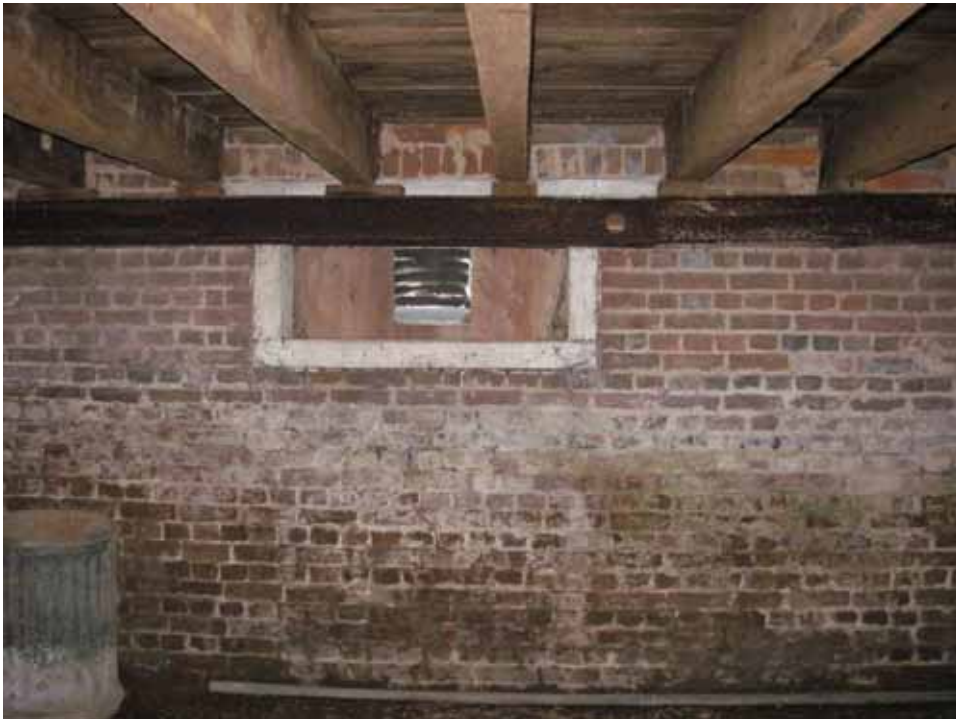
Figure 49. Photograph of the north cellar wall in the west room of the 1722 block of the Abel and Mary Nicholson house. (Source: A. Aiken; taken 2/23/2007.)

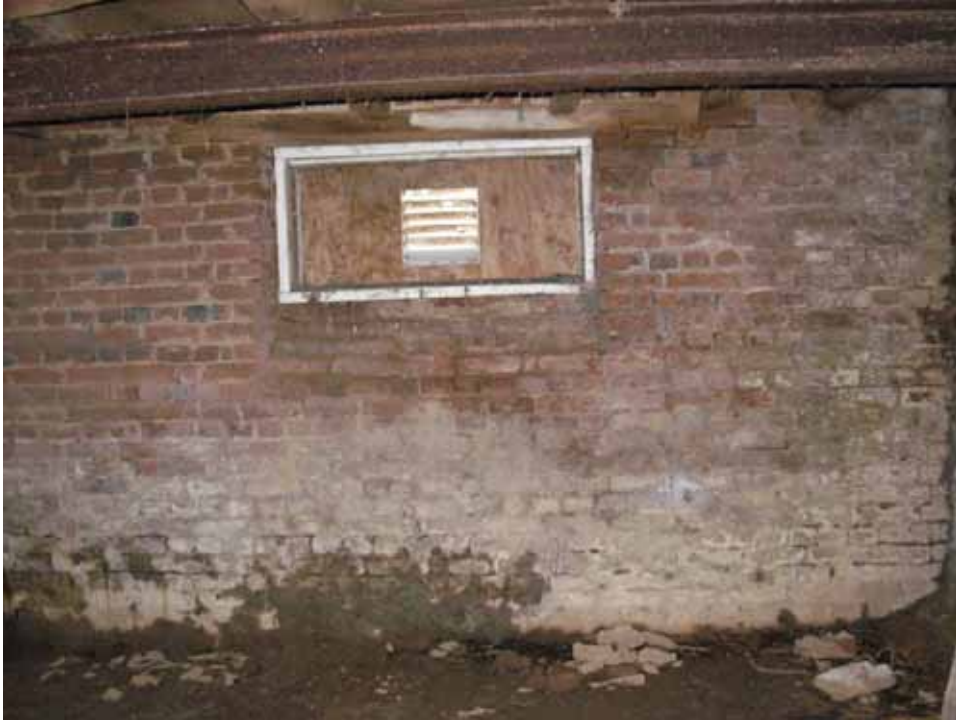
Figure 50. Photograph of the south cellar wall in the east room of the 1722 block of the Abel and Mary Nicholson house. (Source: A. Aiken; taken 2/23/2007.)
