Evaluating the Threat of Environmental Change on Historic Resources: A Case Study and Assessment of Tools

A thesis in Historic Preservation Presented to the Faculties of the University of Pennsylvania in Partial Fulfillment of the Requirements of the Degree of Master of Science in Historic Preservation 2007.

4.3 Existing Conditions	56
4.3.1 Site Observations and Building Context	56
4.3.2 Description of the Cellar's Existing Conditions	59
4.3.3 Regional Characteristics	63

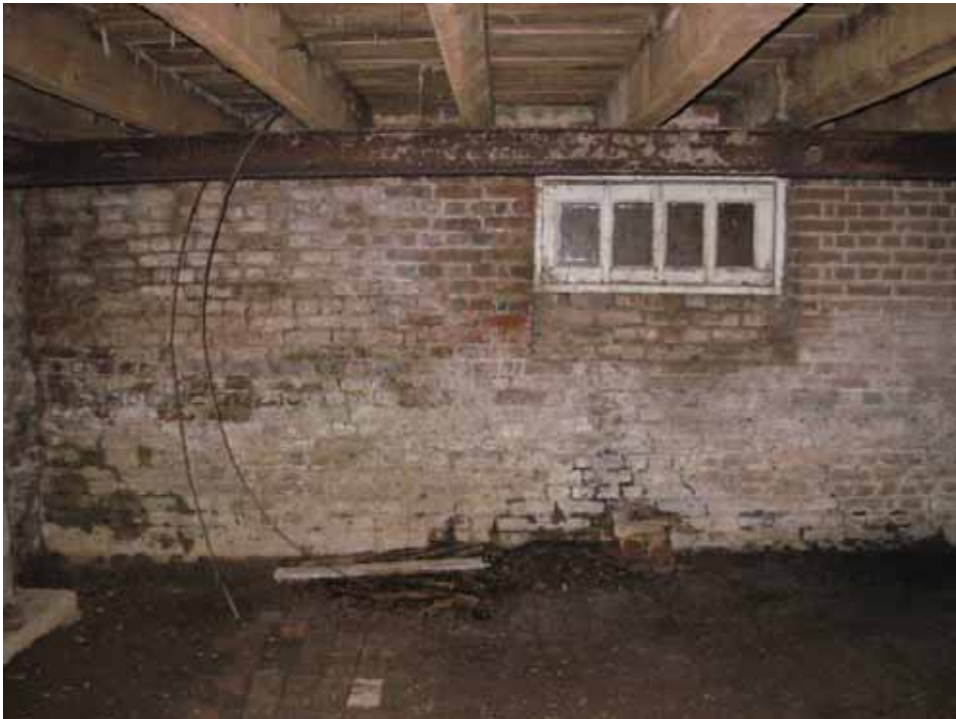
Figure 51. Photograph of the south cellar wall in the west room of the 1722 block of the Abel and Mary Nicholson house. (Source: A. Aiken; taken 2/23/2007.)

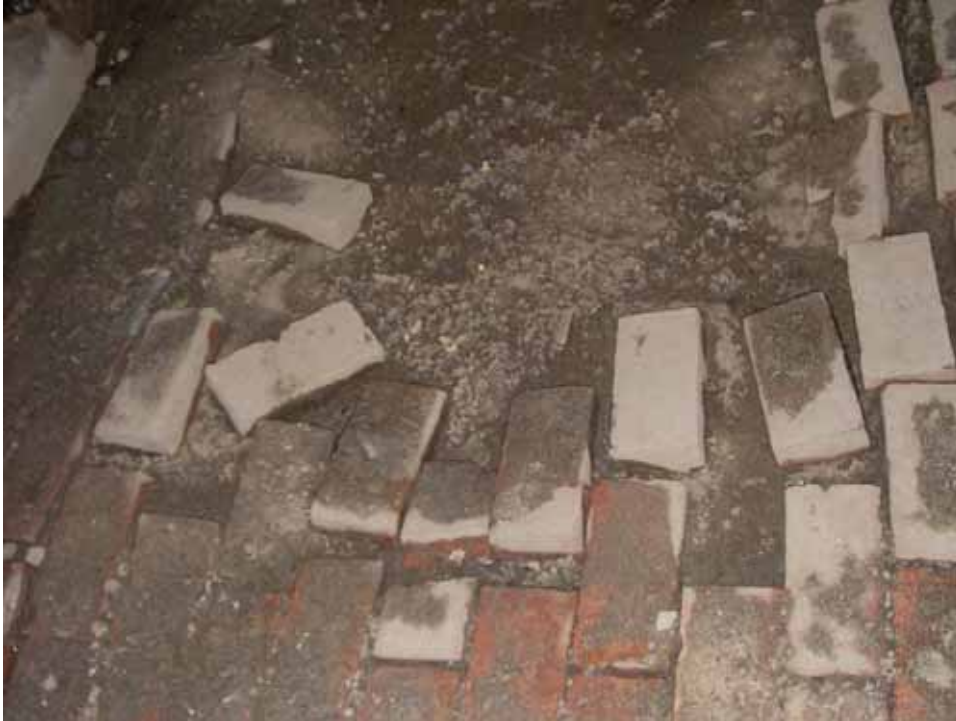
Figure 52. Photograph of the floor in the east corner of the west room of the 1722 addition block of the Abel and Mary Nicholson house. (Source: A. Aiken; taken 2/7/2007.)

running bond brick, although some of the bricks are missing and exposing the soil along the east wall (Figure 52). In the east room of the 1722 block, the entire floor is composed of bare, packed soil. The first floor framing is exposed in both rooms. The joists, which are built into the cellar walls, run 21-inches on center in the west room and 30-inches on center in the east room. Several of the joists are damp to touch and are experiencing moisture-related deterioration. To combat the deflection of the floor joists, two steel I-beams that run east to west in each room have been installed since 1950, and are supported by concrete piers. All of the steel I-beams are corroded. An expired duck (Figure 53) was found on the floor during the first site visit in February 2007, indicating that wildlife is able to enter the house.

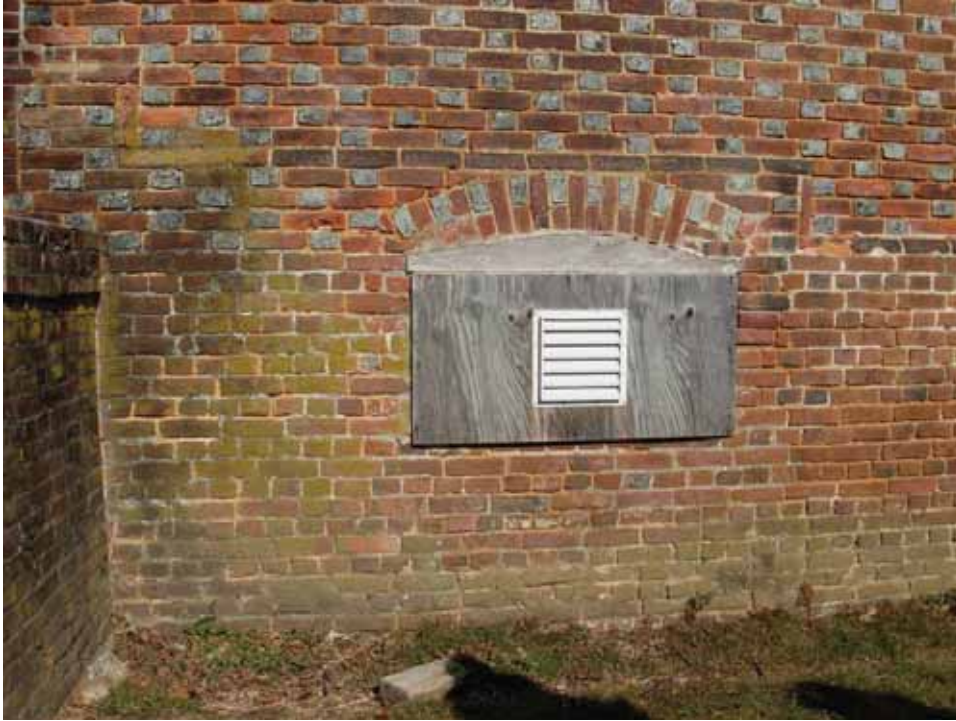
Figure 54. Photograph showing the water table and change in brick coursing on the east end of the south façade of the 1722 block of the Abel and Mary Nicholson house. (Source: A. Aiken; taken 2/23/2007.)

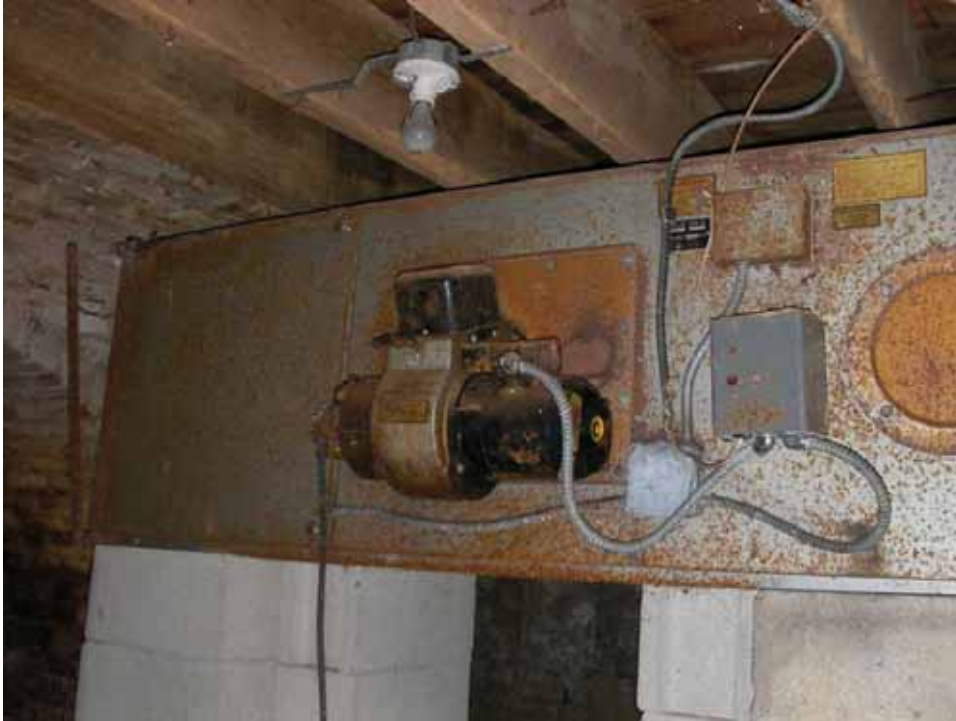
Figure 60. Photograph of the mechanical equipment in the west room of the 1859 addition block of the Abel and Mary Nicholson house. (Source: A. Aiken; taken 2/23/2007.)

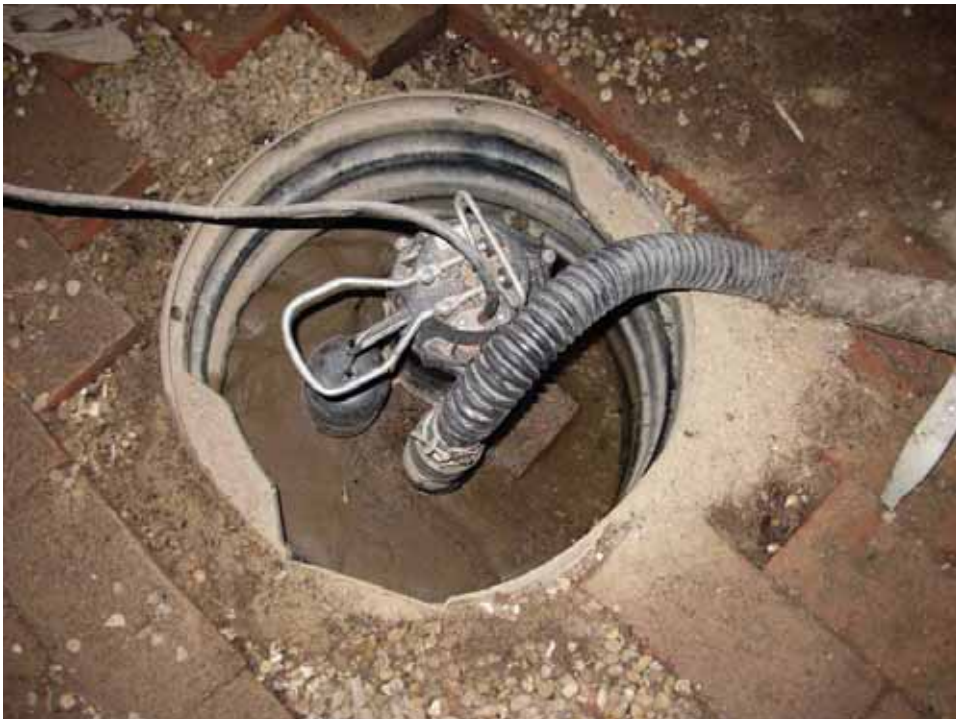
Figure 61. Photograph of the water pump in the west room of the 1859 addition block of the Abel and Mary Nicholson house. (Source: A. Aiken; taken 2/23/2007.)

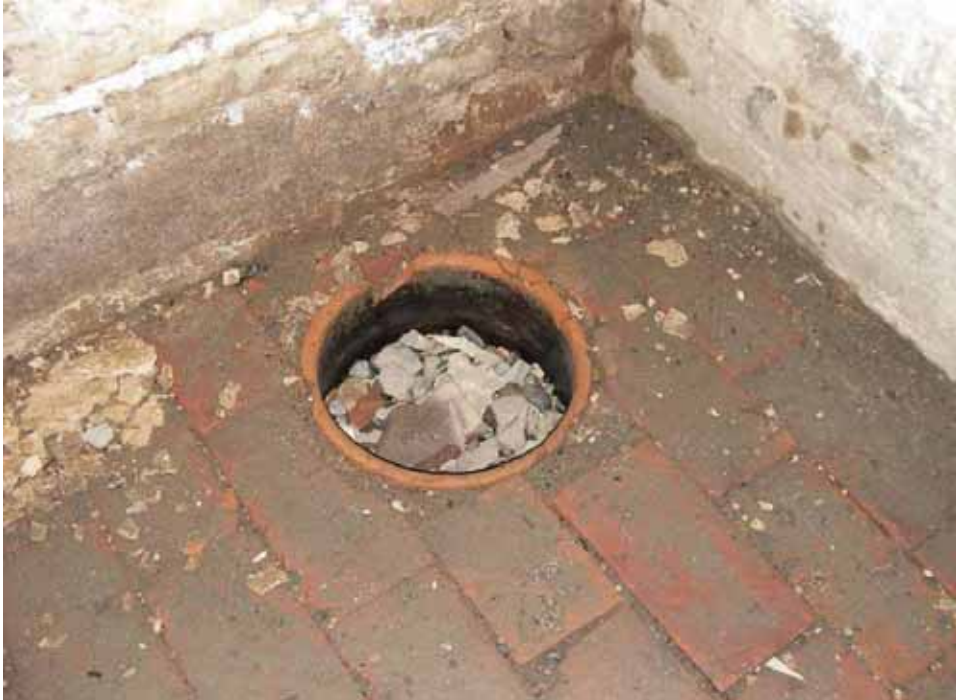
Figure 62. Photograph of a red cylindrical pipe possibly intended for drainage in the east room of the 1859 addition block of the Abel and Mary Nicholson house. (Source: A. Aiken; taken 2/7/2007.)

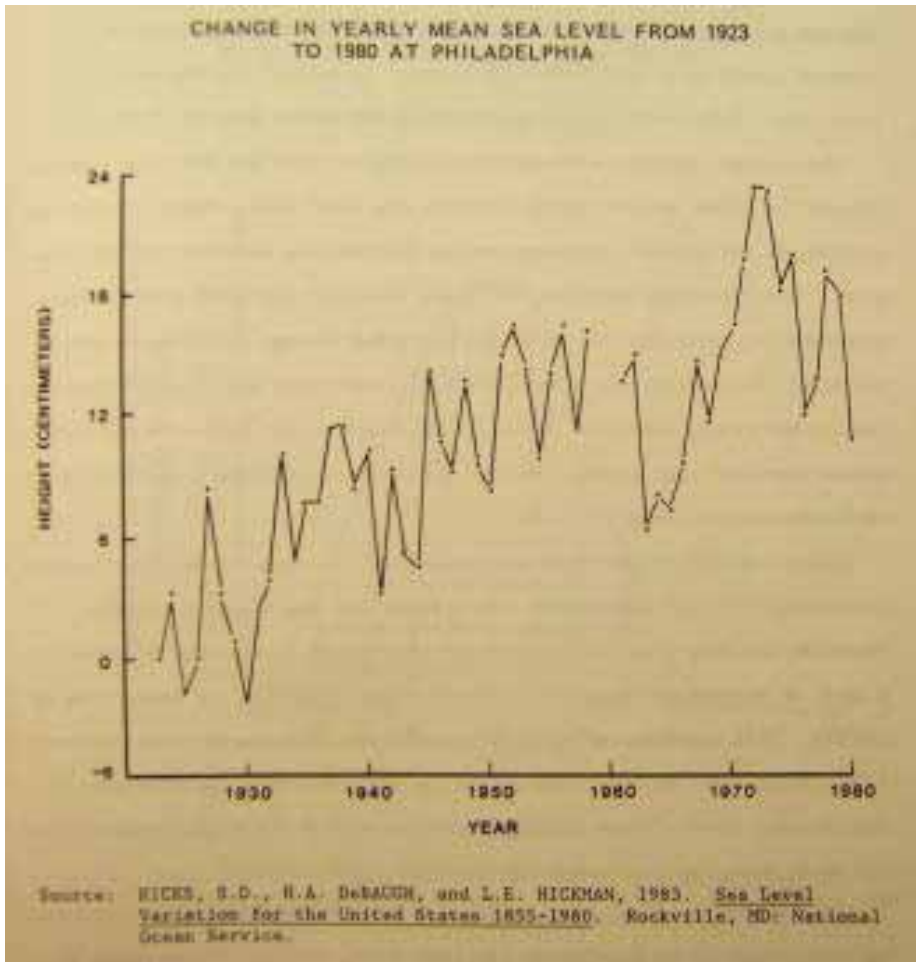
Figure 65. Graph of mean sea level change in Philadelphia over several decades. (Source: *Greenhouse Effect, Sea Level Rise, and Salinity in the Delaware Estuary*.)

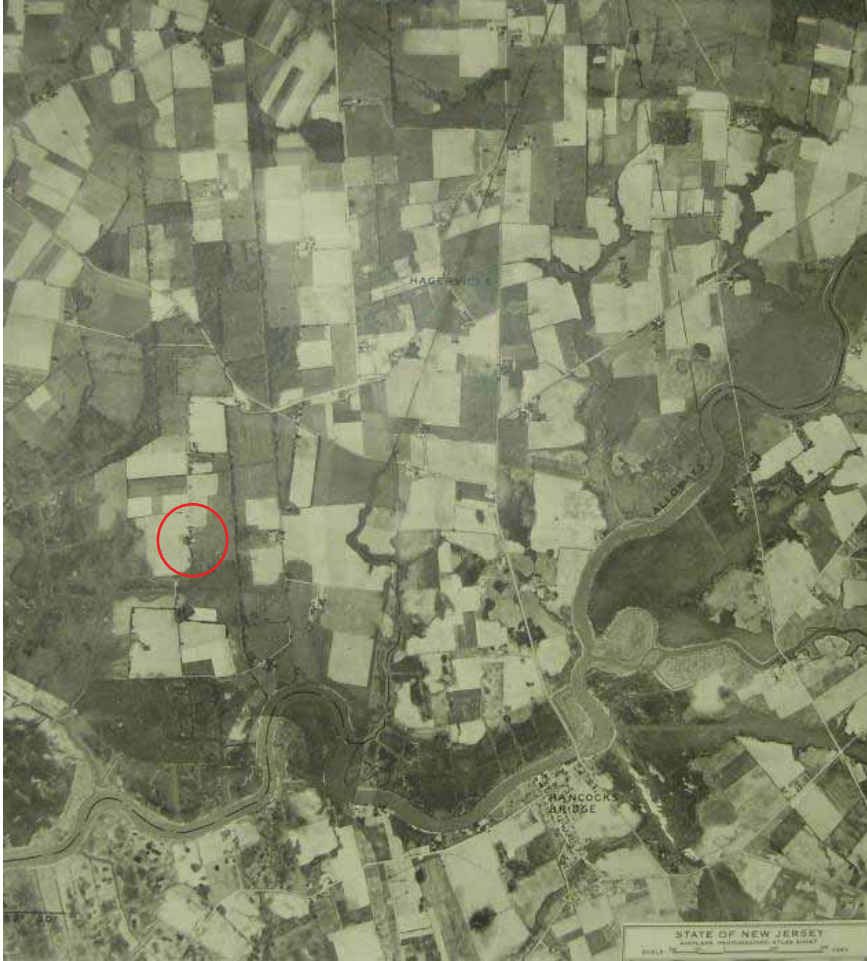
Figure 68. 1932 Aerial photograph of the region surrounding the Abel and Mary Nicholson House (circled). (Source: New Jersey State Department of Environmental Protection: Bureau of Tidelands Management, Trenton, NJ.)

There was a scale on a 1932 aerial photograph (Figure 68) and (Figure 69) of the area surrounding the Nicholson house, which was found in the Aerial Photography Library of the Bureau of Tidelands Management, a sector of the New Jersey state Department of Environmental Protection. There were also stereoscopic aerial photographs of the region taken on January 1, 1940 in the Aerial Photography Library. The stereoscopic aerial photographs were in the form of transparent frames and are intended to be used with a stereoscope, in order to view the three-dimensional qualities of the site's terrain and structures. This state department typically charges a \$100 viewing fee for pulling the aerial footage, which may be waived for the property owner or representative of the property owner who is only looking at the owner's property. The fee may also be waived if this information is intended for a non-profit organization, but both of these special conditions have to be brought to the attention of the department during the application

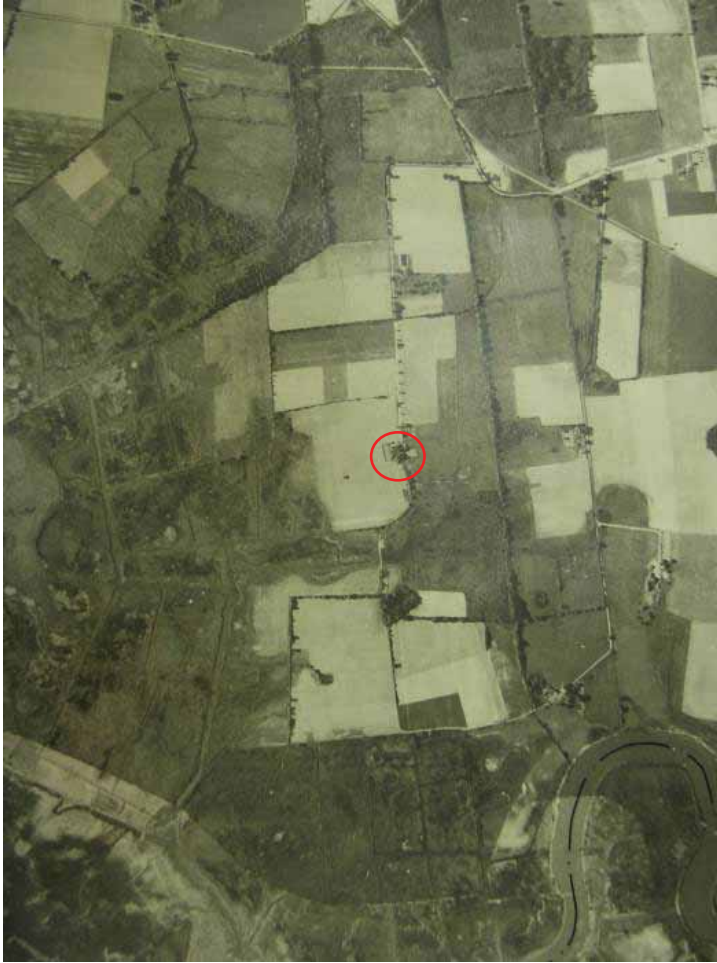
Figure 69. Close-up of 1932 Aerial photograph of the region surrounding the Abel and Mary Nicholson House (circled). (Source: New Jersey State Department of Environmental Protection: Bureau of Tidelands Management, Trenton, NJ.)

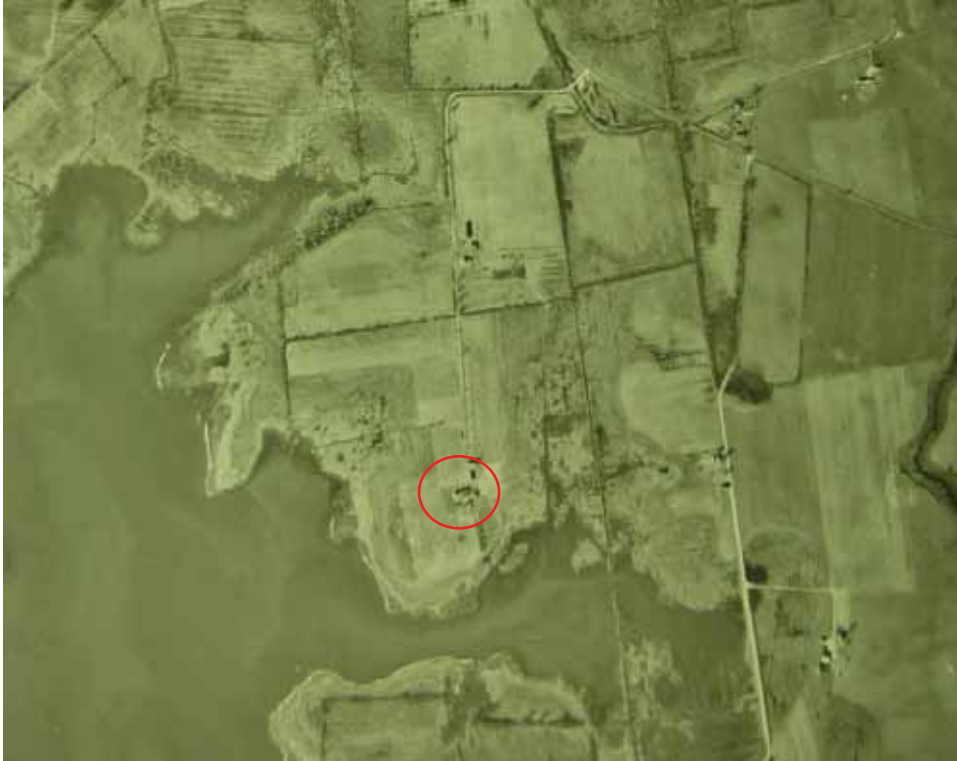
Figure 70. Zoomed view of 1940 Stereoscopic aerial photograph (Frame 8-62) of the region surrounding the Abel and Mary Nicholson House (circled). (Source: New Jersey State Department of Environmental Protection: Bureau of Tidelands Management, Trenton, NJ.)

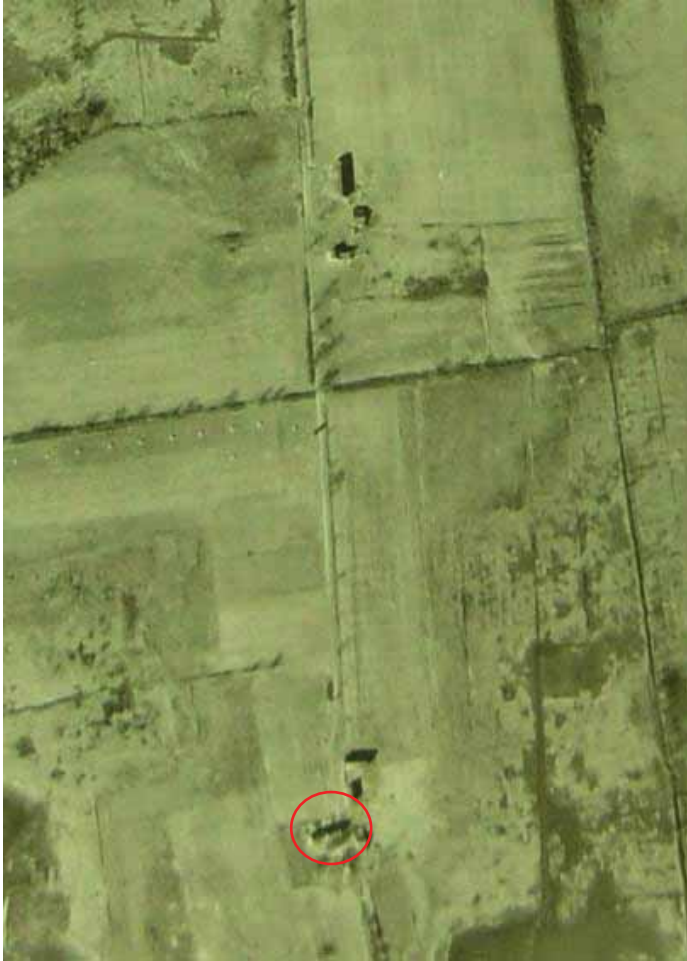
Figure 71. Close-up of zoomed view of 1940 Stereoscopic aerial photograph (Frame 8-62) of the region surrounding the Abel and Mary Nicholson House (circled). (Source: New Jersey State Department of Environmental Protection: Bureau of Tidelands Management, Trenton, NJ.)

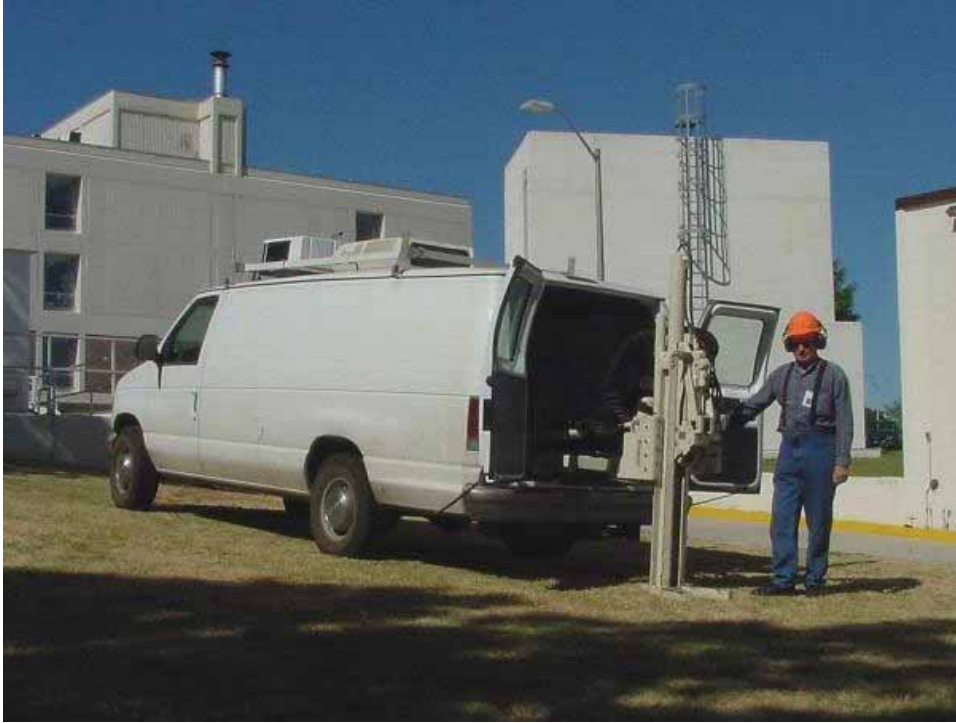
Figure 80. Photograph of Geoprobe Van. (Source: www.epa.gov).

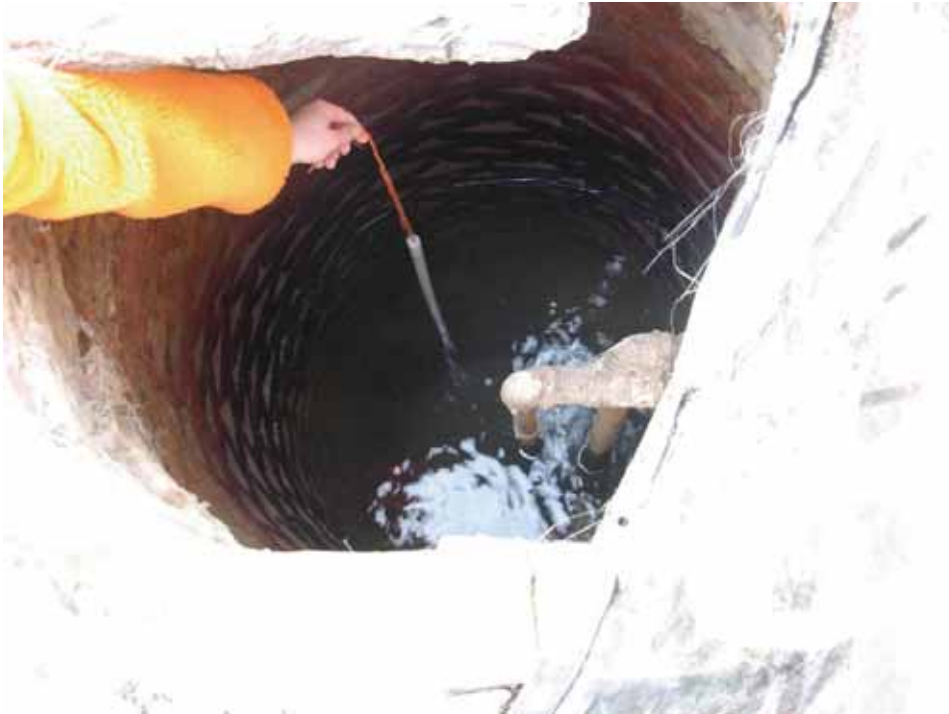
Figure 83. Photograph of bailer sampling of the existing well near the south elevation of the Abel and Mary Nicholson house. (Source: A. Aiken; Taken 3/8/2007.)

Another method of well water sample collection is through the use of bailers. Bailers are containers used to remove water out of a well. They are dropped into a well and into the well water and hung from a stainless steel wire. The bailers are then bobbed up and down to ensure a representative sample and removed. A ball is located at the bottom of the bailer and floats up when surround by water to let the water into the container. The ball falls back into place, sealing the container, when it is removed from the well water. Once the bailer is filled with water, it is removed from the well and positioned over the containers. A small pipe is inserted into the bottom of the bailer, moving the ball, and releasing the well water sample into the container. When pouring, the water should be allowed to overflow the containers to maximize the mixing of the sample.²⁴¹ Photographs from the bailer well water sampling of the existing well on the Abel and Mary Nicholson house site are shown in (Figure 83) and (Figure 84). In general, bailers are fairly inexpensive. Reusable bailers typically are sold for \$80/each and disposable bailers, used on the Nicolson house existing well, are sold for under \$5/each. Bailer rope typically costs \$0.05/foot. Bailers are typically less than 2-inches in diameter in order to fit in standard monitoring wells.

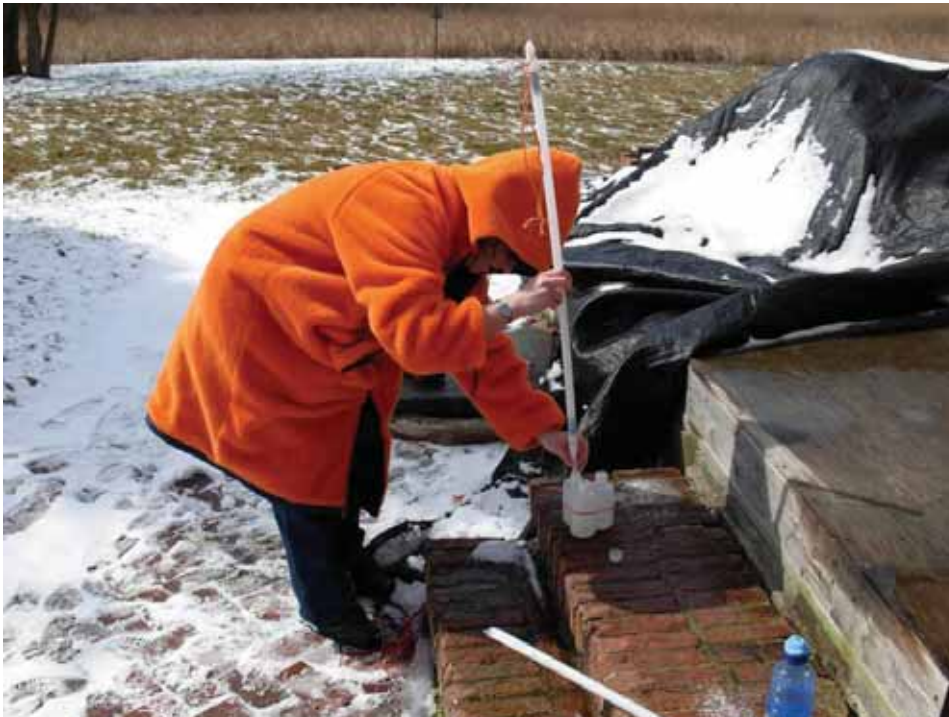
Figure 84. Photograph of transferring the well water sample from the bailer to the containers nearby the source well on the south elevation of the Abel and Mary Nicholson house. (Source: A. Aiken; Taken 3/8/2007.)

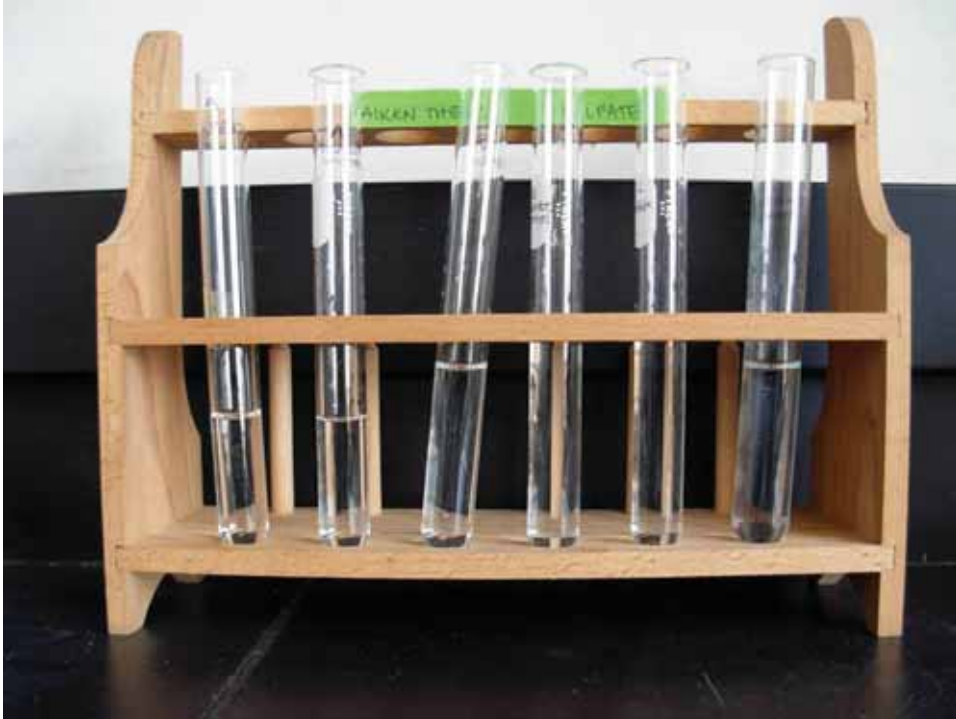
Figure 85. Photograph of the sulfate salt ion laboratory test results of the water taken from the existing well on the Abel and Mary Nicholson house property. (Source: A. Aiken; Taken 3/22/2007.)

were taken from the same well water to ensure the quality of the results. All of the samples were subjected to salt ion spot tests and pH testing. Salt ion strip testing for the concentration of a particular salt ion was only performed once the salt ion spot tests were completed and the presence of various salt ions was confirmed or not. The salt ion spot tests were completed according to the laboratory procedure found in Appendix D. The three well water samples were tested for the following salt ions: sulfates (Figure 85), chlorides (Figure 86), carbonates (Figure 87), nitrites (Figure 88) and nitrates (Figure 89).

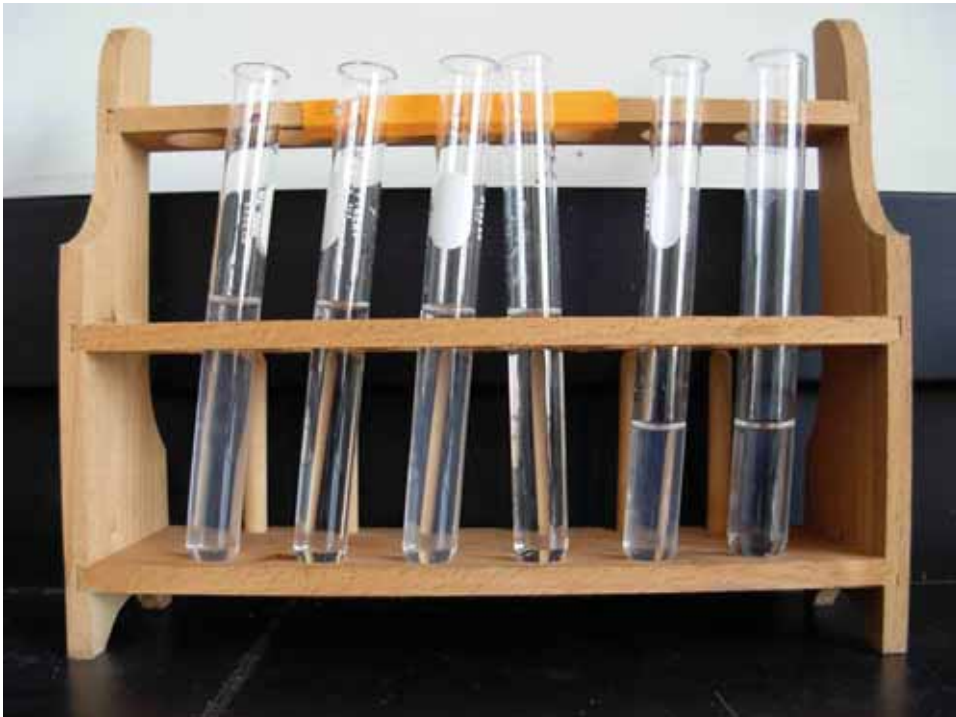
Figure 86. Photograph of the chloride salt ion laboratory test results of the water taken from the existing well on the Abel and Mary Nicholson house property. Notice the difference in clarity between the well water and the control. (Source: A. Aiken; Taken 3/22/2007.)

The results of the tests can be found in (Table 5). The three well water samples only tested positive for chlorides by emitting a whitish/blue precipitate when exposed to the chemical compound indicators. The laboratory procedures for the pH and chloride strips were carried out as specified on the packaging. Two different pH tests were performed; one that specified a range of pH values from 1 to 14 and another that was more precise and ranged from 6.0 – 8.1. Based on the first test, the pH of the samples appeared to agree at a value of 7 (Figure 90). In the second test, the pH of the samples appeared to agree at a value of either 6.6 or 7.2 (Figure 91). Since the samples only tested positive for chlorides, the chloride salt ion strips were the only salt ion strips used. According to the chloride strip results and key, all the samples have no salt concentration (Figure 92) and (Figure 93). Since the samples tested positive for chloride under the spot tests, it is likely that the samples do contain chlorides, but perhaps not at levels recognized by the salt strips. Such a low salt concentration necessitates a re-evaluation of the sampling and testing method and the predicted environmental phenomenon. It would be recommended to try another more standard sampling method and to check the effectiveness of the salt

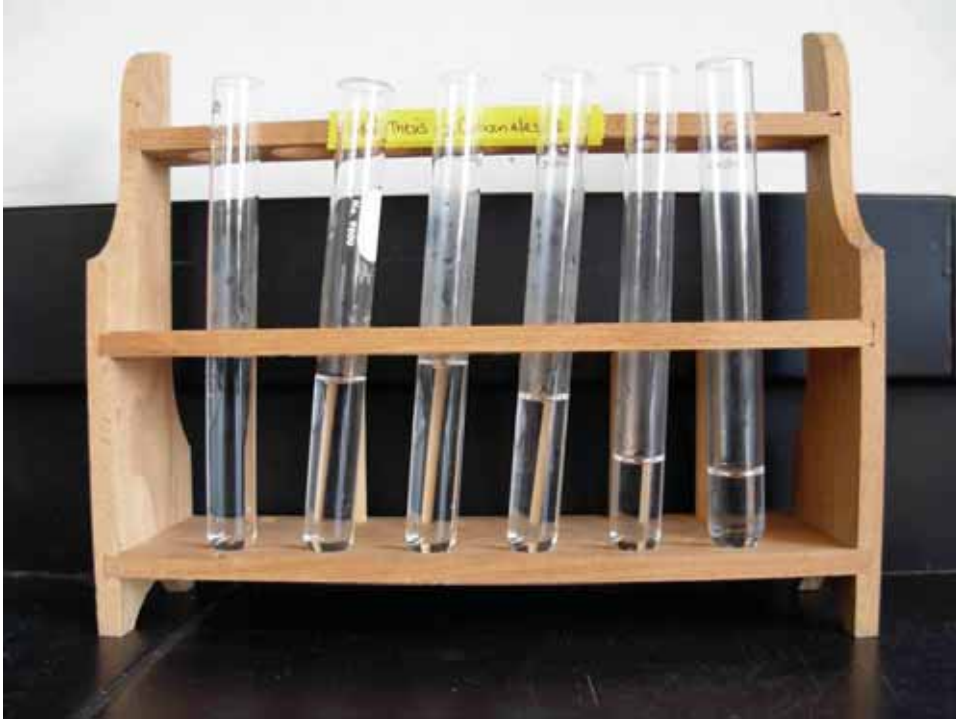
Figure 87. Photograph of the carbonate salt ion laboratory test results of the water taken from the existing well on the Abel and Mary Nicholson house property. (Source: A. Aiken; Taken 3/22/2007.)

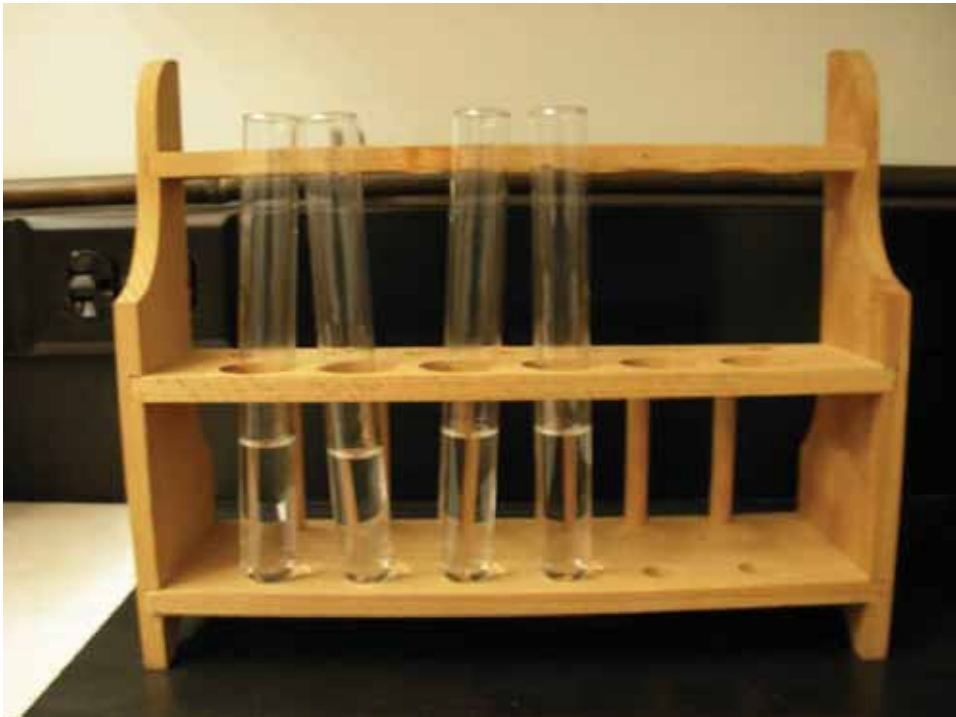
Figure 88. Photograph of the nitrite salt ion laboratory test results of the water taken from the existing well on the Abel and Mary Nicholson house property. (Source: A. Aiken; Taken 4/8/2007.)

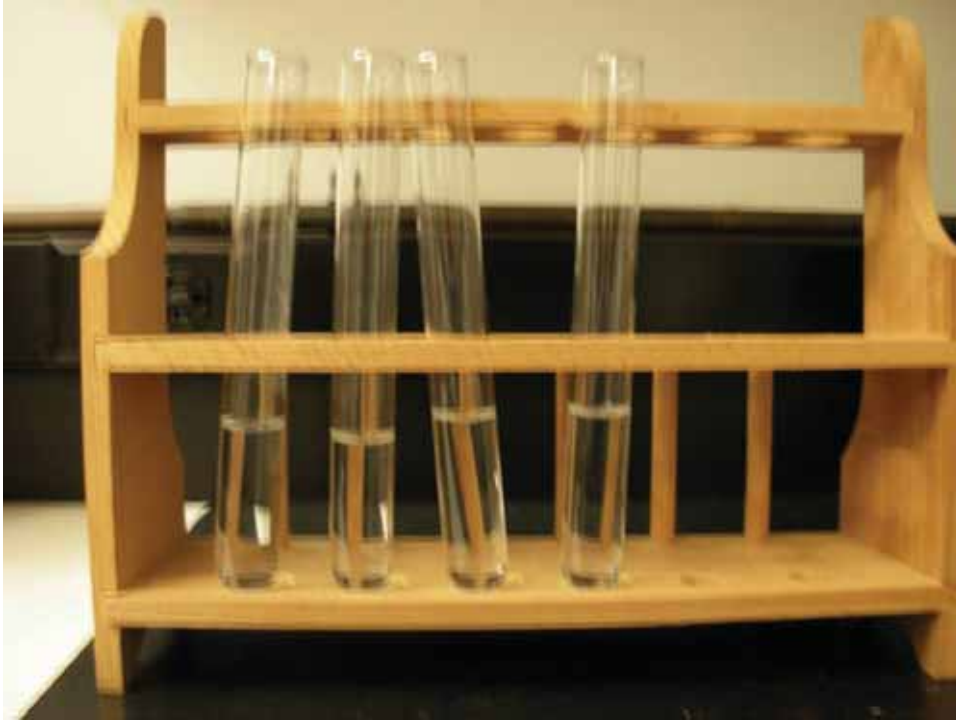
Figure 89. Photograph of the nitrate ion laboratory test results of the water taken from the existing well on the Abel and Mary Nicholson house property. (Source: A. Aiken; Taken 4/8/2007.)

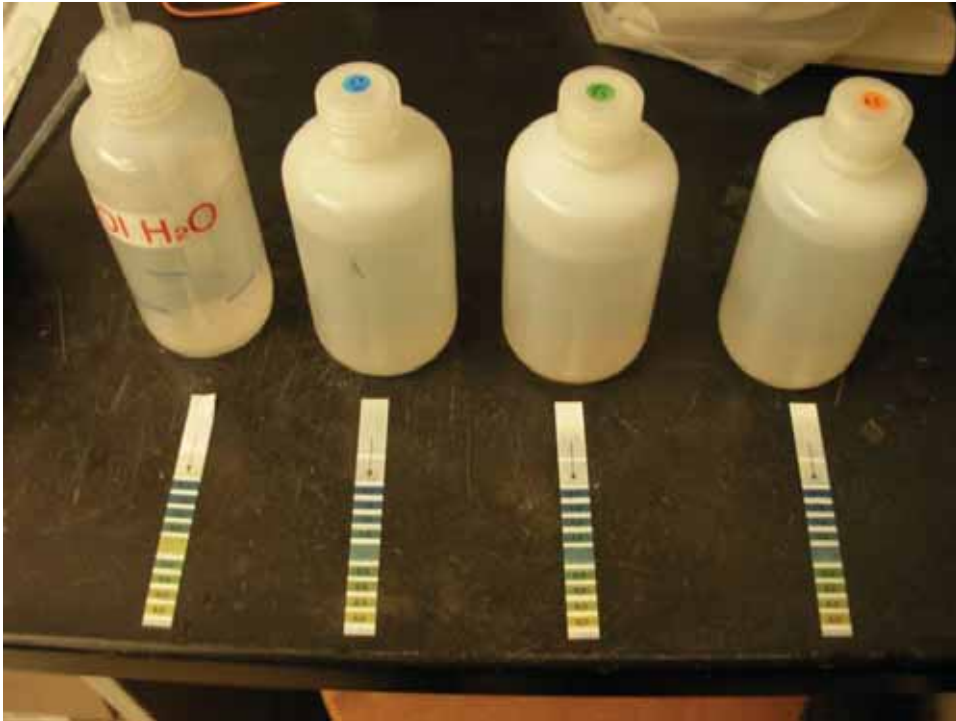
Figure 91. Photograph of a second pH laboratory test results of the water taken from the existing well on the Abel and Mary Nicholson house property. Note the difference in color of the well water strips from the control strip on the far left. (Source: A. Aiken; Taken 4/8/2007.)

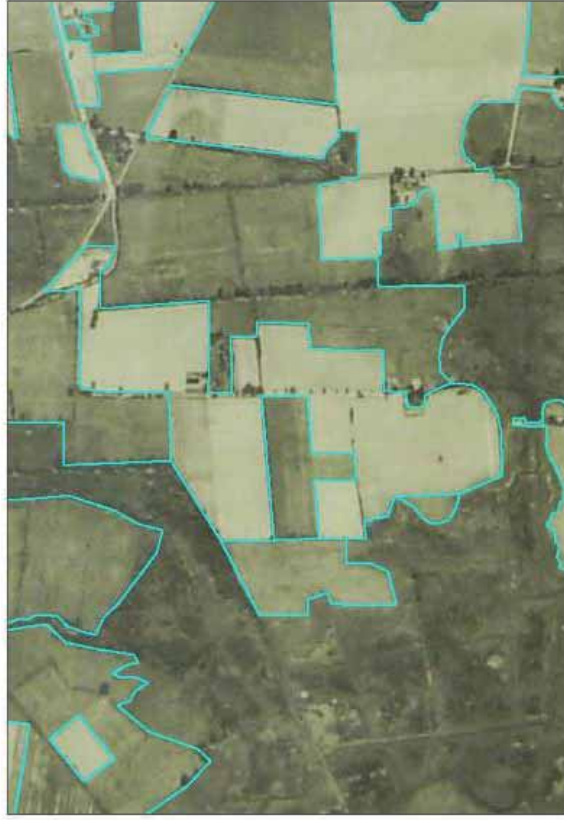
Illustration 1. Aerial Photography Comparison: The Abel and Mary Nicholson House Landscape: Observing Geographic Changes Over a Period of 70 years Using Aerial Photography.

**1932 Aerial Photograph
Bureau of Tidelands Management,
New Jersey Department of Environmental Protection**

**Total Area: 1.00 mi²
Total Light Area: 0.26 mi²
Total Marshland Area: 0.37 mi²
Total Other (Darker) Area: 0.37 mi²**

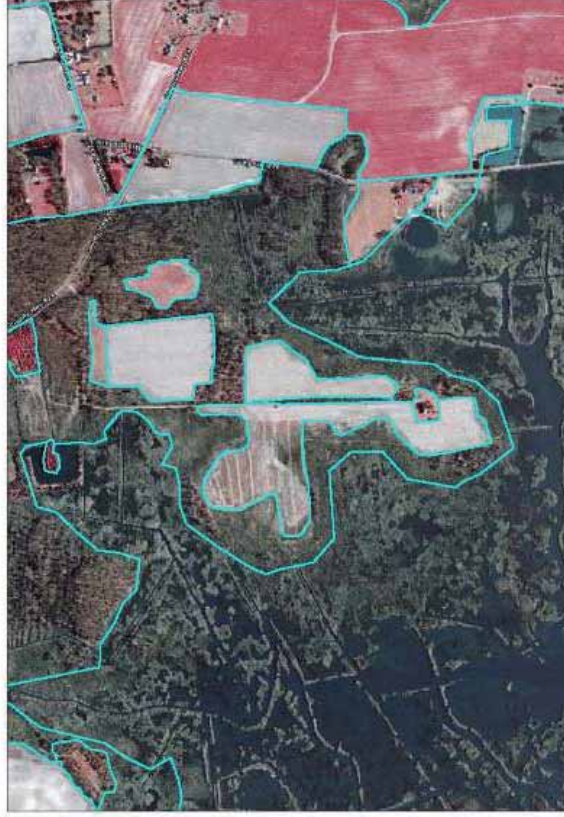
**2002 Aerial Photograph
i-Map NJ
http://www.state.nj.us/dep/gis/imapnj_geolplash.htm
New Jersey Department of Environmental Protection**

**Total Area: 1.00 mi²
Total Light Soil Area: 0.13 mi²
Total Pink-toned Soil Area: 0.18 mi²
Total Marshland Area: 0.47 mi²
Total Other (Darker) Area: 0.22 mi²**

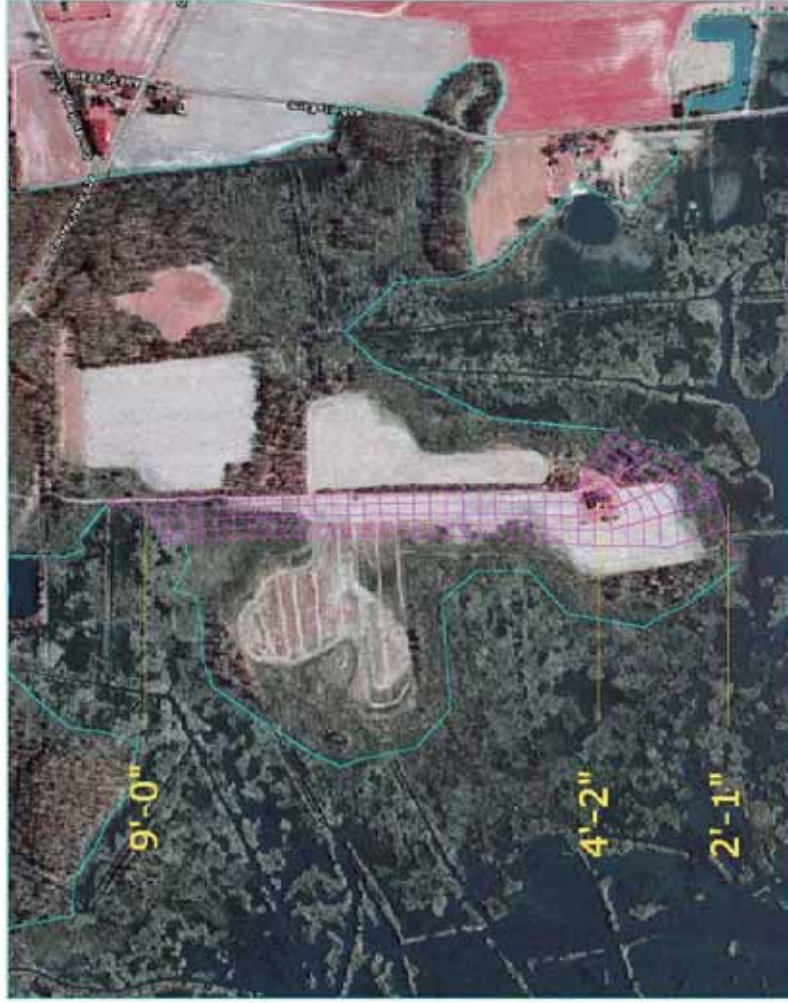
Illustration 2. Possible Flow-net Configuration for the Nicholson site.

Possible Flownet Configuration
